WOOD DESTROYING PESTS AND ORGANISM INSPECTION REPORT

Building No. 12700	Street State Route 1	City Point Reyes Station	ZIP 94956	Date of Inspection 8/7/2020	Number of Pages Page 1 of 29

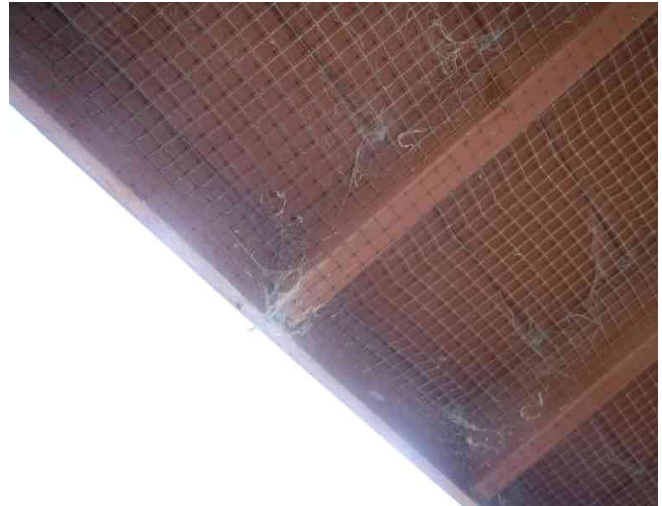
Photo 02

1A. FINDING: Infestation by Drywood Termites was noted at the exterior rafters, patio cover, front deck, attic rafters at the main house and the detached guest house. (See Photo 2) (See Photo 54) (See Photo 94)

1B. FINDING: Drywood termite pellets were evident as noted in the above recommendation. (See Photo 2) (See Photo 55)

1C. FINDING: The rafter tail(s) as indicated on the diagram are damaged by fungus and drywood termites. The contributing moisture source appears to be exposure to the weather. (See Photo 2) (See Photo 6) (See Photo 29)

RECOMMENDATION: Due to the nature of these infestations, it will be necessary to seal the entire structure and fumigate it with Vikane (sulfuryl fluoride), using Chloropicrin as a warning agent. The entire structure must be vacant for this process. It is the owners responsibility to make any preparations required by the fumigators or to have someone to do so at a separate expense and to have the gas turned back on when the fumigation is complete. "NOTICE: The charge for service that this company subcontracts to another registered company may include the company's charges for arranging and administering such services that are in addition to the direct costs associated with paying the subcontractor. You may accept HomeGuard Incorporated's bid or you may contract directly with another registered company licensed to perform the work. If you choose to contract directly with another registered company, HomeGuard Incorporated will not in any way be responsible for any act or omission in the performance of work that you directly contract with another to perform." HomeGuard Incorporated guarantees all fumigations for a period of three years from the date of completion.

RECOMMENDATION: Remove and/or mask over all accessible termite pellets. It is possible for the drywood termite pellets to sift down or reappear in these areas where they have been masked over.

RECOMMENDATION: Remove and replace the end of the damaged rafter tail(s) and install a new sister section alongside for support.

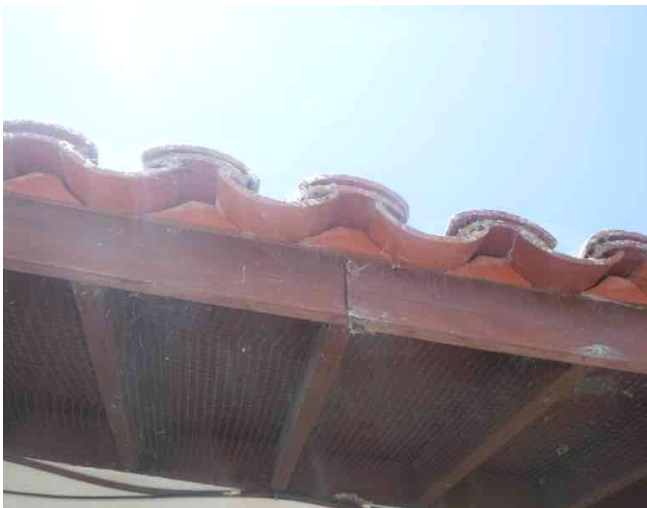
Photo 03

1D. FINDING: The fascia has been damaged by drywood termites where indicated on the diagram. (See Photo 3)

RECOMMENDATION: Remove and replace the damaged fascia to correct this condition. This bid includes repair of the roof covering if disturbed by our repairs. If existing gutters need to be removed to perform the repairs then our bid also includes reinstallation of original gutters. If it becomes necessary or desirable to install new gutters this will be done only if authorized and at an additional cost. The guarantees on the roof covering are limited to the areas where the repairs were performed.

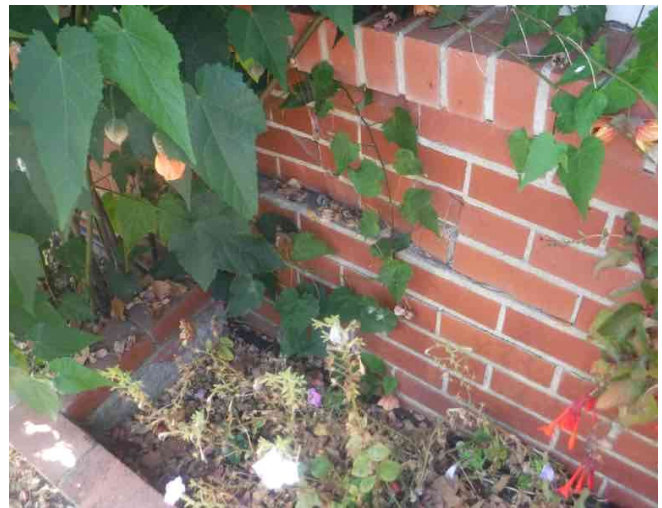
Photo 04

2B. FINDING: Cracks and/or voids were noted in the brick veneer at the wall as indicated on the diagram. (See Photo 4) (See Photo 18)

RECOMMENDATION: Seal these cracks or voids, using mortar or exterior caulk as needed.

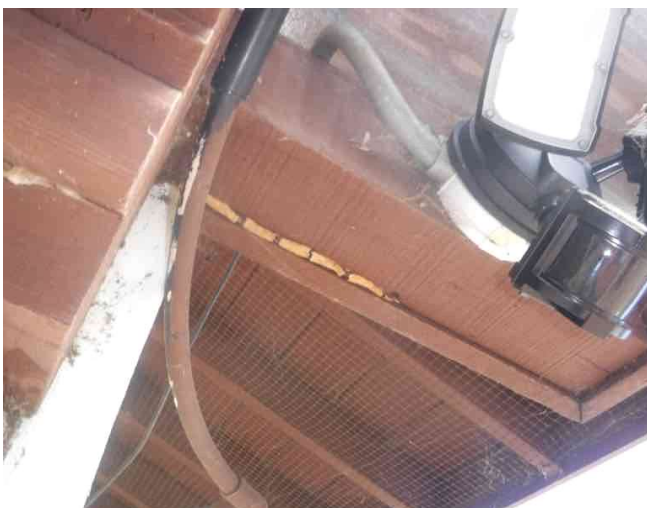
Photo 05

1E. FINDING: The wood members of the front patio cover has been damaged by fungus and drywood termites. (See Photo 5) (See Photo 7) (See Photo 13)

RECOMMENDATION: Remove and replace the entire front patio cover to eliminate these structural deficiencies.

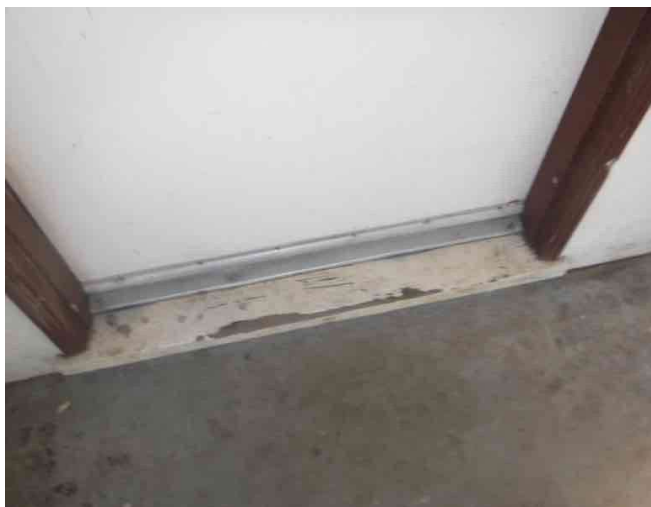
Photo 09

1F. FINDING: The thresholds at the two doors as indicated on the diagram have been damaged by fungus. (See Photo 8) (See Photo 9)

RECOMMENDATION: Remove the thresholds and replace with new materials.

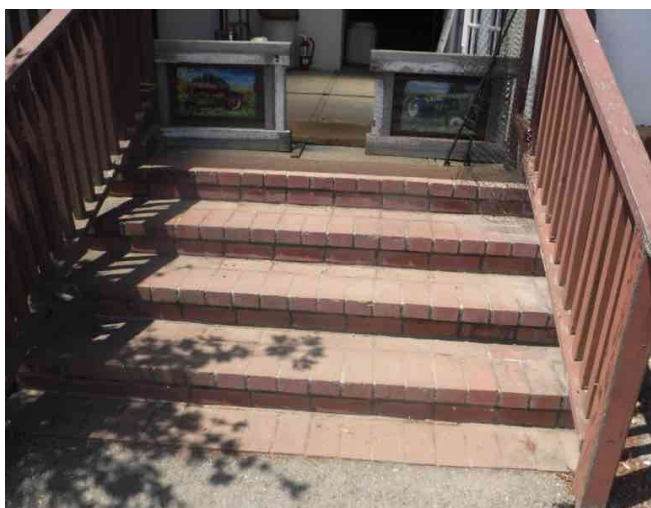
Photo 11

1G. FINDING: The front deck hand railings have been damaged by fungus. The contributing moisture source appears to be exposure to the weather. (See Photo 10) (See Photo 11)

RECOMMENDATION: Remove and replace the structurally damaged wood members. If damage is found to extend into inaccessible areas, a supplemental report will be issued with any findings, recommendations, and/or bids.

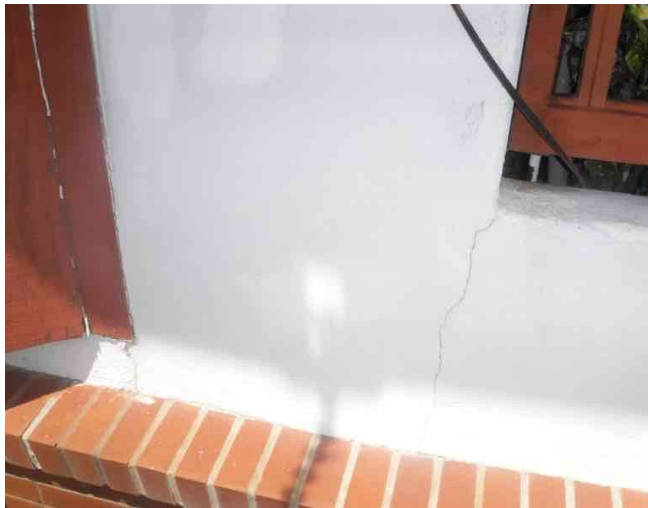
Photo 14

2C. FINDING: Minor stress cracks were noted in the exterior stucco as indicated on the diagram. (See Photo 14) (See Photo 21) (See Photo 25)

RECOMMENDATION: Seal all cracks that are wider than 1/16 of an inch with a exterior grade paintable sealant. If HomeGuard has supplied a bid for this item it does not include paint.

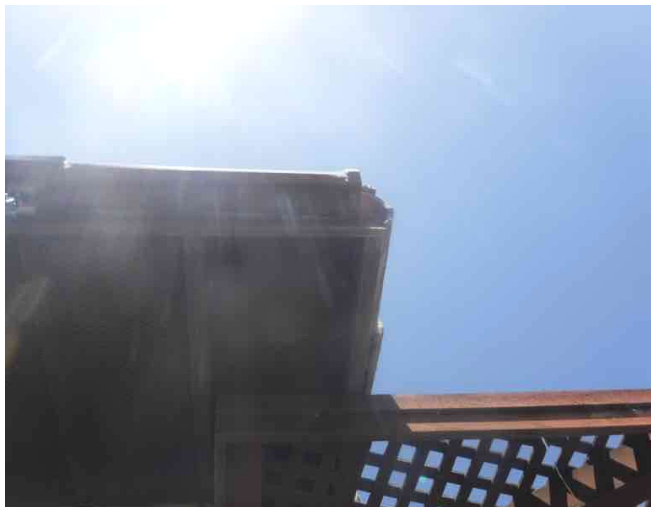
Photo 15

1H. FINDING: The barge rafter(s) as indicated on the diagram are damaged by fungus. The contributing moisture source appears to be exposure to the weather. (See Photo 12) (See Photo 15)

RECOMMENDATION: Remove and replace a section of the damaged barge rafter(s) to correct this condition. This bid includes repair of the roof covering if disturbed by our repairs. If existing gutters need to be removed to perform the repairs then our bid also includes reinstallation of original gutters. If it becomes necessary or desirable to install new gutters this will be done only if authorized and at an additional cost. The guarantees on the roof covering are limited to the areas where the work was performed.

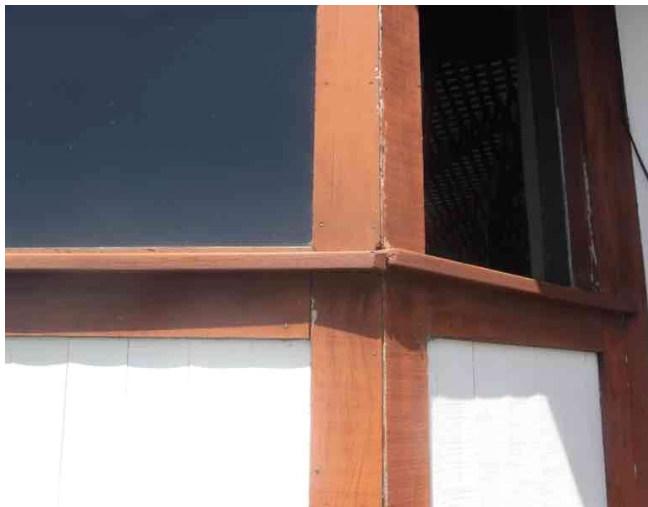
Photo 16

1I. FINDING: The window stool has been damaged by fungus at the front. The contributing moisture source appears to be exposure to the weather. (See Photo 16)

RECOMMENDATION: Remove and replace all the damaged wood members. If any damage is found to extend into any enclosed areas a supplemental report and bid will be issued.

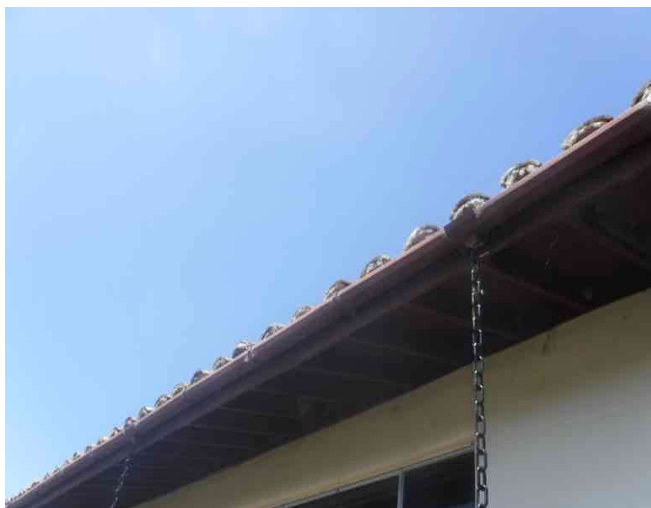
Photo 17

2D. FINDING: The rain gutters and downspouts appear to be leaking and/or clogged (See Photo 17) (See Photo 23)

RECOMMENDATION: The owner should have a sheet metal contractor, or someone in this line of work, clean and/or repair the gutters or downspouts as necessary.

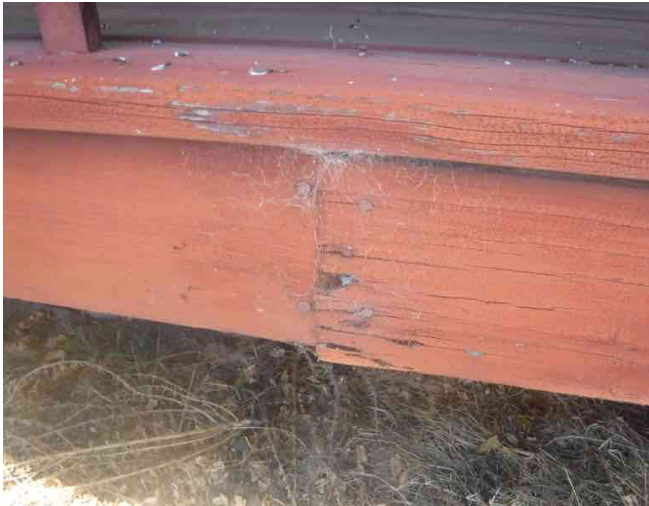
Photo 19

1J. FINDING: The fascia board and deck boards at the front deck has been damaged by drywood termites. The contributing moisture source appears to be exposure to the weather. (See Photo 19) (See Photo 42) (See Photo 43)

RECOMMENDATION: Remove and replace the damaged wood members. If damage is found to extend into inaccessible areas, a supplemental report will be issued with any findings, recommendations, and/or bids.

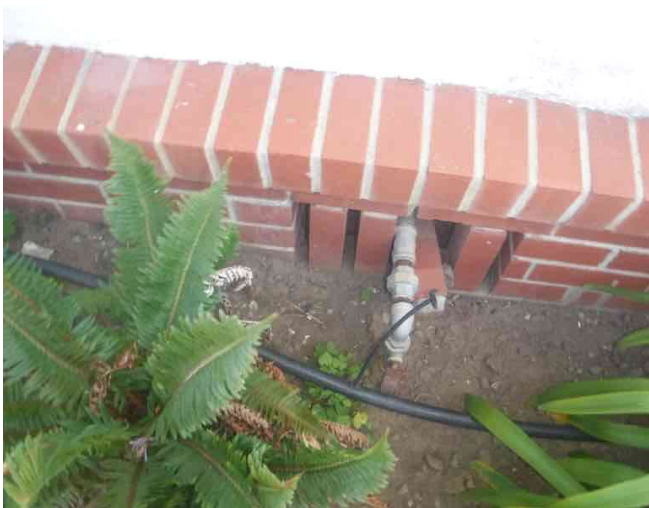
Photo 24

2E. FINDING: The ventilators to the substructure area, as indicated on the diagram, are below the exterior earth level which is allowing moisture to enter the substructure area. (See Photo 24)

RECOMMENDATION: Lower soil to eliminate this condition allowing moisture to drain away from the structure.

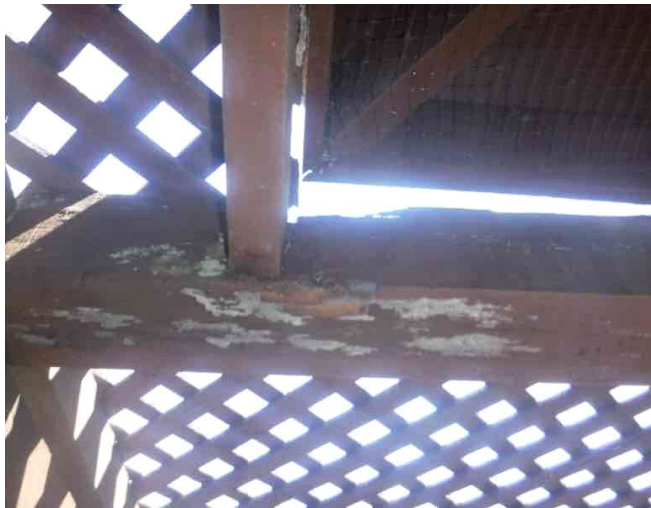
Photo 26

1K. FINDING: The wood members of the rear patio cover have been damaged by fungus and drywood termites. Refer to item(s) for recommendations to control contributing moisture source and or infestation. (See Photo 26) (See Photo 27) (See Photo 32)

RECOMMENDATION: Remove and replace the entire rear patio cover to eliminate these structural deficiencies.

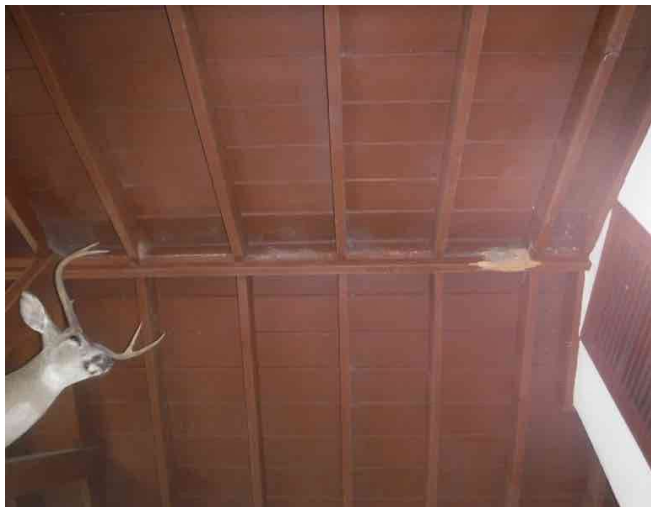
Photo 28

1L. FINDING: The center ridge rafter as indicated on the diagram is damaged by drywood termites. (See Photo 28)

RECOMMENDATION: Remove and replace the entire center rafter to correct this condition. This bid includes repair of the roof covering if disturbed by our repairs. If existing gutters need to be removed to perform the repairs then our bid also includes reinstallation of original gutters. If it becomes necessary or desirable to install new gutters this will be done only if authorized and at an additional cost. The guarantees on the roof covering are limited to the areas where the repairs were performed.

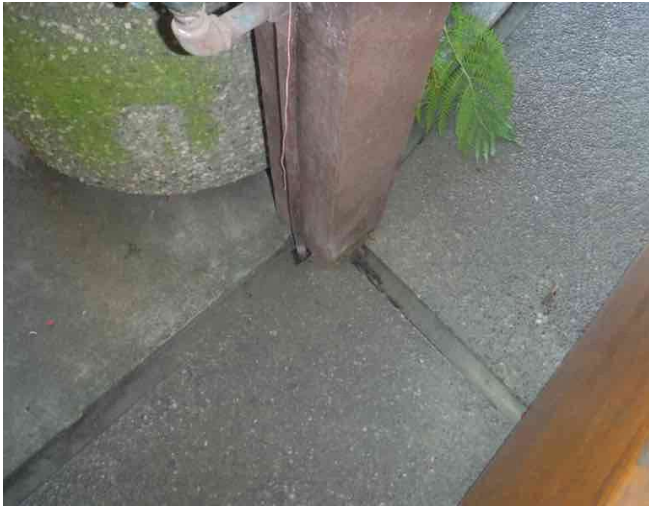
Photo 34

1M. FINDING: The support post(s) at the rear were found to be damaged by fungus. The contributing moisture source appears to be exposure to the weather. (See Photo 34) (See Photo 36)

RECOMMENDATION: Remove and replace the damaged post(s) to correct this condition.

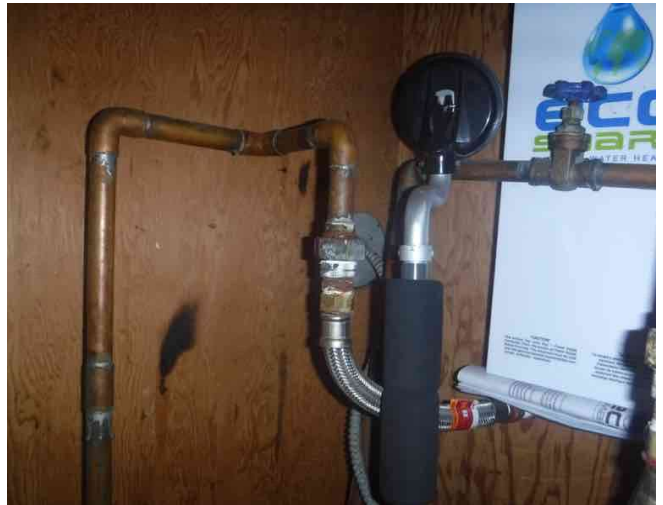
Photo 37

2F. FINDING: The plumbing fittings at the tankless water heater were noted to be corroded. Active leakage evident at this time. (See Photo 37)

RECOMMENDATION: Repair or replace the corroded fittings to prevent against leakage.

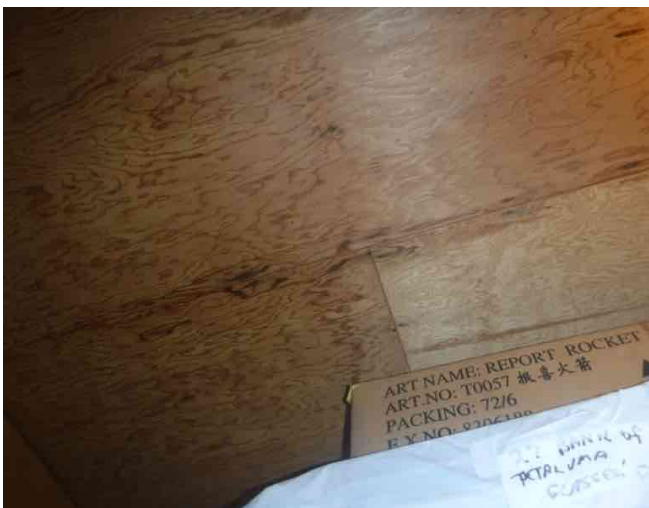
Photo 38

2G. FINDING: Water stains are evident at the tool room wood ceiling and the rear guest house sheathing as indicated on the diagram. This could indicate leakage through the roof covering. (See Photo 38) (See Photo 73)

RECOMMENDATION: The owner should contact HomeGuard Incorporated to arrange for a licensed roof inspector from our roofing division to inspect this area and provide a bid to repair the roof covering if necessary.

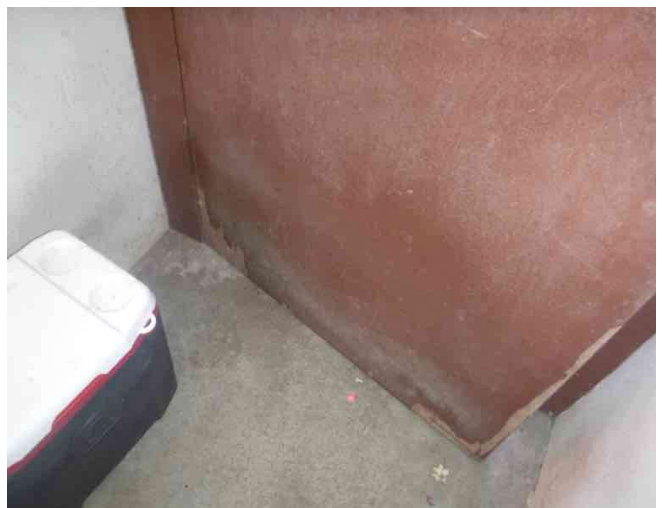
Photo 39

1N. FINDING: The doors at the main house, and detached guest house was found to be damaged by fungus. It appears the damage is a result of exposure to the weather. (See Photo 39) (See Photo 69) (See Photo 70)

RECOMMENDATION: Supply and install a new pre-hung door and jambs to correct this condition. Note: The existing door knob and dead bolt if any will be re-installed in the new door unless prior arrangements are made. We at HomeGuard Incorporated are upgrade experts and can provide proposals that include upgraded fixtures, and doors or any other option you may desire. Please note that if a special order door is needed to complete this item, there could be a three week delay in getting a replacement door. An exact match of the existing door may not be possible.

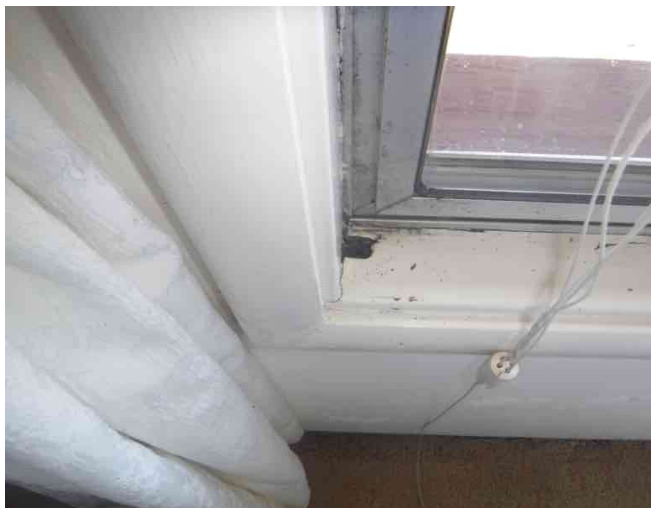
Photo 40

1O. FINDING: The master bedroom window sill has been damaged by drywood termites. The contributing moisture source appears to be exposure to the weather. (See Photo 40)

RECOMMENDATION: Remove and replace all the damaged wood members. If any damage is found to extend into any enclosed areas a supplemental report and bid will be issued.
*****SECTION 1 ITEM*****

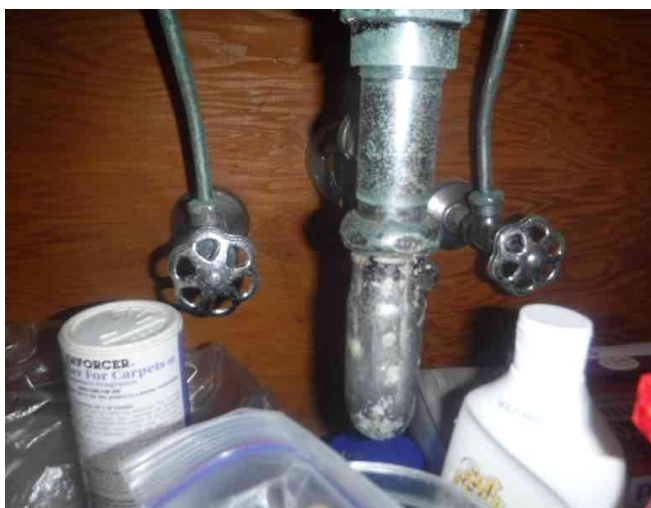
Photo 45

2I. FINDING: The plumbing fittings at the bath sink drain was noted to be heavily corroded. Active leakage not evident at this time. (See Photo 45)

RECOMMENDATION: Repair or replace the corroded fittings to prevent against leakage.

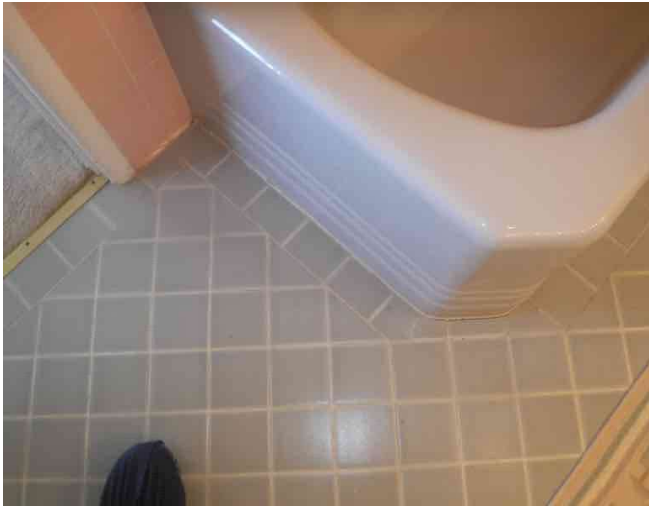
Photo 47

2H. FINDING: Cracked tiles were noted on the bath floor. (See Photo 44) (See Photo 47)

RECOMMENDATION: The owner is advised to replace the cracked tiles and regrout as necessary.

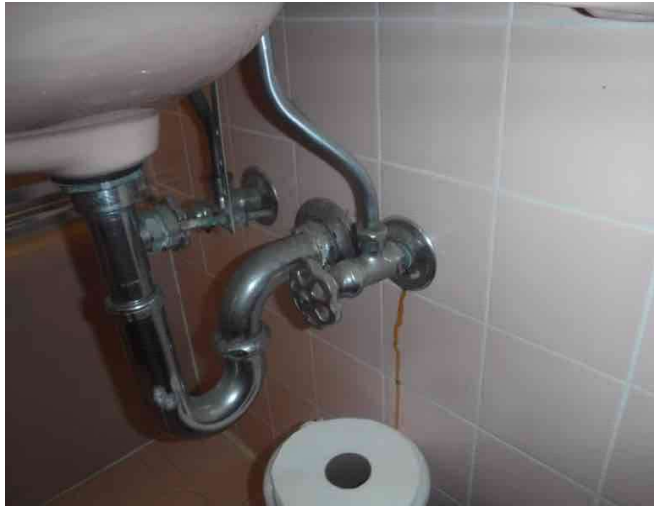
Photo 48

2K. FINDING: There is a plumbing leak at the hall bath and master bath sink supply valve. (See Photo 48) (See Photo 52)

RECOMMENDATION: Reseal or repair this leak in the most practical way.

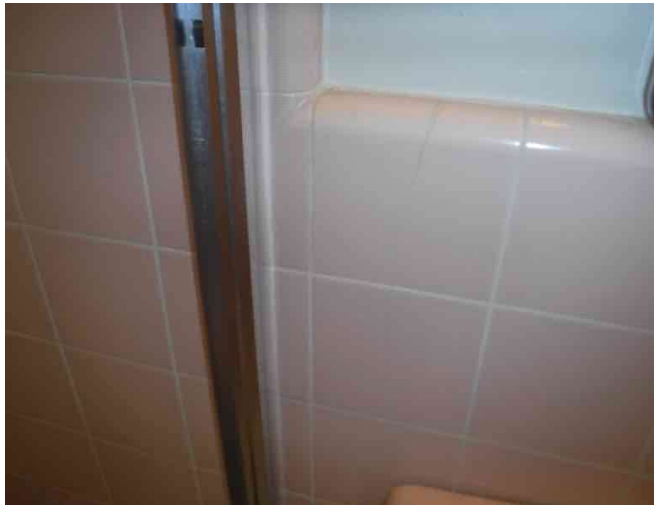
Photo 50

2M. FINDING: Cracked tiles were noted on the hall bath room. (See Photo 50)

RECOMMENDATION: The owner is advised to replace the cracked tiles and regrout as necessary.

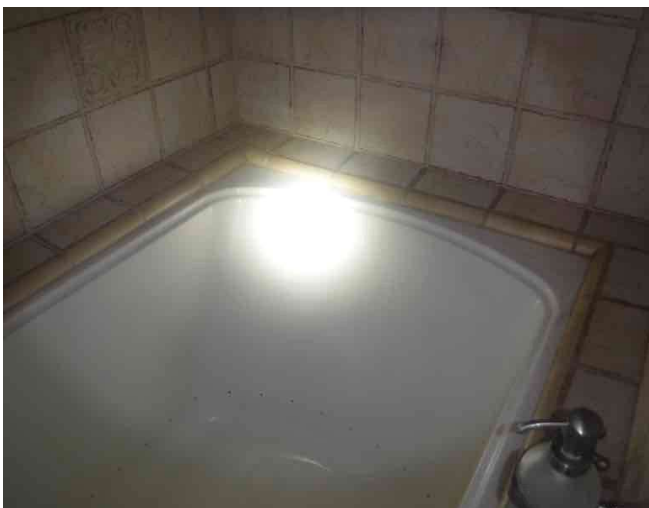
Photo 51

2N. FINDING: Some of the grout is loose or missing around the ceramic tile in the master bath tub. (See Photo 51)

RECOMMENDATION: Reseal the area in the most practical way. Owner to maintain in a water tight condition.

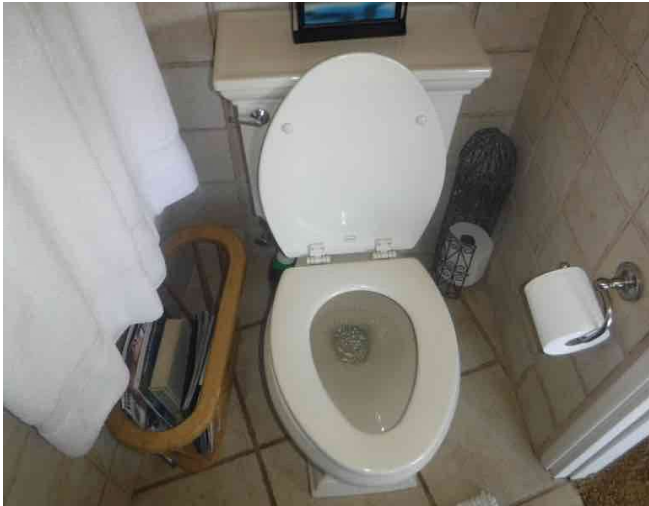
Photo 53

2O. FINDING: The toilet is loose or improperly mounted at the master bathroom. (See Photo 53)

RECOMMENDATION: Reinstall the toilet correctly using a new no-seep toilet seal. If, upon removing the toilet a cracked toilet or damaged toilet flange is revealed there would be additional charges for a new toilet or repairs to the toilet flange.

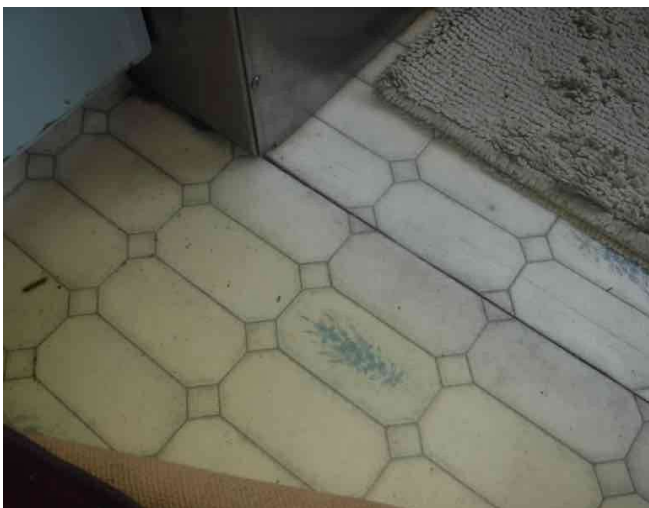
Photo 58

1P. FINDING: The kitchen floor has been damaged by fungus adjacent to the wall at dining area as seen from the subarea. This floor extends into the hall wall into the hall bathroom. (See Photo 58) (See Photo 60)

RECOMMENDATION: Open the floor to repair damaged underlayment as necessary. Install new underlayment and new builder's grade neutral colored vinyl floor covering over the floor area. When the underlayment is removed, if additional contributing factors are found or if fungus damage to the subfloor or walls is revealed, we would issue a supplemental report and bid. It will be the owner's responsibility to remove and reinstall all appliances and furnishings. If this property has a dishwasher, it may be necessary to remove it in order to properly affect this repair. In the event that we remove the dishwasher, we will reinstall it. If the dishwasher is found to be leaking upon reinstallation there will be additional charges to make needed repairs. We at HomeGuard Incorporated are upgrade experts and can provide proposals that include tile, marble, granite, upgraded fixtures, upgraded windows and doors or any other option you may desire.

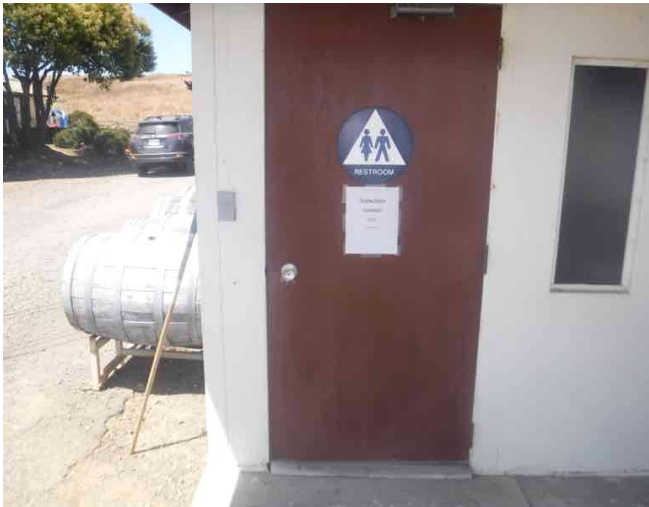
Photo 64

1R. FINDING: The detached bathroom door has been damaged by fungus. It appears the damage is a result of exposure to the weather. (See Photo 64)

RECOMMENDATION: Supply and install a new door. We intend to reuse the existing hardware. We at HomeGuard Incorporated are upgrade experts and can provide proposals that include upgraded windows and doors or any other option you may desire. Please note that if a special order door is needed to complete this item, there could be a three week delay in getting a replacement door. An exact match of the existing door may not be possible.
*****SECTION 1 ITEM*****

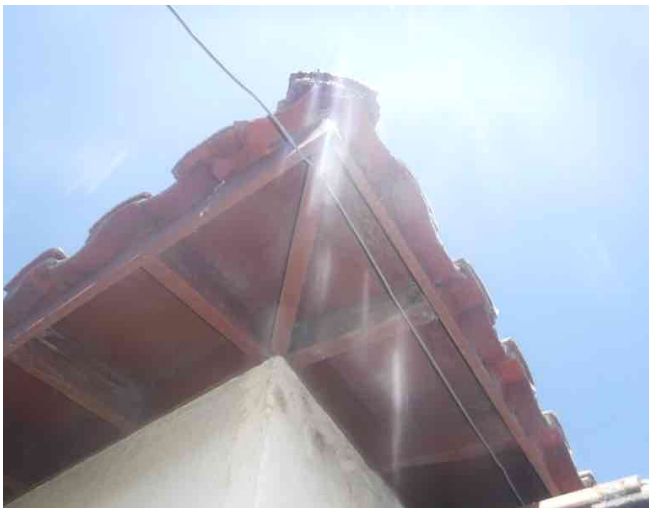
Photo 66

1S. FINDING: The roof sheathing and rafters as indicated on the diagram is damaged by fungus and drywood termites. The contributing moisture source appears to have been caused by a failure of the roof covering. (See Photo 66)

RECOMMENDATION: Remove and replace the damaged wood members to correct this condition. This bid includes repair of the roof covering if disturbed by our repairs. If existing gutters need to be removed to perform the repairs then our bid also includes reinstallation of original gutters. If it becomes necessary or desirable to install new gutters this will be done only if authorized and at an additional cost. The guarantees on the roof covering are limited to the areas where the repairs were performed.
*****SECTION 1 ITEM*****

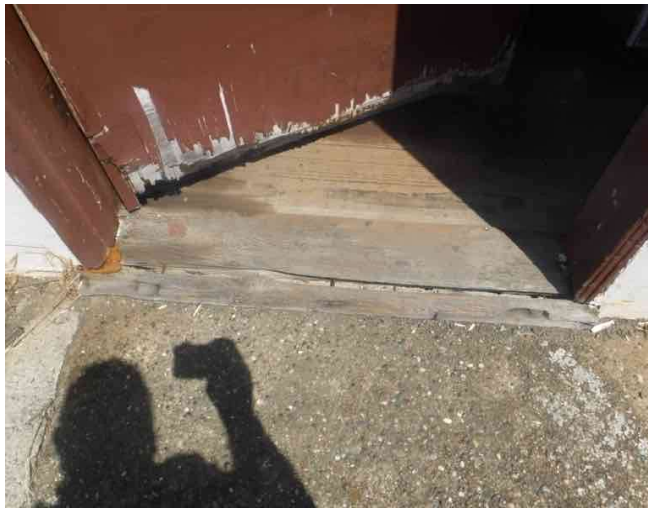
Photo 71

1T. FINDING: The threshold has been damaged by fungus rear guest house. The contributing moisture source appears to be exposure to the weather. (See Photo 71)

RECOMMENDATION: Remove and replace all the damaged wood members. If any damage is found to extend into any enclosed areas a supplemental report and bid will be issued.

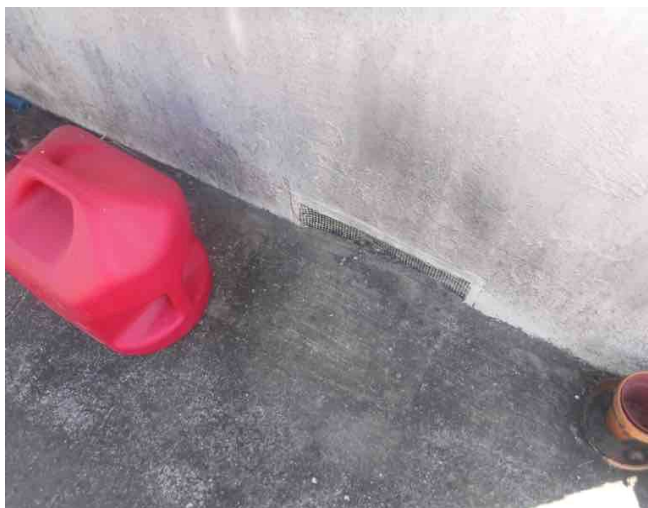
Photo 75

2P. FINDING: The subarea ventilators at finished concrete surfaces are below the exterior grade level. This can allow moisture to run into the substructure area. (See Photo 75)

RECOMMENDATION: Install concrete dams around these vents.

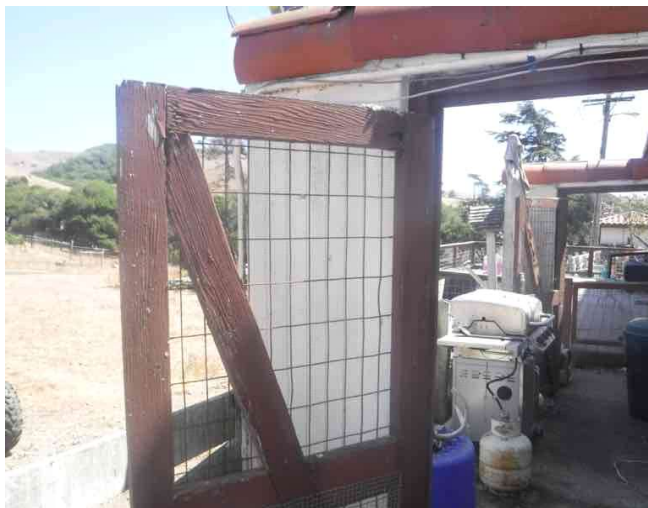
Photo 79

1U. FINDING: The two right side doors and jambs has been damaged by fungus. The contributing moisture source appears to be exposure to the weather. (See Photo 79) (See Photo 82)

RECOMMENDATION: Remove and replace all the damaged wood members. If any damage is found to extend into any enclosed areas a supplemental report and bid will be issued.

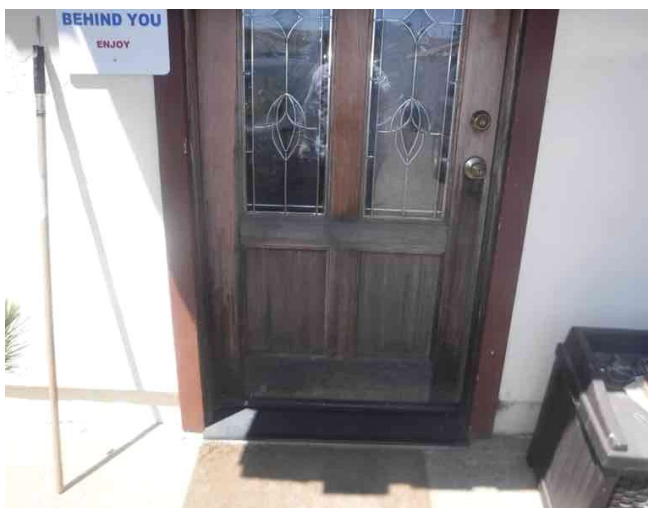
Photo 86

2Q. FINDING: We observed the following conditions in the course of our inspection: The front door to the detached guest house was noted weathered. (See Photo 86)

RECOMMENDATION: The owner should have the proper tradesperson maintain and repair these areas.

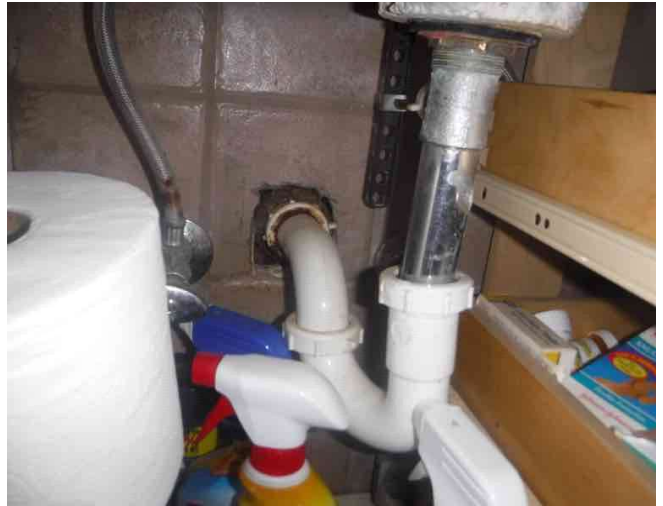
Photo 88

2R. FINDING: The plumbing fittings at the hall bath sink drain were noted to be heavily corroded. Active leakage not evident at this time. (See Photo 88)

RECOMMENDATION: Repair or replace the corroded fittings to prevent against leakage.

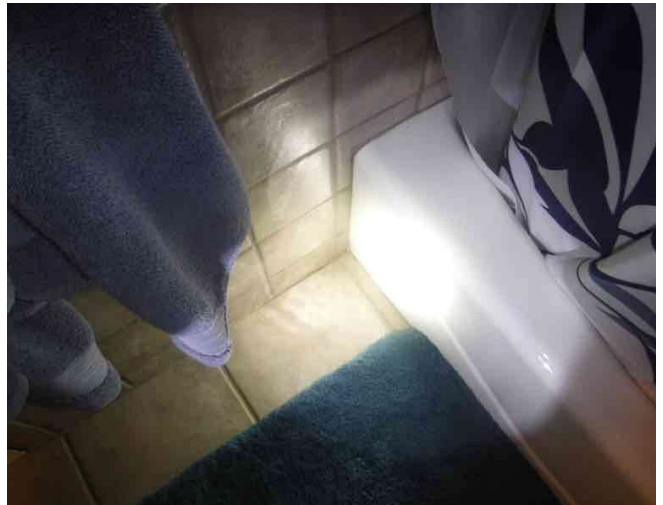
Photo 90

2T. FINDING: Some of the grout is loose or missing around the ceramic tile in the detached master bath tile floor and walls. (See Photo 90) (See Photo 91)

RECOMMENDATION: Reseal the area in the most practical way. Owner to maintain in a water tight condition.

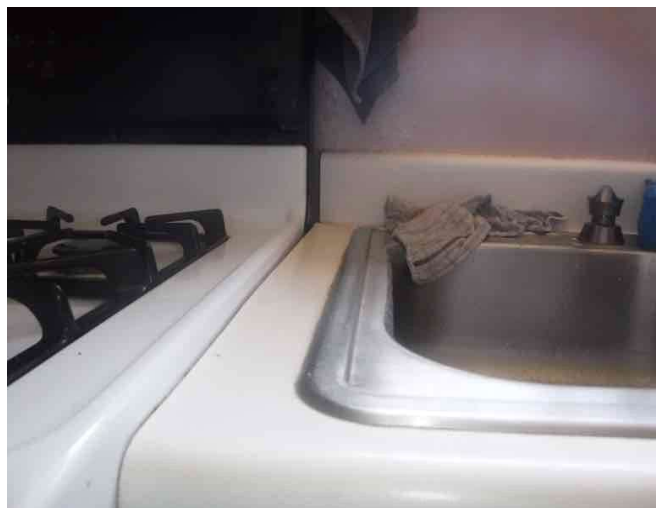
Photo 92

1V. FINDING: Evidence of moisture penetration and damage was noted at the laminate counter in the detached guest house kitchen. (See Photo 92) (See Photo 93)

RECOMMENDATION: Remove the sink. Remove the damaged countertop and replace any damaged support framing. Install a new laminate counter with backsplash. Unless prior arrangements have been made, a builder's grade, readily available laminate counter will be installed. Re-plumb and reset the existing sink. We at HomeGuard Incorporated are upgrade experts and can provide proposals that include tile, marble, granite, upgraded fixtures, upgraded windows and doors or any other option you may desire. If additional contributing moisture conditions are found, a supplemental report will be issued listing all findings, recommendations and bids.

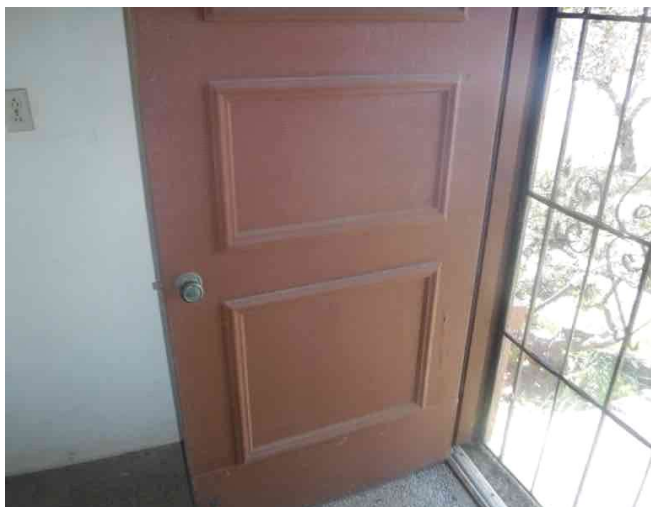
Photo 95

2U. FINDING: The exit door is delaminated and/or deteriorated. It appears the damage is a result of exposure to the weather. (See Photo 95)

RECOMMENDATION: Supply and install a new door. We intend to reuse the existing hardware. Please note that if a special order door is needed to complete this item, there could be a three week delay in getting a replacement door. An exact match of the existing door may not be possible.

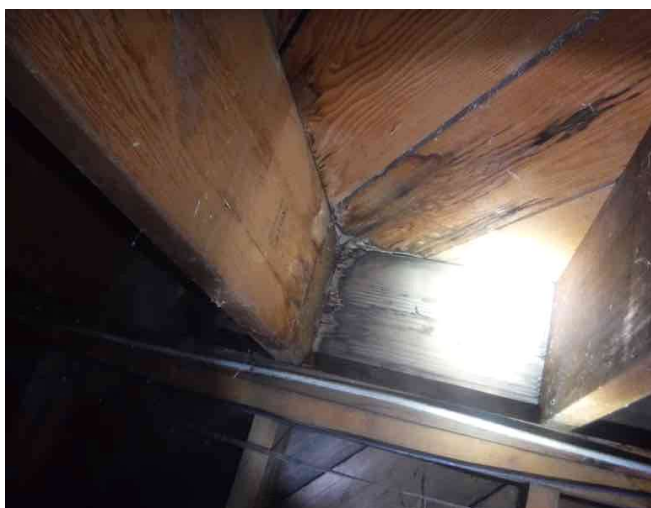
Photo 98

1X. FINDING: The subfloor has been damaged by fungus subarea. (See Photo 98) (See Photo 99)

RECOMMENDATION: Remove and replace all the damaged wood members. If any damage is found to extend into any enclosed areas a supplemental report and bid will be issued.
