Septic Inspection Report

Arlington Inn

03/26/2026

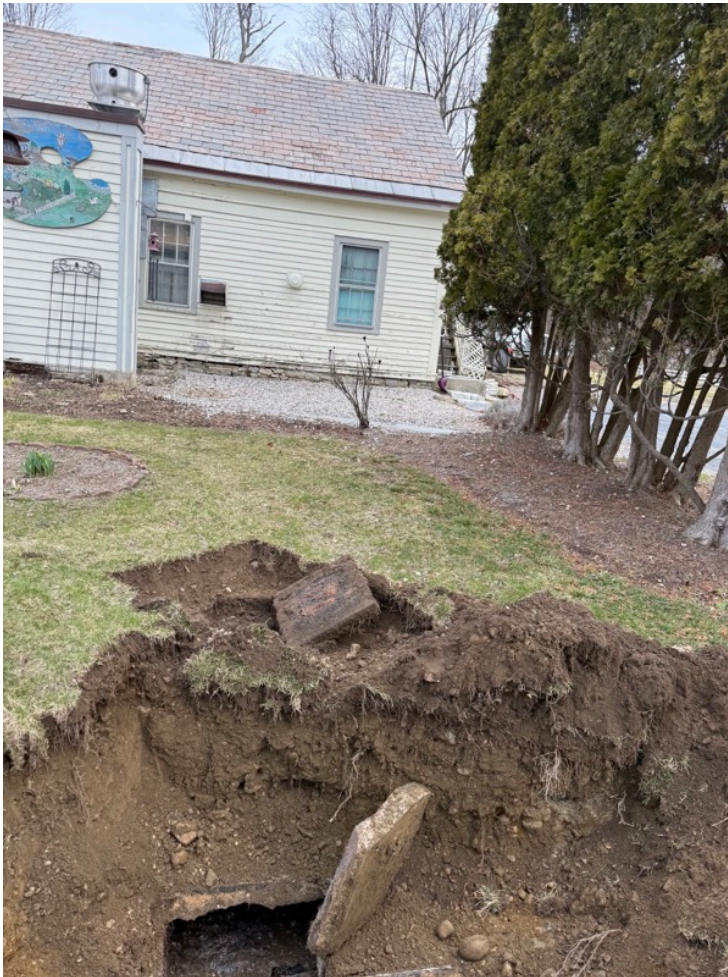
Tank location photo

One tank on left side and one tank on right side of inn
