202 - 220 S. State Street

Appendices

Appendix C: Building Preservation Plans (BPP)

220 South State Street
Chicago, Illinois, IL0315ZZ

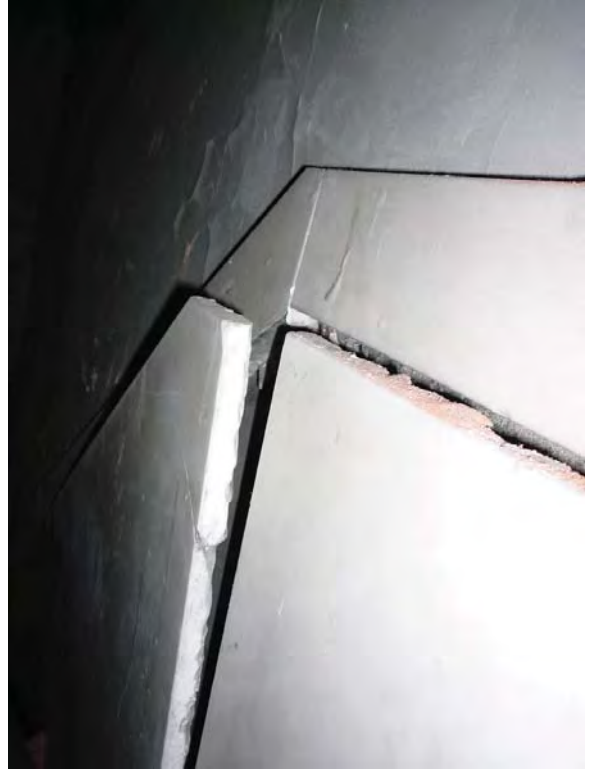
Image 71: Typical stringer condition, main stair, floors 2 and above.

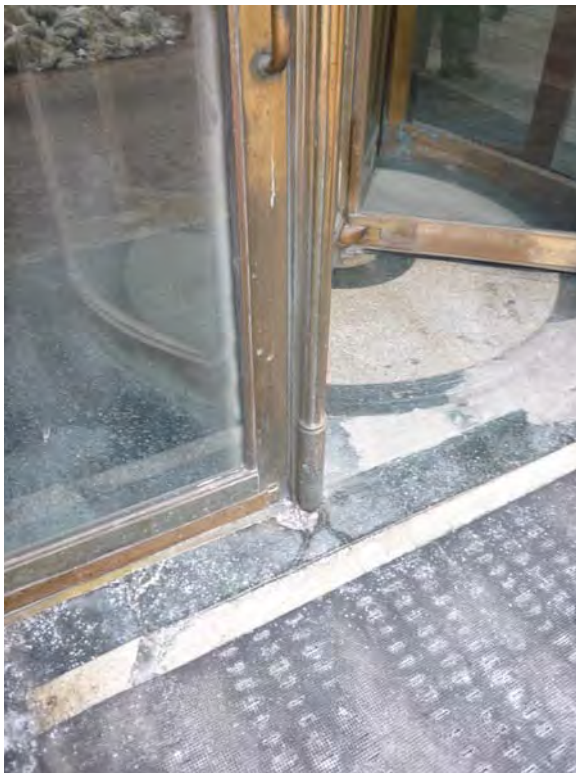
Image 108: One major terrazzo mar, first floor lobby.

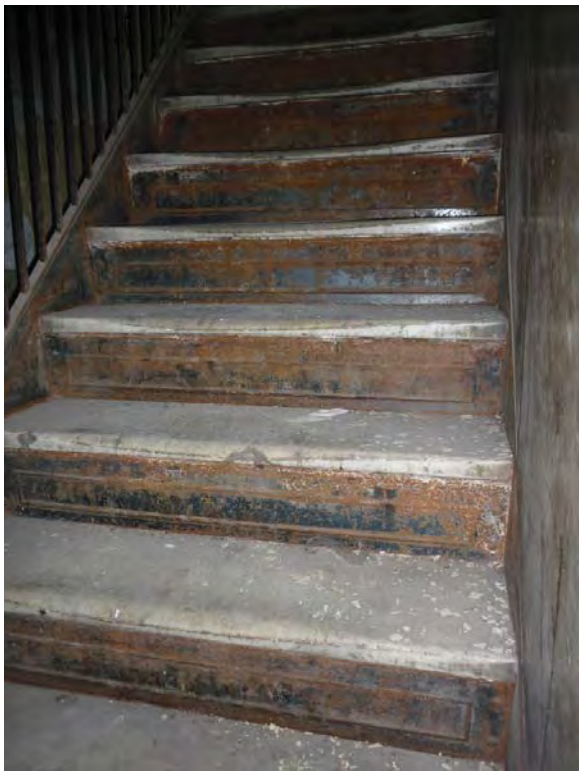
Image 112: Typical condition of railing finish, east stair.

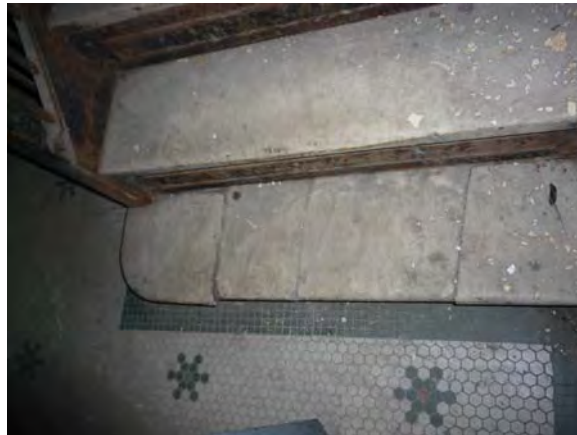
Image 113: West stair, typical condition from first basement to first floor.

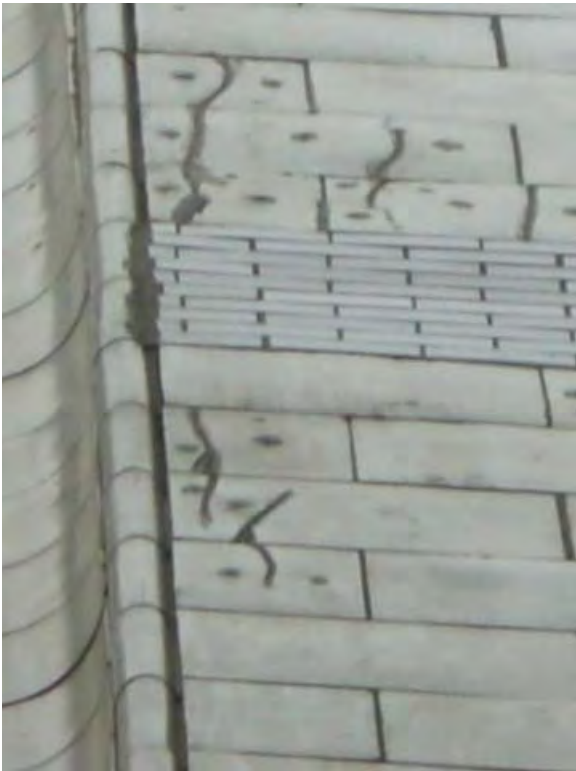
Image 116: Poor substitution of glazed brick for terra cotta, east façade.

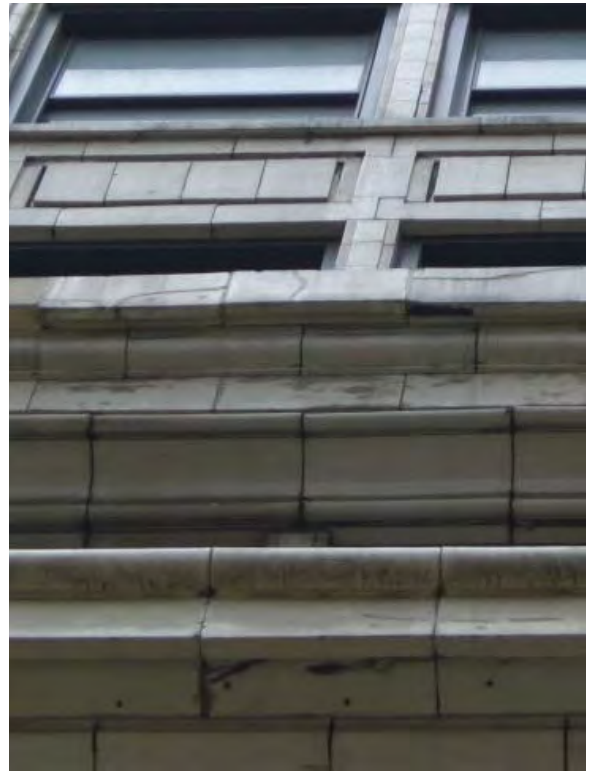
Image 117: Poor substitute cladding material and failure of surrounding terra cotta.

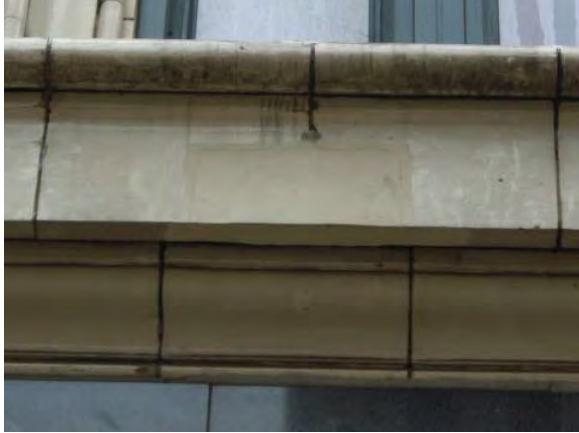
Image 118: Stresses in terra cotta resulting from anchor failure and stresses in wall.

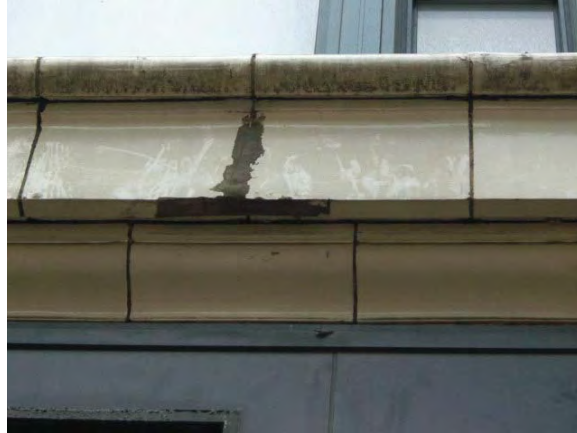
Image 119: Unsightly mortar patch. Doomed to fail.

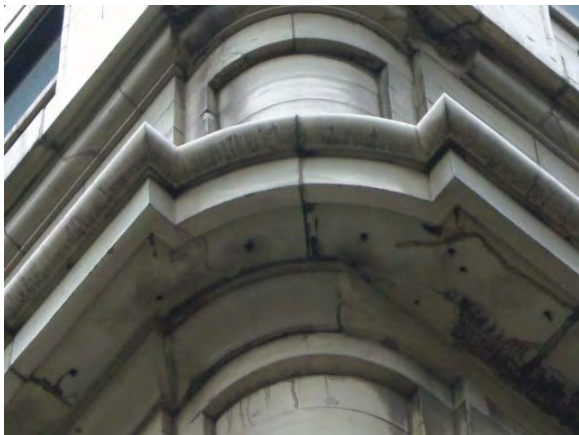
Image 120: Improper repair of failing terra cotta.

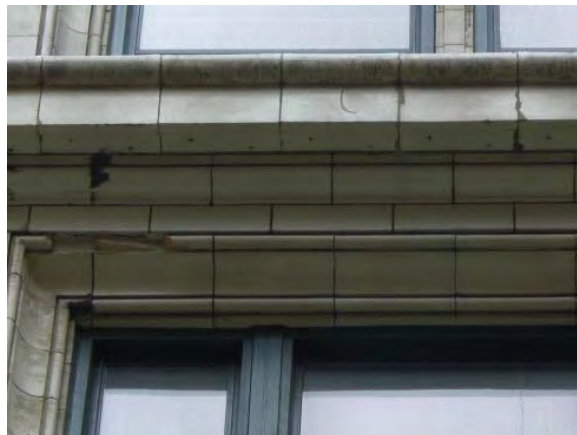
Image 121: Stresses in terra cotta due to anchor failure and stresses in wall. Poor substitution of glazed brick for terra cotta and improper patching also evident.

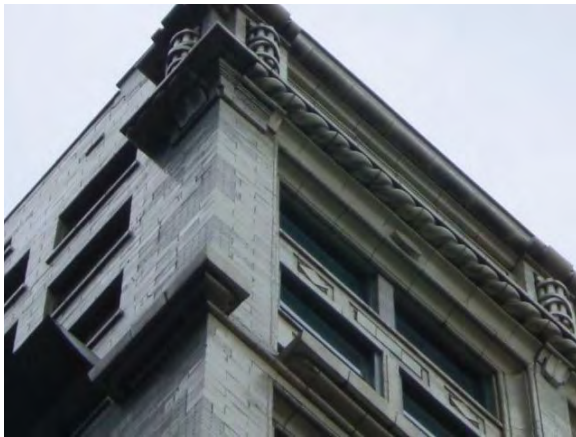
Image 122: Delamination of terra cotta due to stresses in the failing lintel.

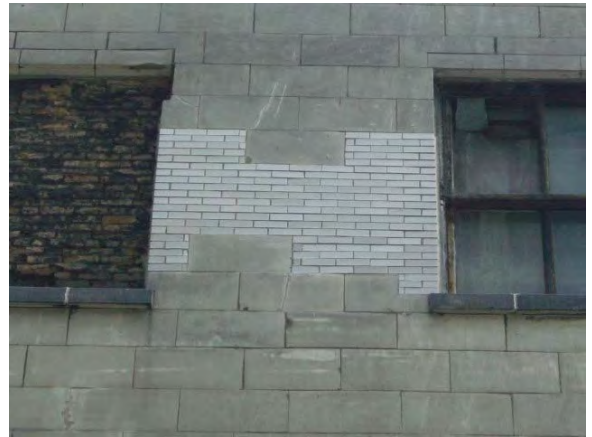
Image 123: Delamination of terra cotta unit due to stresses in the failing lintel.

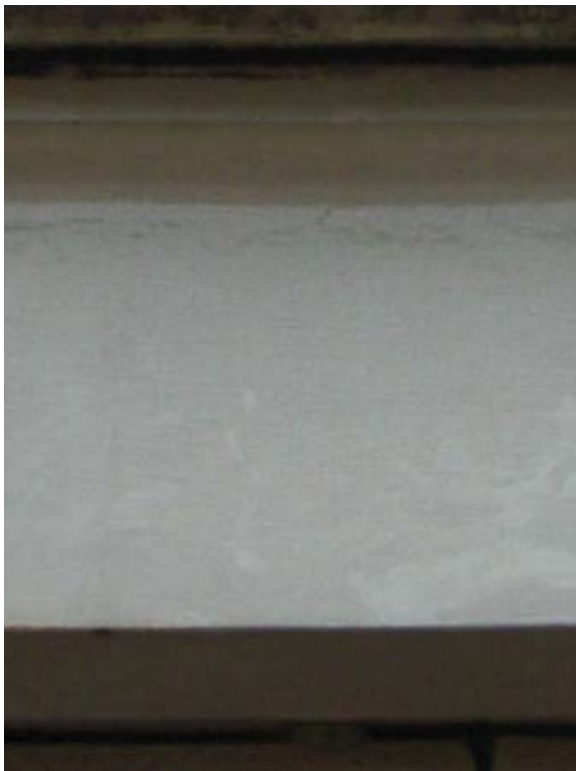
Image 124: Poor substitute cladding material and insensitive replacement of window.

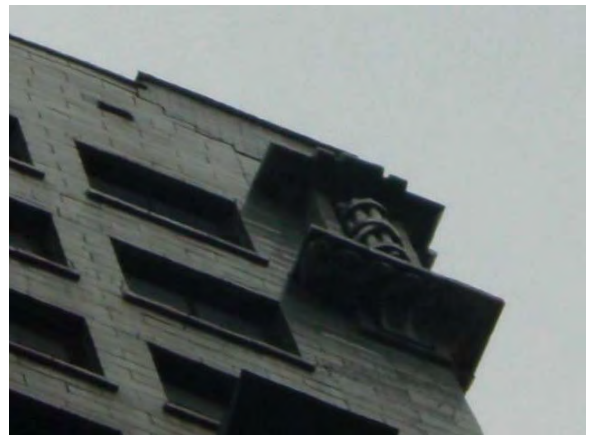
Image 125: Crazing evident in glazed finish of masonry units throughout the facades.
