ABC Herron Tree LLC  
P.O. Box 64  
Gold Bar, WA 98251  
425-293-2443  
mountainredd@comcast.net

February 15, 2025

RE: Property Owner: Kara Trent  
Site Address: 317 N 138<sup>th</sup> St, Seattle, WA 98133  
Parcel#: 0173000075  
Lot Size: 10,125 sq ft

## Assignment

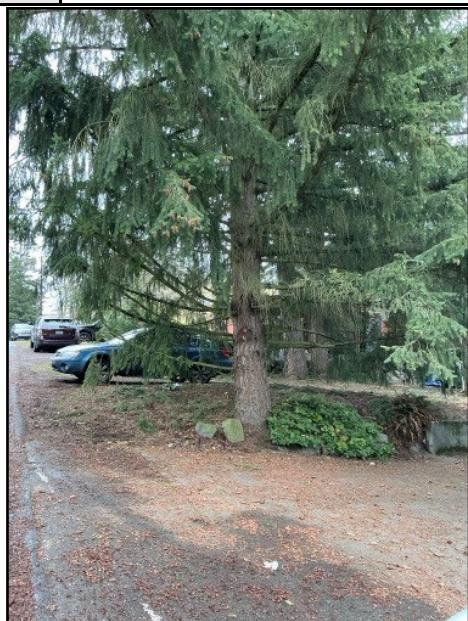
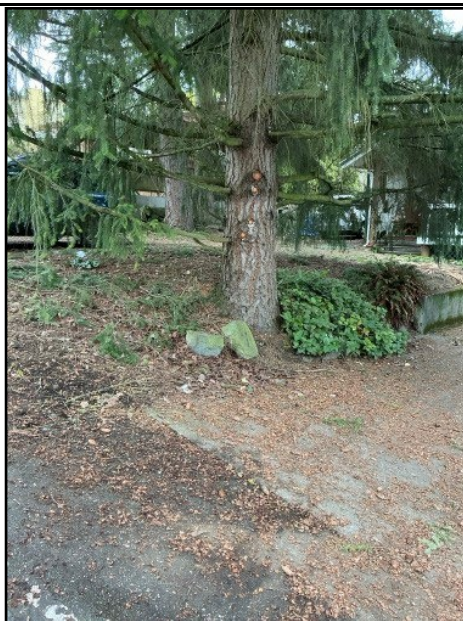
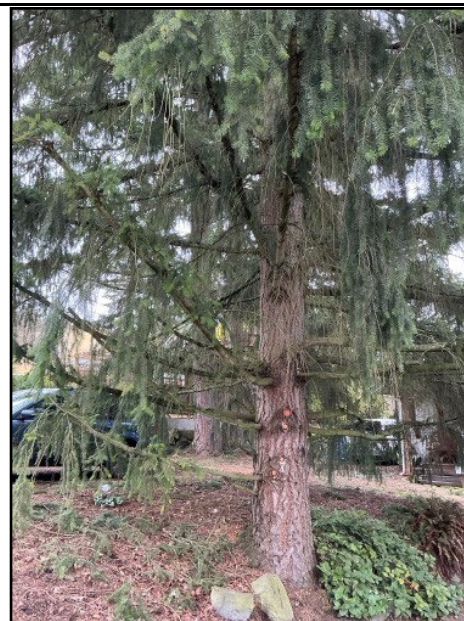
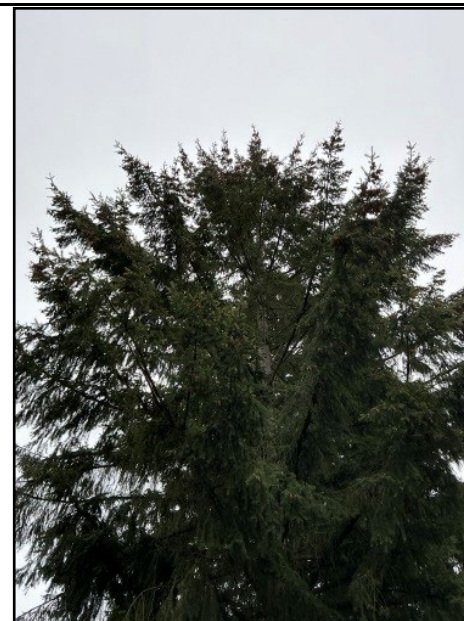
| Tree | Species | DSH (in) | Drip (ft) | CRZ (ft) | Condition | Structure | Risk | Pres. Value | Recommendations |
|---|---|---|---|---|---|---|---|---|---|
| 1 | Douglas fir<br><i>Pseudotsuga menziesii</i> | 22.0 | 18.0 | 22.0 | 4 Good | 4 Good | N/A | N/A | Tree Inventory |

This tree is part of a tree inventory. There's nothing noteworthy about this tree. This tree may be a SDOT tree survey will need to convey this.

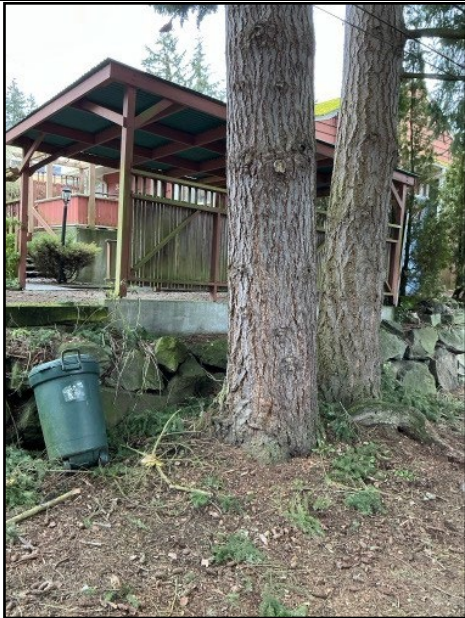
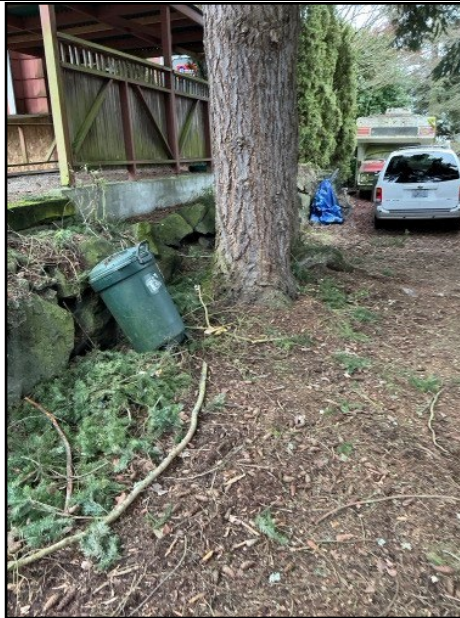
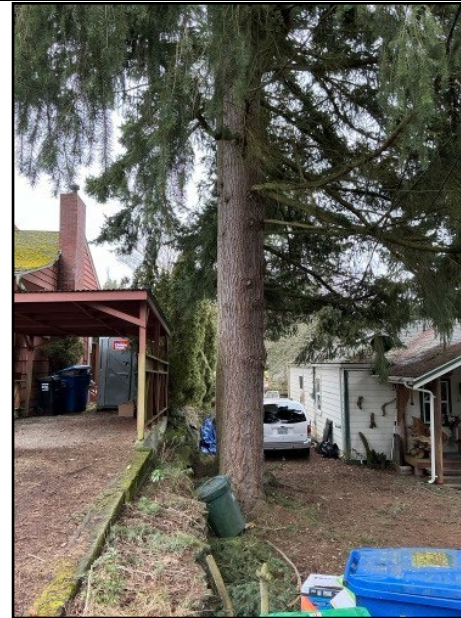
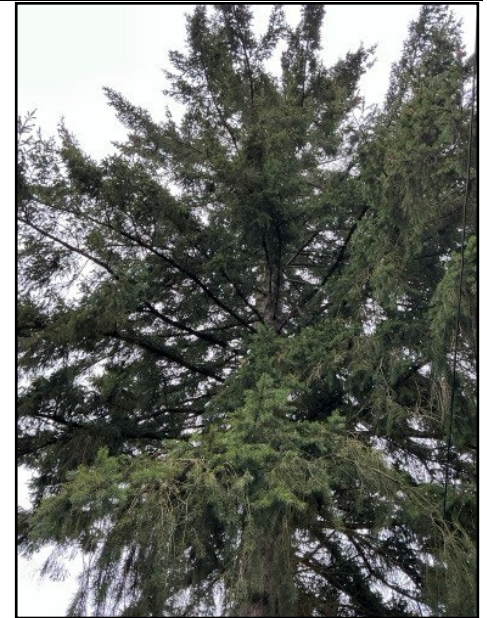
| Tree | Species | DSH (in) | Drip (ft) | CRZ (ft) | Condition | Structure | Risk | Pres. Value | Recommendations |
|---|---|---|---|---|---|---|---|---|---|
| 2 | Douglas fir<br><i>Pseudotsuga menziesii</i> | 29.5 | 30.0 | 29.5 | 4 Good | 4 Good | N/A | N/A | Tree Inventory |
| Notes/<br>Defect | This tree is part of a tree inventory. There's nothing noteworthy about this tree. | | | | | | | | |

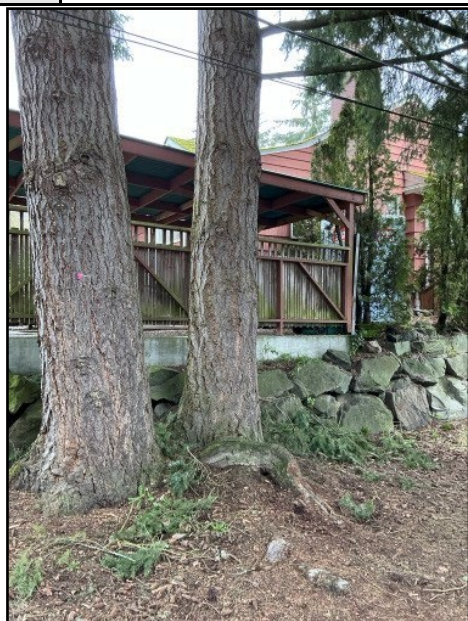
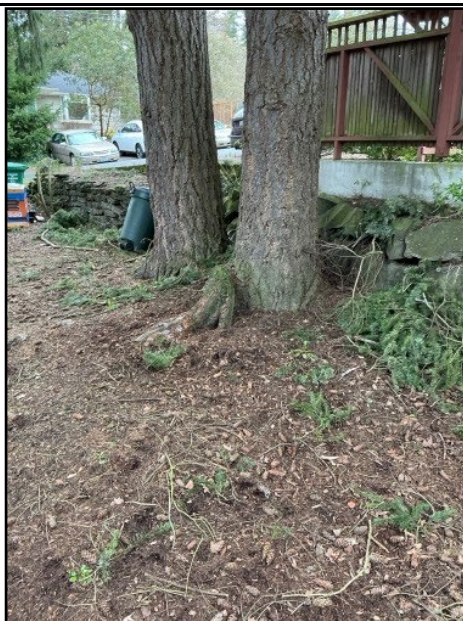
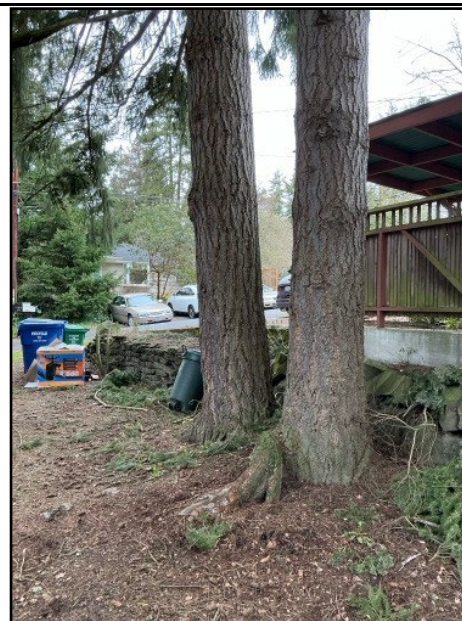
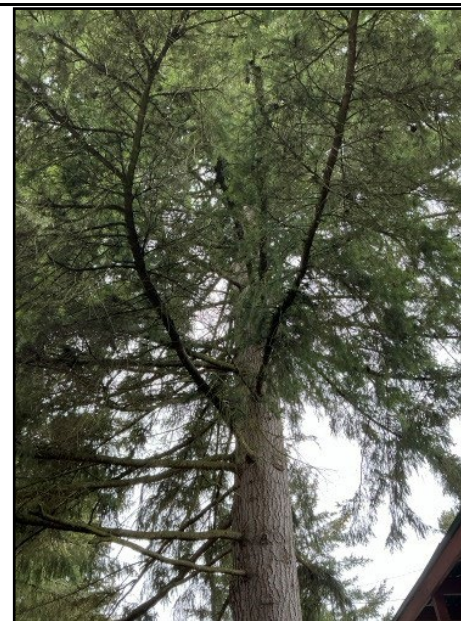
| Tree | Species | DSH (in) | Drip (ft) | CRZ (ft) | Condition | Structure | Risk | Pres. Value | Recommendations |
|---|---|---|---|---|---|---|---|---|---|
| 3 | Douglas fir<br><i>Pseudotsuga menziesii</i> | 25.3 | 20.0 | 25.3 | 4 Good | 4 Good | N/A | N/A | Tree Inventory |

This tree is part of a tree inventory. There's nothing noteworthy about this tree.

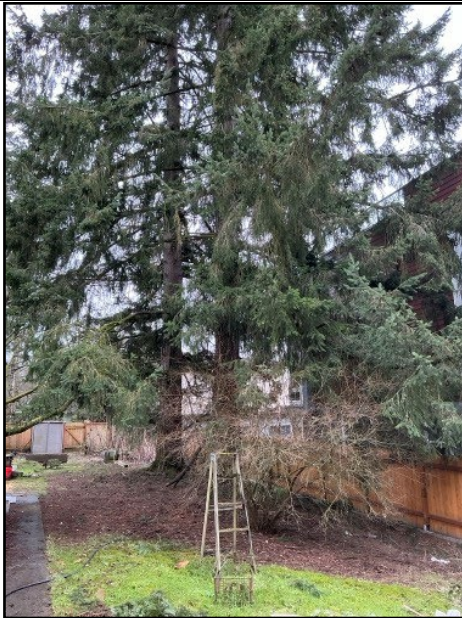
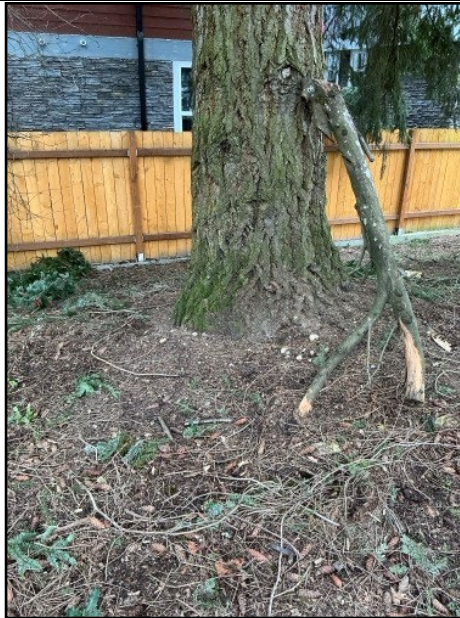
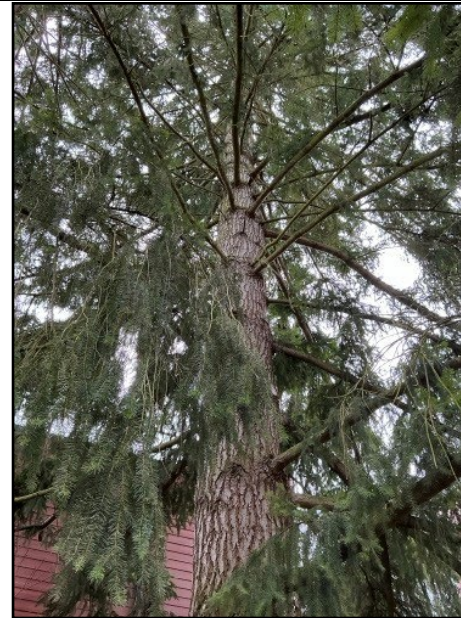
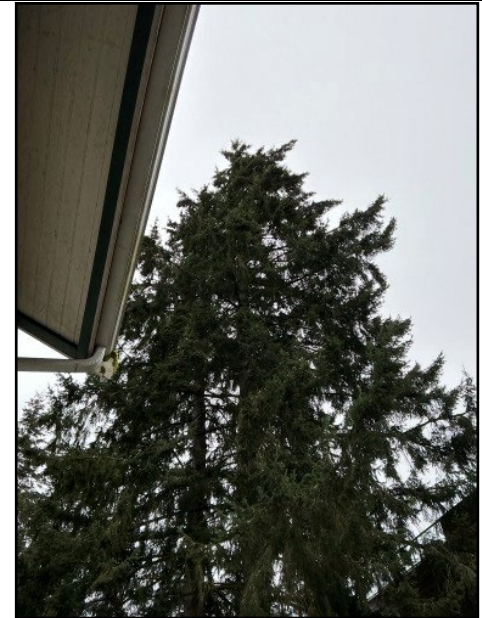
| Tree | Species | DSH (in) | Drip (ft) | CRZ (ft) | Condition | Structure | Risk | Pres. Value | Recommendations |
|---|---|---|---|---|---|---|---|---|---|
| 4 | Douglas fir<br><i>Pseudotsuga menziesii</i> | 31.5 | 30.0 | 31.5 | 4 Good | 4 Good | N/A | N/A | Tree Inventory |

This tree is part of a tree inventory. There's nothing noteworthy about this tree.

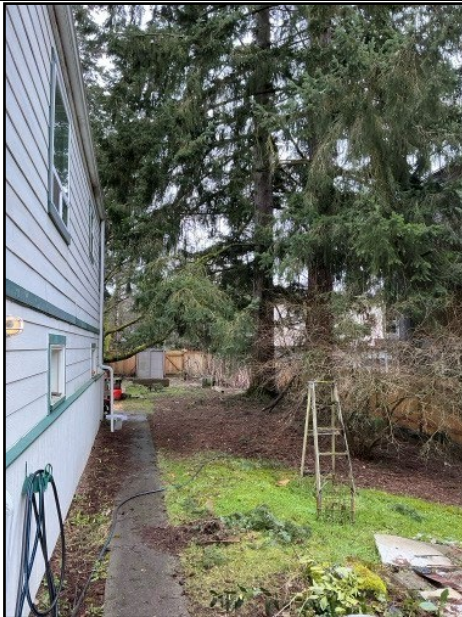
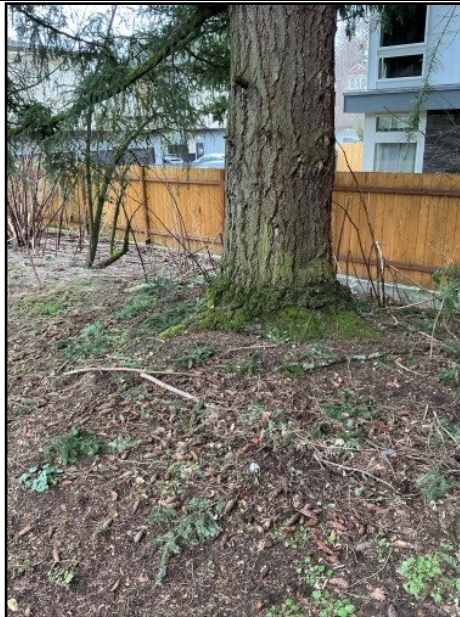
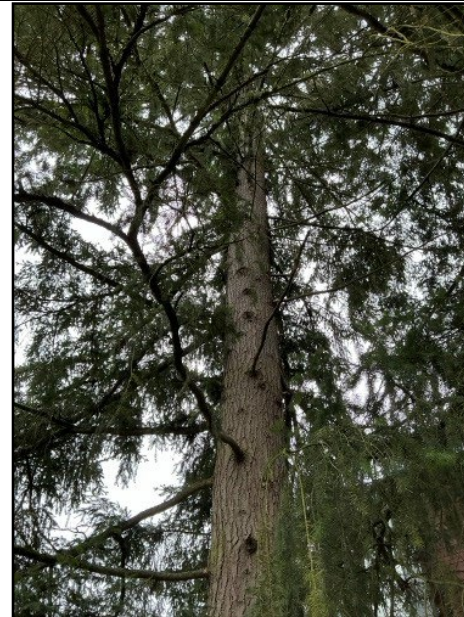
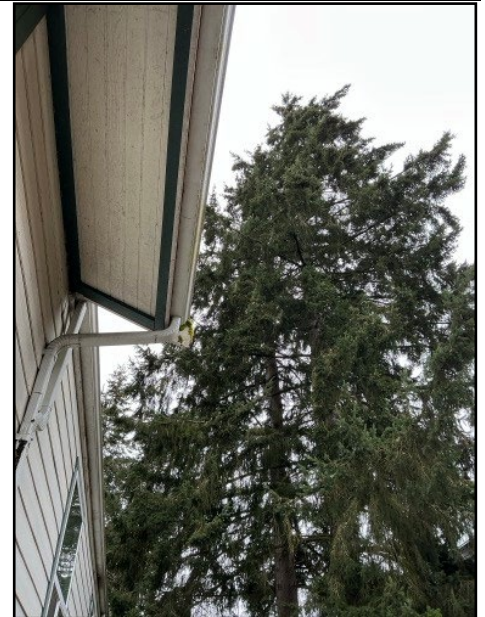
| Tree | Species | DSH (in) | Drip (ft) | CRZ (ft) | Condition | Structure | Risk | Pres. Value | Recommendations |
|---|---|---|---|---|---|---|---|---|---|
| 5 | Douglas fir<br><i>Pseudotsuga menziesii</i> | 35.5 | 25.0 | 35.5 | 4 Good | 4 Good | N/A | N/A | Tree Inventory |
| Notes/<br>Defect | This tree is part of a tree inventory. There's nothing noteworthy about this tree. | | | | | | | | |

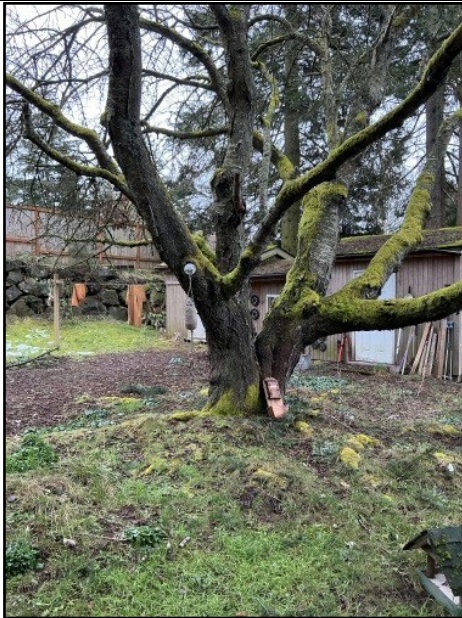
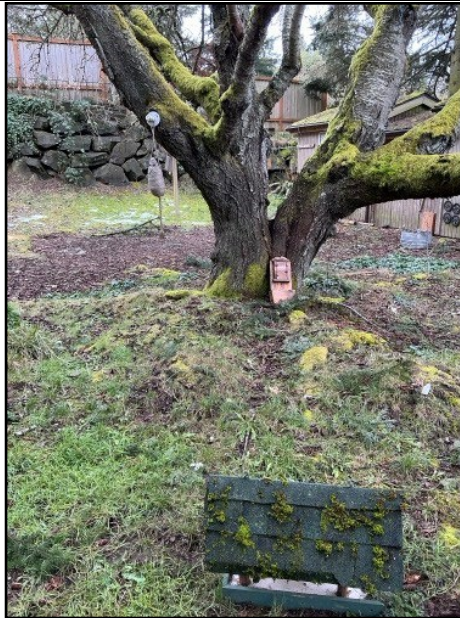
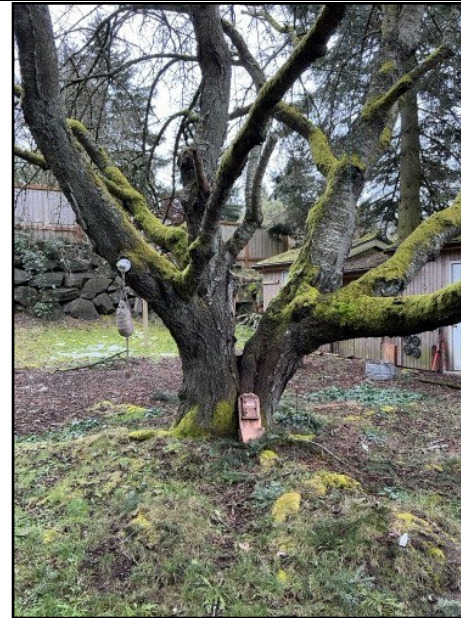
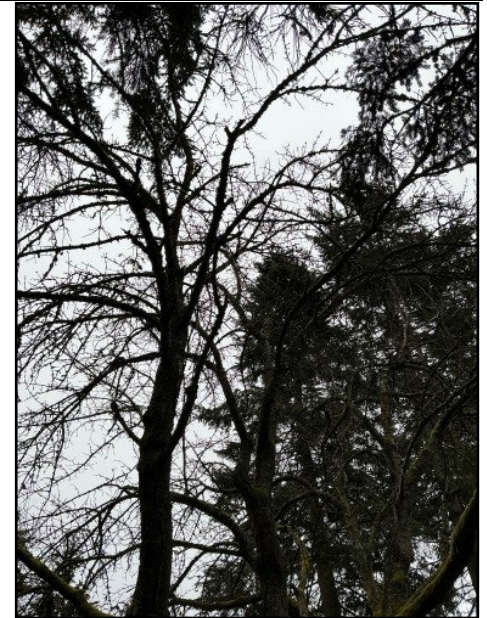
| Tree | Species | DSH (in) | Drip (ft) | CRZ (ft) | Condition | Structure | Risk | Pres. Value | Recommendations |
|---|---|---|---|---|---|---|---|---|---|
| 6 | Cherry<br><i>Prunus species</i> | 35.6 | 35.0 | 35.6 | 3 Fair | 3 Fair | N/A | N/A | Tree Inventory |

This tree is part of a tree inventory. This tree has a two stemmed adjusted DSH codominant. Stem has a large cavity at the union. There is some significant limb die back in the upper canopy.

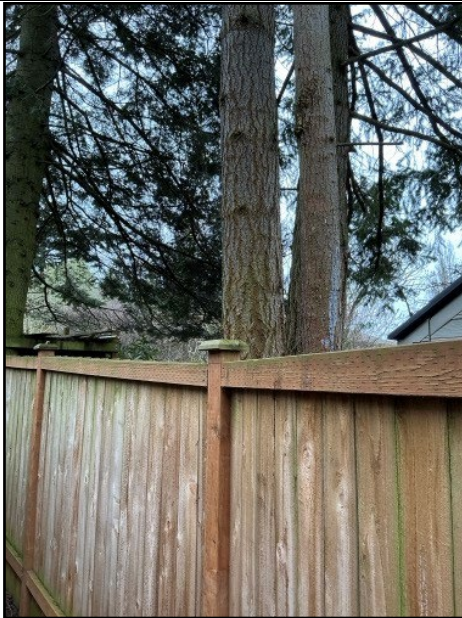
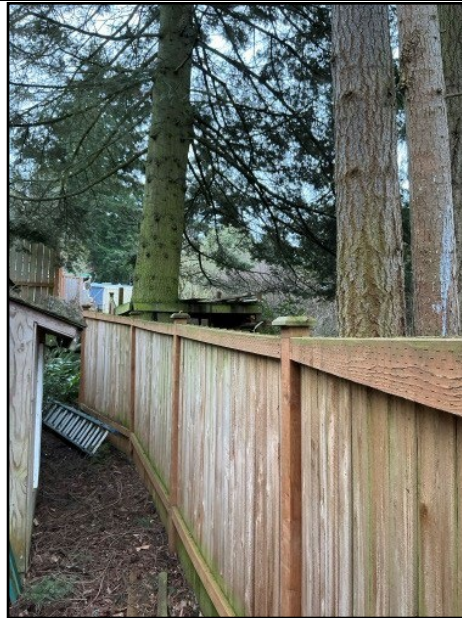
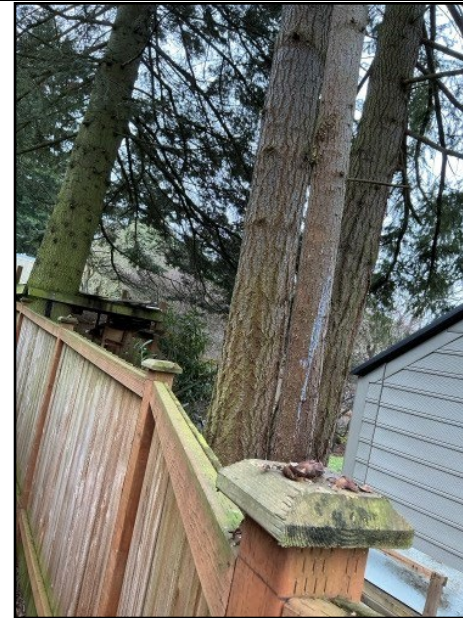
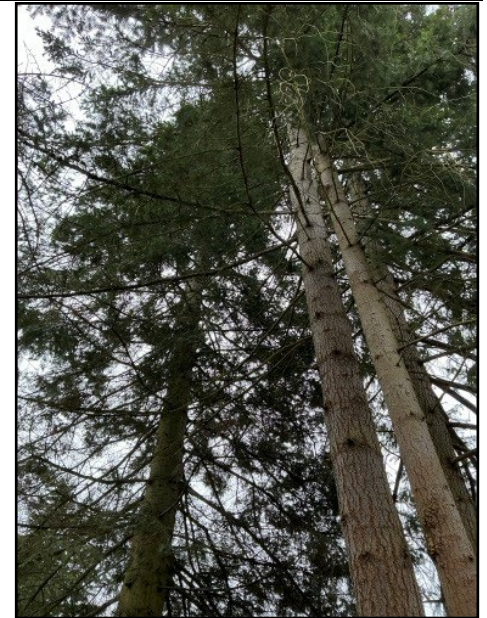
| Tree | Species | DSH (in) | Drip (ft) | CRZ (ft) | Condition | Structure | Risk | Pres. Value | Recommendations |
|---|---|---|---|---|---|---|---|---|---|
| 7 | Douglas fir<br><i>Pseudotsuga menziesii</i> | 15.0 | 17.0 | 15.0 | 4 Good | 4 Good | N/A | N/A | Tree Inventory |
| Notes/<br>Defect | This is an offsite tree located on the adjacent parcel to the south at 318 N 137 <sup>th</sup> St. This tree has a drip line that overlaps the fence by 8 feet to the north. | | | | | | | | |

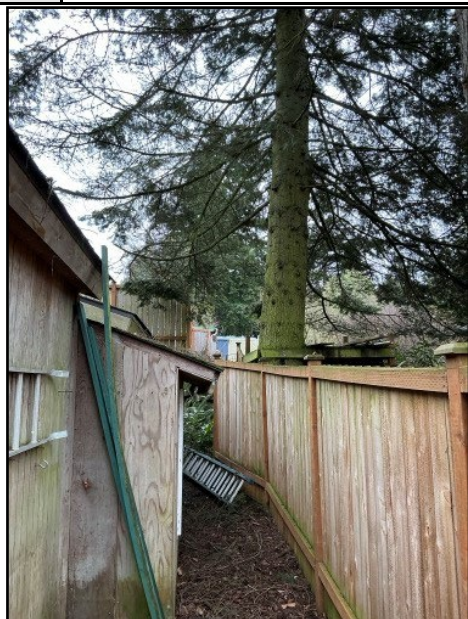
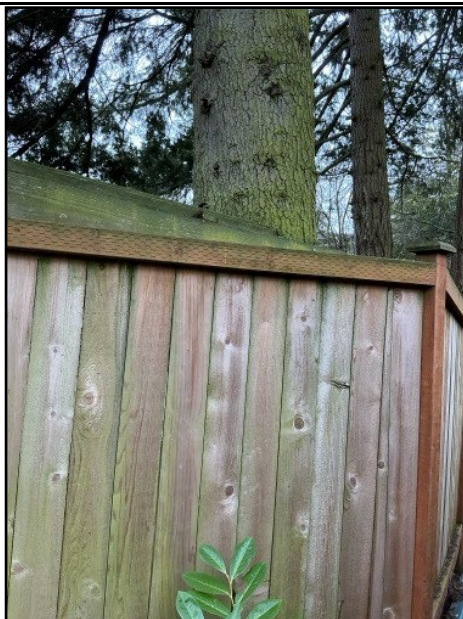
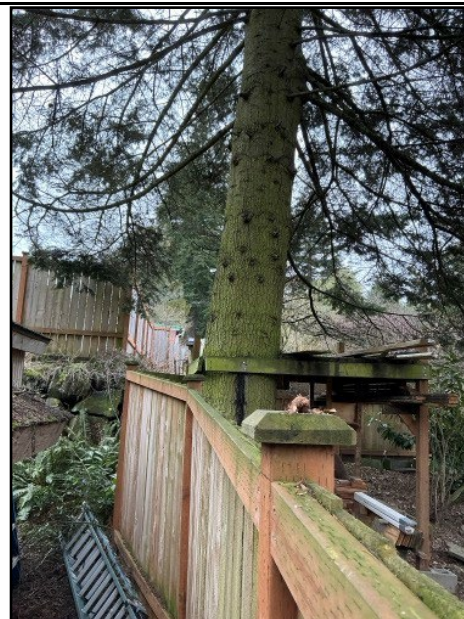
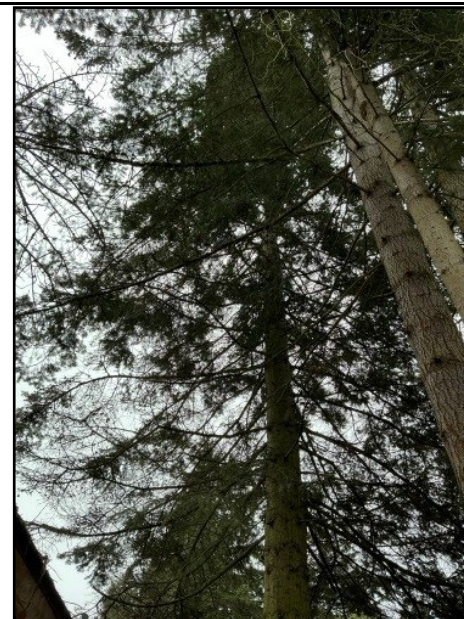
| Tree | Species | DSH (in) | Drip (ft) | CRZ (ft) | Condition | Structure | Risk | Pres. Value | Recommendations |
|---|---|---|---|---|---|---|---|---|---|
| 8 | Silver Fir<br><i>Abies amabilis</i> | 24.0 | 15.0 | 24.0 | 4 Good | 4 Good | N/A | N/A | Tree Inventory |
| Notes/<br>Defect | This is an offsite tree located on the adjacent parcel to the south at 317 N 138 <sup>th</sup> St. This tree has a drip line that overlaps the fence by 8 feet to the north. It appears that a fence line was built around the tree. | | | | | | | | |

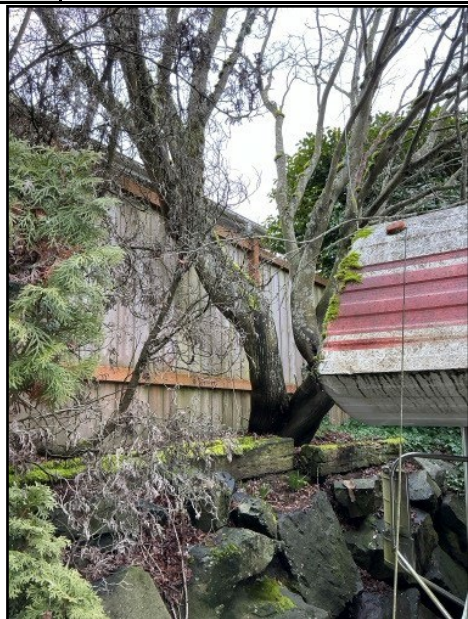
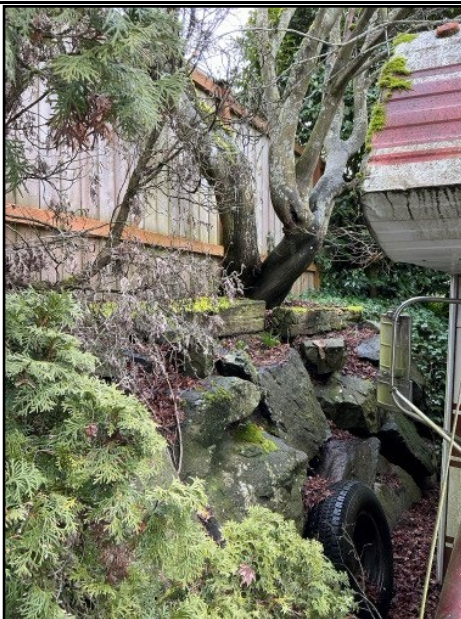
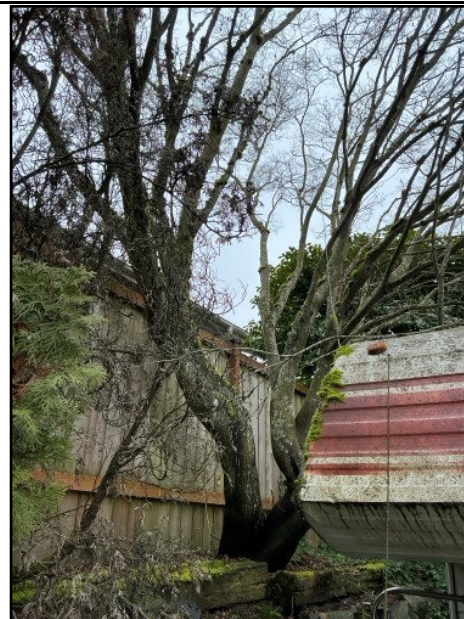
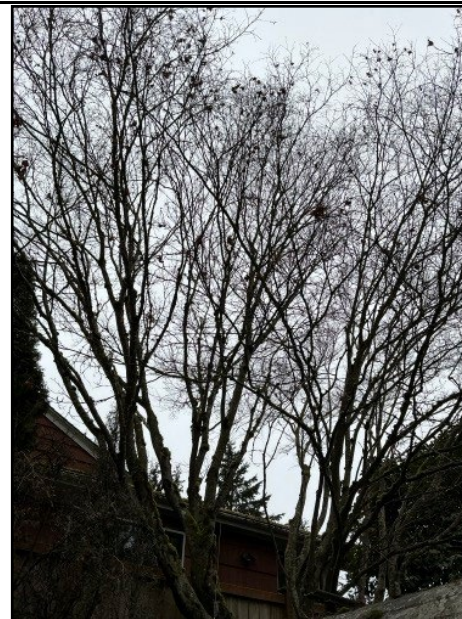
| Tree | Species | DSH (in) | Drip (ft) | CRZ (ft) | Condition | Structure | Risk | Pres. Value | Recommendations |
|---|---|---|---|---|---|---|---|---|---|
| 9 | Japanese maple <i>Acer palmatum</i> | 15.2 | 15.0 | 15.2 | 4 Good | 4 Good | N/A | N/A | Tree Inventory |

This tree is a two stemmed adjusted DSH. The tree sits 5 feet above grade. The tree is located next to the fence line.
