## ALPHA & OMEGA GROUP

### FIELD OBSERVATION REPORT

| <b>Project No. &amp; Description:</b> | 2025.091<br>1852 Liberty St<br>Failed Cistern / Sinkhole | <b>Time Departed:</b> | 1:45 pm |

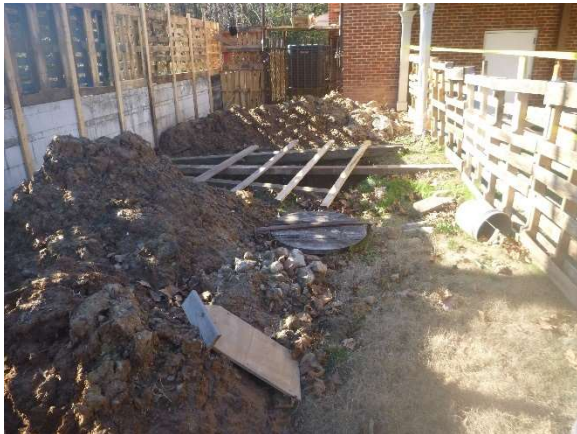
View of secured area of failed Cistern and resulting sinkhole

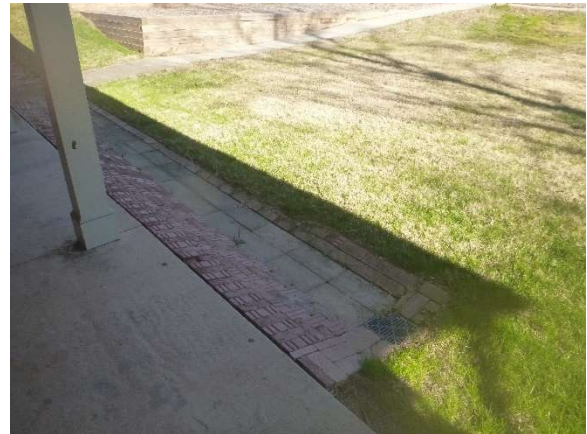
Area that drains into the existing Cistern, note landscape inlet to Cistern

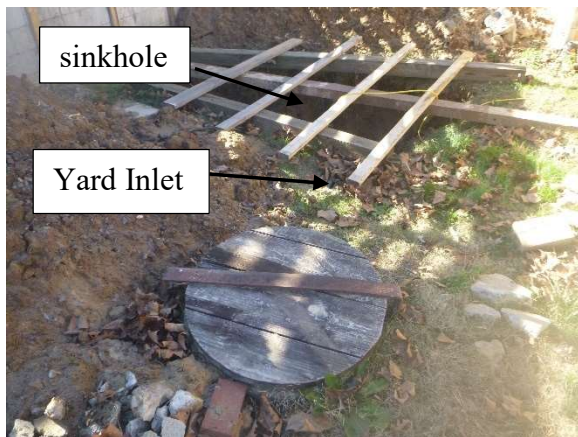
View of secured area of failed Cistern and resulting sinkhole

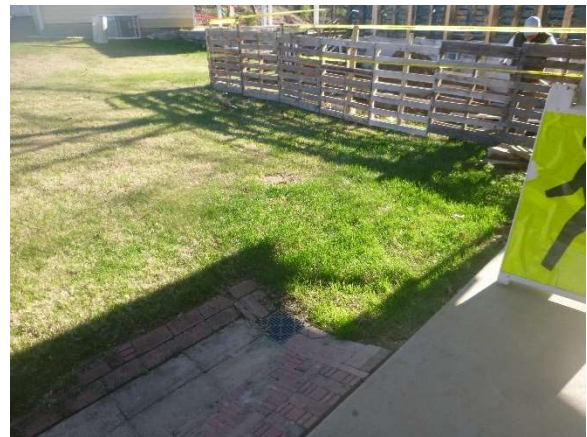
Area that drains into the existing Cistern

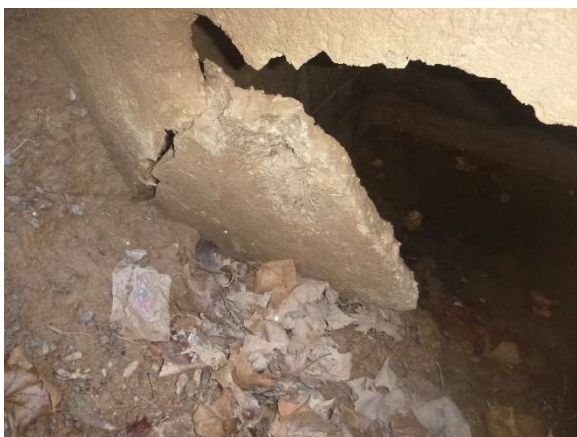
Failed wall of existing Cistern adjacent to sinkhole

- The Church building is constructed in a low lying area of the property such that stormwater is not able to flow around and away from the building. An underground Cistern, with sump pump, was installed to capture the stormwater runoff and discharge away from the building to a lower part of the property. It appears that the Cistern has been installed for 20 plus years or more based on the visual condition of the precast wall that has failed.
- The existing precast concrete Cistern, located about 3-feet below grade, is directly beneath the grated yard inlet adjacent to the sinkhole shown with dimensional lumber laid over the failed Cistern and adjacent sinkhole. The cistern has a sump pump that discharges the collected stormwater to the rear of the property.
- Recommend remove and replace the existing Cistern and Pumps with a new precast concrete Cistern of equal or larger size.

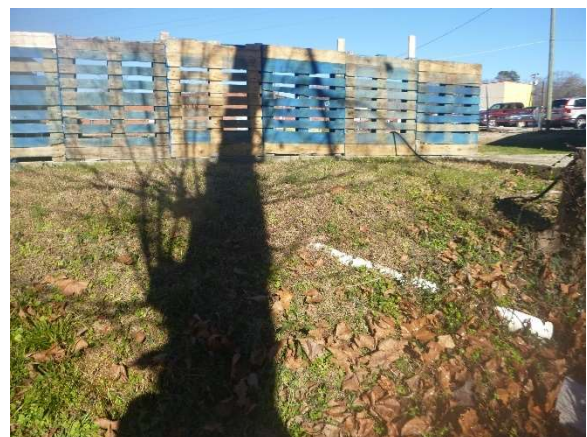
4" dia. Discharge pipe from existing Cistern

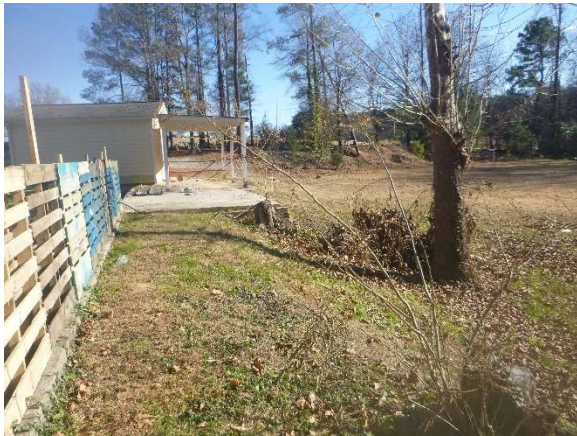
View of area receiving pumped discharge from Cistern

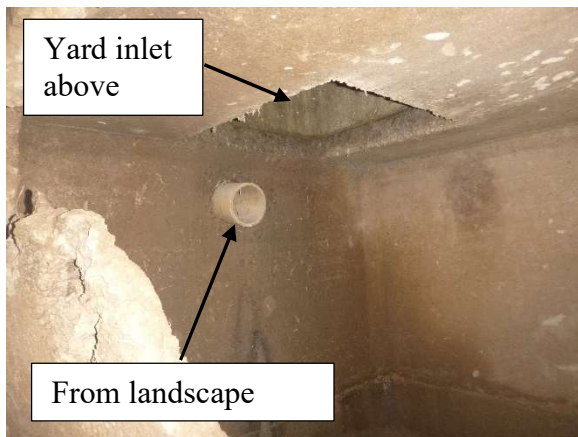
View of inlet above Cistern through failed wall
