Inspection Report

9218-9220 Roosevelt Way NE
Seattle, WA 98115

1/30/2026

260130A

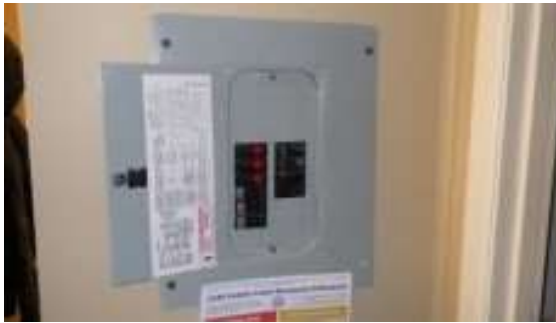
2. **Note** :-> There is a sub-panel located in each commercial space.

Sub-panel in 9218.

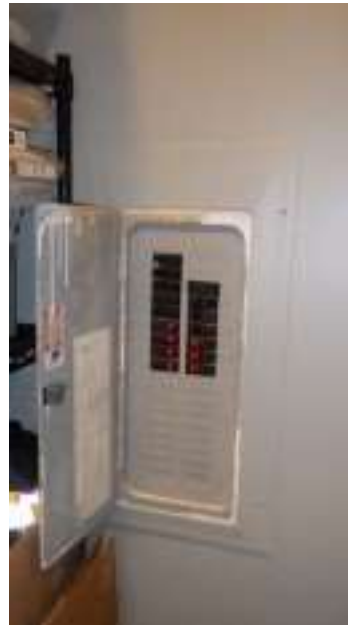
Subpanel in 9220.

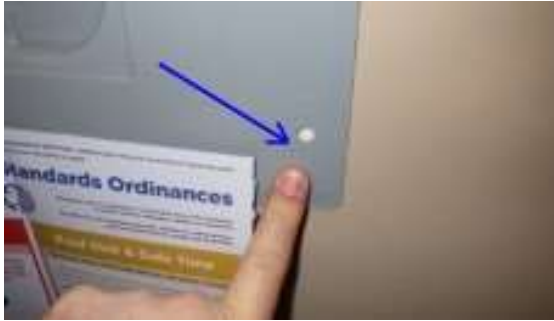
3. **Improvement Item** :-> There are missing dead-front screws noted at both sub-panels. Recommend a licensed electrician evaluate and install.

Install dead-front panel screw.

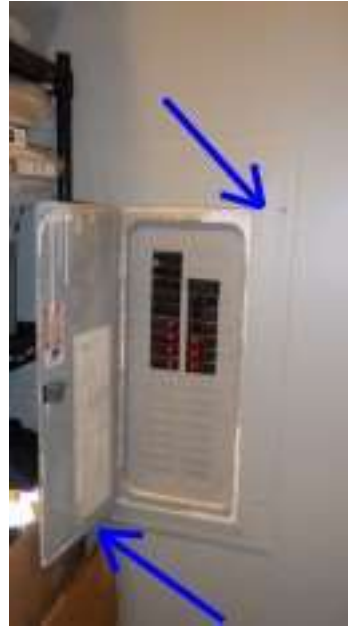
Missing dead-front panel screws.

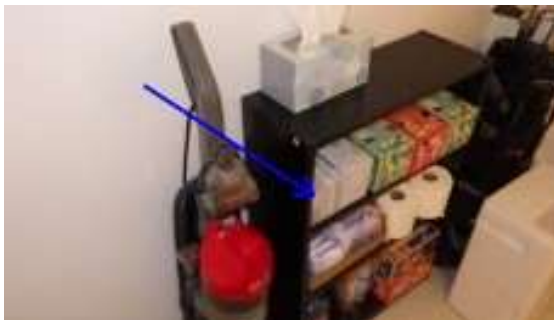
4. Repair :-> There is an outlet in the bathroom of 9218 that is not GFCI protected. Recommend a licensed electrician evaluate and repair.

Outlet behind cabinet in 9218 bathroom is not GFCI protected.

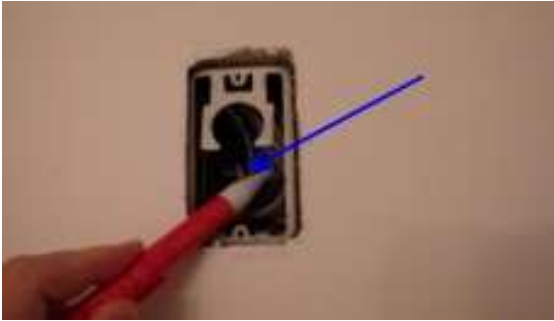
5. Note :-> In the bathroom of 9218, there is a wiring noted in an open junction box. No signs of voltage. Recommend installing a cover.

No voltage detected. Install cover.

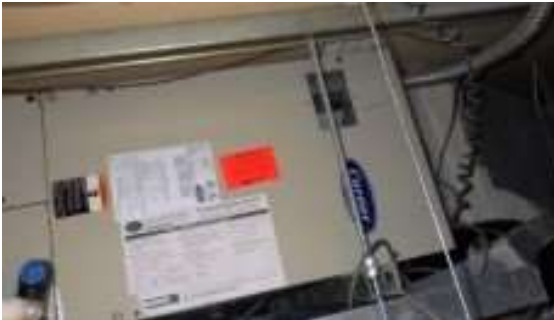
7. Note :-> The heat pumps are located in the garage below the units and there are air handlers noted in each unit above the ceiling tiles. The air handlers were manufactured in 1998. The last service record recorded at the units is from 2012. Recommend servicing yearly.

9218 air handler above the ceiling tiles.

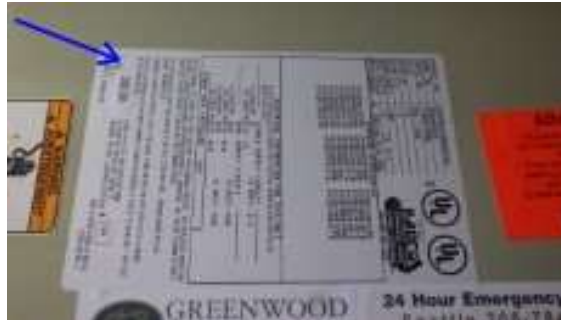
9218 air handler info.

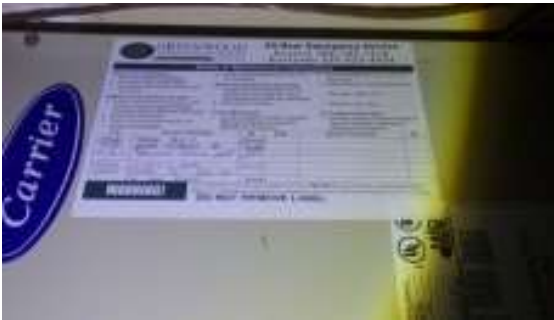
9220 air handler above the ceiling tiles.

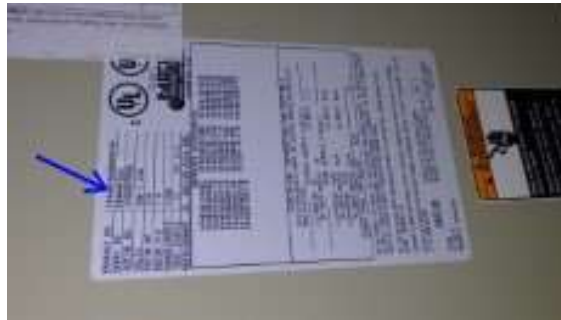
9218 air handler info.

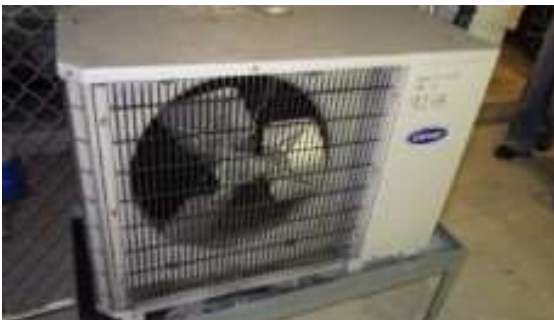
9218 heat pump in garage below.

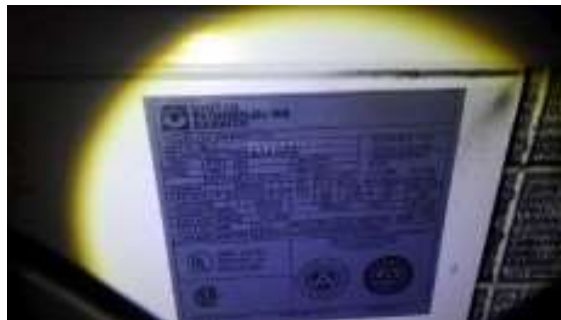
9218 info.

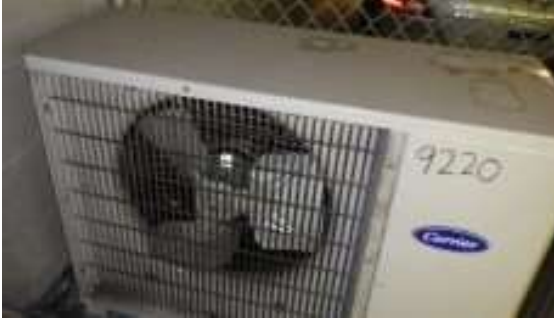
9220 heat pump in garage below.

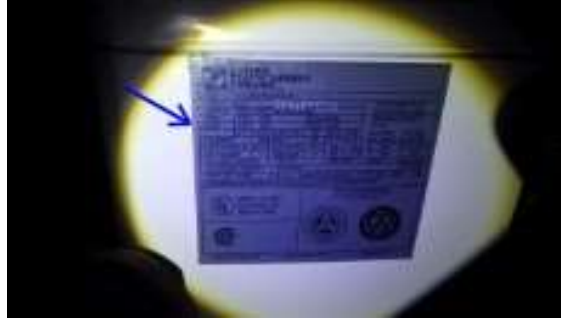
9220 heat pump info.

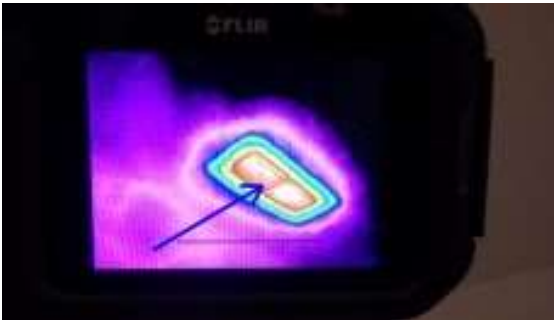
9. Note :-> All visible registers were verified for heat using an infrared camera.

Heat verified at registers.

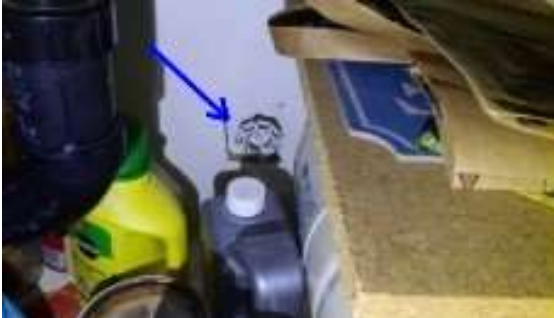
Water shut off beneath sink in 9218.

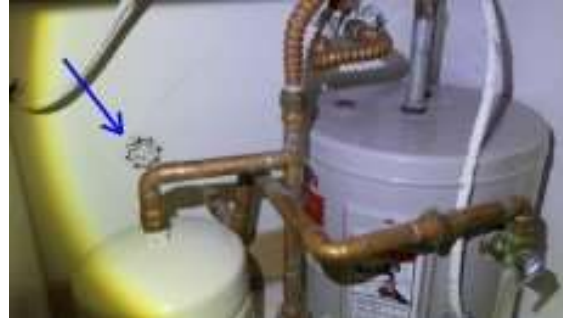
Water shut off beneath bathroom sink in 9220.

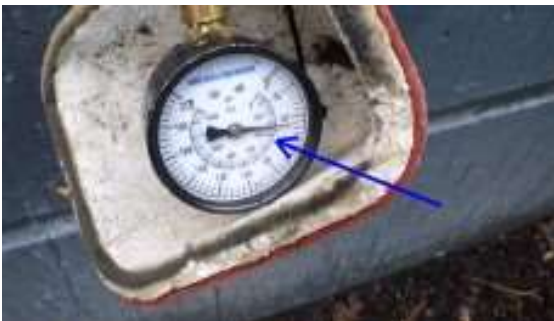
45 PSI at exterior hose bib.

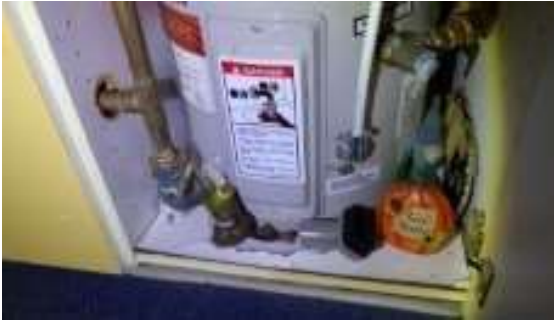
11. Repair :-> The water heater beneath the sink in 9218 is showing signs of oxidation and previous moisture. Water heaters have a design life of 12-15 years. These water heaters appear to have been manufactured in 2000. Recommend a licensed plumber evaluate and replace. Hidden conditions may be present.

9218 water heater.

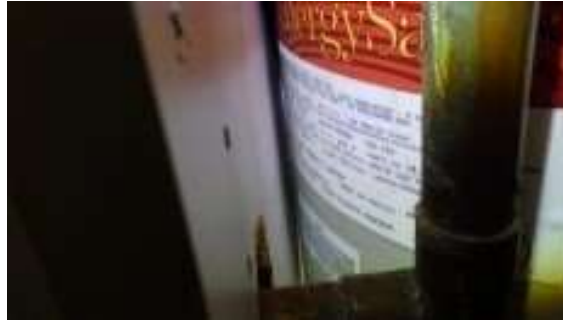
9218 water heater info.

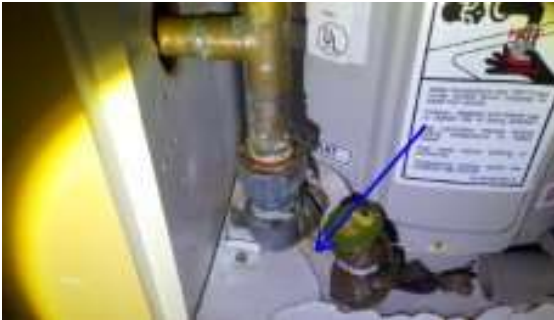
Oxidation and previous moisture noted.

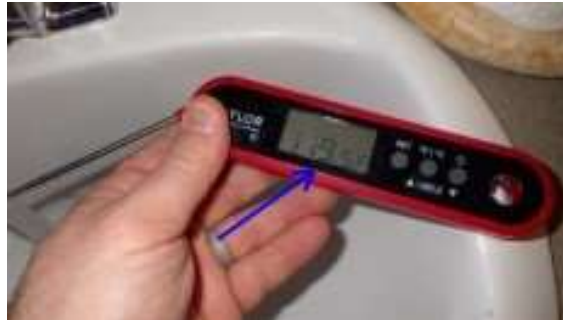
119 degrees F at sink.

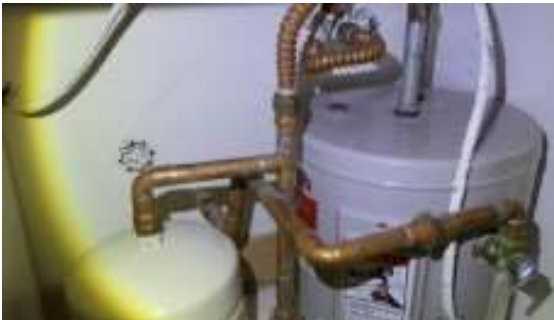
9220 water heater in bathroom.

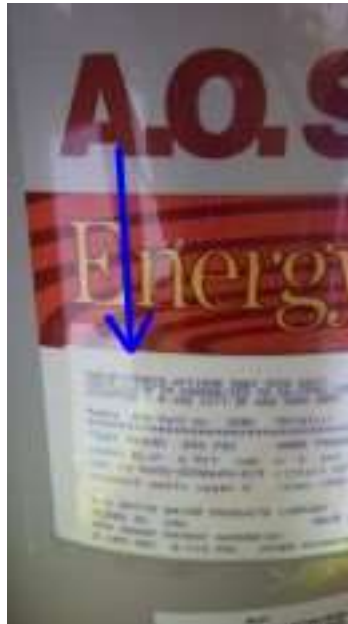
9220 water heater info.

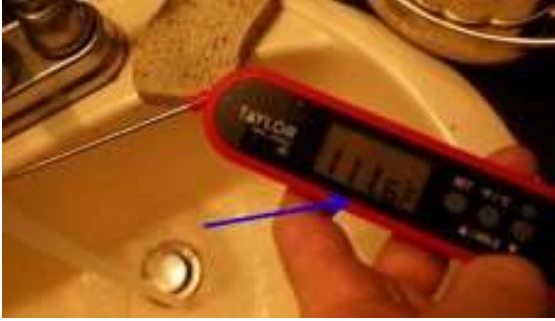
112 degrees F at 9220.

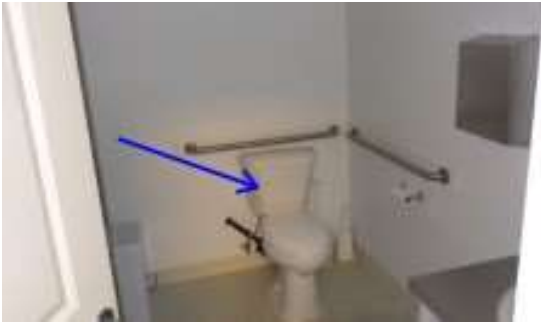
12. Improvement Item :-> The toilet in 9218 has a toilet that runs after being flushed. Recommend replacing/repairing as necessary.

Toilet runs after being flushed.

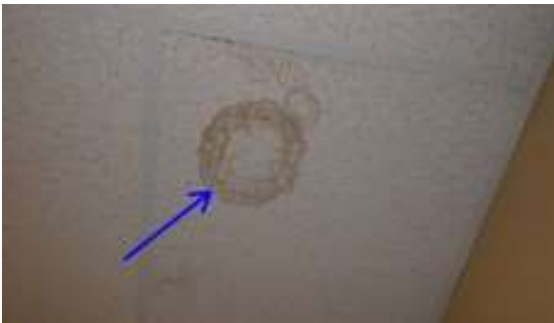
13. Note :-> In 9218, there are signs of discoloration noted in the ceiling tile near the front door. No signs of active moisture noted at the time of the inspection.

Discoloration noted in ceiling tile above the entrance.

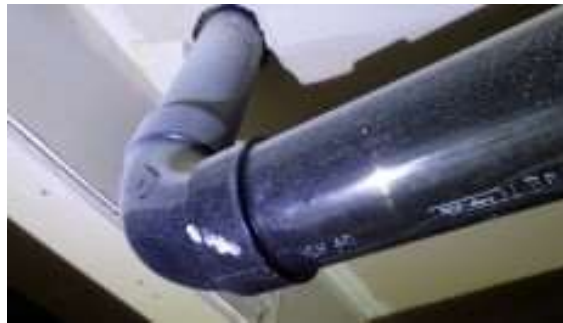
No signs of moisture noted above the tile.

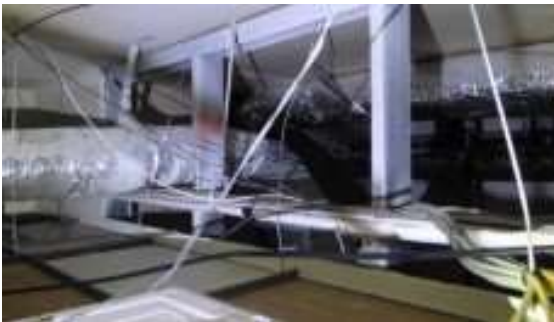
View of space above ceiling tiles.

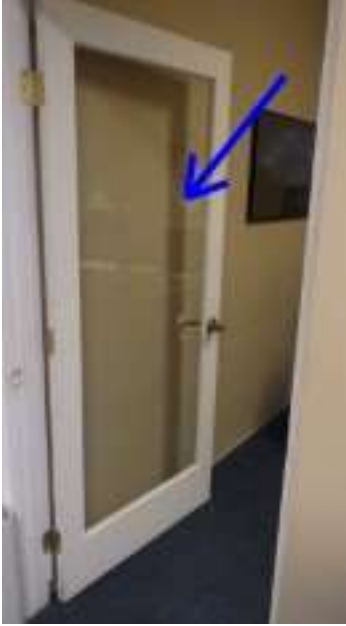
14. Improvement Item :-> The office door in 9218 has trim/stops that don't engage. Recommend adjusting.

Office door is difficult to latch.

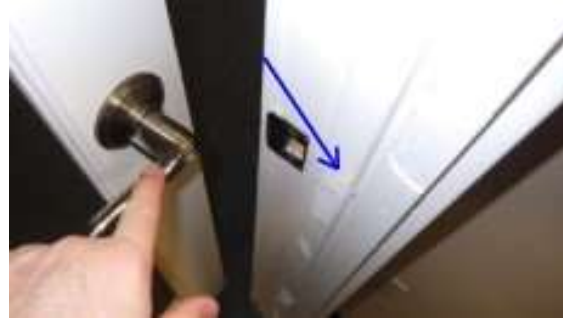
Door stop doesn't stop door.
