March 22, 2023
McGinley Project #BRN093.003

**RE: RESULTS OF GPR SURVEY, 80 WEST FRONT STREET, APN 002-078-01,
BATTLE MOUNTAIN, LANDER COUNTY, NEVADA (SITE), CONTRACT
DEP22-001, TASK MA25-23**

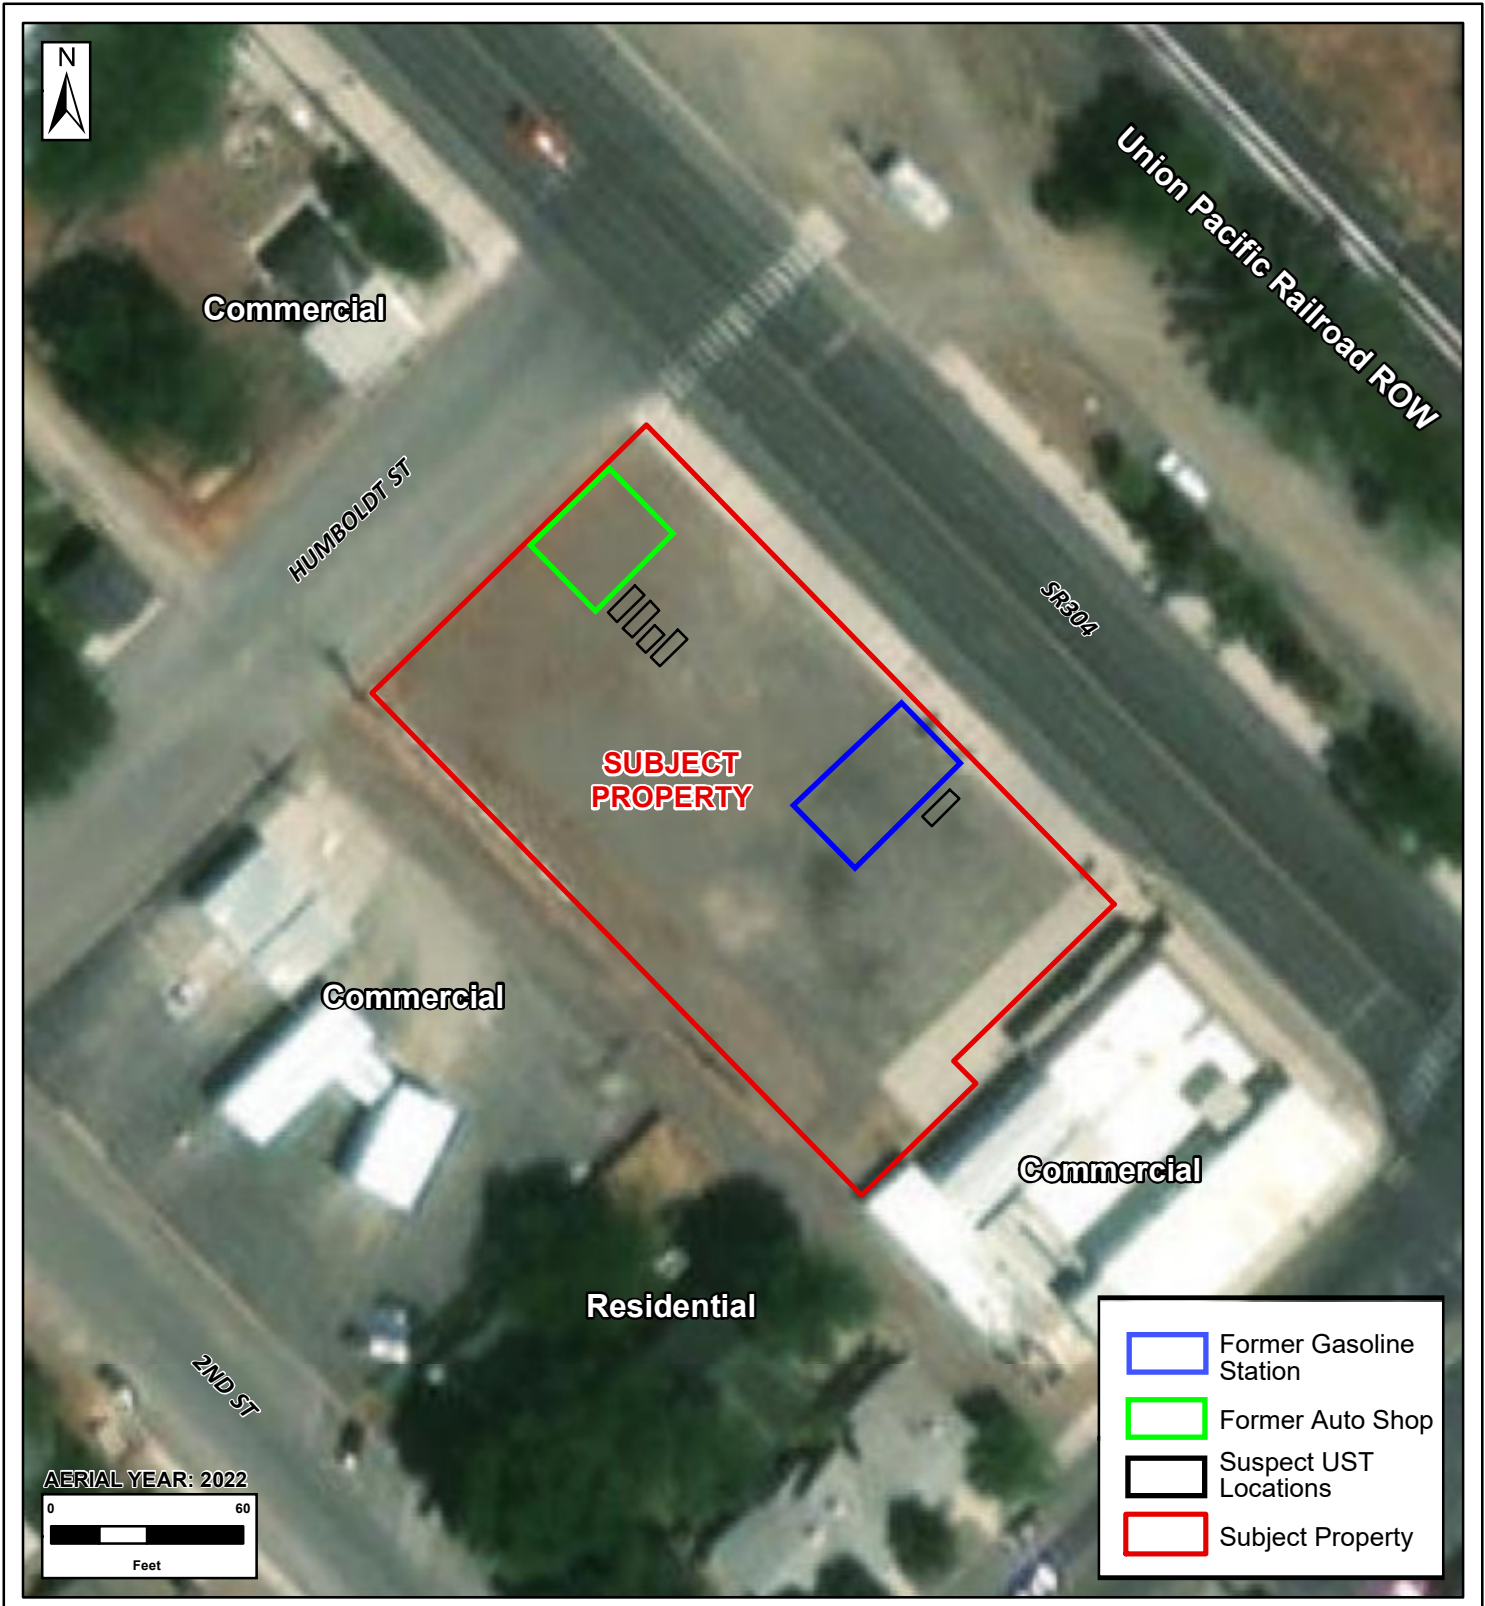
FIGURE 2	
TITLE: SITE MAP -SHOWING- 80 West Front Street APN 002-078-01 Battle Mountain, Lander County, NVV	
JOB NO.: BRN093.001	DATE: 3/21/2023

- Former Gasoline Station
- Former Auto Shop
- Suspect UST Locations
- Subject Property

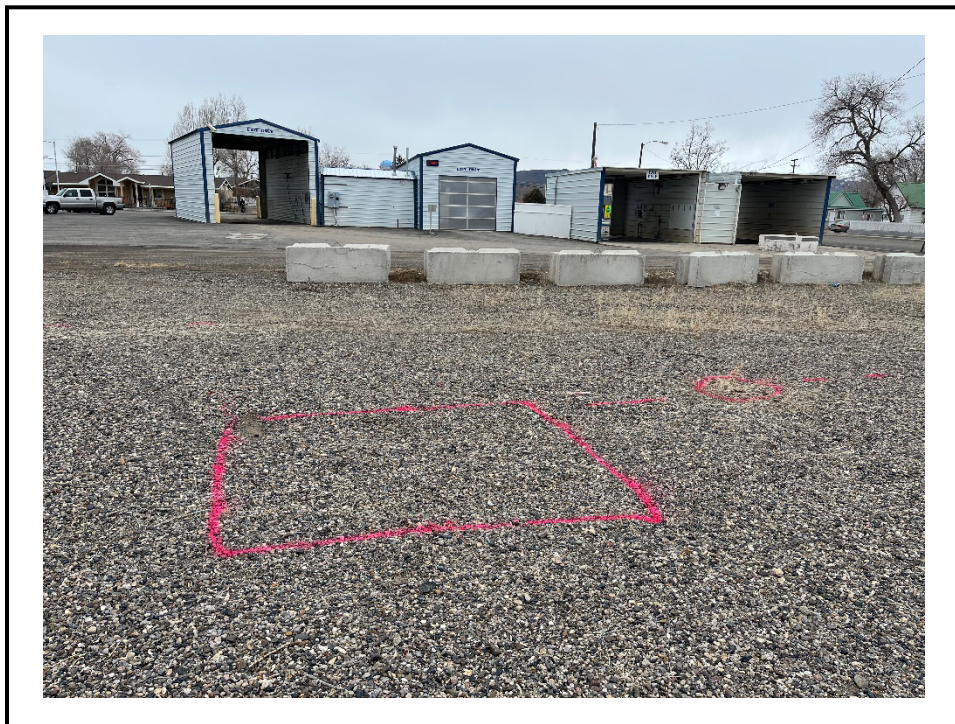
Photograph 1:
View of suspected septic tank near the northwest boundary of the Site.

I believe I also noticed a possible Sewer Tank 6'x7' APPROX. A pipe was noticed going into & out of this tank

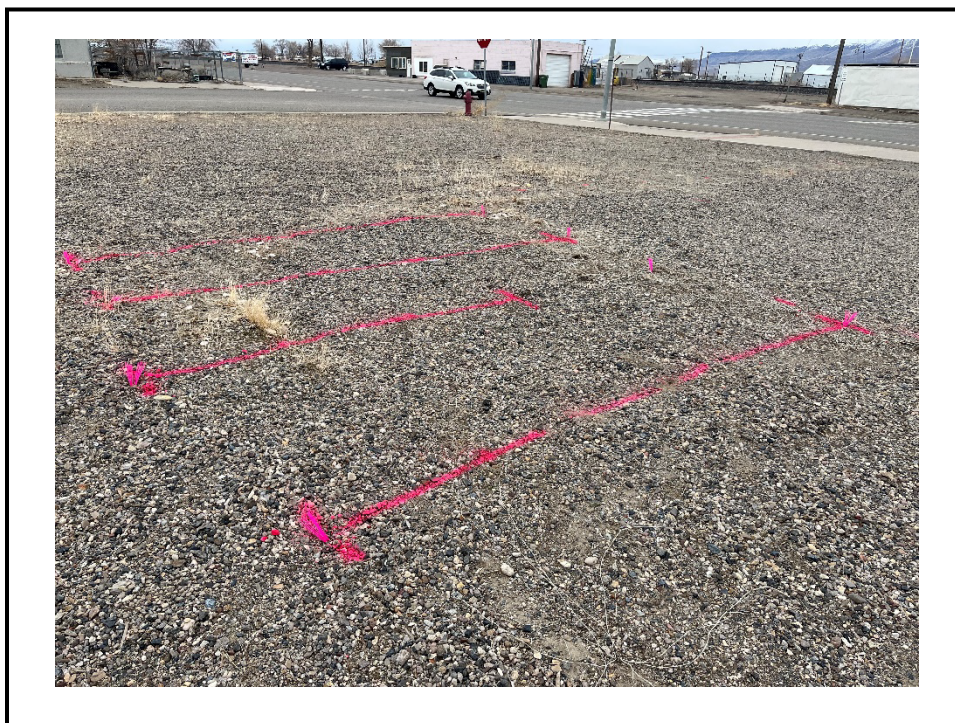
Three of the suspected USTs located in the northern portion of the Site were approximately 12 feet long, and one was approximately eight feet long. The suspect UST located in the central portion of the Site measured approximately 12 feet long.

Photograph 2:
View of four suspect USTs located in the northern portion of the Site.

2'-3' Deep in the Group of 4 - 3 are APPROX 12' Long.

1 is APPROX 8' Long

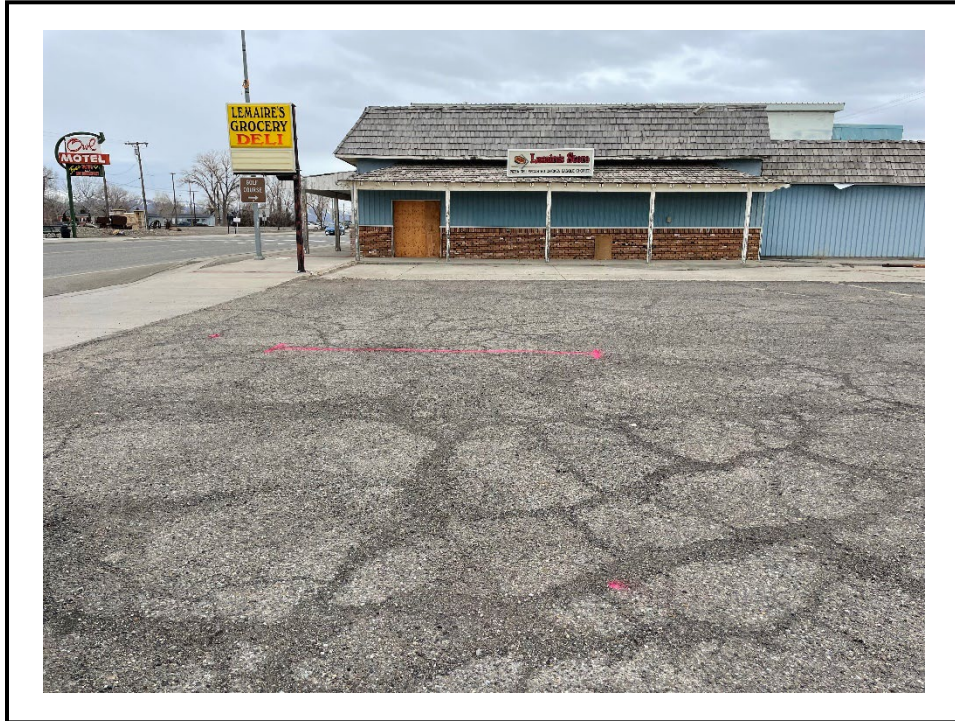
Photograph 3:
View of suspected UST in the central portion of the Site.

2 1/2'-3' Deep The UST By itself is APPROX. 12' Long

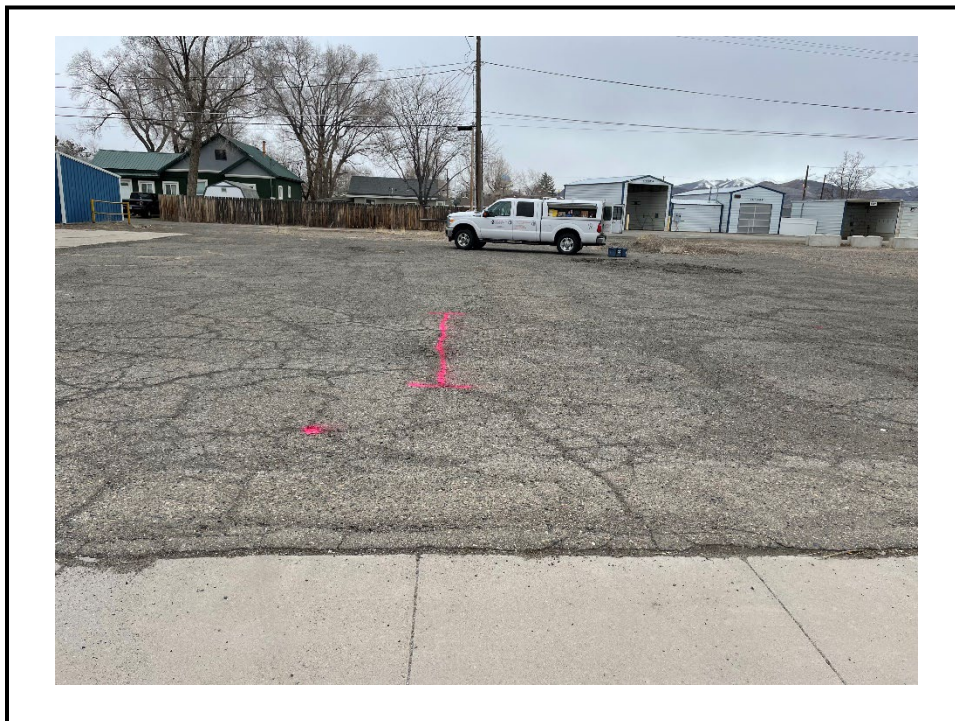
Photograph 4:
Alternative view of suspected UST in the central portion of the Site.

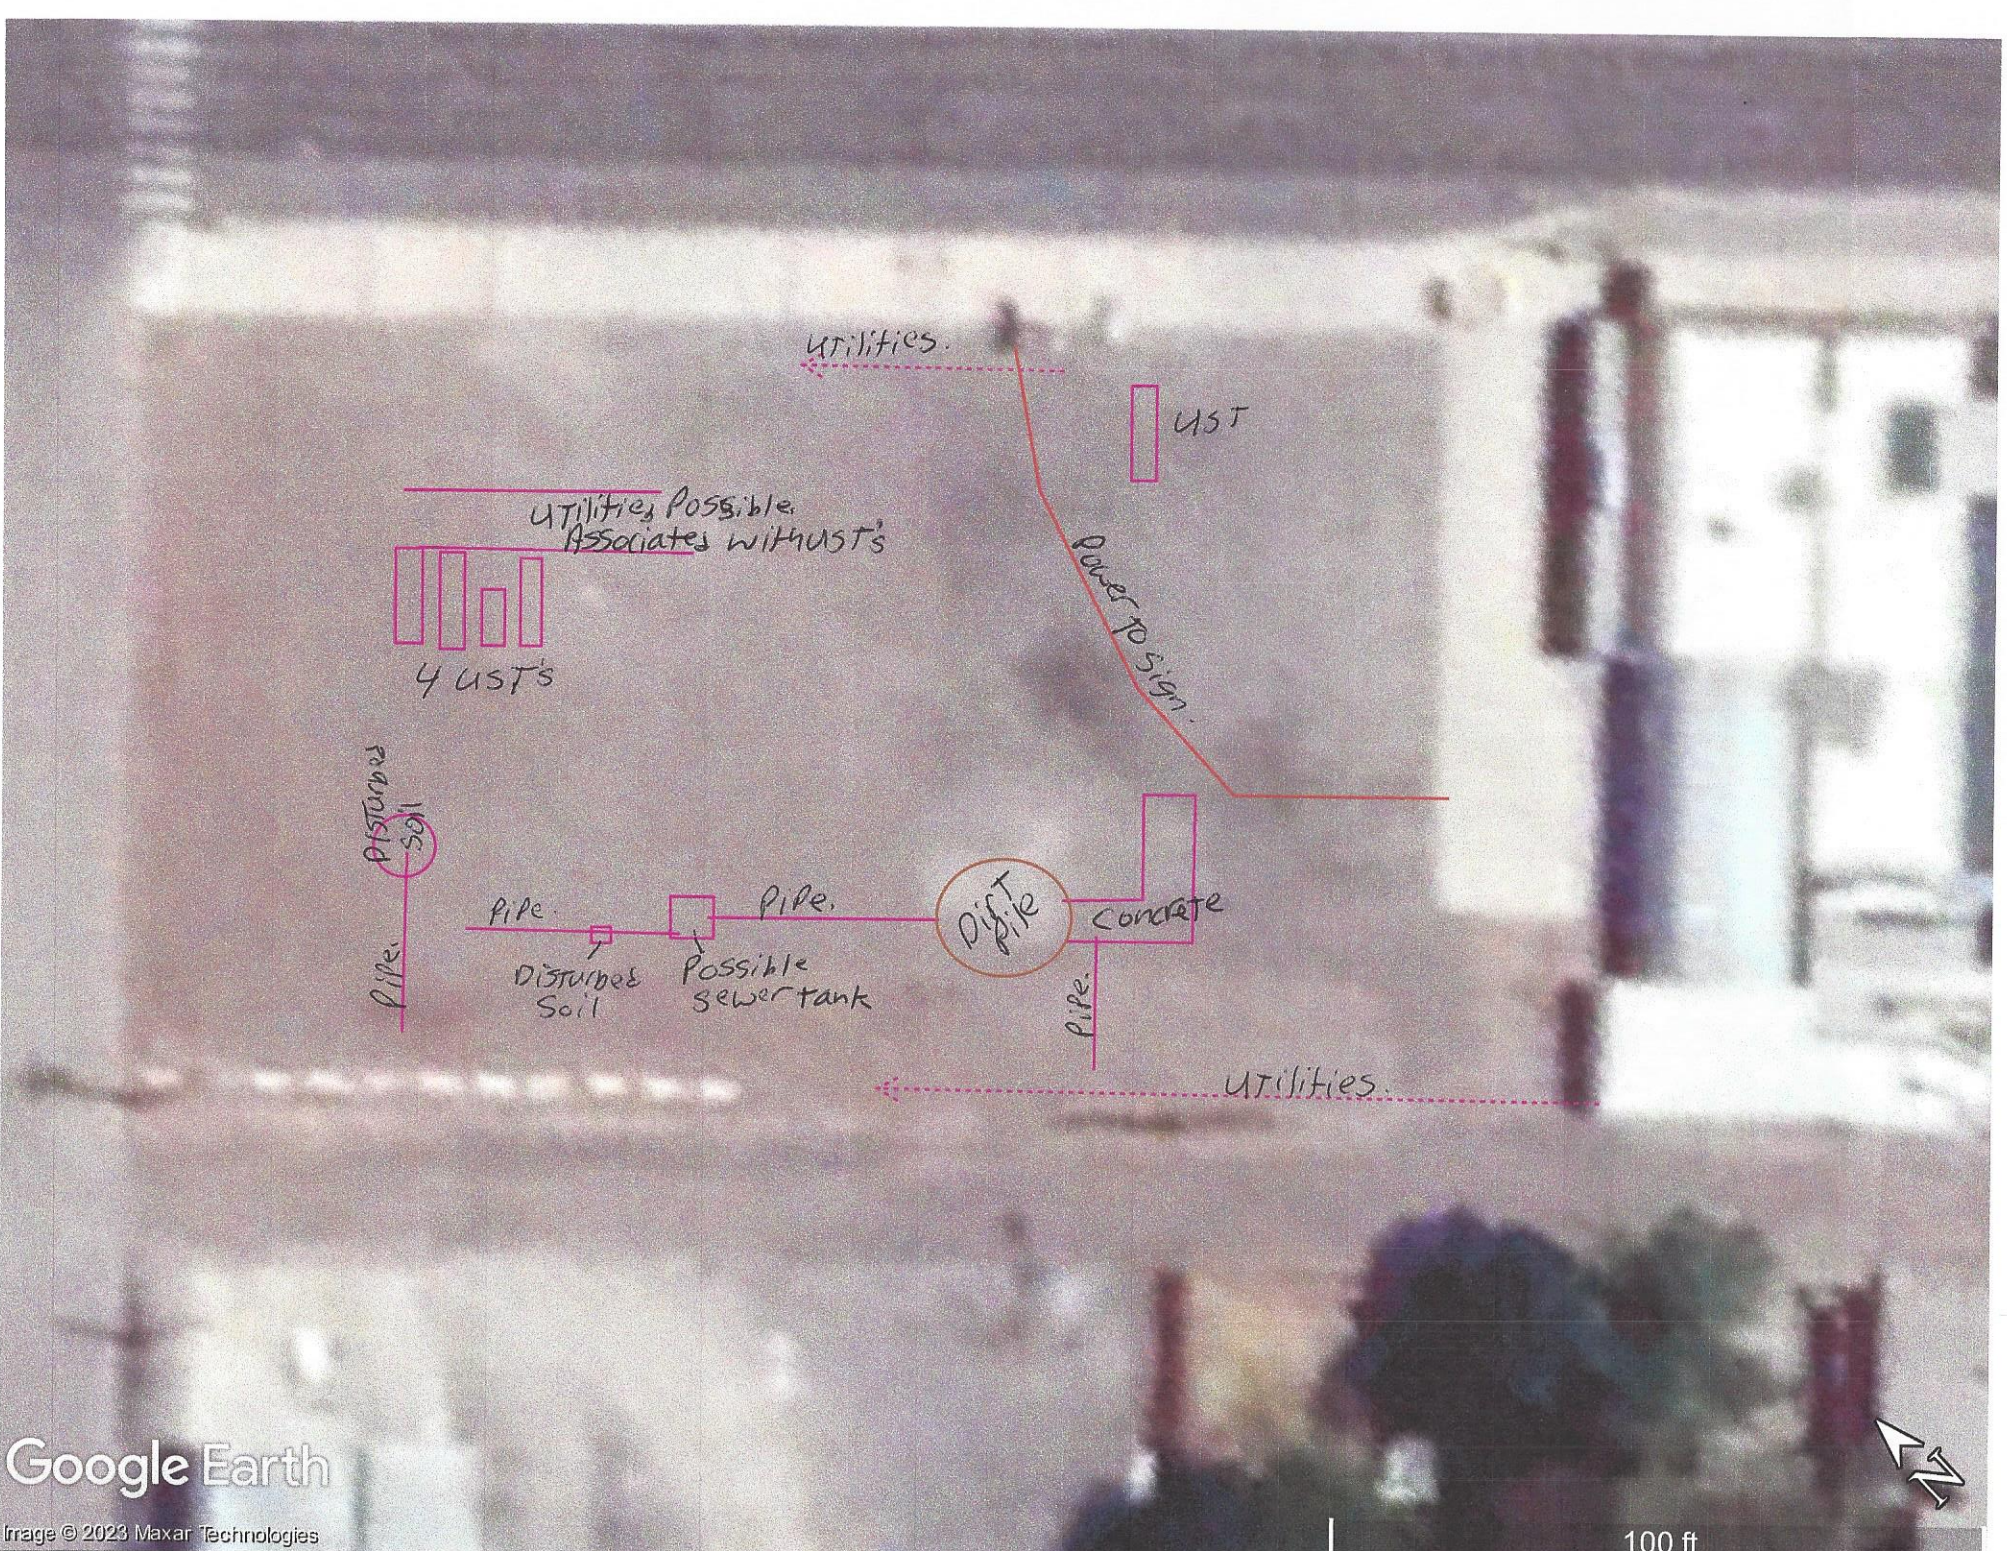
UST

Utilities Possible.
Associated with UST's

4 UST's

Possible
sewer tank
