STRUCTURAL INTEGRITY RESERVE STUDY

**Miramar Club Condominium Association,
Inc.**

3399 Foxcroft Rd., Miramar, FL 33025

**Project Number:
24122110**

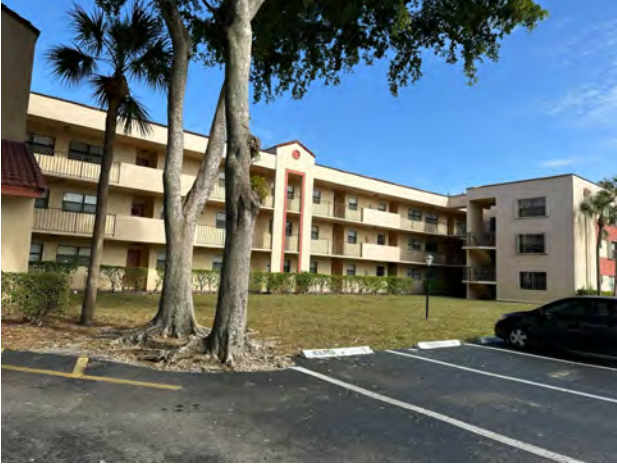
PHOTO 1

GENERAL VIEW OF PROPERTY

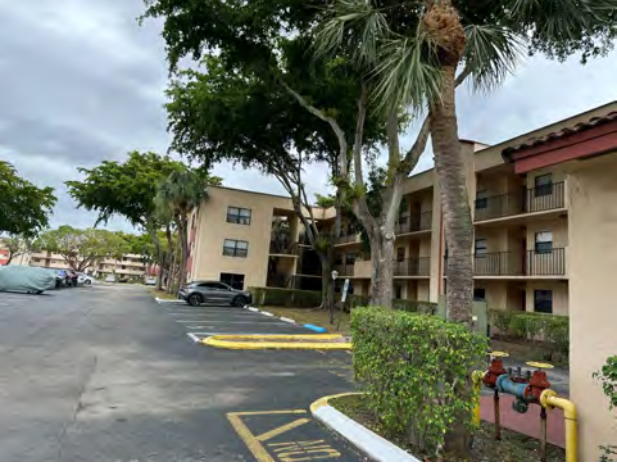
PHOTO 2

GENERAL VIEW OF PROPERTY

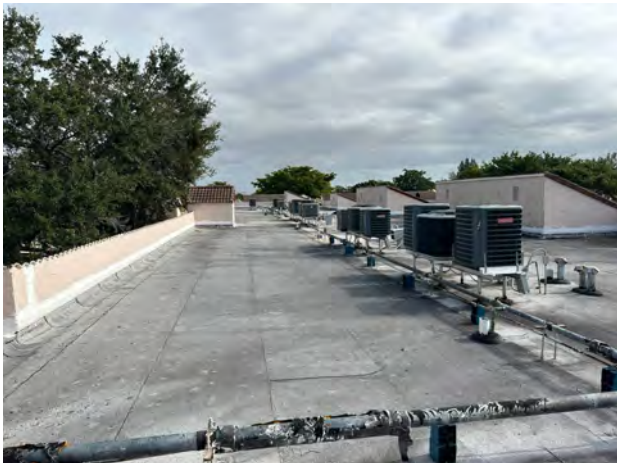
PHOTO 3

GENERAL VIEW OF TYPICAL ROOFTOP

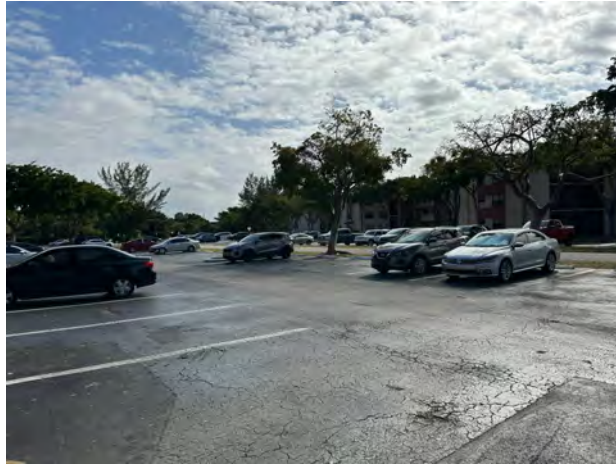
PHOTO 4

GENERAL VIEW OF TYPICAL PARKING AREA

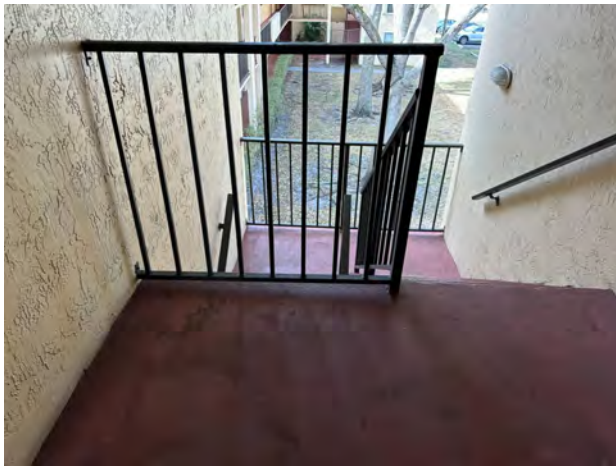
PHOTO 5

GENERAL VIEW OF TYPICAL STAIRCASE

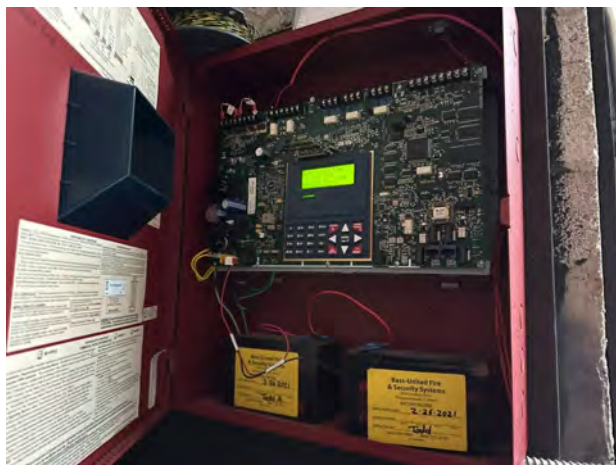
PHOTO 6

GENERAL VIEW OF FIRE ALARM PANEL

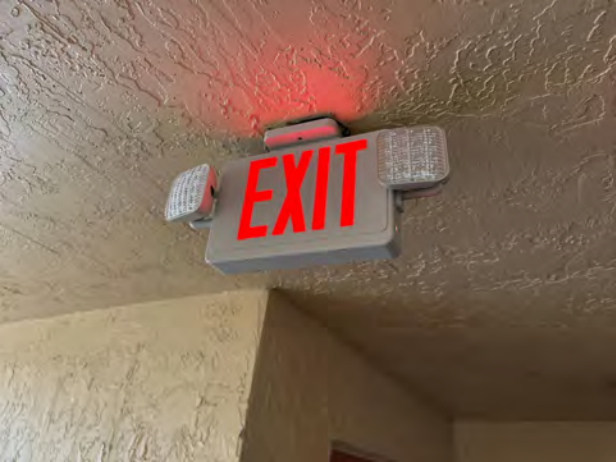
PHOTO 7

GENERAL VIEW OF EXIT LIGHTS

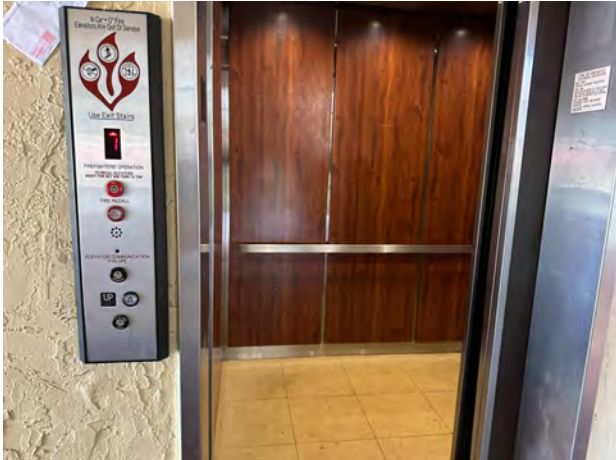
PHOTO 8

GENERAL VIEW OF ELEVATOR

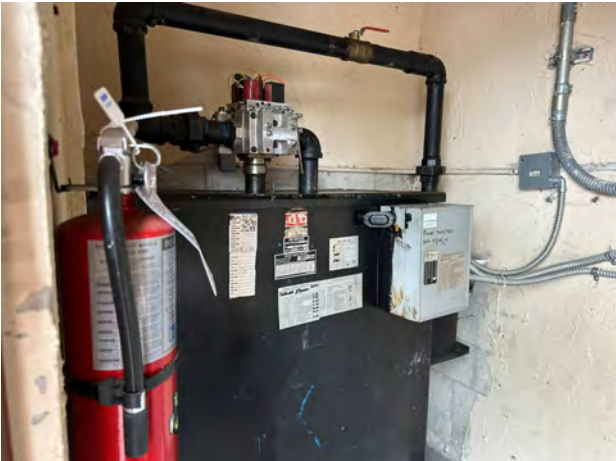
PHOTO 9

VIEW OF TYPICAL ELEVATOR PUMP

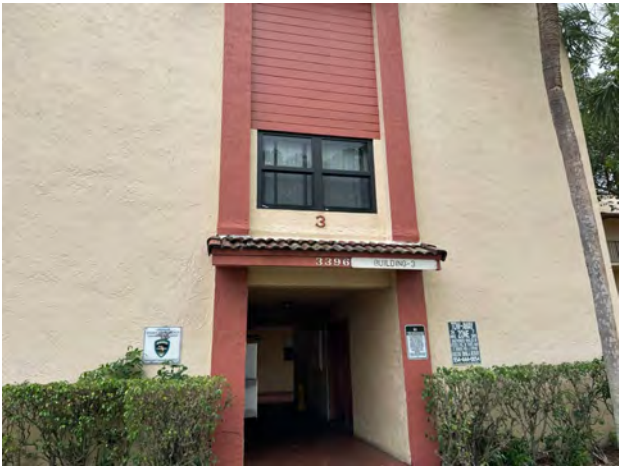
PHOTO 10

GENERAL VIEW OF BUILDING EXTERIOR FINISHES

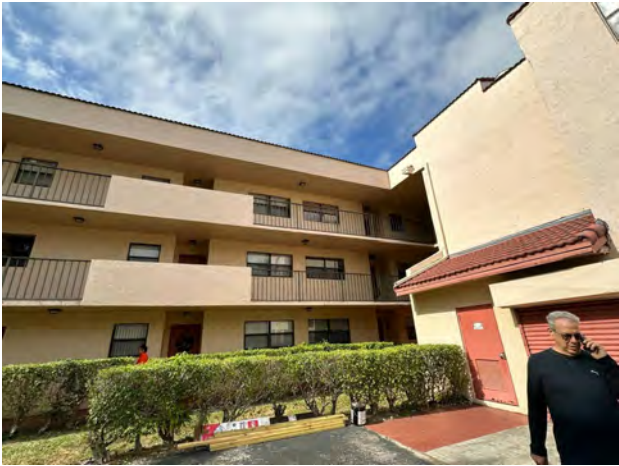
PHOTO 11

GENERAL VIEW OF BUILDING EXTERIOR FINISHES

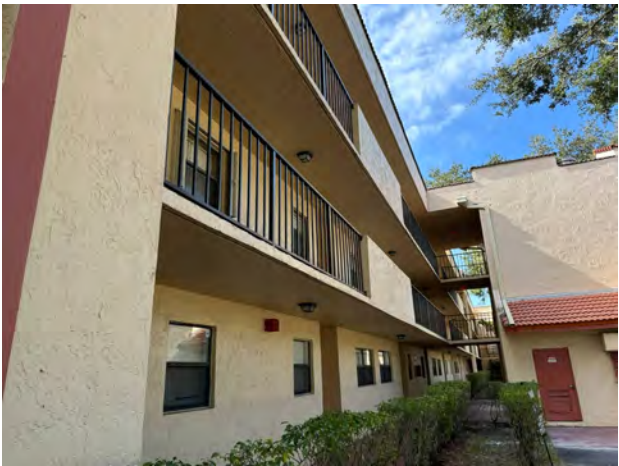
PHOTO 12

VIEW OF BUILDING EXTERIOR FINISHES

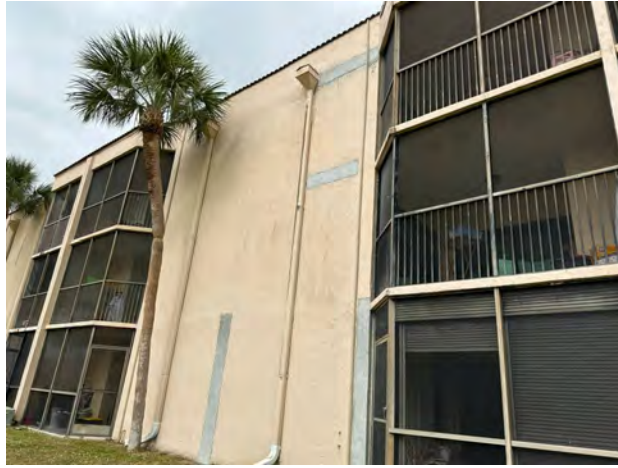
PHOTO 13

VIEW OF TYPICAL BALCONY

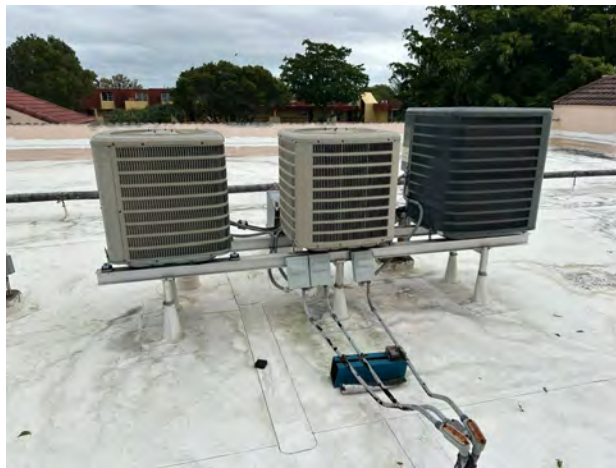
PHOTO 14

VIEW OF HVAC EQUIPMENT

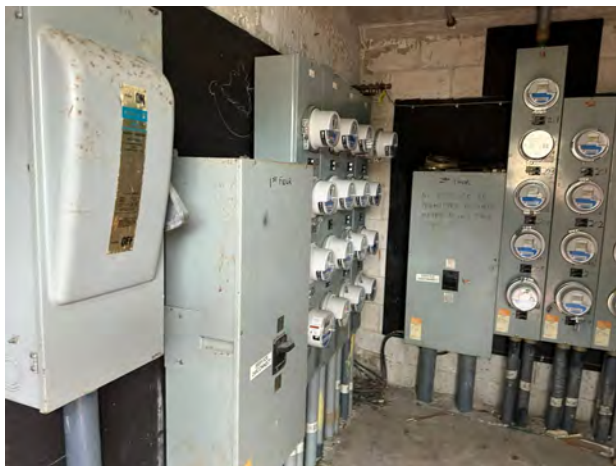
PHOTO 15

VIEW OF ELECTRICAL EQUIPMENT

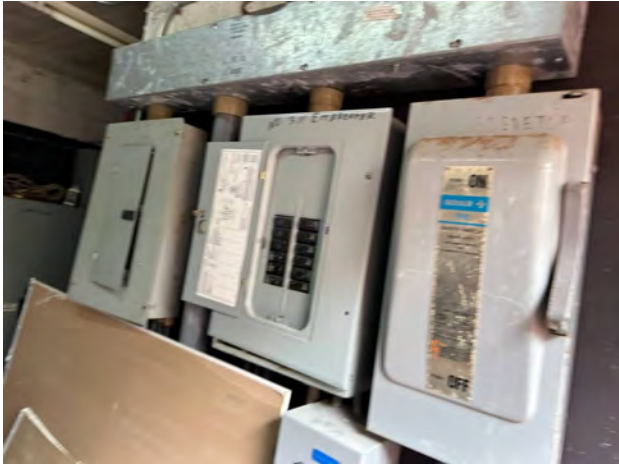
PHOTO 16

VIEW OF ELECTRICAL EQUIPMENT

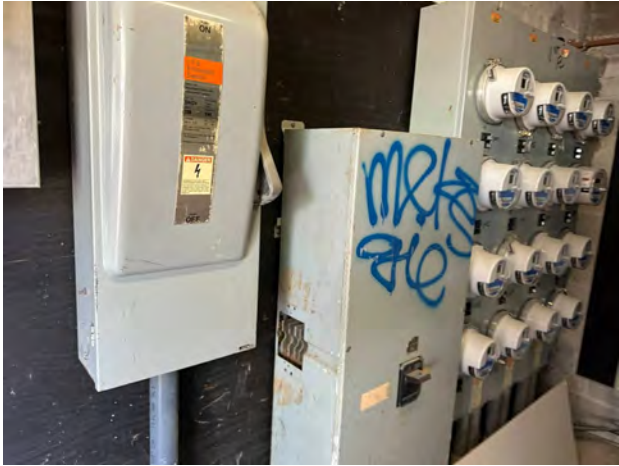
PHOTO 17

VIEW OF ELECTRICAL EQUIPMENT

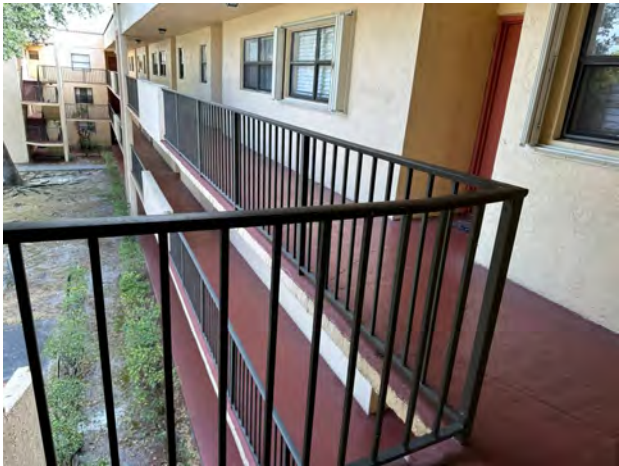
PHOTO 18

GENERAL VIEW OF ELEVATED WALKWAY
