## Septic Inspection Report

Arlington Inn  
Cottage

03/26/2026

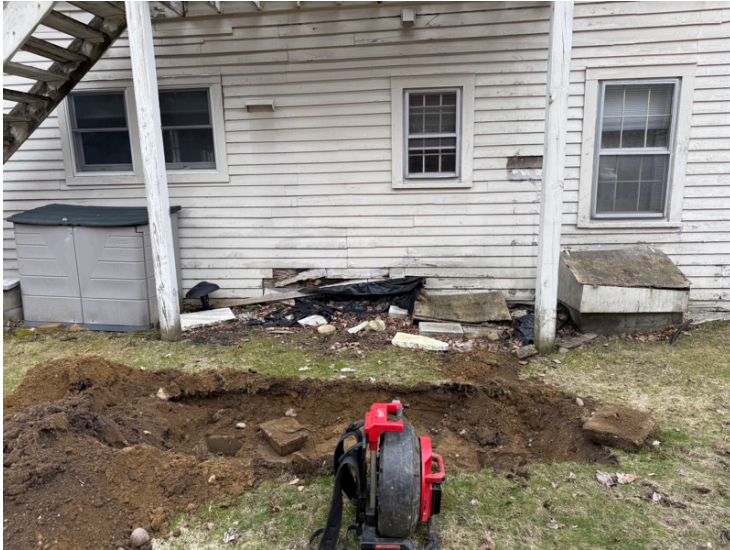
Tank location photo

Behind house
