February 3, 2023

Ref. SS23-0101.01

REF: STRUCTURAL INSPECTION OF THE PROPERTY @  
1081-1085 Mt Vernon Ave,  
Columbus, OH 43203

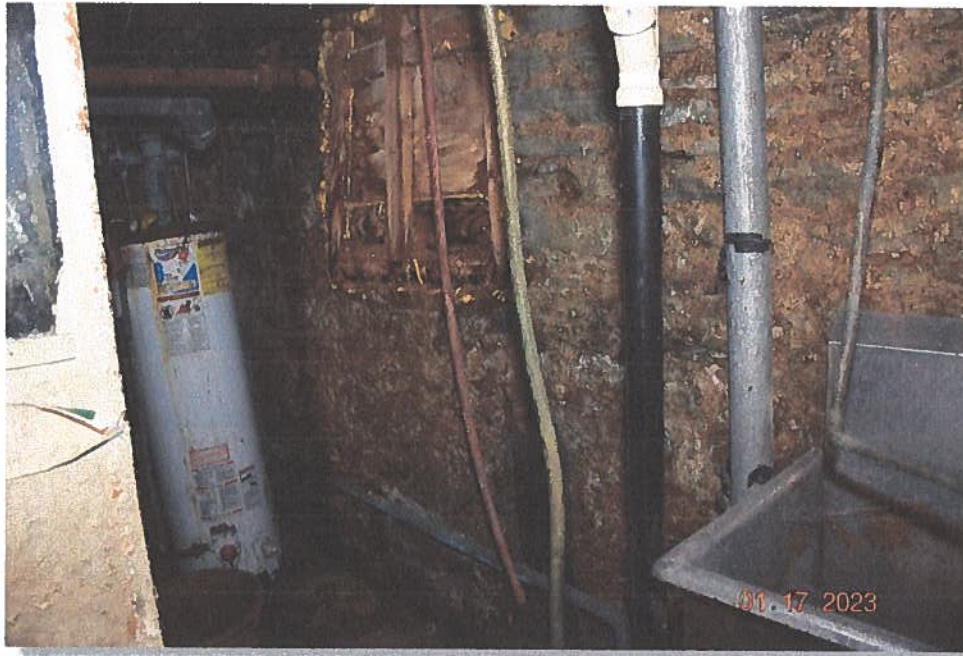
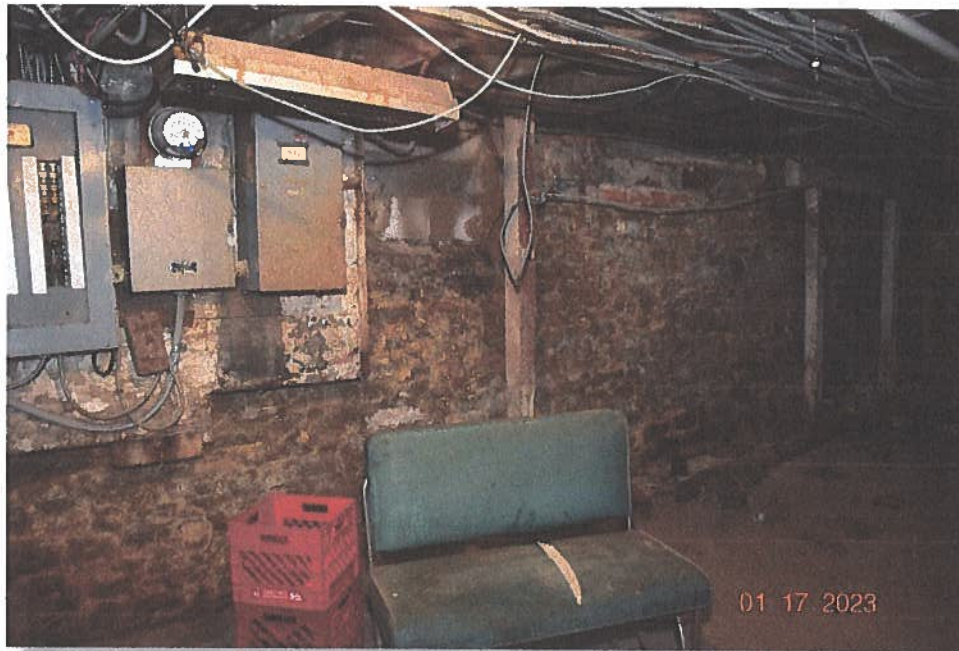
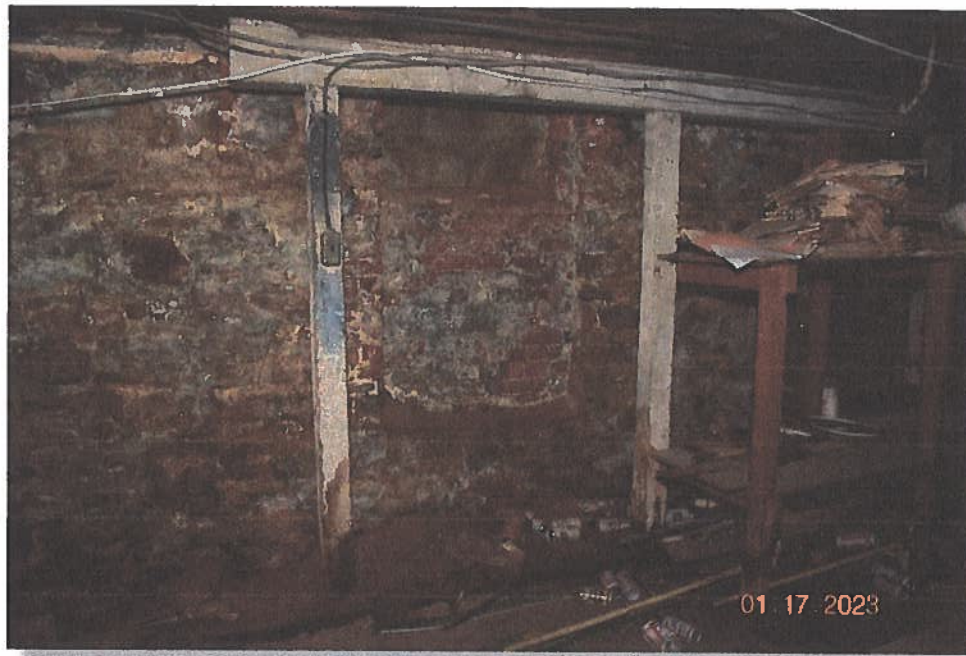
The pictures (Pic. 1 through Pic. 16) show the exterior and interior foundation wall of the basement of the three units. Based on the inspection, it is our opinion that most of the foundation is in acceptable condition, and there is no structural foundation repair required except a portion of the wall at the northeast corner in the basement of unit #1085 with heavy water seep through the foundation as shown in the picture (Pic. 13). It is recommended to waterproof the wall to prevent the foundation from deterioration.

**Pic. 1: Typical view of the foundation (exterior wall) of unit #1081**

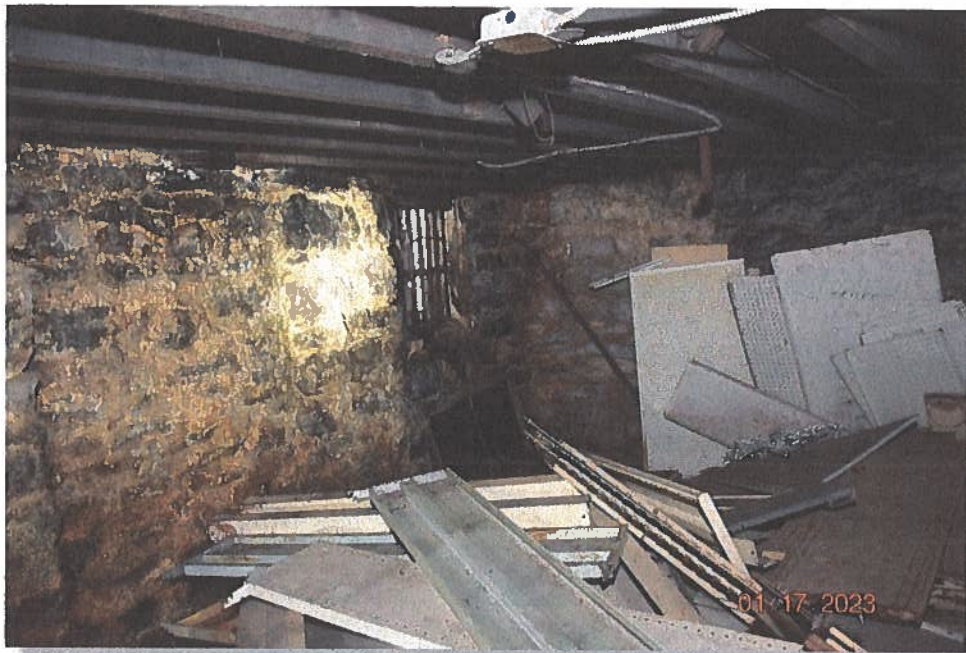
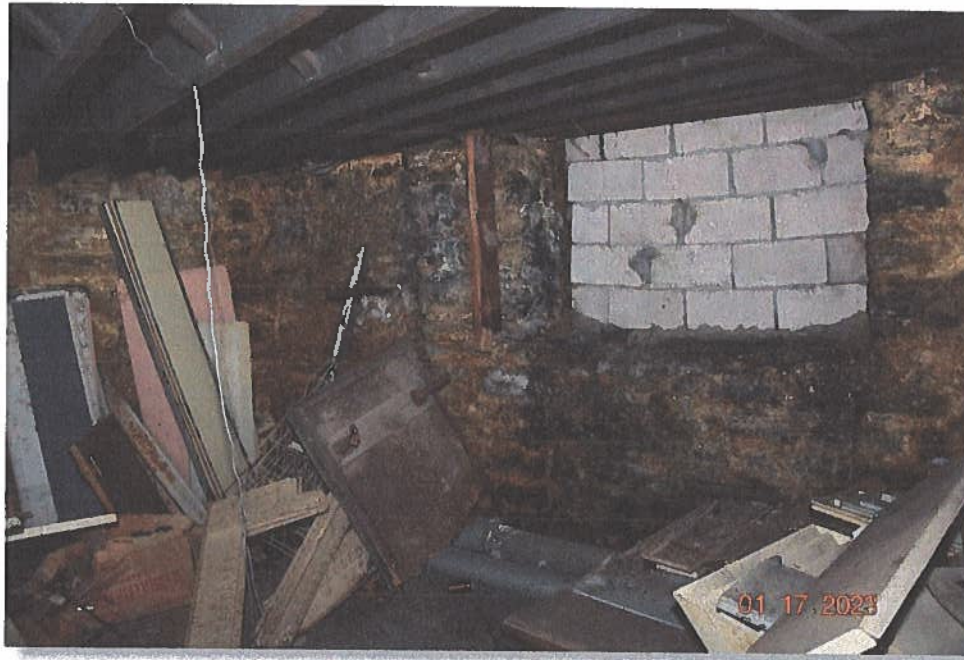
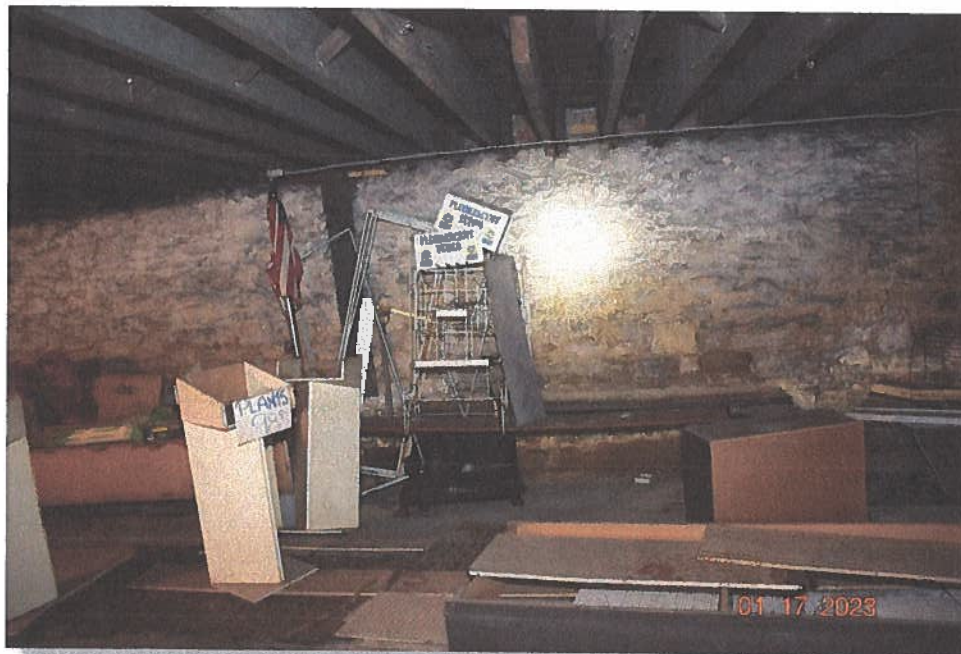
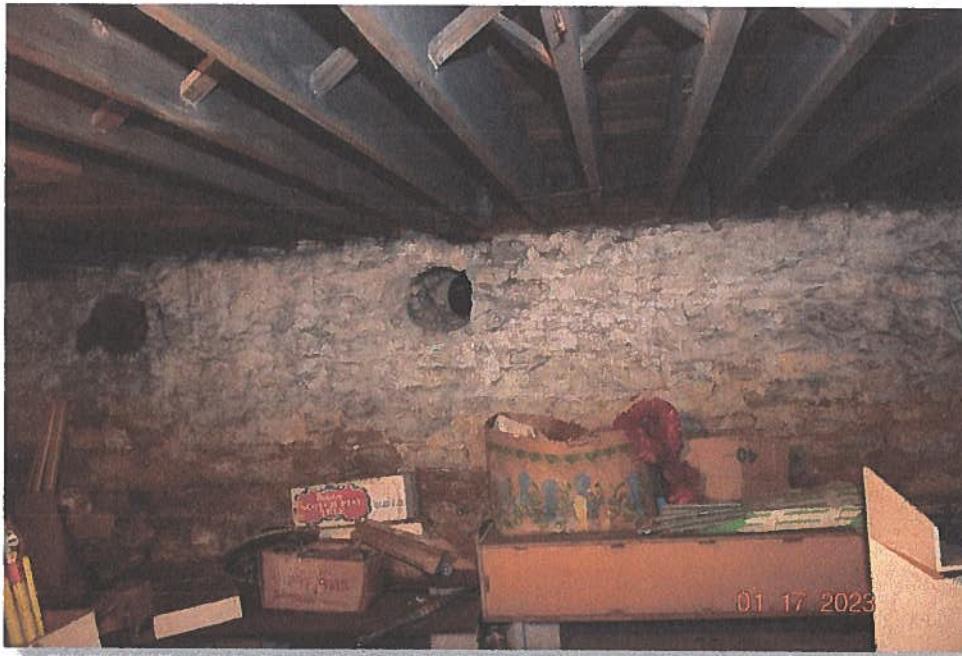
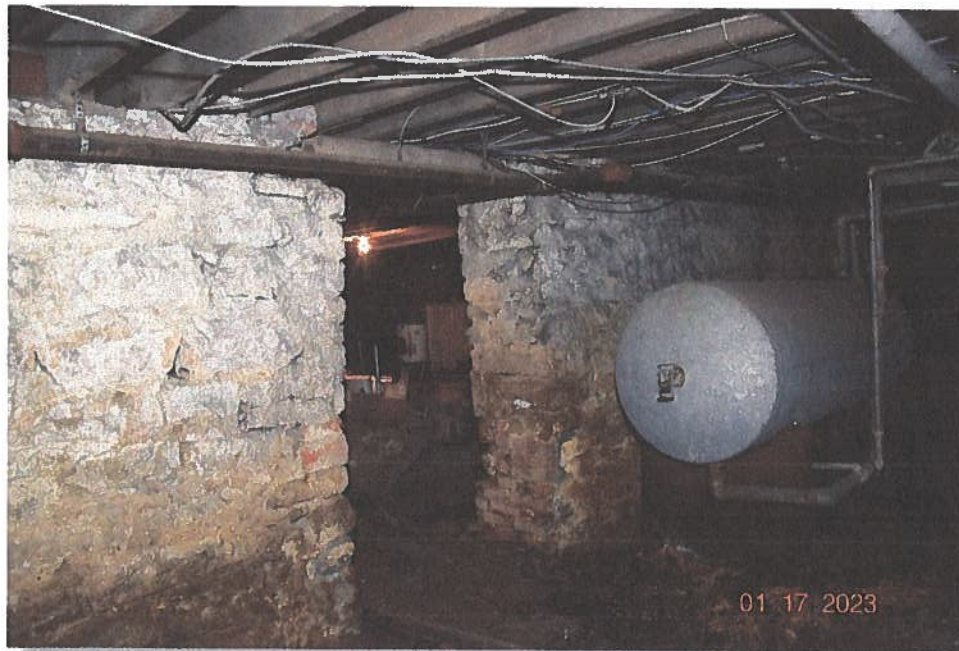
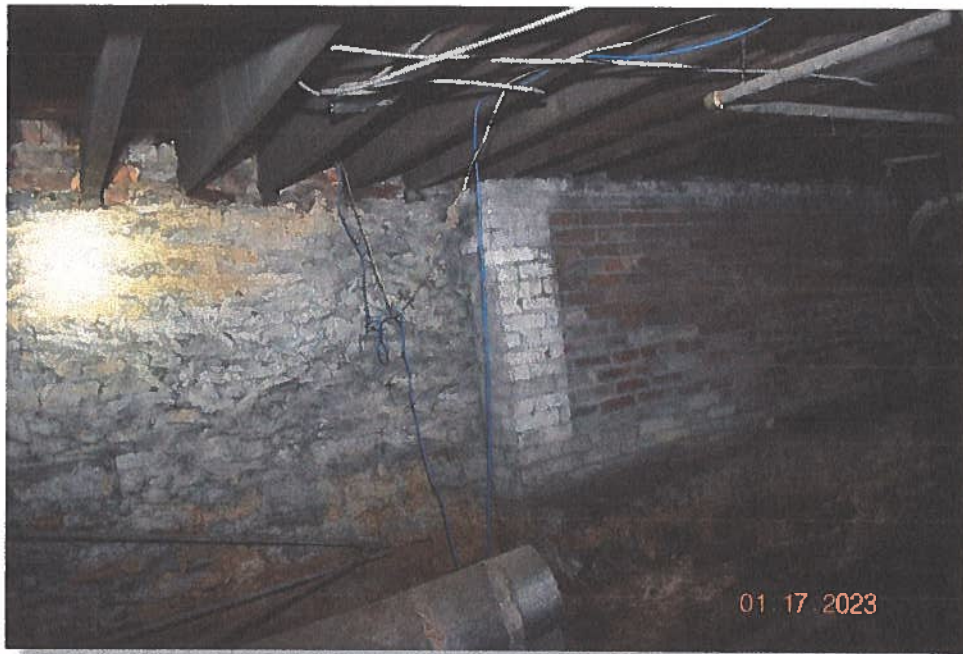
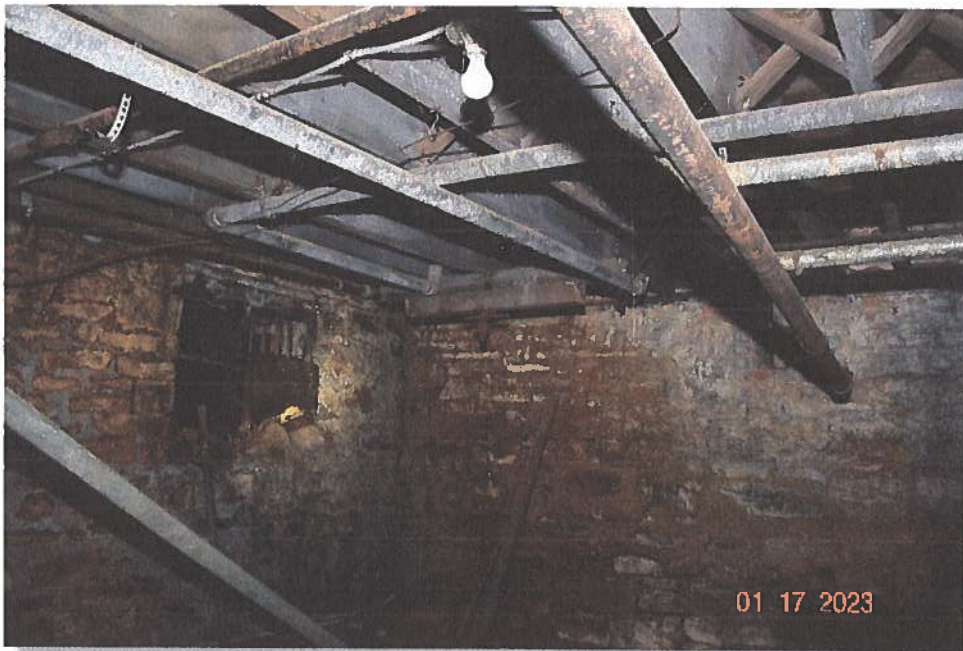
***Pic. 4: Typical view of the foundation (inexterior wall) of unit #1083***

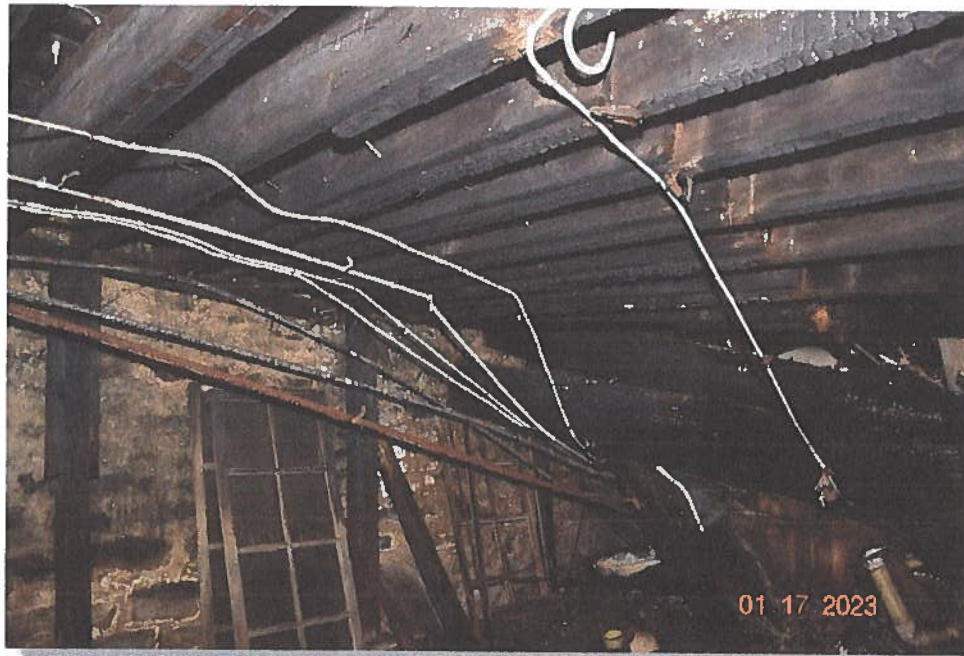
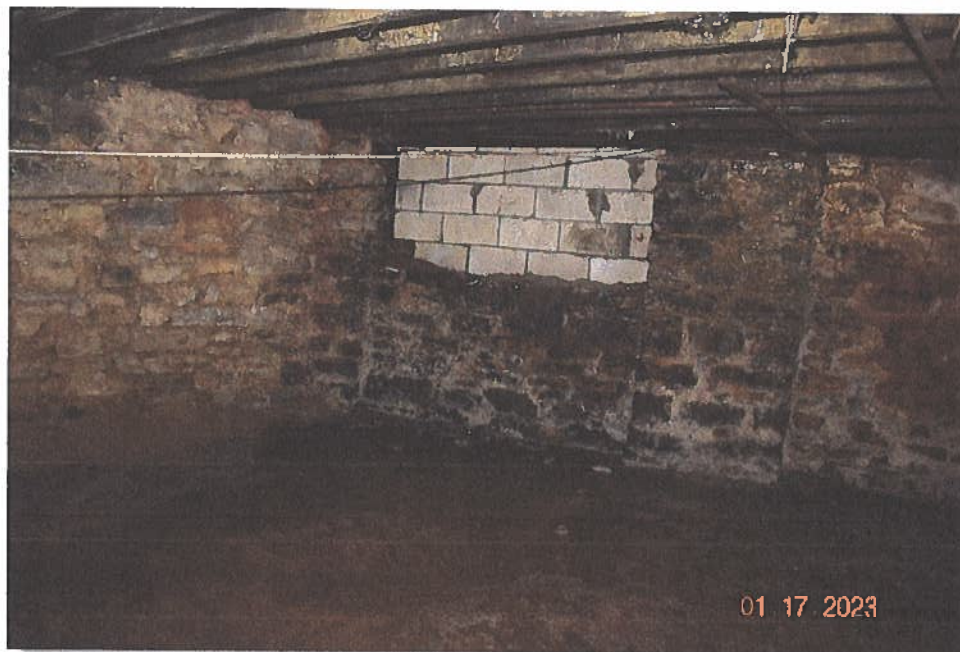
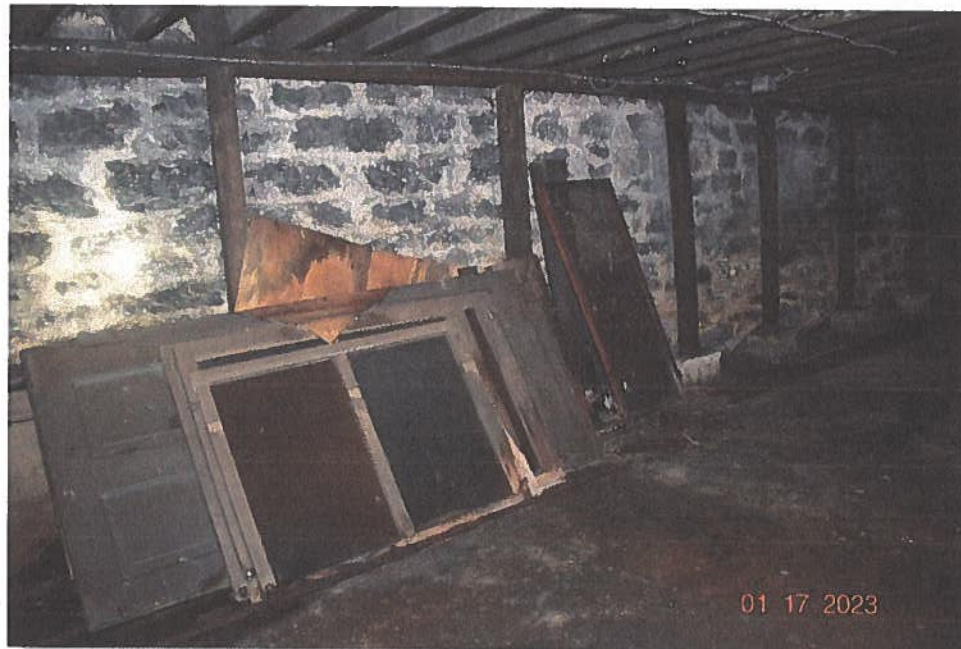
***Pic. 11: Typical view of the foundation (exterior wall) of unit #1085***

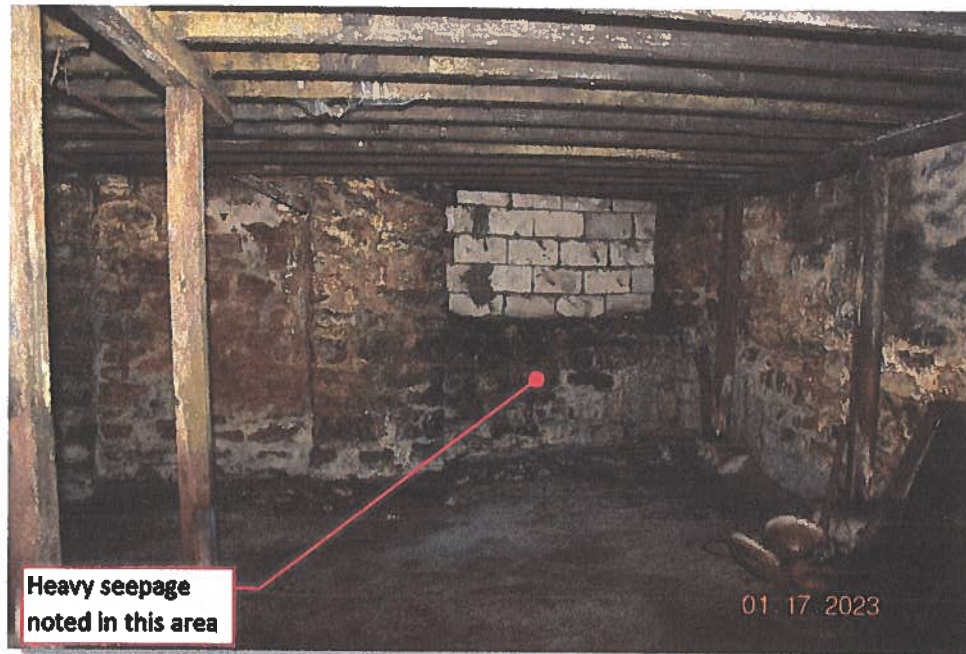
**Pic. 13:** Typical view of the foundation (exterior wall) of unit #1085

1. A portion of the foundation wall needs to be waterproofed at unit #1085
2. The exterior & interior walls are in good condition, and there no repair is required.
3. Units #1081 & #1085 shall not be occupied unless the floor framings are restored.
4. There is no structural issue noted in Unit #1083 floor framing.
5. There is no significant structural issue noted in the second & third floor residential floor framing system. However, the moisture damage on the roof framing system should be repaired to prevent other areas from future moisture damage.
6. Residential units shall not be occupied unless item 5 above and the staircase hand/guard railing system are repaired as appropriate.

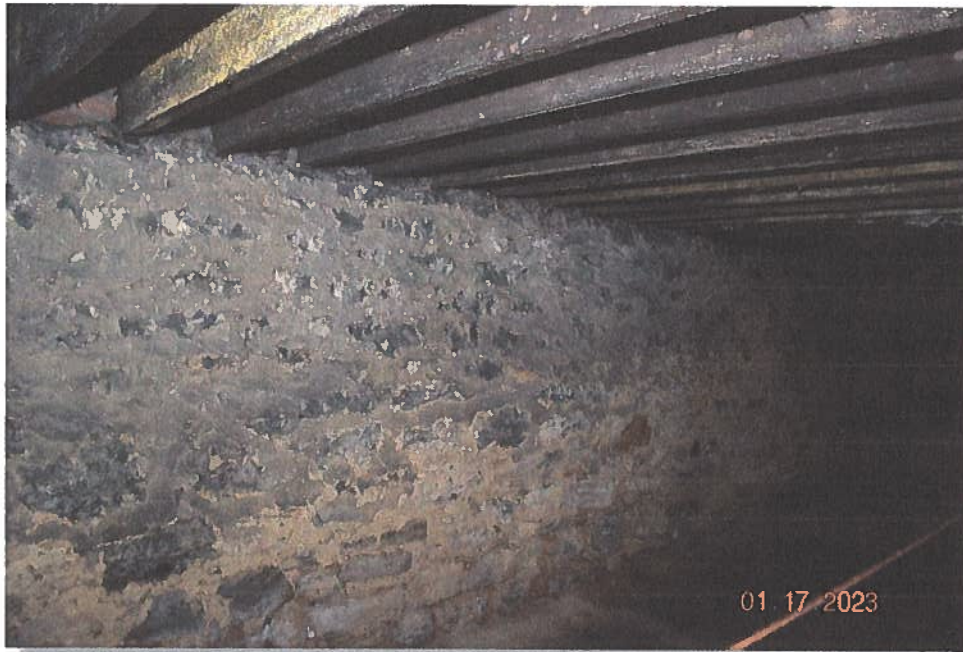
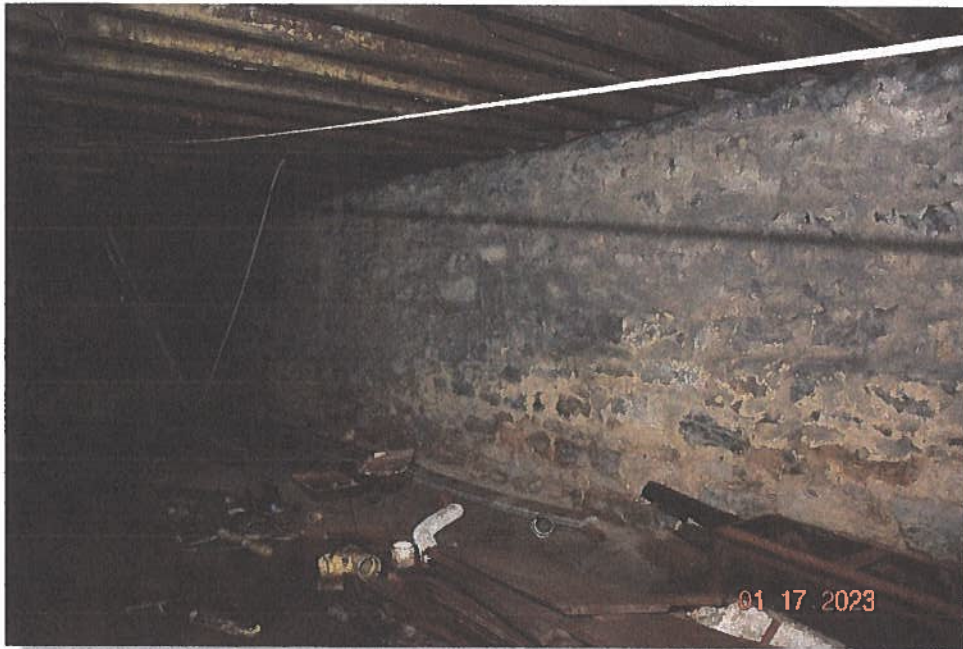
**Pic. 15:** Typical view of the foundation (interior wall) of unit #1085

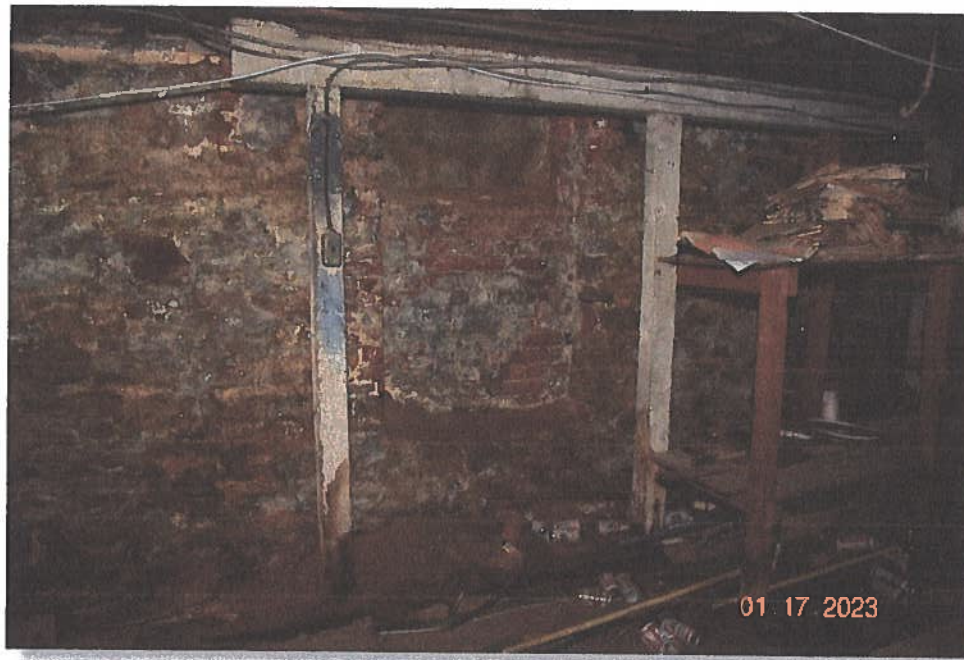
The pictures (Pic. 17 through Pic. 20) show the typical view of the first-floor framing of unit #1081. Based on the inspection, we believe the floor is NOT structurally supported adequately for the intended purposes due to poor maintenance. Therefore, the business space of unit #1081 shall not be used. However, the exterior walls of the unit are directly supported by the foundation wall. Therefore, there are no structural issues with the wall system above ground, and no structural repair is required on the walls.

**Pic. 17:** View of the first-floor level joist framing exterior support @ unit #1081

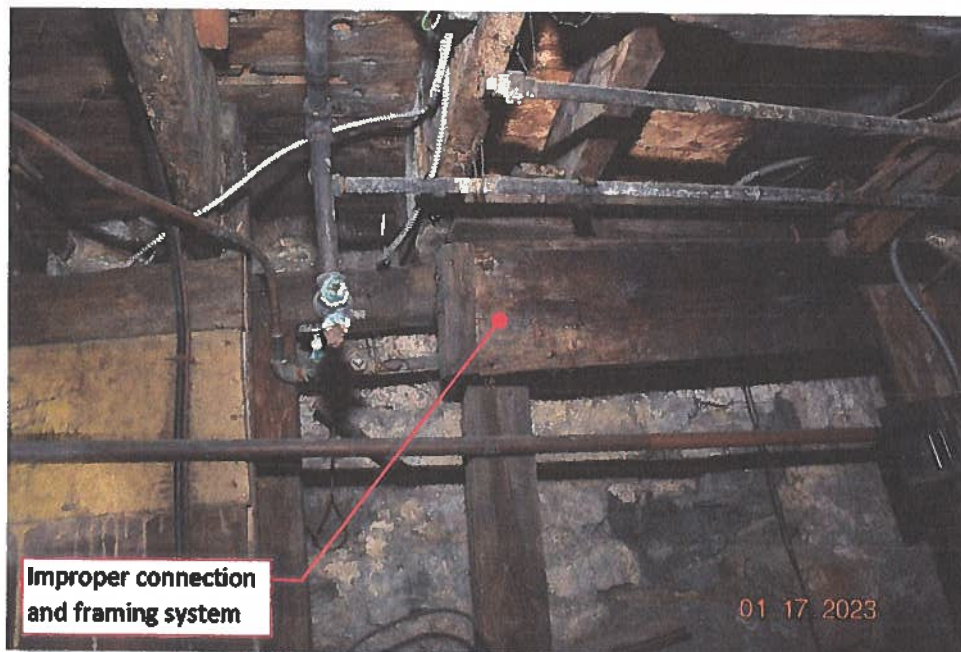
**Pic. 18:** View of the first-floor level joist framing & support @ unit #1081

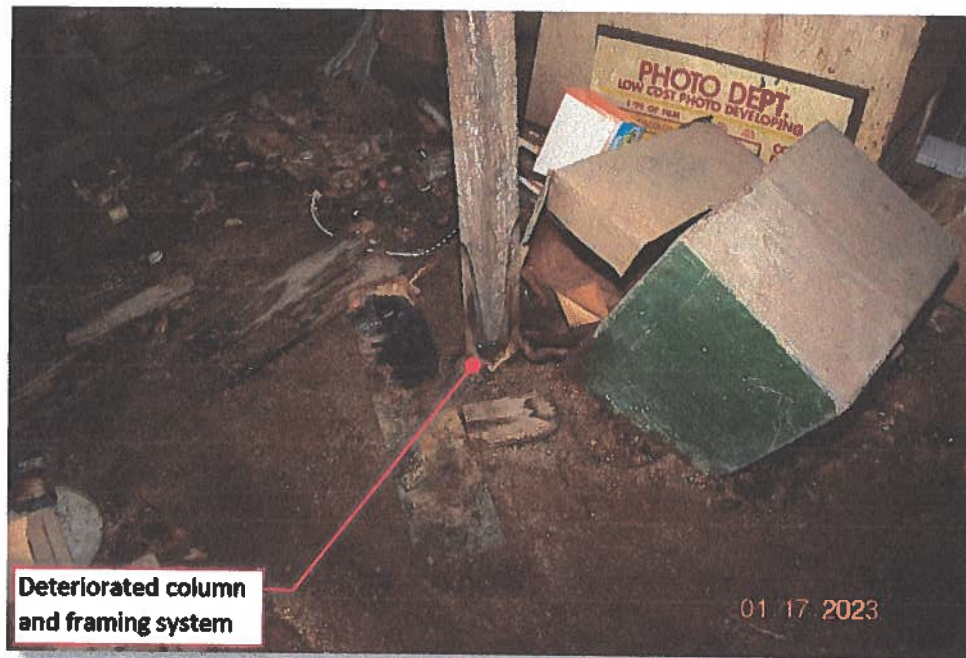
Deteriorated column  
and framing system

*Pic. 19: View of the first-floor framing intermediate support @ unit #1081*

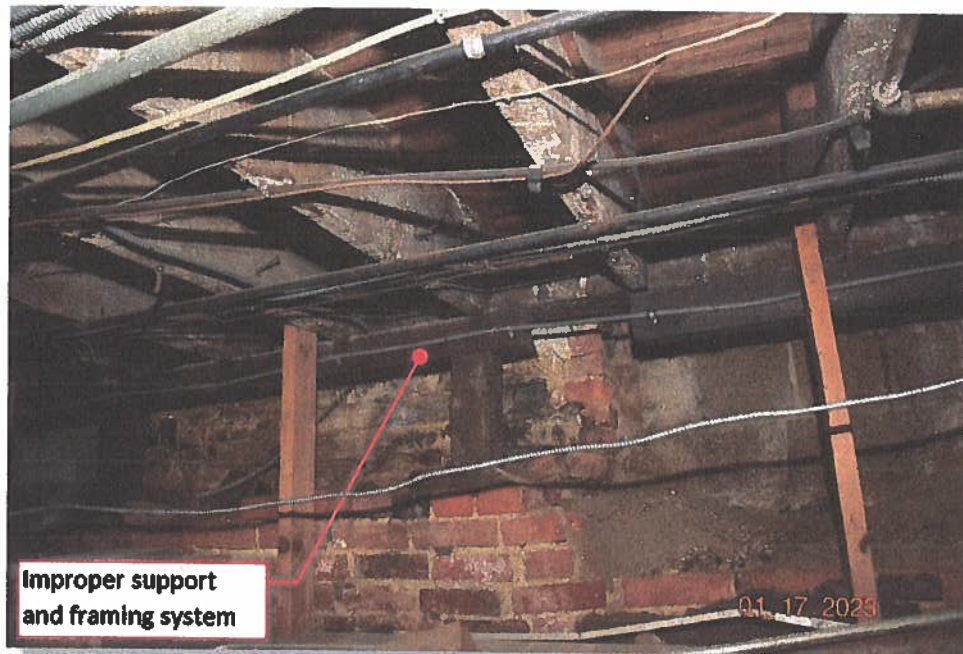
Improper support  
and framing system

*Pic. 20: View of the first-floor level joist framing & support @ unit #1081*

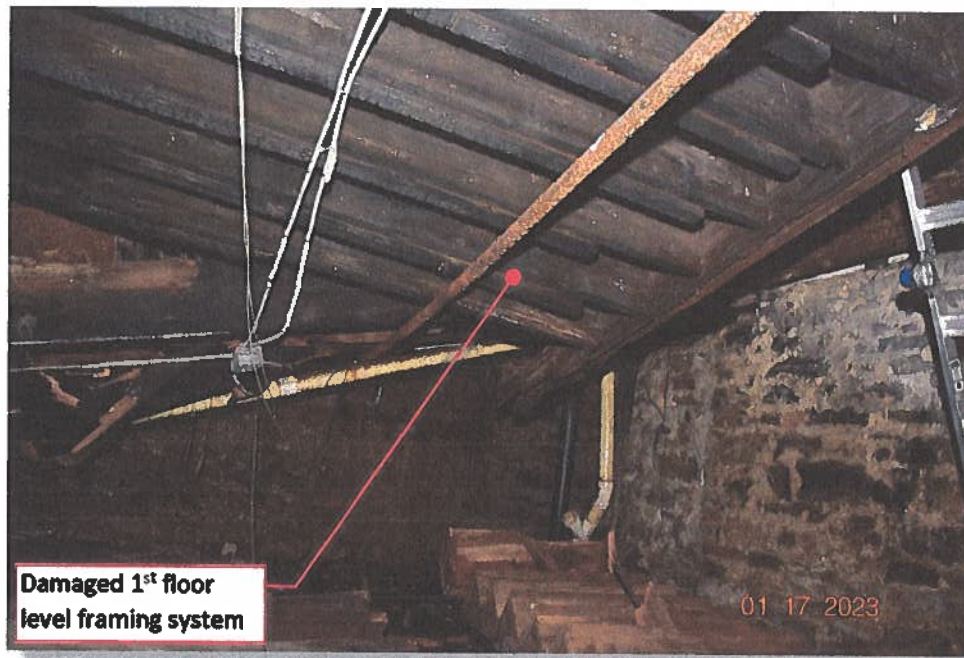
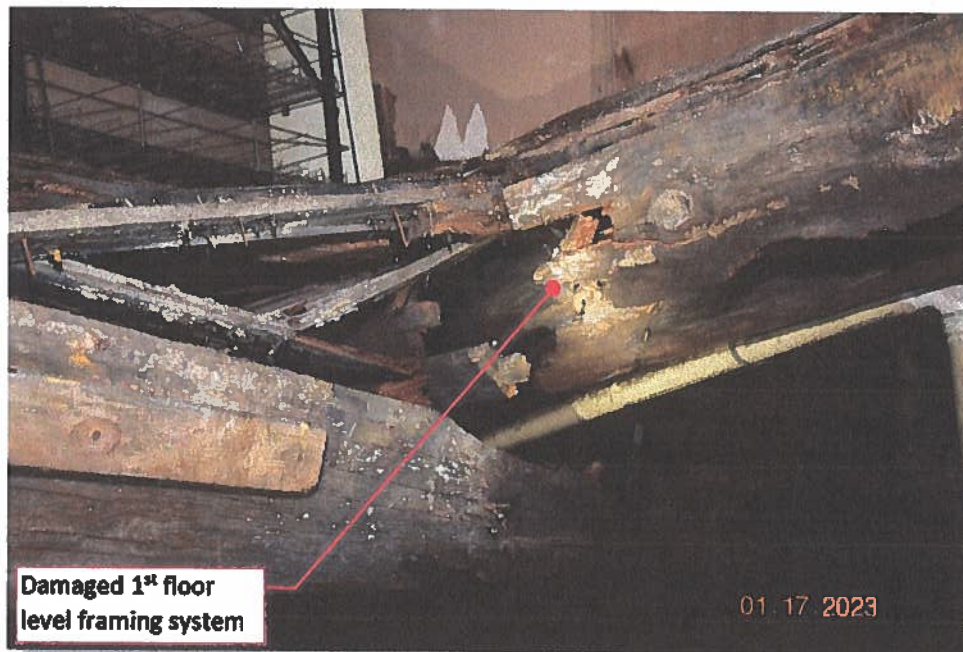
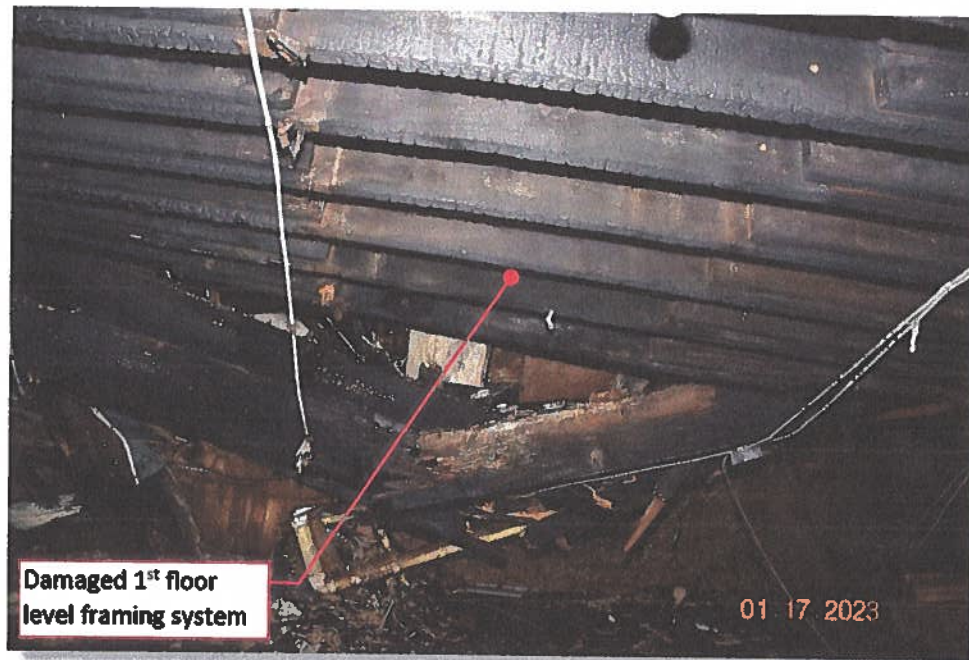
The pictures (Pic. 21, Pic. 22, Pic. 23 & Pic. 24) show the typical view of the damaged first-floor framing of unit #1085. Based on the inspection, we understand that the floor framing should have failed due to fire damage and the subsequent prolonged moisture exposure due to the roof leak. Therefore, the business space of unit #1085 shall not be used unless restoring the floor framing. However, the exterior walls of the unit are directly supported by the foundation wall. Therefore, there are no structural issues with the wall system above ground, and no structural repair is required on the walls.

**Pic. 21: View of the damaged first-floor level joist @ unit #1085**

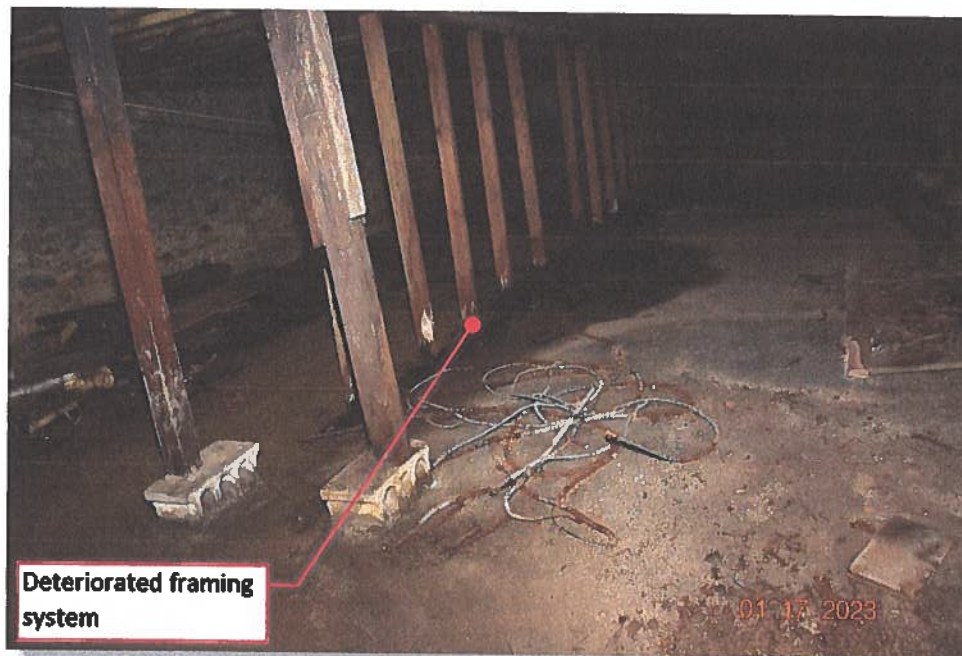
*Pic. 24: View of the intermediate support to first-floor level joist @ unit #1085*

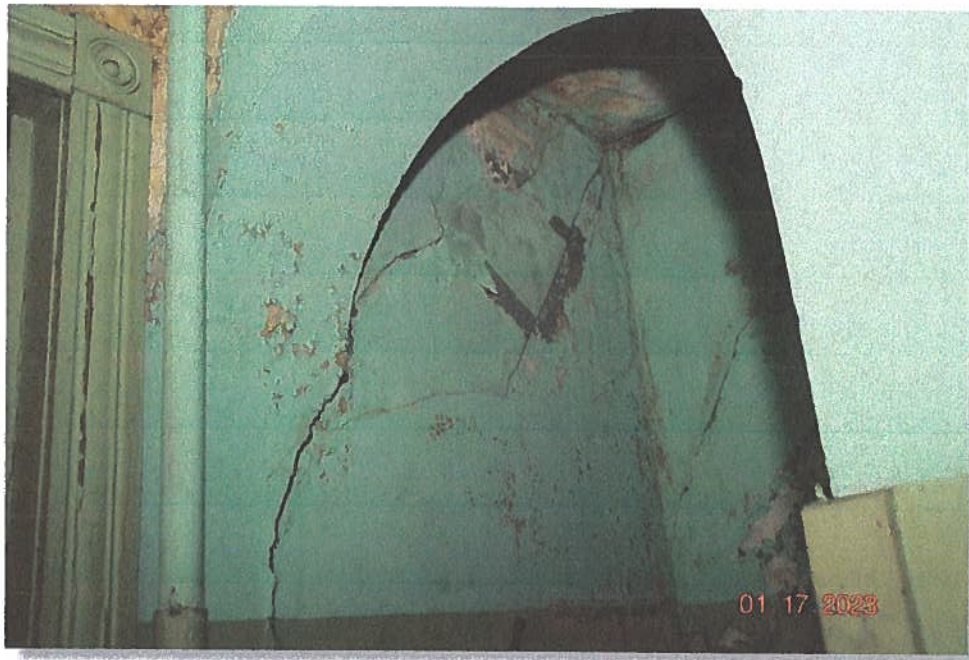
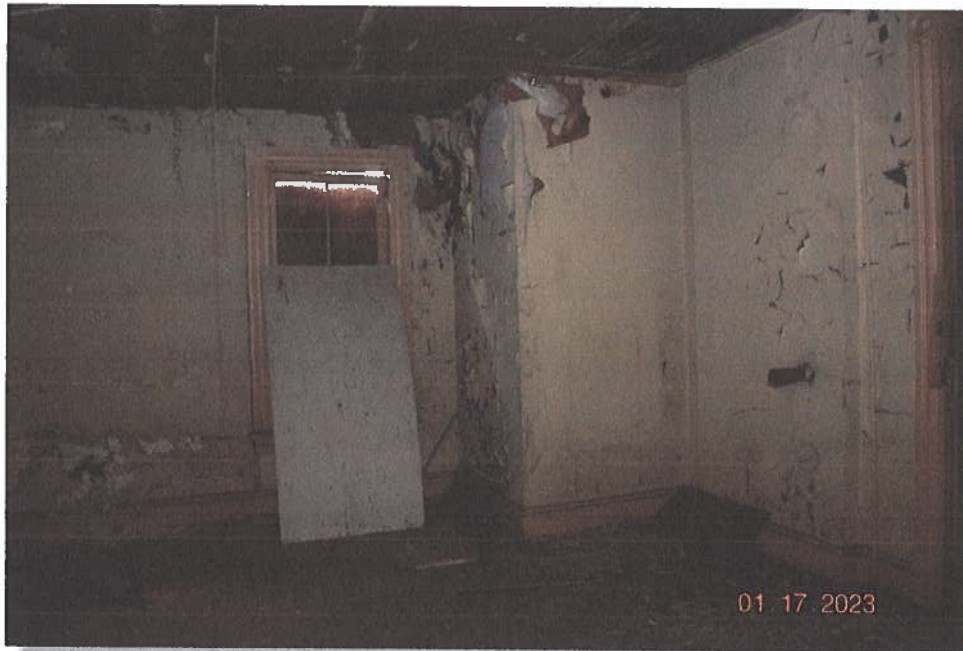
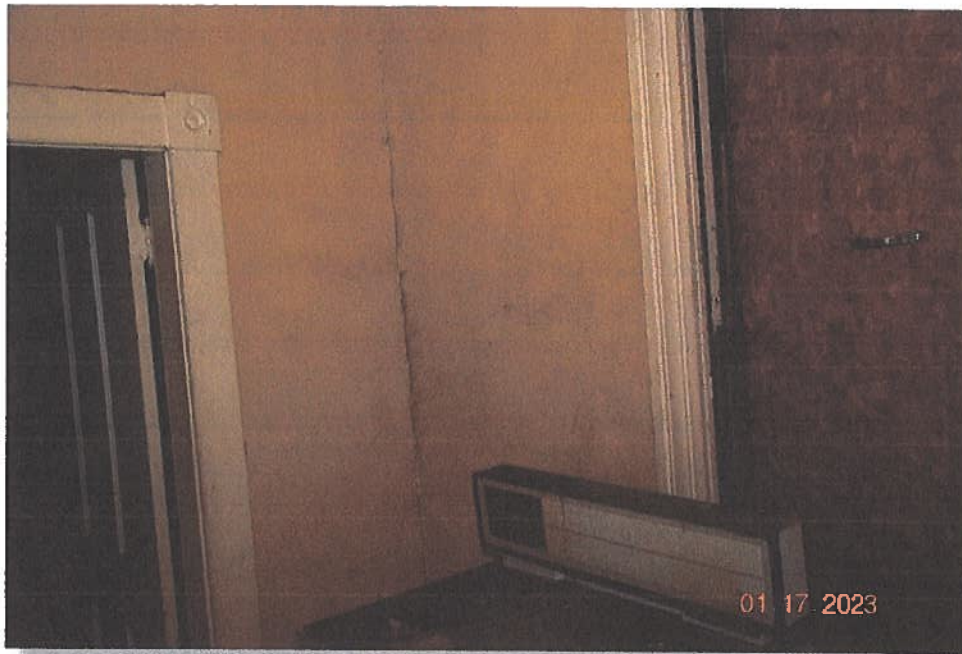
The pictures (Pic. 25 through Pic. 31) show the typical view of the second and third-floor residential units. The residential units are not in acceptable condition for use due to poor maintenance, including the stair railing. As shown in the pictures, a few cracks were noted on the wall. Based on the inspection, we believe those cracks are not affecting the load-bearing wall's structural integrity. Therefore, there is no structural repair required on the walls. However, it is recommended to repair the roof leak to prevent the existing floor framing from deteriorating.

**Pic. 25:** Typical view of the cracks in the interior walls on the third-floor level

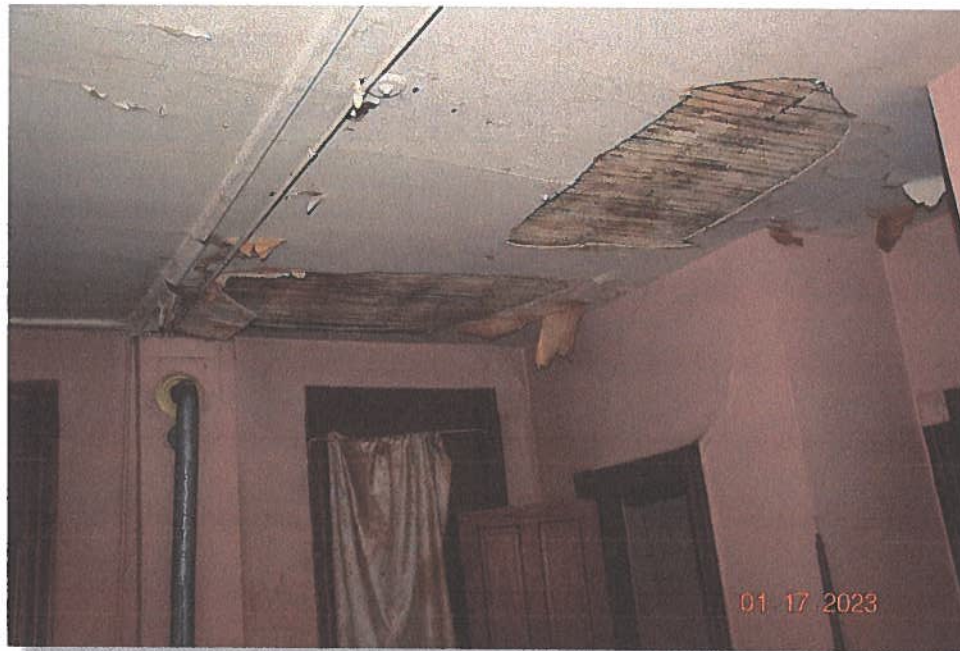
**Pic. 28:** Typical view of the existing ceiling on the roof level

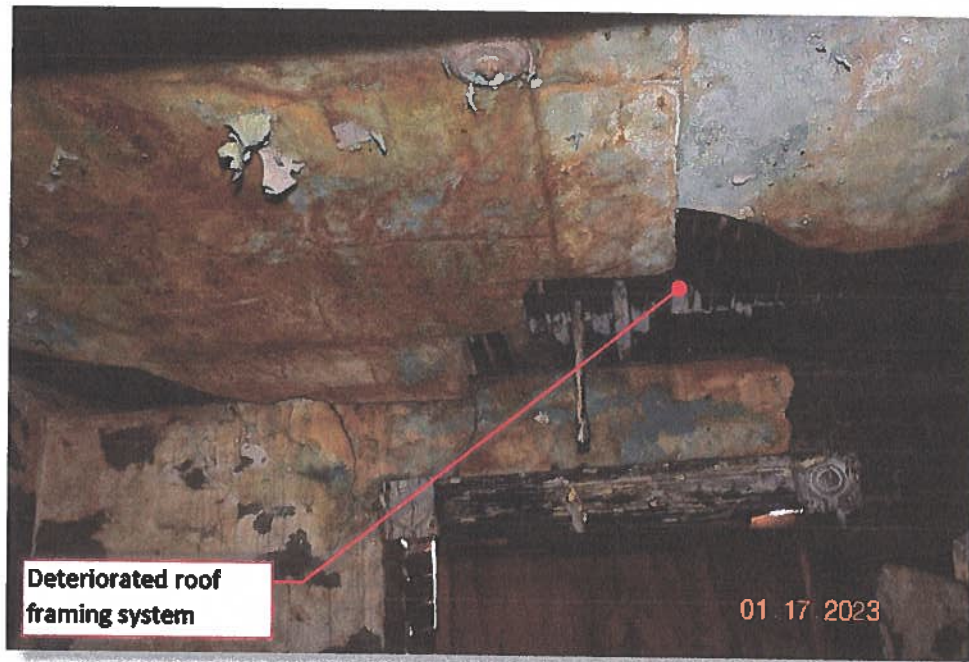
Deteriorated roof  
framing system

*Pic. 29: Typical view of the existing ceiling framing on the roof level*

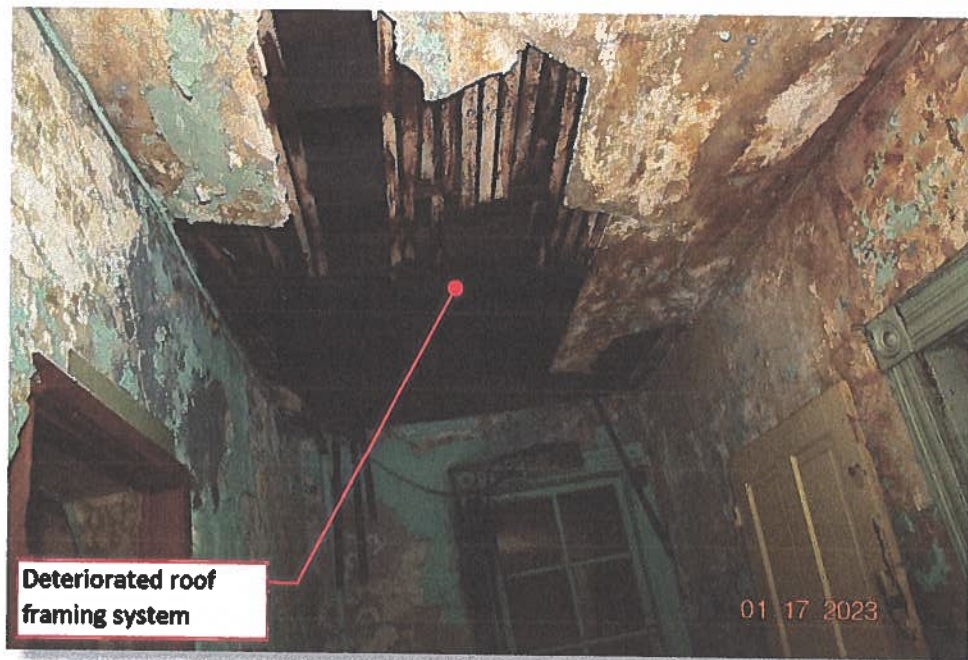
Deteriorated roof  
framing system

*Pic. 30: Typical view of the existing ceiling framing on the roof level*

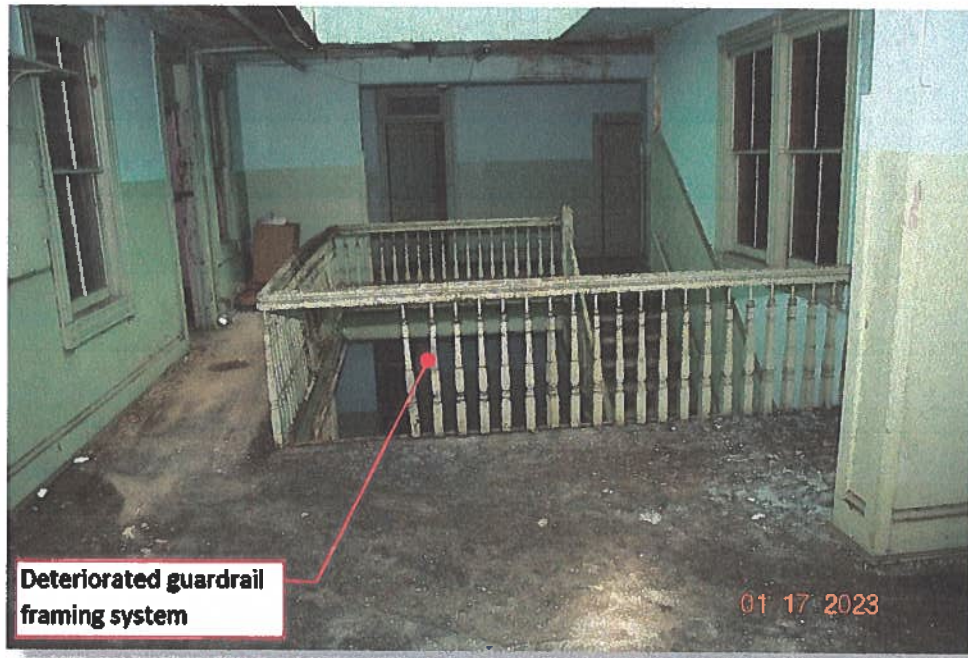
*Pic. 31: View of the existing guard rail on the third-floor level*
