## Inspection Report

**Property Address:**  
3620 Elkhorn Blvd  
North Highlands CA 95660

**Granite Bay Home-Building Inspections**

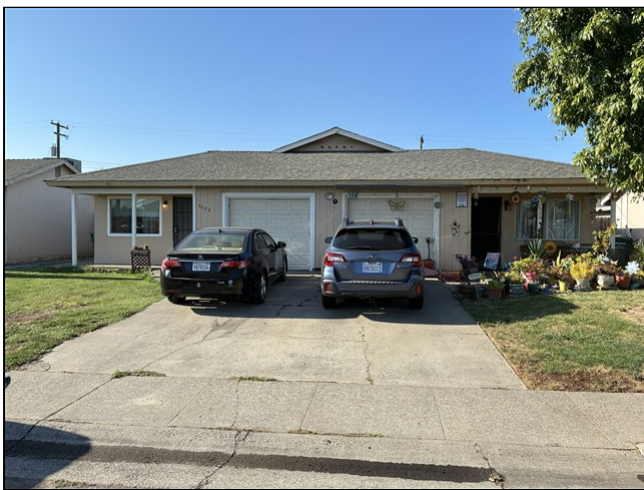
1.4 Item 1(Picture)

Note: The two units of this duplex building suffer from deferred maintenance. Most of the deficiencies are cosmetic, not structural, and less mechanical. Make note also of the professional pest report on this building.

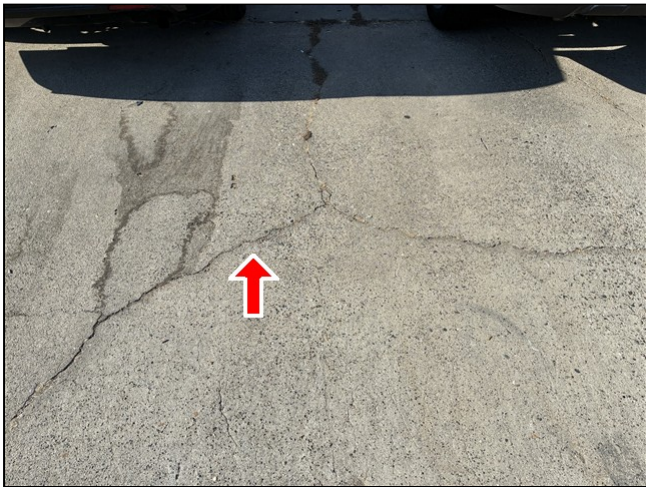
3.1 Item 1(Picture)

(1) Issue: Common cracks noted in driveway. Location: Front of home.

Recommend: No professional repairs required at this time.

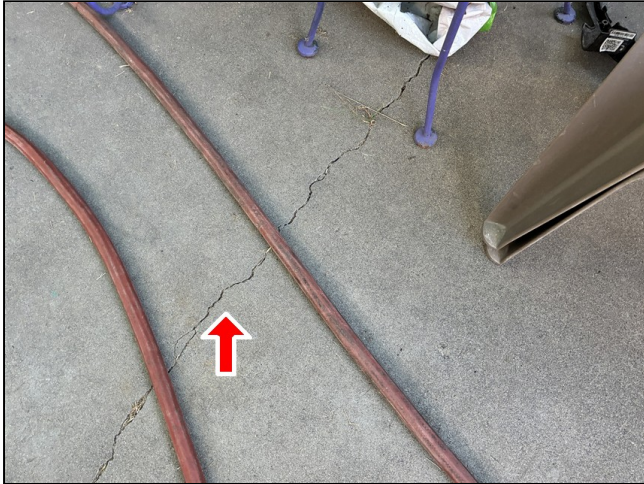
3.1 Item 2(Picture) Unit 3620

(2) Note: The patio exhibits normal cracks in the surface but shows no structural issues. The patio is otherwise in adequate condition. Noted at the right side.

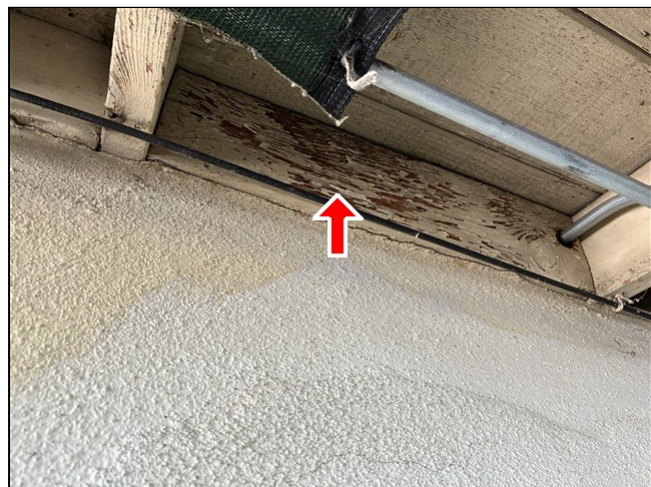
3.3 Item 3(Picture) Eaves paint peeling

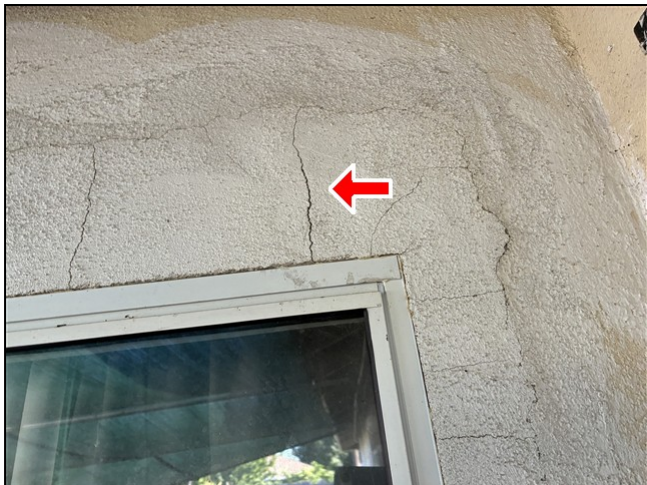
3.3 Item 4(Picture) 3620

(2) Issue: There are small (hairline) cracks and/or holes in the stucco on the exterior of the building. This may be caused by (normal) home settling or stucco curing issues during construction.

Recommend: If concerned, a licensed, qualified contractor could review these surfaces and further advise.

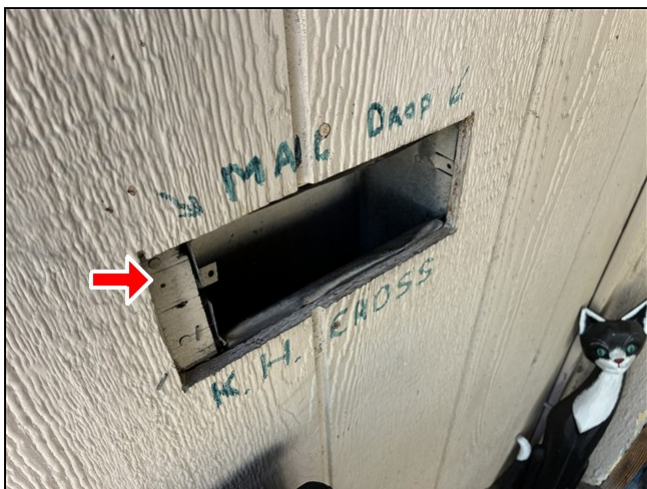
3.3 Item 6(Picture)

(3) Note: Mail drip frame missing, 3620.

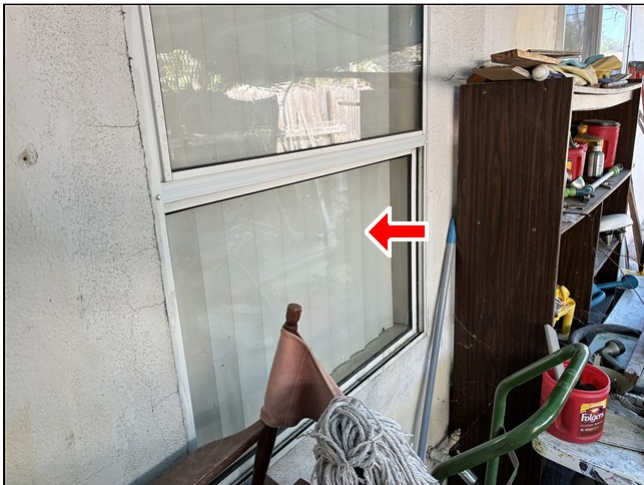
3.4 Item 2(Picture)

(2) Issue: Several window screens are removed. Both units 3622-20.

Recommend: All window screens should be repaired or replaced as necessary.

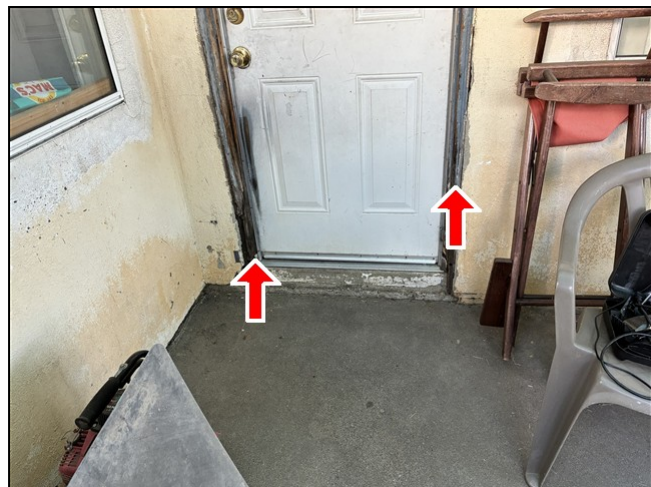
3.5 Item 1(Picture)

(2) Issue: The right side door jamb is damaged/deteriorated. Unit 3620

Recommend: The damaged elements of the jamb should be repaired, or the entire assembly replaced to restore proper operation.

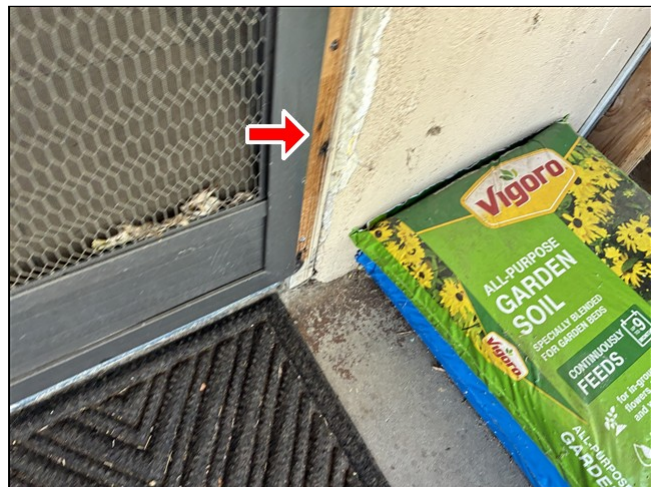
3.5 Item 3(Picture)

(3) Issue: The front door jamb is damaged/deteriorated. 3620.

Recommend: The damaged elements of the jamb should be repaired, or the entire assembly replaced to restore proper operation.

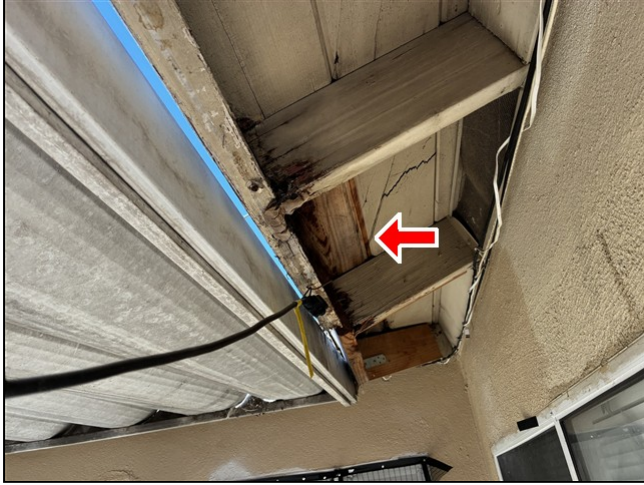
3.6 Item 1(Picture)

Issue: We note evidence of wood rot in the eaves roof sheathing material of the building.

Recommend: A qualified **pest service** may review and advise as to repairs required.

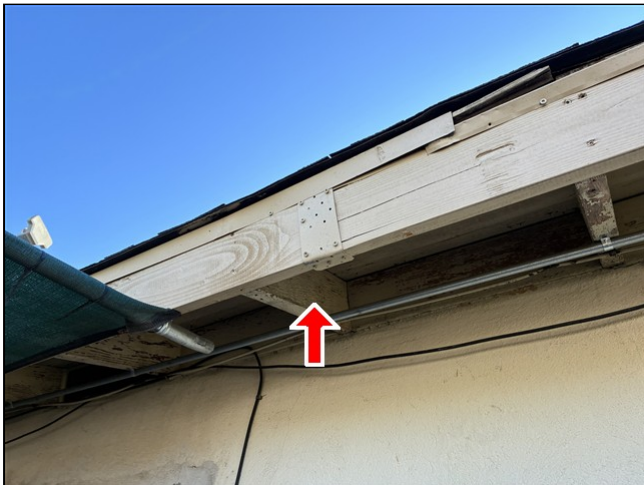
3.6 Item 2(Picture)

(2) Issue: Fascia trim / roof edge is deteriorated at the front, rear and sides of the home.

Recommend: A licensed, qualified **pest company** may examine all exterior trim for deterioration/damage and repair or replace as necessary.

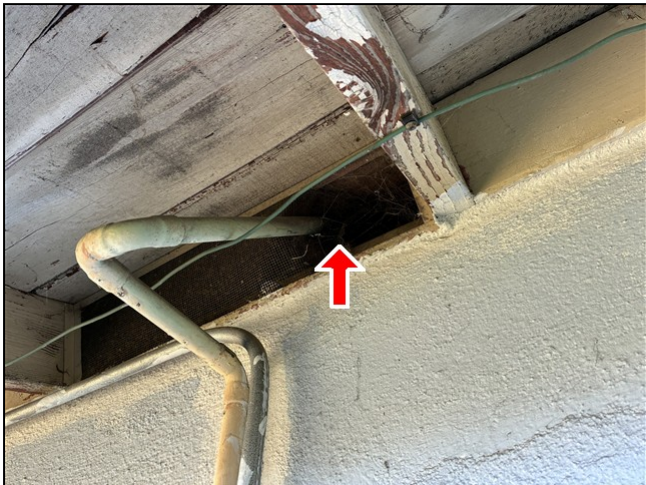
3.6 Item 6(Picture)

(3) Issue: One or more of the attic vent screen in the eaves/soffit area are torn or gapped. (This may allow for possible entry of insects or rodents). Both units 3622-20.

Recommend: A qualified handyman or licenced contractor review and repair as needed for health purposes. Refer also to the building pest report.

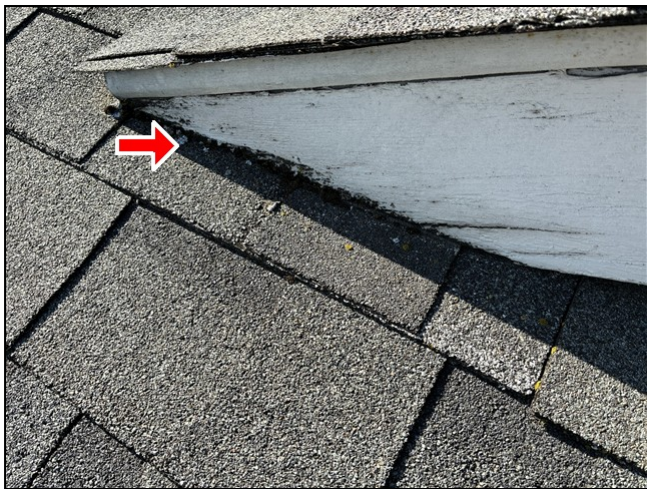
(4) Issue: Sections of the exterior barge rafters exhibit deterioration at the front of the home.

3.6 Item 9(Picture) Barge board touching roof

Recommend: A qualified, licensed **pest company** should review and advise as to repairs / maintenance required.

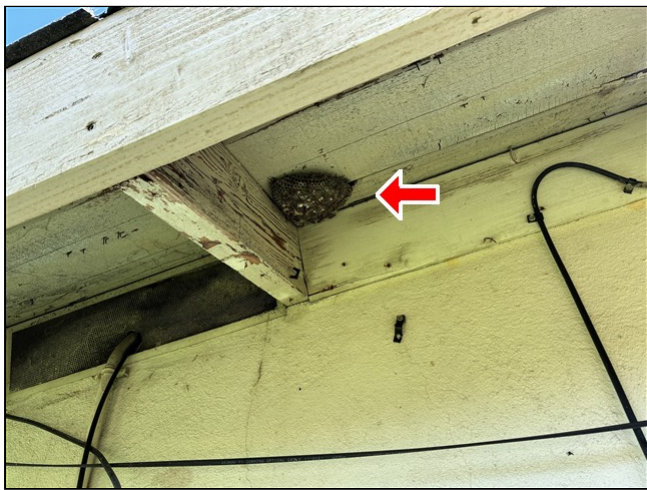
3.6 Item 11(Picture)

(5) Issue: Nests (bees / wasps / insects) noted under the overhang at the exterior.

Recommend: While not a deficiency in the structure, they should be removed to reduce a potential for personal injury or possible building intrusion.

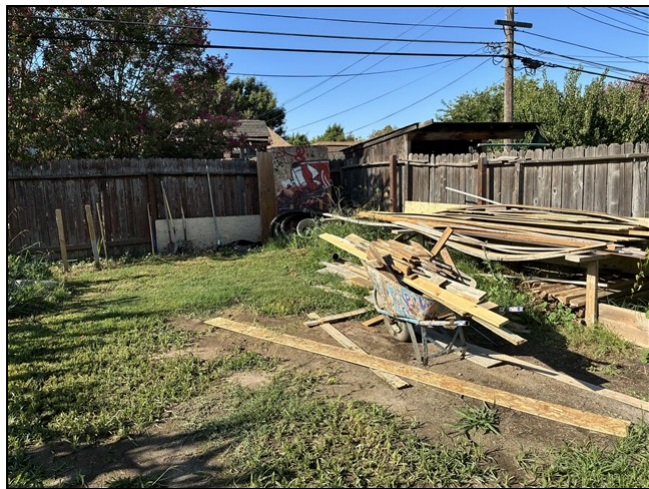
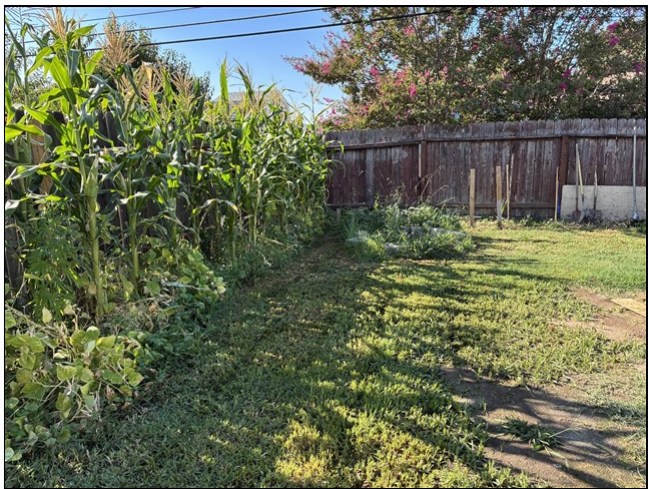
Issue;      There is minor damage to the fencing at the rear of the property, although it is functioning as designed.

Recommend:    Damaged fence elements should be repaired if possible, or replaced as necessary.

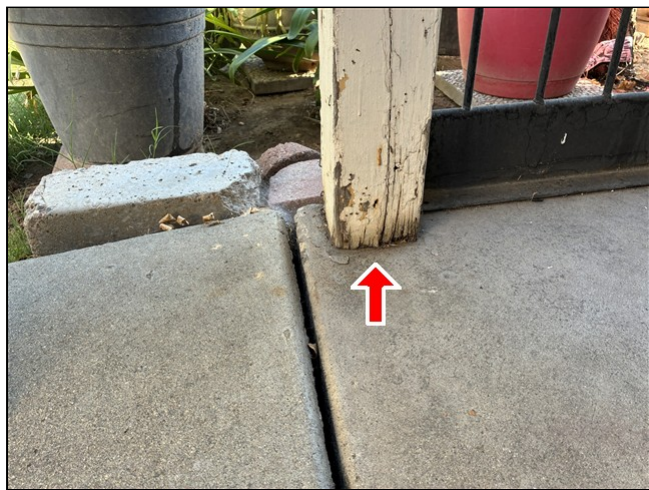
Issue:      Sections of the support post material for the front deck are deteriorated and/or damaged.

3.9 Item 1(Picture) Wood-cement contact may wick moisture, damaging wood

Recommend:    To adequately support the structure, all damaged or deteriorated material should be replaced or repaired.    A licensed contractor should review and advise as to proper maintenance or repair.

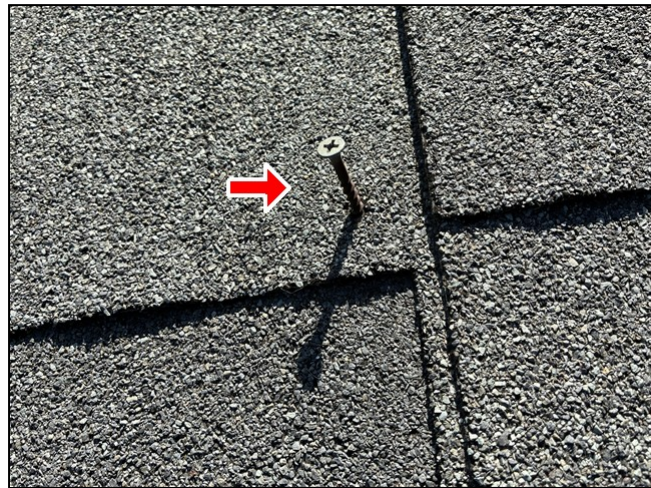
4.1 Item 3(Picture)

(2) Issue: Some (shingle / flashing) fasteners are not installed flush with the roof surface. The protruding fasteners have penetrated some of the flashings or overlying shingles.

Recommend: A qualified, licensed roofing contractor should review and make repairs or modifications as necessary.

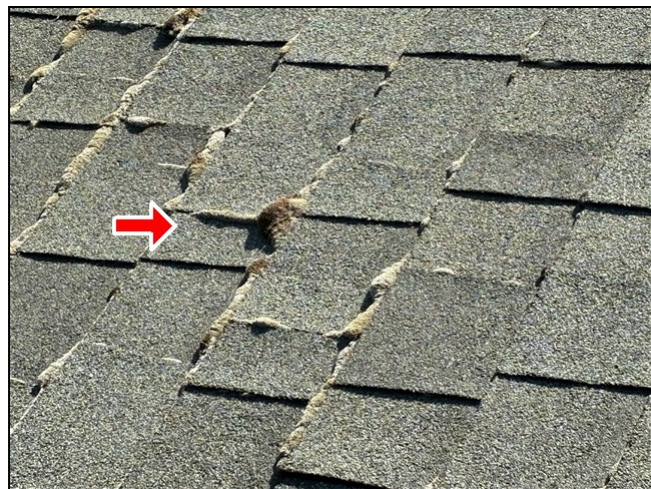
4.1 Item 6(Picture) Front

(3) Issue: Moss or an organic growth on the roof. This condition may affect the life expectancy of the roofing if allowed to build up.

Recommend: Action be taken to remove this growth buildup.

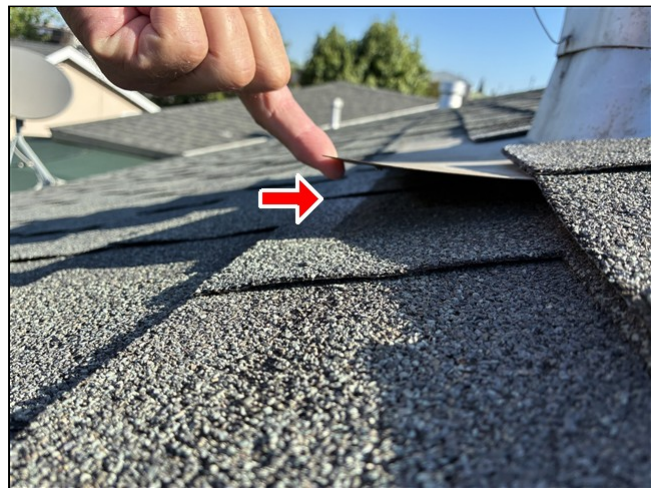
4.2 Item 1(Picture)

(1) Issue: The jack flashing on the rear of the roof surface is improperly installed. The flashing is surface mounted or not properly laced into the roofing surface. This may allow leaks.

Recommend: If concerned, a qualified technician could repair as needed.

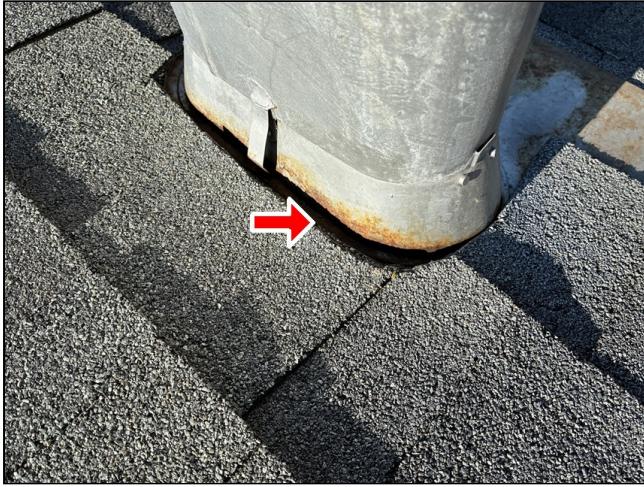
4.2 Item 3(Picture) Rusted vent penetrations

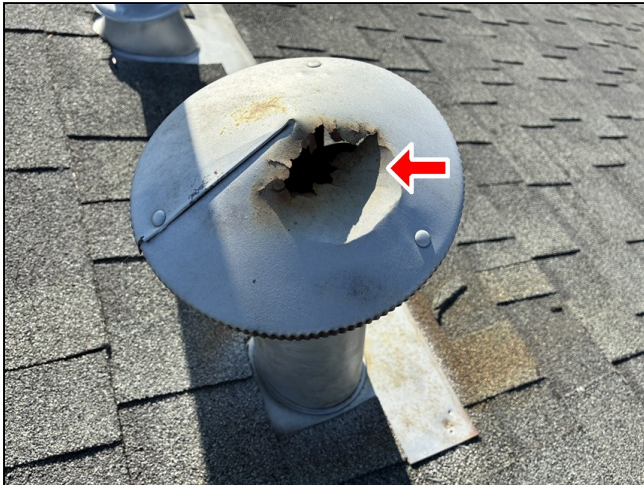
4.2 Item 4(Picture) 3620 side

(2) Issue: Vent is in poor condition, (rust, damage).

Recommend: Depending on the severity of the issue, a ladder qualified handyman or qualified, licensed contractor may review and advise as to proper repair.

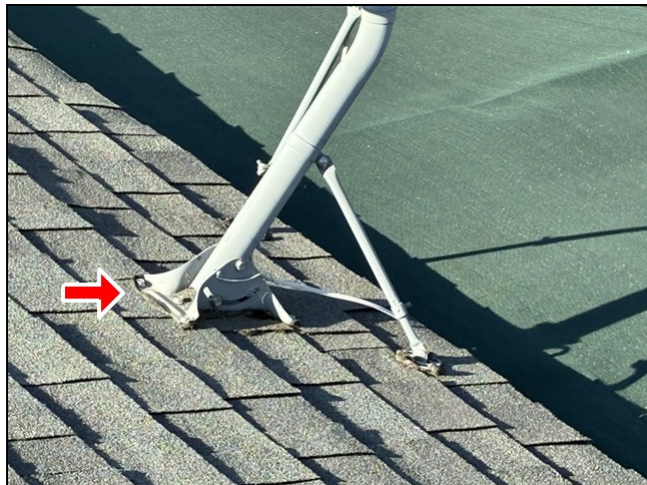
4.2 Item 5(Picture) 3620

(3) Issue: The antenna mounting bracket is bolted through the roof. This is not considered a proper installation practice.

Recommend: The caulking around the bracket should be maintained and the flashing upgraded when the roof is replaced.

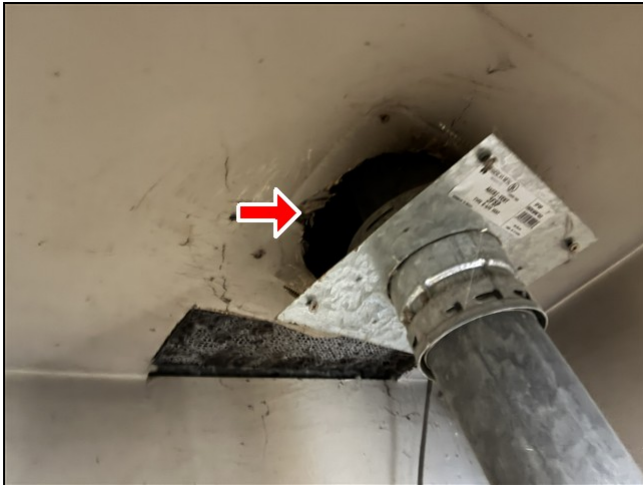
5.5 Item 3(Picture) 3622

(2) Issue: The water heater vent passes through a ceiling or wall with gapped thimble or spacer. This could be a fire hazard. Unit 3622.

Recommend: A qualified technician should install an approved, listed thimble or spacer.

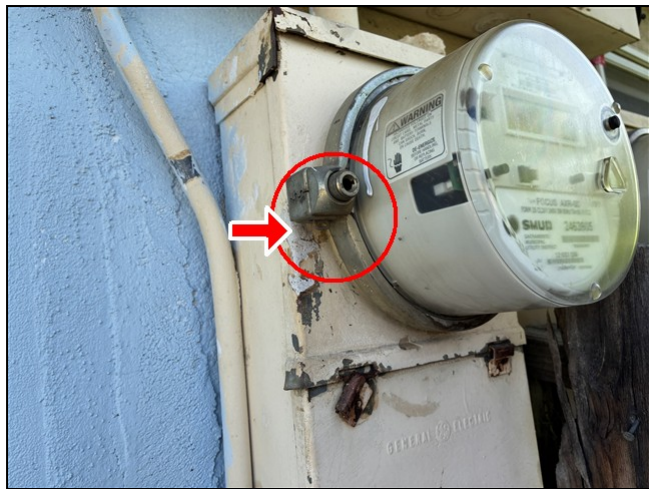
6.1 Item 1(Picture)

(1) Issue: The seal on the electric panel is broken.

Recommend: Notify the electric utility provider. They may want to investigate this situation before replacing the seal.

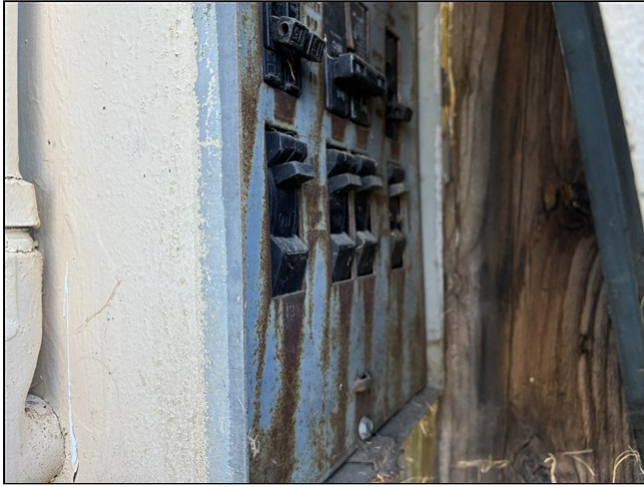
Issue: There is rust or moisture inside the main service panel, indicating past or active water entry. This may become a hazard if essential parts corrode and deteriorate.

6.1 Item 4(Picture) Rusty panel

Recommend: Have a qualified, licensed electrician evaluate the panel and make any required repairs.

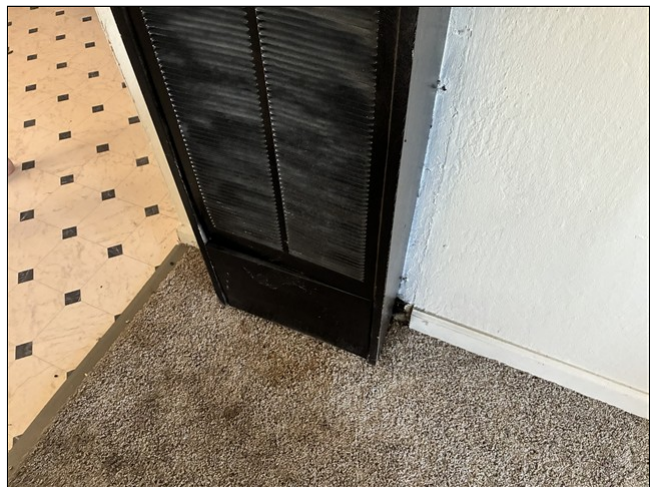
Wall heater not operational unit 3622. Wall heaters are operational unit 3620

7.1 Item 2(Picture) Wall heater 3620

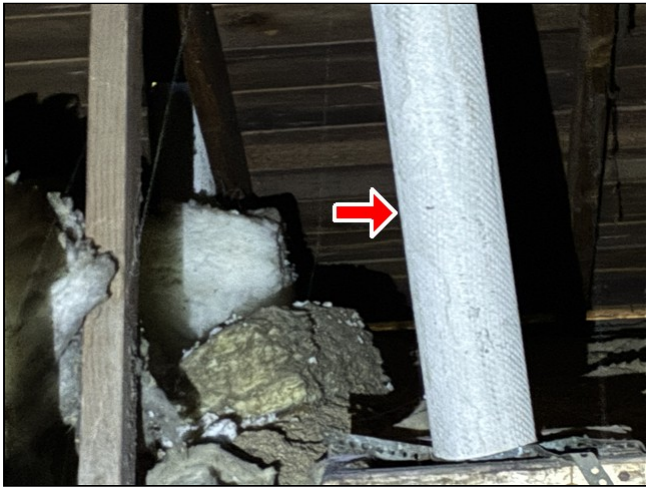
8.1 Item 1(Picture)

Information Note: Asbestos pipe (vent) is found in the attic space. While its current use or presence causes no major concern, it is when re-modeling of a home occurs that the pipe may be broken and cause asbestos dust to become airborne.

Recommend: If the home is to be re-modelled, a qualified, licenced contractor familiar with asbestos product removal should be made available for this work/issue. If concerned, consult further with a qualified, licensed contractor prior tot he close of escrow.

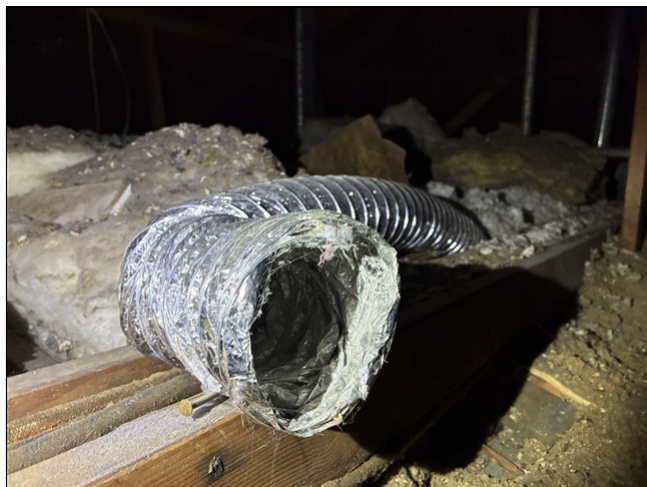
12.7 Item 1(Picture)

Issue: The vent pipe in the attic for the hallway bathroom exhaust fan is loose or has become disconnected from the vent hood to the exterior. This can allow moisture from the bathroom to enter the attic and cause deterioration of the structure. Unit 3620.

Recommend: The vent pipe should be properly connected to the vent hood by a qualified technician.

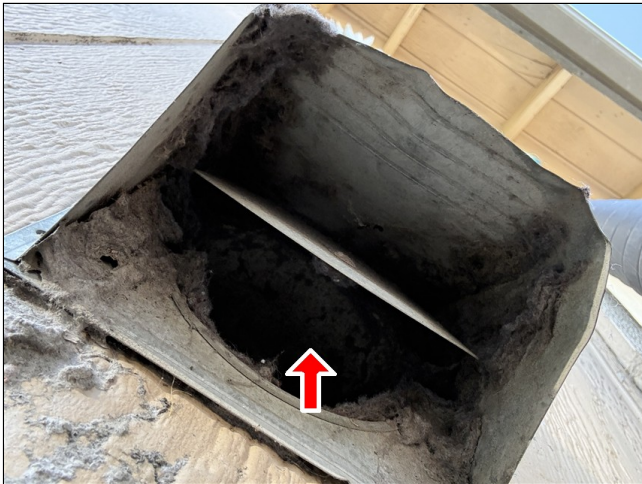
13.3 Item 2(Picture) 3620

(2) Issue: The dryer vent back-draft damper is missing/damaged at its termination. Pests could enter the duct.

Recommend: The back draft damper should be repaired/replaced by a qualified technician.
