# Pacific Inspection Services

Home Inspection Report for 18935 5th Street West, Sonoma CA

Property Address: 18935 5th Street West  
Sonoma, CA

Date Of Inspection: June 4, 2026

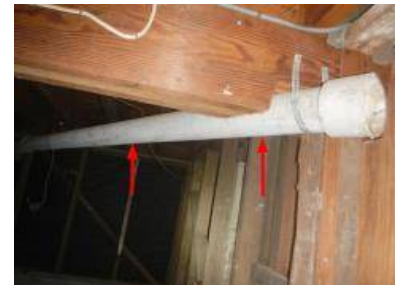
Transite pipe is observed to be present in the structure. Transite is a material that was commonly used for exhaust venting on water heaters and furnaces. This material is known to contain amounts of asbestos. See the Asbestos addendum toward the end of this report for more information about asbestos.

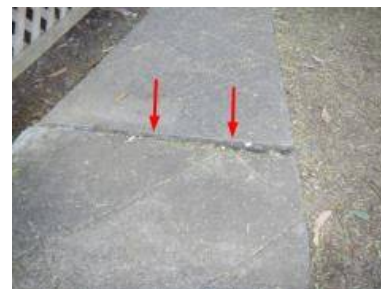
The walkway surfaces are noted to be raised or settled in some areas creating Potential Tripping Hazards.  
Recommend having this condition evaluated and corrected by the appropriate qualified trades person.

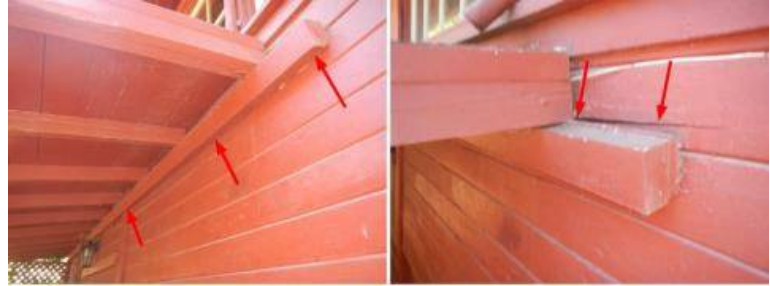
The framing that is attached to the exterior siding of the house is tilted and there are visible cracks in the siding. This connection does not appear to be securely attached to the house structure. We recommend having these conditions further evaluated and corrected by the appropriate qualified professional.

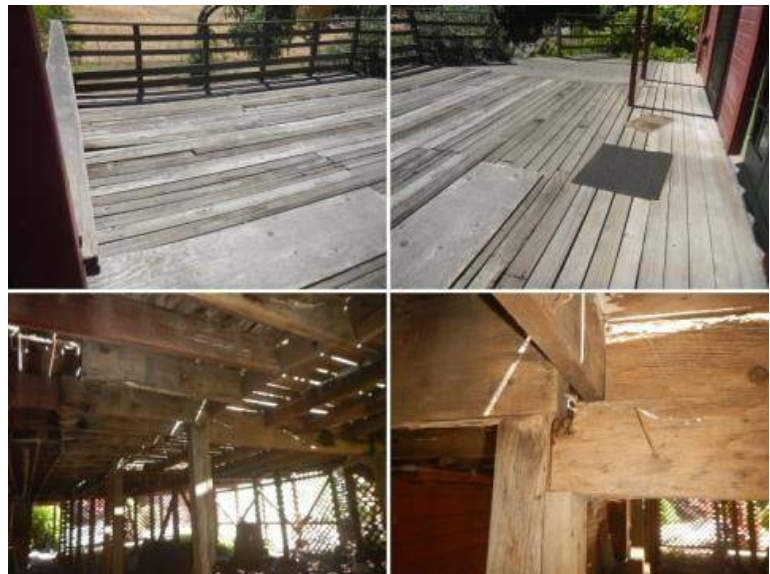
All of the decks, balconies and wooden walks around the house have areas where there is either wood fungus present or moisture damage / deterioration. The most severe damage is noted to the deck at the right side of the house. For safety reasons, we advise NOT using any of the decking, wooden walkways and balconies until they have been further evaluated, repaired or replaced by a qualified professional.

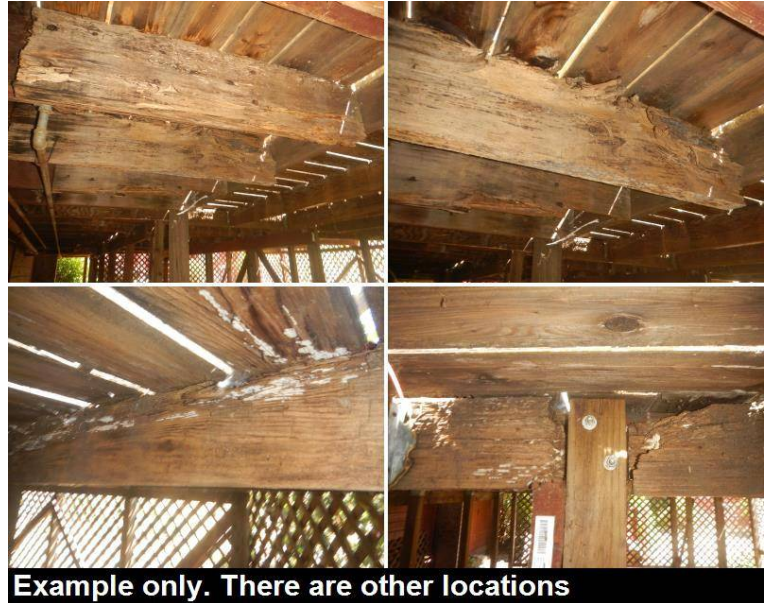
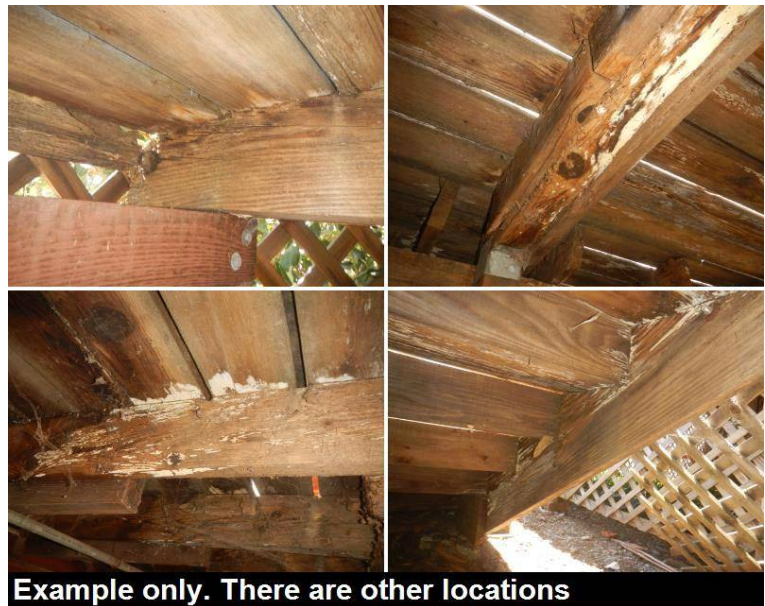
Pictures for examples of the damaged / deteriorated conditions noted.

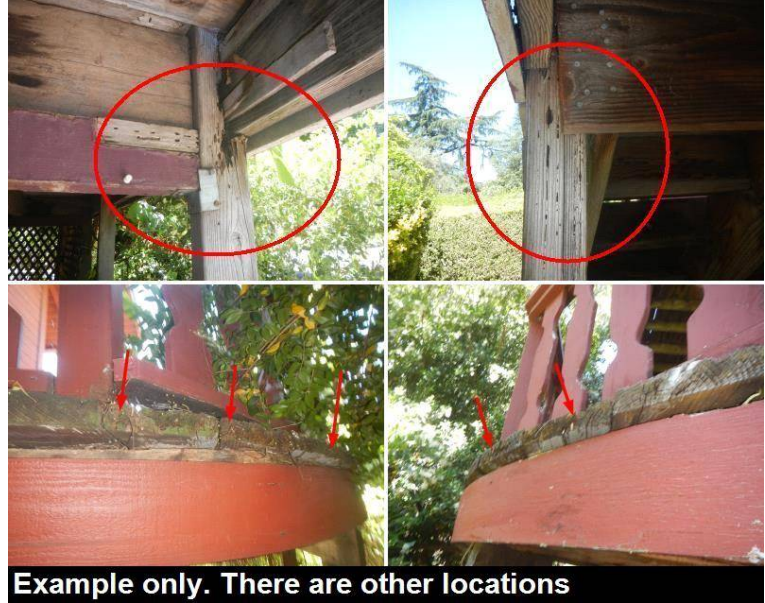
Pictures for examples of the damaged / deteriorated conditions noted.

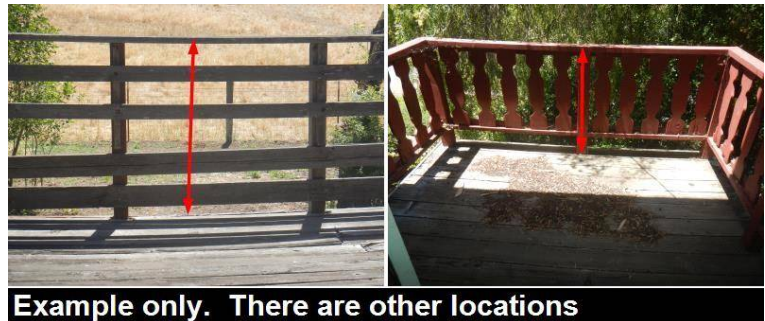
The vertical height of the railings is less than the current standard of 42 inches. This requirement changed January, 2008. While there is no requirement to upgrade to the latest standard, as a safety upgrade, we recommend having the railings evaluated and corrected by the appropriate qualified tradesperson.

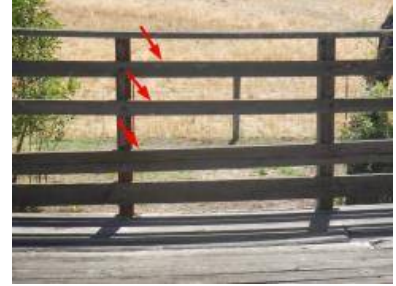
The railing dividers/balustrades in some places are installed horizontally instead of vertically. This is not typical. Railing balustrades that are installed horizontally create a ladder effect and can be easily climbed. This can be a very hazardous condition if children are present. For the safety of children, we recommend direct supervision when they are in these areas.

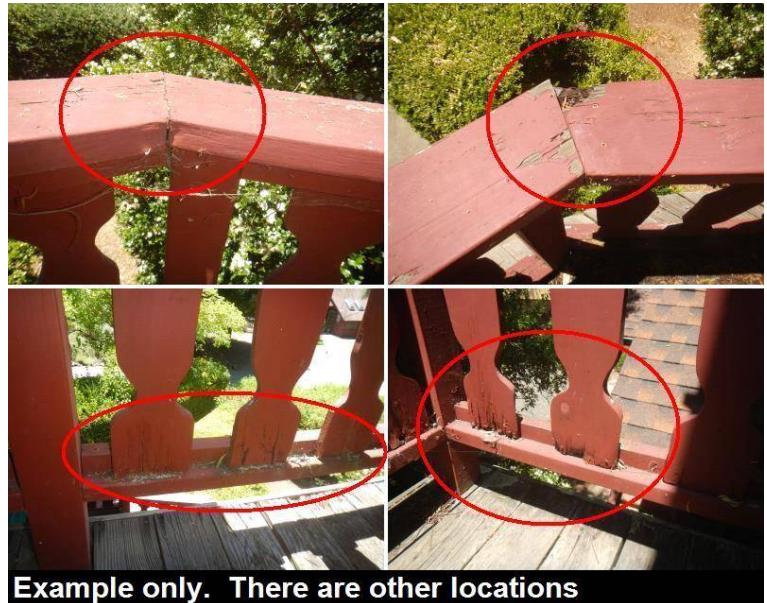
Deterioration is noted to one or more of the railings or railing components. Recommend having this condition evaluated and corrected by the appropriate qualified trades person.

Example only. There are other locations

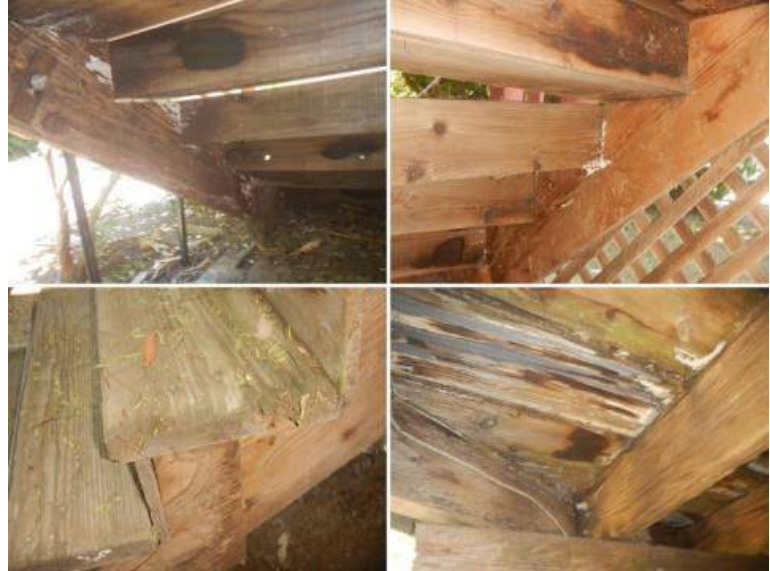
Wood fungus and damage / deterioration was noted to the surface boards or framing at the underside of the steps in various locations. Wood fungus is the first stage of dry rot, and is usually treatable with a fungicide. We recommend that you consult a licensed pest inspection company for information regarding this procedure.

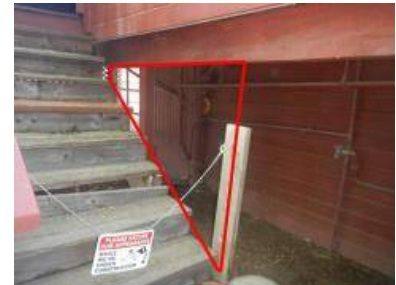
There are NO balustrades installed at the stairs on the left side of the structure. Current requirements are to have balustrades installed with a spacing / gap not to exceed 4 inches. We recommend installation of balustrades as the current configuration presents a Potential Hazard.

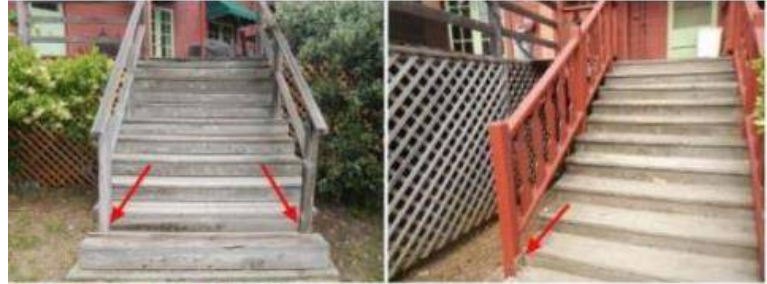
The handrails are loose at multiple stair assemblies around the structure. Recommend having this condition evaluated and corrected by the appropriate qualified trades person.

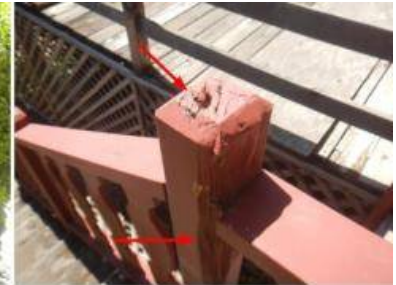
Damage / deterioration is noted to one or more of the railings or railing components around the house. Recommend having this condition evaluated and corrected by the appropriate qualified trades person.

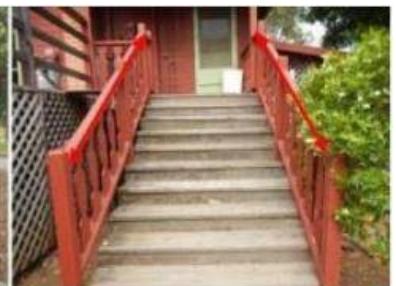
There are NO graspable handrails installed at some of the stairways around the house. For safety, current standards require a graspable handrail be installed on at least one side of a stairway. Recommend having this condition evaluated and corrected by a licensed and qualified building contractor.

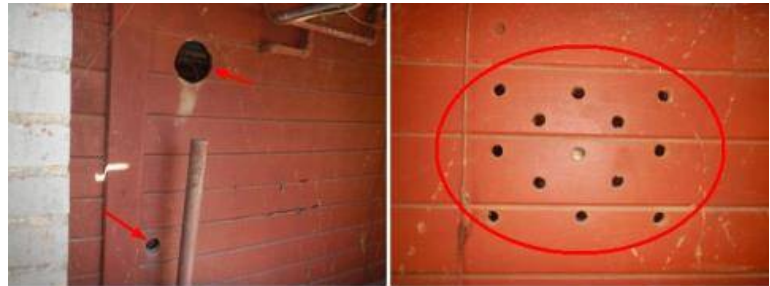
There are one or more holes in the exterior siding. This condition can allow birds, bats, rodents etc. access to interior framing and other areas of the structure. We recommend sealing up any voids, holes or openings in the exterior.

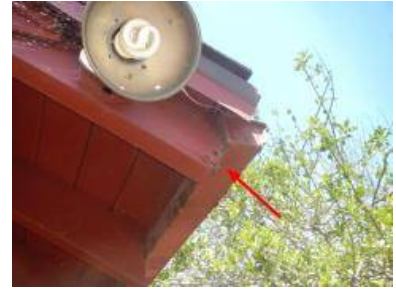
There is deterioration noted to the lower ends of the barge rafters at one or more locations around the structure. Barge rafters are the rafters that run along the outside edges on the gable ends (sloped sides) of the roof. Recommend having this condition evaluated and corrected by the appropriate qualified trades person.

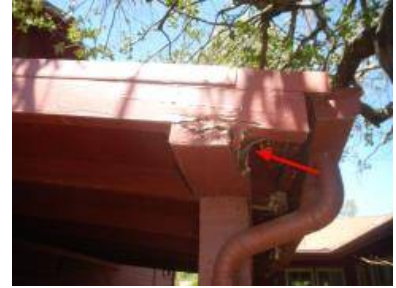
The perimeter support framing and roof sheathing at the eave overhangs for the rear patio covering is deteriorated in multiple places. Recommend having this condition evaluated and corrected by the appropriate qualified trades person.

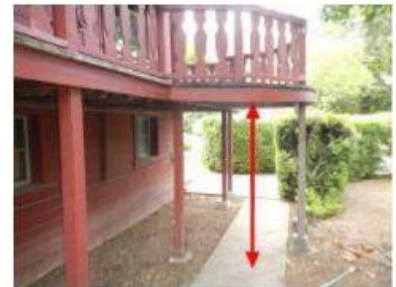
The vertical clearance noted between the left side decking and the walkway is lower than the minimum height of six feet eight inches (6' 8") and poses a potential head bump concern. This condition is also present at the front of the house where the overhead deck / walkway is located. Where it is practical we recommend correcting this condition.

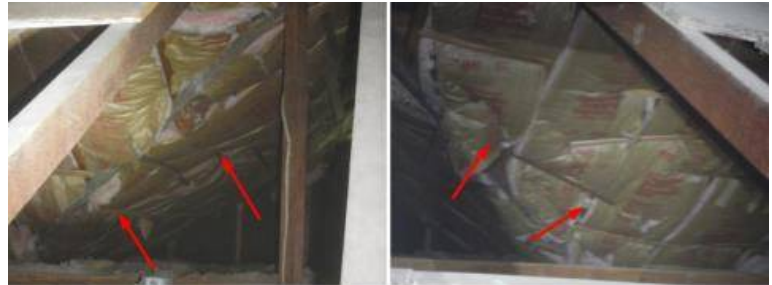
The insulation in some areas is placed / installed against the underside of the roof sheathing instead of on the upper side of the ceiling. This allows any moisture that condensates in the attic to get trapped against the framing members.

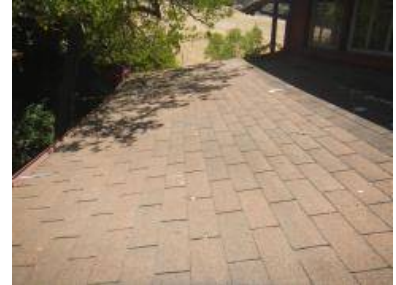
The pitch of the roof over the rear patio area is not appropriate for the type of roofing materials used. This may not allow the roof coverings to perform as intended / designed. Composition shingles are not typically recommended to be installed on roof pitches that are less than 4:12. Typically a roof pitch between 2:12 & 4:12 is considered a low slope application and requires a double layer of felt underlayment or a specialty type of felt paper / waterproof membrane underlayment. We are unable to fully determine if the proper installation methods have been used (without removal of roofing materials.) If proper methods were not used on the entire roof, the life expectancy of this roof will be somewhat shortened from what is estimated below.

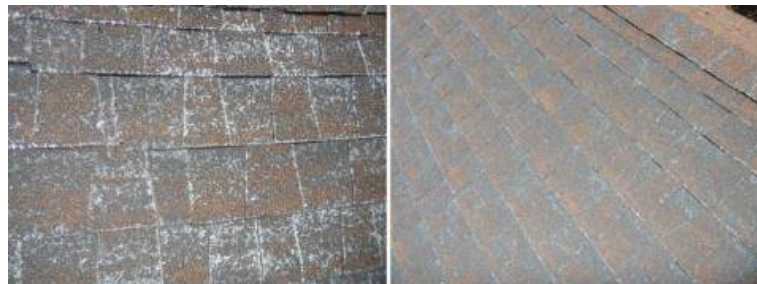
The fiberglass asphalt composition shingles have moderate to heavy granular loss / deterioration noted in some sections. Despite this condition, they appeared to be adequately protecting the underlying home structure at the time of the inspection.

Be aware that this condition does indicate a limited life expectancy. You may wish to consult with a qualified roofing contractor to discuss options and costs for replacement.

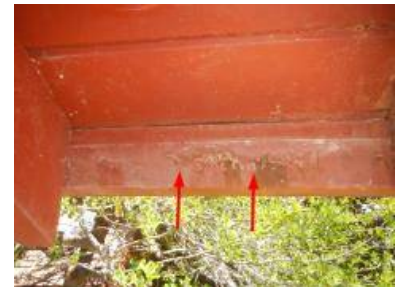
The gutters were noted to be rusted through and leaking at one or more locations around the structure. This is typical for older gutters but indicates a very limited life expectancy. Recommend having this condition evaluated and corrected by the appropriate qualified trades person.

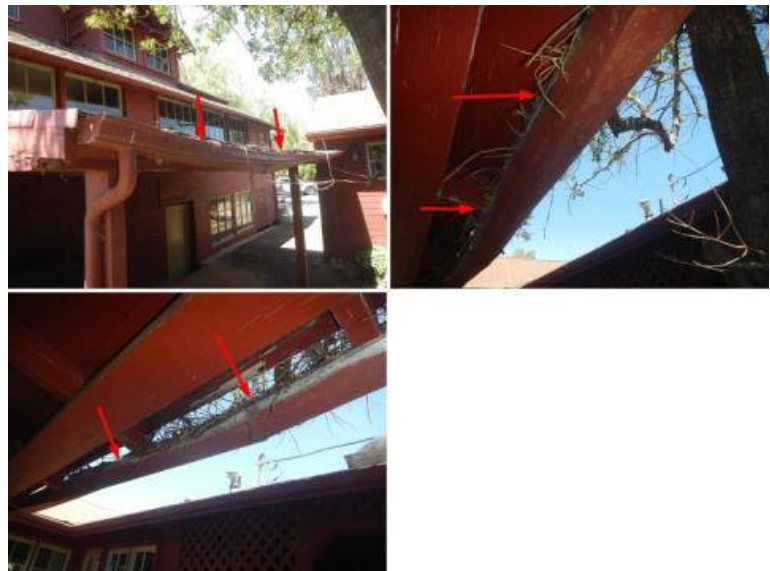
The rain gutters along the lower edge of the rear patio covering have pulled away from the eaves and are sagging and will not function as intended. We recommend having these conditions further evaluated and corrected by the appropriate qualified professional.

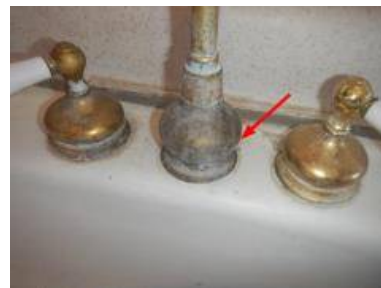
The sink faucet (or water spout) is loose where it attaches to the countertop. We recommend adjustment or repair by an appropriate qualified tradesperson.

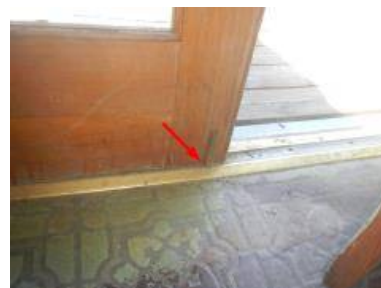
The double doors leading to the deck are rubbing at the bottom which makes operation difficult. We recommend having these conditions further evaluated and corrected by the appropriate, qualified professional.

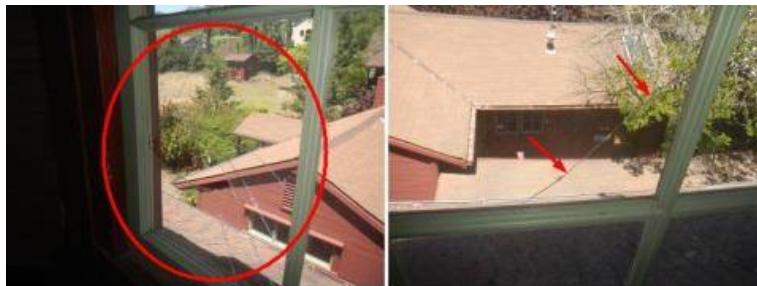
One (or more) of the upper windows in this room are noted to be chipped, cracked or broken. Any type of damage to window glass compromises its integrity. We recommend having any cracked or broken windows repaired or replaced by the appropriate, qualified window & glass professional.

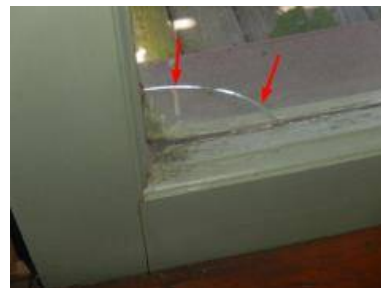
One of the windows in the sun room are noted to be cracked or broken. Any type of damage to window glass compromises its integrity. We recommend having any cracked or broken windows repaired or replaced by the appropriate, qualified window & glass professional.

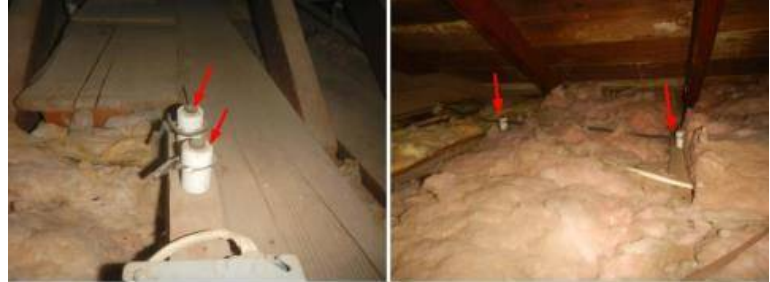
Knob & tube wiring is an antiquated wiring that was used prior to the 1940's. Many insurance companies will refuse to insure homes that still use this type of wiring. I recommend you consult with the current owners to determine if all of this wiring has been abandoned. If it has NOT, I recommend that a licensed Electrician specializing in older construction further evaluate and repair/upgrade as needed.

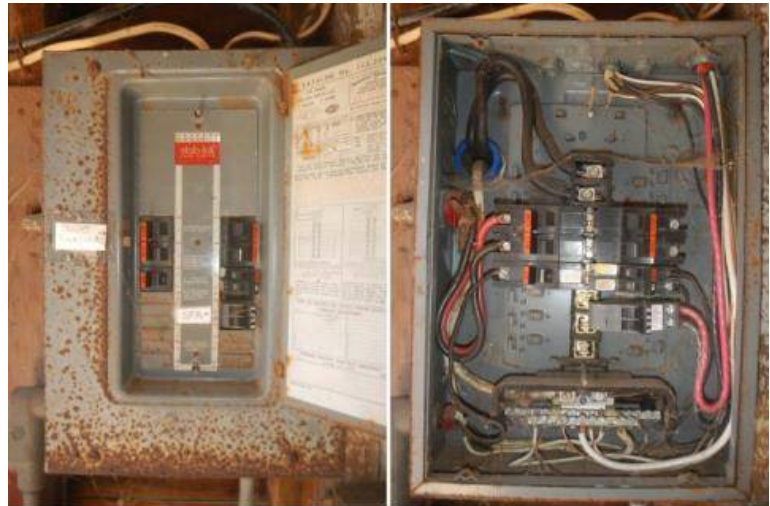
A Federal Pacific Electric (FPE) 'Stab-Lok' circuit breaker panel is noted to be present. Federal Pacific brand electric panels have inherent flaws that make them more hazardous than modern panels. The circuit breakers have a much higher failure rate and will not reliably trip when an overload condition is present. The connection point between the breaker and the bus bar is also weak by nature and can work loose over time resulting in overheating. Both of these items increase the chance of a house fire. We suggest doing further research and consult with a licensed electrician who is familiar with Federal Pacific panels to determine what action is to be taken.

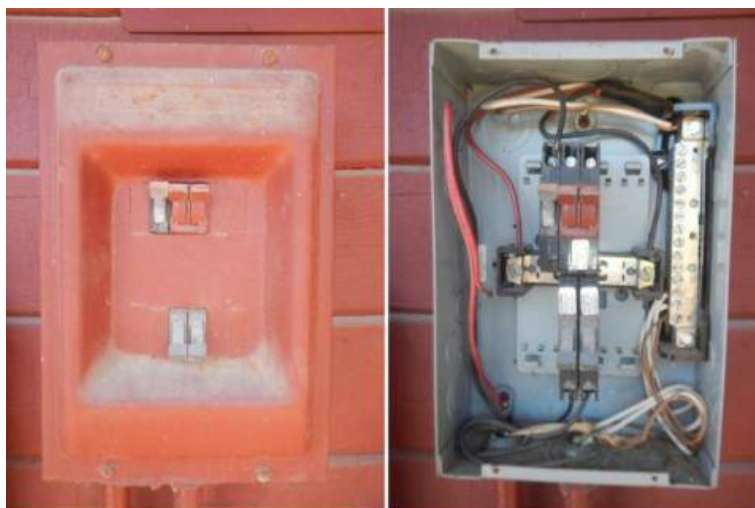
A Federal Pacific Electric (FPE) 'Stab-Lok' circuit breaker panel is noted to be present. Federal Pacific brand electric panels have inherent flaws that make them more hazardous than modern panels. The circuit breakers have a much higher failure rate and will not reliably trip when an overload condition is present. The connection point between the breaker and the bus bar is also weak by nature and can work loose over time resulting in overheating. Both of these items increase the chance of a house fire. We suggest doing further research and consult with a licensed electrician who is familiar with Federal Pacific panels to determine what action is to be taken.
