**WOOD DESTROYING PESTS AND ORGANISMS INSPECTION REPORT**

| Building No.<br>18935 | Street<br>5th Street West | City<br>Sonoma | Zip<br>95476 | Date of Inspection<br>06/04/26 | Number of Pages<br>14 |

| GENERAL DESCRIPTION: Chalet, Barn house, Manzanita cottage, Oak Hill cottage, and chalet basement. | Inspection Tag Posted:<br>Basement |

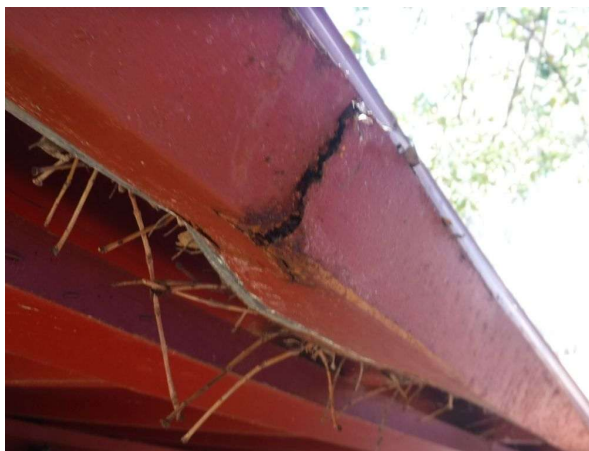
1A. The downspouts and/or gutter systems at the exterior were noted as having possible leak spots and in need of improvements at some locations. Downspouts and/or gutters that do not properly direct water away from the structure can result in dry rot and water damage to wood members.

1. Item 1A Damaged & leaking gutters sample

RECOMMENDATION: Have a roofing contractor install new downspouts and/or gutters as deemed necessary and seal up any current holes, leaks, or rust spots. (INFORMATIONAL)

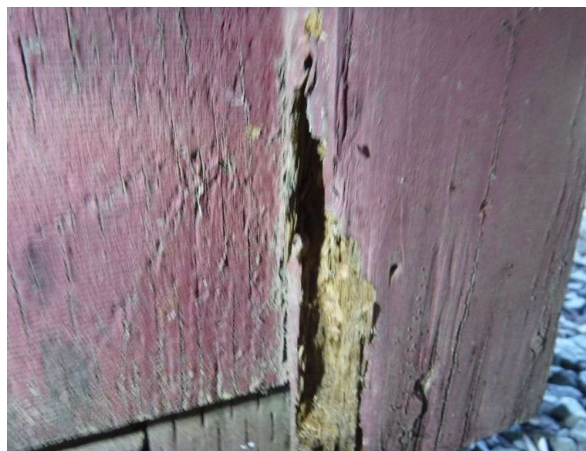
1F. Dry rot fungus-damaged wood was noted to the **Barn house** door trim, thresholds, siding, house trim, roof eaves, rafter tails, and additional wood members at the areas marked on the diagram and additional areas.

2. Item 1F Damaged barn house wood sample

RECOMMENDATION: Cut out damaged wood and replace with new wood materials. New Z-Bar flashing should be installed at any areas of newly installed siding where deemed necessary. Newly installed siding may not match the original depending upon the availability of current materials. Upon completion of repairs, have a roofing contractor properly seal the area directly above to ensure that newly installed wood does not become damaged once again by future roof or gutter leaks. Areas with a minor amount of dry rot can be repaired and patched as deemed necessary. (SECTION 1)

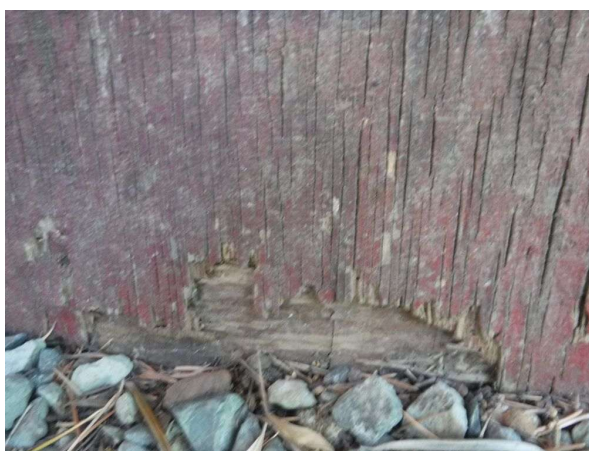
3. Item 1F Damaged barn house wood sample #2

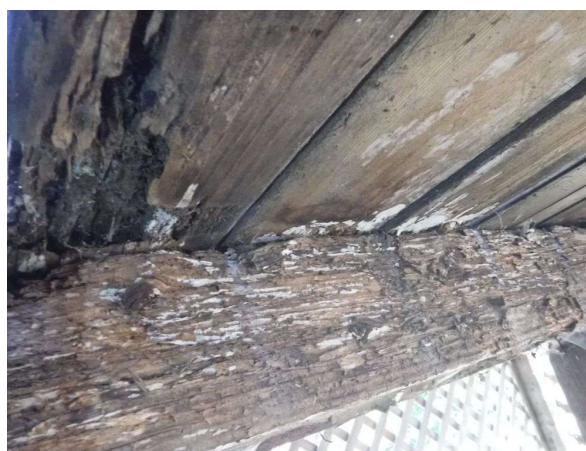
1J. Various wood members of the **Chalet** (main house), **Barn house**, **Manzanita** cottage, and **Oak Hill** cottage deck systems, balcony decks, handrail (or railing) systems, wooden steps, and overhang systems were noted as being weathered and having extensive areas of dry rot fungus-damaged wood, drywood termite-damaged wood, and powderpost beetle-damaged wood to wood members including deck posts, deck joists, deck beams, deck ledgers, deck blocking, deck fascia, risers, treads, deck bracing, lattice, deck trim, pier pads, railing boards, railing posts, railing tops, balusters, overhang posts, overhang eaves, overhang beams, overhang joists, overhang ledgers, deck boards, and associated wood members. Much of this weathering and damages have resulted from the lack of pressure-treated wood, weathering and age, and fungus growth. Damaged deck areas include areas beneath the cantilevered section of the main house.

4. Item 1J Damaged decks framing & wood sample

RECOMMENDATION: Perform repairs to **Chalet** (main house), **Barn house**, **Manzanita** cottage, and **Oak Hill** cottage deck systems, balcony decks, handrail (or railing) systems, wooden steps, and overhang systems to eliminate dry rot fungus-damaged wood. Each and every piece of wood will need to be checked and tested for soundness or dry rot. All wood framing members with any amount of dry rot, termite damage, and beetle damage should be removed, disposed of properly, and replaced with new pressure-treated wood. Damaged deck boards can be replaced with new redwood or composite deck boards. If a cost estimate for deck repairs is given on our Agreement page, this price can be considered a rough estimate (or price range) which might be charged by a general contractor based on the visible extent of damages. A more exact estimate for deck repairs can be provided by a general contractor who can perform the work. Lomax Termite does not perform larger-scale deck repairs (due to lack of a work crew) or provide clearance for damaged deck wood members repairs. Clearance for deck repairs must be obtained from the general contractor performing the repairs. An alternative option is to remove existing decks, railings, and overhangs and dispose of properly. A contractor can then rebuild new decks, railings, and overhangs to building code standards. **Due to the current state of disrepair, all of the decks, balcony decks, and wooden steps of the Chalet (main house) should be considered a current safety hazard and not be used at this time (until repairs can be performed).** (SECTION 1)

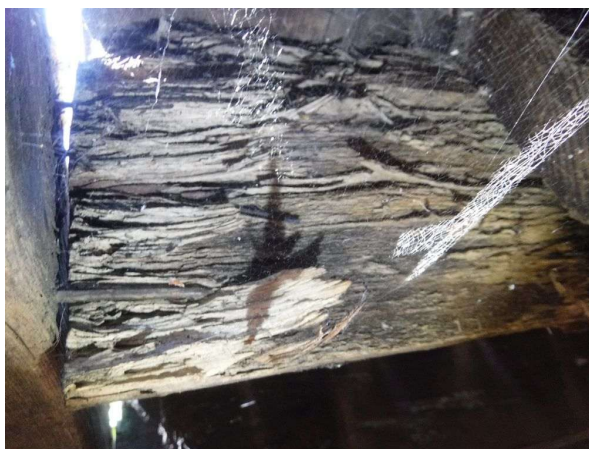
5. Item 1J Damaged decks framing & wood sample #2

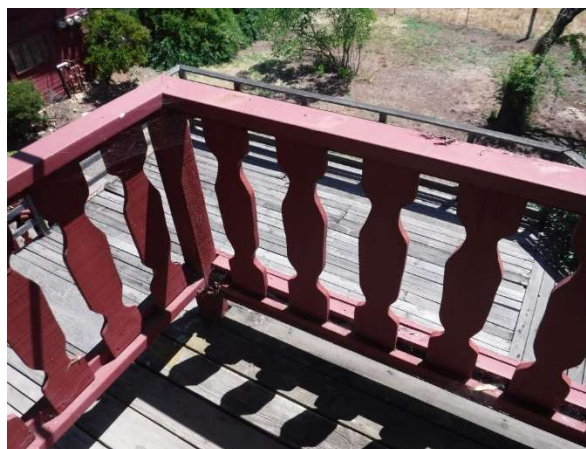
6. Item 1J Damaged main house decks safety hazard sample

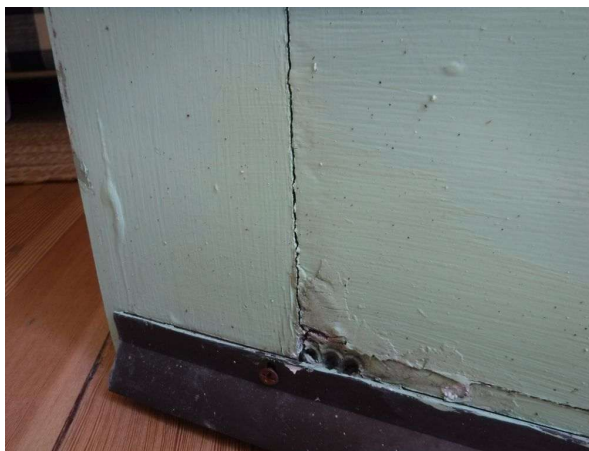
1L. Dry rot fungus-damaged wood was noted to the **Manzanita cottage** door, door trim and frames, roof fascia, beam extension ends, window trim and frames, siding, roof eaves, water heater closet wood

members (which are also moisture-stained from potential leaks), and additional wood members at the areas marked on the diagram and additional areas.

7. Item 1L Damaged Manzanita cottage wood sample

**RECOMMENDATION:** Cut out damaged wood and replace with new wood materials. New Z-Bar flashing should be installed at any areas of newly installed siding where deemed necessary. Newly installed siding may not match the original depending upon the availability of current materials. Upon completion of repairs, have a roofing contractor properly seal the area directly above to ensure that newly installed wood does not become damaged once again by future roof or gutter leaks. Areas with a minor amount of dry rot can be repaired and patched as deemed necessary. (SECTION 1)

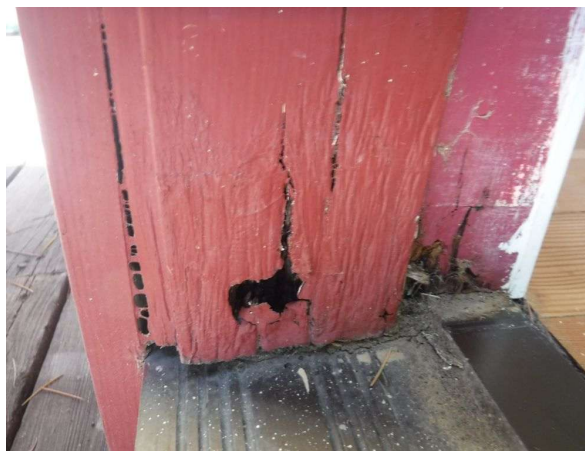
8. Item 1L Damaged Manzanita cottage wood sample #2

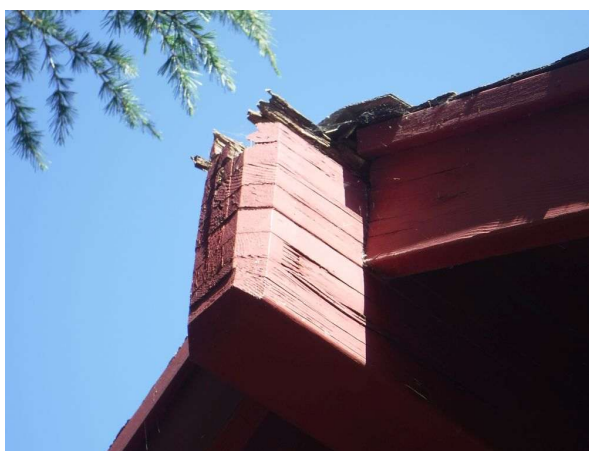
9. Item 1L Damaged Manzanita cottage wood sample #3

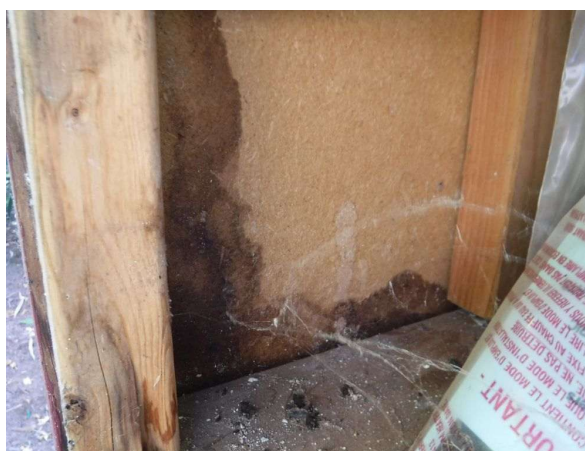
10. Item 1L Damaged Manzanita cottage wood sample #4

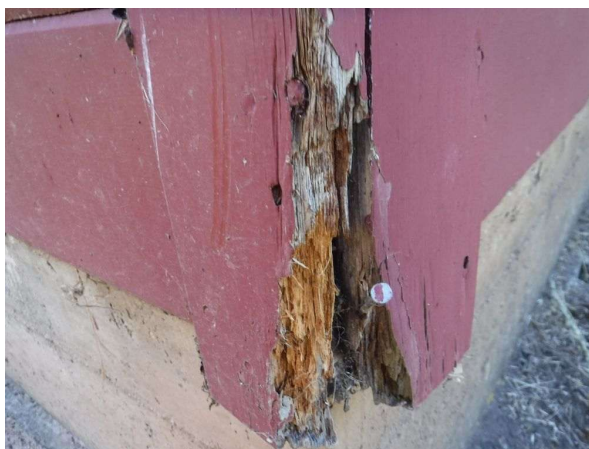
11. Item 1L Damaged Manzanita cottage wood sample #5

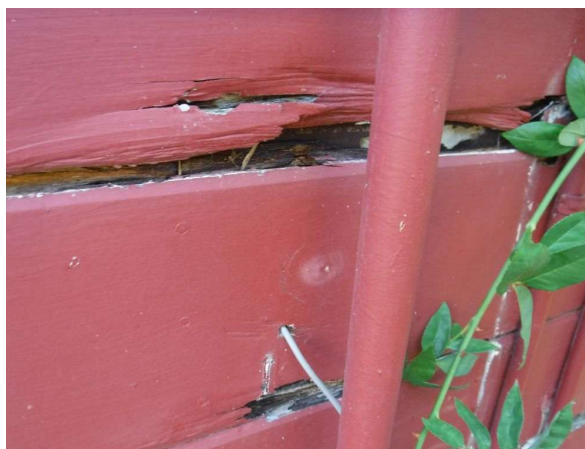
12. Item 1L Damaged Manzanita cottage wood sample #6

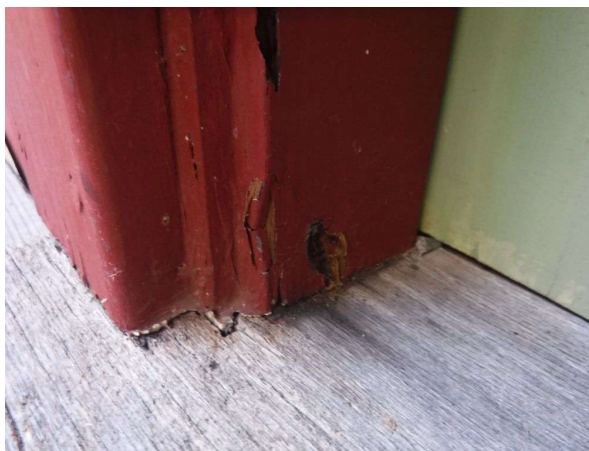
1P. Dry rot fungus-damaged wood was noted to the **Oak Hill cottage** door trim and frames, siding, house trim, chimney siding, chimney trim, window trim and frames, thresholds, roof eaves, roof fascia, and additional wood members at the areas marked on the diagram and additional areas.

13. Item 1P Damaged Oak Hill cottage wood sample

**RECOMMENDATION:** Cut out damaged wood and replace with new wood materials. New Z-Bar flashing should be installed at any areas of newly installed siding where deemed necessary. Newly installed siding may not match the original depending upon the availability of current materials. Upon completion of repairs, have a roofing contractor properly seal the area directly above to ensure that newly installed wood does not become damaged once again by future roof or gutter leaks. Areas with a minor amount of dry rot can be repaired and patched as deemed necessary. (SECTION 1)

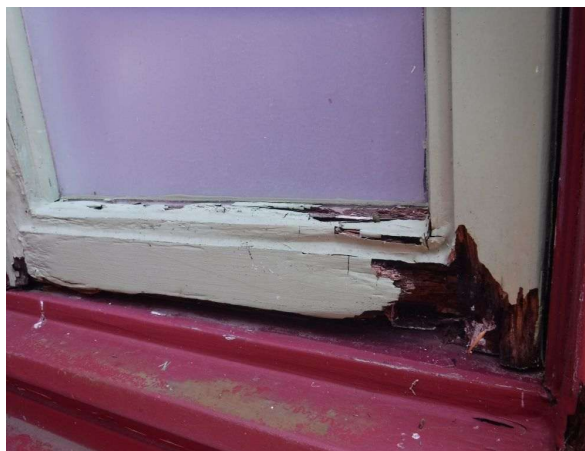
14. Item 1P Damaged Oak Hill cottage wood sample #2

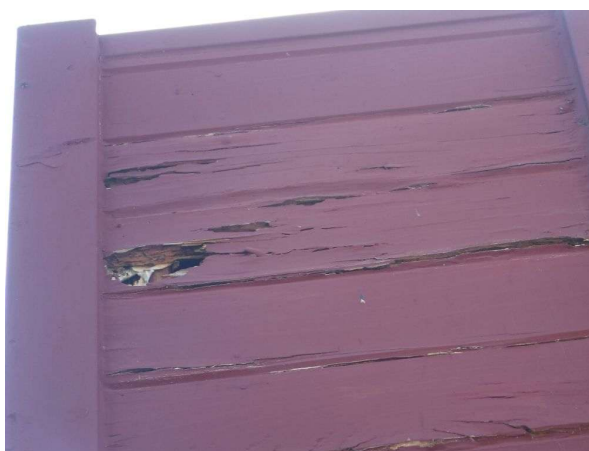
15. Item 1P Damaged Oak Hill cottage wood sample #3

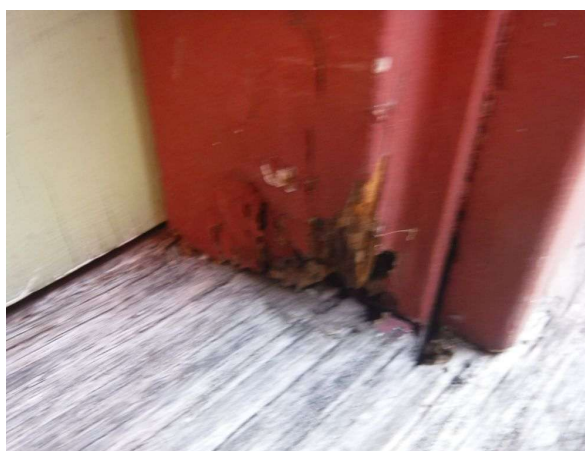
16. Item 1P Damaged Oak Hill cottage wood sample #4

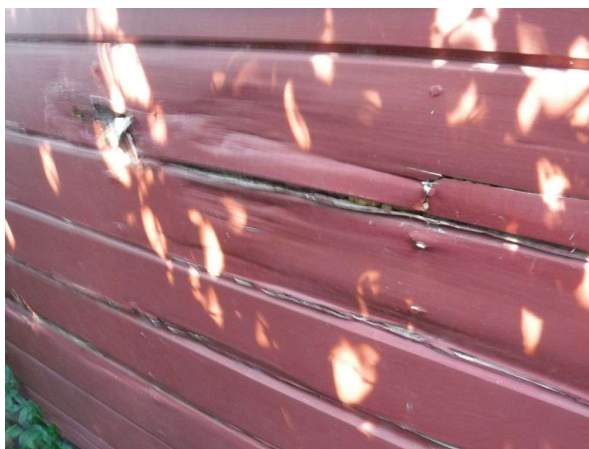
17. Item 1P Damaged Oak Hill cottage wood sample #5

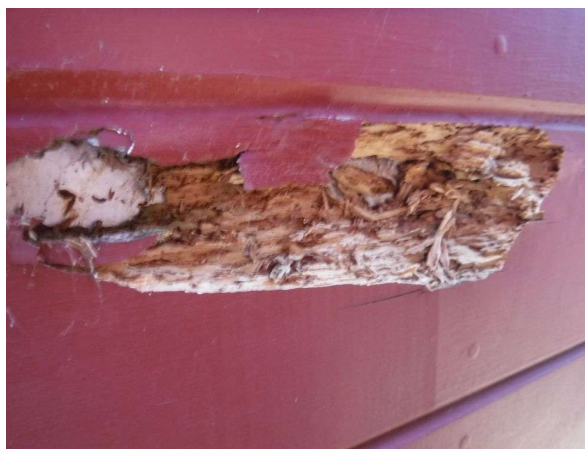
1Q. Evidence of an infestation of powderpost beetles was noted in the Oak Hill cottage chimney siding in the form of visible beetle exit holes and powder-damaged wood at the areas marked on the diagram.

18. Item 1Q Beetle activity at Oak Hill cottage siding

**RECOMMENDATION:** The primary recommendation for control of powderpost beetles is to tarp and fumigate the entire structure with Vikane Gas. A price for fumigation is only provided upon request as arrangements must be made to have the cubic footage measured. More information regarding fumigations can be found in the Standard Notes section below. (SECTION 1)

**SECONDARY ALTERNATIVE:** We recommend as a secondary alternative measure that a direct surface spray treatment of all exposed wood members, framing, and associated boards should be performed with Tim-Bor Insecticide and/or Premise Foam or Termidor Foam to help control powderpost beetles and preserve and protect all surrounding wood that is accessible. This may include drilling holes directly into the wood where practical to inject Tim-Bor and/or Premise Foam or Termidor Foam into powderpost beetle tunnels. Owner should have all wood showing evidence of powderpost beetle activity removed if possible and disposed of properly, then replaced with new wood. Any other evidence of powderpost beetle activity should be swept up or removed by owner so that it is not mistaken for a current infestation during future inspections. (SECTION 1)

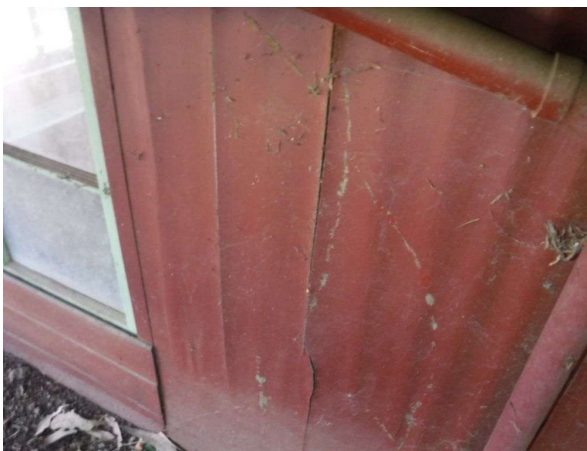
1S. Dry rot fungus-damaged wood was noted to the **Chalet (or main house)** window trim and frames, door trim and frames, siding, house trim, roof fascia, roof eaves, and additional wood members at the areas marked on the diagram and additional areas.

19. Item 1S Damaged Chalet (main house) wood sample

RECOMMENDATION: Cut out damaged wood and replace with new wood materials. New Z-Bar flashing should be installed at any areas of newly installed siding where deemed necessary. Newly installed siding may not match the original depending upon the availability of current materials. Upon completion of repairs, have a roofing contractor properly seal the area directly above to ensure that newly installed wood does not become damaged once again by future roof or gutter leaks. Areas with a minor amount of dry rot can be repaired and patched as deemed necessary. (SECTION 1)

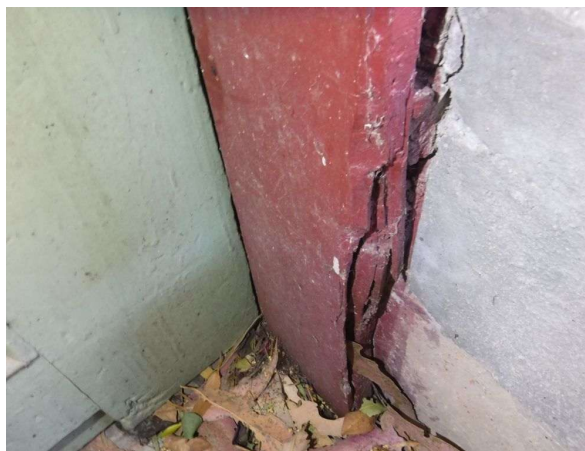
20. Item 1S Damaged Chalet (main house) wood sample #2

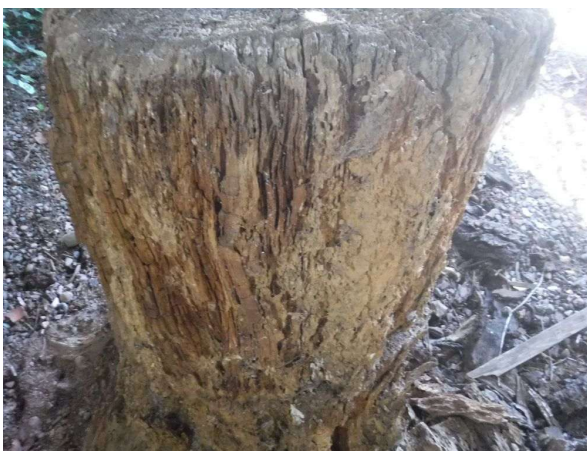
1T. A possible termite-infested stump was noted underneath the Chalet deck.

21. Item 1T Termite-infested stump

RECOMMENDATION: Dig out stump and dispose of properly. As an alternative measure, owner may wish to have a subterranean termite treatment performed at areas with stumps to provide protection against termite entry into the structure. A price for subterranean termite treatment can be provided upon request. (SECTION 2 and FURTHER INSPECTION)

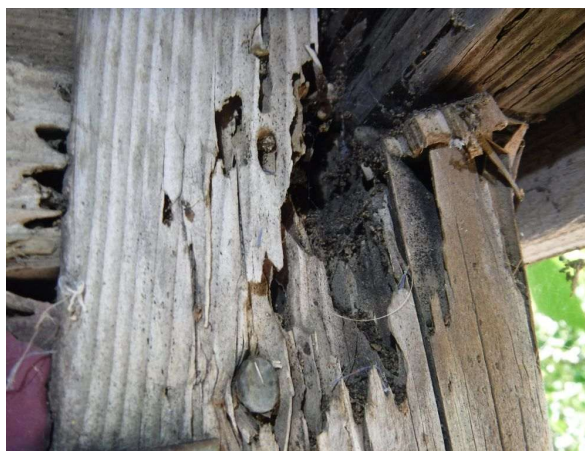
1U. Evidence of an infestation of wood-boring beetles and drywood termites was noted in the exterior Chalet deck framing at various scattered locations in the form of beetle exit holes, powder-damaged wood, and drywood termite pellets to deck joists, deck beams, and associated wood members at the areas marked on the diagram.

22. Item 1U Beetle/drywoods activity in deck sample

RECOMMENDATION: Owner should have all wood showing evidence of wood-boring beetle and drywood termite activity removed if possible and disposed of properly, then replaced with new wood. As an additional measure, we recommend that a direct surface spray treatment (including drilling and injecting as needed) of all nearby wood members, framing, and associated boards should be performed with Tim-Bor Insecticide and/or Premise Foam to help control powderpost beetles and drywood termites, and preserve and protect all surrounding wood that is accessible. Further inspection should be performed upon removal of decks to ensure that infestation does not extend into the main structure. If infestation does extend into main structure, fumigation would be necessary. (SECTION 1 and FURTHER INSPECTION)

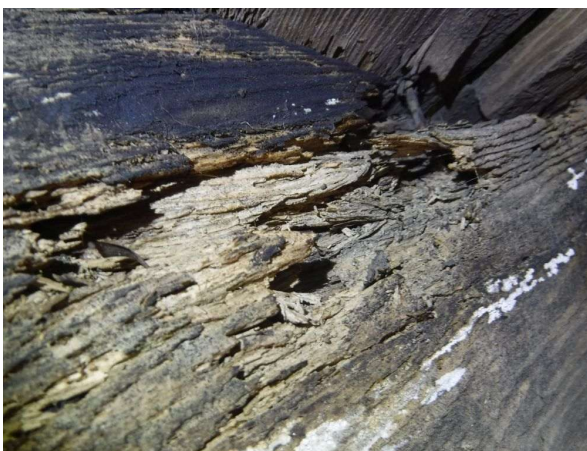
23. Item 1U Beetle/drywoods activity in deck sample #2

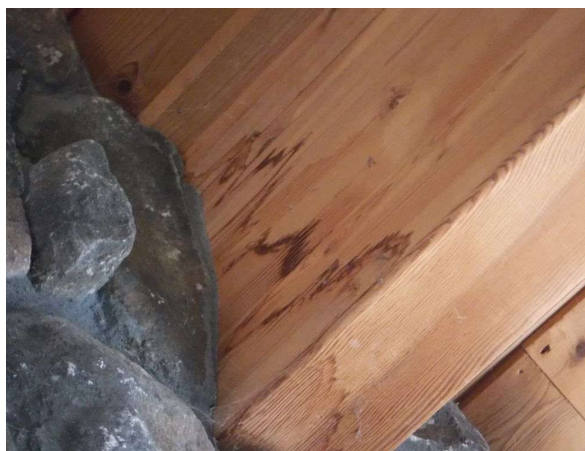
2D. Some possible moisture stains were noted on the wood panel ceiling, wall and ceiling framing and beams, and areas near chimneys in various scattered areas of the interiors of the buildings.

24. Item 2D Ceiling framing moisture stains sample

RECOMMENDATION: Have a painting contractor clean up any moisture stains and apply a fresh coat of paint or preservative. Monitor the areas during heavy rainstorms to see if any areas such as the roof, windows, or walls are leaking. (FURTHER INSPECTION)

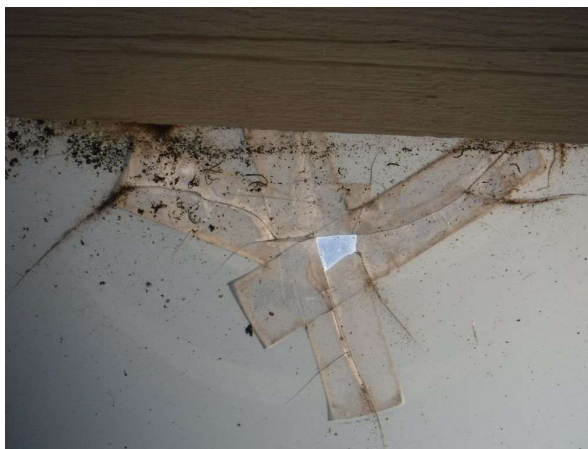
2E. A cracked or broken skylight was noted in the Barn house and Oak Hill cottage. Cracked or broken skylights can allow for moisture entry onto interior sheetrock and wood surfaces.

25. Item 2E Cracked skylight at barn house

RECOMMENDATION: Have a roofing or skylight contractor replace or properly repair cracked or broken skylight and apply a fresh coat of sealant and caulking. (SECTION 2 and FURTHER INSPECTION)

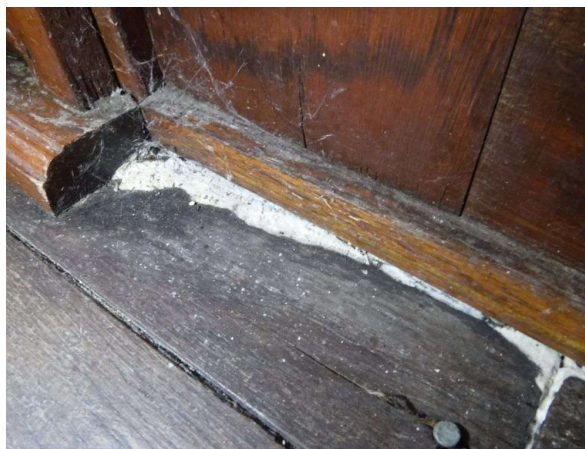
26. Item 1I Moisture stains/fungus at wood door areas

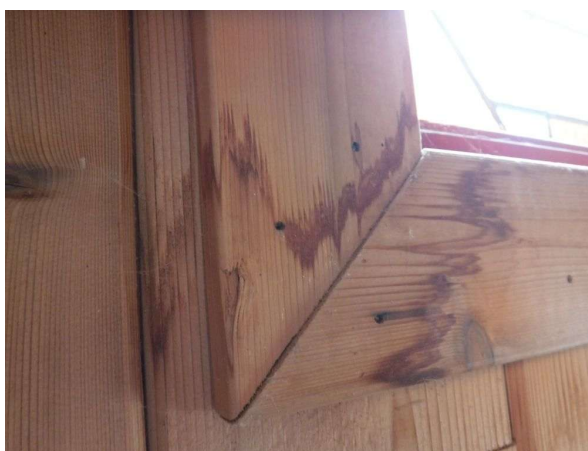
27. Item 1I Moisture stains at wood window areas sample

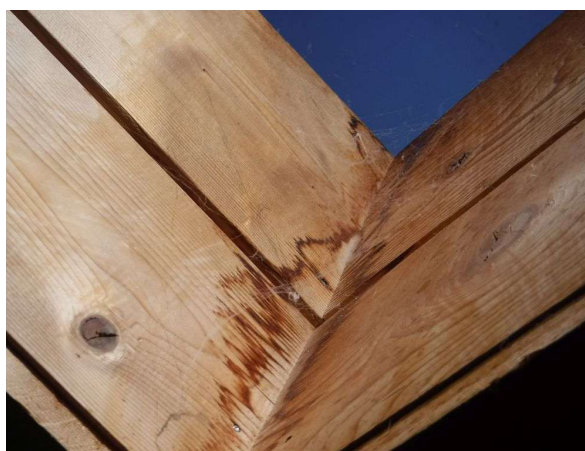
28. Item 1M Moisture stains at wood skylight areas sample

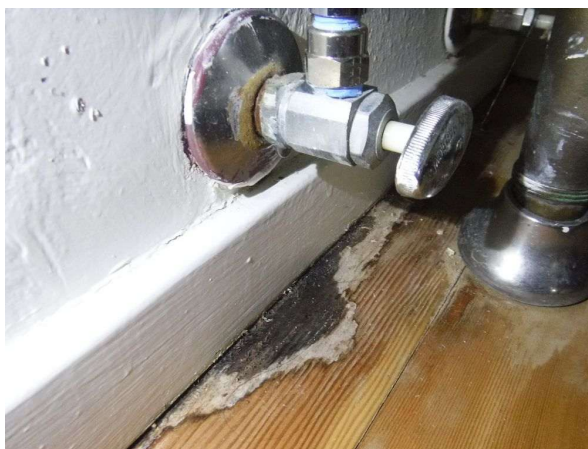
29. Item 2N Interior plumbing leaks/stains (Barn)

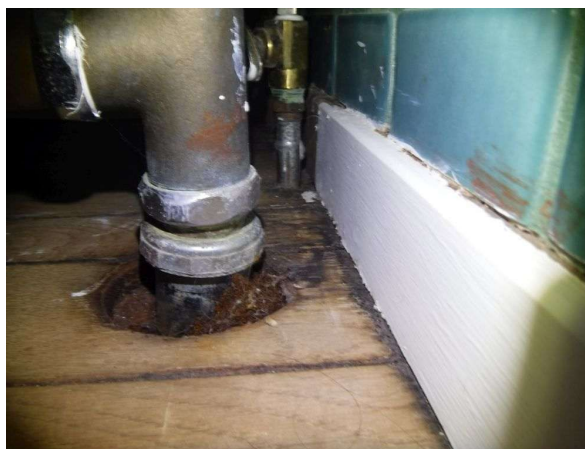
30. Item 2N Interior plumbing leaks/stains (Oak Hill)

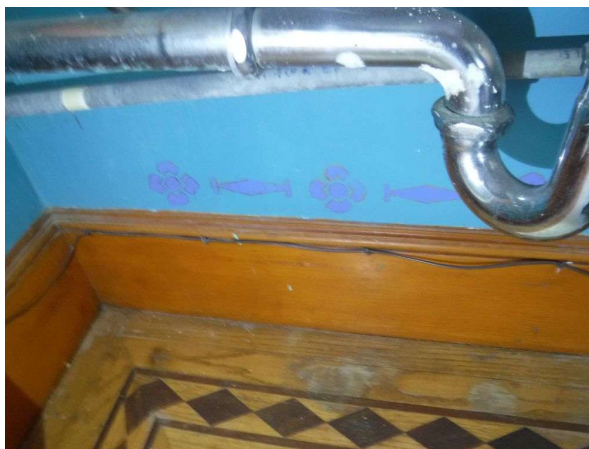
31. Item 2N Interior plumbing leaks/stains (Chalet)

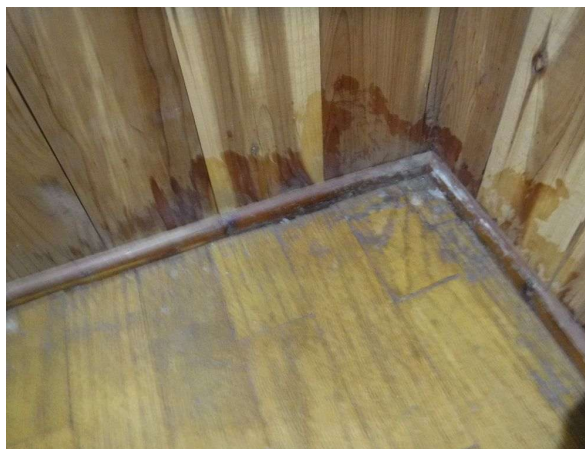
32. Item 2P Moisture stains at walls/floors (Chalet) sample

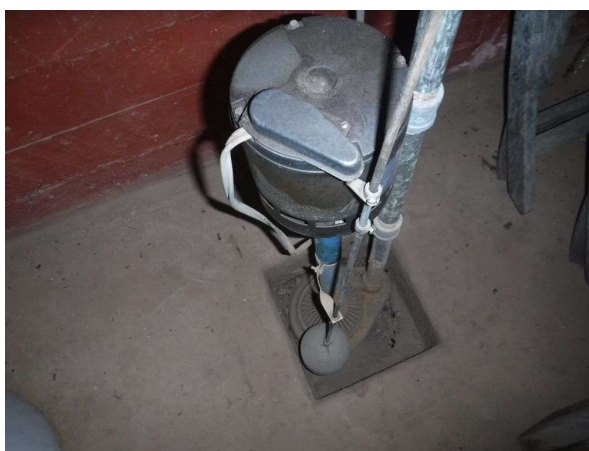
33. Item 4C Sump pump (not tested) in basement

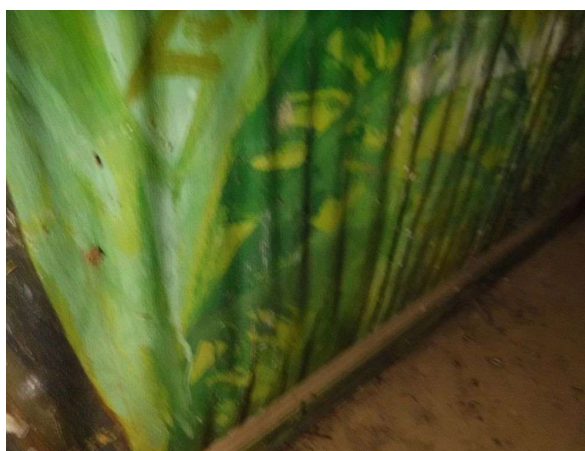
34. Item 4D Wall damages in basement sample

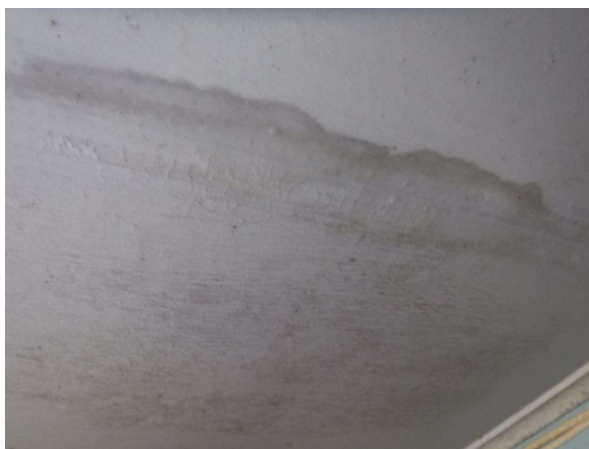
35. Item 4E Moisture stains on basement ceiling sample

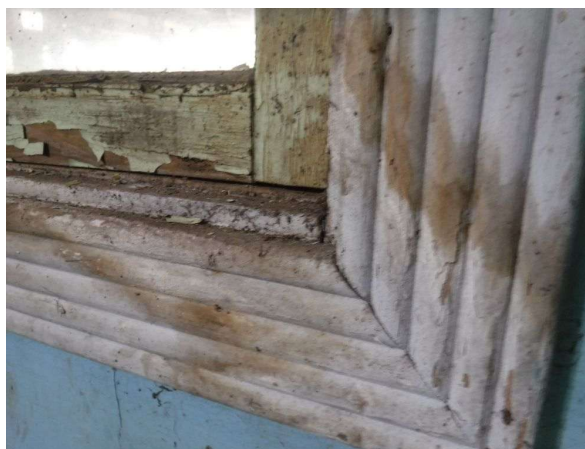
36. Item 4H Moisture stains basement window trim sample
