## COMMERCIAL BUILDING INSPECTION REPORT

2100 Hwy 290 E  
Brenham, TX 77833

JR Enterprises

02/26/2026

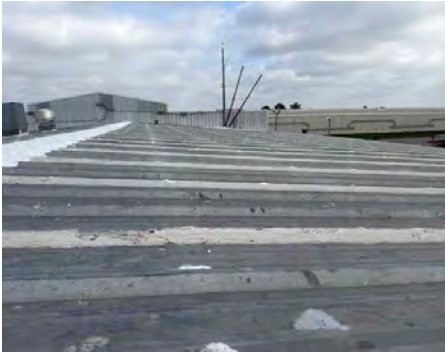
Rear

Indications of previous repairs were visible on the roof, which are typically an indication of previous leakage. I recommend inquiring with the sellers as to any repair done and documentation of repair for warranty purposes.

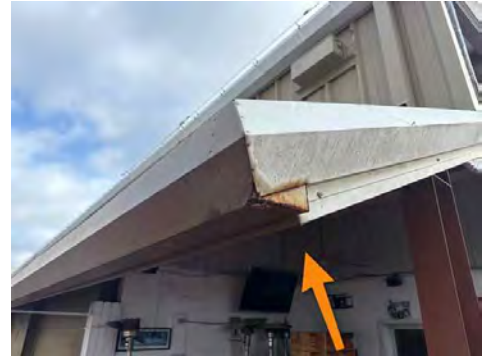
Rear Right

#### **GUTTER RUSTED**

The end cap was rusted and there was no downspout at end. I recommend improving slope of gutter to downspout.

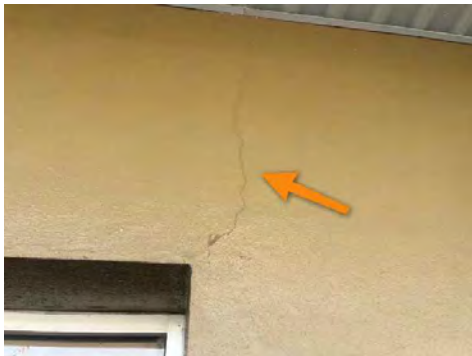
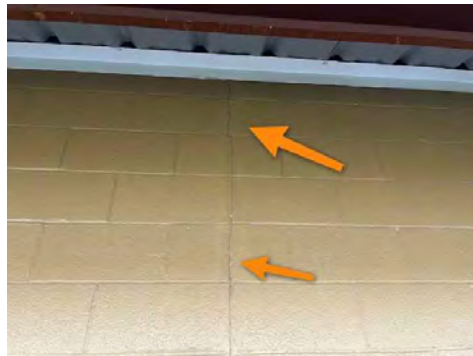
#### **CRACKS IN BRICK**

A few vertical cracks were observed on the exterior wall at areas pictured. This implies that some settling or movement has occurred, as is typical of most old buildings. I recommend monitoring of these areas for any growth or widening in the cracks.

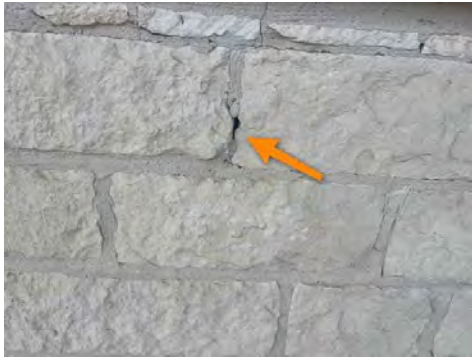
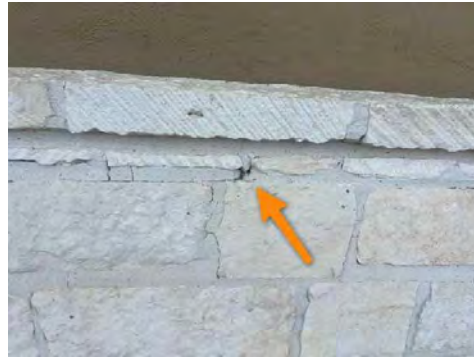
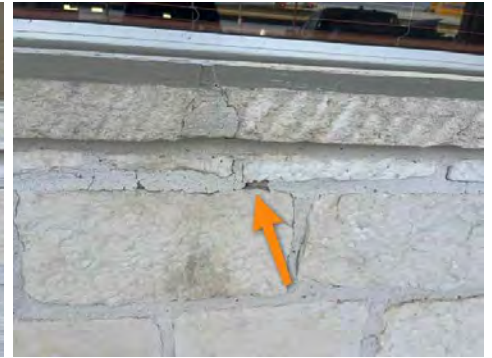
**MORTAR DETERIORATION/WASHOUT**

Stone veneer mortar joints were deteriorated leaving gaps in some places. These openings should be repointed and sealed to prevent water entry and brick deterioration.

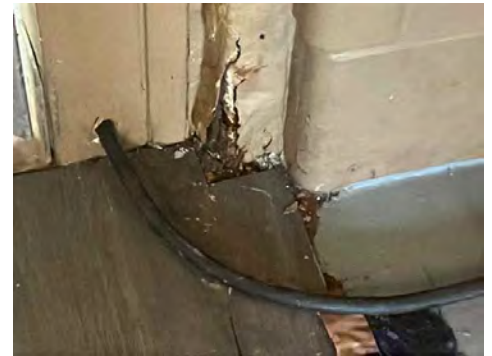
Bar

**WATER DAMAGED BASEBOARD**

One of the baseboards appeared to have previous water damage. Elevated moisture levels were not detected with a moisture meter at the time of inspection. I recommend cleaning/removal of damaged baseboard.

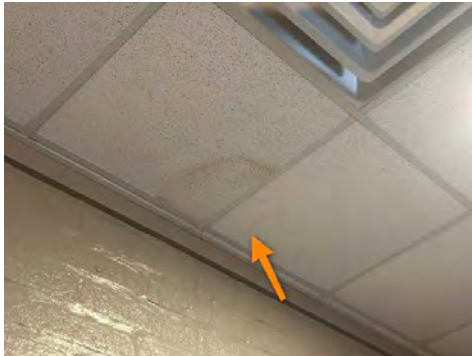
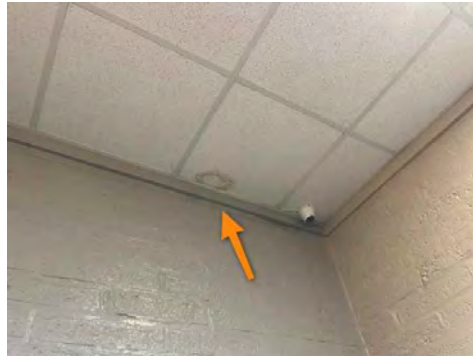
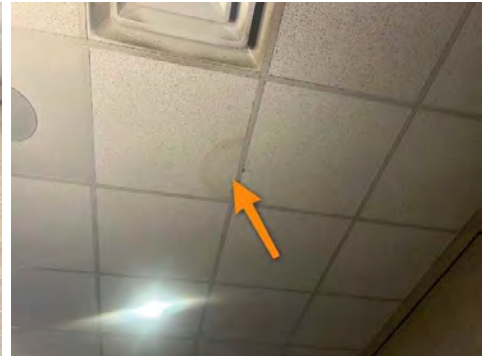
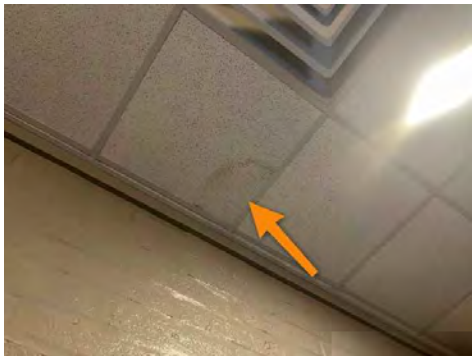
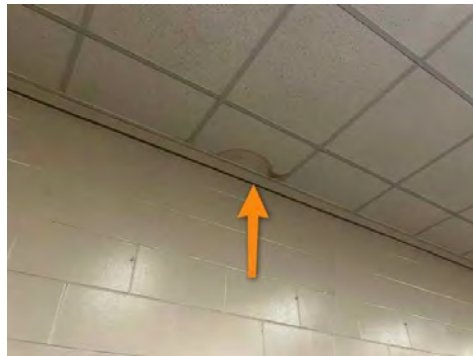
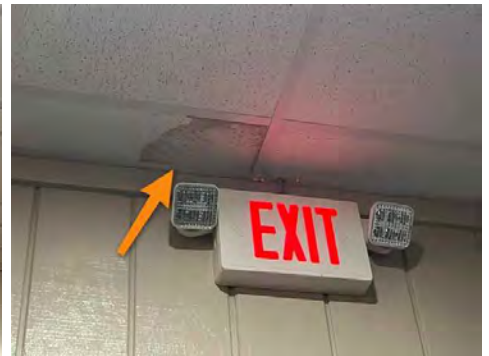
**WATER STAINS ON CEILING**

Several water stains were observed on the ceiling at areas pictured. My moisture meter and thermal imaging camera indicated slightly elevated moisture level indicating the leaks may have been repaired or they only leak intermittently. I recommend replacing damaged ceiling tiles.

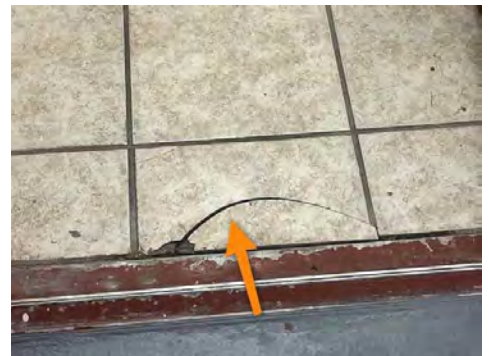
Storage Closet

**CRACKED TILES**

A crack in tiles was observed at area(s) pictured. This could be due to foundational movement. I recommend replacement of damaged tiles.

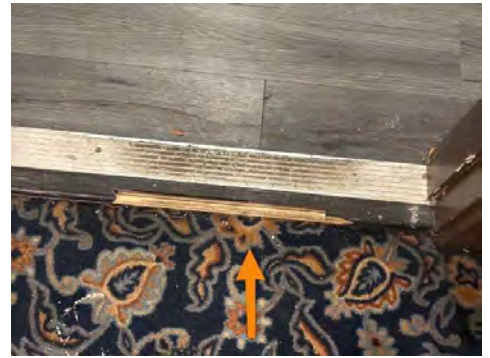
Party Room

**DAMAGED THRESHOLD**

A damaged transition piece was noted at area pictured.

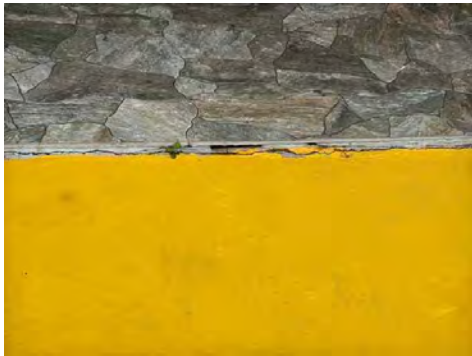
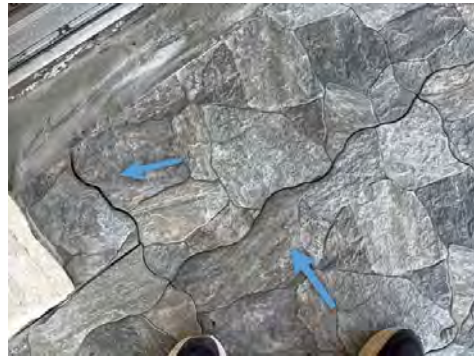
**DETERIORATED GROUT**

The tiles porch exhibited weathering with gaps in areas. This is a high traffic area. I recommend repointing joints to prevent further deterioration.

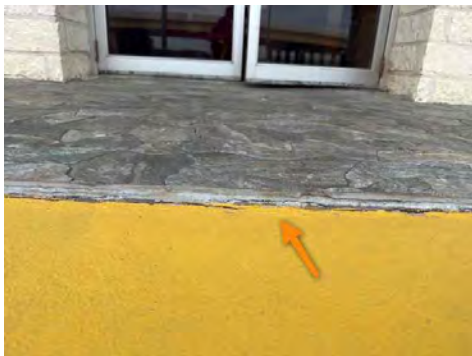
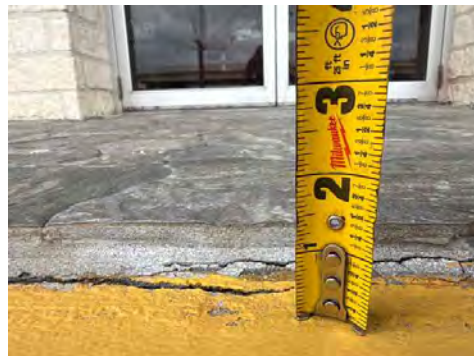
**TRIP HAZARD**

A 1 inch rise was measured at main entry front porch. I recommend raising height of ramp at this transition to remove a trip hazard. ADA requires the transition between the ramp and sidewalk must be smooth and free of abrupt changes. Anything more than 1/2" vertical change is not allowed.

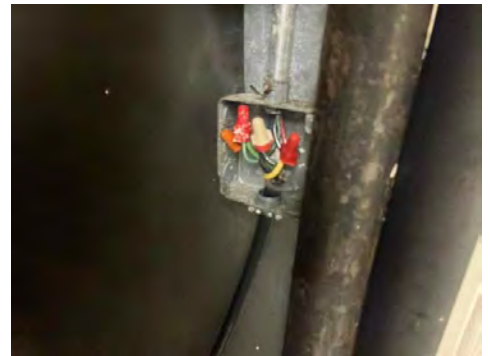
Kitchen

### COVER PLATE MISSING

One of the J-boxes was missing a cover plate. This condition left energized electrical components exposed to touch, which can lead to electric shock. All outlets should have cover plates installed.

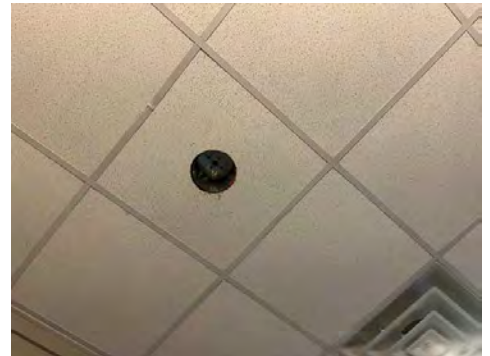
Party Room

### MISSING LIGHT FIXTURE

One of the light fixtures was missing. I recommend proper termination of conductors and a light fixture or listed cover be installed by a qualified electrical contractor.

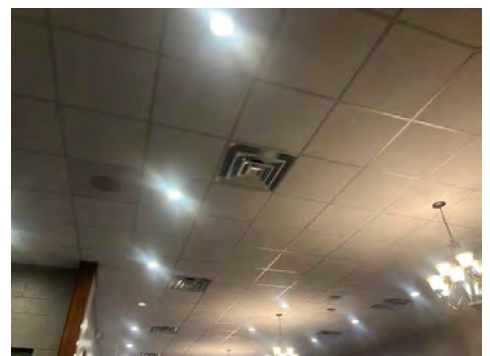
Rear Dining Area

### FLICKERING LIGHTS

Lights that flicker when a large appliance is turned on may be a sign of voltage fluctuation or loose wire connections. Further evaluation is needed by licensed electrician.

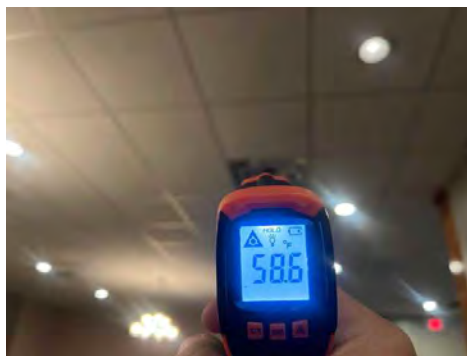
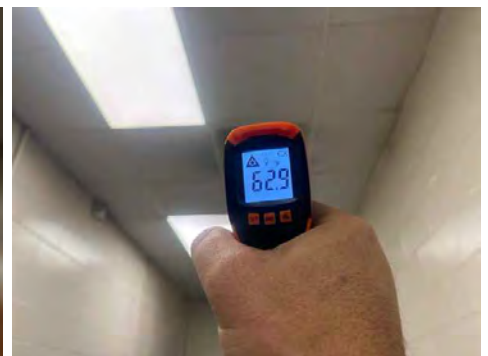
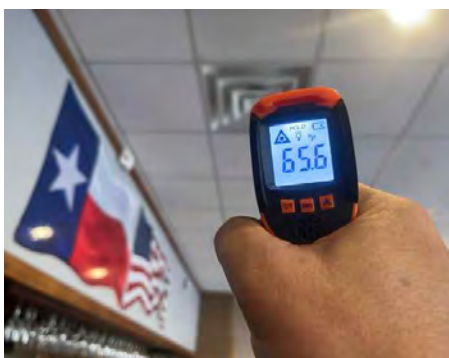
Difference: **10 F** (15 degrees Fahrenheit to 22 degrees Fahrenheit temperature differential is desired)

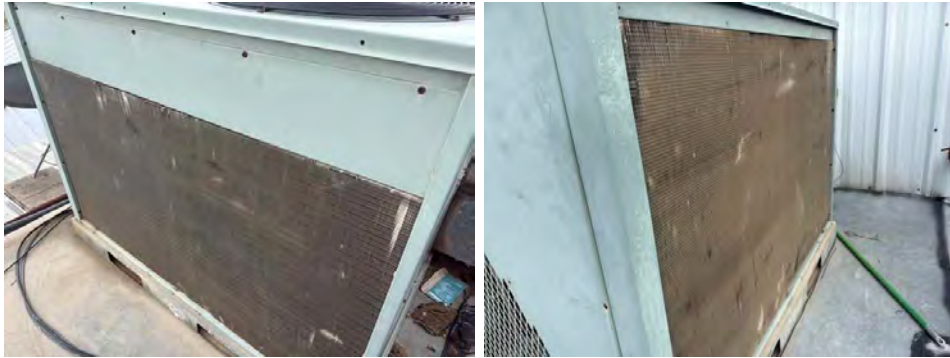
**DIRTY CONDENSER COILS**

The coils for the A/C condenser units were excessively dirty. It is recommended to have the grills cleaned to promote air flow and better energy efficiency.

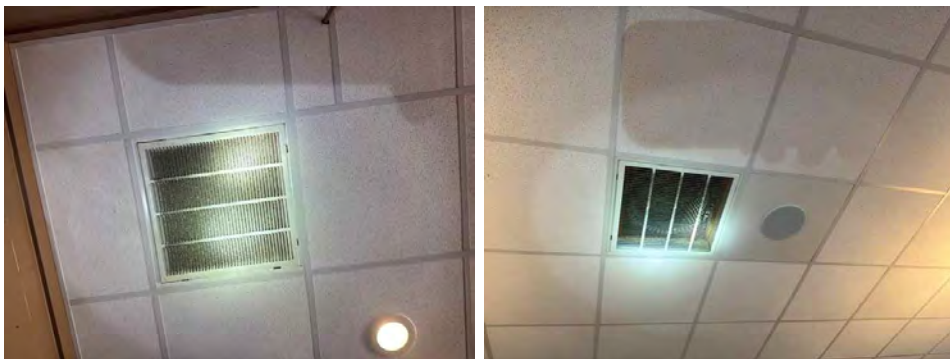
Dining

**DIRT ON VENTS**

Dirt and debris was noted at the heating/air condition vents. I recommend cleaning the registers and having the ductwork professional cleaned and filters replaced.

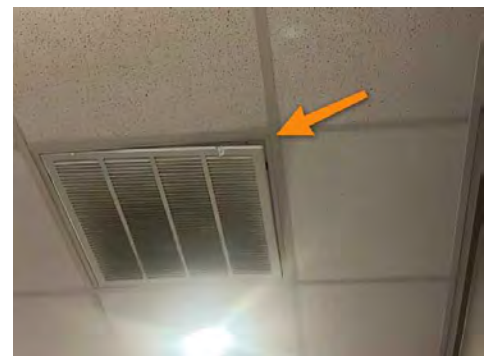
Hallway

**LOOSE RETURN GRILL**

An opening was observed in the return air plenum. I Recommend closing and sealing any gaps in the return air plenum to promote maximum efficiency of the unit.

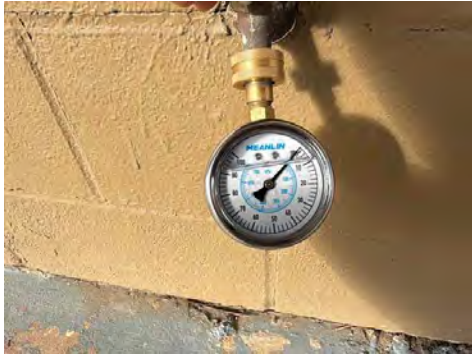
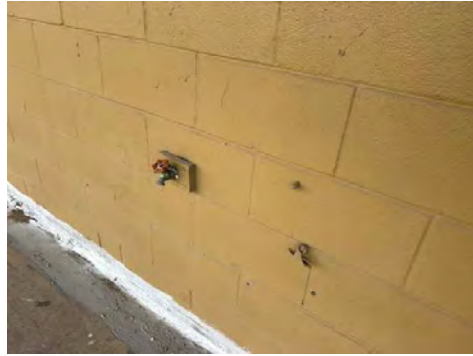
**HOSE BIBS DISCONNECTED**

There was no water present at the exterior hose bibs. There were abandoned copper water lines.

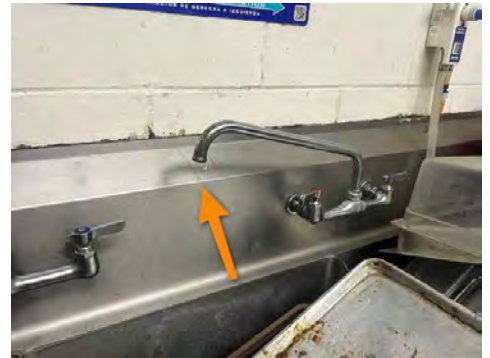
**FAUCET LEAKING**

Kitchen faucet valve was leaking at the sink when operated. Repair is needed

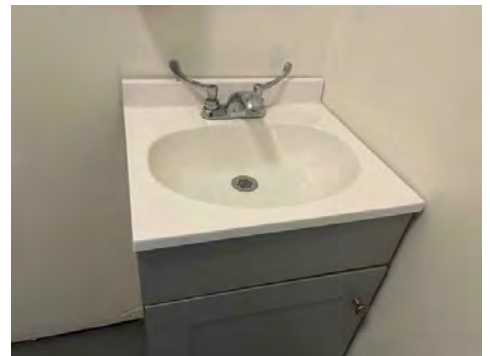
Rear Right Side Bathroom

**SINK SLOW TO DRAIN**

This sink was slow to drain, suggesting that an obstruction may exist. I recommend further evaluation and improvement by a licensed plumber.

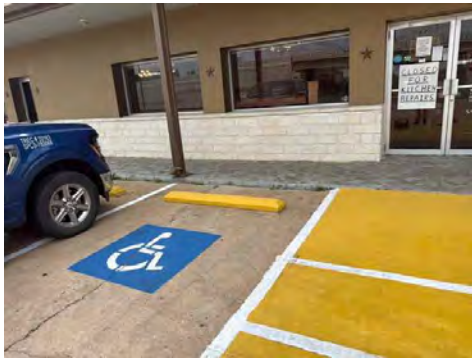
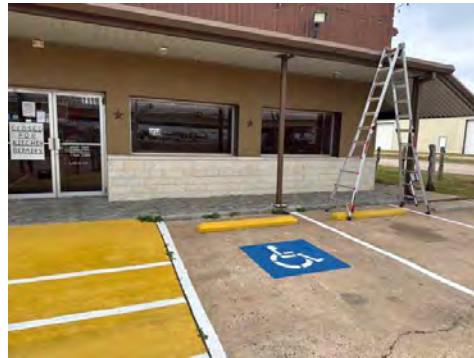
#### MISSING HANDICAP SIGN

Handicap parking must have signs prominently display the International Symbol of Accessibility (ISA) and be mounted at a height of at least 60 inches above the ground. Van-accessible spaces also require an additional sign stating "van-accessible". In Texas, disabled parking placards must also feature the ISA and include an identification number, expiration date, and the department's seal, according to Texas law.

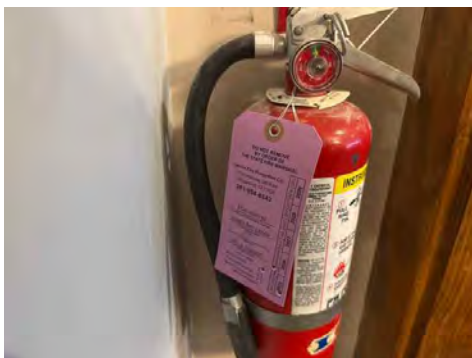
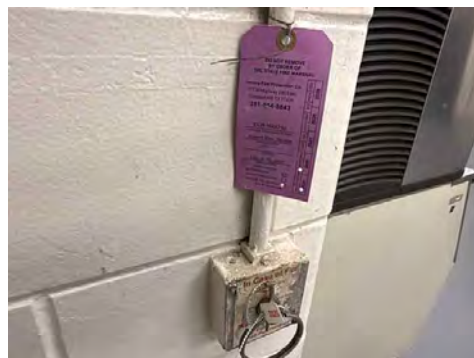
Portable fire extinguishers were in need of inspection or recharging. The inspection tags had recently expired.

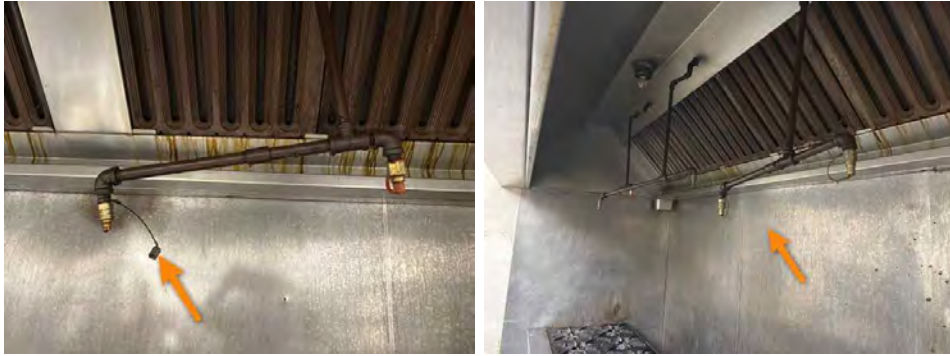
Vent hood

The fire suppression nozzles need to be degreased.

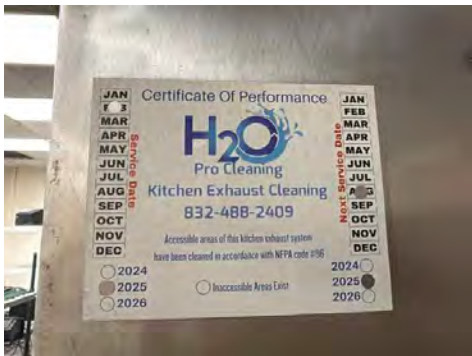
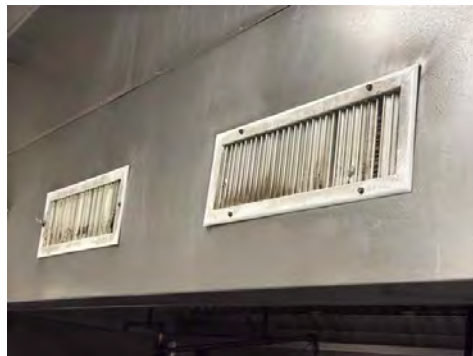
The certificate for vent hood exhaust was not up to date. I recommend updating certificate of performance.

Make up Air dirty
