**REPORT OF INVESTIGATION  
Phase I  
Environmental Assessment**

**Halliburton Logging Services  
3701 East Rio Grande Street  
Victoria, Victoria County, Texas**

**November 18, 1996**

**B-ENVIRONMENTAL PROJECT NO. ANG1096-1**

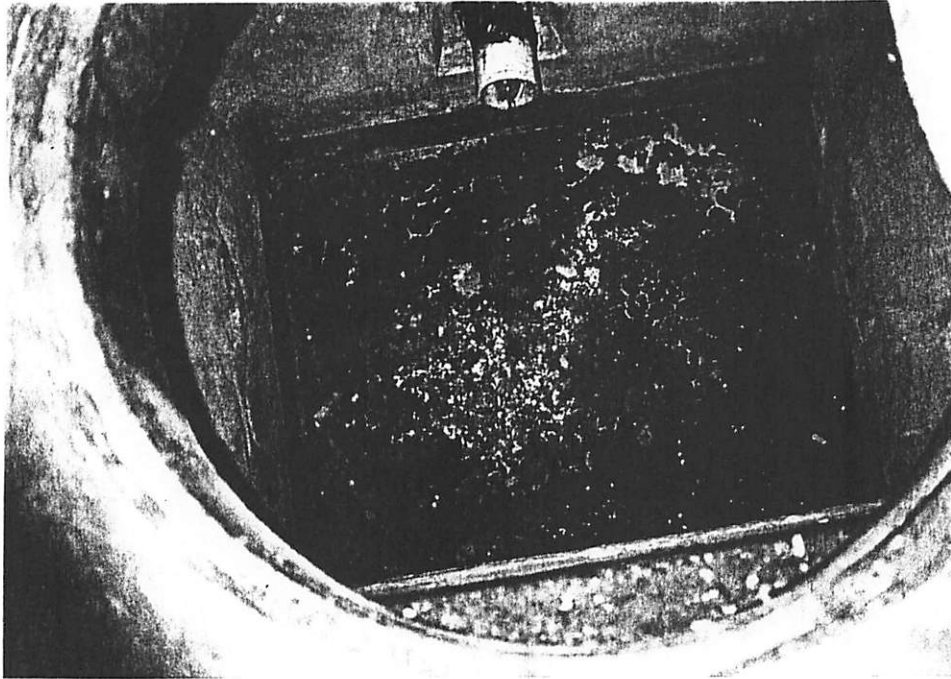
PHOTOGRAPH 1

**Area 07: Inside wash bay; Southwest corner of building:** The inside wash bay has apparently been cleared of debris, chemicals, and waste residues. A drain grate and concrete sump is located in the center of the wash bay which served as an oil, grease, and solids trap before emptying into city sewer facilities. A close inspection of this sump and trap indicated no cracks or integrity violations verifying that a subsurface release was not probable. The sump compartments are completely empty and dry with only a very slight hydrocarbon odor noted. See photograph no. 1 showing clean sump on effluent end.

Clean Sump at Interior Wash Bay -- effluent side

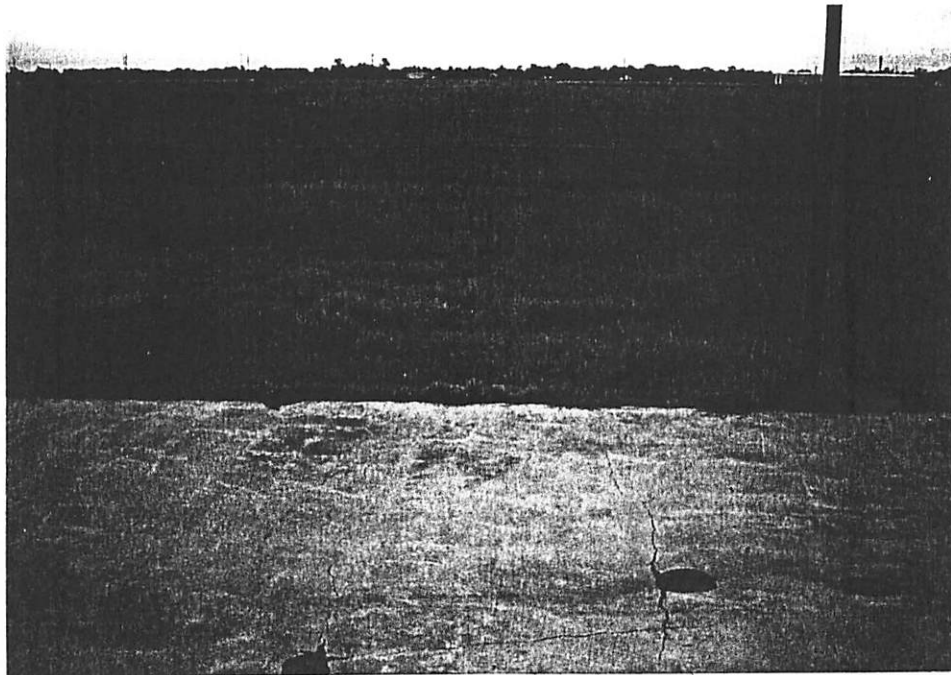
PHOTOGRAPH 2

**Area 10: *South-end grassy area:*** The grassy area behind the building has in the past been the subject of a contamination cleanup by the owners. This area is now covered in green grass with no evidence of distressed vegetation (see photograph no. 2). A very close inspection of soil surfaces and root structures indicated a healthy environment at the surface and review of past clean up data indicates a clean subsurface (see section 10 for review information).

Grassy area at south end of fenced yard -- site of past contamination clean up

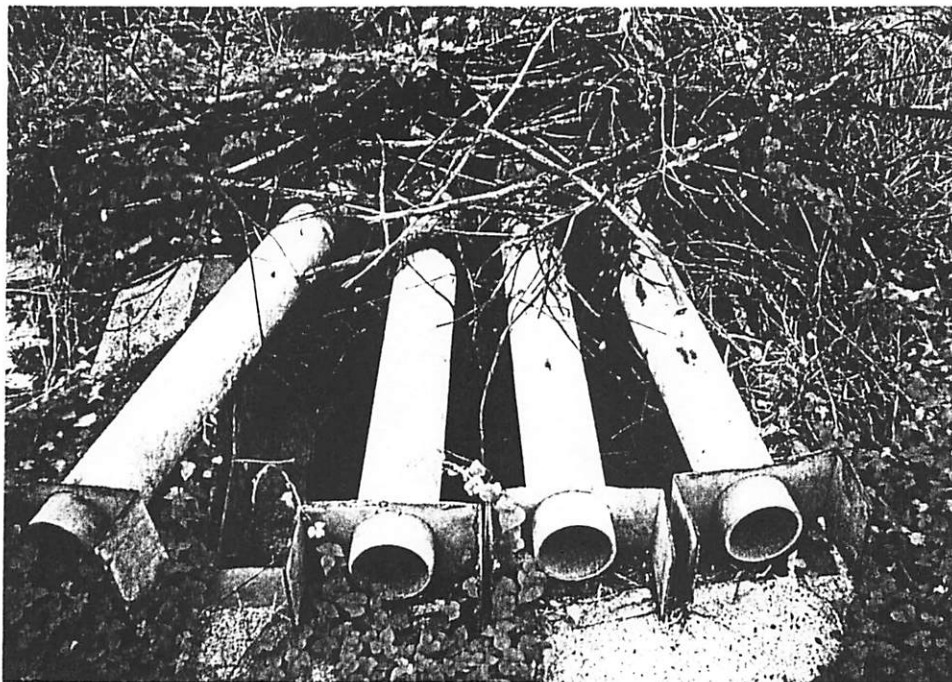
PHOTOGRAPH 3

**Area 12: *Radioactive storage silo area:*** The radioactive silo storage area is located along the western edge of the concrete apron, near the rear of the fenced area. This area checked out to be clean of radioactive contamination by an exit survey performed on February 1, 1995. A request was made by Halliburton to the Texas Department of Health in a letter dated February 16, 1995 to terminate Radioactive Storage License #L02113. Please note that B-Environmental could find no record of that request being granted. Also note that the storage silos have not been plugged with cement at the time of our last visit. This either indicates that it was neglected or that the Texas Department of Health never came for the verification survey to approve closure. See photograph no. 3 showing an open view of the large silo. This also is a safety hazard with no fixed cover.

- Radioactive storage silos have not been properly closed and, though an exit survey proved satisfactory, the Texas Department of Health has not issued final closure.
- The subsurface area involved with the past underground storage tanks has been screened and found to contain minor amounts of Petroleum Hydrocarbons which may be an indicator of higher concentrations within the abandoned tank hole itself and/or the surrounding soils.

Open view of unclosed radioactive storage silo

- Obtain the final closure status report from the pertinent State Agency for the release of the radioactive storage silos or, locate the proper correspondence if this has already been obtained.
- Properly cement and close the storage silos.
- Obtain records of underground storage tank removal from Halliburton to better ascertain the condition of the subsurface at the time of closure.
- Conduct a comprehensive Phase II Environmental Site Assessment in the abandoned underground storage tank area to determine the concentration, extent, and volume of potentially contaminated soils, or the lack thereof.

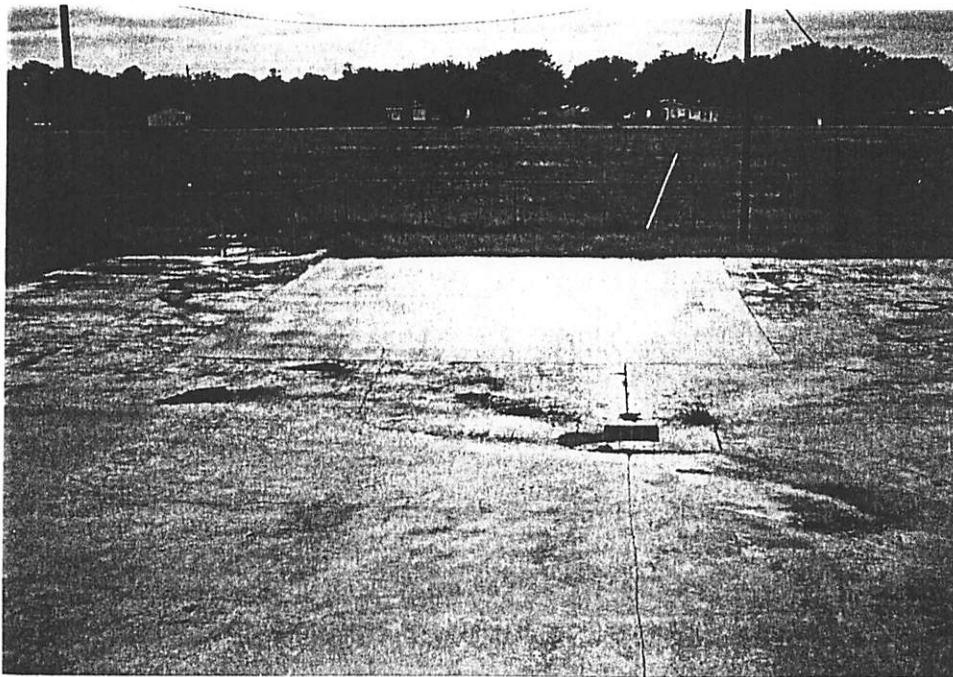
PHOTOGRAPH 4

**Area 13: *Abandoned underground storage tank location:*** Evidence of past underground storage tanks is indicated by three different sources: 1) Page C1 of the site plans dated 10/27/81 indicates the installation of one - three thousand gallon diesel storage tank and one - three thousand gallon gasoline storage tank at the western edge of the fenced area just north of the radioactive storage area. 2) The State

Underground Storage Tank (UST) database indicates that the two tanks were installed January 1, 1982 and that the current status is "removed". The records indicate that Halliburton registered the tanks. The facility ID number is 0025914. The unit ID numbers are 00066537 and 00066538. 3) An area of new concrete now covers the area where the tanks obviously were installed. The original concrete covering the tanks was saw-cut and removed during removal of the tanks and replaced upon completion (see photograph no. 4 for view of this area). A fourteen foot boring was made near the center of the UST area along the western edge of concrete at a forty-five degree angle towards the tank hole in an effort to screen the area for possible Petroleum Hydrocarbon contamination. This is addressed further in section 8.3 below.

This soil sample screening method was chosen in lieu of a soil vapor screening done only in the field. This screening indicates that Petroleum Hydrocarbons do exist in the area of the abandoned underground storage tanks. This information is qualitative in nature and not quantitative. We have merely discovered that contamination does exist and have not delineated the extent or concentrations. This would require a much more extensive survey consisting of numerous penetrations bored through the concrete apron directly into the subsurface soils utilizing the services of a licensed monitoring well driller. This, of course is addressed further in the recommendations (section 13 of this report).

View of abandoned underground storage tank area -- note newer concrete near grass
