Home Inspection Report

5418 Park Heights Ave
Park Heights, MD 21215

Prepared for: Charles Shelton

Inspected by:
Luke Bunting
Blue Crab Inspections

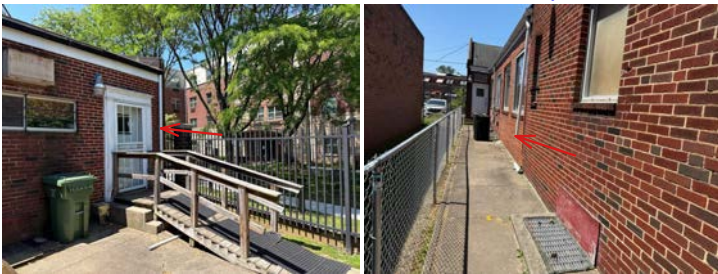
2. Downspouts: Metal - Loose sections of downspout noted, recommend securing. A qualified contractor is recommended to evaluate and estimate repairs.

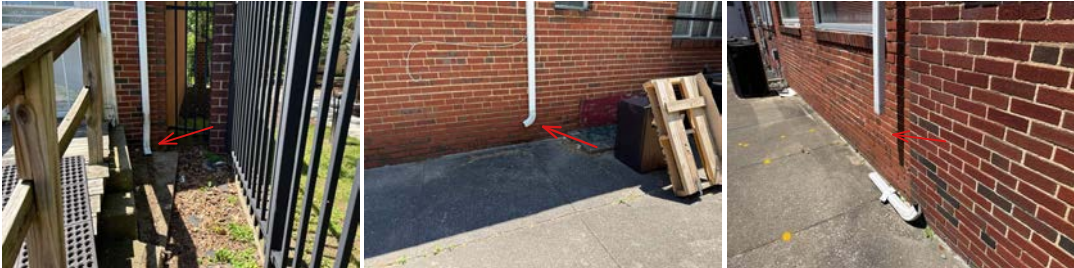
3. Leader/Extension: Missing - Roof drainage system is discharging next to home. Recommend extending runoff drains to move water away from foundation. A qualified contractor is recommended to evaluate and estimate repairs.

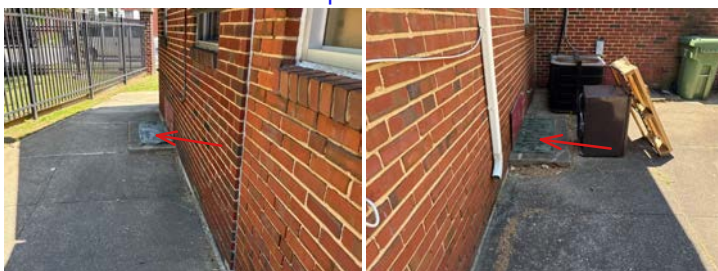
9. Window Wells: Covered - Covers were torn, recommend replacing. A qualified contractor is recommended to evaluate and estimate repairs.

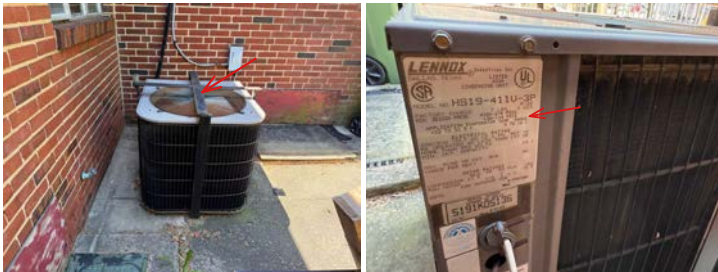
12. Right Side AC System A/C System Operation: Functional - The unit is currently in service beyond average life expectancy, recommend budgeting for repair and or replacement. A qualified air conditioning contractor is recommended to evaluate and estimate repairs.

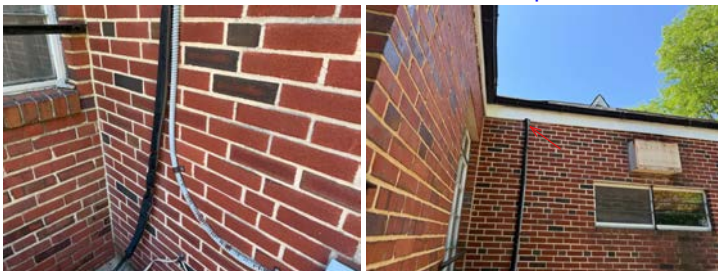
13. Right Side AC System Refrigerant Lines: Suction/Liquid Line - Insulation for refrigerant lines is torn, missing, and deteriorated. Recommend replacing the insulation to improve energy efficiency. Entry point into home is not sealed, recommend sealing to prevent moisture penetration. A qualified air conditioning contractor is recommended to evaluate and estimate repairs.

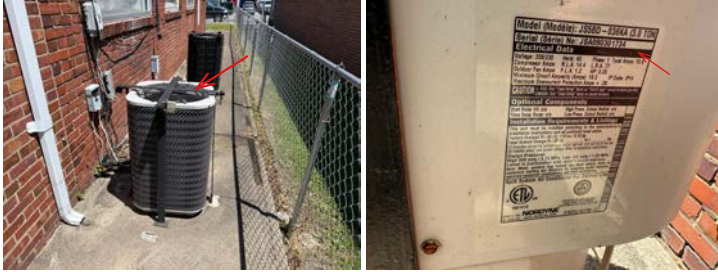
15. Rear Left AC System A/C System Operation: Functional - The unit is currently in service beyond average life expectancy, recommend budgeting for repair and or replacement. A qualified air conditioning contractor is recommended to evaluate and estimate repairs.

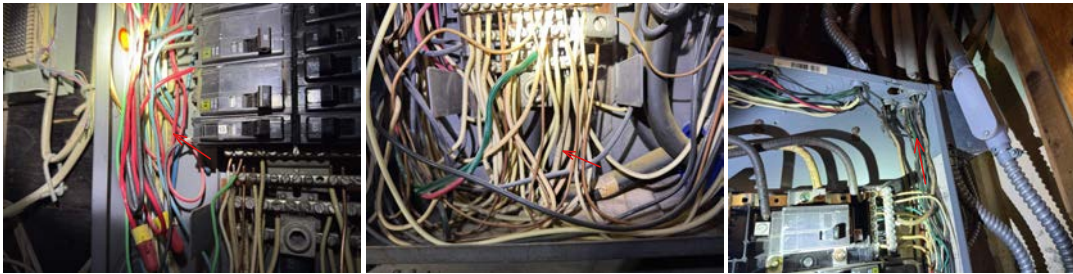
20. Conductor Type: Cloth, Non-Metallic Sheathed Cable - Cloth wiring noted throughout, recommend updating. Evaluation by a licensed electrician is recommended.

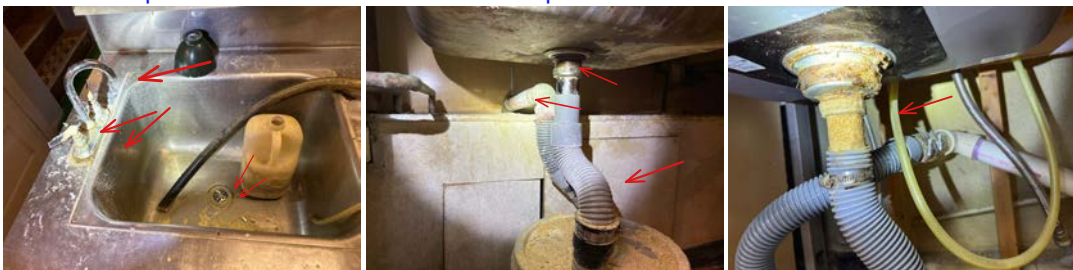
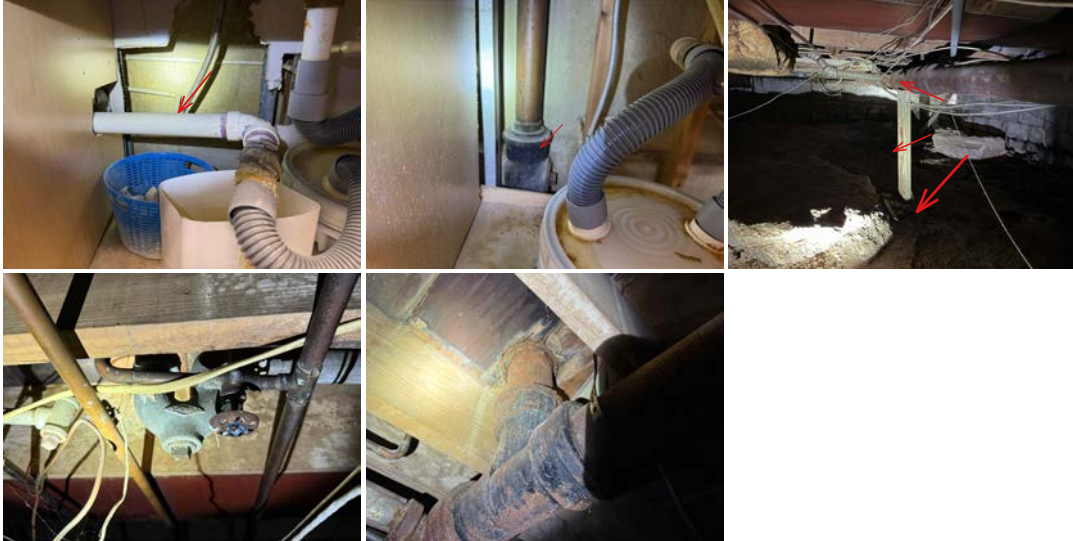
23. Drain Pipes: Plastic, Metal - Large amount of debris inside the drains, recommend cleaning. Evidence of past leaking noted. Slow drain noted, recommend repair. Due to the age and nature of metal drain piping, a sewer scope is recommended. Galvanized steel piping observed in use. Galvanized steel piping corrodes from inside causing decreased flow-rates and will eventually require updating. Improper support and support was loose. Evidence of previous leak noted. A licensed plumber is recommended to evaluate and estimate repairs.

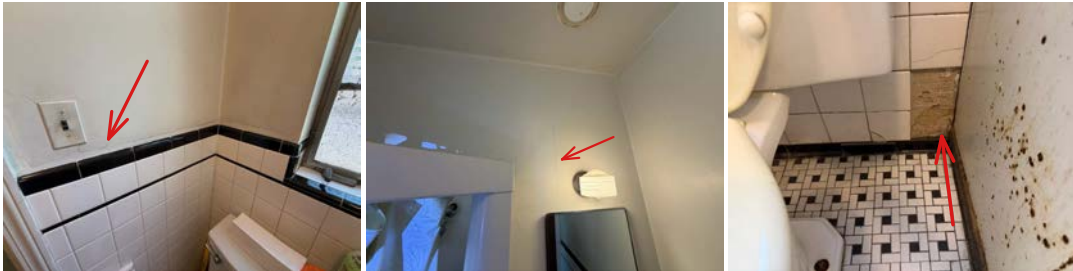
33. Office 4 bathroom Bathroom Walls: Paint - Crack(s) and damaged wall material noted, recommend identifying the source and conducting repairs. A qualified contractor is recommended to evaluate and estimate repairs.

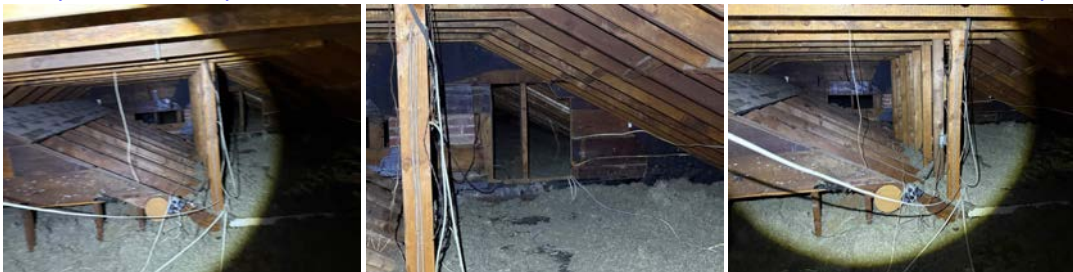
45. Main Attic Roof Framing: Trusses - Multiple areas were not fully accessible to inspect and space constraints in multiple areas. A qualified contractor is recommended to evaluate and estimate repairs.

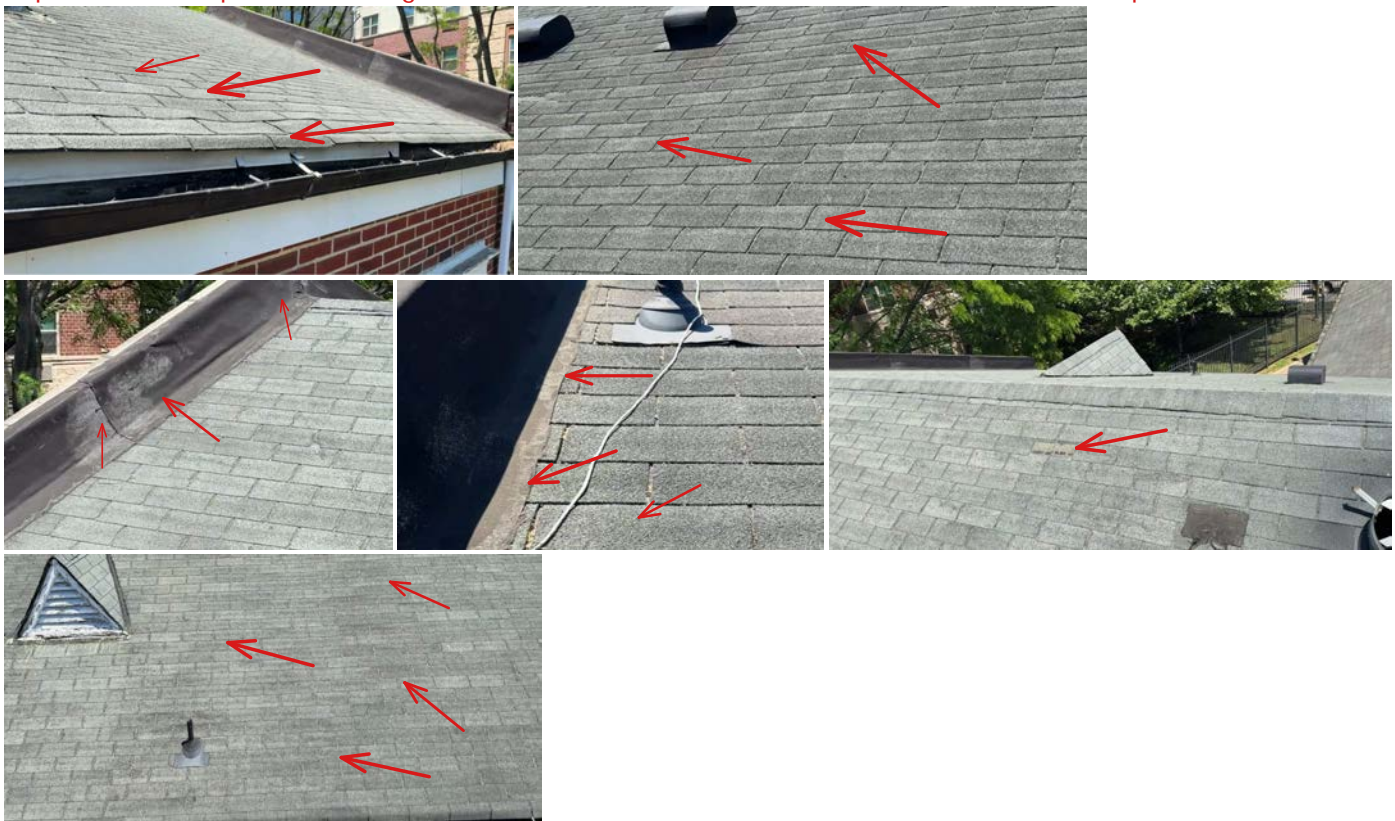
1. Rear and Left/Right Roof Surface Material: Asphalt Shingle, Rubber - **Soft and damaged area noted. Granule loss noted throughout the roofing surface, recommend further evaluation. Missing shingles and rubber material was not properly sealed on side walls. Roofing material is reaching average age expectancy, recommend budgeting for replacement. A qualified roofing contractor is recommended to evaluate and estimate repairs.**

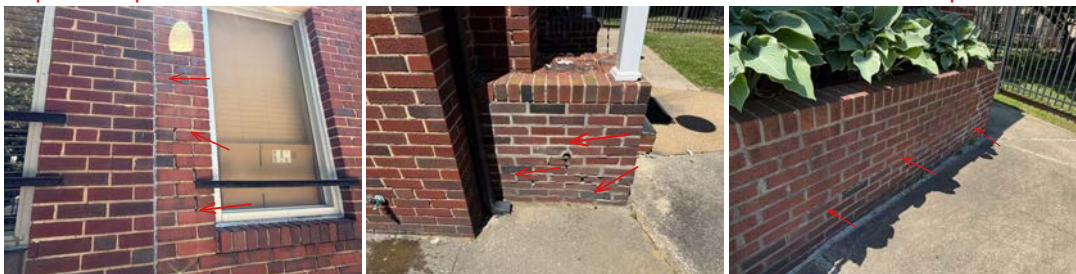
9. Type: Metal - Step cracks noted in multiple areas and gaps in the mortar throughout the exterior, recommend repair. A qualified contractor is recommended to evaluate and estimate repairs.

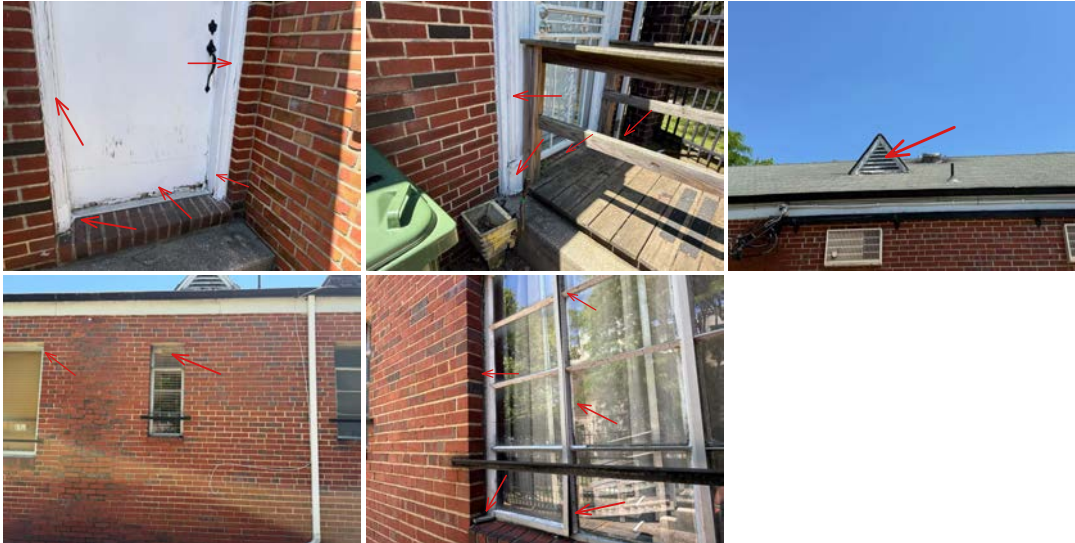
Trim: (continued)

10. Trim: Metal, Wood - Wood rot present, recommend replacement of all deteriorated material. Wood rot may be present in other areas not visible. Corroded lintels present, recommend the areas be prepared and sealed. Gaps and cracks noted. Recommend filling all gaps and cracks throughout exterior of home to prevent moisture penetration. Recommend monitoring all exterior caulking. A qualified contractor is recommended to evaluate and estimate repairs.

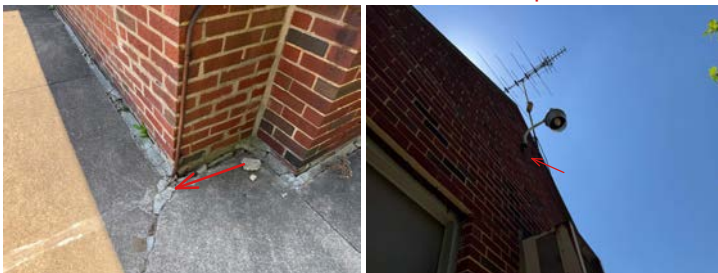
12. Exterior Lighting: Present - Cut in underground wiring. Exposed wiring noted. A qualified contractor is recommended to evaluate and estimate repairs.

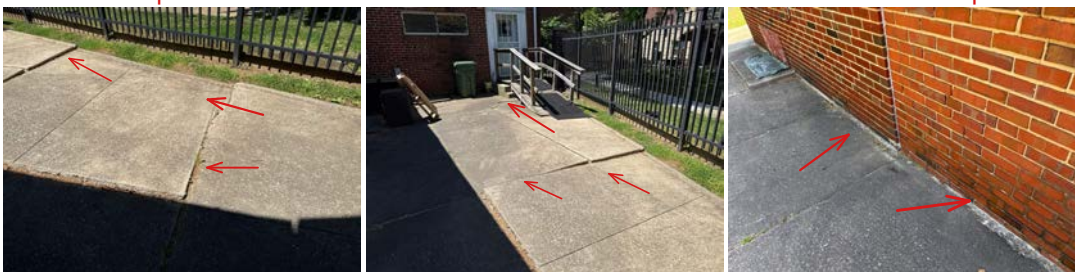
13. Walks: Present - Walkway is no longer level and a trip hazard is present. Cracks and gaps noted in multiple locations. A qualified contractor is recommended to evaluate and estimate repairs.

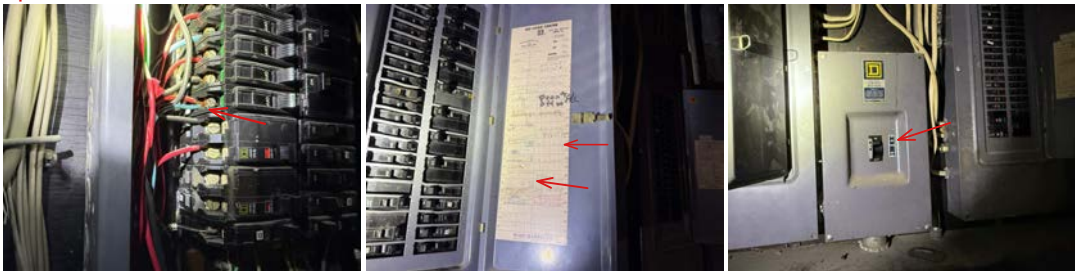
20. Basement Left Electric Panel Manufacturer: Square D - Double taps present. Unlabeled circuitry present in panel, recommend all circuitry have correct labeling. Unable to remove front panel for main shut off. Neutrals and grounds bonded together at subpanel installation. A licensed electrician is recommended to evaluate and estimate repairs.

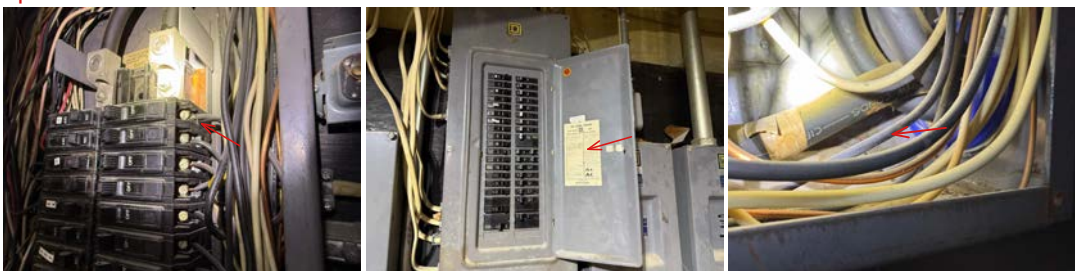
21. Basement Center Electric Panel Manufacturer: Square D - Double taps present. Unlabeled circuitry present in panel, recommend all circuitry have correct labeling. Corrosion present on and inside the panel. Neutrals and grounds bonded together at subpanel installation. A licensed electrician is recommended to evaluate and estimate repairs.

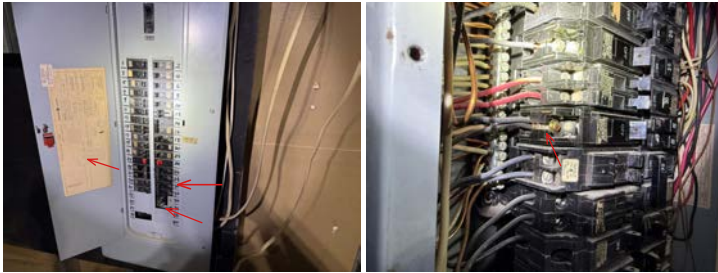
22. Basement Right Electric Panel Manufacturer: General Electric - Unlabeled circuitry present in panel, recommend all circuitry have correct labeling. Missing knock-out recommend replacing to cover opening. Double taps present. Multiple breakers were off at time of inspection. A licensed electrician is recommended to evaluate and estimate repairs.

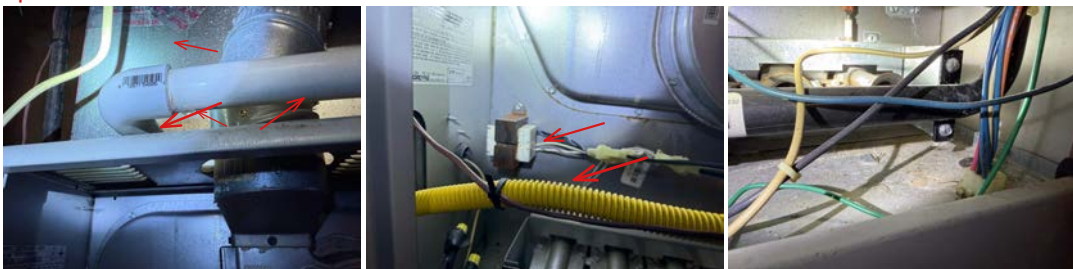
24. Basement Heating System Heating System Operation: Functional - Condensation line was leaking, recommend repair. Corrosion and debris noted throughout the interior. Flexible gas piping improperly penetrates the furnace cabinet. The unit is nearing the end of its expected average life expectancy, recommend budgeting for repair and or replacement. Unable to determine the last service date for the heating/cooling system. Heating/cooling systems should be serviced annually. A licensed HVAC contractor is recommended to evaluate and estimate repairs.

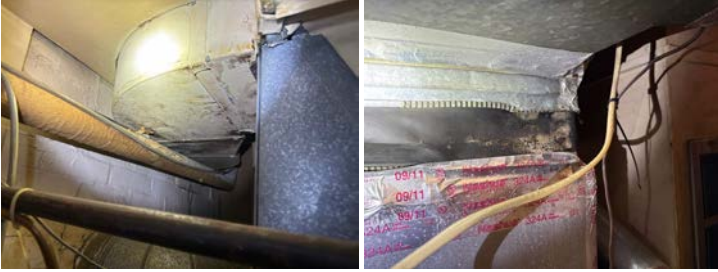
25. Basement Heating System Distribution: Duct Work - Evidence of potential biological growth noted on the ductwork, recommend further evaluation. A qualified contractor is recommended to evaluate and estimate repairs.

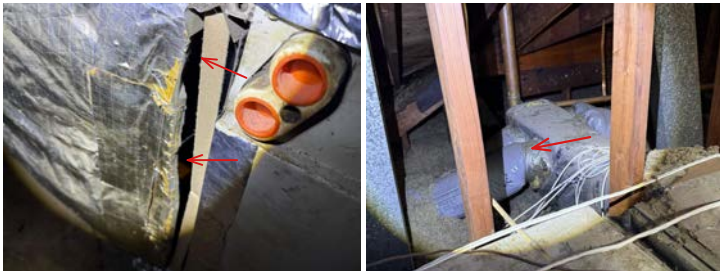
30. Attic Heating System Distribution: Duct Work - Separated and gaps in the ducts in the attic space. A qualified heating system contractor is recommended to evaluate and estimate repairs.

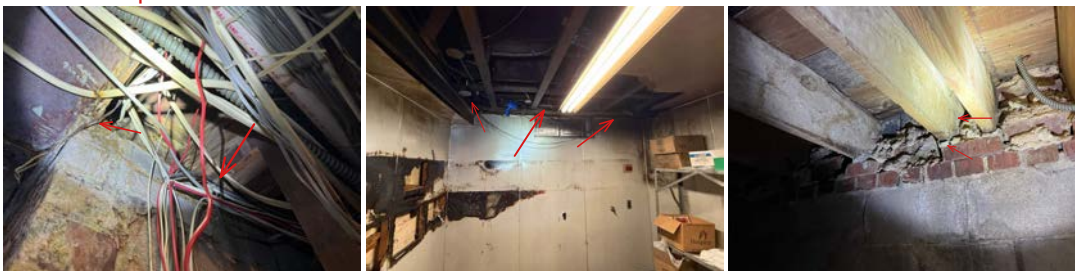
37. Joists/Trusses: Wood - Water and fire damage on multiple joists. Water damage noted on multiple joists and shims and bricks were loose throughout the crawl space. A qualified contractor is recommended to evaluate and estimate repairs.

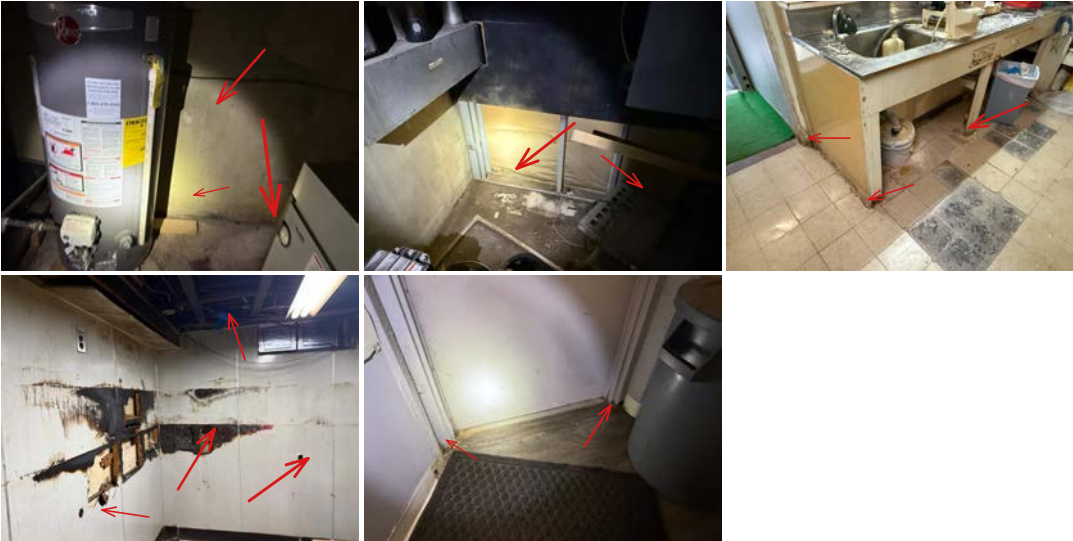
39. Main Basement Walls: Paint, Paneling, Exposed Framing - Moisture staining and fire damage noted in multiple areas, recommend further evaluation. A qualified contractor is recommended to evaluate and estimate repairs.

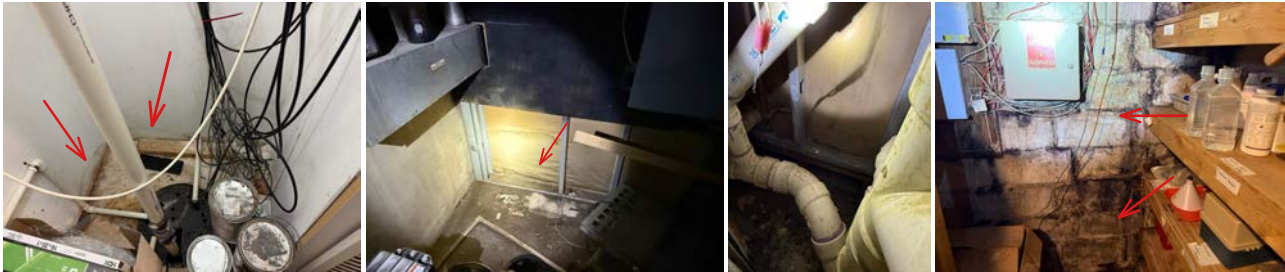
42. Main Basement Moisture Penetration: Present - Evidence of potential biological growth and moisture staining, recommend further testing and evaluation. Moisture penetration present in basement area. Recommend the source of the moisture penetration be identified and corrected. Moisture penetration may be present in other areas not visible. A qualified contractor is recommended to evaluate and estimate repairs.

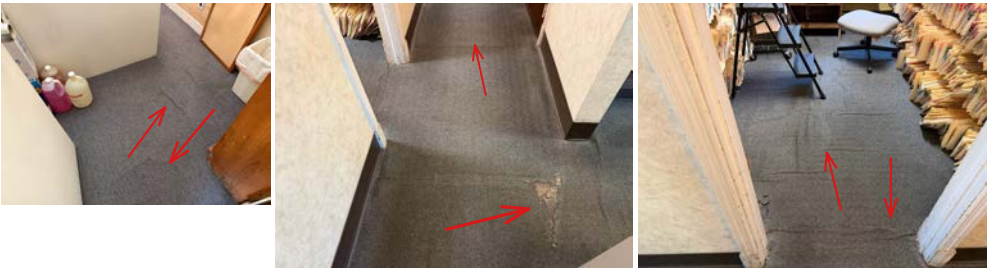
66. Office 1 Living Space Floor: Carpet - Loose/torn carpeting noted throughout the property, recommend addressing the affected areas to prevent hazards. A qualified contractor is recommended to evaluate and estimate repairs.

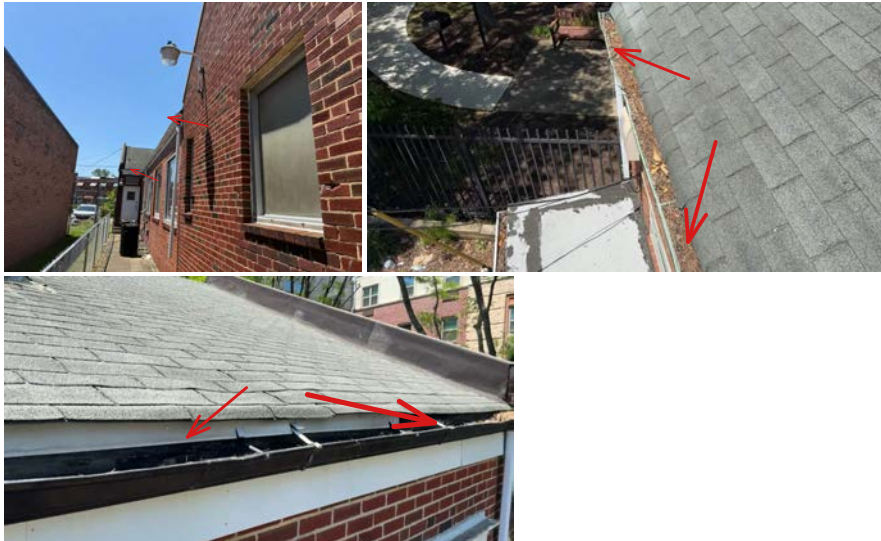
- 16. Skylights: Not Present
- 17. Electrical Mast: Surface Mount
- 18. Gutters: Metal - Gutters were loose, sagging, and bent throughout. Large amount of debris present in multiple gutters. A qualified contractor is recommended to evaluate and estimate repairs.

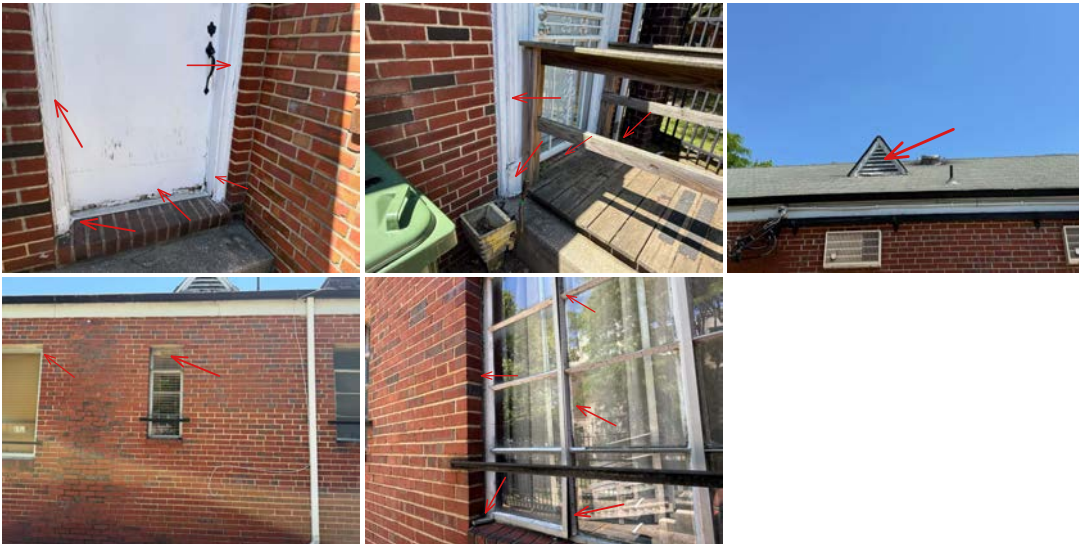
2. Trim: Metal, Wood - **Wood rot present, recommend replacement of all deteriorated material. Wood rot may be present in other areas not visible. Corroded lintels present, recommend the areas be prepared and sealed. Gaps and cracks noted. Recommend filling all gaps and cracks throughout exterior of home to prevent moisture penetration. Recommend monitoring all exterior caulking. A qualified contractor is recommended to evaluate and estimate repairs.**

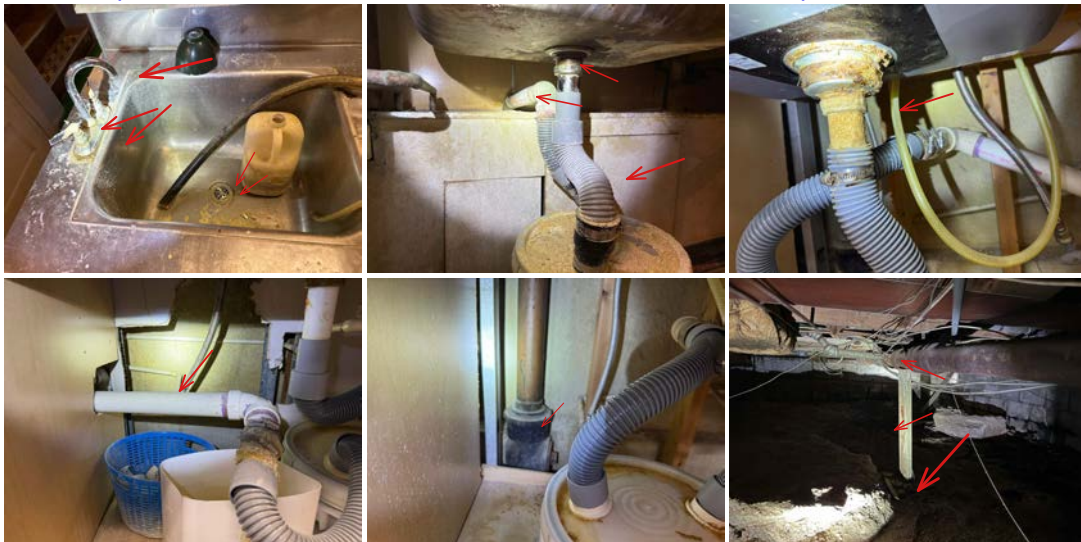
4. Drain Pipes: Plastic, Metal - Large amount of debris inside the drains, recommend cleaning. Evidence of past leaking noted. Slow drain noted, recommend repair. Due to the age and nature of metal drain piping, a sewer scope is recommended. Galvanized steel piping observed in use. Galvanized steel piping corrodes from inside causing decreased flow-rates and will eventually require updating. Improper support and support was loose. Evidence of previous leak noted. A licensed plumber is recommended to evaluate and estimate repairs.
