Roof Inspection Report

12700 State Route 1, Point Reyes Station

Desmond Willis
August 7, 2020
Reg. No: 111413 SP

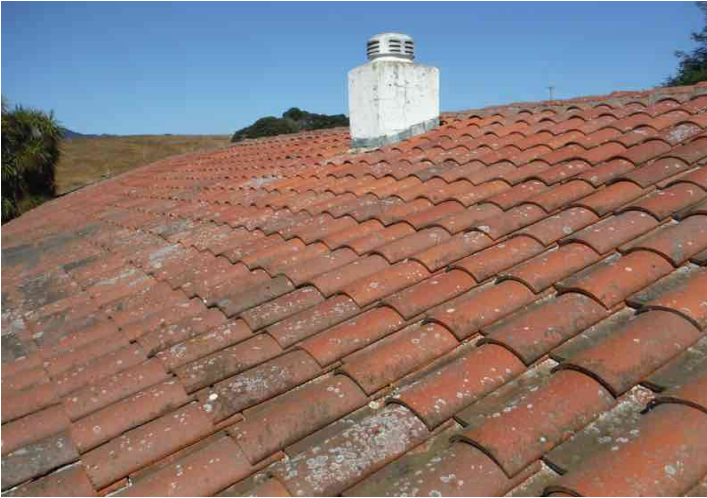
Photo 01

1. On the main roof:
2. General roof photos: (See Photo 1) (See Photo 2) (See Photo 3)
3. During the course of this inspection we noted a few broken field tile(s). (See Photo 4) (See Photo 5)
4. A tree is overhanging the roof's surface. Under windy conditions the branches will rub against the roof causing subsequent damage to the roof surface. To prevent premature roof wear, owner is to trim away all tree branches that can potentially rub against the surface of the roof. (See Photo 6)
5. On the detached guest unit roof:
6. General roof photos: (See Photo 7) (See Photo 8) (See Photo 9)
7. During the course of this inspection we noted several broken field tile(s). (See Photo 10) (See Photo 11) (See Photo 12)
