# *Evolve Property Inspections*

1011 Euclid Ave, Miami Beach, FL 33139  
Inspection prepared for: Jason Saint  
Real Estate Agent: -

Date of Inspection: 10/13/2023 Time: 10:30 AM  
Age of Home: 1959 Size: 0  
Weather: sunny  
unit 1

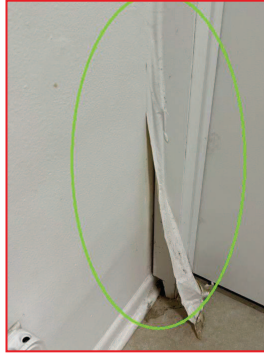
- Minor patchwork for drywall is recommended

Amateur Drywall Finish

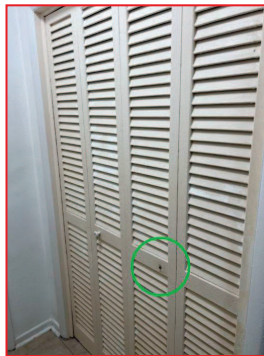
- The closet door is missing a handle inspector suggest replacement be installed.

Closet Doors Observation

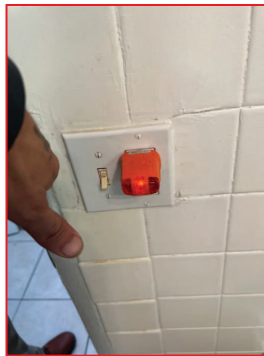
- Recommend upgrading All receptacle to **GFCI** protection within 6 feet of all potential wet locations.
- Open ground (or 2-wire) outlets present. This means that the 3rd (round) part of an appliance plug is not getting ground protection.

Open Ground Outlet

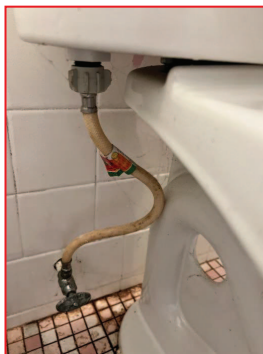
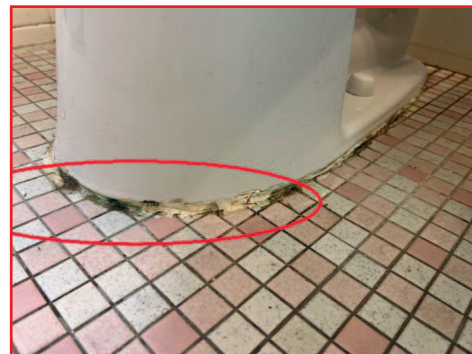
- Mold and bio-growth noted at caulked seal at the base of the toilet recommend to be scraped and re caulked

Possible mold noted

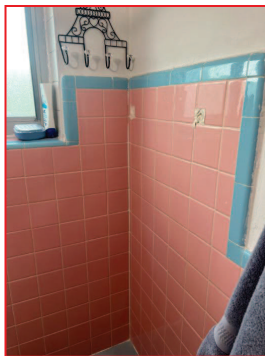
- Minor patchwork for Tile wall in shower recommended.
- Minor drywall damage noted.

Wall Tile Damaged

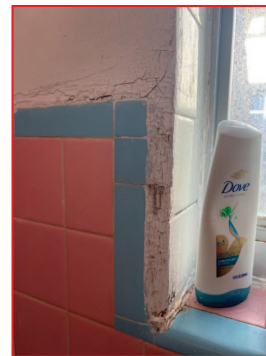
Drywall Damaged

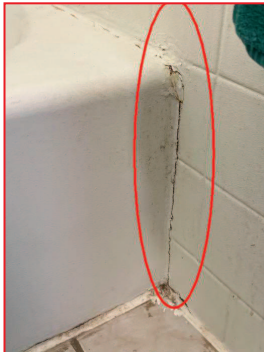
- We recommend sealing around tub perimeter to keep water from infiltrating the walls.
- The tubs finish is stained. Suggest repair or refinish.

Tub needs sealing

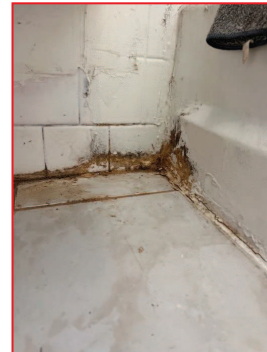
Tub Rusted

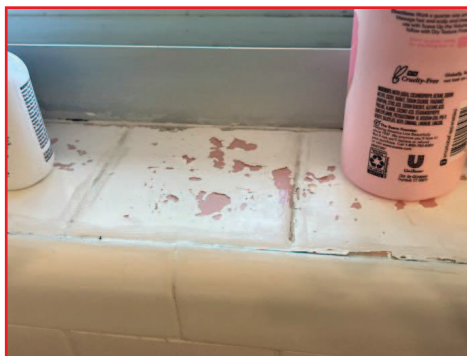
- Normal wear and tear in the interior walls. Suggest interior walls to be repainted.

Painted Tile Peeling
