## Phase I Environmental Site Assessment 771 Gibsons Way, Gibsons, BC

**Type of Document:**  
FINAL

**Project Number:**  
VAN-22023004-A0

**Report Date:**  
20 October 2022

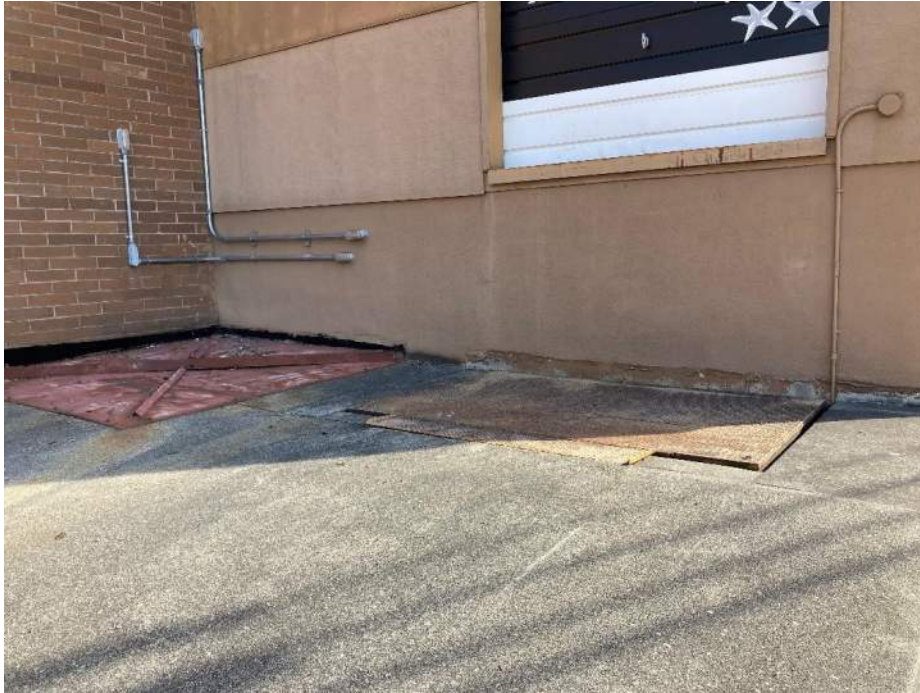
**Photograph No. 27.**

Area of Potential Environmental Concern (APEC)	APEC Description / Comments	Media and Potential Contaminants of Concern (PCOCs)	Risk Rating
<b>Onsite</b>			
<b>APEC 1</b> Hydraulic Lift	A hydraulic lift is present servicing the Kern's Furniture warehouse and showroom areas. This lift is likely associated with a hydraulic oil reservoir.	<b>Soil and Groundwater:</b> hydrocarbons (LEPH, HEPH, PAHs), PCBs	Low to moderate (We assume that there have been no leaks of hydraulic oil over time)

View of uninstalled elevator shaft and inground hydraulic lift located adjacent to Kern's Furniture warehouse space.

Based on the results of the Phase I ESA, additional sub-surface investigations in the form of a Phase II ESA are not required at the Site at this time as there is considered to be a low to moderate potential of environmental concern to the Site for contaminants being present above the BC CSR Commercial Land Use (CL) Standards (numerical or risk-based).

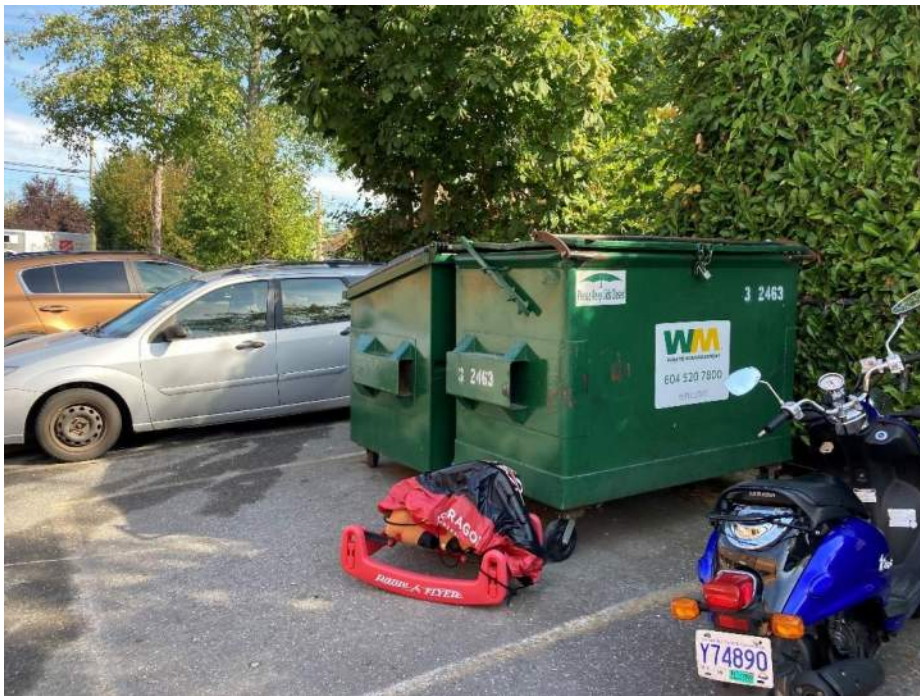
**Photograph No. 28.**

Third-party garbage dumpsters were observed along the southeastern Site boundary (Appendix A, Photograph 28).

View of dumpsters observed along the southeastern boundary of the Site.
