Septic Inspection Report

Arlington Inn

Book store

03/26/2026

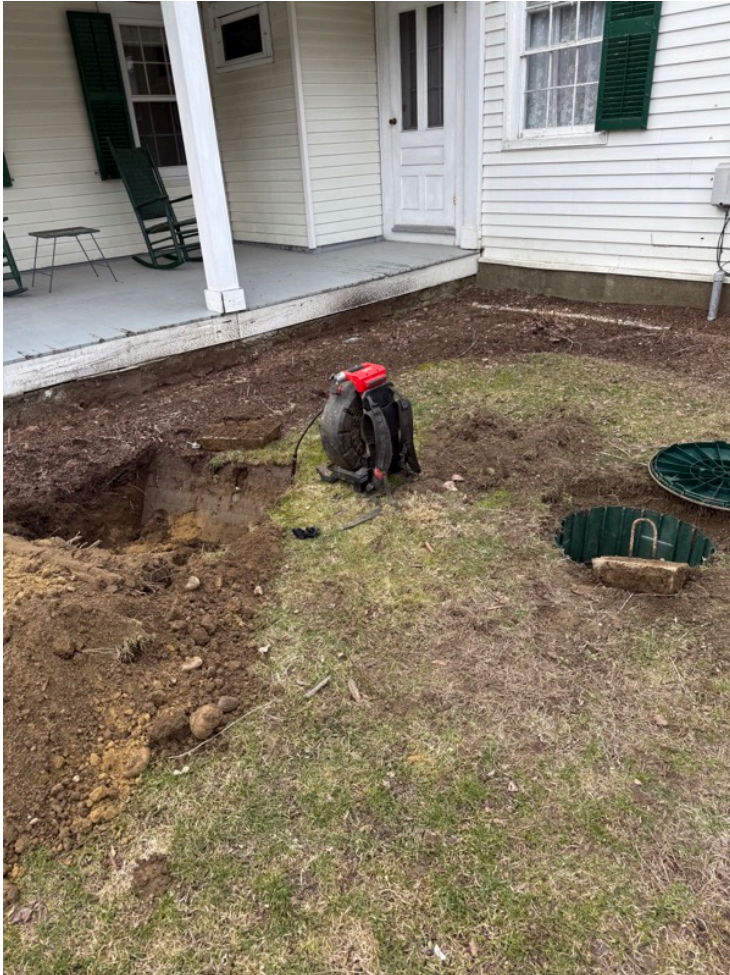
Tank location photo

Front yard
