Home Inspection Report for 18935 5th Street West, Sonoma CA

## HOME INSPECTION REPORT

Property Address: 18935 5th Street West  
Sonoma, CA

Report Number: 60426-2

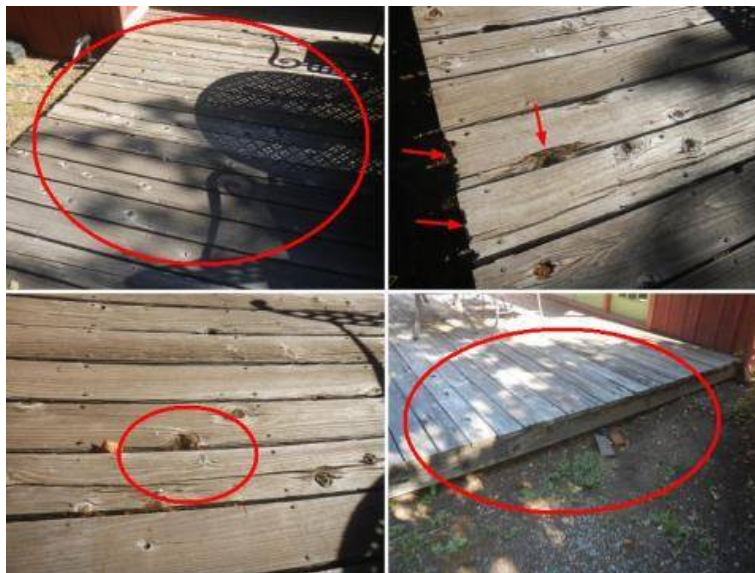
Damage and / or deterioration was noted to one or more of the deck surface boards. Be aware that the damaged conditions may extend into inaccessible areas. I am unable to determine the extent of this condition without destructive discovery (ie: removing component materials). Destructive discovery is outside the scope of this limited visual inspection. Recommend having this condition further evaluated and corrected by a licensed and qualified building contractor.

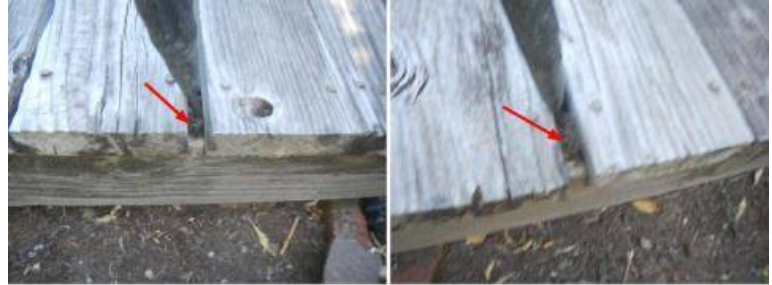
Damage and / or deterioration was noted to some of the deck framing members (as viewed and probed from the top in between the surface boards. Unless otherwise specified, the locations of the damaged components is random.

Be aware that this condition may extend into inaccessible areas. I am unable to determine the extent of this condition without destructive discovery (ie; removing component materials). Destructive discovery is outside the scope of this limited visual inspection. Recommend having this condition further evaluated and corrected by a licensed and qualified building contractor.

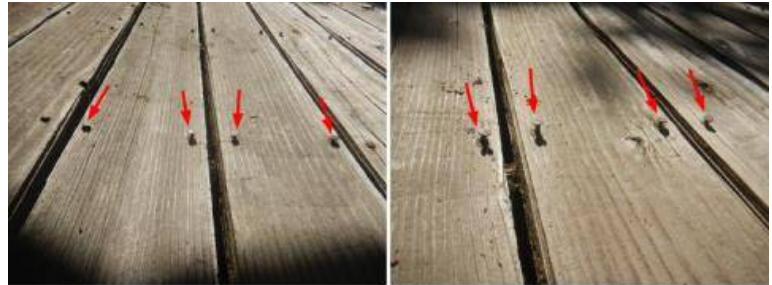
Some surface board nails / fasteners are noted to have backed out and are protruding from the deck surfaces. This condition creates Potential Tripping Hazards. Recommend having this condition evaluated and corrected by the appropriate qualified trades person.

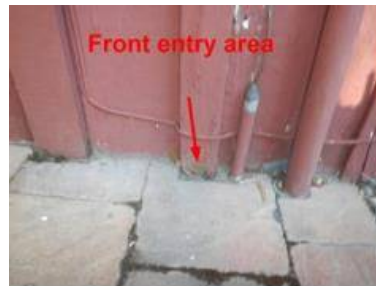
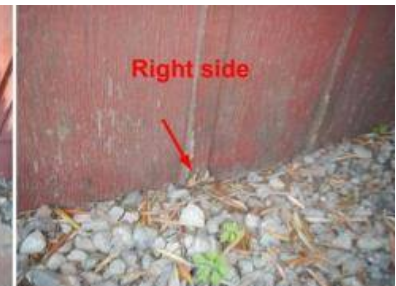
The siding at one or more locations around the structure is damaged or deteriorated. Recommend having this condition evaluated and corrected by the appropriate qualified trades person.

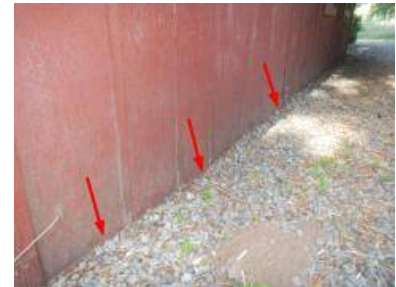
There are wooden siding components that are in contact with the soil, landscaping materials or concrete. This condition will have an adverse affect on the duration of wood materials. Where practical, it is recommended to create adequate separation between the ground and wooden trim components.

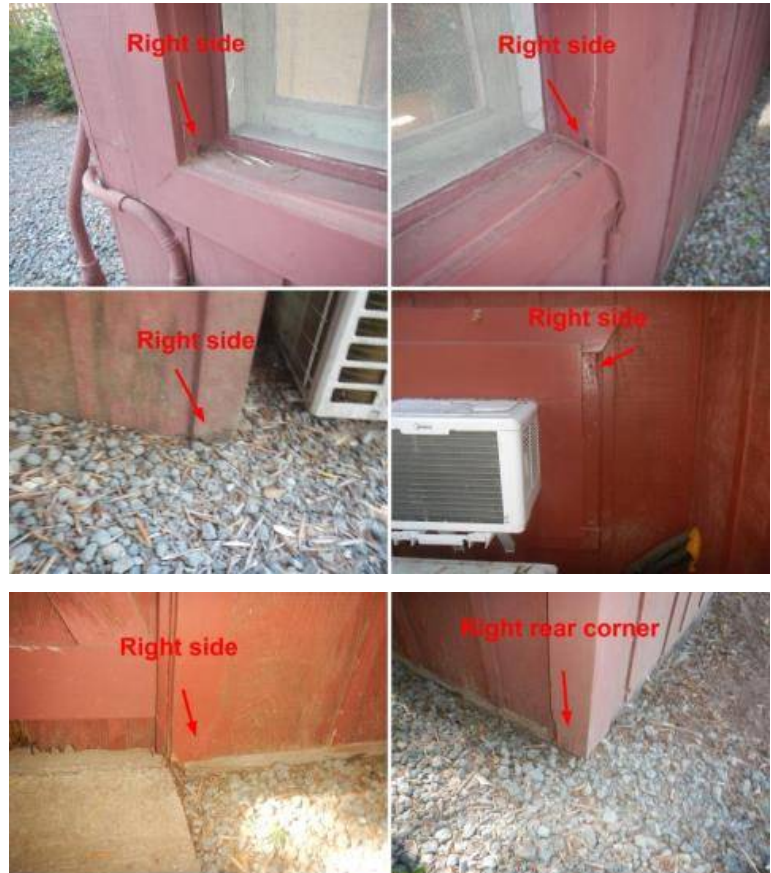
The trim (and possibly adjacent materials) at one or more locations around the structure is damaged or deteriorated. Recommend having this condition evaluated and corrected by the appropriate qualified trades person.

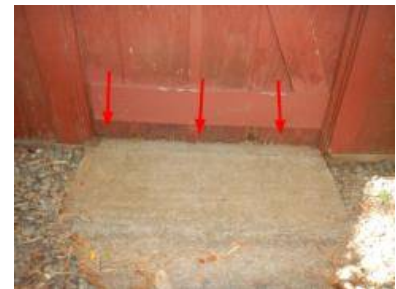
There is moisture damage noted to the bottom of the right side storage closet door. We recommend further evaluation and correction by the appropriate, qualified professional.

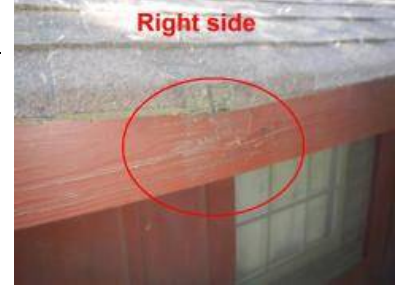
There is deterioration noted to the fascia boards and/or associated components at the eave overhangs in one or more locations around the structure. Recommend having this condition evaluated and corrected by the appropriate qualified trades person.

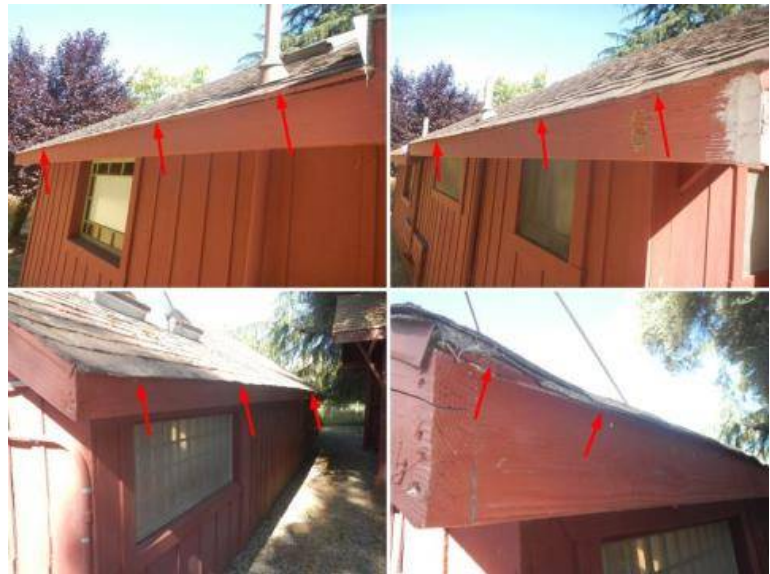
There is no drip edge flashing installed on the lower edges of the roof sheathing in some places around the structure. Without a proper drip edge installed or roofing felt paper sufficiently extending over the edge of the sheathing, moisture will collect on the lower edge of the roof sheathing, fascia board, and rafter tails and cause premature deterioration.

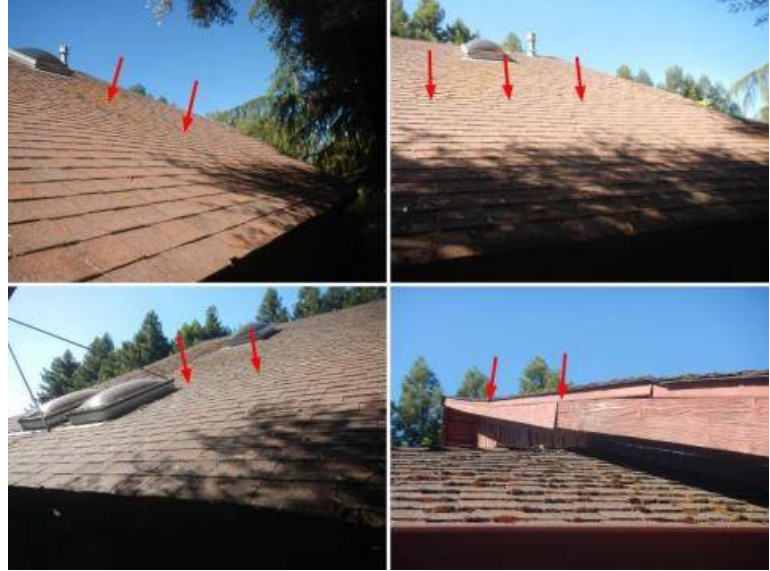
The roof rafters both at the outer edges and in the roof field areas have visible sagging and deflection noted as viewed from the exterior of the structure. Due to construction design, we are unable to openly view these components. The only way to determine the cause would be destructive discovery (ie: removing materials) which is outside the scope of a home inspection. If this is a concern to interested parties, we recommend further evaluation and correction by a licensed and qualified building / framing contractor.

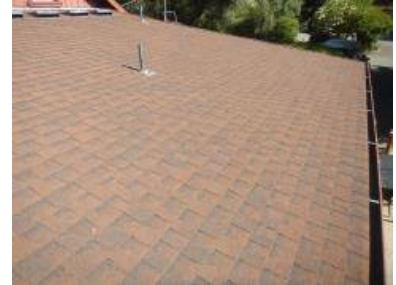
The pitch on some sections of this roof is not appropriate for the type of roofing materials used. This may not allow the roof coverings to perform as intended / designed. Composition shingles are not typically recommended to be installed on roof pitches that are less than 4:12. Typically a roof pitch between 2:12 & 4:12 is considered a low slope application and requires a double layer of felt underlayment or a specialty type of felt paper / waterproof membrane underlayment. We are unable to fully determine if the proper installation methods have been used (without removal of roofing materials.) If proper methods were not used on the entire roof, the life expectancy of this roof will be somewhat shortened from what is estimated below.

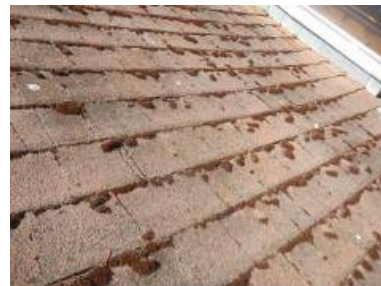
Moss is growing on the roof surfaces in some places. Moss growth can lift shingles and leads to gradual deterioration of the roofing surface. We recommend that the roof surfaces be cleaned of this growth with the appropriate cleaning solution.

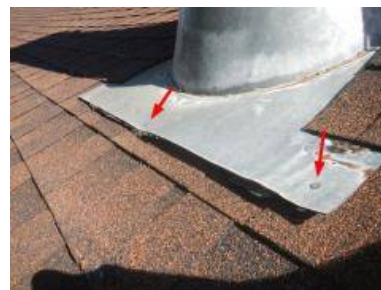
There are nails (or other fasteners) present on the roof or roof flashings that are not sealed to prevent moisture entry. All exposed nails should be properly sealed because they are a potential cause of roofing leaks. We recommend further evaluation and correction by the appropriate qualified tradesperson.

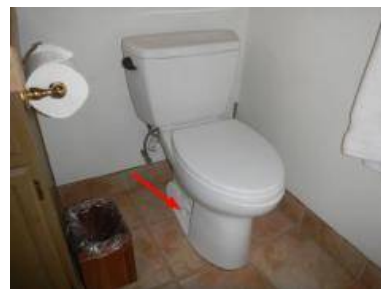
The toilet in this bathroom is loose at the connection to the floor. There are no visible signs of leakage at this time, however loose toilets are prone to leaking. We recommend further evaluation and correction by the appropriate, qualified professional.

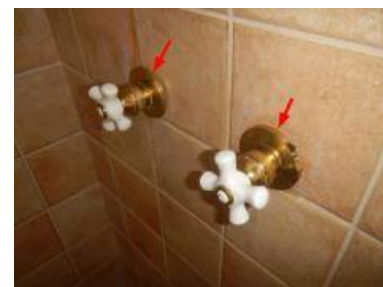
One (or more) of the escutcheon plates for the water control valves are loose or improperly sealed where they connect to the shower surround. This can allow moisture into the wall cavities. We cannot determine the extent of this condition without destructive discovery (which is outside the scope of this inspection.) Recommend having this condition evaluated and corrected by the appropriate qualified trades person.

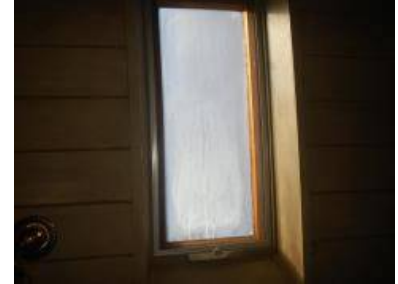
There is evidence that the dual pane seal for the glass in the skylight(s) has failed as evidenced by moisture/dirt between the panes. This condition is sometimes difficult to detect due to lighting conditions at the time of the inspection. For this reason, you may encounter additional skylights that exhibit this condition which are not noted in this report. We recommend further evaluation and repair by the appropriate, qualified professional.

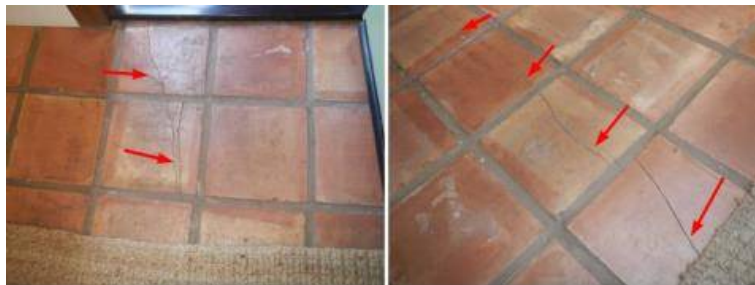
There are one (or more) chipped, cracked, or broken floor tiles noted.  
We recommend further evaluation and repair by the appropriate, qualified professional.

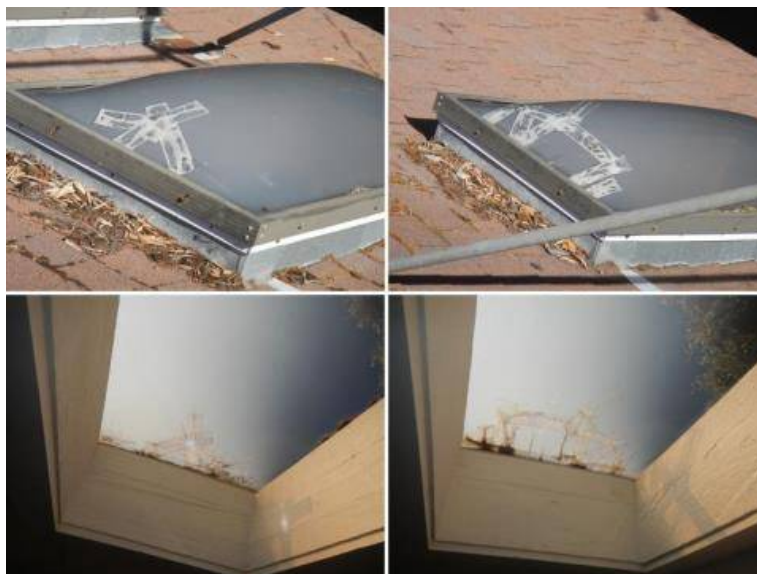
One or more of the polycarbonate (or equivalent) domes in the skylights are observed to be cracked and broken. Tape has been applied to prevent moisture entry. We recommend repairing or replacing any damaged skylight components. We recommend further evaluation and correction by the appropriate qualified tradesperson.

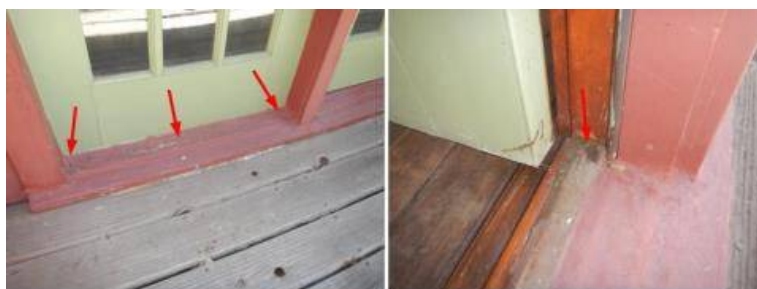
There is damage / deterioration noted to the exterior door threshold and trim. We recommend further evaluation and repair by the appropriate qualified tradesperson.

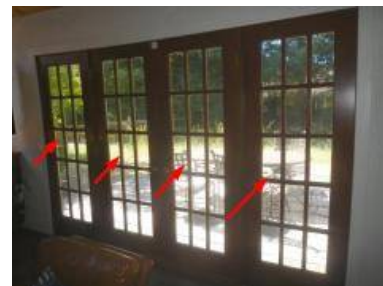
The dual pane seal has failed at one or more of the windows in the exterior doors. This condition is evidenced by fogging, moisture, evidence of moisture, or hazing between the two panes of glass. We recommend contacting a qualified window glass company to determine if these windows can be repaired.

Note: This condition is sometimes very difficult to detect due to climatic conditions and/or lighting conditions at the time of the inspection. For this reason you may encounter additional windows that exhibit this condition which are not noted in this report.

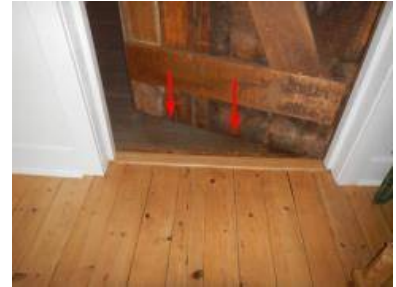
The flooring or landing in front of the outward swinging entry door is lower than the typical height of 1 inch below the bottom of the door. This is not typical and creates a Potential Hazard. Current requirements state a maximum difference of 1-1/2 inches between the bottom of the door and the floor or landing. Recommend having this condition evaluated and corrected by the appropriate qualified professional.

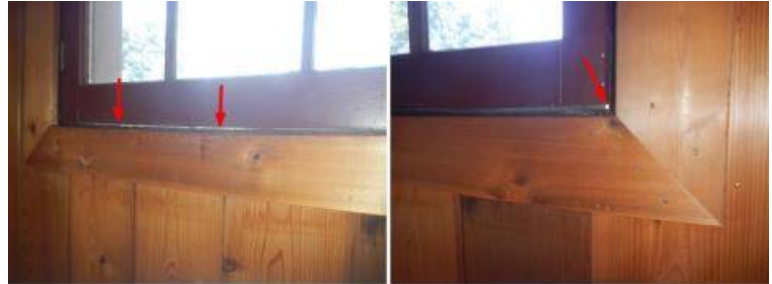
There are gaps / voids around the windows that is letting light show through. Consideration should be given to having these areas sealed. We recommend having these conditions further evaluated and corrected by the appropriate, qualified professional.

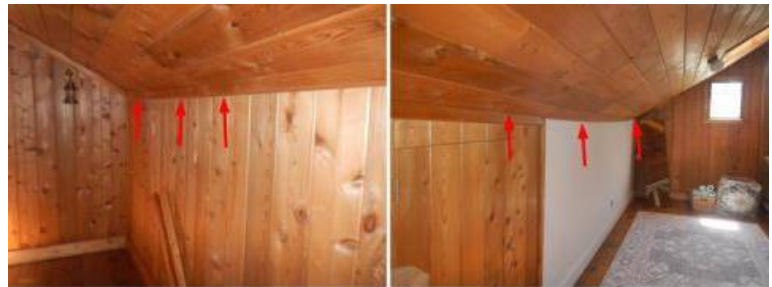
The ceiling is visible sagging which is evident along the back wall of this area. This sagging is consistent with the sagging that was viewed in the roofing surfaces. We are unable to determine the extent of this condition without destructive discovery (ie: removing materials) which is outside the scope of a home inspection.

If this is a concern, interested parties should engage the services of a licensed structural framing contractor.

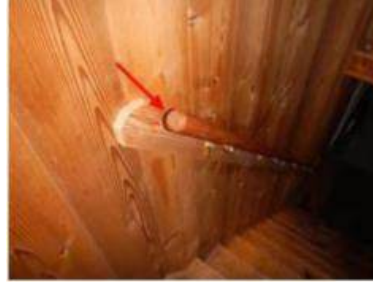
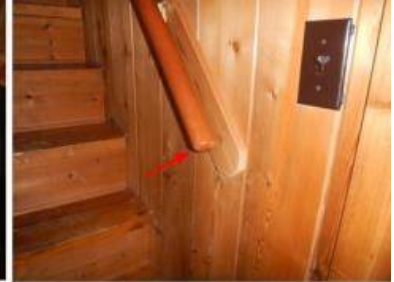
The handrails at the stairway do not conform to the current design standard for handrails. For safety, the railings should return back to the wall at both the upper and lower termination points. This method is to eliminate the section that ends abruptly on the top and bottom of the railing. Recommend having this condition evaluated and corrected by a licensed and qualified building contractor.

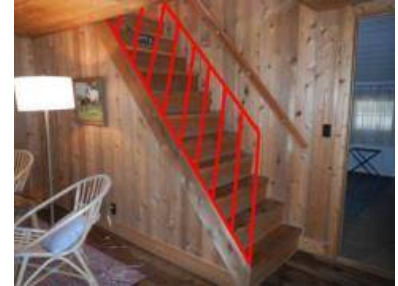
There are NO railings or vertical balustrades installed at the side of stairway. Current requirements are to have balustrades with a spacing not to exceed 4 inches. We recommend installation of balustrades as the current configuration presents a Potential Hazard.

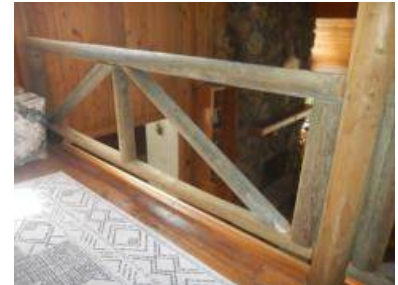
The spacing of the railing balustrades exceeds the current standard of 4". This standard has changed over the years and has progressively decreased in width. The balustrade spacing for older homes was 9" on center and then it became 6". While there is no requirement for upgrading to 4" centers, you should be aware that this condition presents a Potential Hazard to infants and small children.

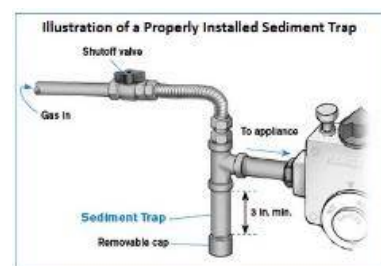
There is NO capped sediment trap installed at the incoming gas supply line for this appliance. This is commonly a code requirement as well as a requirement by most appliance manufacturers. The sediment trap, when properly installed, will change the direction of the gas flow thereby allowing it to collect any sediment or debris before it reaches the appliance gas controls. We recommend having this gas line modified to incorporate a sediment trap.
