## Home Inspection Report

**12700 State Route 1, Point Reyes Station**

Cameron Jones  
August 7, 2020

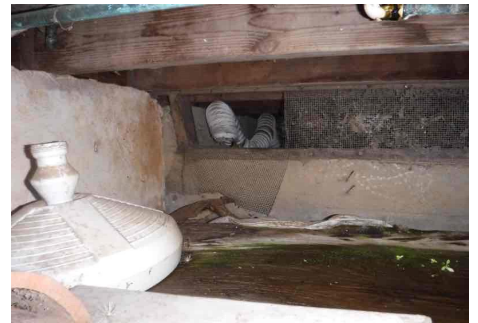
Photo 58

1. The guest unit crawl space access has no door. We recommend a tight fitting door be installed to help prevent entry by animal or rodents. (See Photo 58)

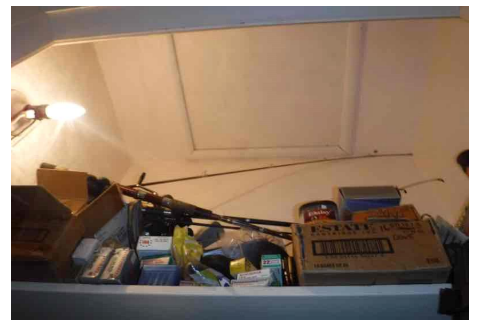
Photo 21

2. Personal storage was blocking the closet attic access opening, therefore, the attic space was not inspected. With access and an opportunity for a complete inspection, conditions in need of attention may be discovered. The personal belongings should be removed so the attic may be inspected. (See Photo 21)

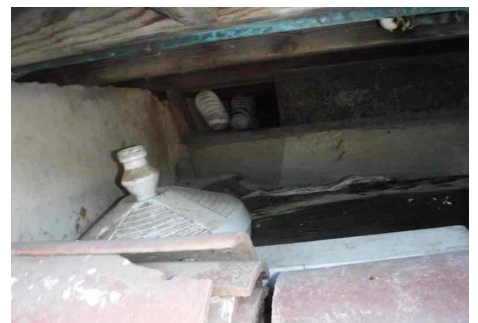
Photo 56

3. Due to owner storage blocking the access, the guest unit crawl space was not inspected. With access and an opportunity for a complete inspection, conditions in need of attention may be discovered. We recommend further inspection when the storage has been removed and access is provided. (See Photo 56)

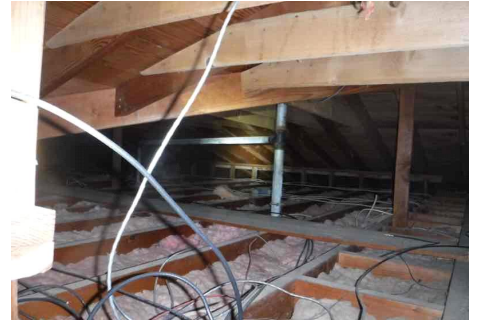
Photo 35

4. Water stains were evident in the attic. This could indicate leakage through the roof covering. We recommend the services of a licensed roofing contractor to further evaluate this condition. (See Photo 35)

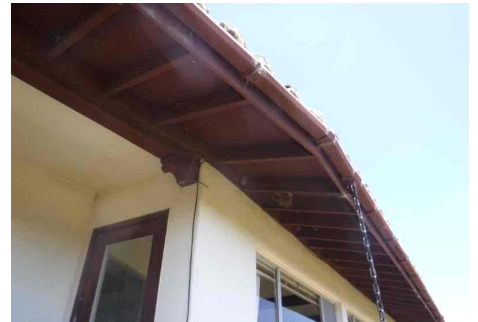
Photo 19

5. Leaks were noted in the downspouts and/or gutters. During wet weather conditions these areas are more obvious and during dry weather conditions they are noted from the stains at the areas where the leaks have occurred. We recommend all leaks be repaired. (See Illustration 2D) (See Photo 19)

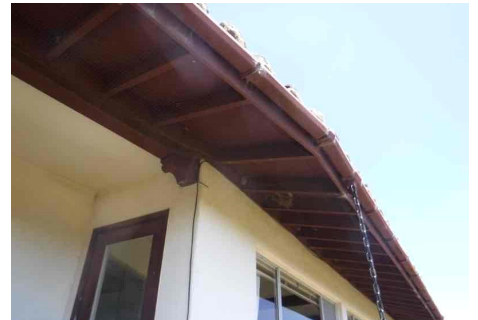
Photo 19

6. Missing downspouts at the rear gutters should be replaced as necessary. (See Photo 19)

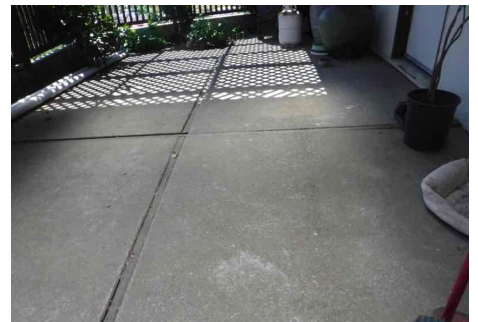
Photo 03

7. The wood borders between the slab sections of the patio have deteriorated. These voids create a trip hazard and should be filled in or replaced with treated wood or mortar. (See Photo 3)

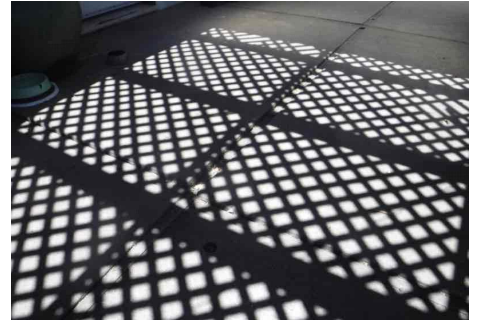
Photo 04

8. The cracked and heaved sections of the patios present a trip hazard. This condition should be corrected for improved safety. (See Photo 4)

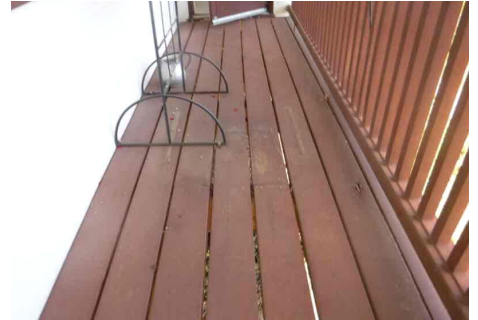
Photo 30

9. Water damage was noted at the rear deck(s). We recommend the services of a licensed general contractor and/or structural pest control company. (See Photo 30)

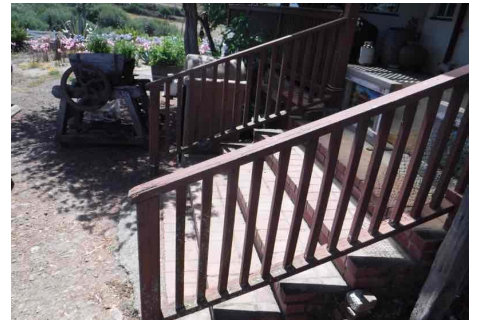
Photo 09

10. The railing is loose at the left side steps. It is recommended that this be repaired for improved safety. (See Photo 9)

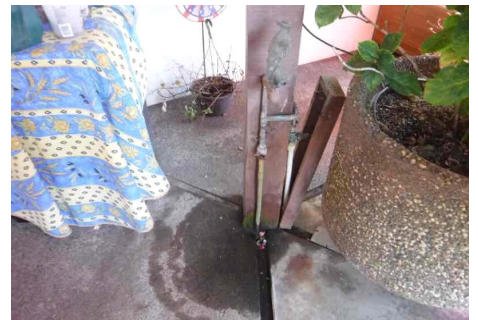
Photo 14

11. The base of the support post(s) at the right rear patio cover or overhang are water damaged. We recommend the advice and services of a licensed contractor and/or structural pest control company. (See Photo 14)

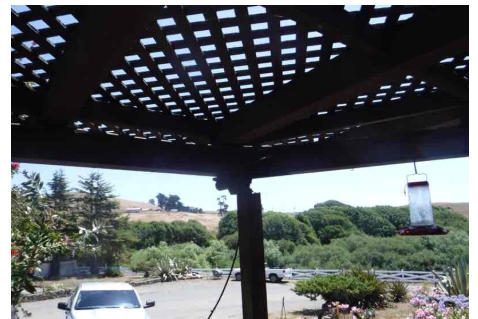
Photo 05

12. Evidence of water damage was noted at the patio covers. Consult a licensed structural pest control company regarding necessary repairs. (See Photo 5) (See Photo 15)

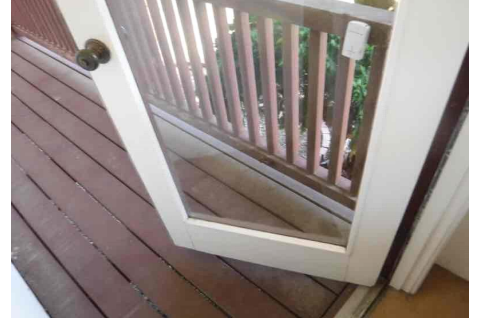
Photo 38

13. Water damage was noted at the guest bedroom exterior door, guest unit rear exterior door, guest unit rear exterior laundry/storage door and the detached bathroom exterior door. We recommend the services of a licensed general contractor and/or structural pest control company regarding repairs. (See Photo 38) (See Photo 43) (See Photo 50)

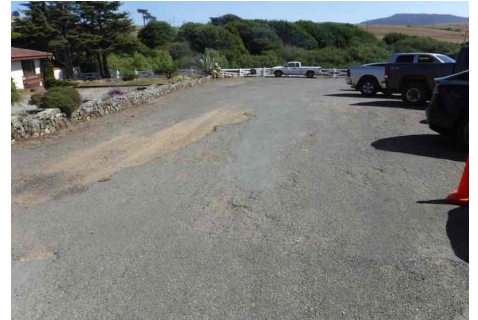
Photo 61

14. The cracked and heaved sections of the driveway present a trip hazard. This condition should be corrected for improved safety. (See Photo 61)

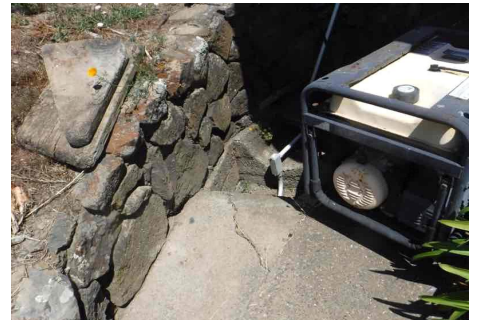
Photo 17

15. The open, cracked and/or heaved walkway sections at various locations present a trip hazard. This condition should be corrected for improved safety. (See Photo 17) (See Photo 18)

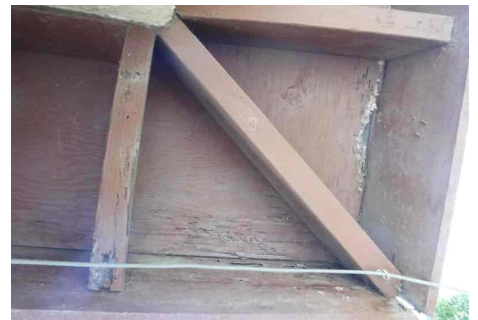
Photo 39

16. Water damage was observed to the roof eaves/sheathing at the guest unit. We recommend the services of a licensed general contractor and/or structural pest control company. (See Photo 39)

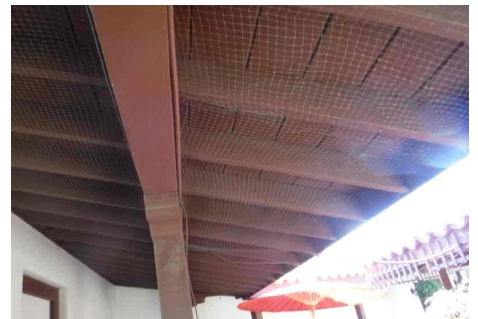
Photo 13

17. Water damage was observed to the rafters at various locations. We recommend the services of a licensed general contractor and/or structural pest control company. (See Photo 13)

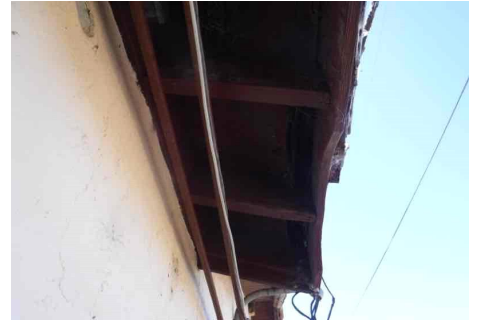
Photo 60

18. Water damage was observed to the fascia at the guest unit. We recommend the services of a licensed general contractor and/or structural pest control company. (See Photo 60)

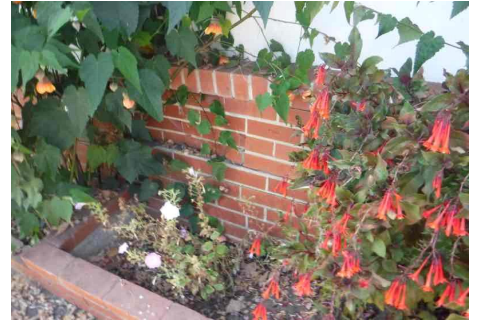
Photo 10

19. The veneer at the left side is damaged and has pulled away from the building and/or has become unbounded from the wood frame. The exterior brick masonry walls are only a veneer over the basic wood frame construction. The masonry is not a structural element of the house. Minor cracks are fairly typical and not considered a structural deficiency. We recommend repair or removal of the brick masonry. (See Photo 10)

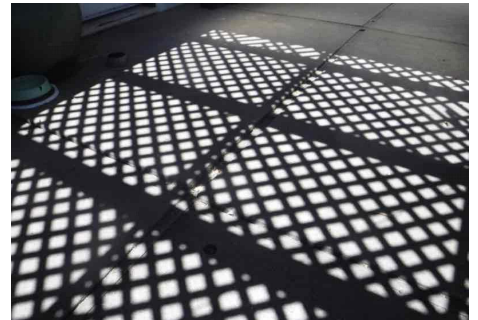
Photo 04

20. The concrete is badly settled and/or heaved at the patio. We recommend the appropriate trade(s) for further evaluation and/or repair. Replacement may ultimately be necessary. (See Photo 4)

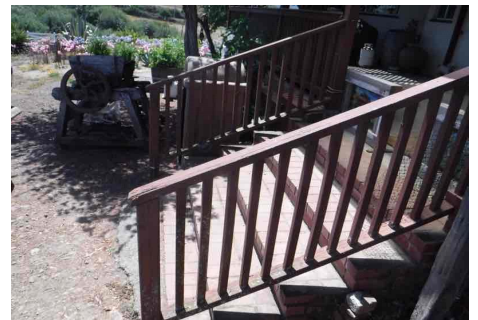
Photo 09

21. The railings at various locations are water damaged. We recommend the services of a licensed general contractor and/or structural pest control company. (See Photo 9) (See Photo 29)

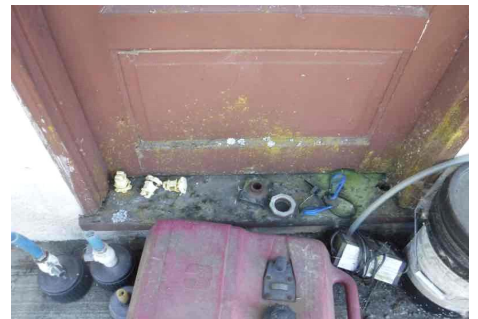
Photo 55

22. The door sill/threshold is water damaged at the guest unit rear exterior. We recommend the services of a licensed general contractor and/or structural pest control company. (See Photo 55)

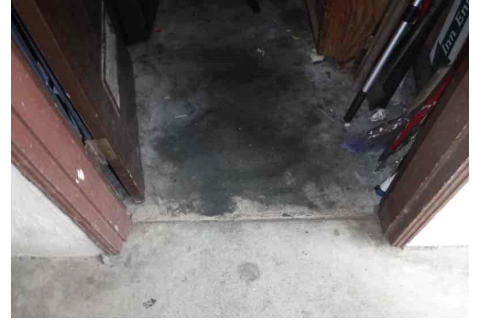
Photo 07

23. Missing or improper thresholds were noted at the exterior rear patio doors, guest unit rear exterior door and detached bathroom exterior door. We recommend the installation of a threshold that conforms to present building standards. This will also help to avoid possible trip hazards and limit moisture intrusion. (See Photo 7) (See Photo 52) (See Photo 62)

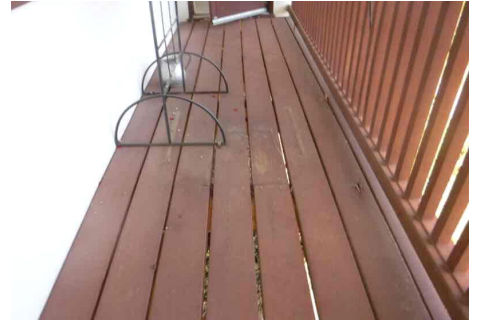
Photo 30

24. One or more of the deck boards are loose. It is recommended that this be repaired for improved safety. (See illustration 3X) (See Photo 30)

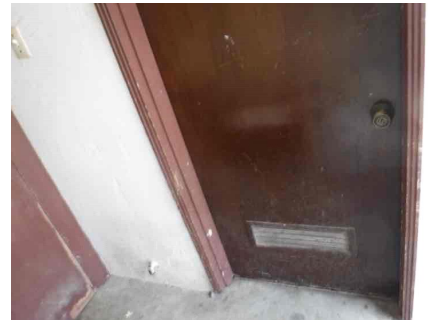
Photo 08

25. The door did not latch properly at the exterior rear storage closet. We recommend that hinges, latches and strike plates be adjusted to restore full operation. (See Photo 8)

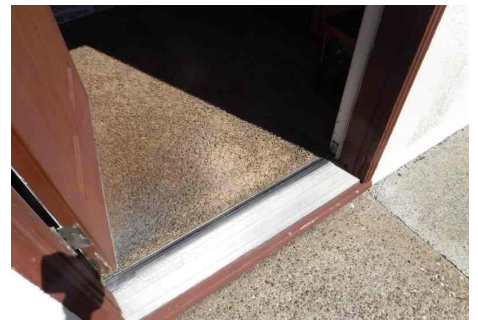
Photo 42

26. Water damage was noted at the guest unit rear exterior door jamb. We recommend the services of a licensed general contractor and/or structural pest control company. (See Photo 42)

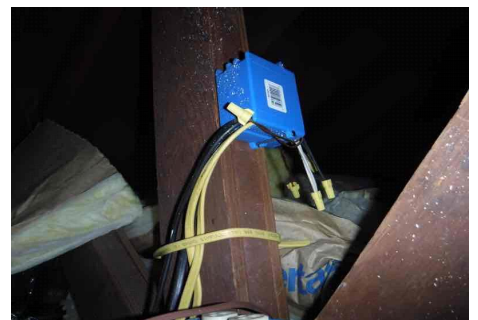
Photo 47

27. Running splices, which are improper connections outside of a junction box, were observed in the guest unit attic. We recommend connections be joined with approved connectors inside a junction box to prevent accidental contacts or mechanical damage. (See Photo 47)

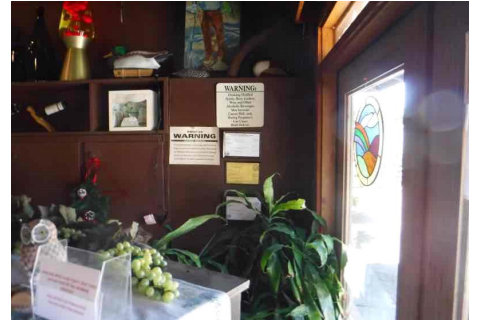
Photo 11

28. The main electrical panel was obstructed and inaccessible at the time of our inspection. We recommend the circuitry and wiring in the panel be inspected by a licensed electrical contractor when the obstructions/storage is removed. (See Photo 11)

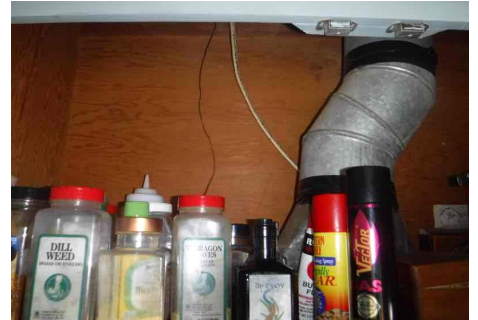
Photo 23

29. Exposed wiring inside the kitchen hood cabinet should be relocated, covered or protected by rigid conduit. (See Photo 23)

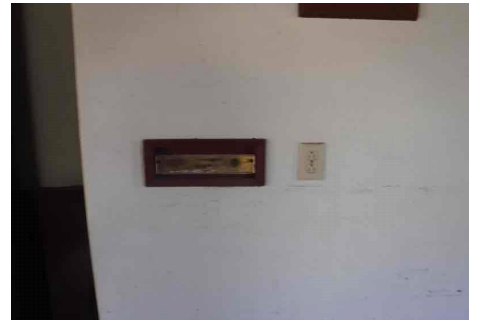
Photo 16

30. Exterior receptacles at various patio locations are missing water proof cover plates. We recommend approved exterior covers be installed. (See Photo 16)

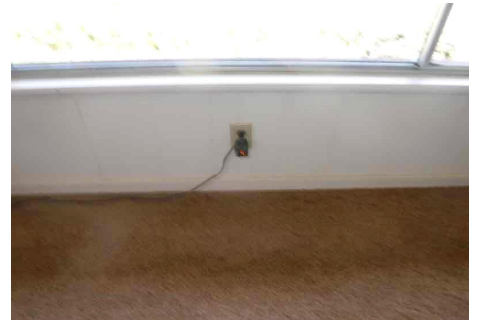
Photo 27

31. Ungrounded "3-prong" outlets at the master bedroom should be improved. A grounded cable or ground wire could be installed at these outlets, the outlet labeled as ungrounded or the original "2-prong" receptacle could be reinstalled. Based upon our inspection of a representative number of outlets, we recommend testing of every outlet. Repairs or rewiring are recommended at all deficient locations. For additional information we recommend a licensed electrician be consulted. (See Illustration 4O) (See Photo 27)

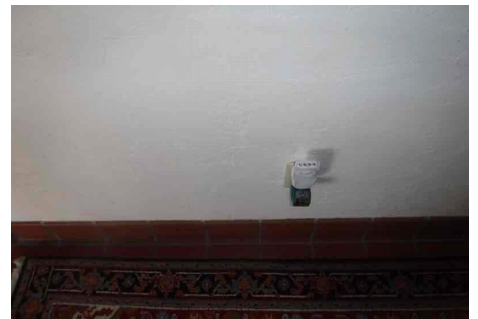
Photo 34

32. One or more outlets at the right side hall were inoperative at the time of our inspection. Possibly due to turned off switches which were not located during our inspection. These outlets and circuits should be investigated and corrected as necessary. Based upon our inspection of a representative number of outlets, we recommend testing of every outlet at a later date. Repairs or rewiring are recommended at all deficient locations. (See Photo 34)

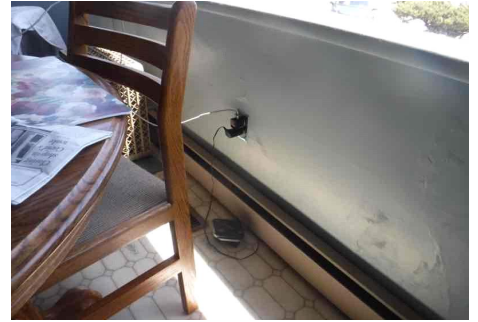
Photo 22

33. The location of the outlet over the baseboard heater at the kitchen can present a safety issue. We recommend the outlet be moved. (See Photo 22)

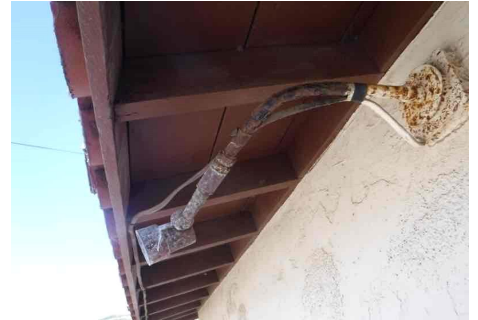
Photo 54

34. Abandoned wiring was noted in the guest unit rear exterior and crawl space. We recommend the wiring be disconnected at its source or terminated in an approved manner in a covered junction box. (See Photo 54) (See Photo 63)

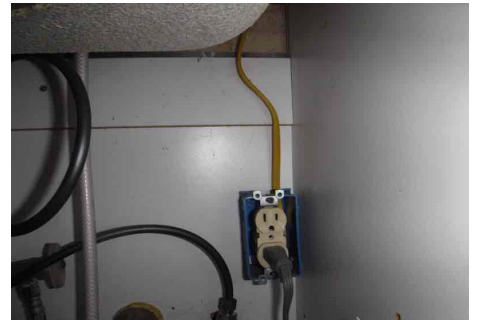
Photo 40

35. We found exposed wiring at the kitchen sink cabinet. Even if insulated, we recommend all wiring be encased in conduit or otherwise protected in accordance with present standards. (See Photo 40)

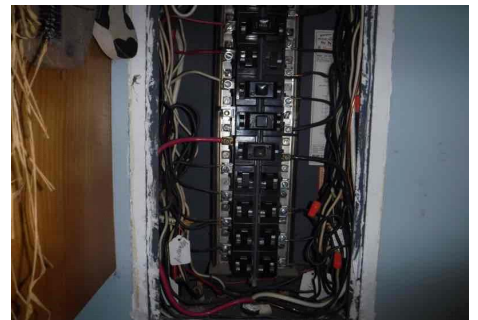
Photo 25

36. Circuits within the electrical branch/auxiliary panel that are doubled up (referred to as "double taps") should be separated. We recommend reconfiguration of the circuitry so that each wire connects only to one terminal. (See Illustration 4D) (See Photo 25)

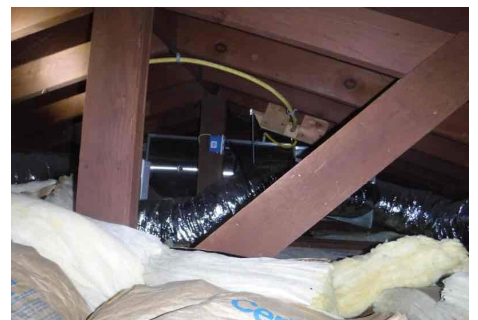
Photo 48

37. Access to the furnace in the guest unit attic is insufficient. There are specific standards for clearance of forced air systems in attics. Consult a heating and air conditioning contractor regarding this matter. We also recommend further inspection of the forced air system by licensed HVAC contractor when access is provided. (See Photo 48)

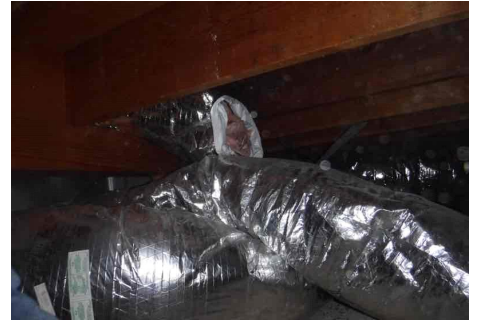
Photo 64

38. One or more of the heating ducts have come apart at the crawl space. This will allow conditioned air into surrounding area. We recommend they be repaired and secured. (See Photo 64)

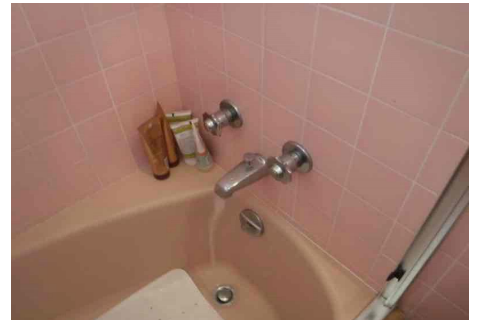
Photo 33

39. The tub faucet and/or handles are leaking at the right side hall bathroom. We recommend all leaks be repaired. (See Photo 33)

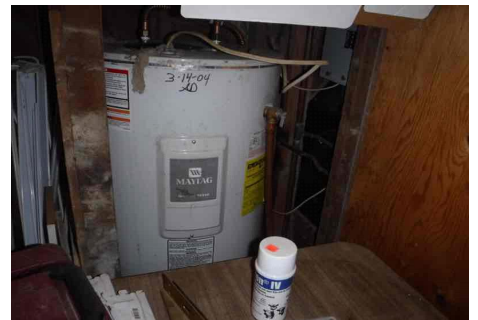
Photo 51

40. The guest unit water heater was not strapped. All water heaters (gas or electric) in seismic zones should be properly anchored or strapped in the upper and lower section of the tank to resist movement during earthquake conditions. Specifically California state code is as follows.

1. All water heaters gas or electric must be strapped.
2. Tanks up to 52 gallons require two straps, one in upper one-third and one in the lower one-third of the fixture. Water heaters with a capacity of 52 or above require three, one in upper one-third, one in middle and one in lower one-third are required. There are cases where there is an exception to this rule, we recommend consulting the local building authority regarding the adequacy of the seismic restraints for the water heater at this property.

5. Straps should be secured to adjacent wall or stud and from opposing directions
6. Straps should be secured to the wall or studs using 1/4" diameter by 3" long lag bolts with washers. (See Illustration 8E) (See Photo 51)

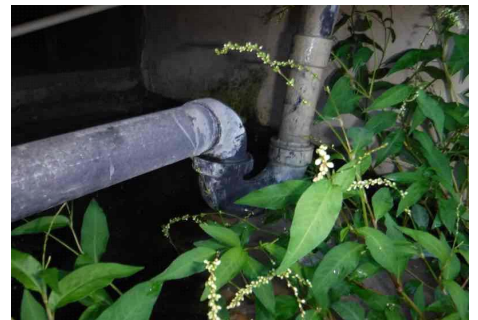
Photo 59

41. The exterior drain is leaking under the guest unit bathroom. We recommend all leaks be repaired. (See Photo 59)

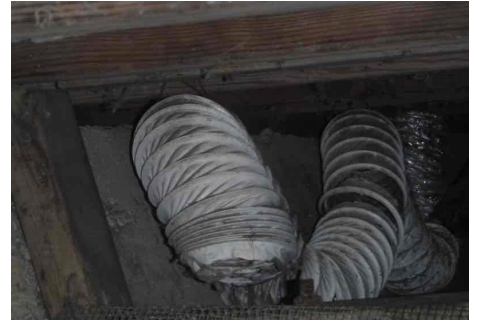
Photo 57

42. The clothes dryer is venting to the crawl space. We recommend the vent exhaust to the building exterior. Typical standards for dryer vents require a four inch, smooth wall duct, no longer than fourteen feet, with a hooded damper at the termination. A flexible vent six feet maximum may be used at the dryer connection but cannot pass through floors or walls. (See Photo 57)

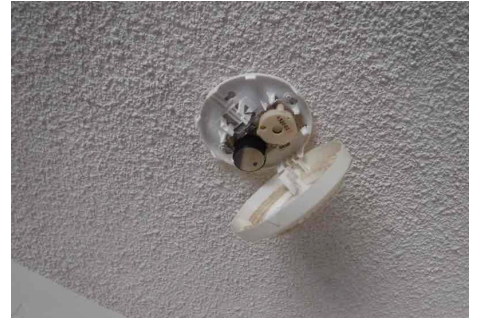
Photo 32

43. One or more smoke detector batteries have been removed. Interested parties are advised to replace the batteries and test for proper operation. (See Photo 32)

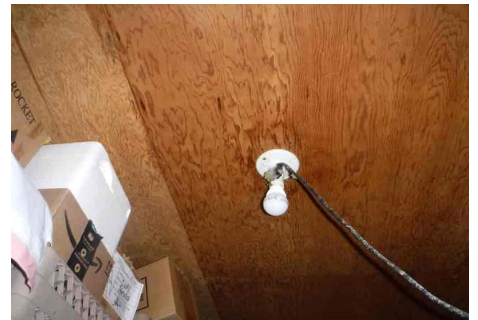
Photo 06

44. The ceilings at the exterior front and rear exterior guest unit closet show evidence of water stains. It is recommended that the source of these stains be identified and corrected and the surfaces be refinished. (See Photo 6) (See Photo 49)

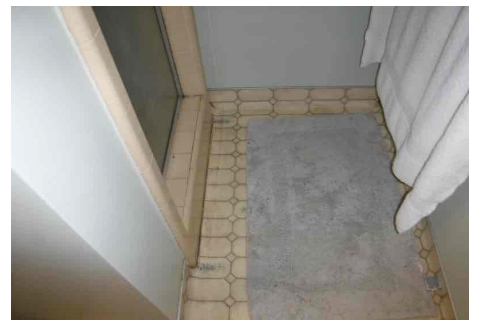
Photo 26

45. Evidence of water damage at the hall bathroom floor was observed. The extent of the damage is difficult to predict without removing floor coverings. We recommend the services of a licensed structural pest control operator for investigation of this condition. (See Photo 26)

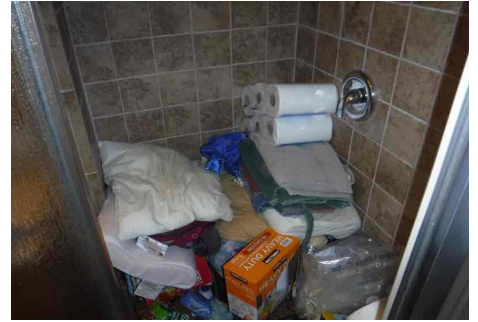
Photo 44

47. Personal storage was blocking access to the interior of the guest unit hall bathroom. Therefore, the area is considered inaccessible and was not fully inspected. With access and a opportunity for complete inspection, conditions in need of attention may be discovered. The personal belongings should be removed so the area may be examined. (See Photo 44)

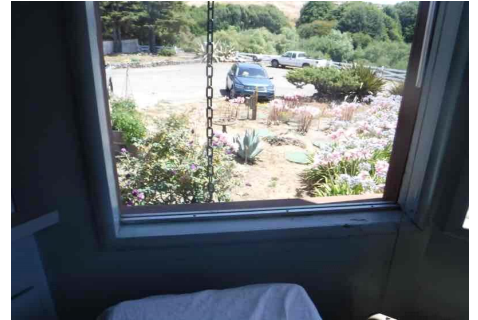
Photo 24

48. The window sills/frames at the kitchen, guest bedroom and various guest unit locations are water damaged. We recommend they be repaired or replaced. (See Photo 24) (See Photo 36) (See Photo 41)

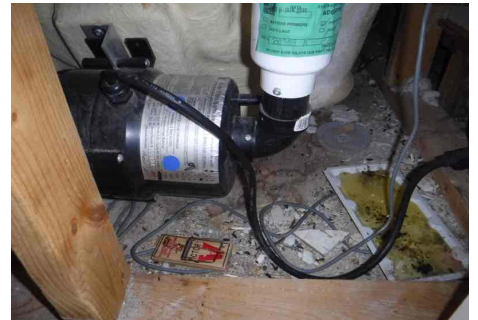
Photo 28

49. There is evidence of vermin activity in the structure. It is likely that this infestation is also in inaccessible areas. The owner is advised to contact the appropriate trades for all remedial measures necessary. (See Photo 28)

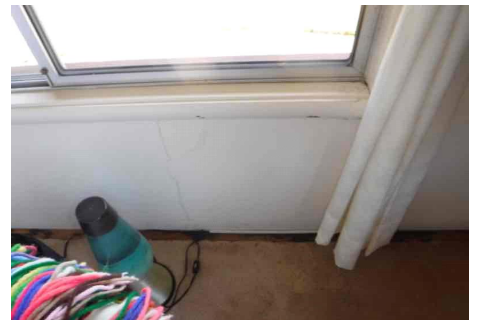
Photo 37

50. The wall at the guest bedroom shows evidence of water stains. It is recommended that the source of the moisture be identified and corrected and the surface be repaired and refinished to restore its appearance. (See Photo 37)
