AAA Home & Termite Inspections

Property Inspection Report

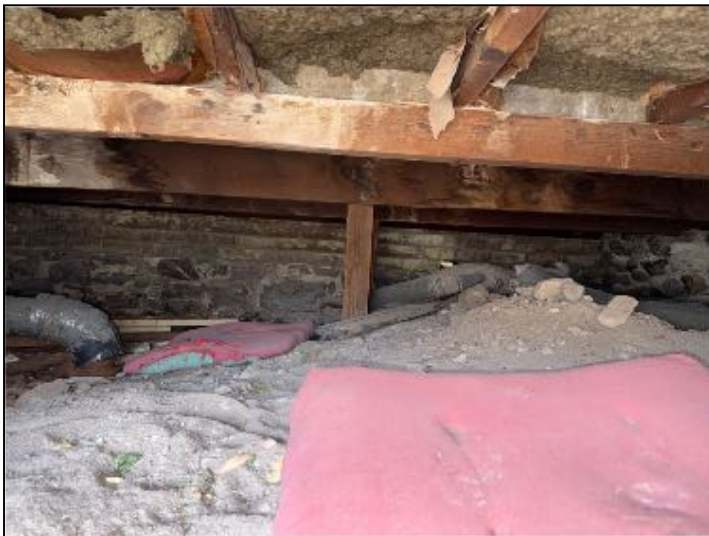
A.3. IMPROVE: A 4x4 wood column in basement showed to be overly notched. Recommend further evaluation and correction.

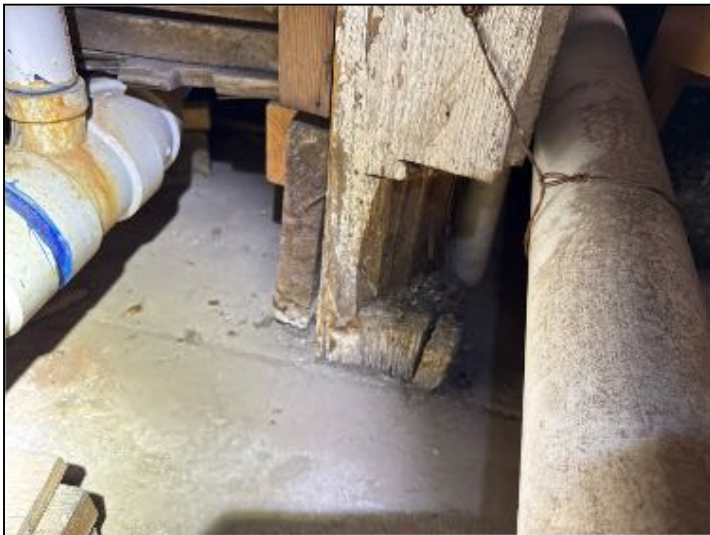
IMPROVE: A 4x4 wood column in basement showed to be overly notched. Recommend further evaluation and correction.

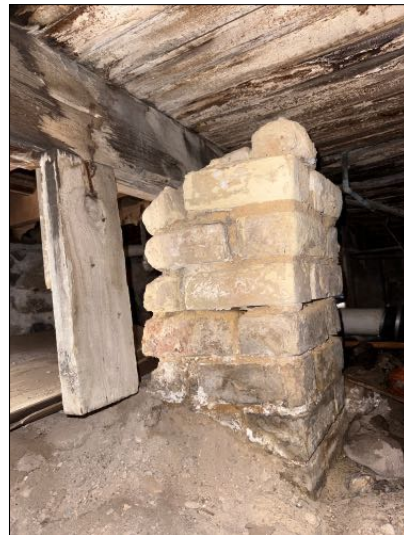
Addition foundation structure showed to be lacking support. Sloped floors, cracks in floors, walls and ceilings in unit 4 were evident. Recommend a structural engineer for further details and correction

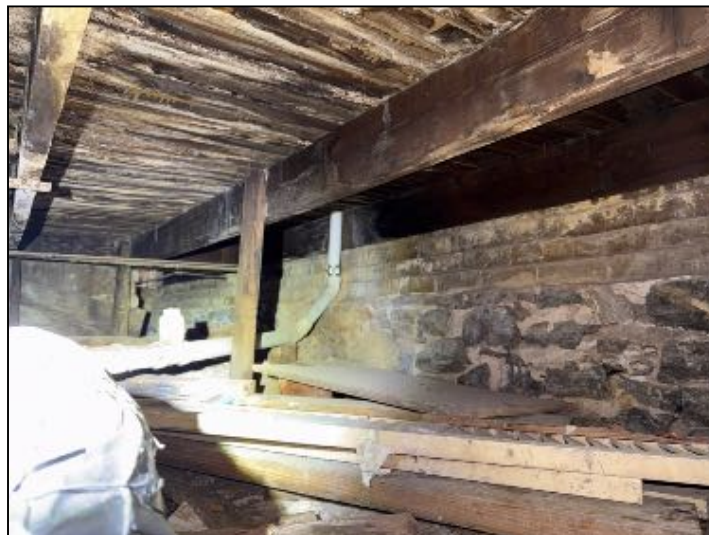
View of crawl space wall

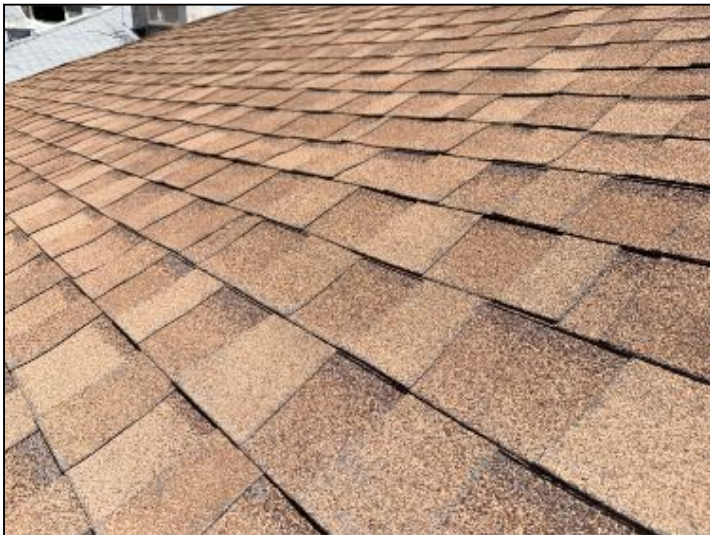
Hail damage was evident on roof top material. May allow further rapid deterioration of material, water intrusion and or moisture related issues. Recommend further evaluation by roofer

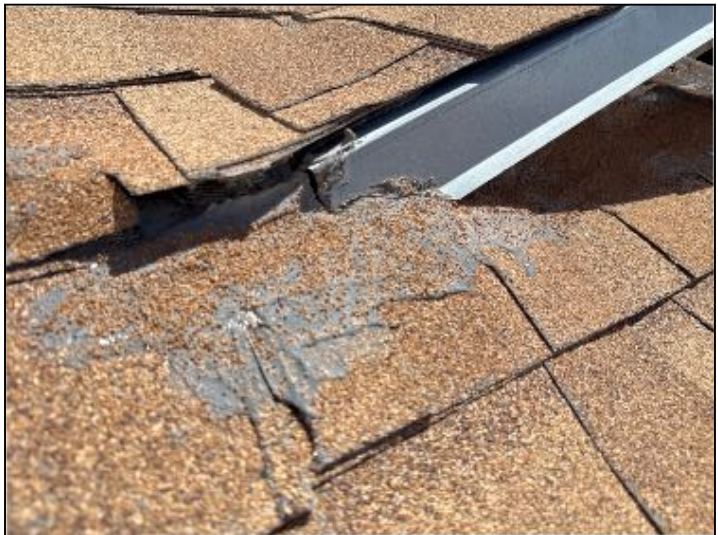
MAINTENANCE: Recommend resealing ALL cracks and crevice on roof top material.

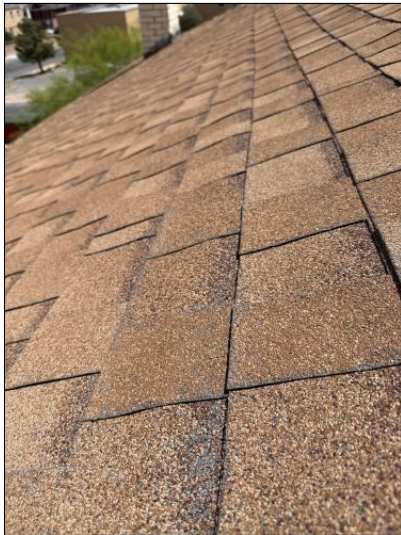
Another representative example of hail damage on roof top material

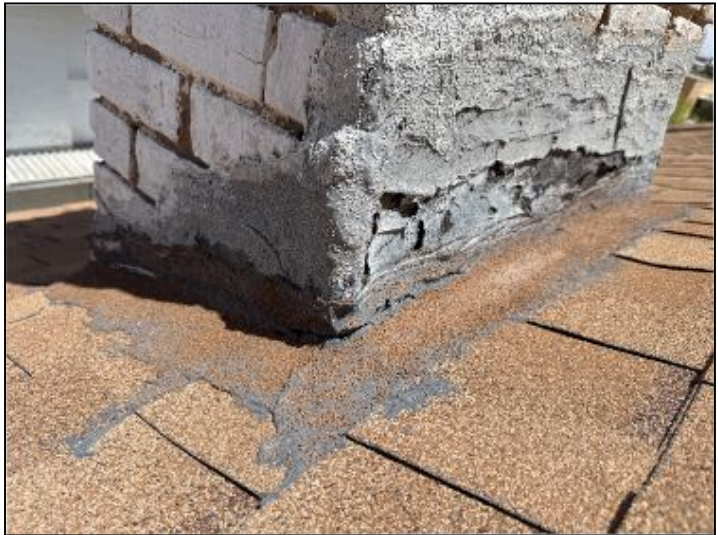
MAINTENANCE: Recommend resealing ALL cracks and crevice on roof top material.

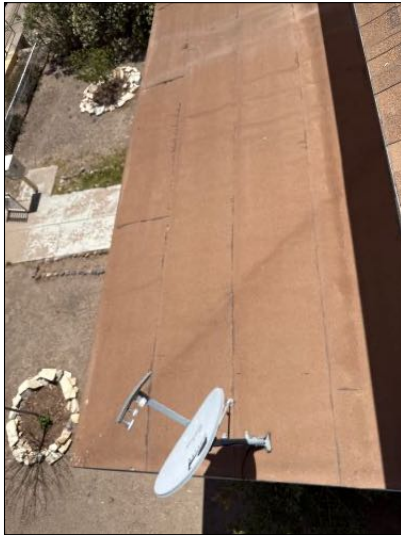
View of roof top material

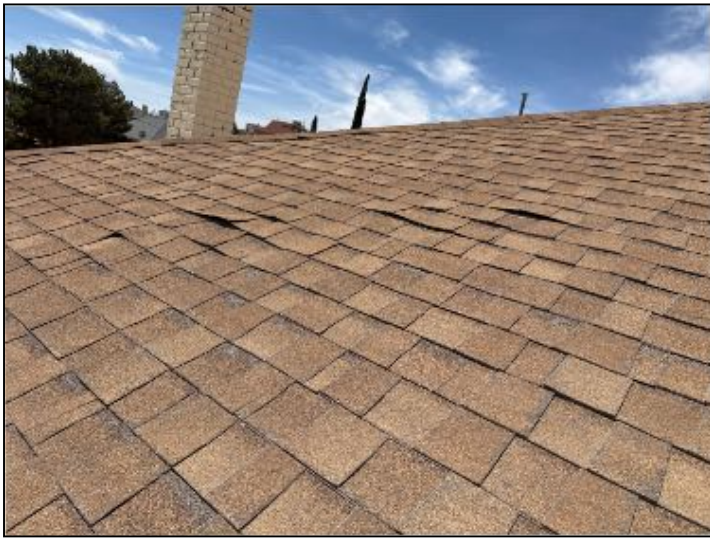
MAINTENANCE: Wind damage was evident on roof top material. Various shingles showed to have been lifted. Recommend correction

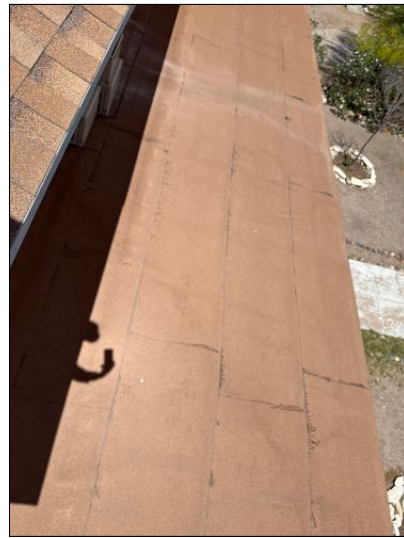
View of roof top material

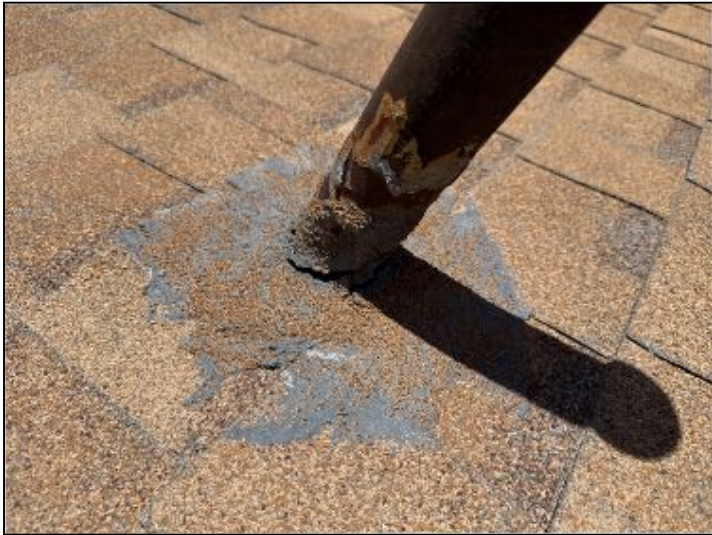
MAINTENANCE: Recommend re-sealing of ALL protrusions through the roof.

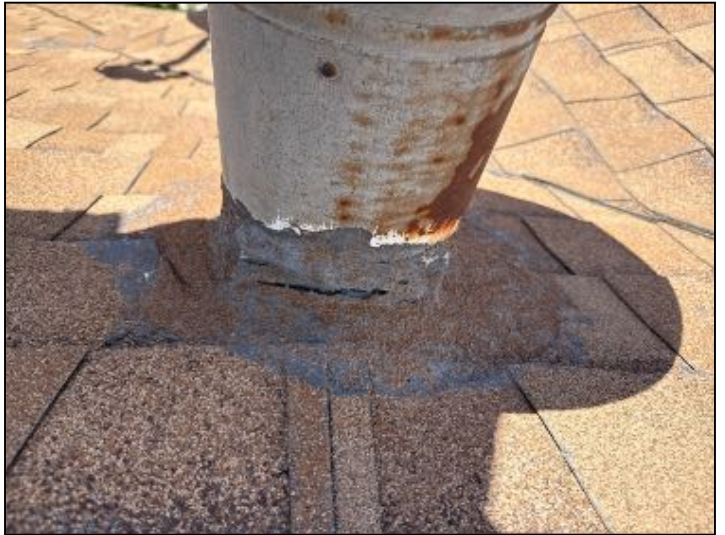
Another representative example of unsealed roof top protrusions

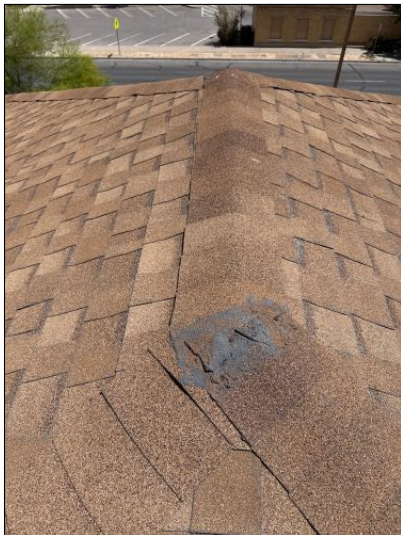
MAINTENANCE: Exposed nails were present on roof top material. Recommend sealing of ALL exposed nails on roof top

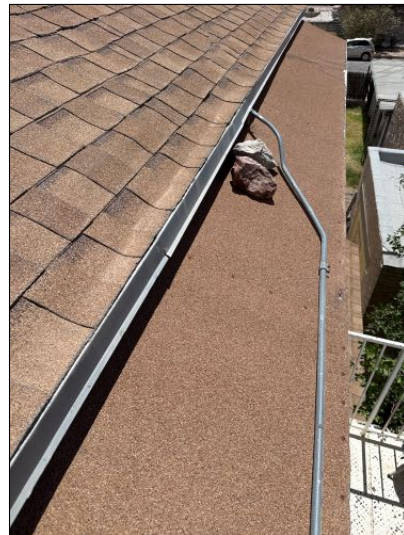
Another representative example of exposed nails on roof top material

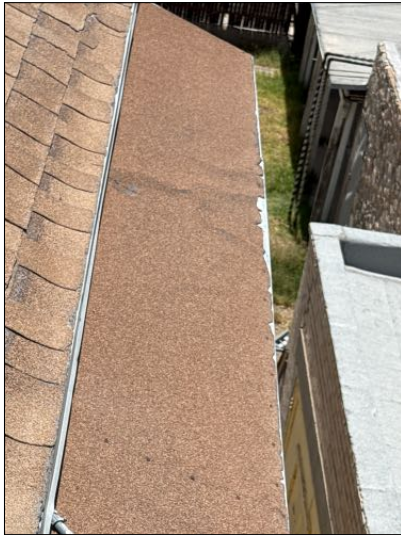
MAINTENANCE:Roof material showed to have been improperly placed from drip edge. Recommend correction.

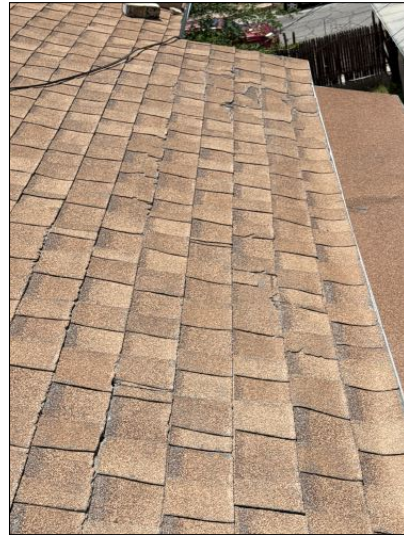
Damaged roof material, various shingles showed wear, loss of granules and or damaged shingles on backside of roof. Recommend correction

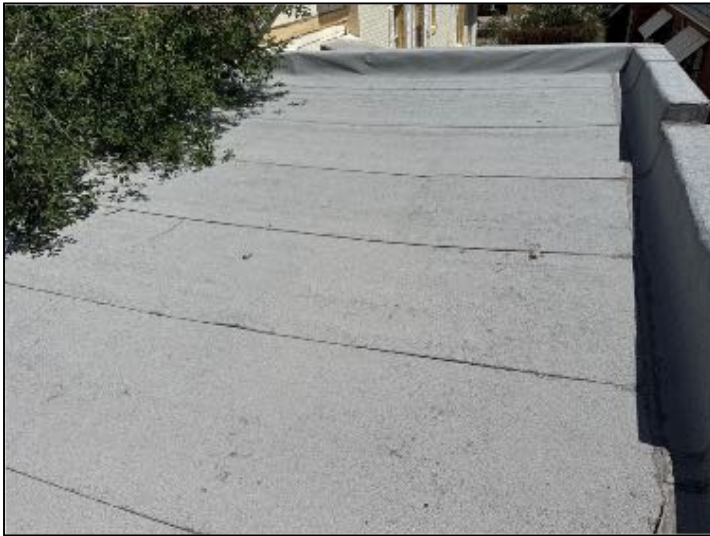
View of roof top material

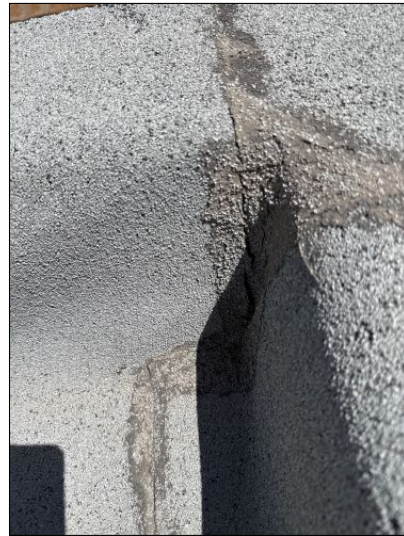
Another representative example of cracks and crevice on roof top material

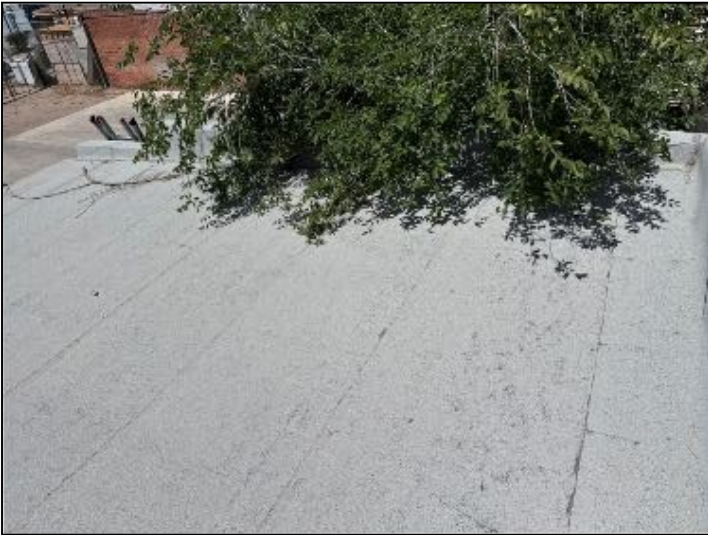
Tree branches were touching parts of the detached structure roof, which has caused damage to roof top material. Recommend trimming back of ALL tree branches and correction to roof top material

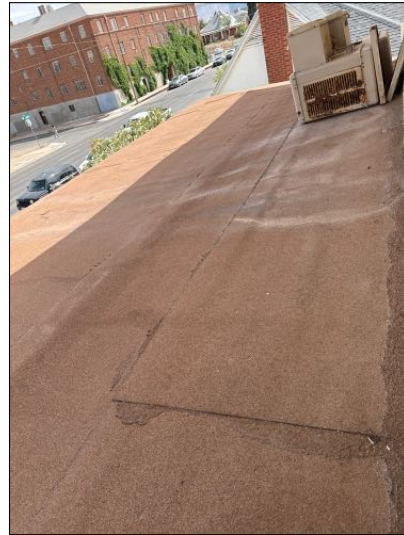
Ponding on rolled roofing areas were evident. Recommend further evaluation and correction.

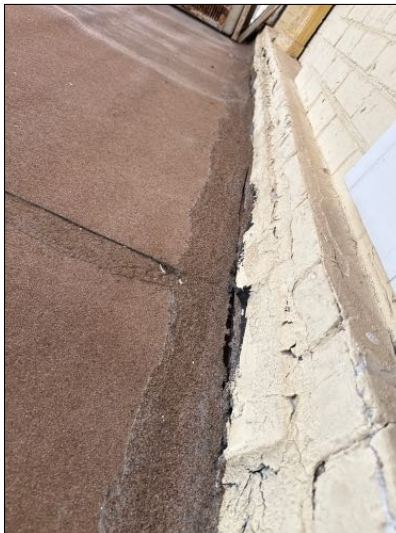
Another representative example of cracks and crevice on roof top material

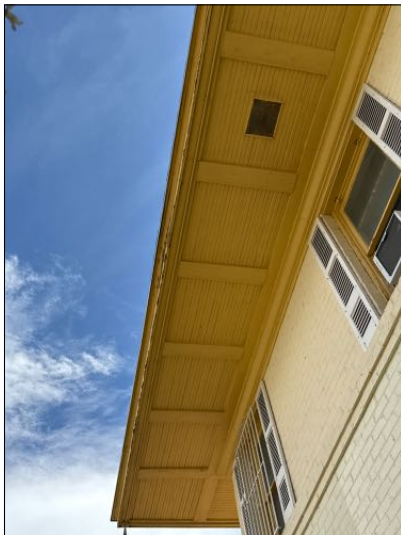
MAINTENANCE: Various areas of soffits, eaves and Facias showed evidence of water damage, recommend correction.

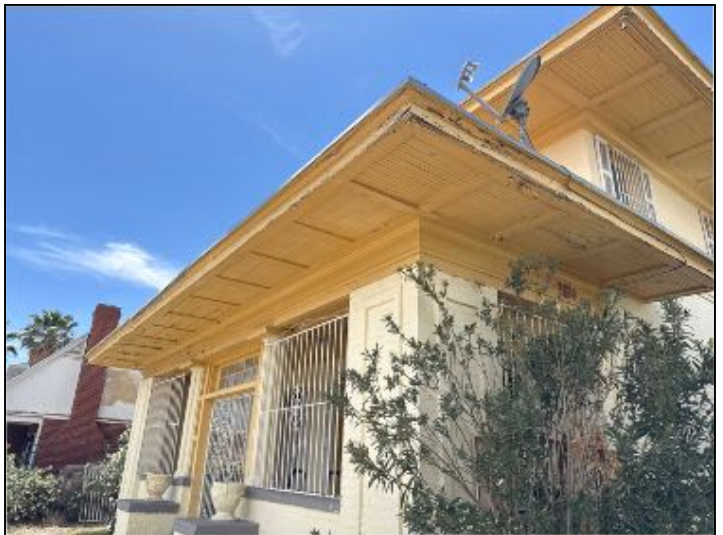
Another representative example of weathered, soffit, fascia, and eaves on front of structure

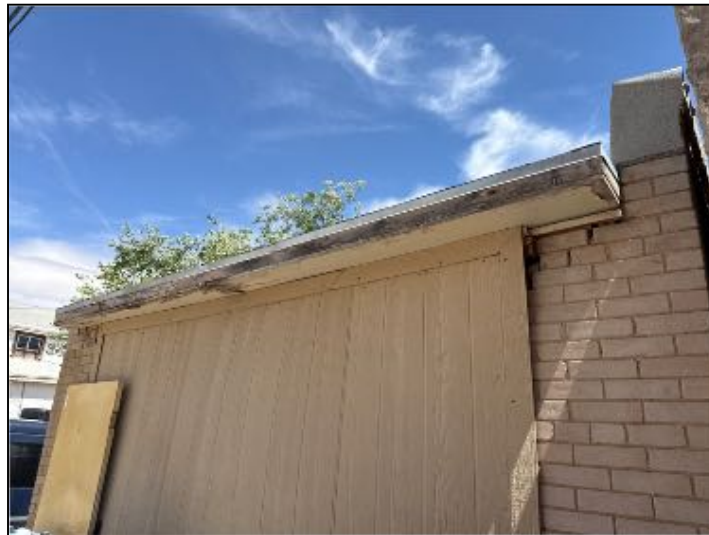
View of weathered, fascia, and soffits on detached structure

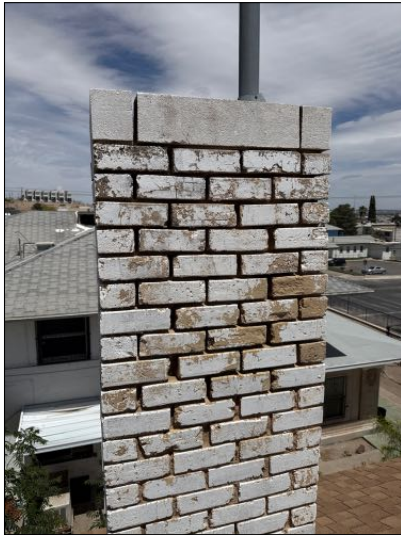
View of cracks and crevice on chimney structure walls

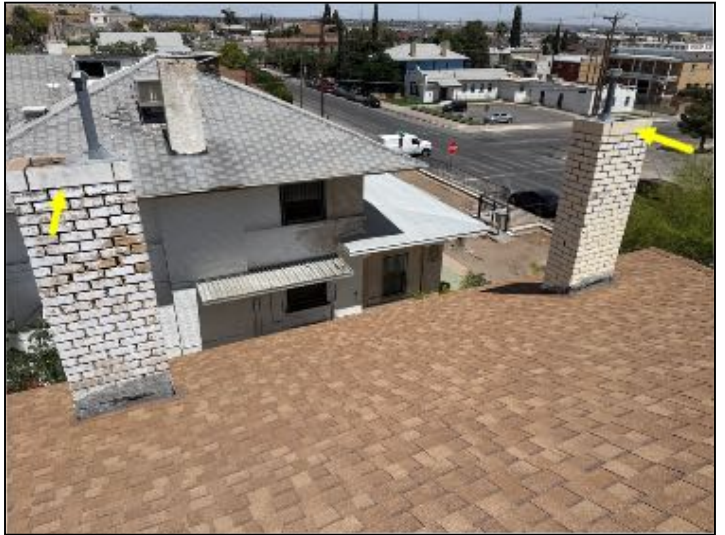
View of cracks and crevice on chimney structure walls

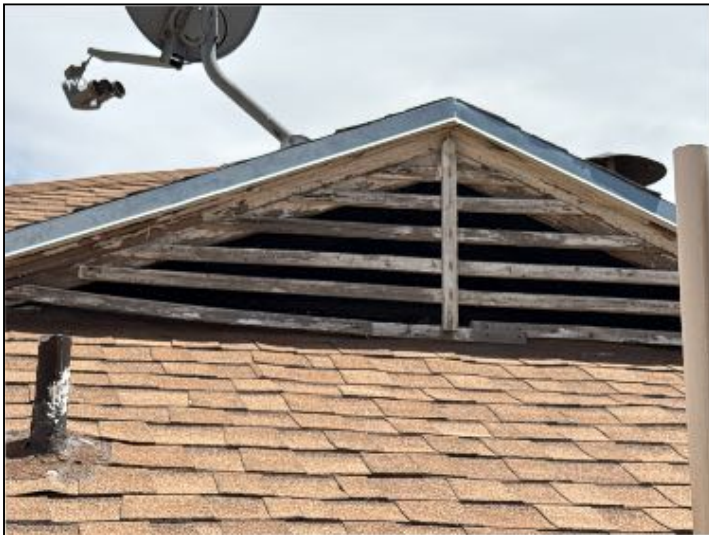
MAINTENANCE: Weathered wood was evident on various areas of structure. Recommend correction.

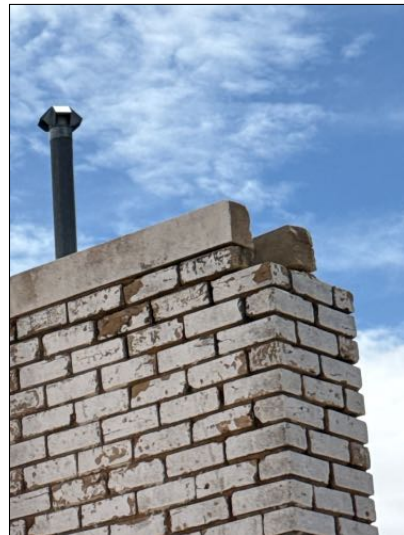
View of cracks and crevice on chimney structure walls

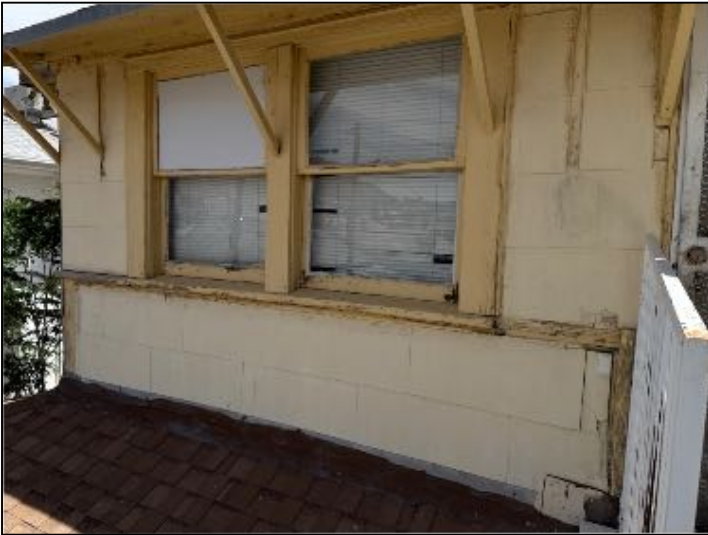
View of weathered wood on backside of structure walls

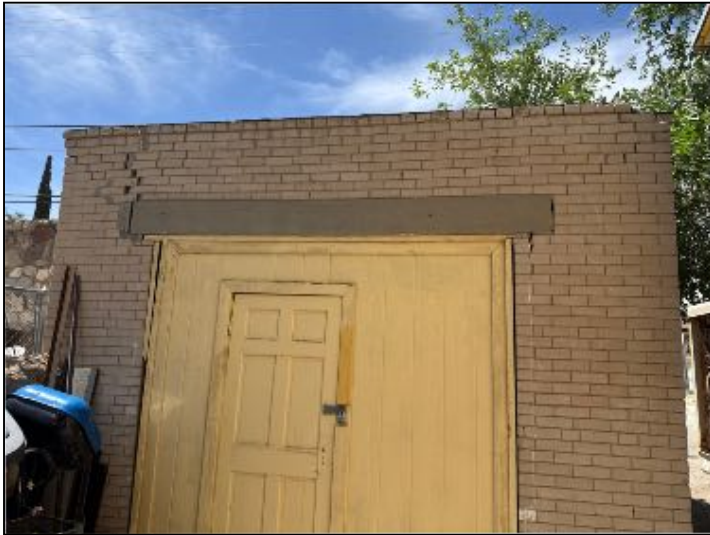
View of cracks and crevice on detached structure walls

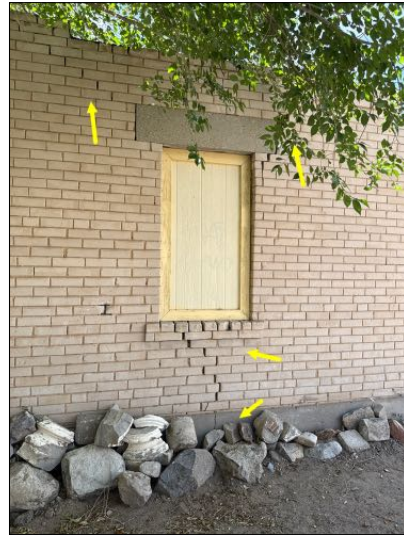
View of detached structure with crack in foundation stem wall going up alongside brick. Recommend further evaluation and correct correction.

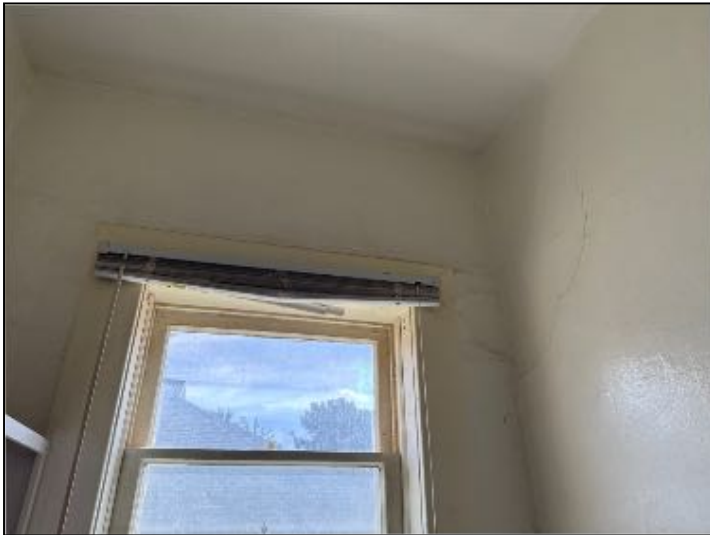
View of cracks in walls over unit 3 kitchen window

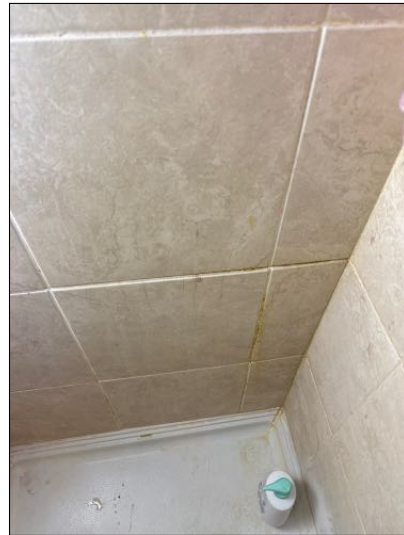
MAINTENANCE:Bathroom tile walls showed to have deteriorated grout/ caulking. Recommend correction.; unit 5

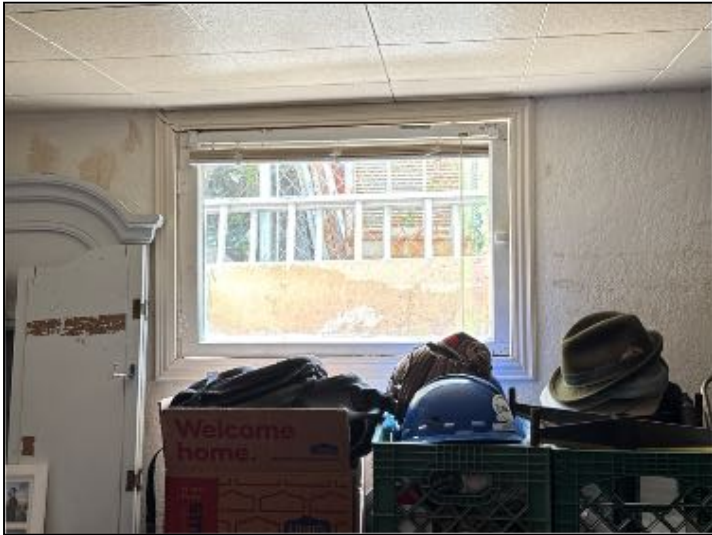
MAINTENANCE: Recommend sealing around interior window frame walls. As to allow proper efficiency

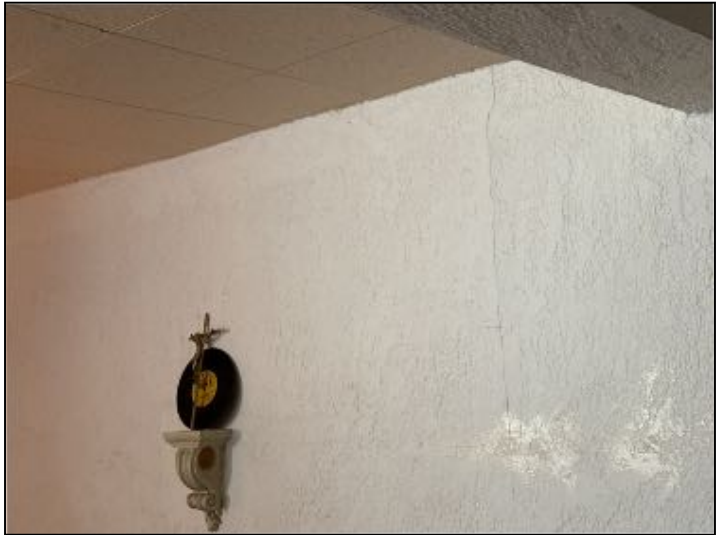
View of crack in unit 5 wall bedroom

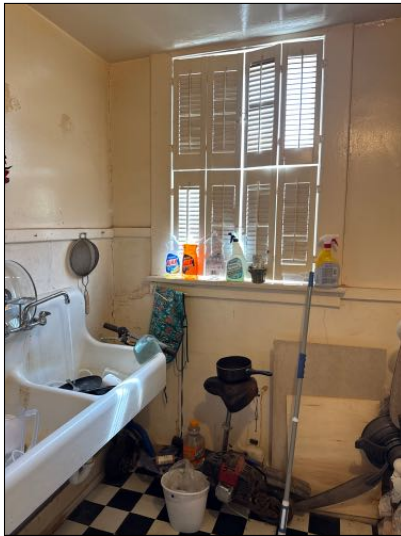
View of cracks in unit four kitchen walls

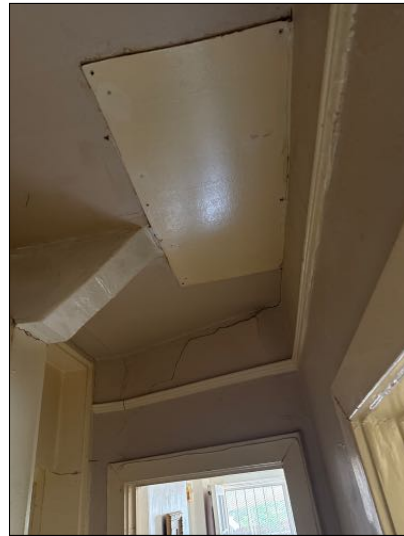
View of cracks in unit 4 hallway, ceiling and walls

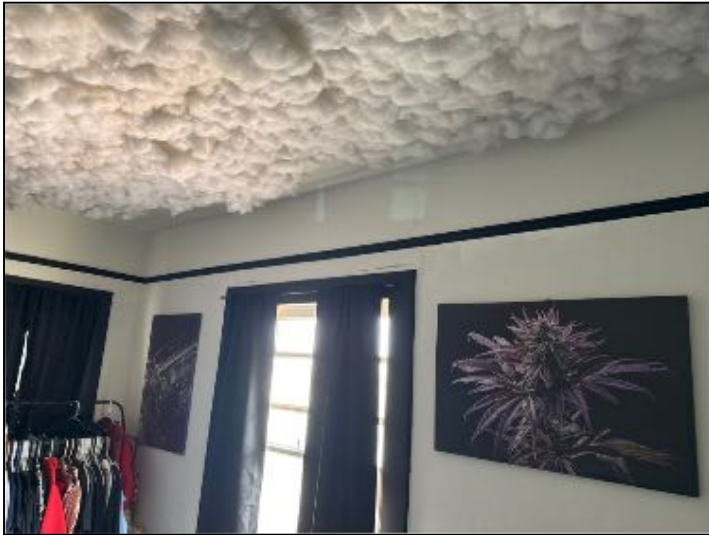
View of cracks in walls of unit 1

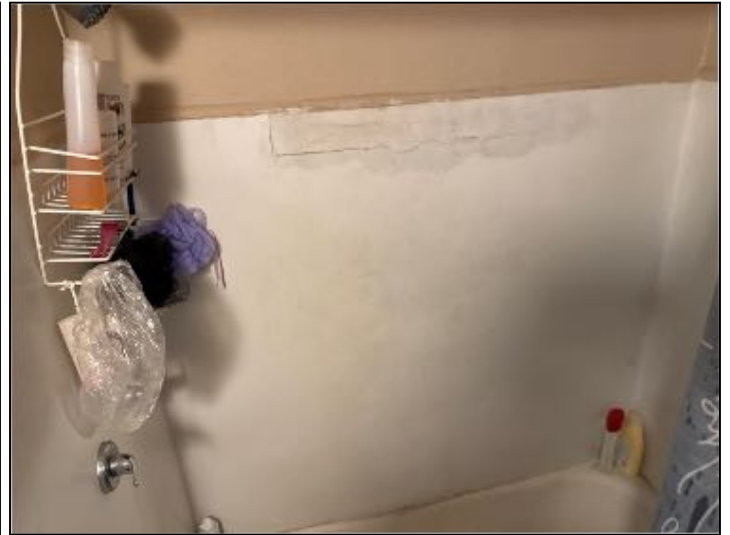
And other representative example of cracks in shower walls

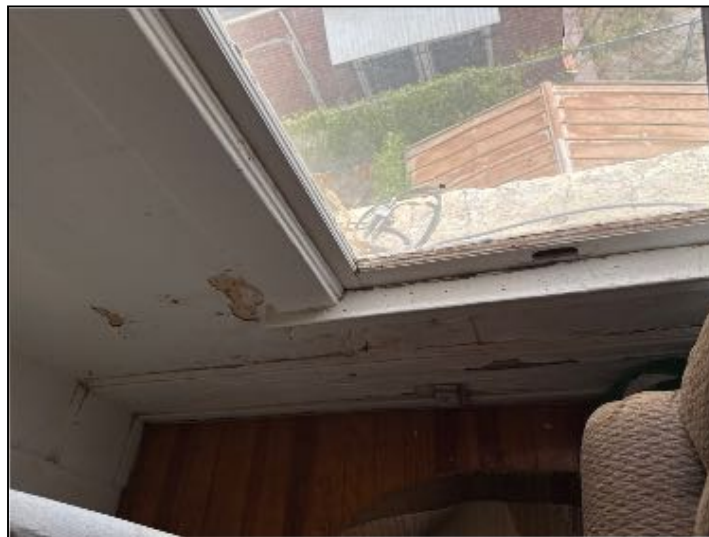
View of previous water damage to walls in unit 2

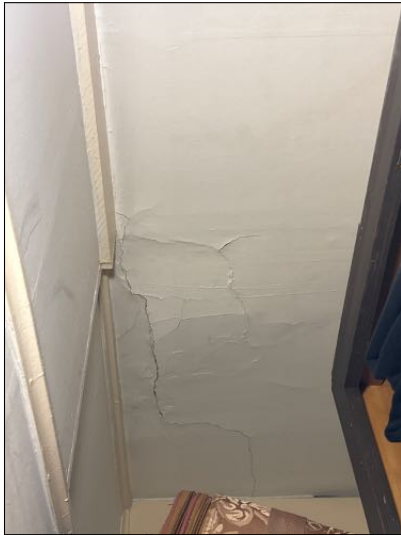
View of previous water intrusion and damage to ceilings in Unit 3 Closet area of structure

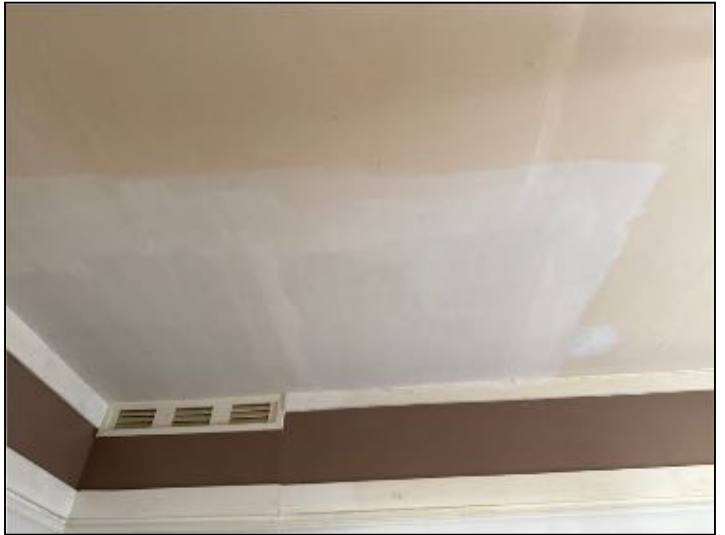
View of previous repairs to ceilings in Unit 3 area of structure

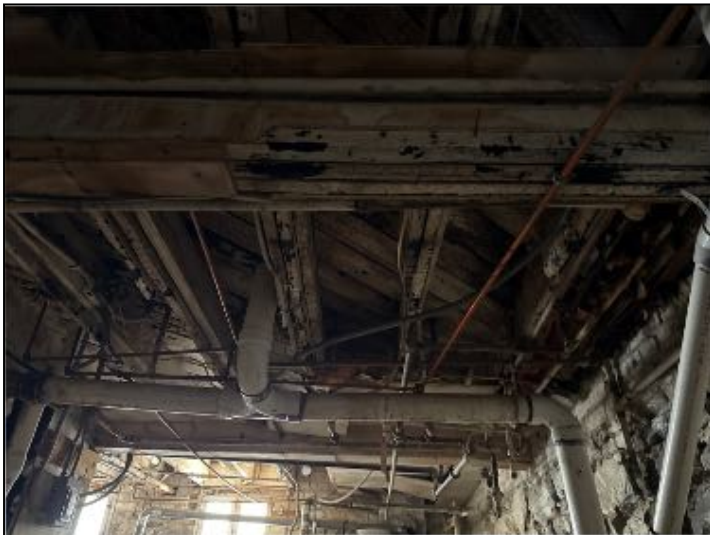
FYI: charred wood was evident in basement joists. However, seemed to be structurally sound.

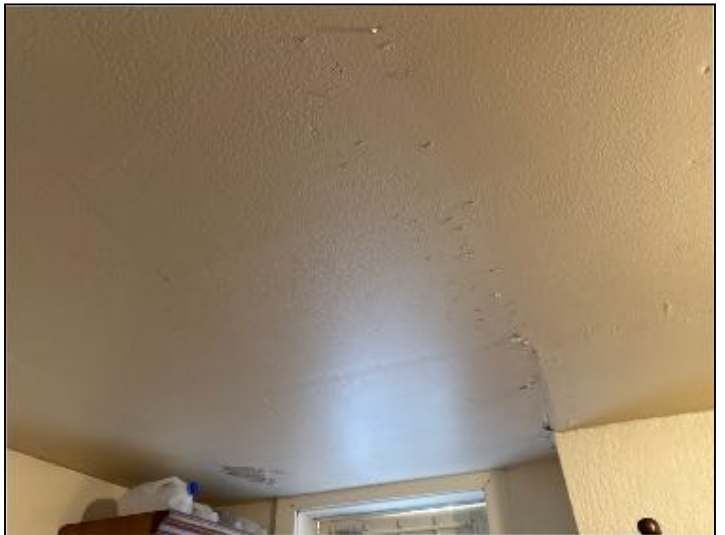
View of previous water intrusion and damage to ceilings in Unit 5 area of structure

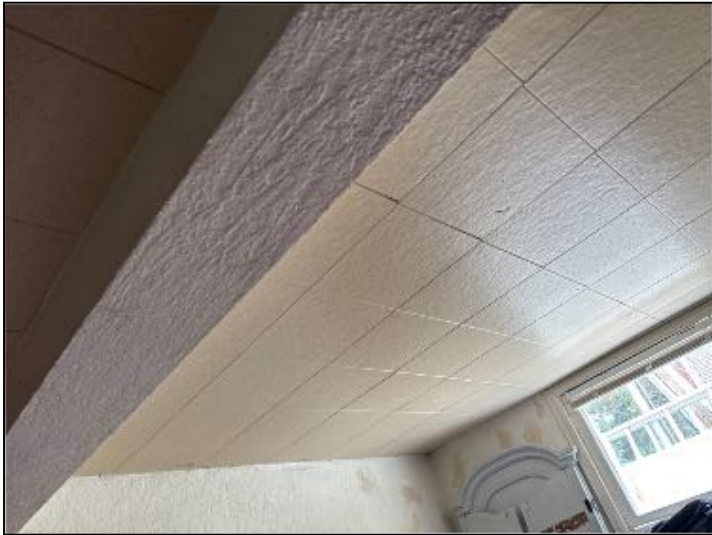
SAFETY CONCERN: Ceiling tiles in unit 5 may be Asbestos-Containing Material (ACM,) and if "handled" or otherwise "disturbed," a qualified environmental specialist should be consulted."

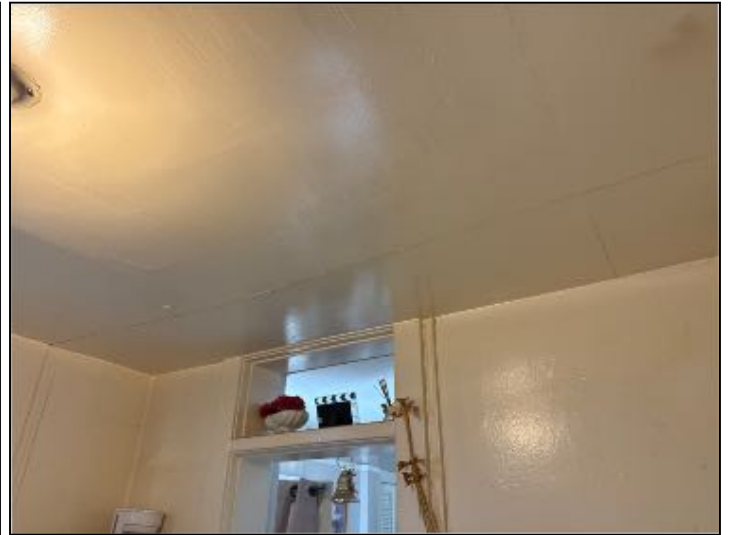
View of cracks in unit 4 kitchen ceiling

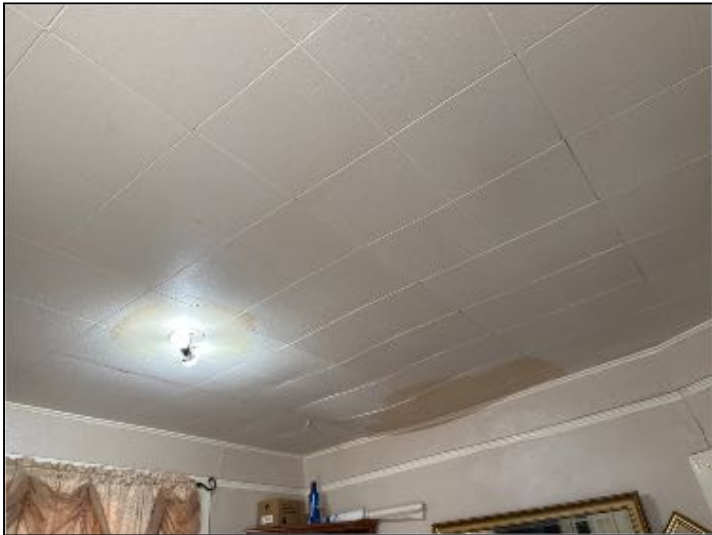
View of previous repairs to ceilings in Unit 4 area of structure

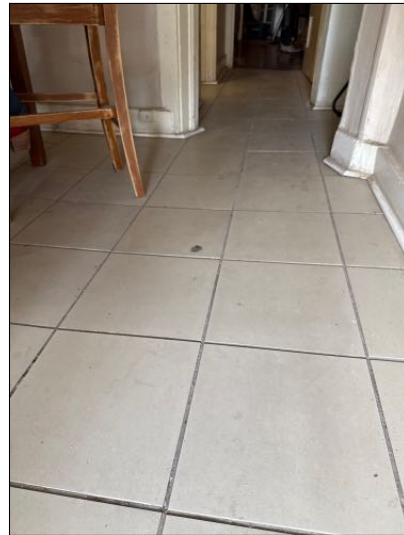
Unit 4 floors showed have been sloped in hallway, living, bathroom

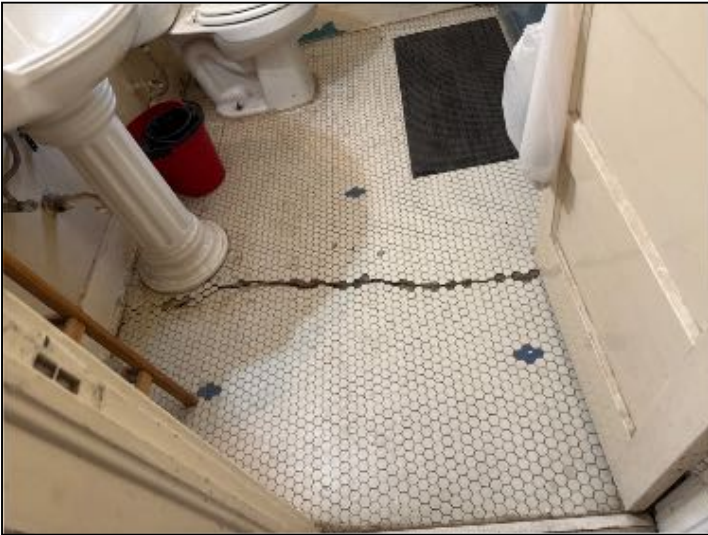
View of cracks in unit 4 bathroom floor

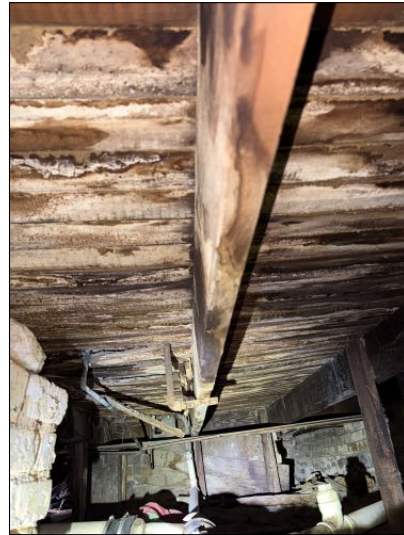
IMPROVE: unit 4 subfloor (viewed from crawl space) showed to be water damaged and rotted. Recommend correction.

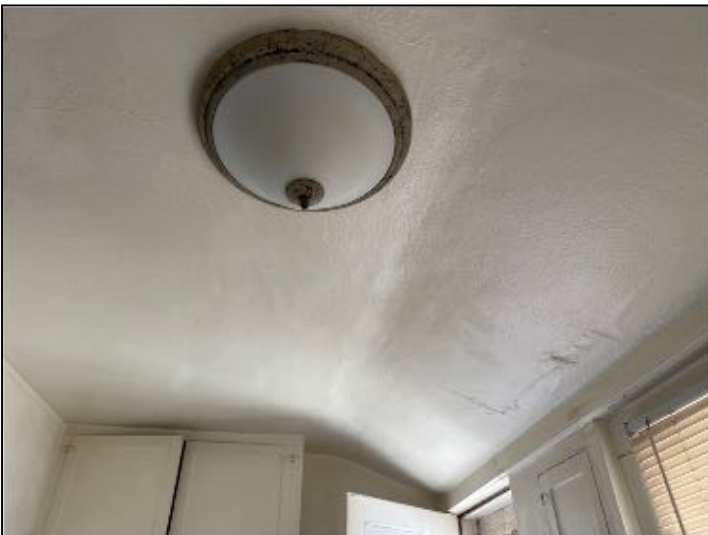
View of cracks in unit one kitchen ceiling

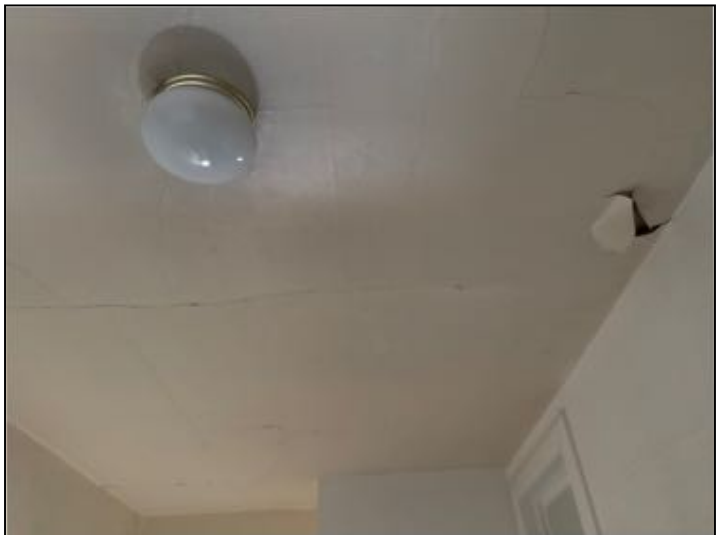
View of previous water intrusion and damage to ceilings in foyer hallway area of structure

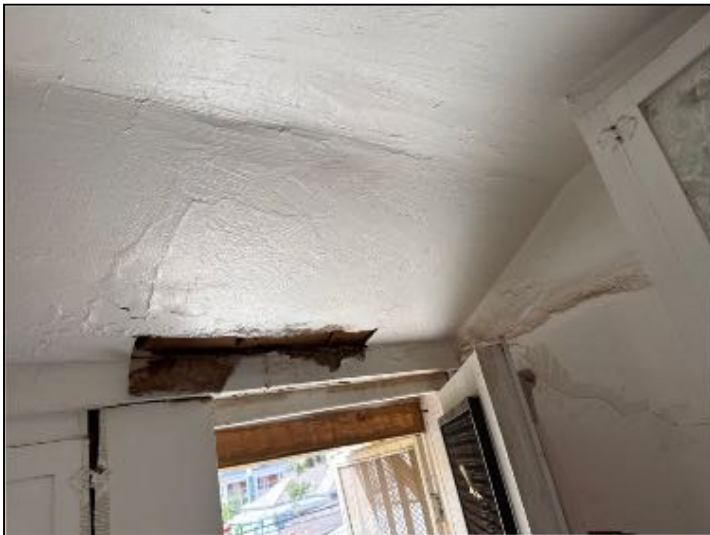
View of previous water intrusion and damage to ceilings in Unit 2 area of structure

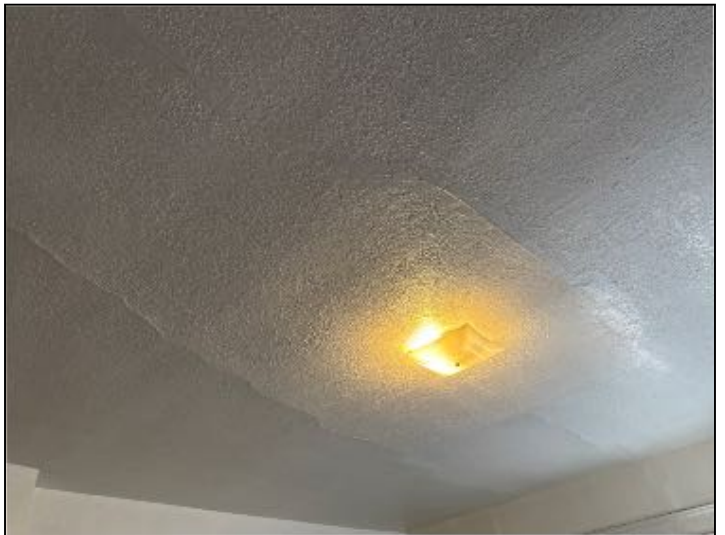
View of cracks in unit two bedroom ceiling

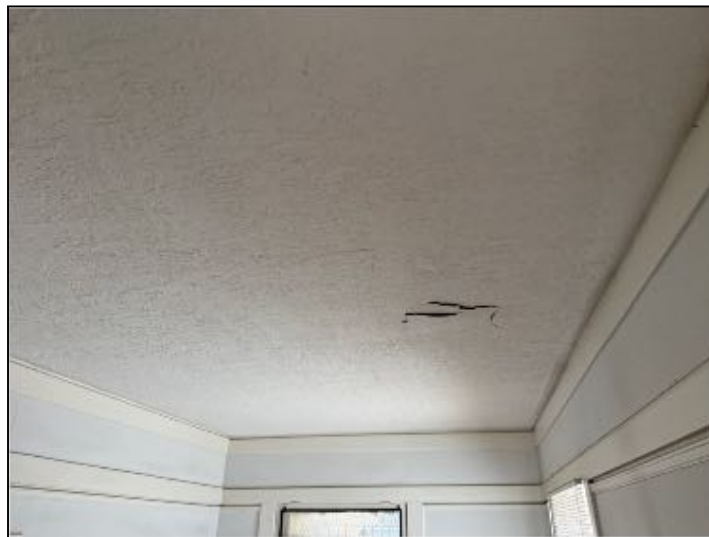
View of cracks in foyer ceiling drywall

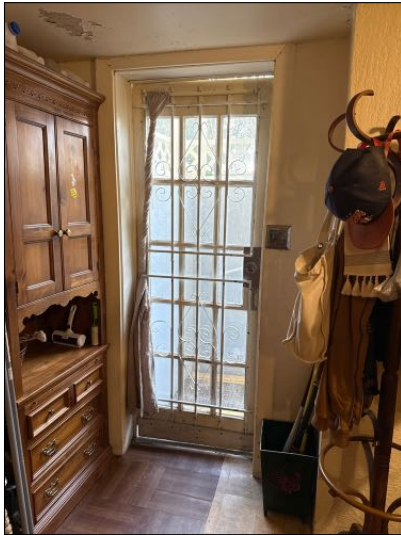
Sunlight showed to be entering through cracks of **unit 5 door**

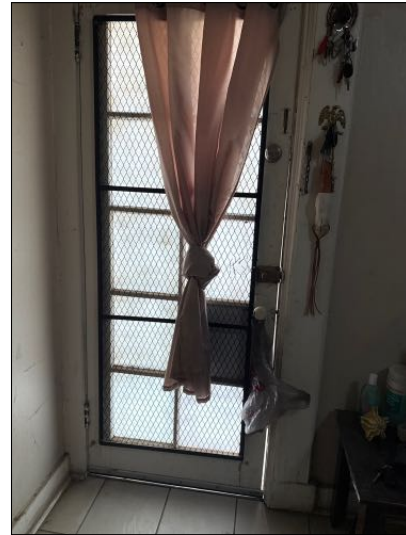
Sunlight showed to be entering through cracks of **unit 4 door**

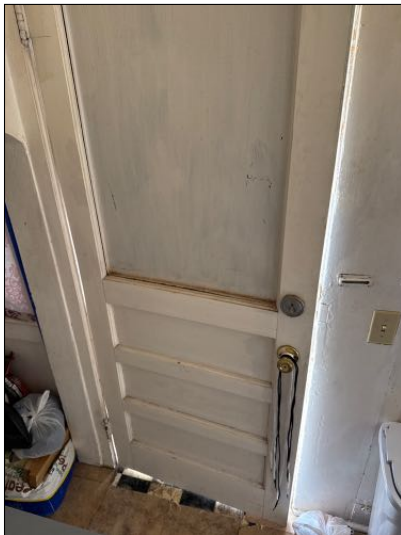
Sunlight showed to be entering through cracks of **unit 1 door**

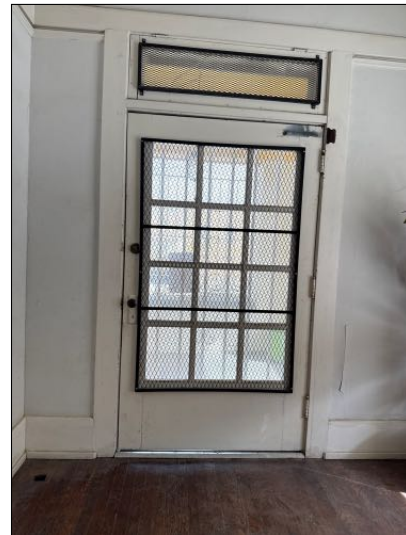
Sunlight showed to be entering through cracks of **foyer door**

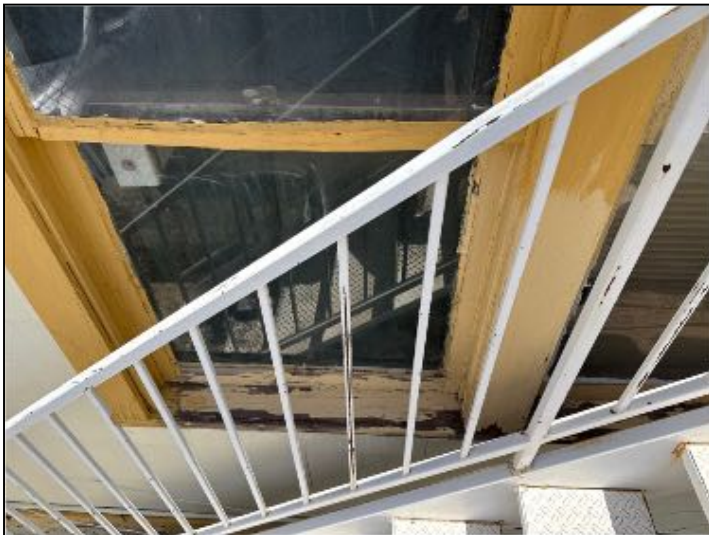
MAINTENANCE: Weathered wood was evident around **various** window frames. Recommend correction as to prevent further damage.

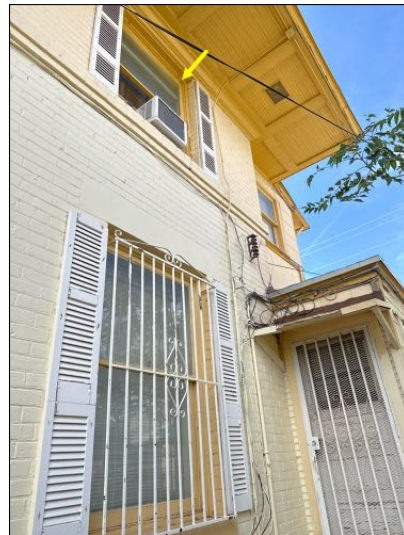
SAFETY CONCERN: **rightside upstairs** window showed to be broken. Recommend replacement of ALL defective windows

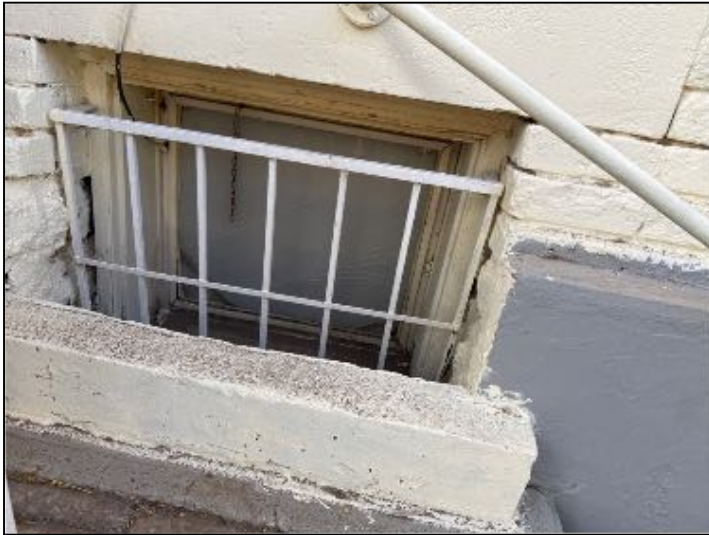
SAFETY CONCERN: rightside bottom window showed to be broken. Recommend replacement of ALL defective windows

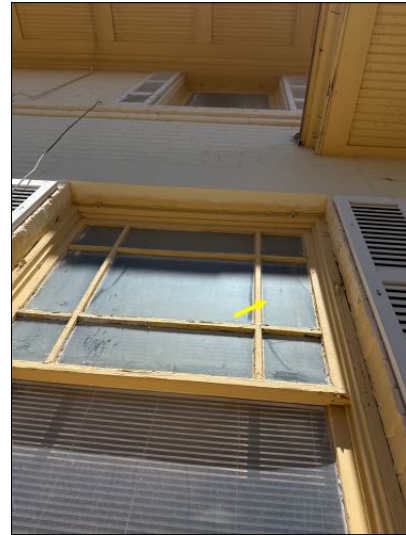
SAFETY CONCERN: leftside middle level window showed to be broken. Recommend replacement of ALL defective windows

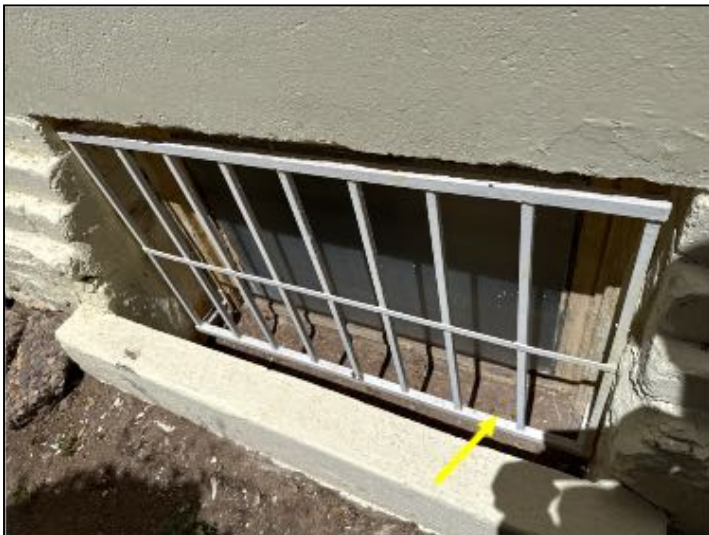
SAFETY CONCERN: leftside bottom window showed to be broken. Recommend replacement of ALL defective windows

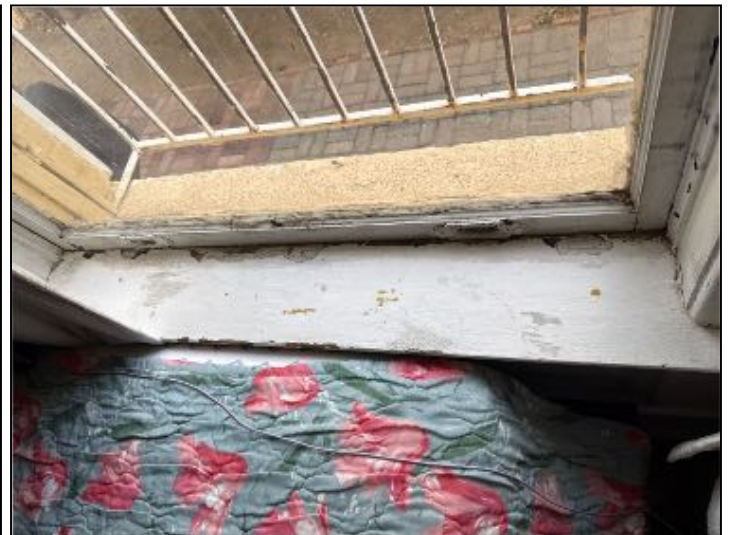
SAFETY CONCERN: Various windows were painted shut. Recommend correction as to allow proper function and safety for proper egress

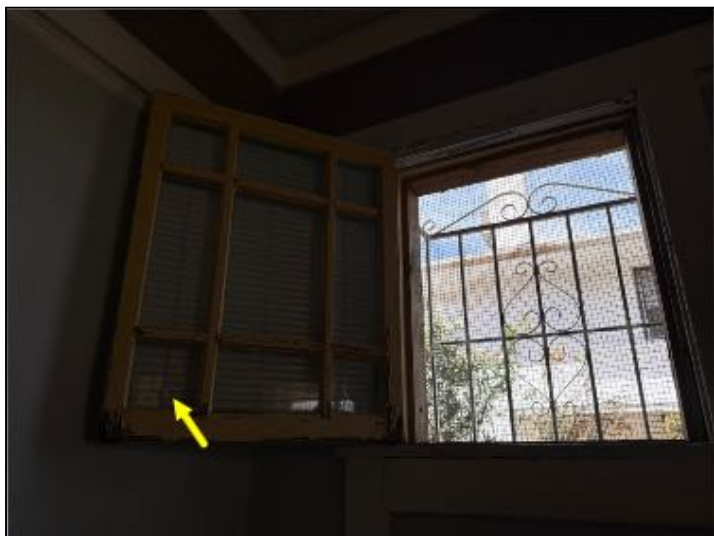
SAFETY CONCERN: unit 3 window showed to be broken. Recommend replacement of ALL defective windows

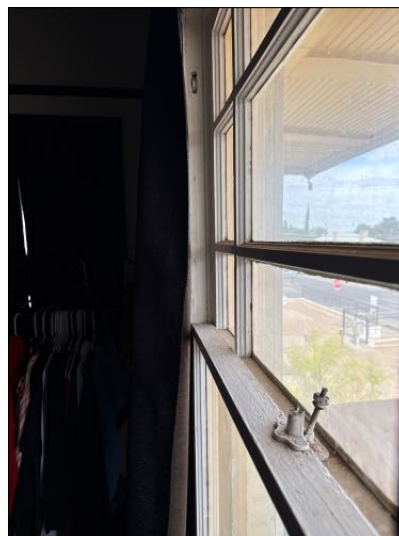
MAINTENANCE: Various windows showed to have defective hardware. Recommend correction to ALL defective windows
