AAA Home & Termite Inspections

Property Inspection Report

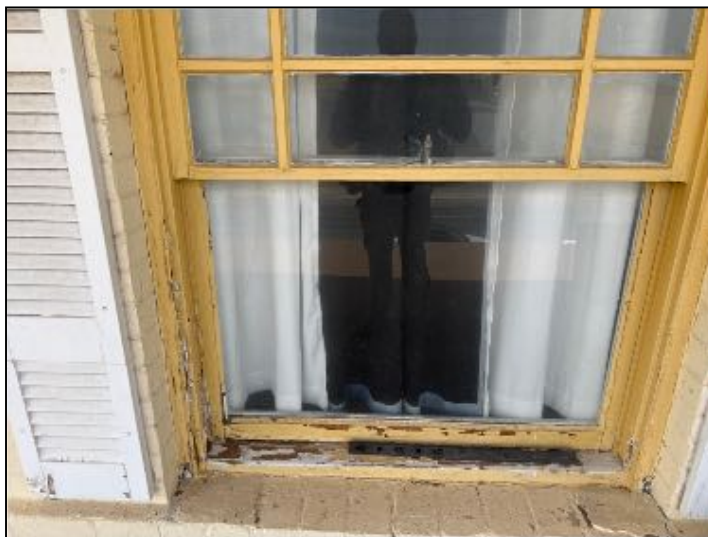
SAFETY CONCERN: front window showed to be broken. Recommend replacement of ALL defective windows

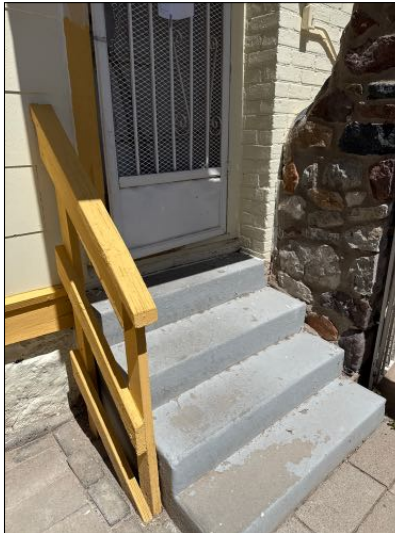
SAFETY CONCERN: Hand railing on stairs, were to wide to properly grip, may allow accidents and injuries to occur. Recommend correction

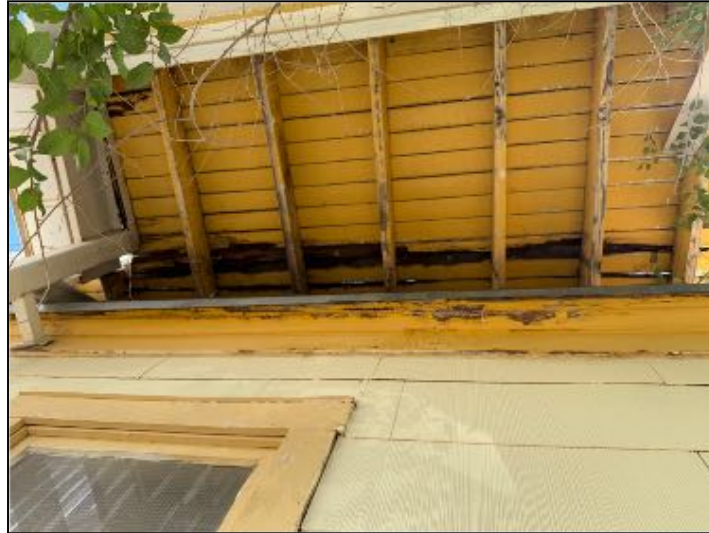
MAINTENANCE:Rotted wood was evident on back porch decking . Recommend correction as to prevent further damage

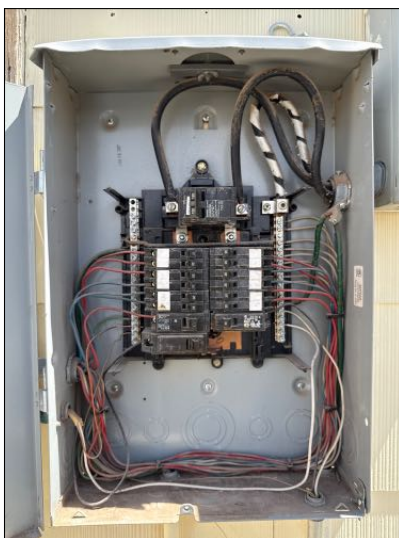
Main electrical panel with shut off

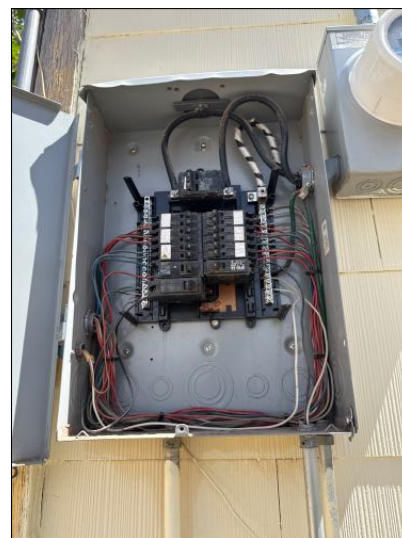
IMPROVE: surge protection device didn't appear to be present for dwelling within panel.
Recommend further evaluation and correction

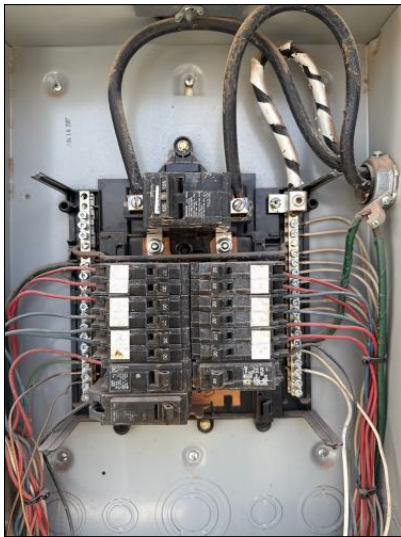
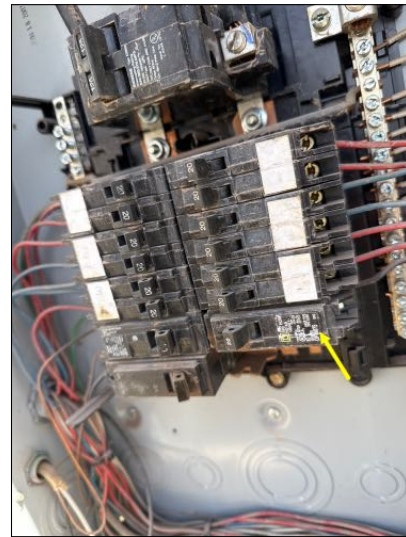
IMPROVE: AFCI type breakers/receptacles were not present throughout the structure (in the following locations: bedrooms; kitchens; family rooms; dining rooms; living rooms; closets; hallways; and laundry area). Recommend correction

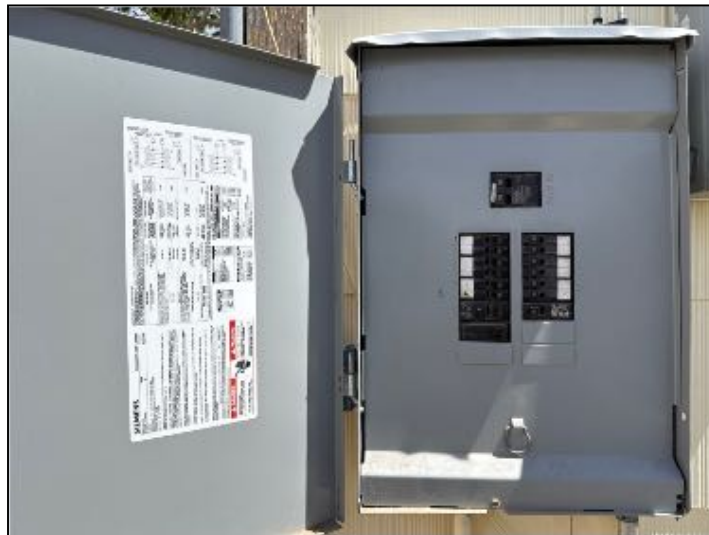
IMPROVE: Main Panel showed to be missing label. Recommend correction as to allow proper safety and function

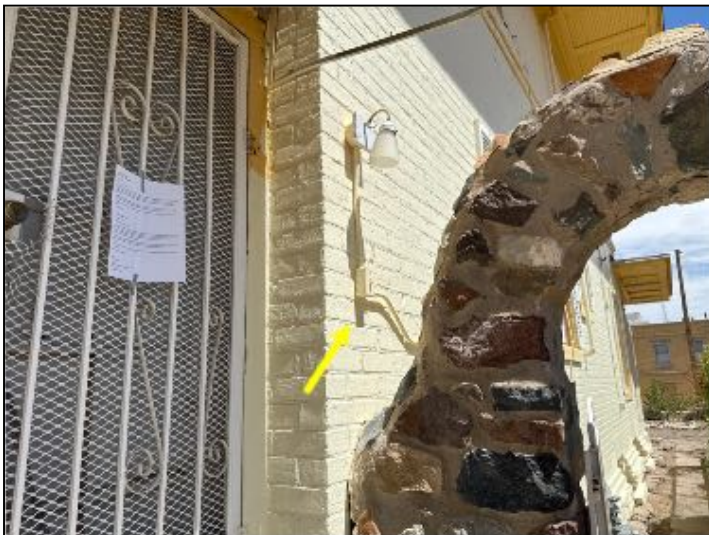
MAINTENANCE: Exterior switch was missing weather poof cover. Recommend correction

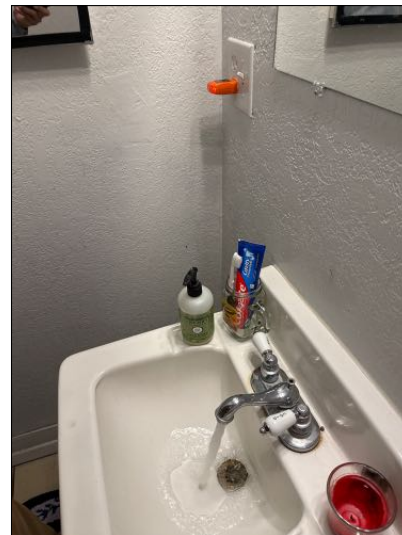
Bathroom outlets, not GFCI

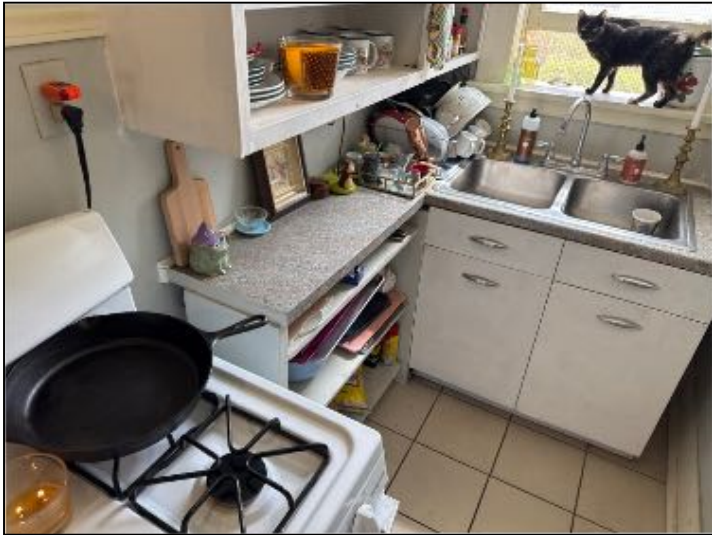
Outlets within 6 feet of kitchen sink, not GFCI

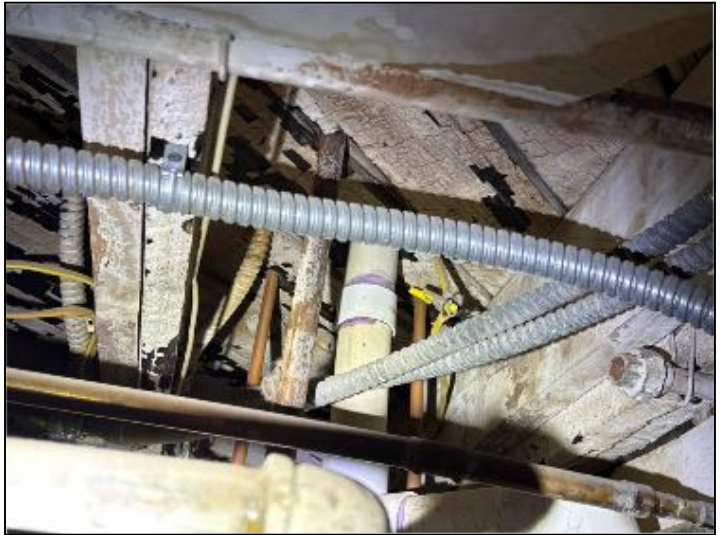
IMPROVE: Junction box was missing cover in basement . Recommend correction as to allow proper safety and function

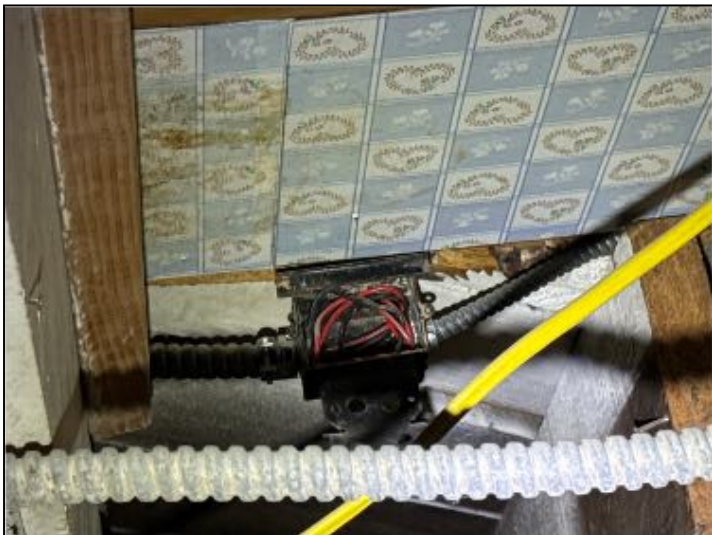
Another representative example of missing junction box cover in basement

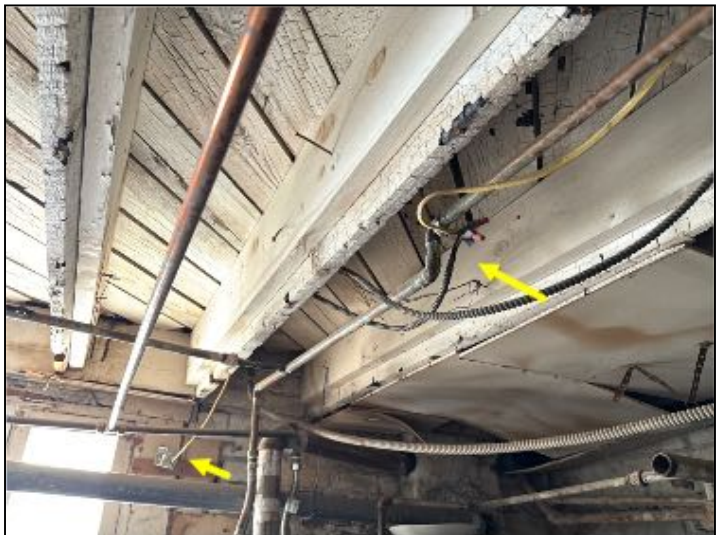
Another representative example of missing junction box cover in basement

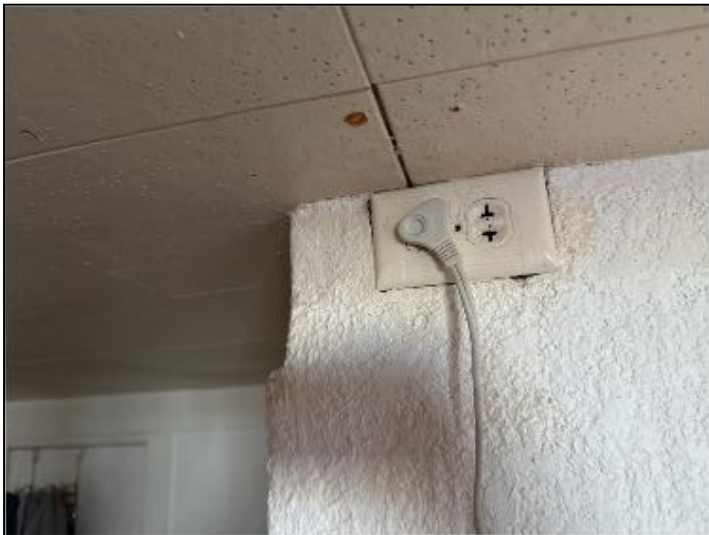
IMPROVE:"TWO-prong outlets" receptacles (no equipment ground) throughout structure. This is a common problem in a home of this age when 2-wire Romex is present without an equipment ground. Recommend further evaluation for different types of corrections and allow proper safety and function

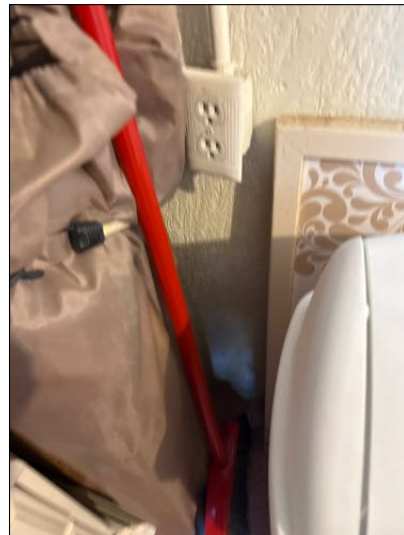
IMPROVE:Tamper resistant type receptacles less than five & one half feet above floor were not present throughout structure. Recommend placement.

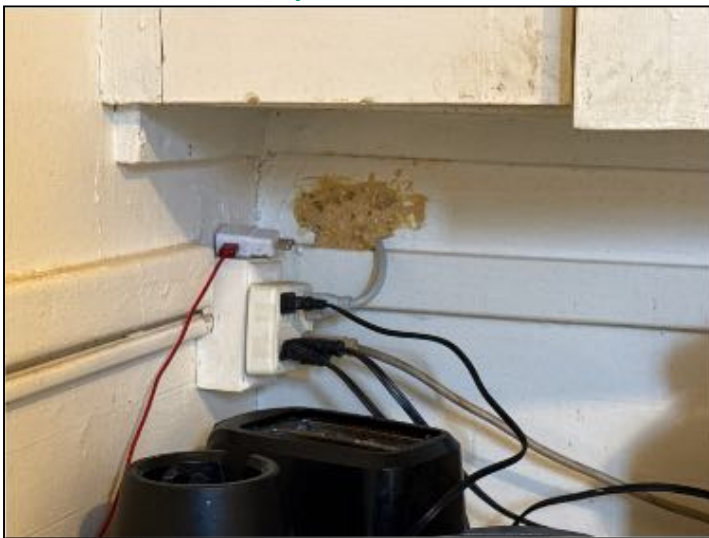
SAFETY CONCERN:Extension cord showed to be going through wall from unit 4 kitchen. Recommend correction with proper type wiring and conduit as to allow proper safety and function

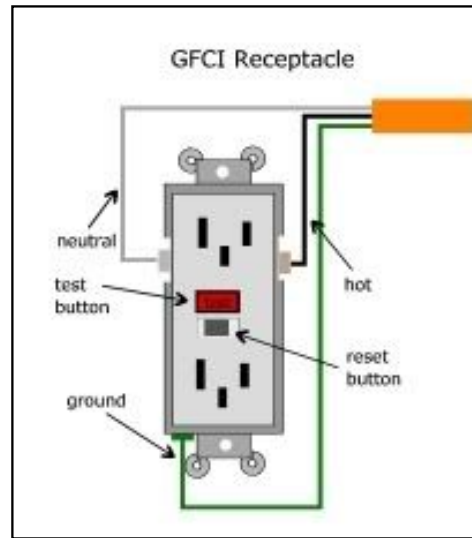
I=Inspected NI=Not Inspected NP=Not Present D=Deficient

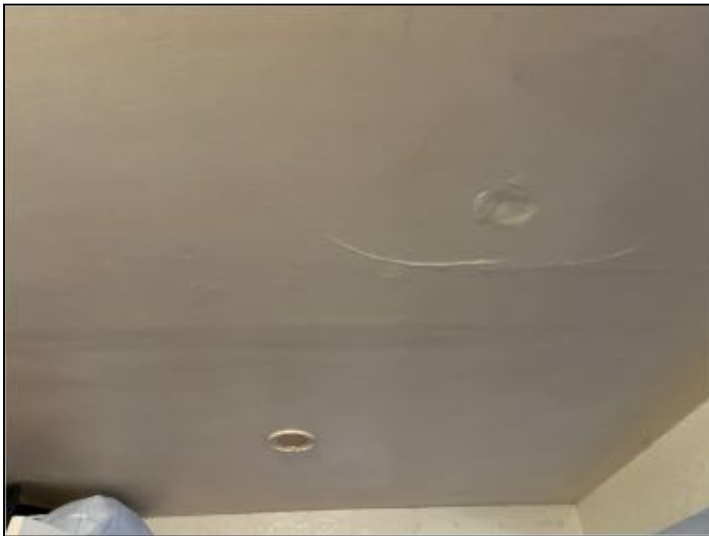
SAFETY CONCERN:Carbon detectors were missing in **hallways**. Recommend correction as to allow proper function: **all units**

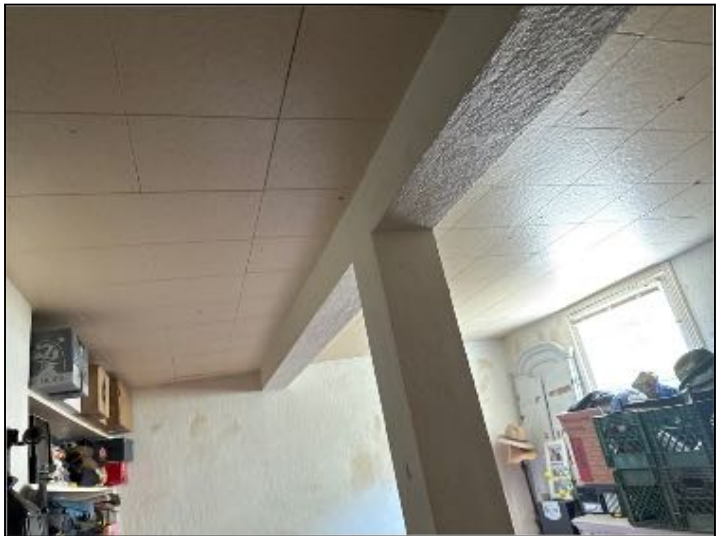
SAFETY CONCERN:Smoke detectors were missing in **Bedrooms**. Recommend correction as to allow proper function: **all units**

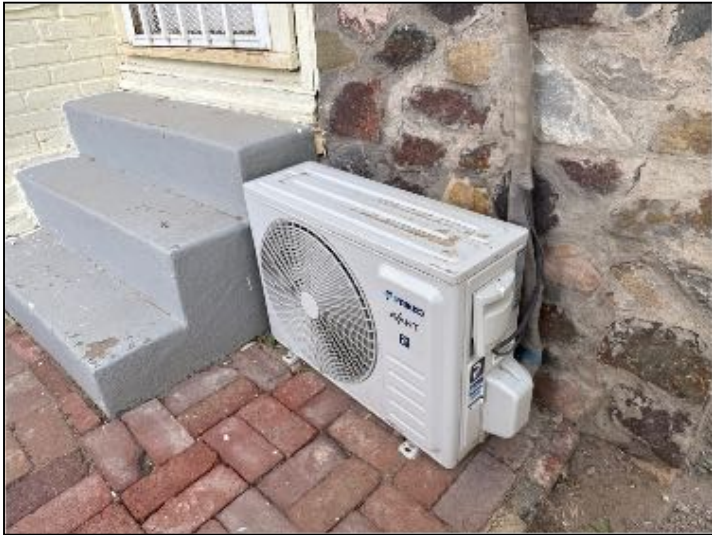
I	NI	NP	D
---	----	----	---

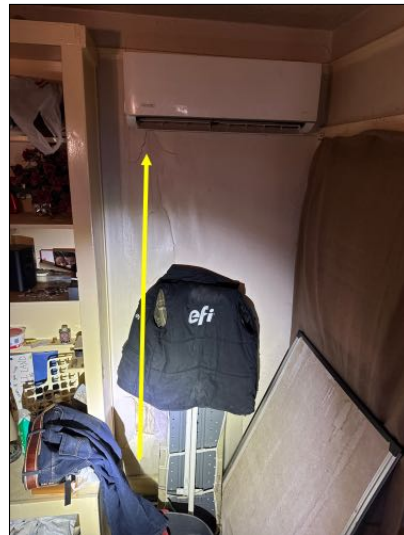
IMPROVE: unit 4 mini split showed to be leaking condensation into bedroom. Recommend correction.

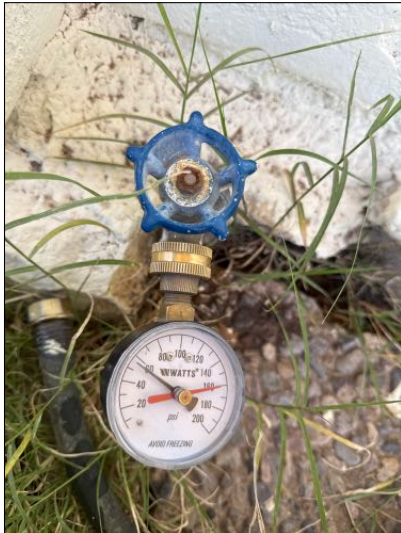
Static Water Pressure Reading: 60psi

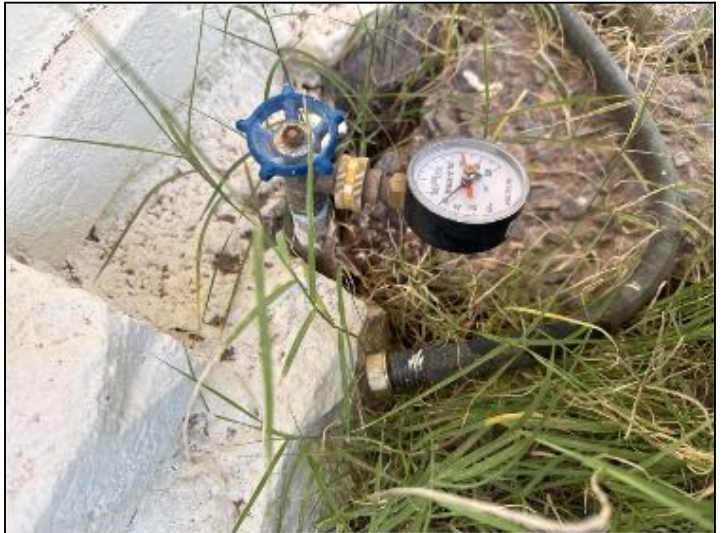
MAINTENANCE:Recommend back flow prevention nozzle on all exterior hose bibs

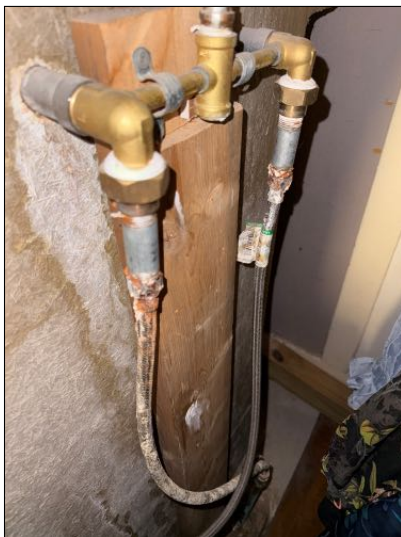
MAINTENANCE:Corrosion of water pipes in unit 3 bathroomseemed to be evident, recommend repair and or correction

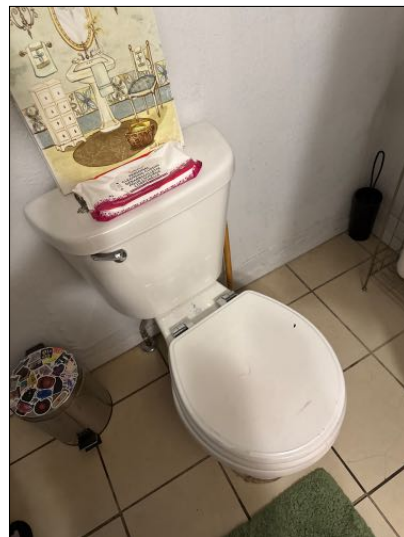
MAINTENANCE:Commode seemed to be loose from base. Recommend correction as to prevent water seeping onto floor: unit 3

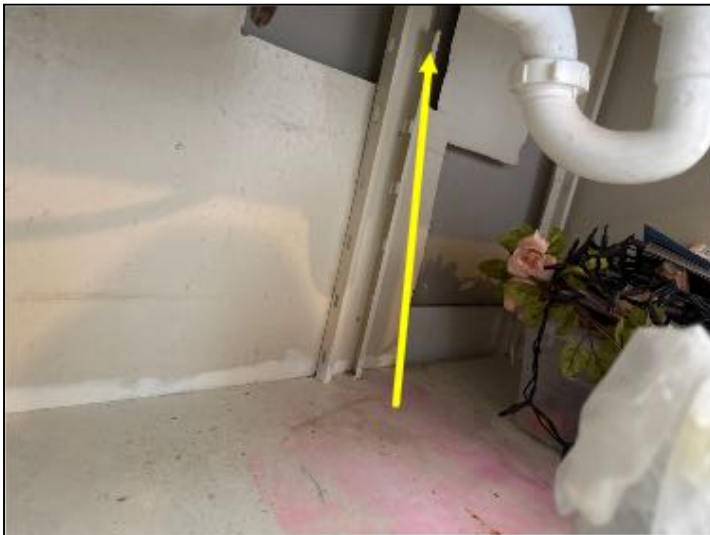
MAINTENANCE: Plumbing for **unit 3 kitchen sink** showed to be actively leaking, recommend correction as to prevent excess moisture.

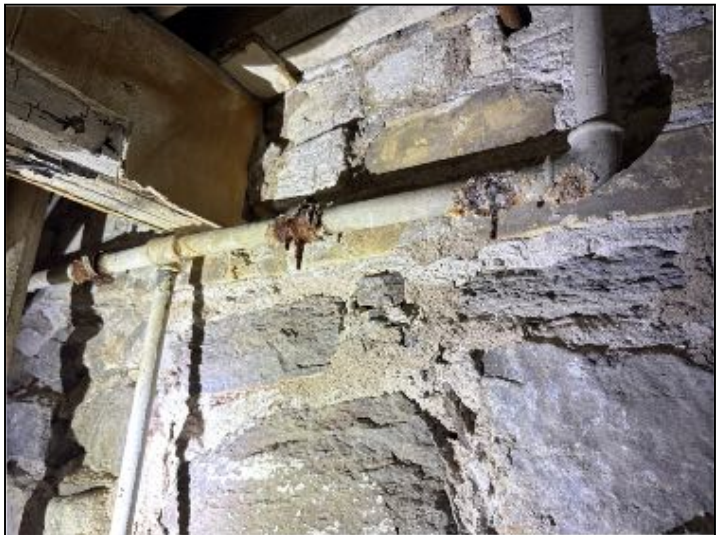
MAINTENANCE: Plumbing for **basement galvanized water line** showed to be actively leaking, recommend correction as to prevent excess moisture.

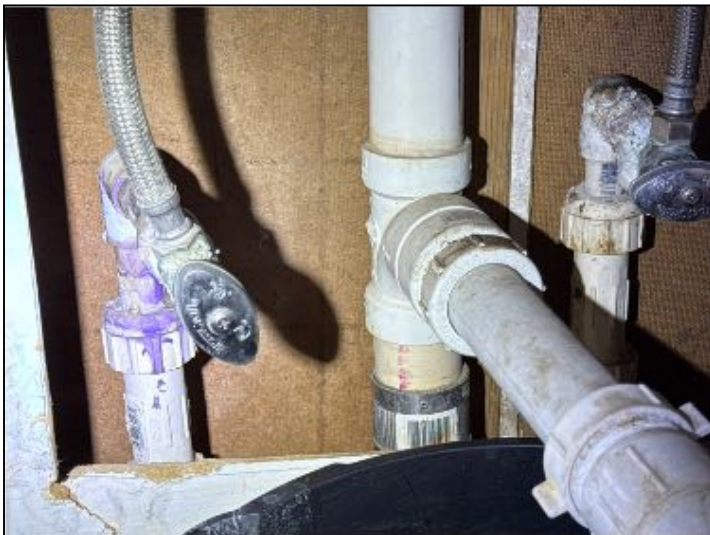
IMPROVE: unit 2 hot water supply showed to be using PVC. Recommend proper hot water type material.

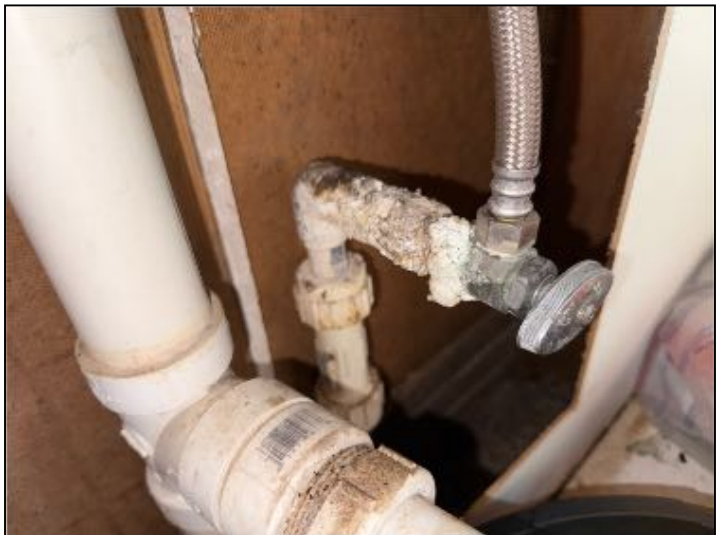
MAINTENANCE: Corrosion of water pipes in **unit 2 kitchen** seemed to be evident, recommend repair and or correction

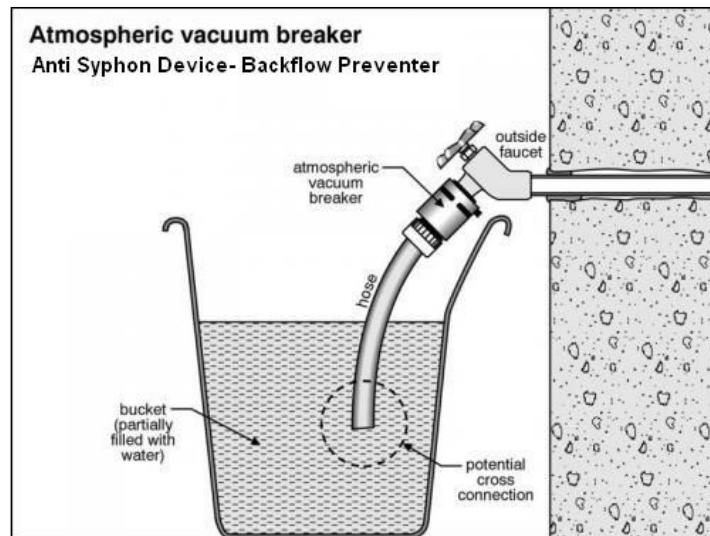
I	NI	NP	D
---	----	----	---

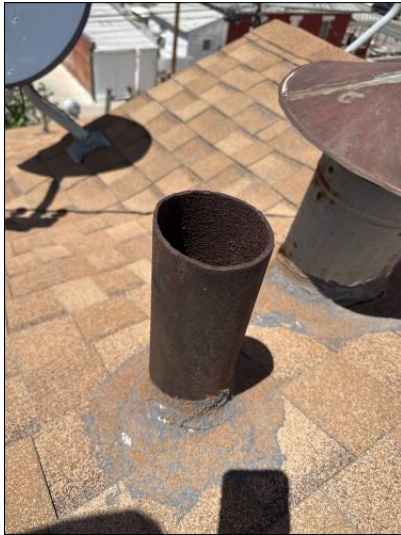
A sewer scope inspection was performed on the main laterals drain lines at the time of the inspection. One or more deficiencies were noted in the accompanying report, including **channeling of pipes, standing water**. Further evaluation and or repairs by a plumber are advised.

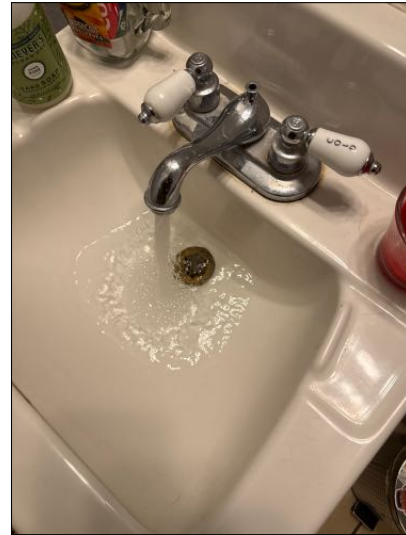
MAINTENANCE:unit 3 bathroom sink plumbing drained slow, recommend repair and or correction

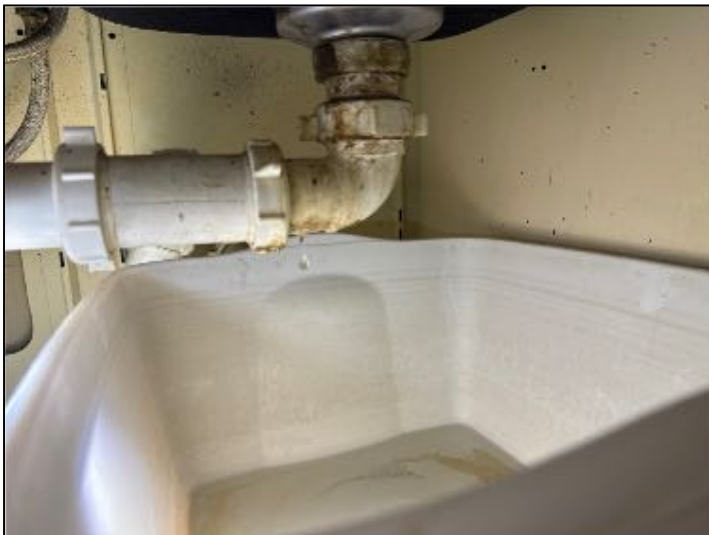
MAINTENANCE:Plumbing for unit 5 kitchen sink was leaking, recommend correction as to prevent damage, excessive moisture.

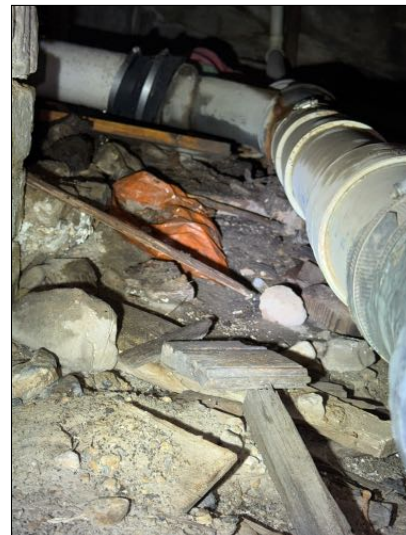
MAINTENANCE:Plumbing for back crawlspace was leaking, recommend correction as to prevent damage, excessive moisture.

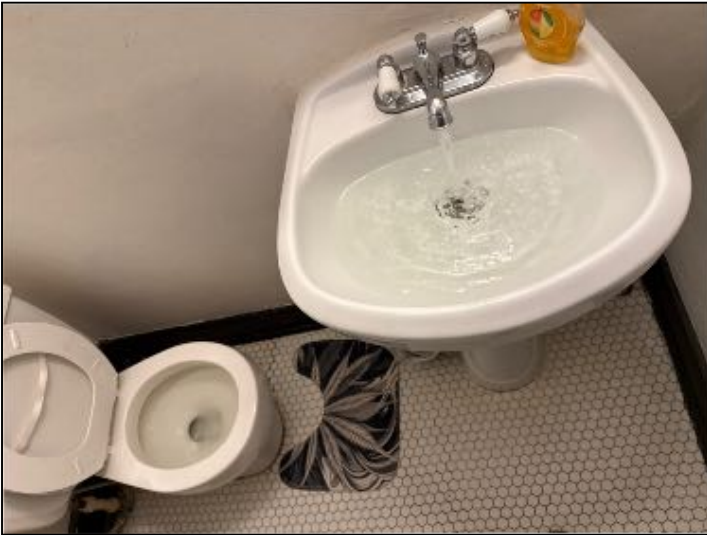
MAINTENANCE:unit 1 bathroom sink plumbing drained slow, recommend repair and or correction

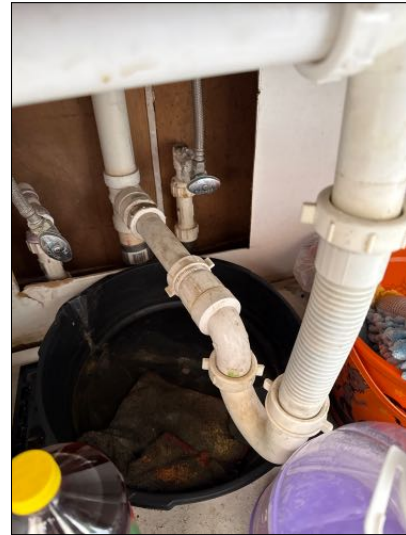
MAINTENANCE:Plumbing for unit 2 kitchen sink was leaking, recommend correction as to prevent damage, excessive moisture.

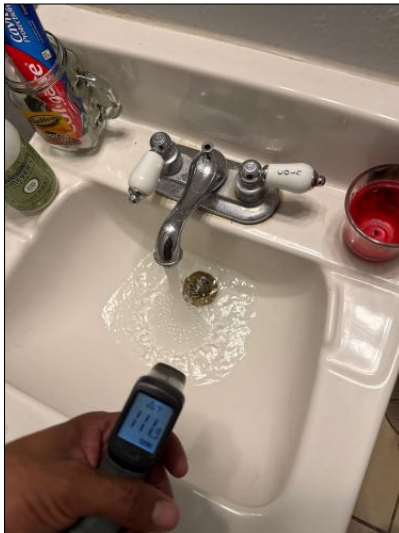
Water heater was functional as need be

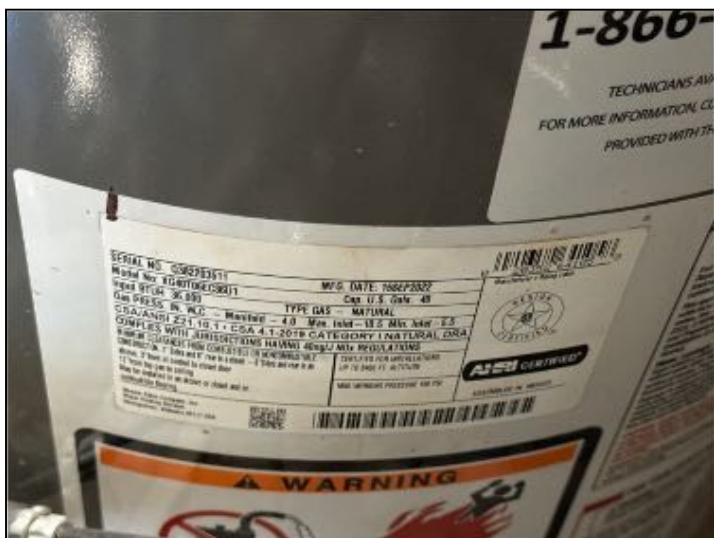
Water heater information plate: 40gal 2022

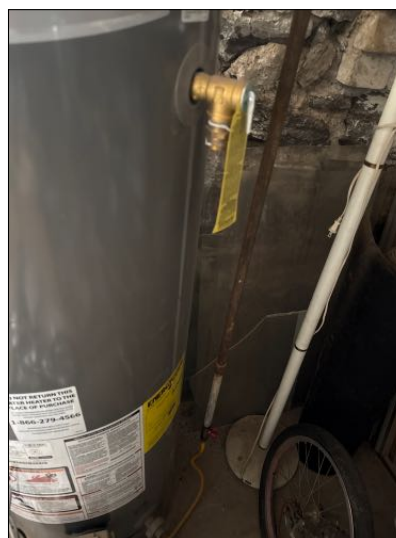
MAINTENANCE: Temperature relief valve didnt seem to be exiting toward exterior. As such, may cause damage to base and floors. Recommend correction and or the switching over to a watts 210 system with proper regulation.

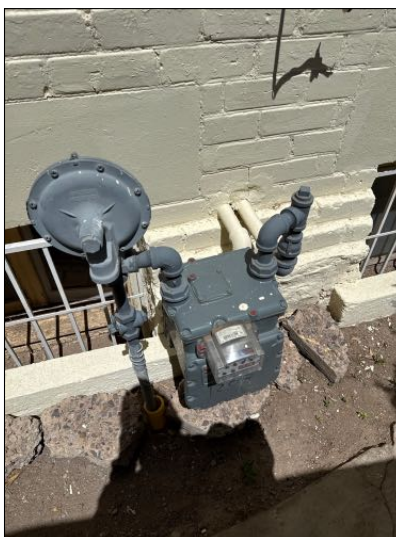
Location of Gas Meter: South W.
Type of Gas Distribution Piping Material: Rigid Steel Pipe

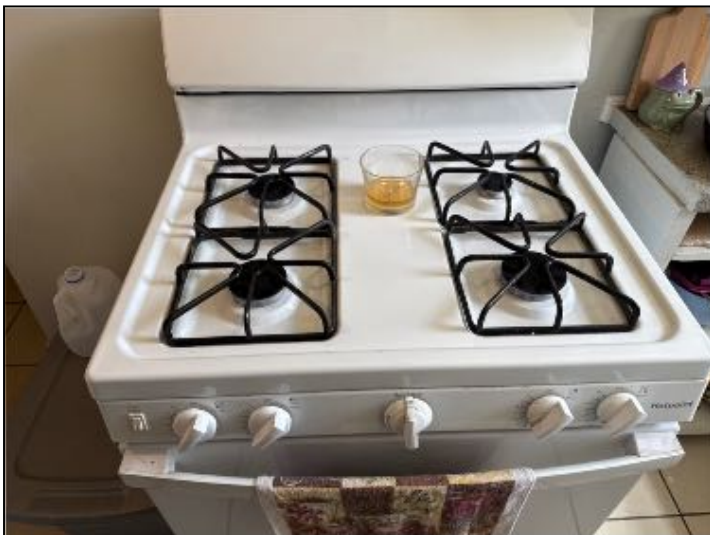
Unit operated normally (cook top): unit 3

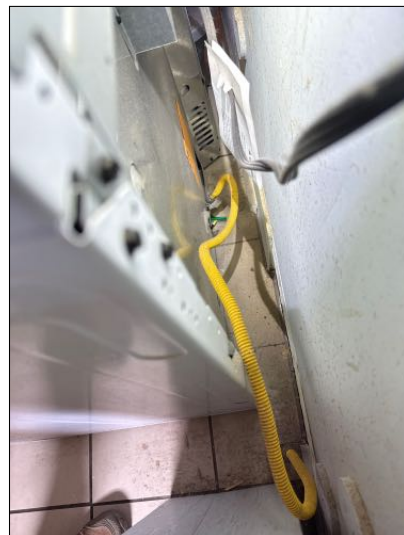
SAFETY CONCERN:Missing anti-tip devise, may result in injury from range tipping over, recommend installation: All units

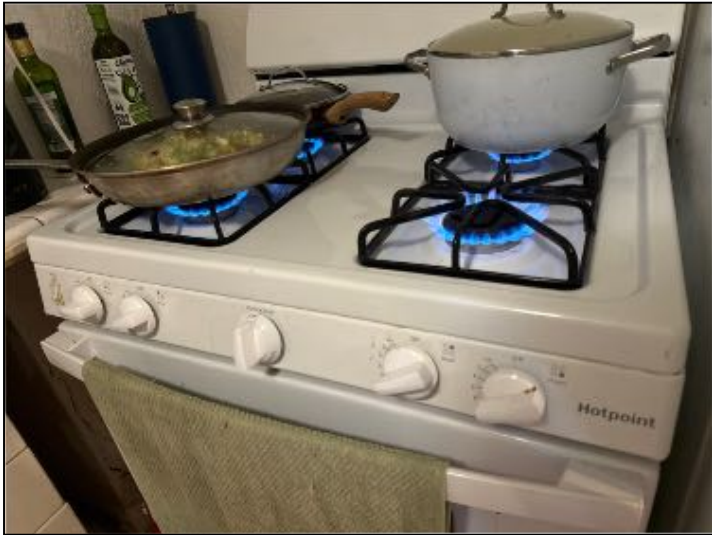
Unit operated normally (cook top): unit 5

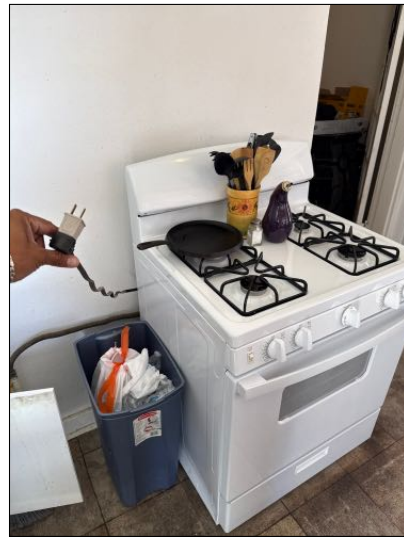
MAINTENANCE: Stove top: burners did not ignite with switch. Due to missing nearby outlet, recommend correction.: unit 2

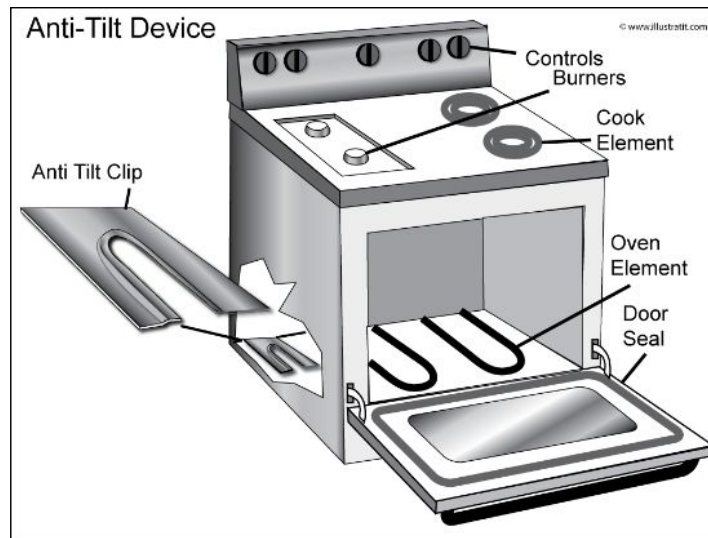
I	NI	NP	D
---	----	----	---
