Restoration & Rehabilitation

3821-3823 West 13th Street, Little Rock (Pulaski County), Arkansas 72204

Historic Structure Report

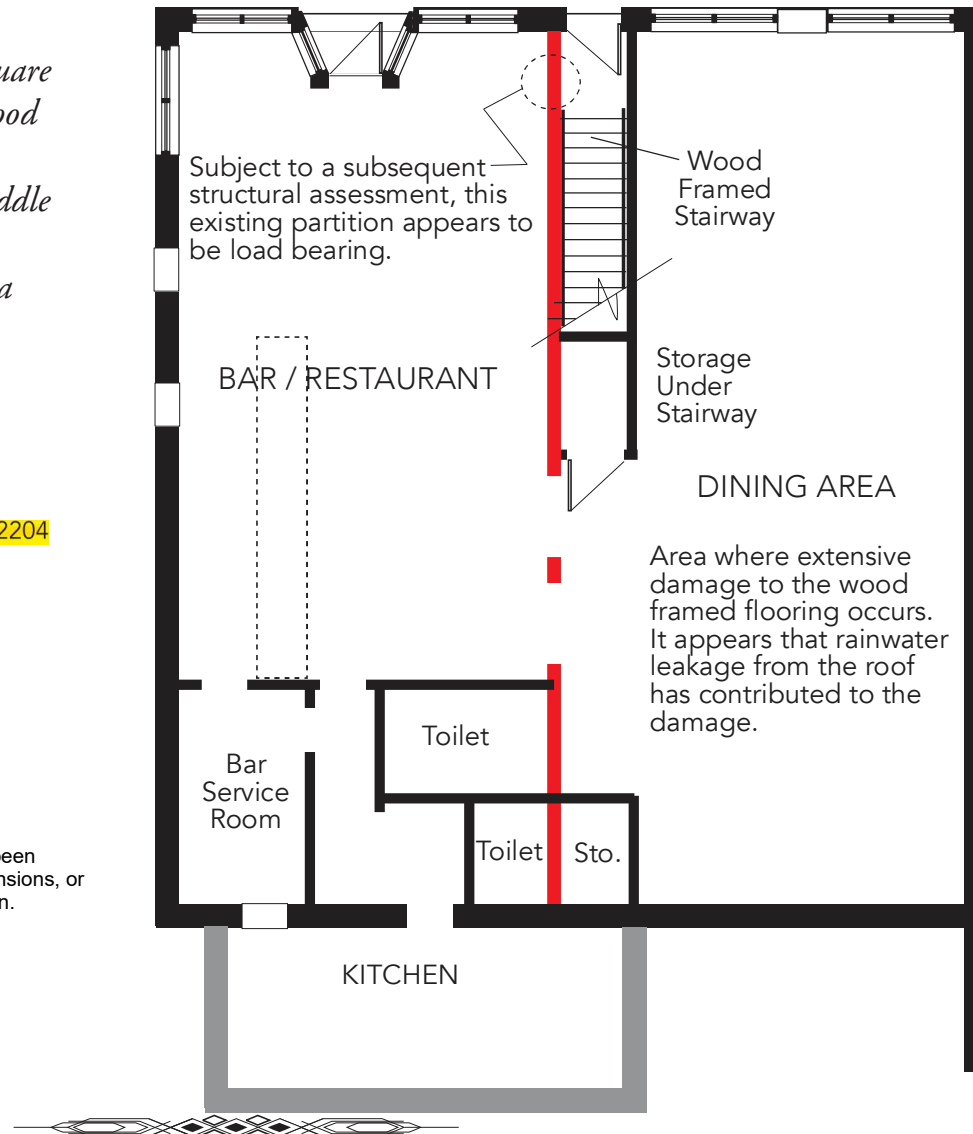
38 Existing Ground Floor Plan
June 7, 2021

.....the existing ground floor covers approx. 2,250 square feet above a structural wood framed crawl space. A wood plank floor finish occurs and the walls and ceiling are cement plastered on wood lath. It appears that the middle span (north / south) partition on the west side of the existing stairway is load bearing - to be confirmed by a subsequent structural engineer's assessment.

Enclosed door opening to now demolished balcony

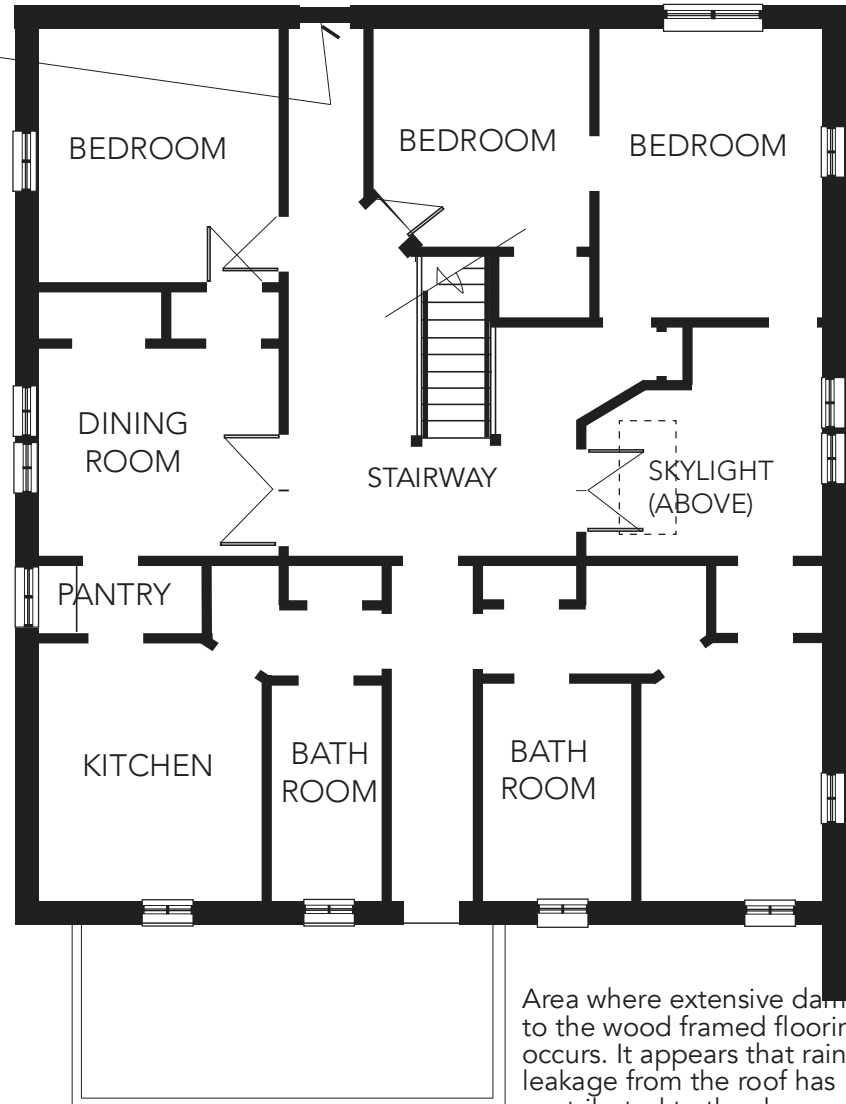
39 Existing Upper Floor Plan
June 7, 2021

.....the existing upper floor covers approx. 2,250 square feet onto a structural wood framed floor system. A wood plank floor finish occurs and the walls and ceiling are cement plastered on wood lath.

Existing windows blocked by Lee Theater brick wall

Area where extensive damage to the wood framed flooring occurs. It appears that rainwater leakage from the roof has contributed to the damage.
