# WOOD DESTROYING PESTS AND ORGANISMS INSPECTION REPORT

| Building No.<br>1262 | Street<br>N. Marks Avenue | City<br>Fresno | ZIP<br>93722 | Date of Inspection<br>06/22/2026 | Number of Pages<br>5 |
| GENERAL DESCRIPTION:<br>Single-level stucco apartments with a composition roof | | | | Inspection Tag Posted:<br>Water heater<br>Other Tags Posted: | |

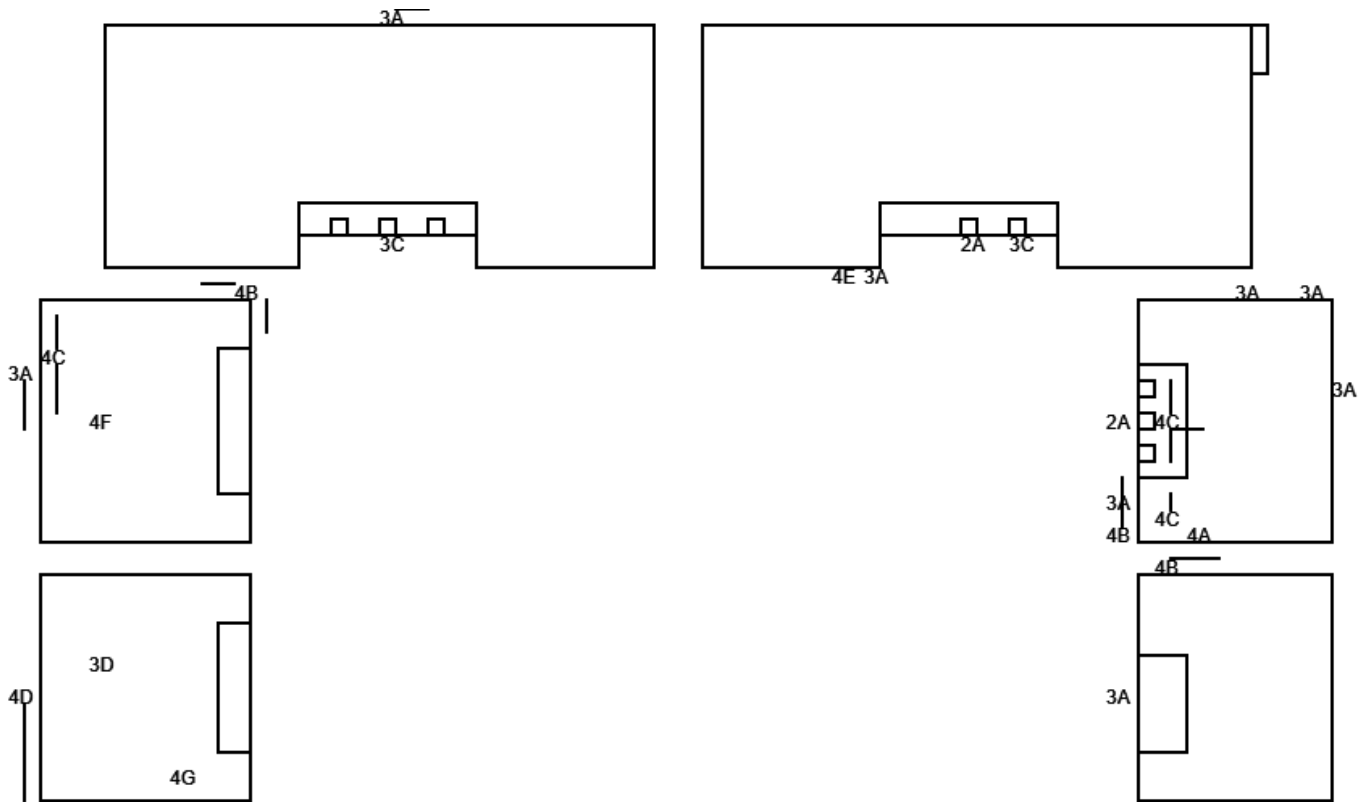
**Diagram Not To Scale**

**FINDING** - Evidence of drywood termites noted to the post bottom and decor wood.

**FINDING** - Fungus damage noted to the fascia at area(s) indicated in the diagram.

**FINDING** - Fungus damage noted to the post bottom at area(s) indicated in the diagram.

**FINDING** - Fungus damage noted to the kitchen sink cabinet at area(s) indicated in the diagram.

FINDING - Faulty grade level at area(s) indicated in the diagram.

**RECOMMENDATION** - Vacate premises and seal the structure. Fumigate with Vikane gas (active ingredient; sulfuryl fluoride), Chlorpicrin (active ingredient; chlorpicrin, used as a warning agent with Vikane fumigant). For the extermination of dry wood termite infestations, remove seals and air outbuilding ready for occupancy. The fumigant can not be done in strong winds and will be rescheduled if there is inclement weather. Back Off Bugs will not be liable for damage to plants, paints, roofs, or TV antennas. Reasonable care will be exercised. There is a 72hour (excluding weekends and holidays) advance cancellation notice. If the job is canceled after the 72hour period, there will be a \$200.00 cancellation fee. Please see the occupants' fumigation notice for further instructions. Notice: The charge for services that this company subcontracts to another person or entity may include the company's charges for arranging and administering such services that are in addition to the direct costs associated with paying the sub-contractor. In conjunction with fumigation, mask, or remove all accessible termite pellets to facilitate further inspections.

**RECOMMENDATION** - Remove and replace damaged wood and/or gauge and patch as needed at area(s) indicated on the diagram. Primed and ready for paint.

RECOMMENDATION - Remove and replace damaged wood and/or gauge and patch as needed at area(s) indicated on the diagram. Primed and ready for paint.

RECOMMENDATION - Lower grade level as needed.
