**REMOVAL PROGRAM
PRELIMINARY ASSESSMENT/
SITE INVESTIGATION REPORT
FOR THE
ATLAS TACK SITE
FAIRHAVEN, BRISTOL COUNTY, MASSACHUSETTS
10 DECEMBER 2025**

Weston Solutions, Inc.
Region I
Superfund Technical Assessment and Response Team
101 Billerica Avenue, Building 5, Suite 103
North Billerica, Massachusetts 01862

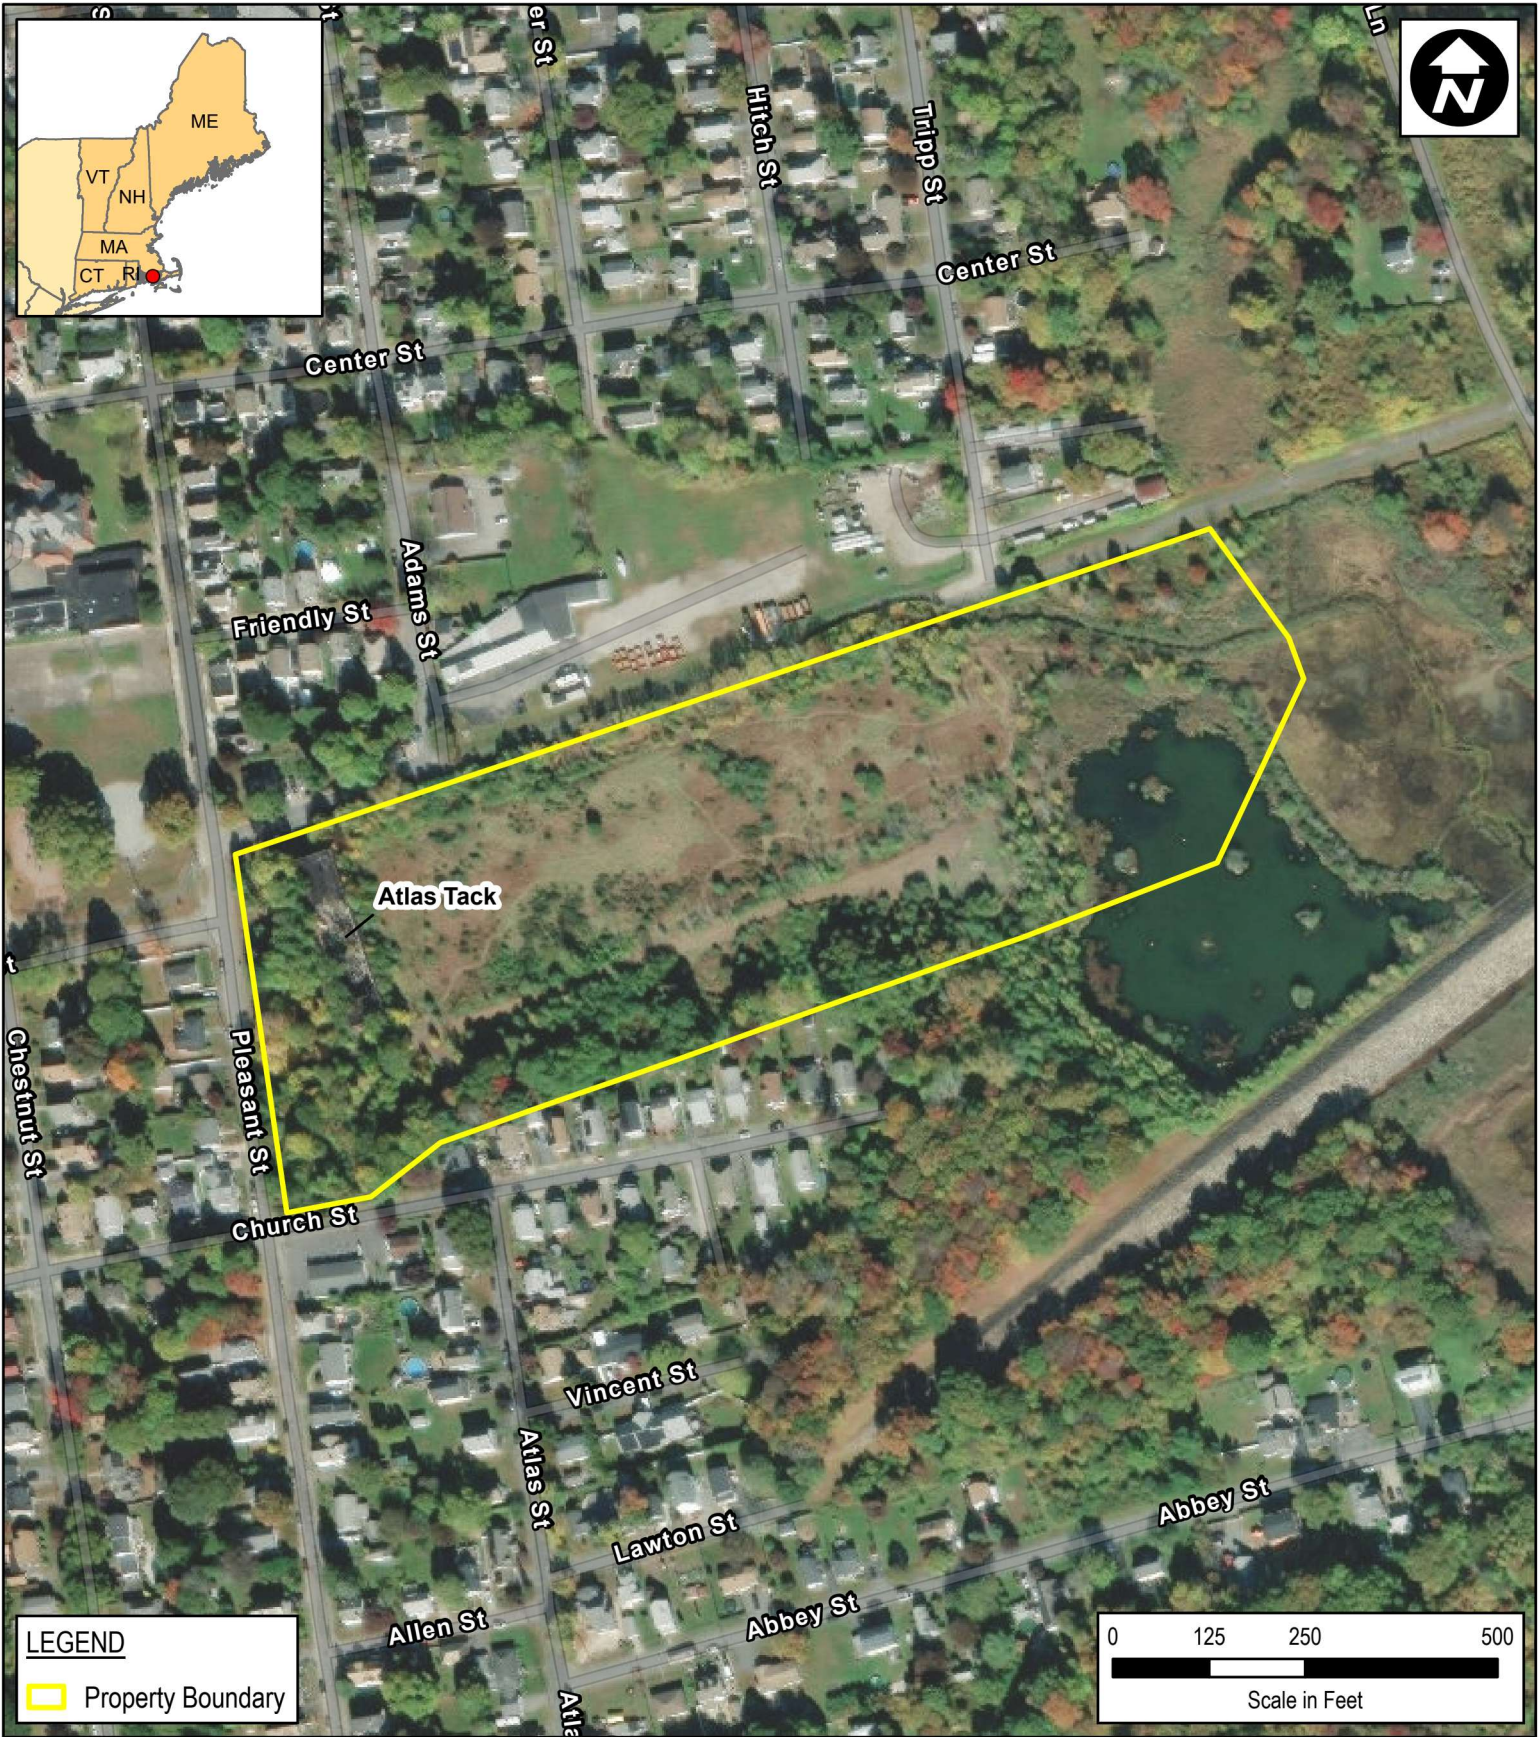
Figure 2

Site Diagram

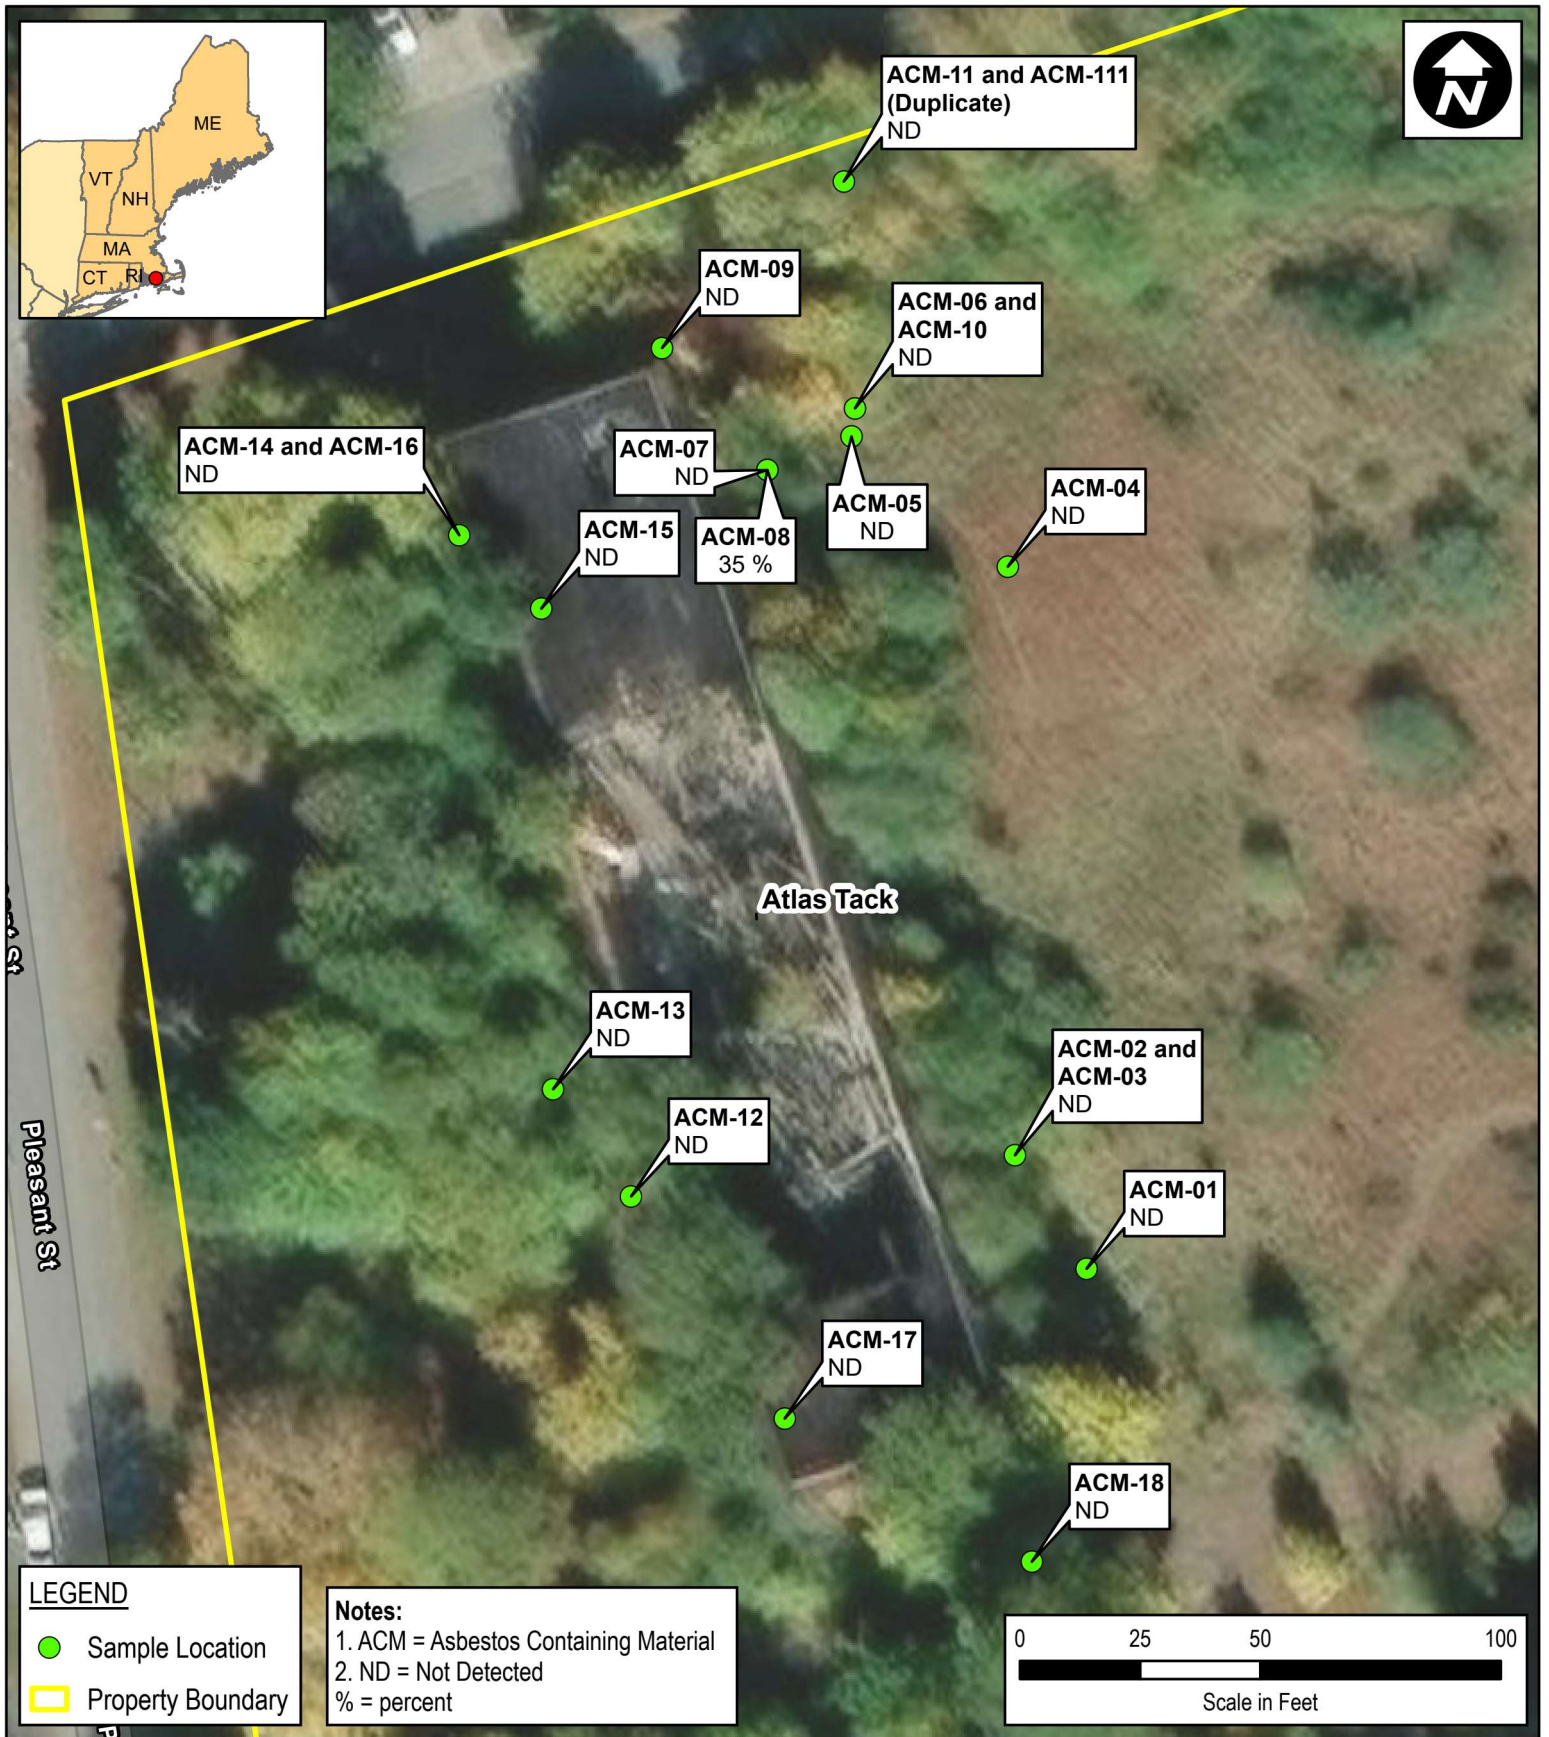
Figure 3
Sample Location Map

START collected a total of 19 samples of potential ACM debris (ACM-01 through ACM-18), including one field duplicate (ACM-111), from around the dilapidated building structure. A summary of sample locations and descriptions is shown in Appendix A, Figure 3 and Appendix B, Table 1.

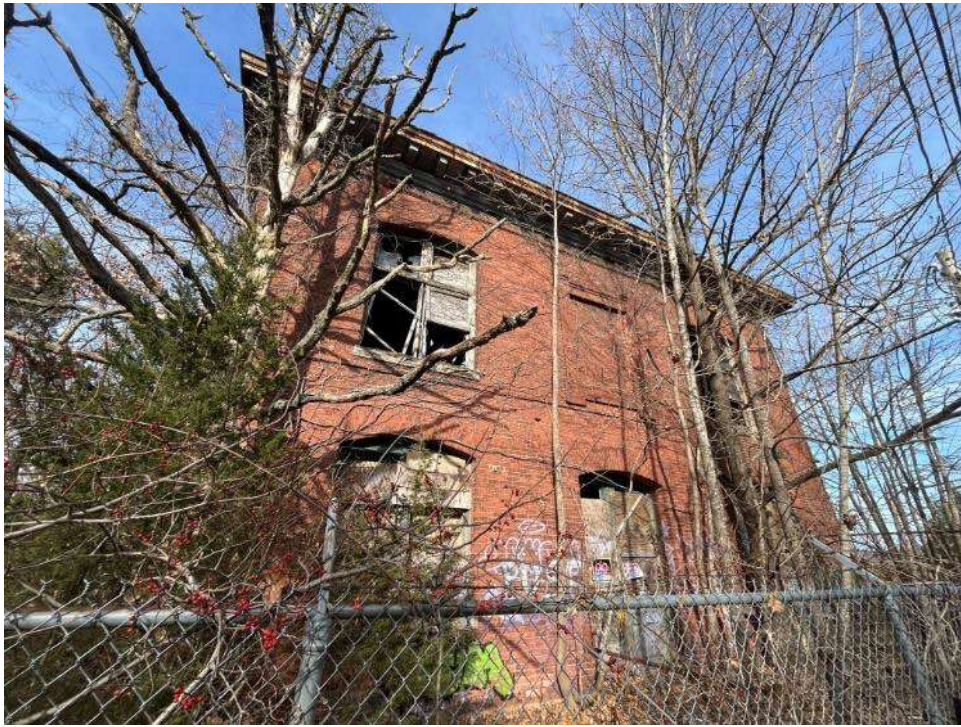
SCENE: View of the south side of the dilapidated Atlas Tack building. Photograph taken facing north.

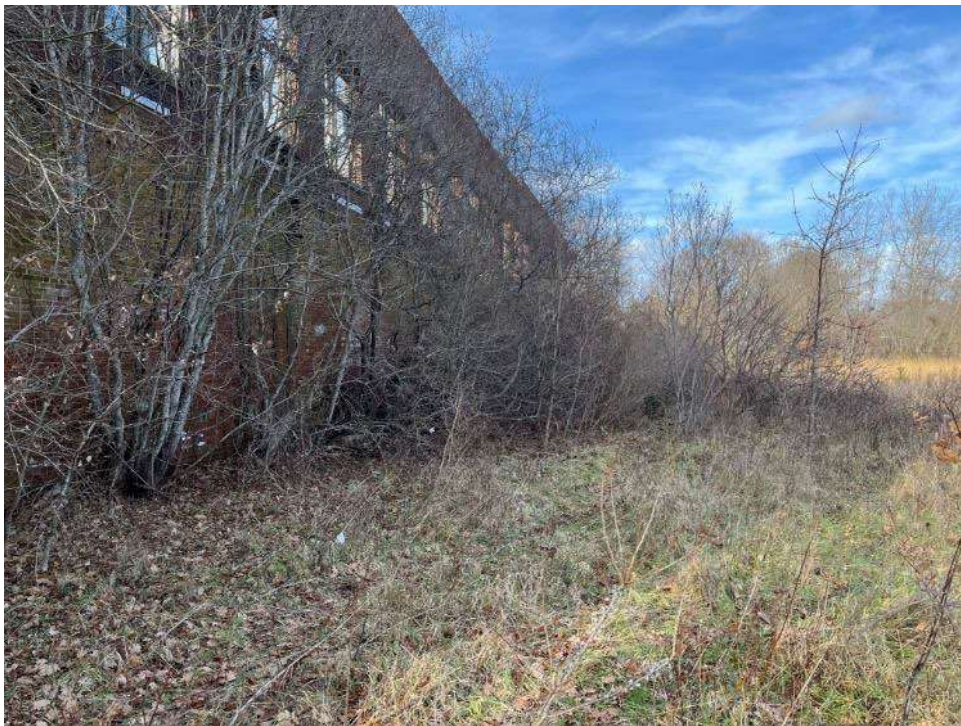
SCENE: View of the southeast corner of the building, where debris samples ACM-01, ACM-02, and ACM-03 were collected. Photograph taken facing northwest.

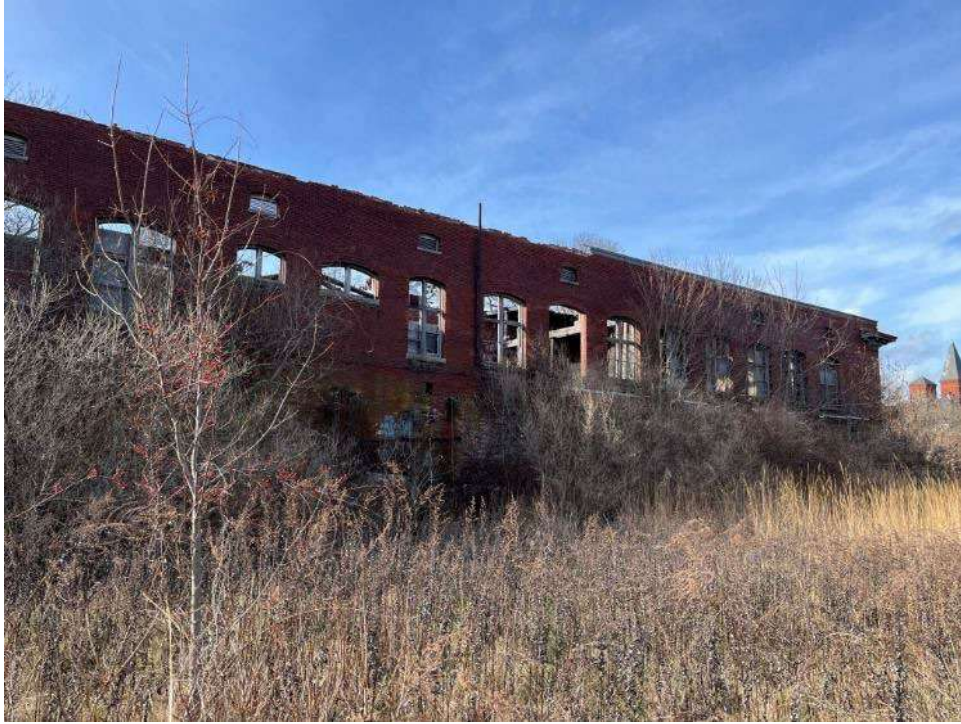
A dilapidated two-story brick building currently remains on the western portion of the Atlas Tack property. As of January 2025, the majority of the roof had collapsed into the two-story building. A small metal shed is located along the southern boundary of the Commercial Area.

SCENE: View of the portion of the Atlas Tack building with a collapsed roof. Photograph taken facing northwest.

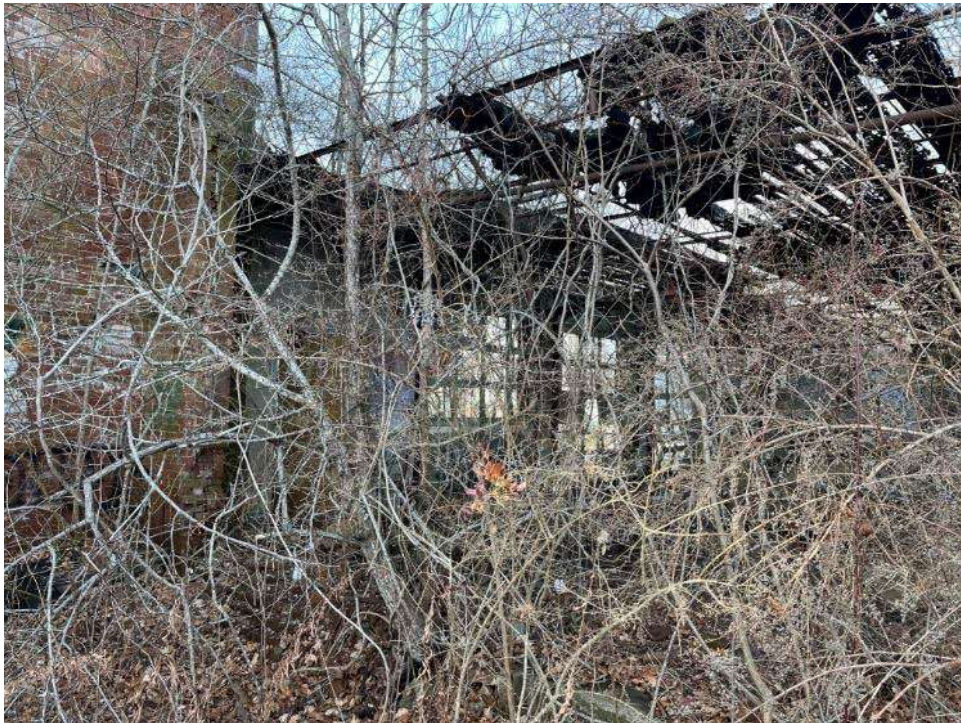
SCENE: View of a deteriorating steel-roofed building where samples ACM-05, ACM-06 and ACM-10 were collected. Photograph taken facing west.

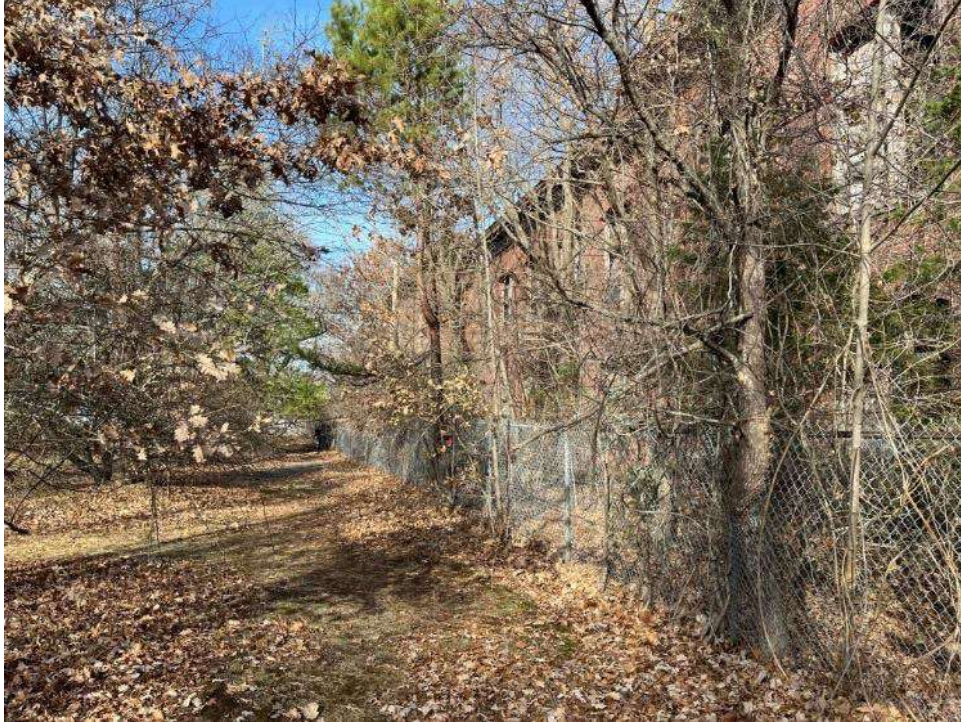
Local Fire and Police Departments have reported trespassing on the property despite the security fencing surrounding the Site.

SCENE: View of the security fence on the west side of the Atlas Tack building. Photograph taken facing north.

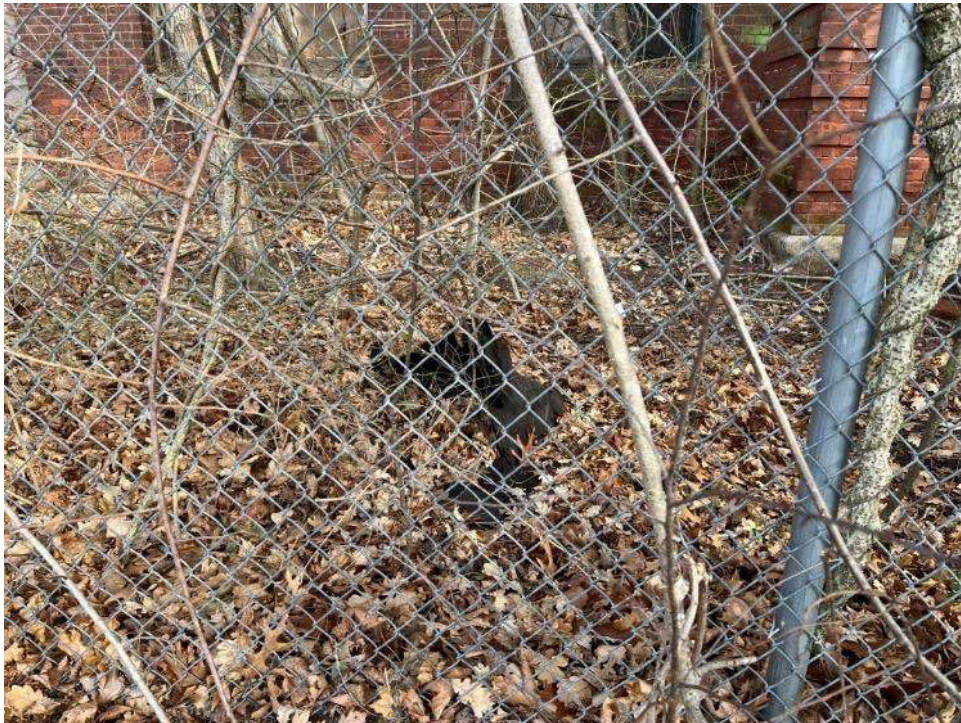
SCENE: View of the green shingles/roofing collected as sample ACM-13. Photograph taken facing east.
