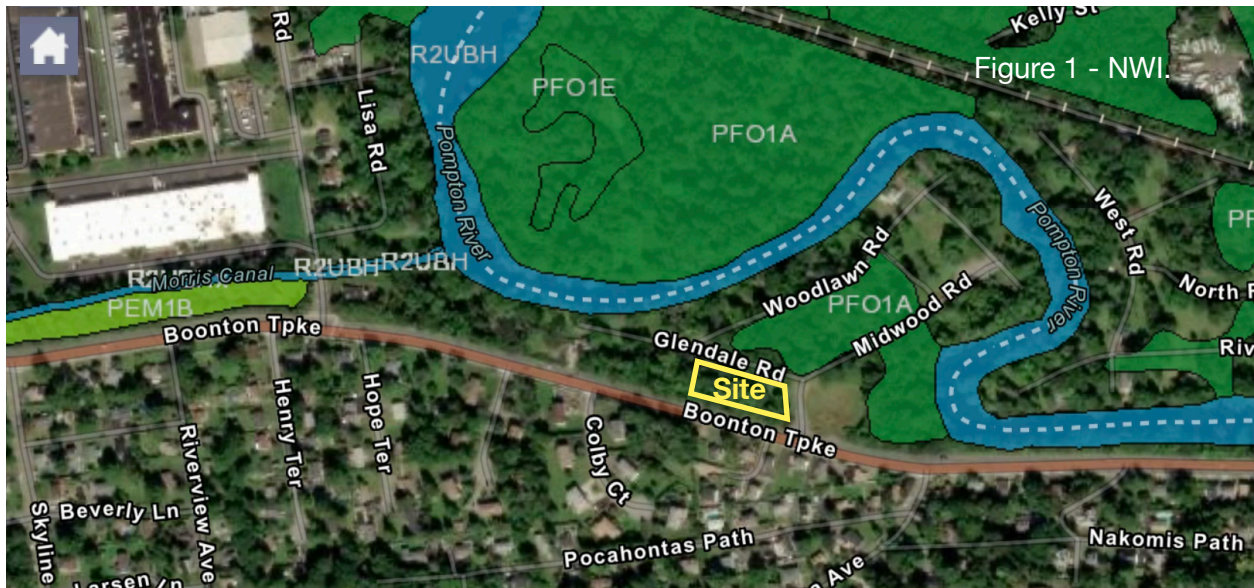
Let me begin with the National Wetland Inventory (NWI) map (Figure 1) for a pretty large areas around the subject Site. My choice here is to get right down to business and show you not only the location but the surroundings with respect to the river and roadways in the area. I have marked the Site on the NWP map. As you can see, there is no wetland shown for the Site. Next is the NJDEP version (Figure 2) and both require comment and interpretation and both maps show wetlands very near. In addition to the wetlands there is also a transition area (buffer) from the wetland. We assume the buffer here will be 50 feet but you will not know for sure until the LOI is actually granted; it could be 150 feet but that is

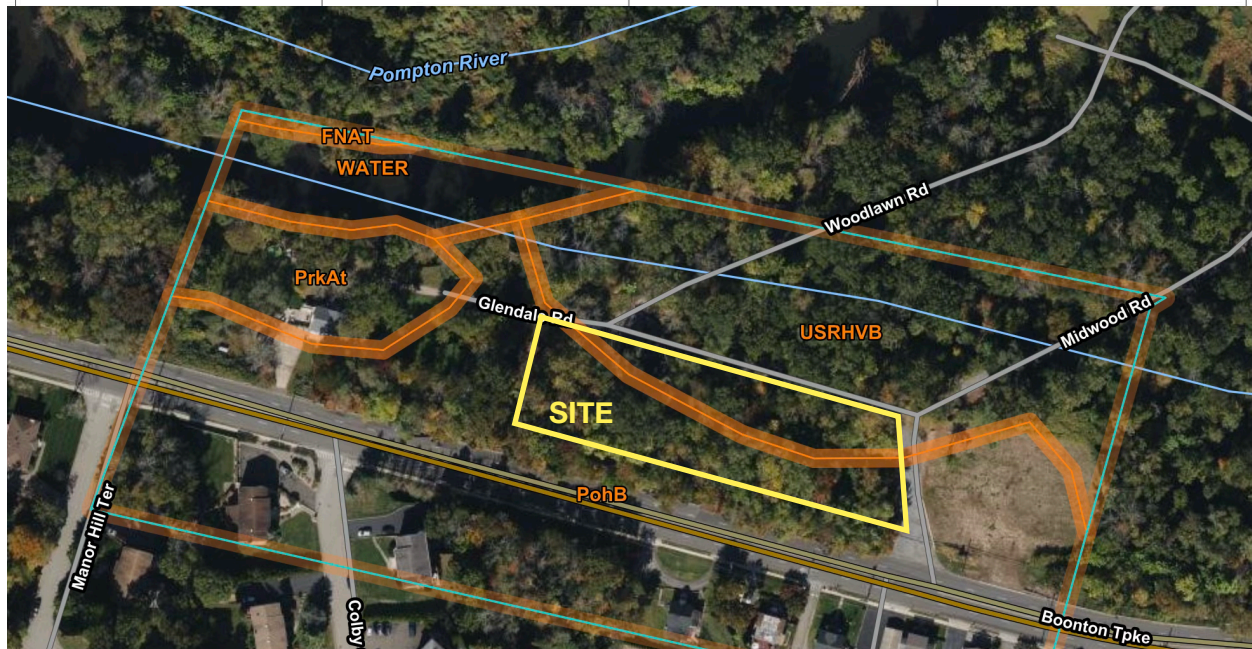
Figure 3 - Soil Survey Summary

The Soil Survey is shown below and the Site is mostly Pompton sandy loam according to the County Soil Survey and is not a hydric soil; this matches our field review findings. There is more of this Series than shown on the map, almost all of the Site is Pompton sandy loam, only a tiny amount at the roadway seems to be The Urban land complex. The Urban land-River head complex is a complicated, man-made soil and some of holds tiny isolated wetland vegetation on the site - however, the spots are isolated and can be filled by permit in accordance with the regulations. Almost all of the Site is a few feet higher than the Glendale Road. With respect to the soils and vegetation one can be optimistic.

Map Unit Symbol	Map Unit Name	Acres in AOI	Percent of AOI
PohB	Pompton sandy loam, 3 to 8 percent slopes	6.8	58.1%
PrkAt	Preakness sandy loam, 0 to 3 percent slopes, frequently flooded	0.8	7.0%
USNESB	Urban land-Neshaminy complex, 0 to 8 percent slopes	0.0	0.1%
USRHVB	Urban land-Riverhead complex, 3 to 8 percent slopes	3.2	27.7%
WATER	Water	0.8	6.8%

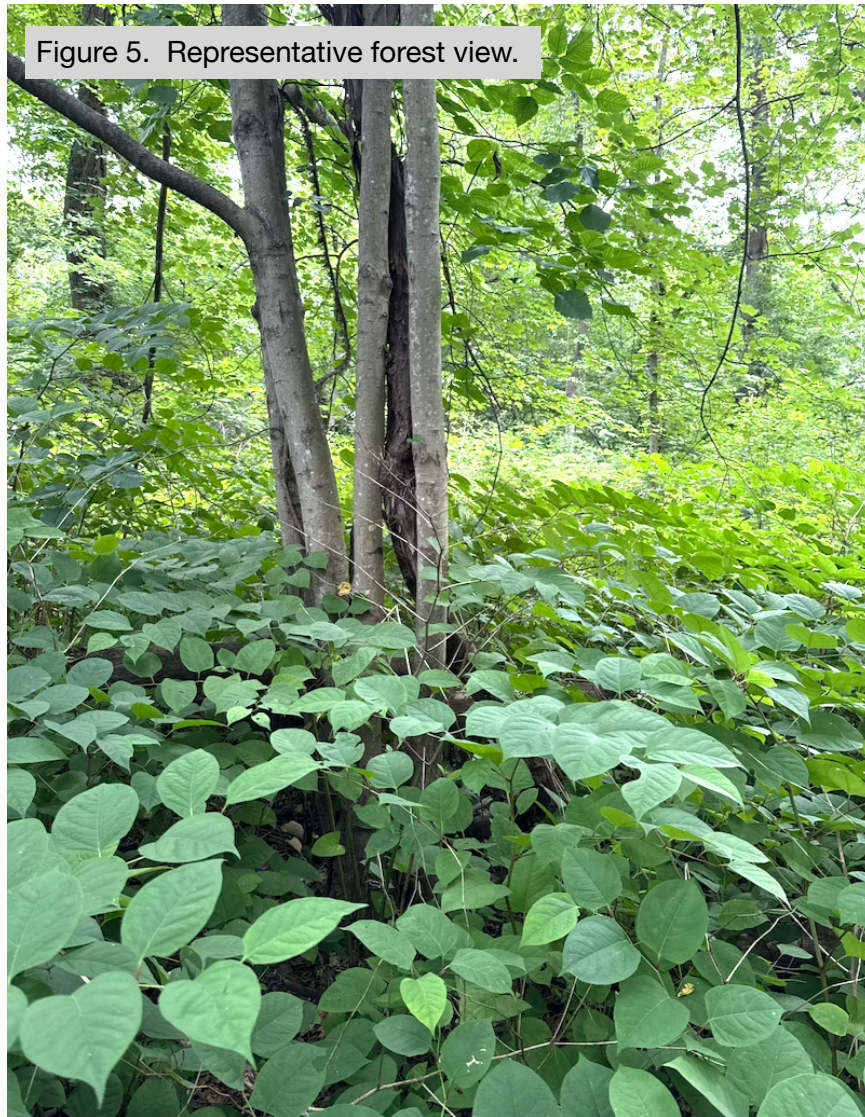
If you have seen this photo you have essentially seen it all. The beautiful but, invasive, Mexican Cane species and upland trees such as American Elm provide the greatest amount of land cover on Site.

Figure 5. Representative forest view.
