# SOIL SCAN REPORT

**Maiden Tire and Wheel**

15 N Carolina Ave, Maiden,  
North Carolina, 28650

Customer wanted to know if an old fuel storage tank has been removed or not.

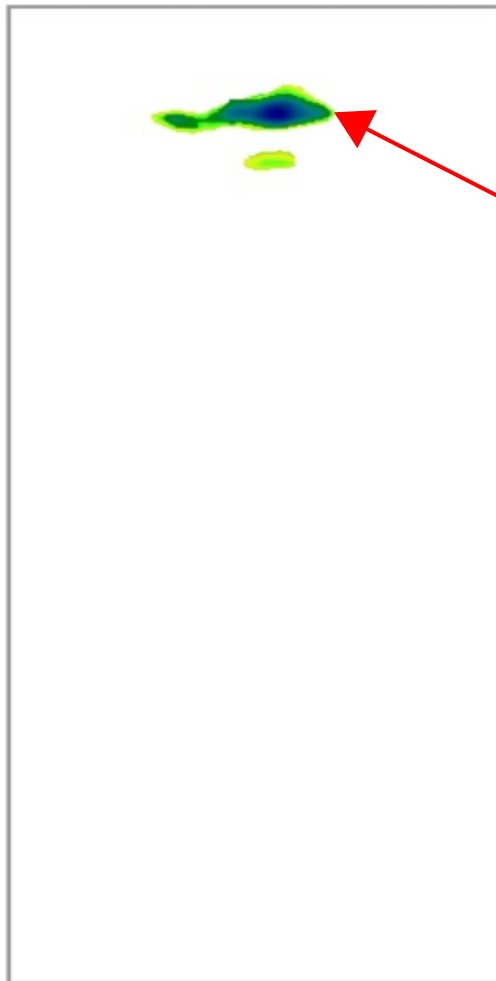
### Scan in front of the building - side view

Utility Line, small soil disturbance and undisturbed soils

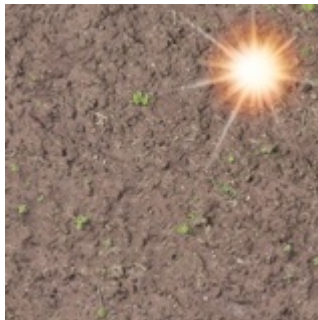
## Soil Type Information

| <b>Soil Type:</b> | Unknown dry |
| <b>Dielectric Constant:</b> | 5.00 |
| <b>Relative Permeability:</b> | 7.75 |
| <b>Mineralization:</b> | 25 % |
| <b>Humidity:</b> | 10 % |
| <b>Homogeneity:</b> | 79 % |

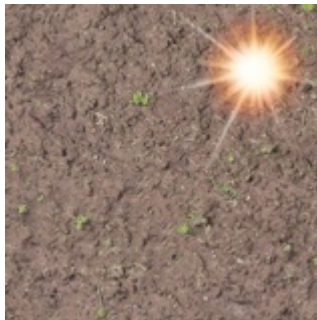
## Soil Type Information

| <b>Soil Type:</b> | Unknown dry |
| <b>Dielectric Constant:</b> | 5.00 |
| <b>Humidity:</b> | 10 % |
