**SECTION 404  
JURISDICTIONAL DELINEATION  
SANDHU LOGISTICS PROPERTY  
ALVIN, BRAZORIA COUNTY, TEXAS  
HJN 25033.001JD**

**21 MARCH 2025**

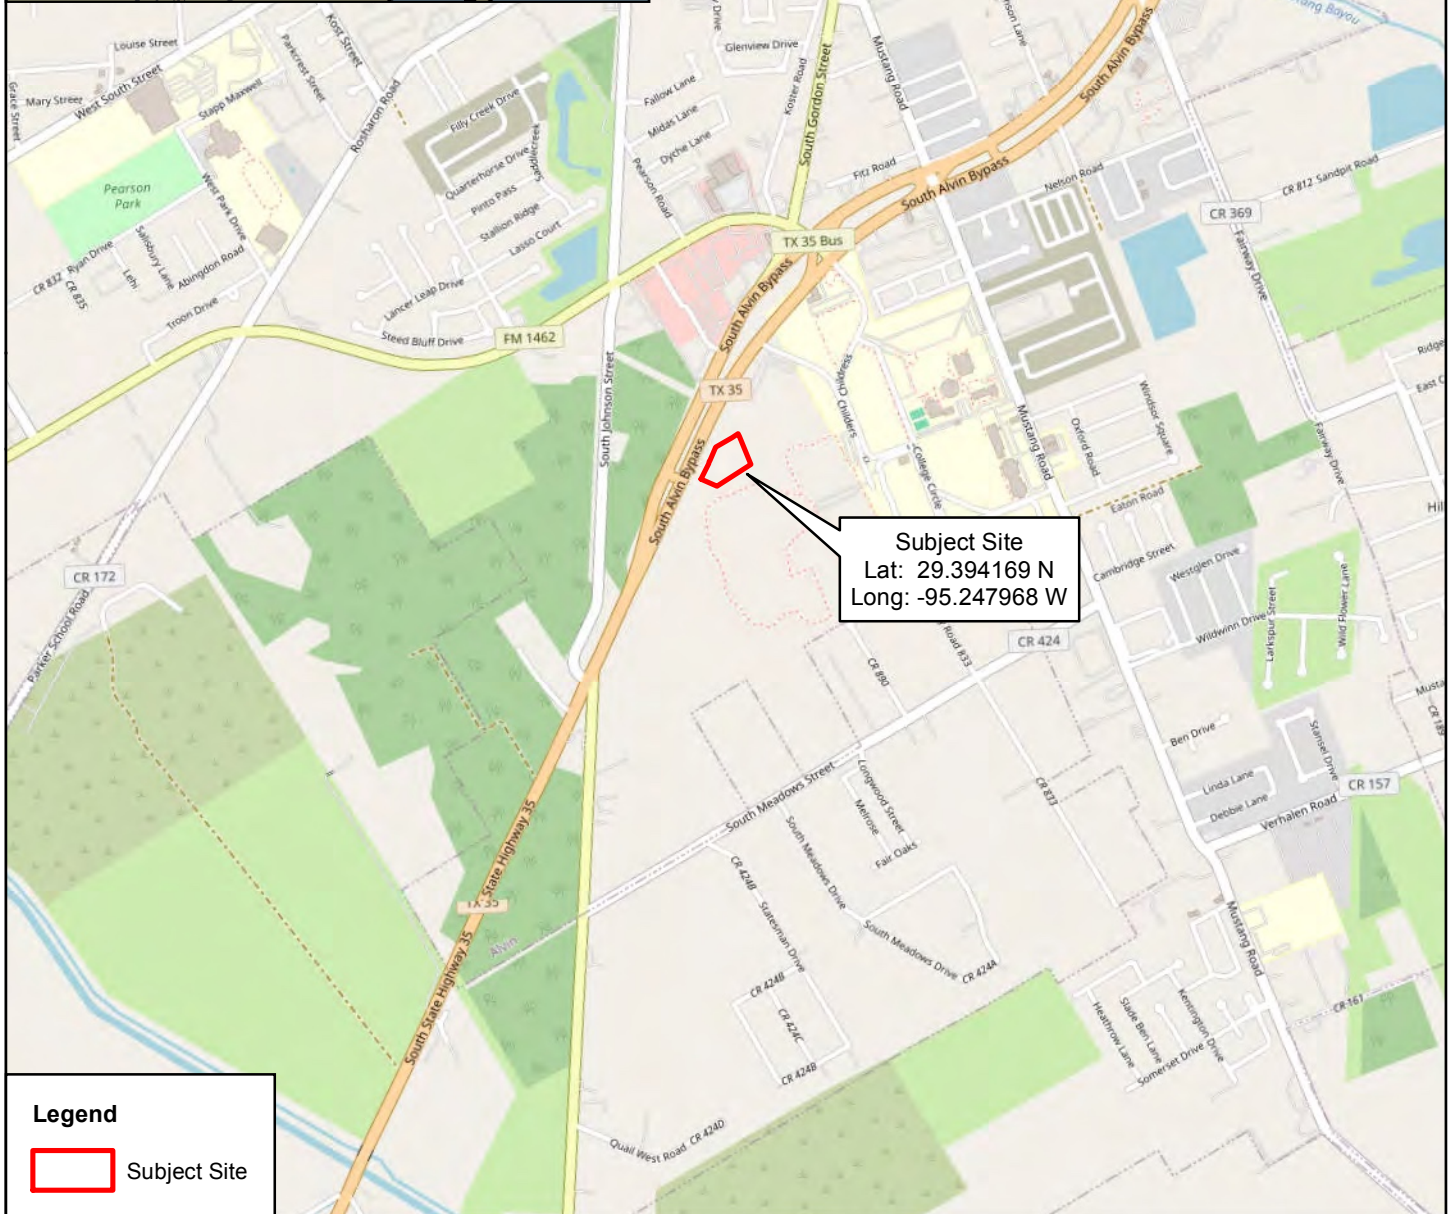
**Figure 1**

The approximately 3.56-acre subject site is located south of the intersection of State Highway (TX) 35 and the entrance to Bob Briscoe Park in Alvin, Brazoria County, Texas (Figure 1). The adjacent land use surrounding the subject site includes parkland, vacant land, roadways, and commercial development.

Vicinity Map  
Sandhu Logistics Property  
Alvin, Brazoria County, Texas

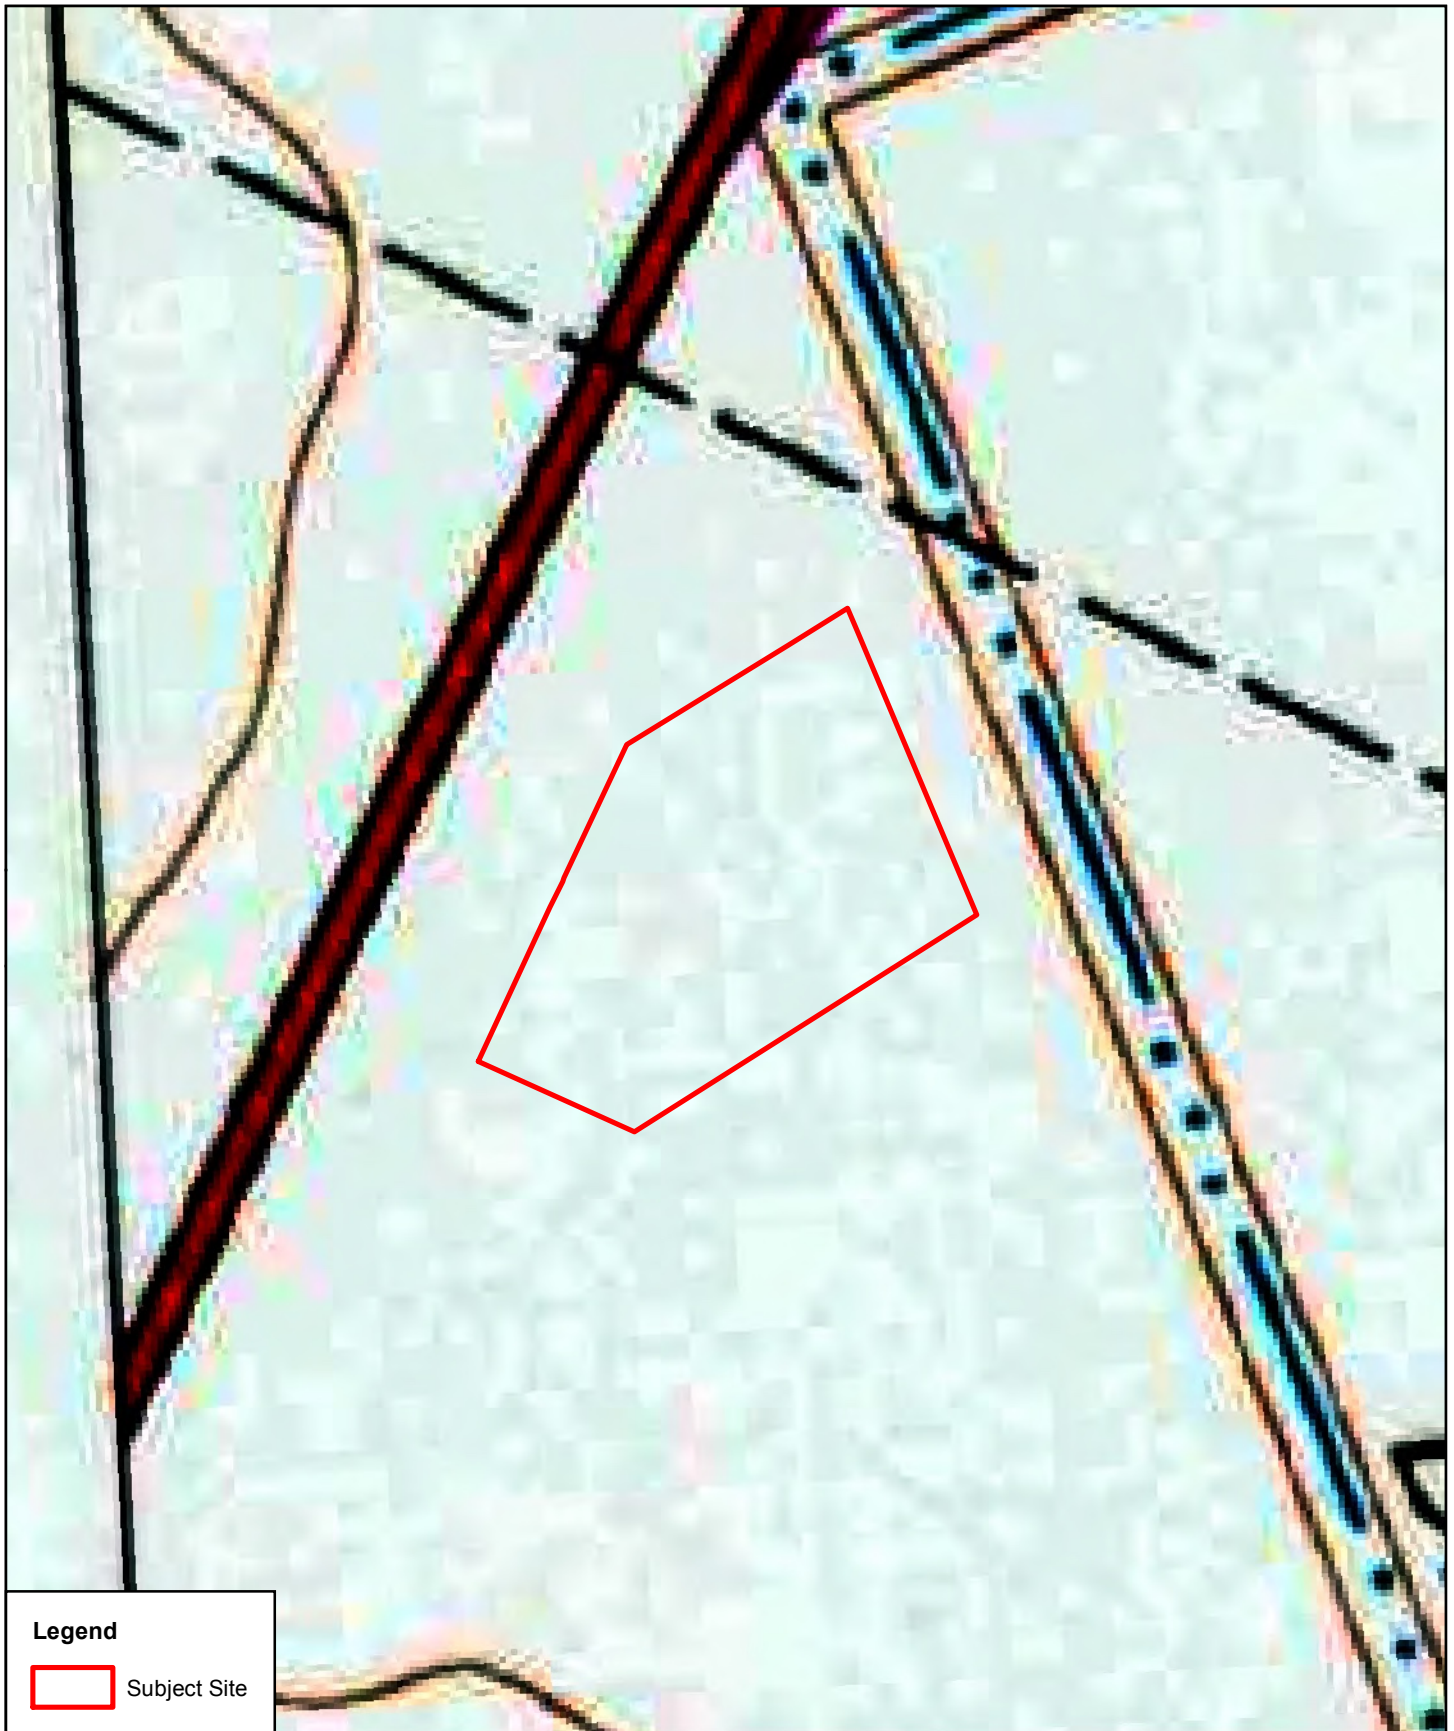
**Figure 2**

Topographically, the subject site is flat, with elevation approximately 35 feet above mean sea level (AMSL) throughout the site (USGS, 1977) (Figure 2). No aquatic features were indicated on the topographic map.

Topographic Map  
Sandhu Logistics Property  
Alvin, Brazoria County, Texas

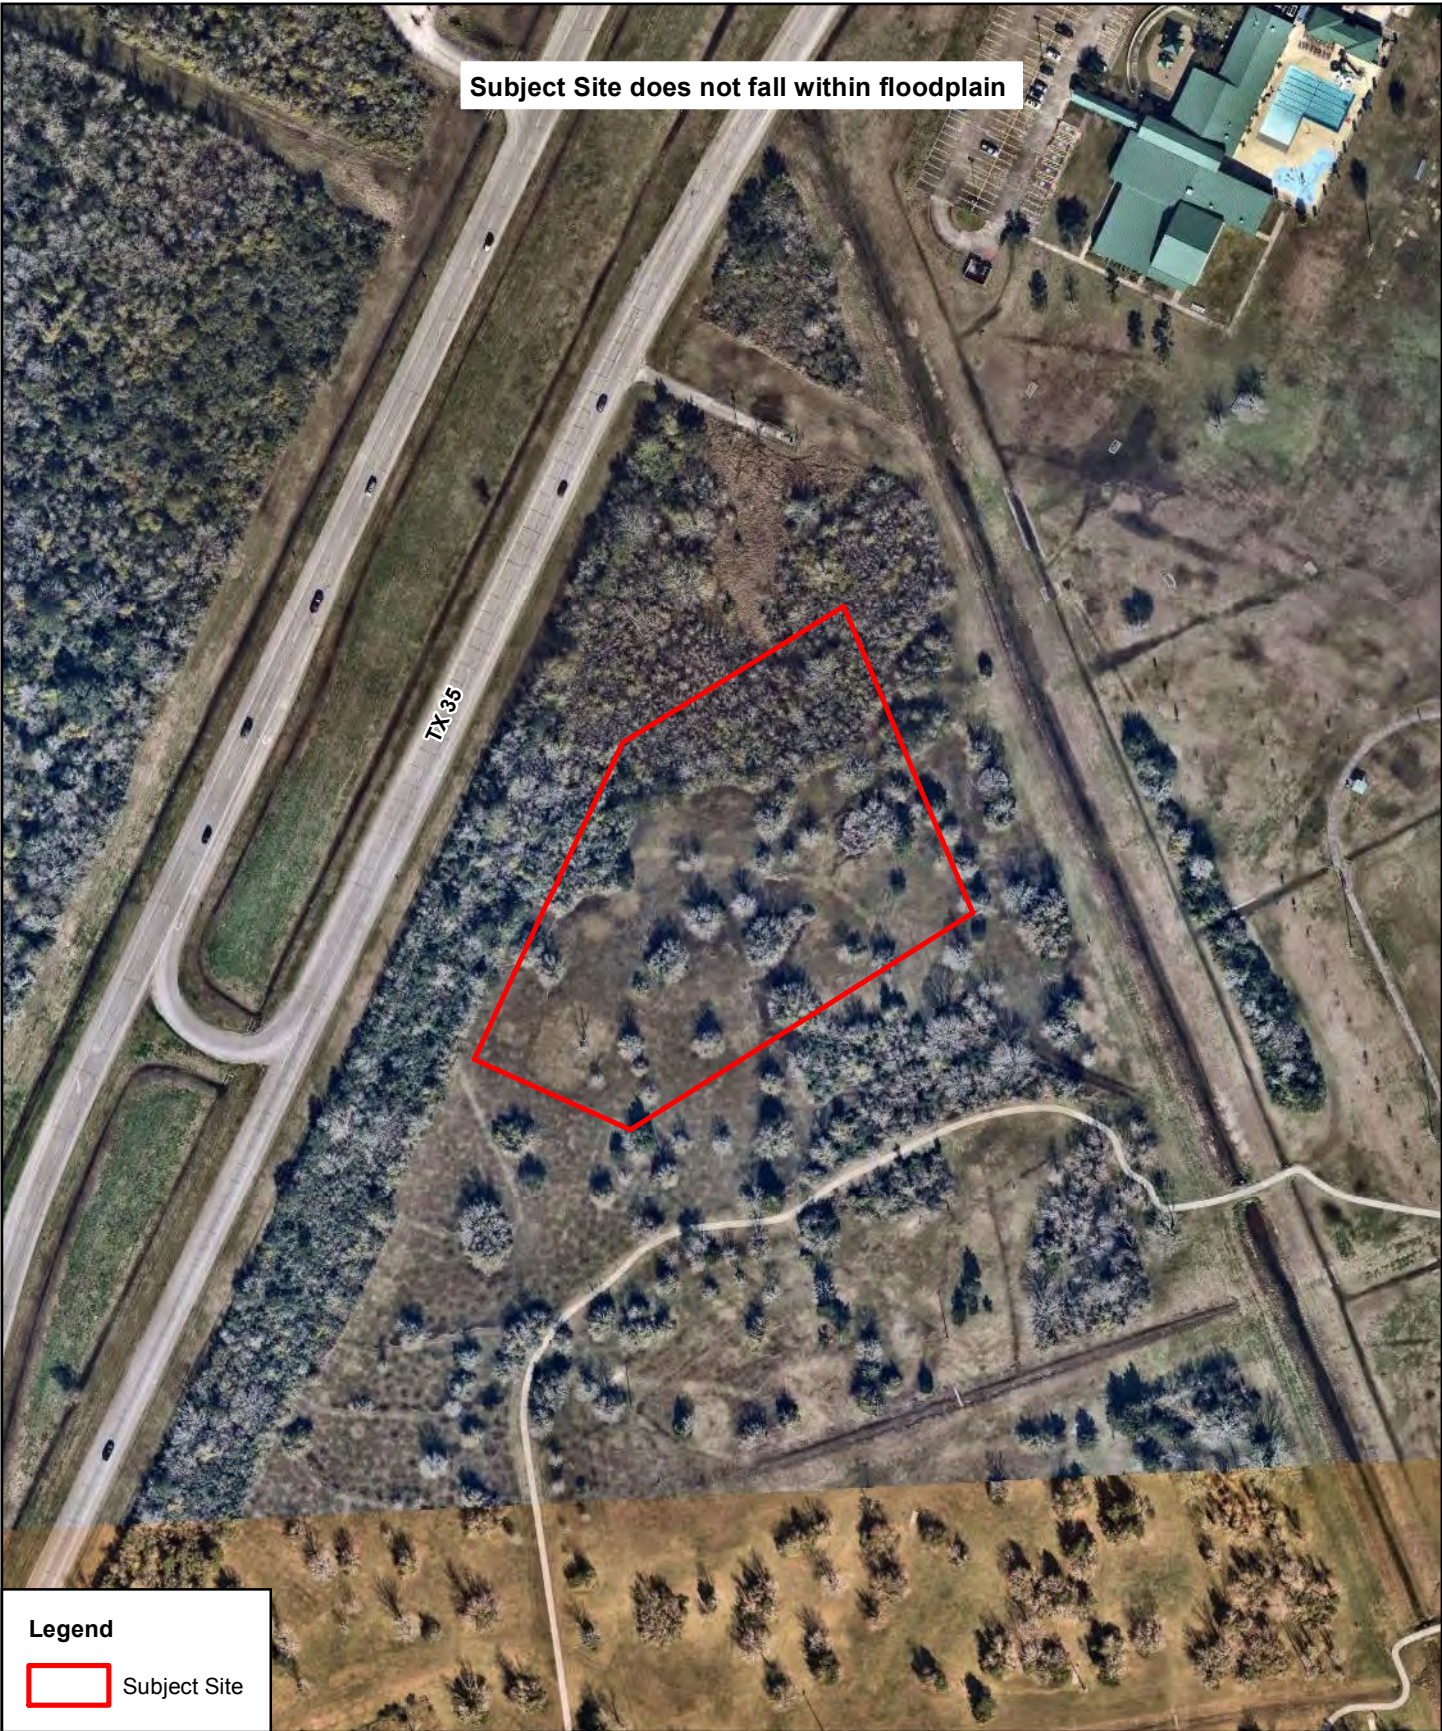
**Figure 3**

None of subject site is located within the 100-year floodplain (FEMA, 2020) (Figure 3).

Subject Site does not fall within floodplain

Flood Hazard Map  
Sandhu Logistics Property  
Alvin, Brazoria County, Texas

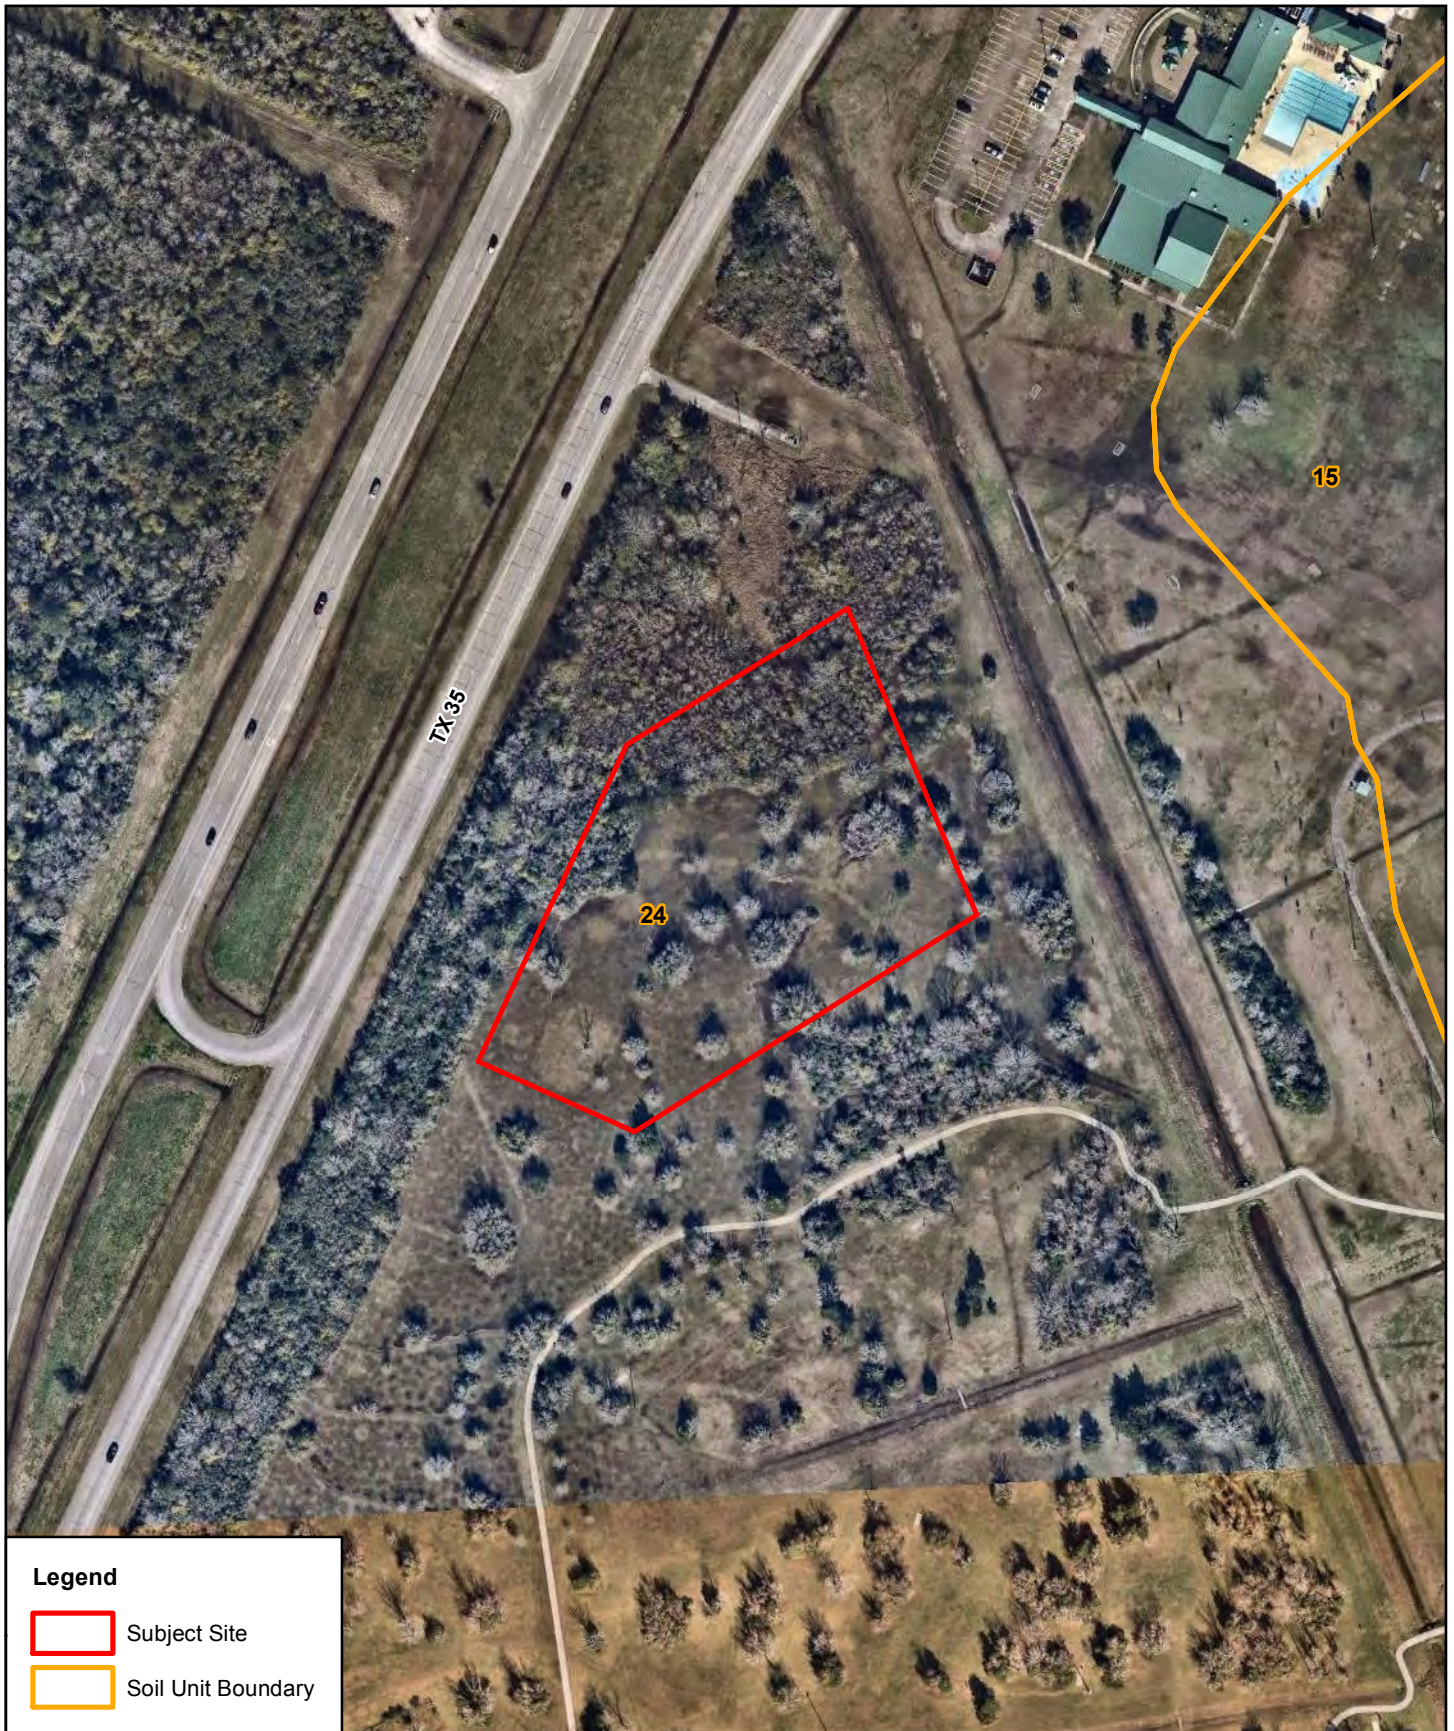
According to the Brazoria County soil survey, the subject site and surrounding vicinity are dominated by the following soil (Figure 4):

Soil Name	Soil Type	Soil Depth (feet)	Underlying Material	Permeability	Available Water Capacity	Shrink-Swell Capacity	Hydric?
Lake Charles clay, 0 to 1% slopes (24)	clay	0 to 6.6	mottled clay	very slow to slow	high	high	non-hydric

**Figure 4**  
Soils Map  
Sandhu Logistics Property  
Alvin, Brazoria County, Texas

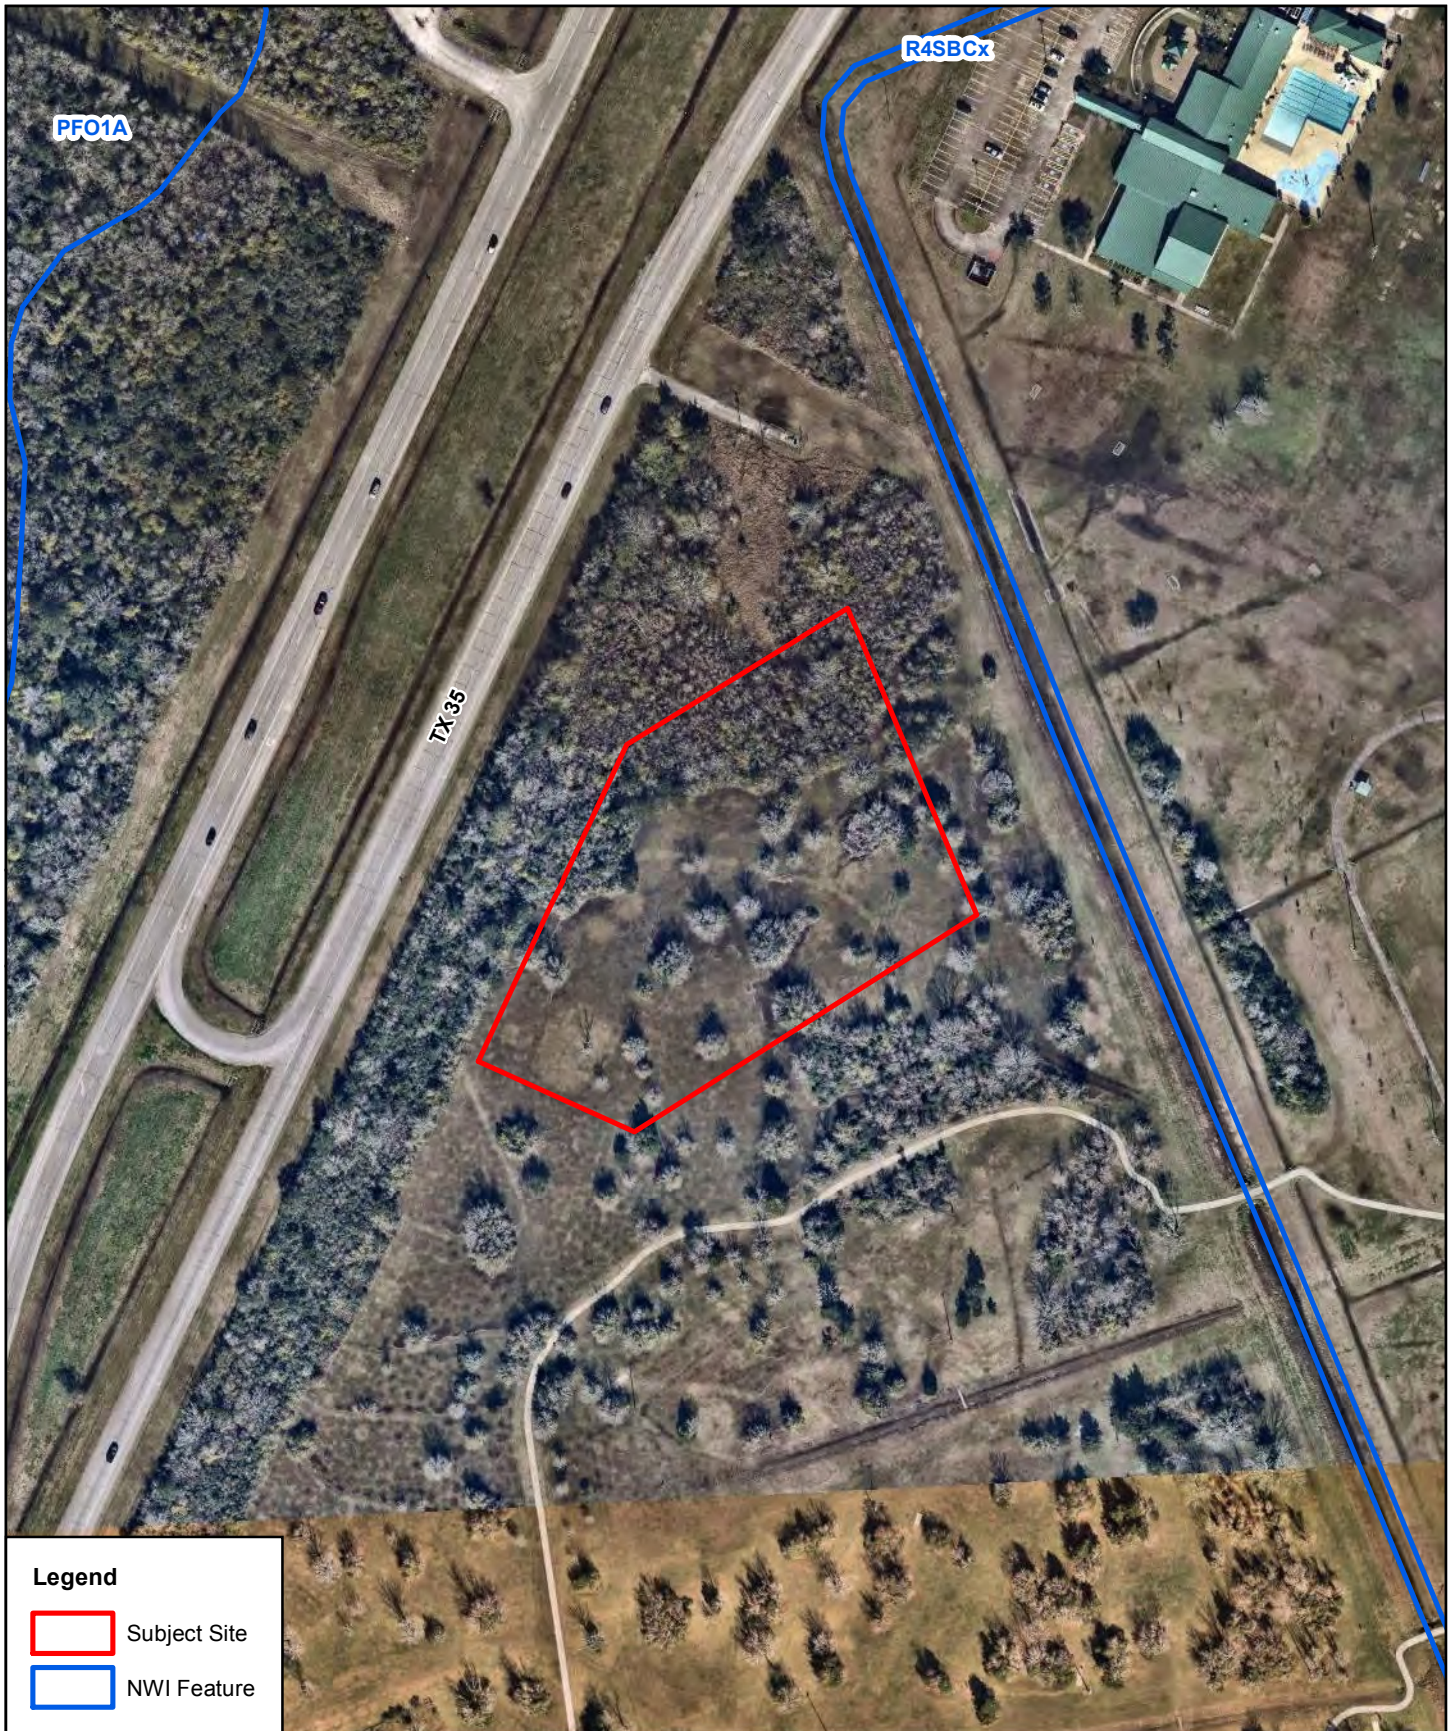
The review of the USFWS NWI map revealed that no aquatic features may be located within the subject site (Figure 5).

**Figure 5**  
 NWI Map  
 Sandhu Logistics Property  
 Alvin, Brazoria County, Texas

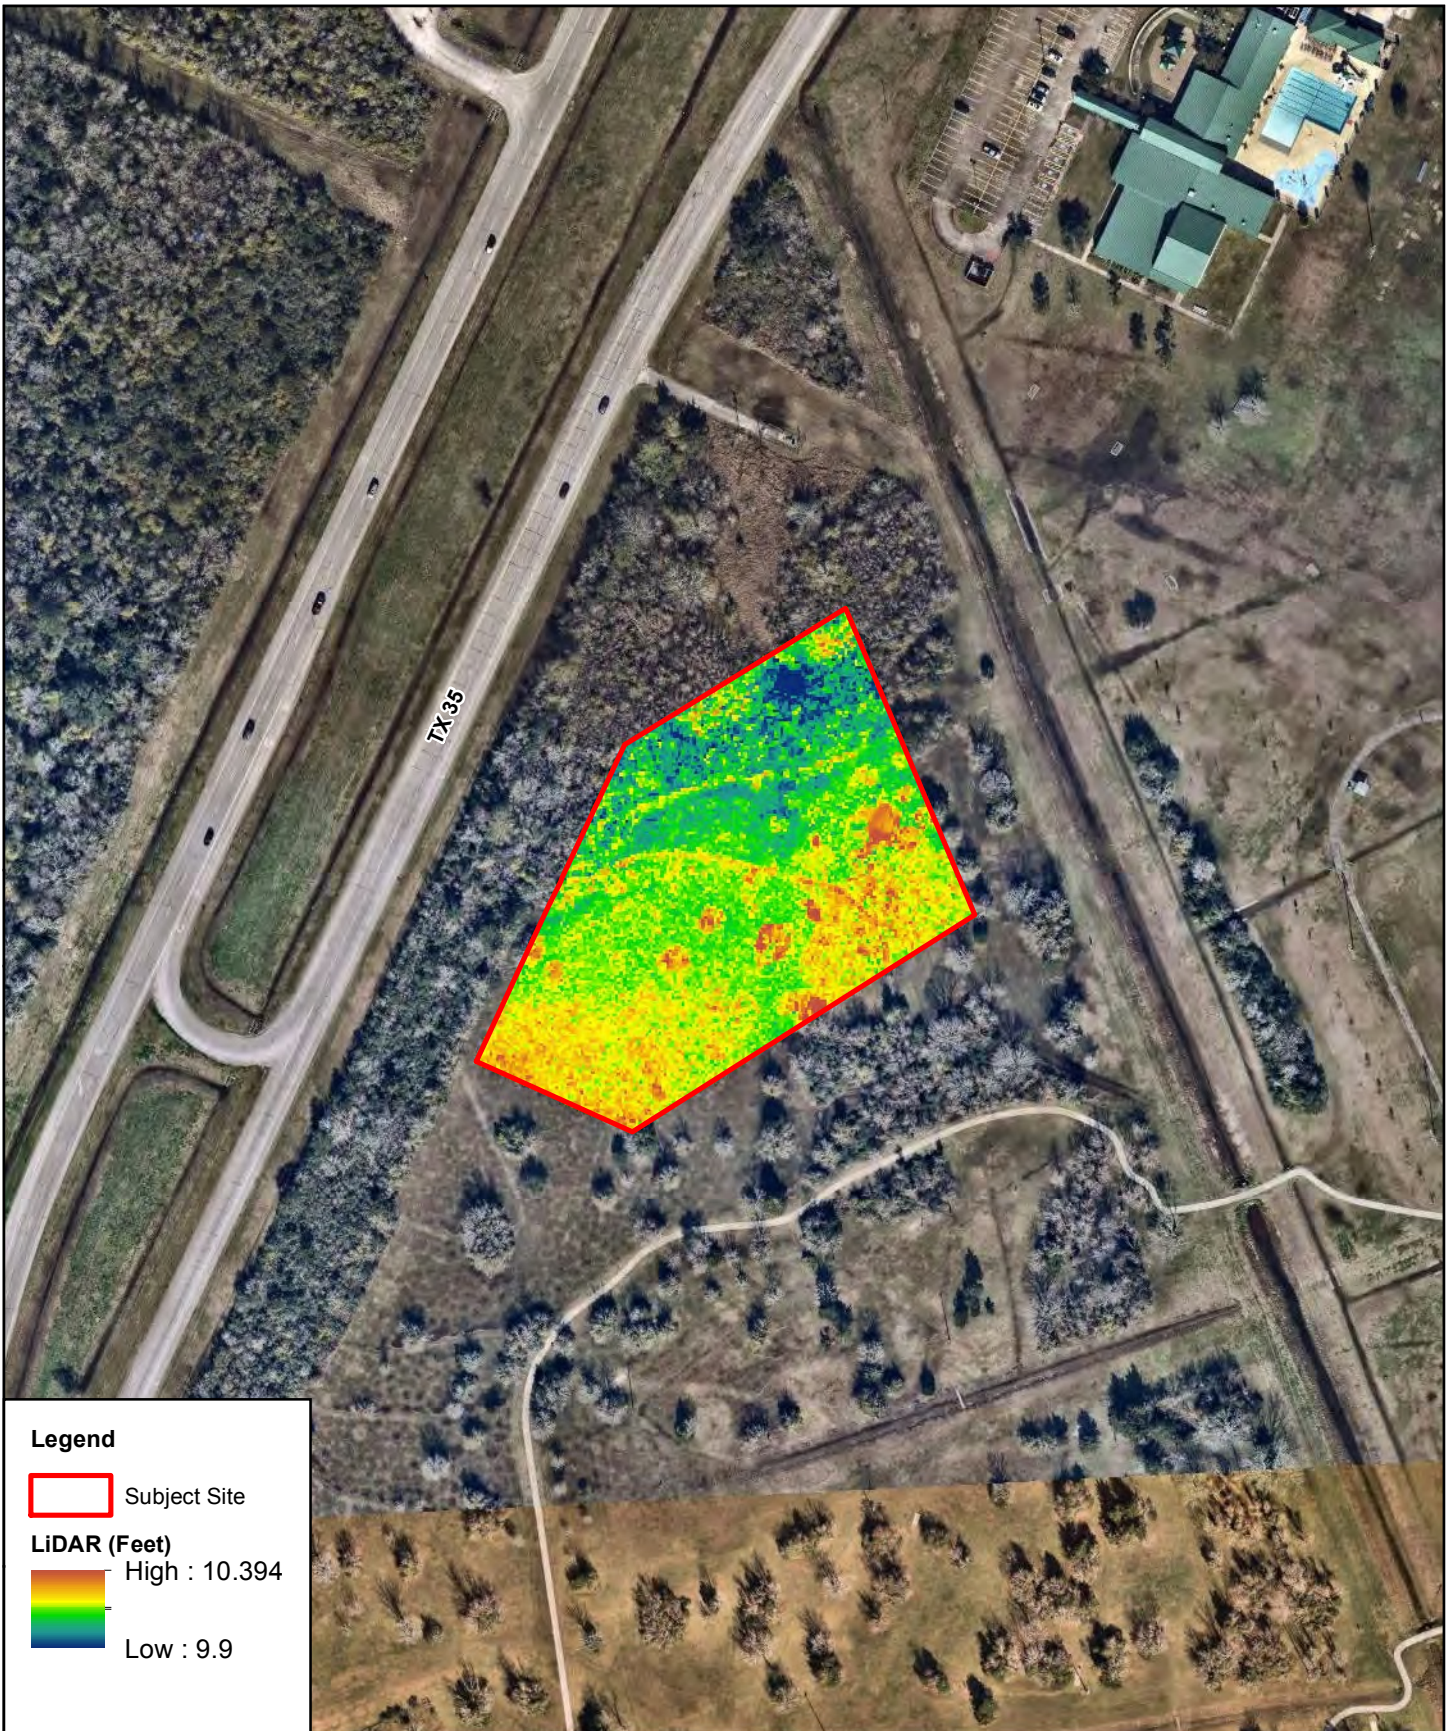
A review of LiDAR data indicated that the subject site is generally flat, with elevations ranging from approximately 9.9 feet above mean sea level (AMSL) to 10.4 feet AMSL on the southern portion of the site. The LiDAR data indicated lower elevation on the northern portion of the subject site. Refer to Figure 6 for an illustration of LiDAR data within the subject site.

High : 10.394  
 Low : 9.9

**Figure 6**  
 LiDAR Map  
 Sandhu Logistics Property  
 Alvin, Brazoria County, Texas

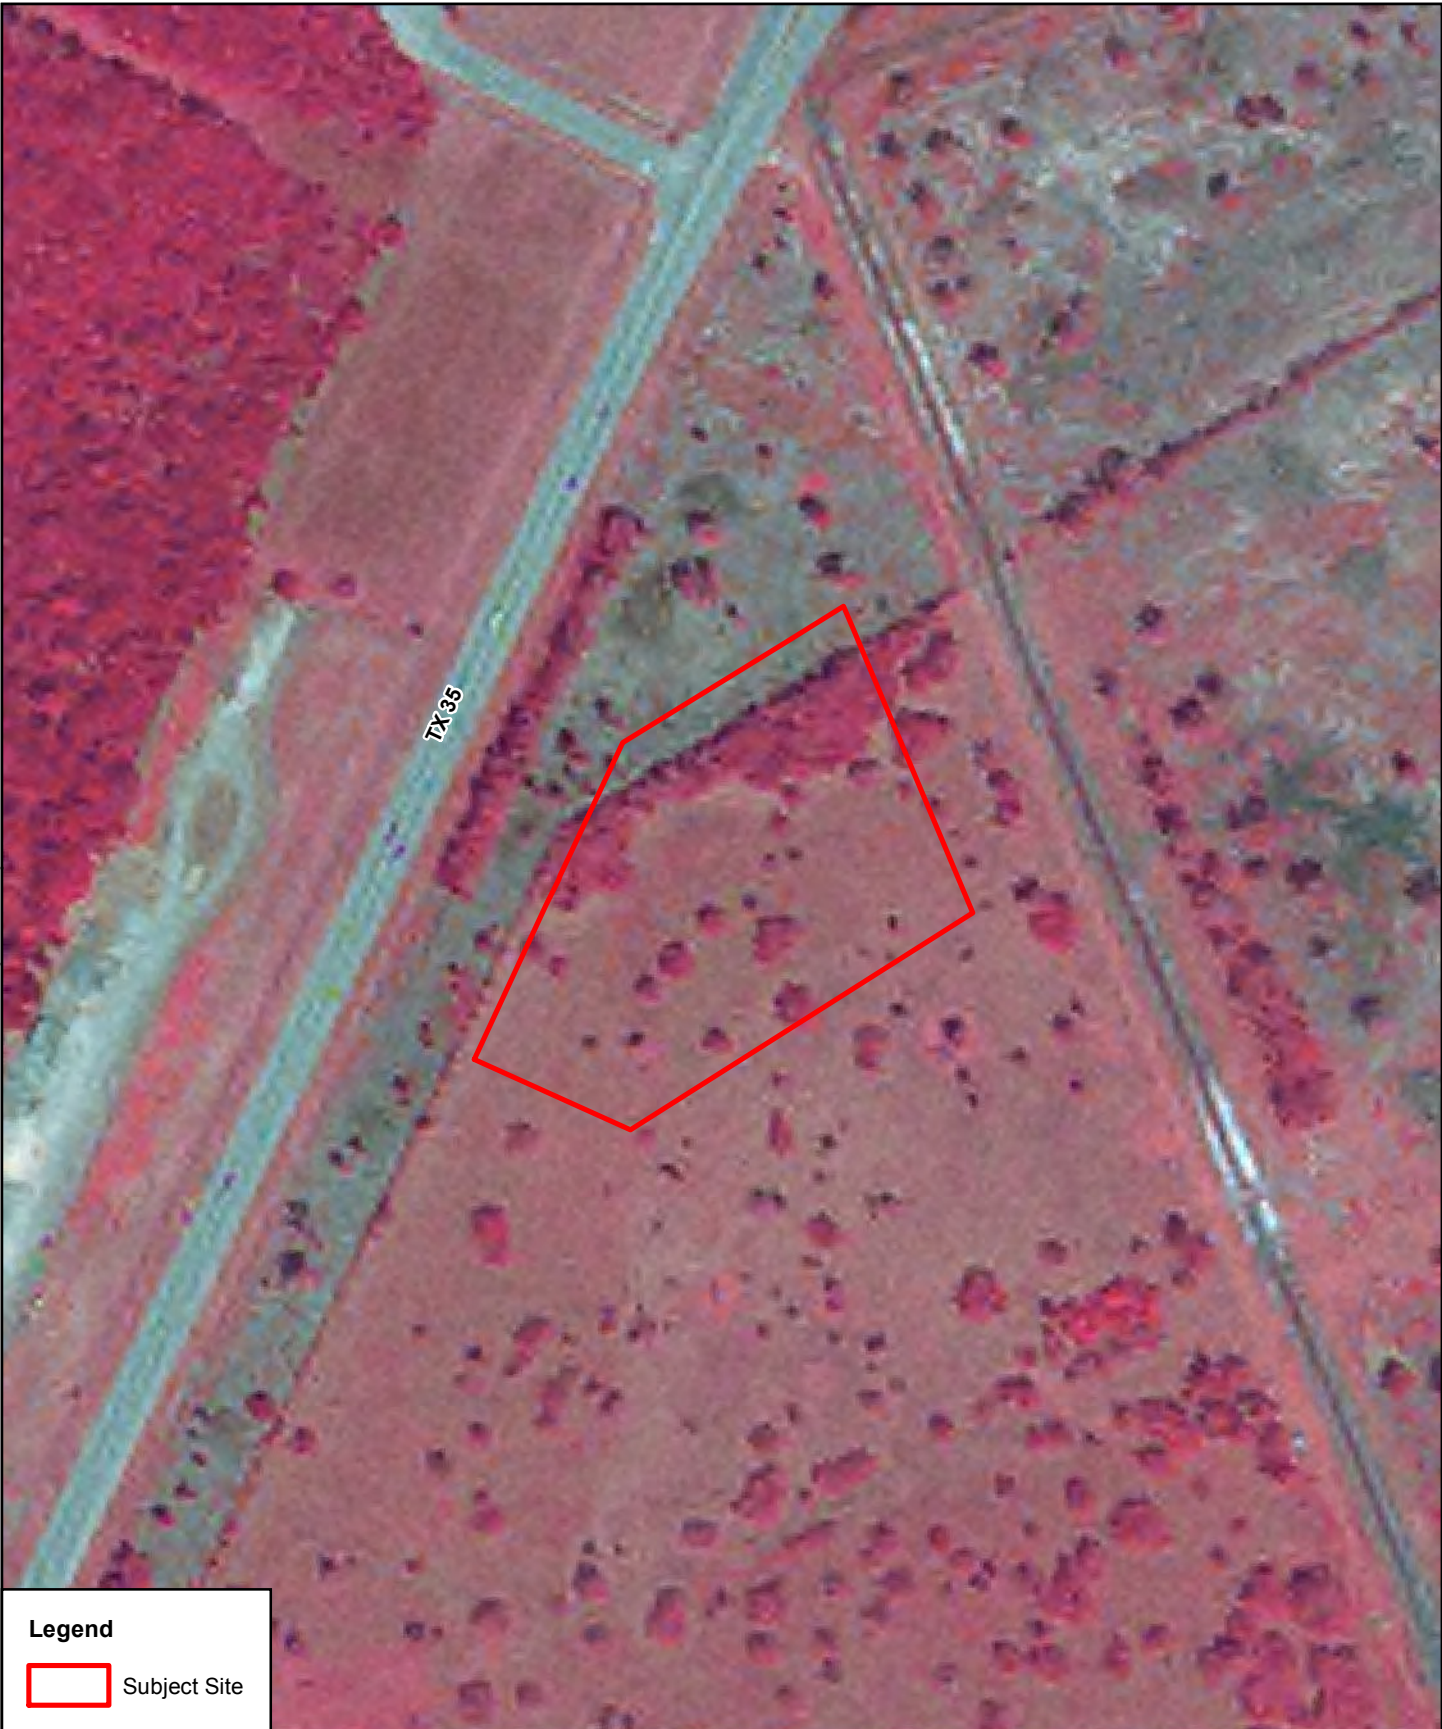
**Figure 7**

A review of the 2004 infrared aerial photograph indicates that the subject site consists of upland grassland with scattered trees and dense vegetation along a fence (Figure 7). The 2025 aerial photograph shows the subject site in a similar nature as in the 2004 photo, with increased canopy cover and denser vegetation (Figure 8). No potential wetlands were observed on the subject site based on the review of aerial photography.

2004 Infrared Aerial Photograph  
Sandhu Logistics Property  
Alvin, Brazoria County, Texas

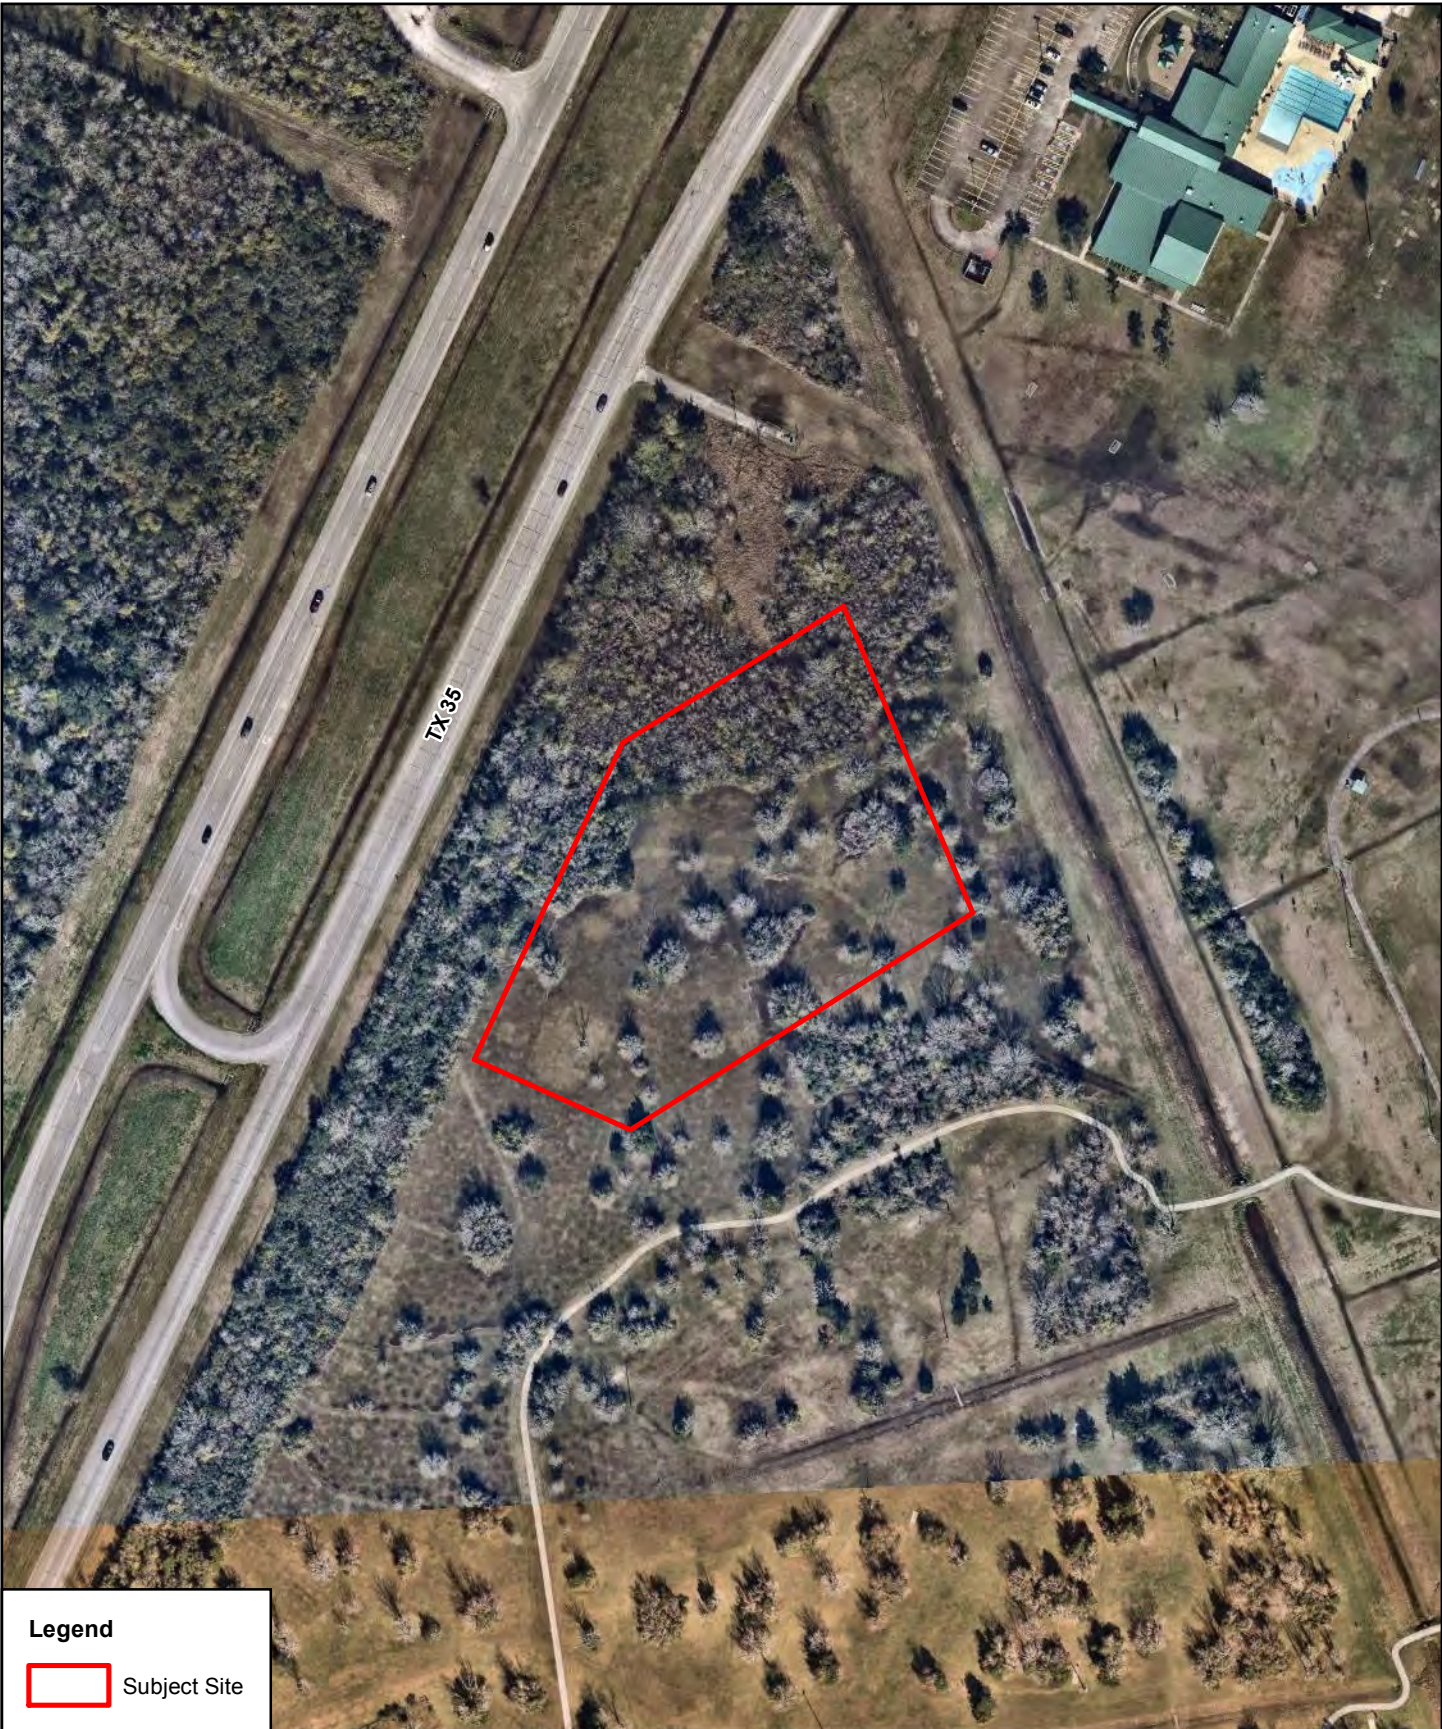
**Figure 8**

2025 Aerial Photograph  
 Sandhu Logistics Property  
 Alvin, Brazoria County, Texas

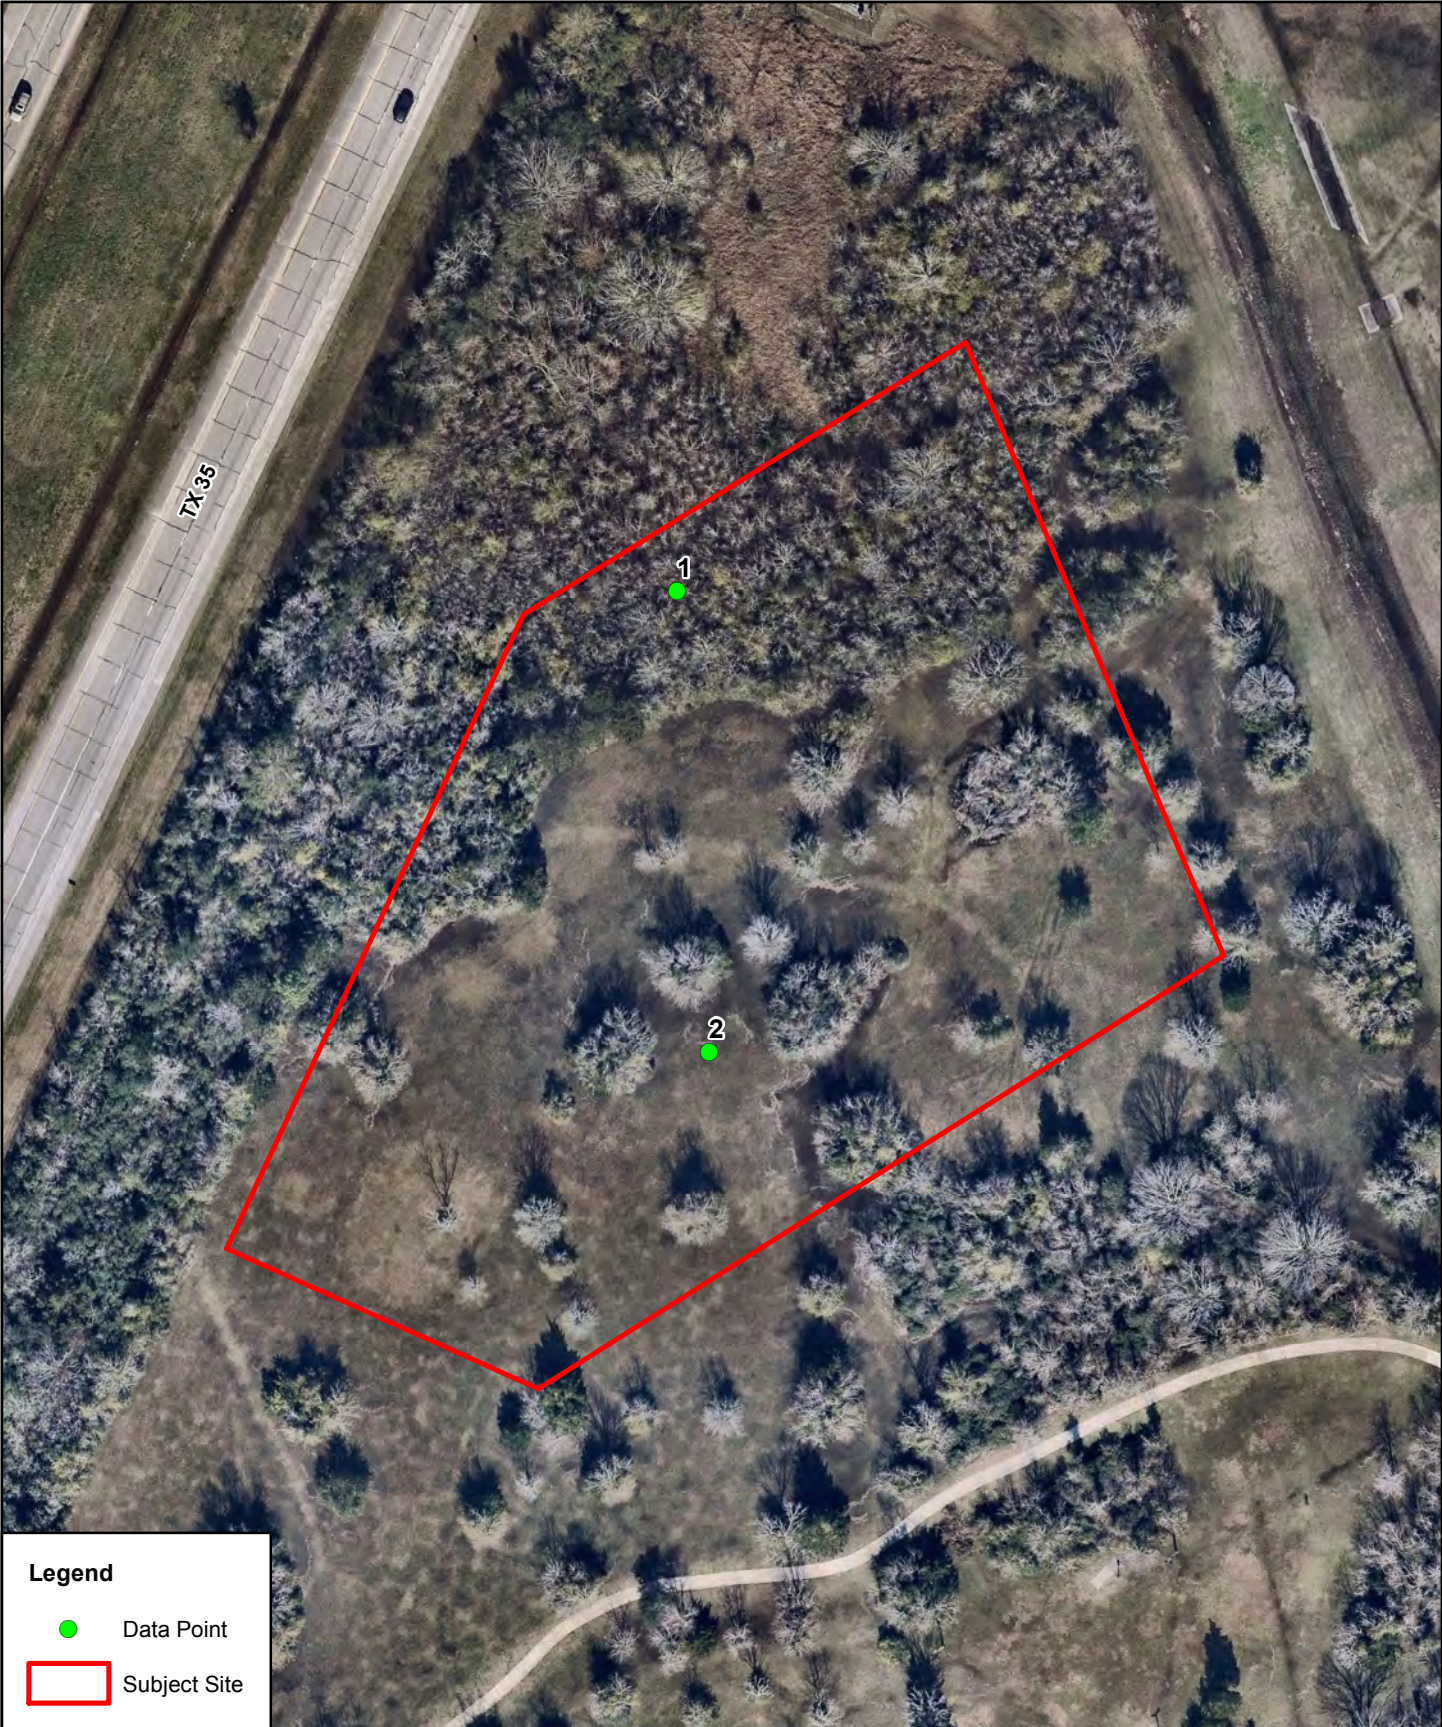
**Figure 9**

Data point locations were selected based upon a review of electronic, aerial, and topographic data (see Figure 9). Horizon's field visit was conducted on 4 March 2025. Field data forms and site photographs are provided in Appendix A.

The results of the jurisdictional delineation indicated that no aquatic features or wetlands were observed within the subject site. The site consists of upland woodlands and maintained parkland. No areas meeting the requisite criteria for jurisdictional WOTUS were identified within the subject site.

Jurisdictional Delineation Map  
Sandhu Logistics Property  
Alvin, Brazoria County, Texas
