**SECTION 404  
JURISDICTIONAL DELINEATION  
SANDHU LOGISTICS PROPERTY  
ALVIN, BRAZORIA COUNTY, TEXAS  
HJN 25033.001JD**

**21 MARCH 2025**

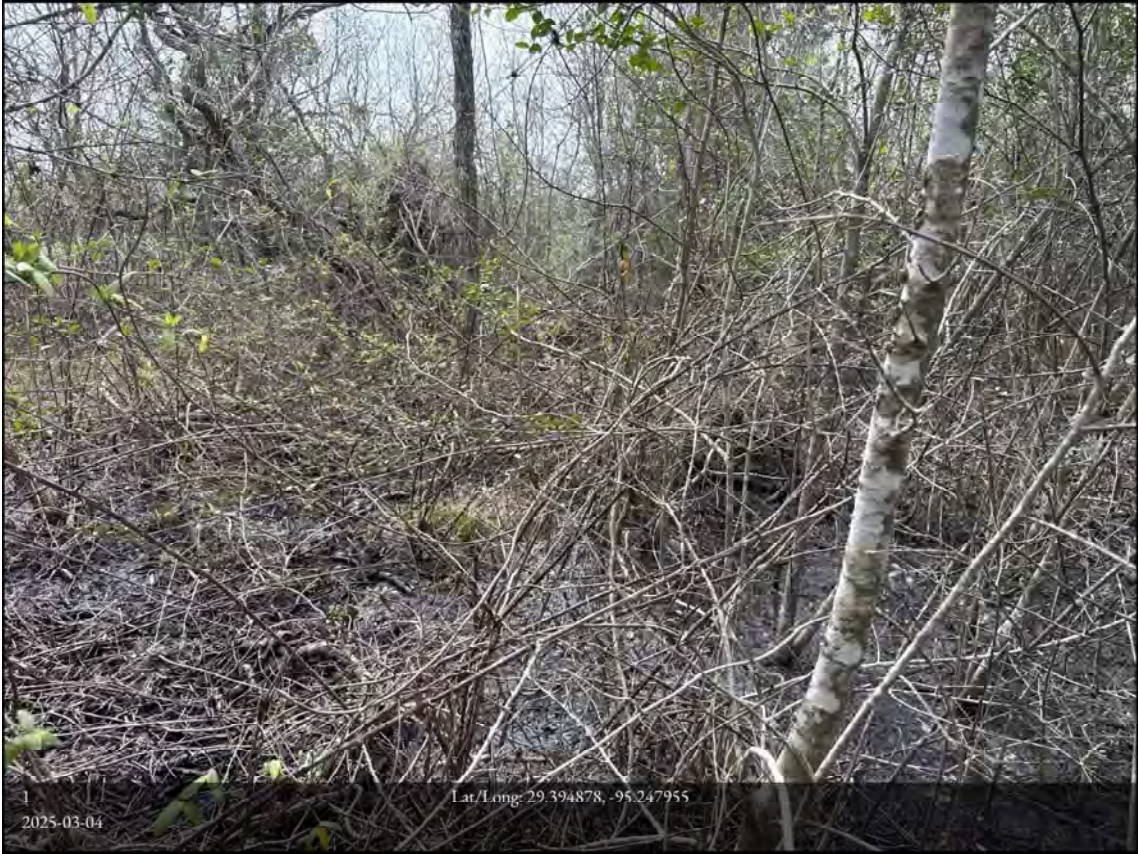
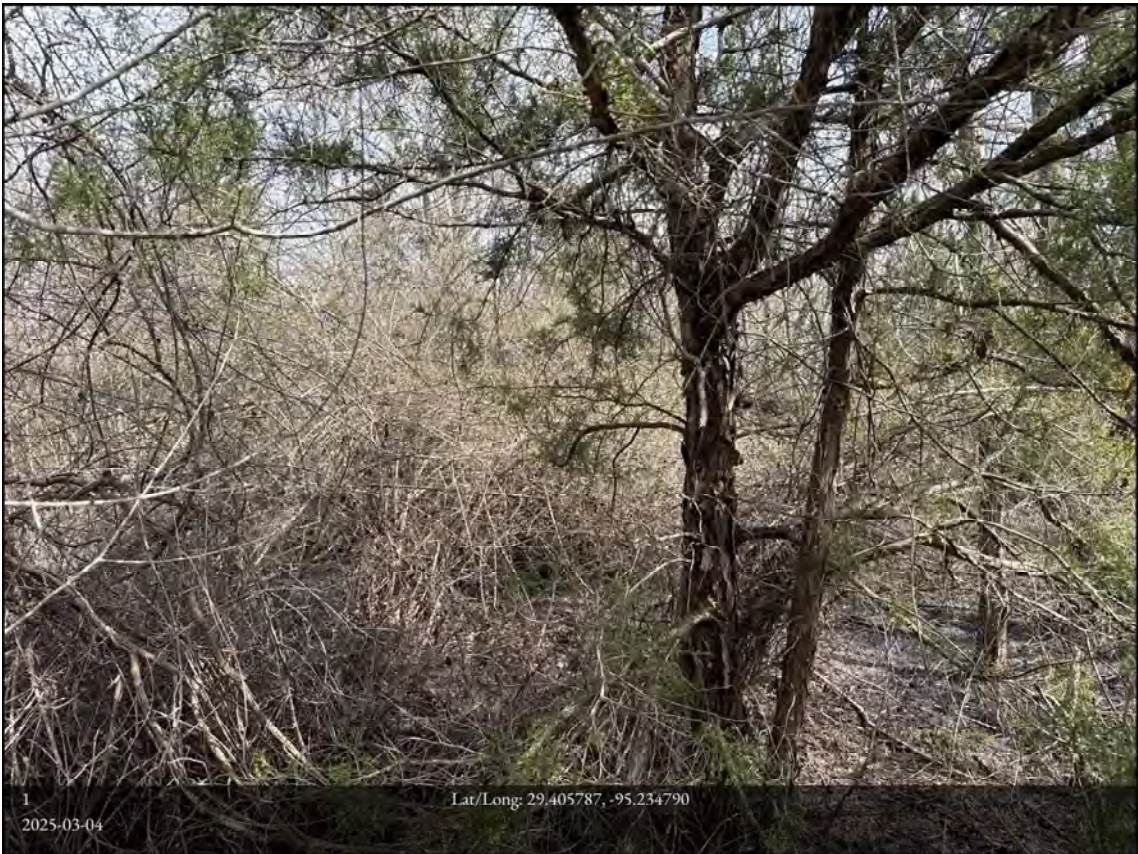
Hydrophytic Vegetation Present? Yes <input checked="" type="checkbox"/> No _____ Hydric Soil Present? Yes _____ No <input checked="" type="checkbox"/> Wetland Hydrology Present? Yes _____ No <input checked="" type="checkbox"/>	Is the Sampled Area within a Wetland? Yes _____ No <input checked="" type="checkbox"/>
Remarks: Sample point was taken in an upland forested area.

Soil criteria not met.

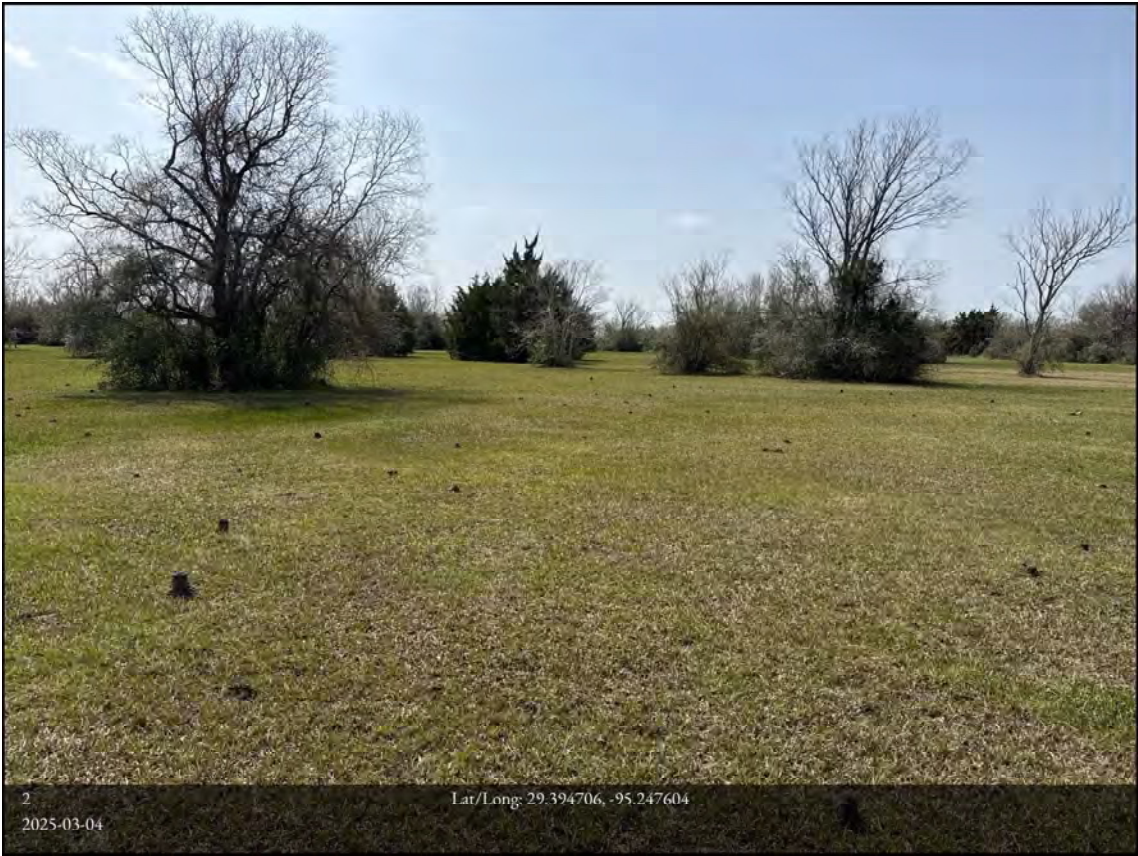
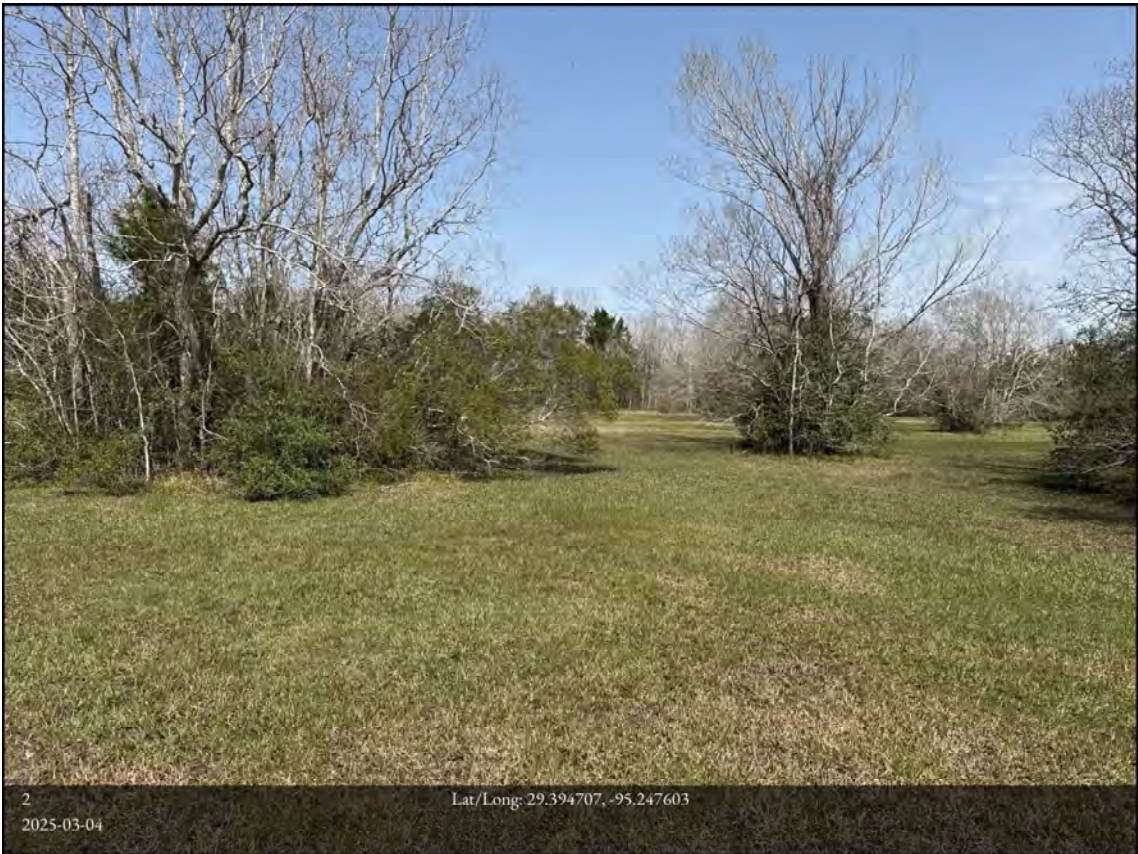
2  
2025-03-04

Remarks:  
 Sample point was taken in an upland grassland area.

Remarks:  
Soil criteria not met.

Lat/Long: 29.394706, -95.247604
