PHASE I ENVIRONMENTAL SITE ASSESSMENT

**87 & 89 Glen Cameron Road
Thornhill, Ontario**

RiskCheck Project No. 31576

September 12, 2025

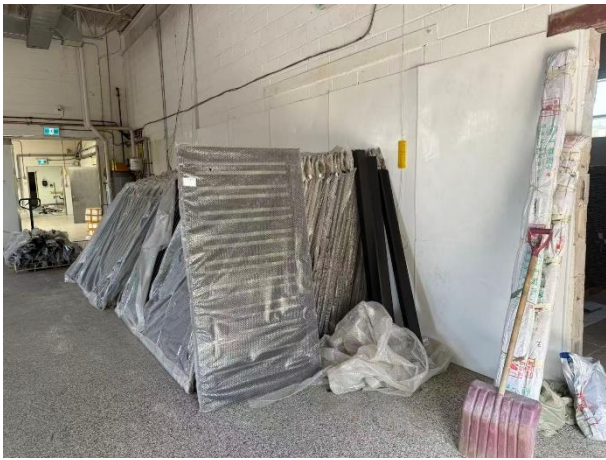
Photo 1.
View of a section of the warehouse space within the subject property, used for the storage of metal fencing materials.

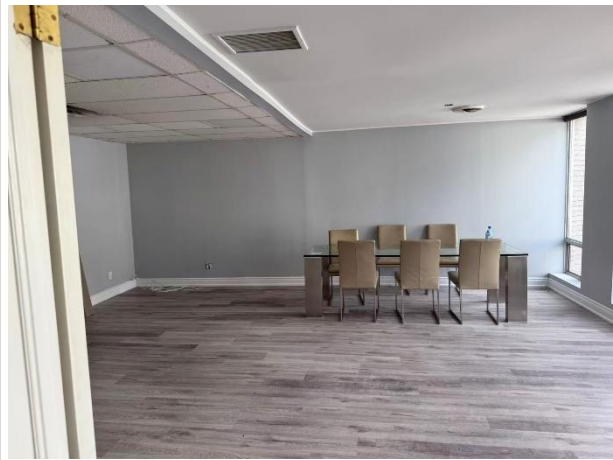
Photo 4.
View of a portion of the office space within the subject property, finished with laminate flooring, drywall walls and ceiling, and acoustic ceiling tiles.

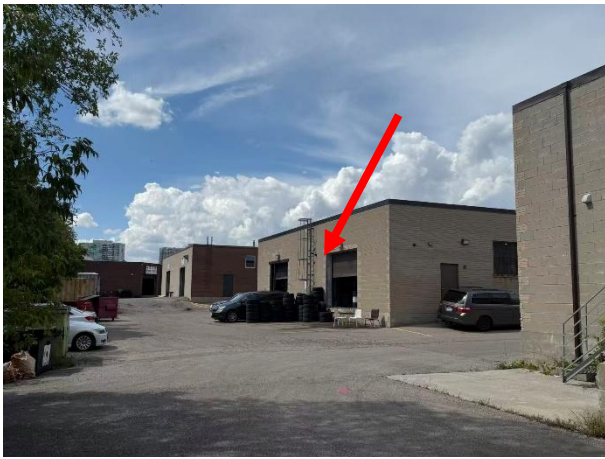
The neighbouring property approximately 20 m to the west at 83 Glen Cameron Road was historically occupied by an automobile service garage during approximately the 1990s and 2000s and is currently occupied by MR Automotive (auto repair shop). A review of the ERIS Database Report (see Section 3.7 for details) and the MECP HWIN Databases (1986 to 2020) did not identify any records of hazardous waste generation associated with historical or current tenants. A historical spill of potassium hydroxide was reported in 1989; however, potassium hydroxide is not a substance addressed under the O. Reg. 153/04 site condition standards tables and is therefore not considered a regulated contaminant of concern during this investigation. Based on the available information to-date, including the historical and current occupancy and activities related to automobile repair operations with suspected fuel and lubricant ASTs, the close proximity of this property to the subject property, and the inferred up-gradient groundwater flow direction, there remains potential for subsurface concerns migrating to the subject property from this neighbouring property.

Photo 5.
View of the neighbouring property to the west (see arrow) at 83 & 85 Glen Cameron Road, looking northwest from the south portion of the subject property.

A Phase II ESA is recommended to be completed at the subject property to confirm the subsurface conditions at this time based on the above noted potential environmental concerns.

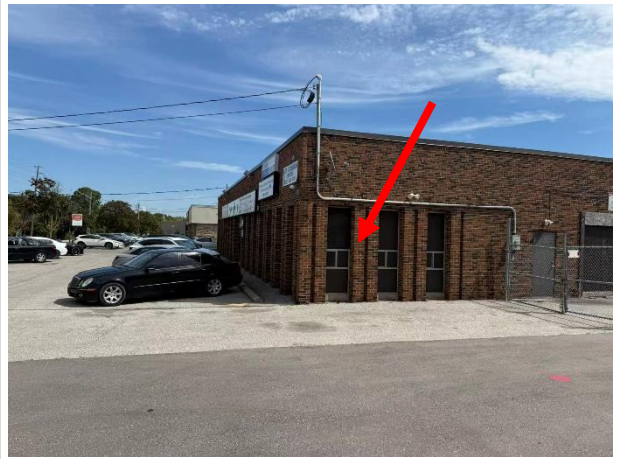
- immediately east of the subject property at 91 & 93 Glen Cameron Road;
- Various auto repair shops (Eurolize Auto Boutique and Mr. Automotive) and a dancing academy (Stepanova Ballet Academy Inc.) were observed on the neighbouring property immediately to the west of the subject property at 83 & 85 Glen Cameron Road;
 - An auto repair shop (Simplicity Car Care) was observed on the neighbouring property approximately 35 m to the east of the subject property at 95 & 97 Glen Cameron Road; and
 - A plastic fabricator (Plastics Source), a marketing agency (AIO Agency), and an accounting firm (TACS) were observed on the neighbouring property approximately 30 m to the west of the subject property at 79 & 81 Glen Cameron Road.

Photo 6.
View of the neighbouring property to the east (see arrow) at 91 & 93 Glen Cameron Road, looking east from the northeast portion of the subject property.
