# LIMITED PRE-RENOVATION HAZARDOUS BUILDING MATERIALS SURVEY

**Lander County  
Lemaire Grocery Store  
Battle Mountain, Nevada**

***Contract: DEP22-001  
Task Number: MA26-23***

***December 21, 2023***

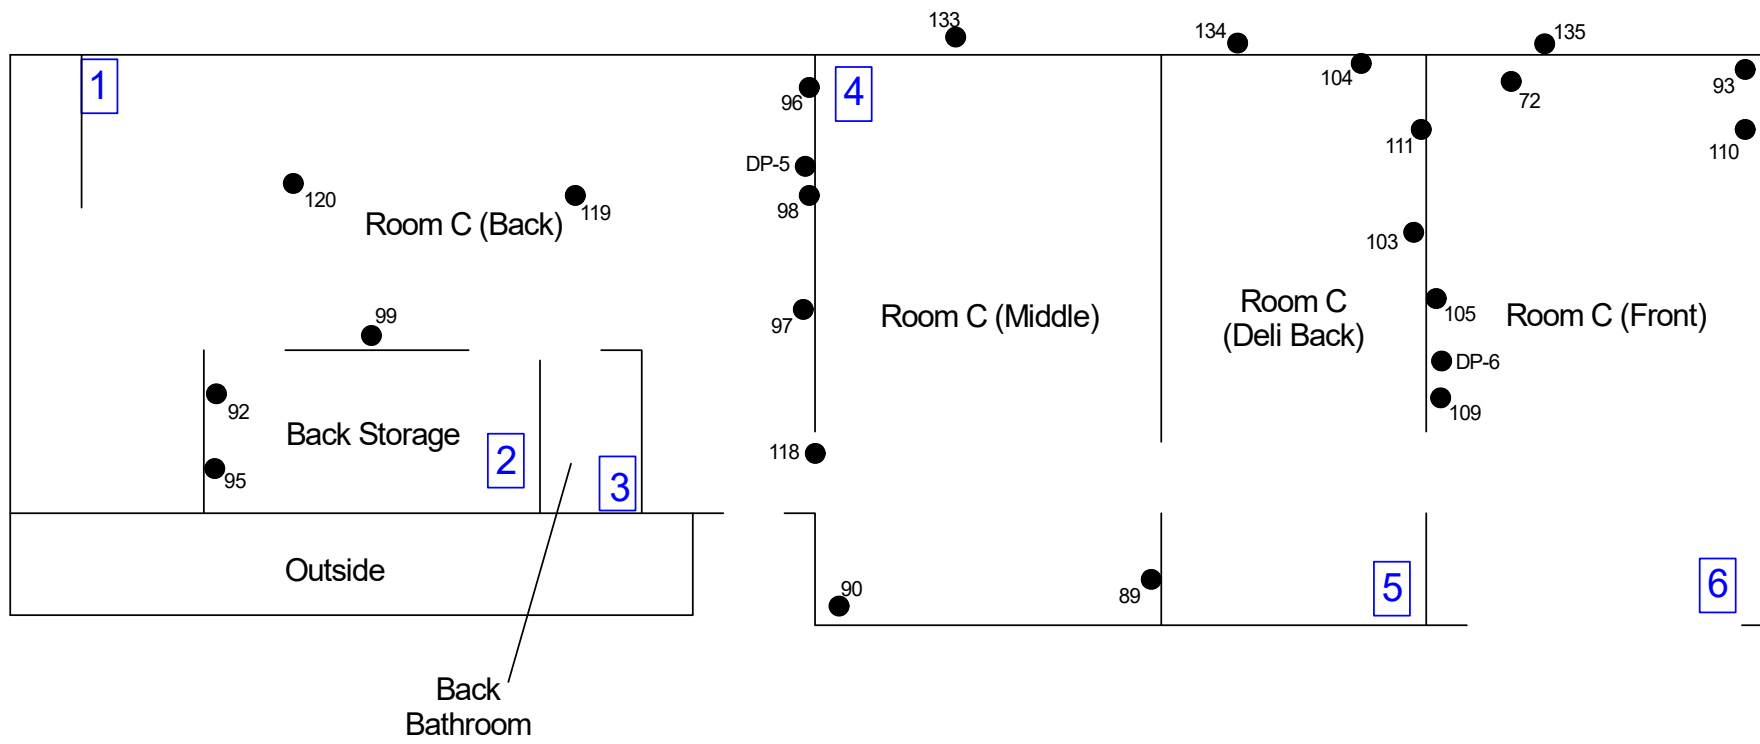
# **Figure 2B**

**Asbestos Bulk Sample  
Location Map – 1<sup>st</sup> Floor,  
North Portion**

- Asbestos-Containing Bulk Sample Location
- Non-detected PLM Bulk Sample Location

Figure 2B  
Asbestos Bulk Sample Location Map - 1st Floor, North Portion  
6 West Front Street  
Battle Mountain, Nevada 89820

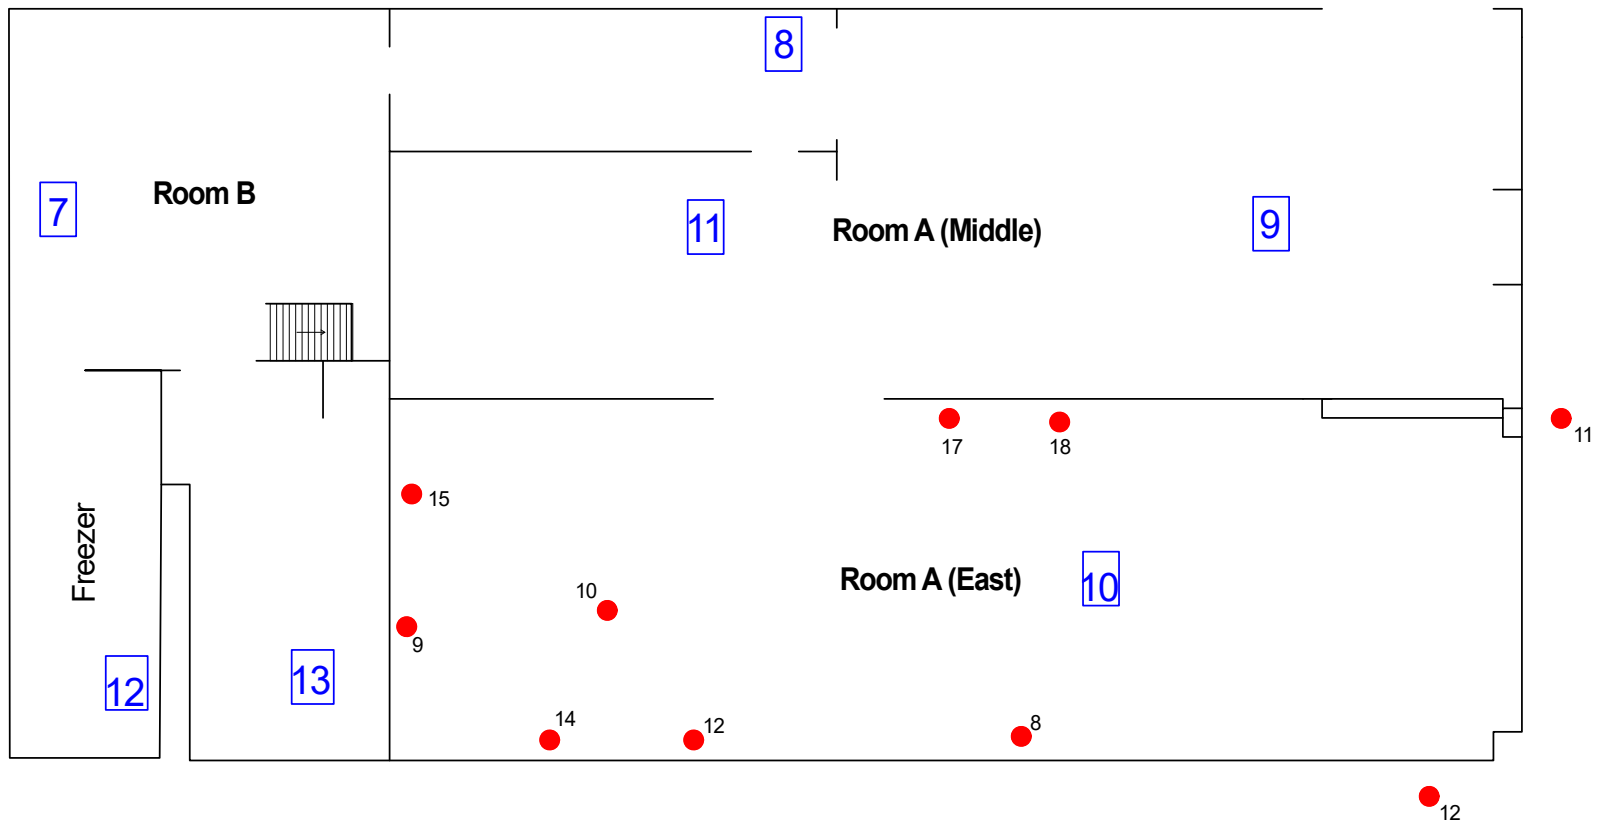
# **Figure 3A**

**Lead Bulk Paint Chip Sample  
Location Map - 1<sup>st</sup> Floor,  
South Portion**

● Lead Bulk Paint Chip Sample Location

Figure 3A  
Lead Bulk Paint Chip Sample Location Map - 1st Floor, South Portion  
6 West Front Street  
Battle Mountain, Nevada 89820
