Date: November 21, 2025
Revised November 26, 2025

Job No: 25.11857.00

**Subject: 483 Thurston Street – Wrentham, MA
Site Assessment**

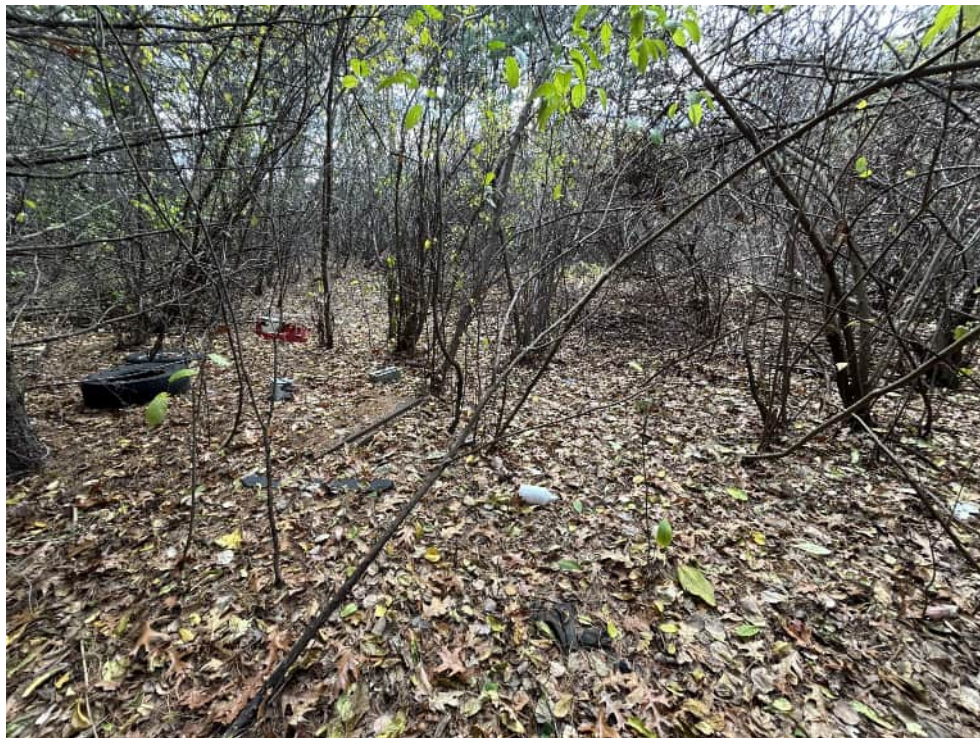
Photo 1

View of the area mapped as a wetland on MassMapper with evidence of debris—facing southeast.

During the Site Visit, BETA reviewed the Site and the approximate location of the mapped wetland for evidence of hydrology, hydric soils and hydrophytic vegetation. The area was observed in the field with clear evidence of fill material and anthropogenic waste and debris. Two PVC pipes were observed onsite that appeared to be monitoring wells. Piles of apparent fill material were observed in addition to metal debris, chunks of concrete, tires, and household objects. With reference to 1-foot contours as depicted on MassMapper, the upper limit of fill generally corresponded with elevation 200².

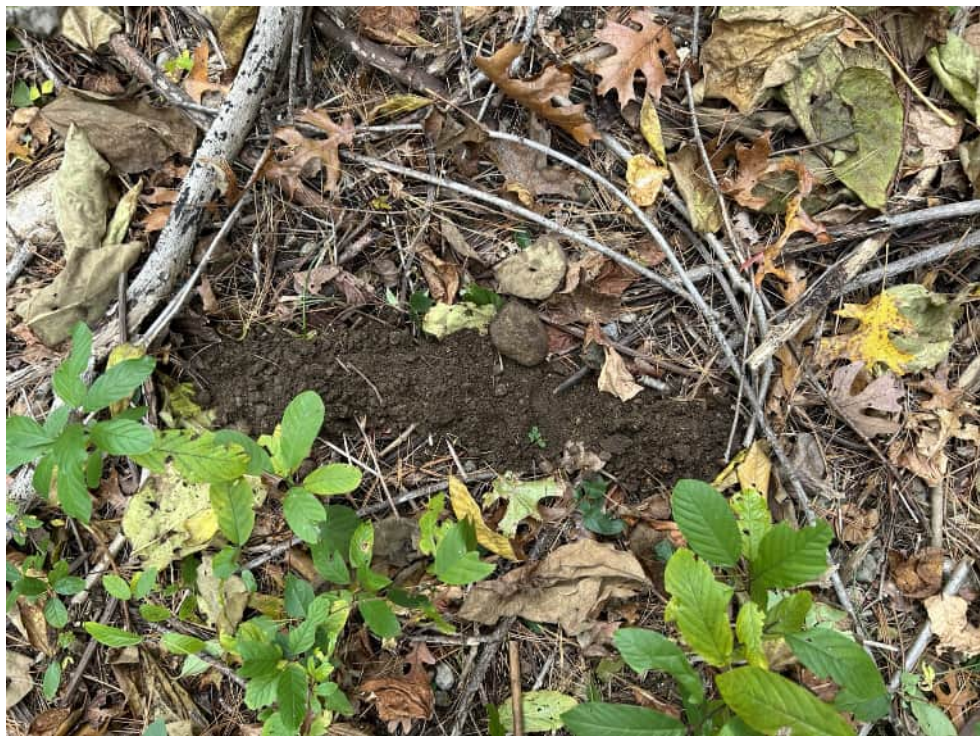
Photo 2

View of stony fill encountered within the mapped wetland area.

Over 12 soil plots were taken but could not be advanced greater than a depth of 14 inches due to rocky soils and large stones up to 1 foot in diameter or greater. Fill material containing small fragments of brick, plastic, and glass with a matrix color of 10YR 3/3 were observed in all soil plots. No evidence of hydrology or visible hydrologic connections were observed.

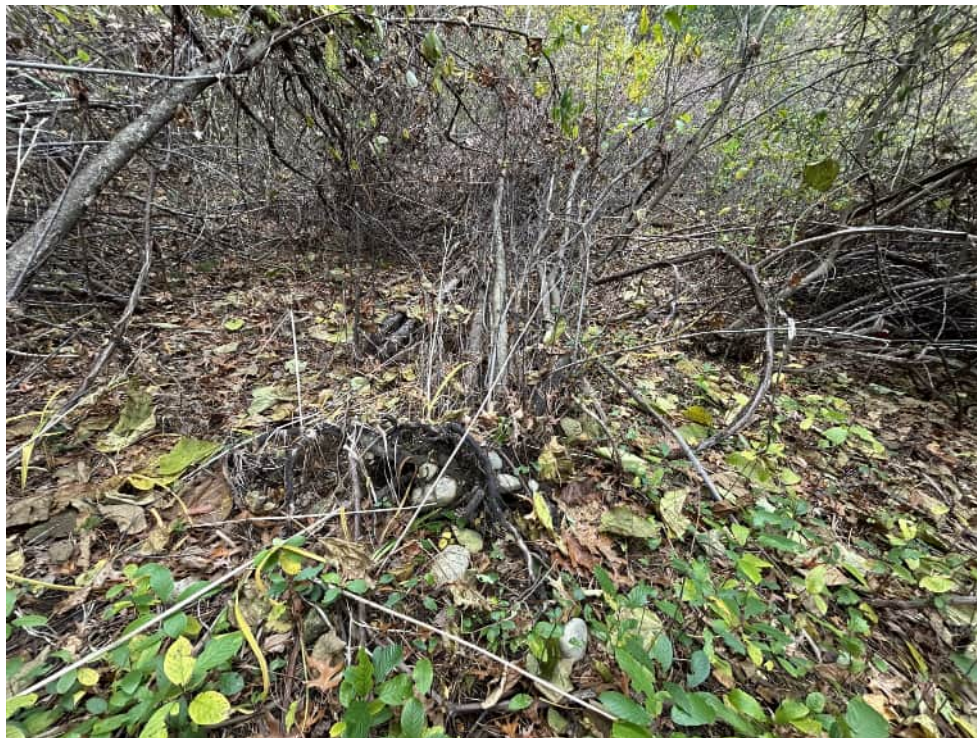
Photo 3

Another view of the area mapped as a wetland on MassMapper—facing north.

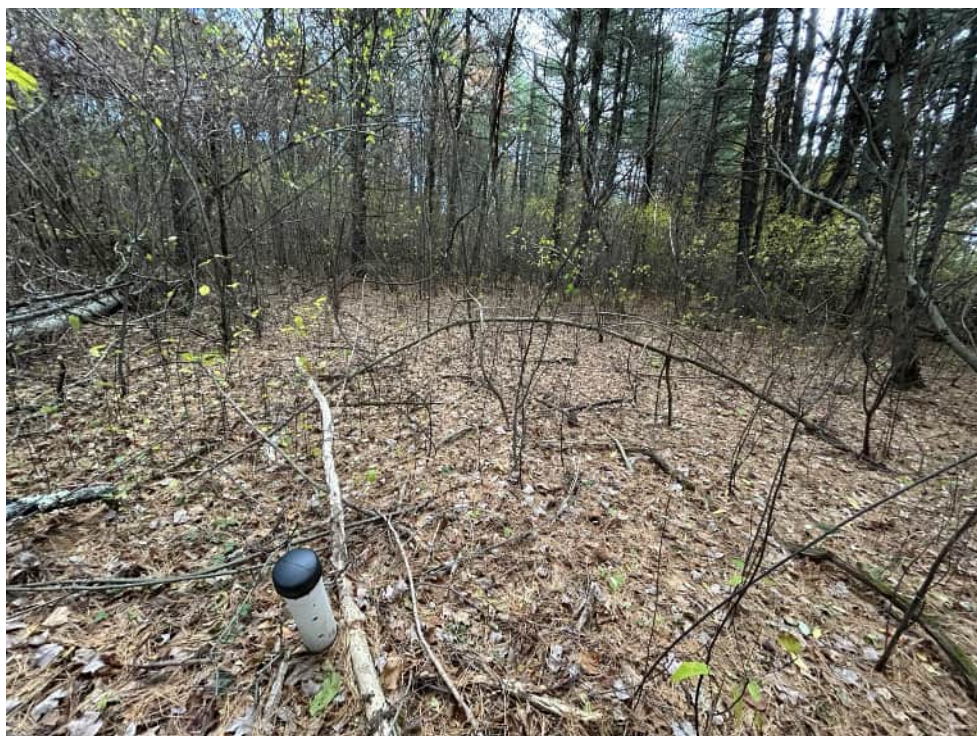
Photo 4

View of the upland area and potential monitoring well—facing southeast

The upland area at the Site was vegetated with glossy false buckthorn, northern catalpa, eastern white pine (*Pinus strobus*), northern red oak (*Quercus rubra*), and black walnut (*Juglans nigra*). The typical soil profile consisted of sandy loam. Two profiles were logged within the upland areas that surround the area mapped as a wetland as follows:

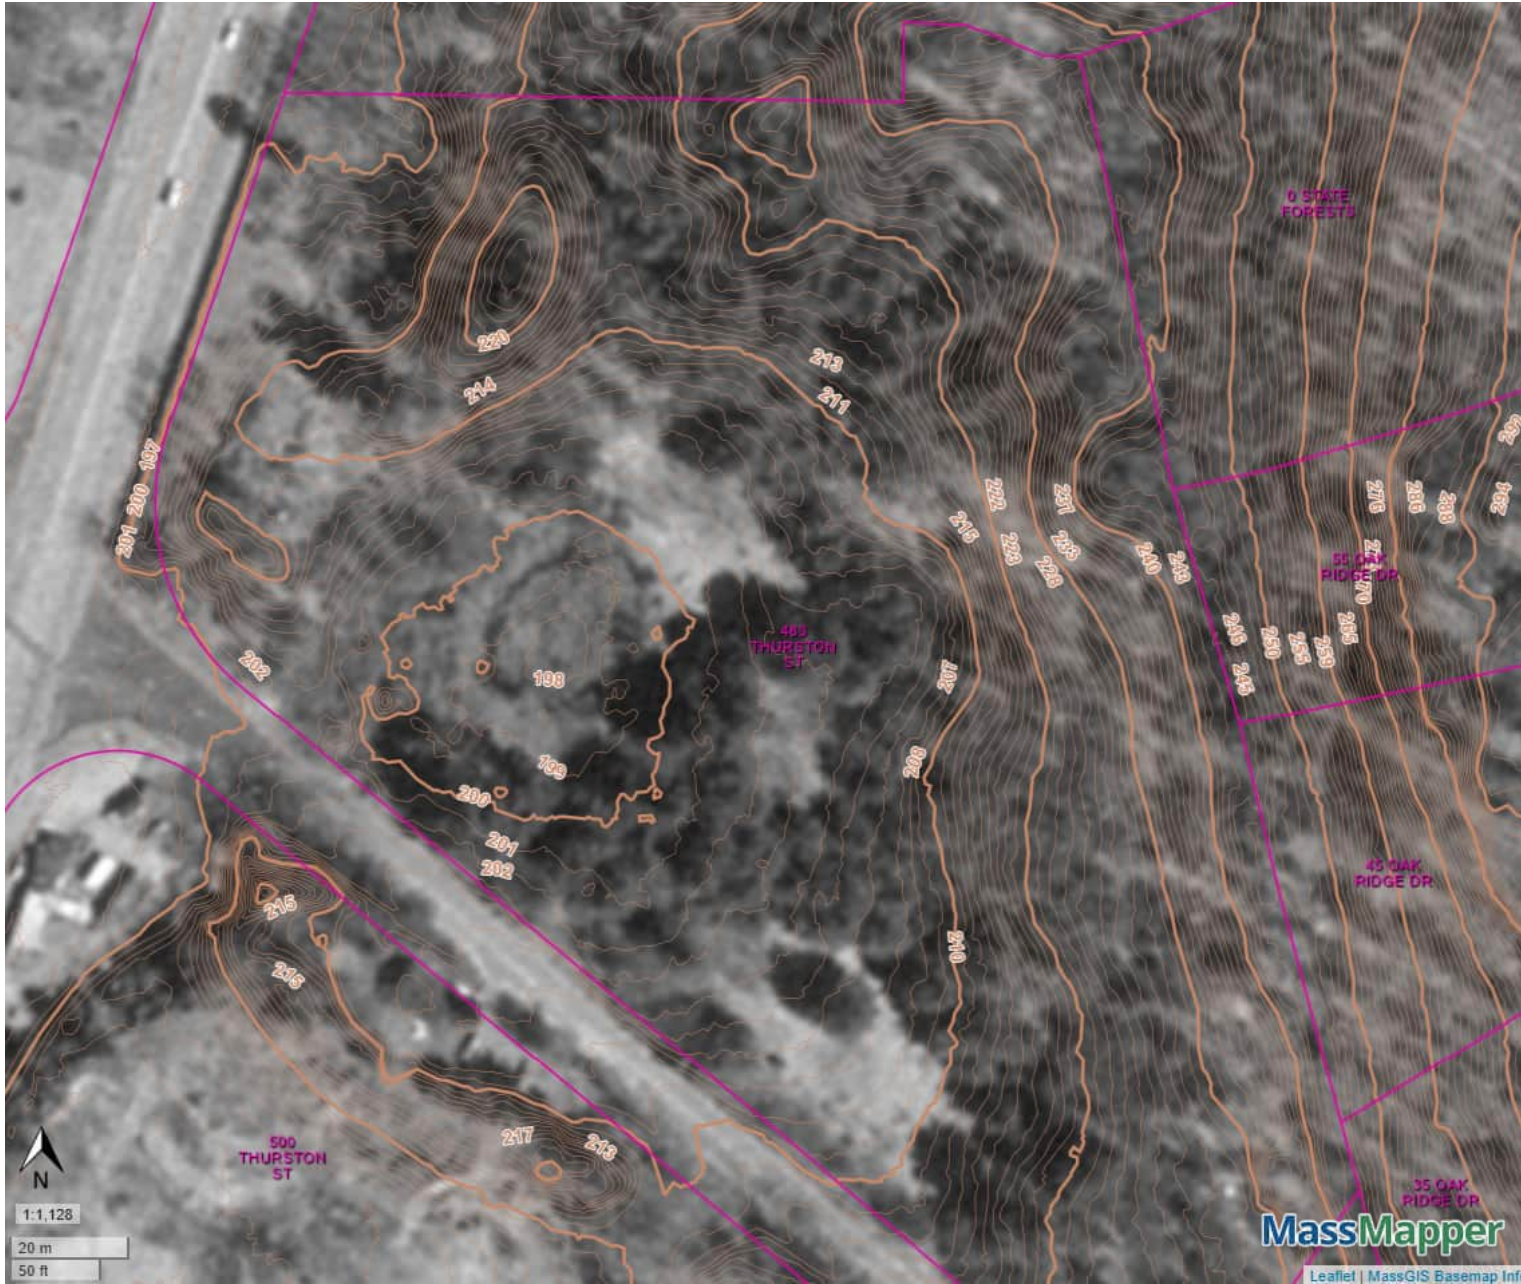
1990's Imagery

The presence of a wetland at 483 Thurston Street appears to be supported by historical aerial imagery available on MassMapper. This is represented by a visually darker area which typically represents water and is suggestive of a potential wetland in the 1990, 2001, and 2005 aerials (see attached). The 2005 aerial imagery shows potential disturbance at the Site and reduction in size of the potential wetland. Conditions at the Site within the location of a potential wetland appear generally consistent from the 2008/2009 aerial imagery to the 2023 aerial imagery (see attached).

Property Tax Parcels
Contours 1ft (Labels in Feet)
1990s Black and White Aerial Imagery

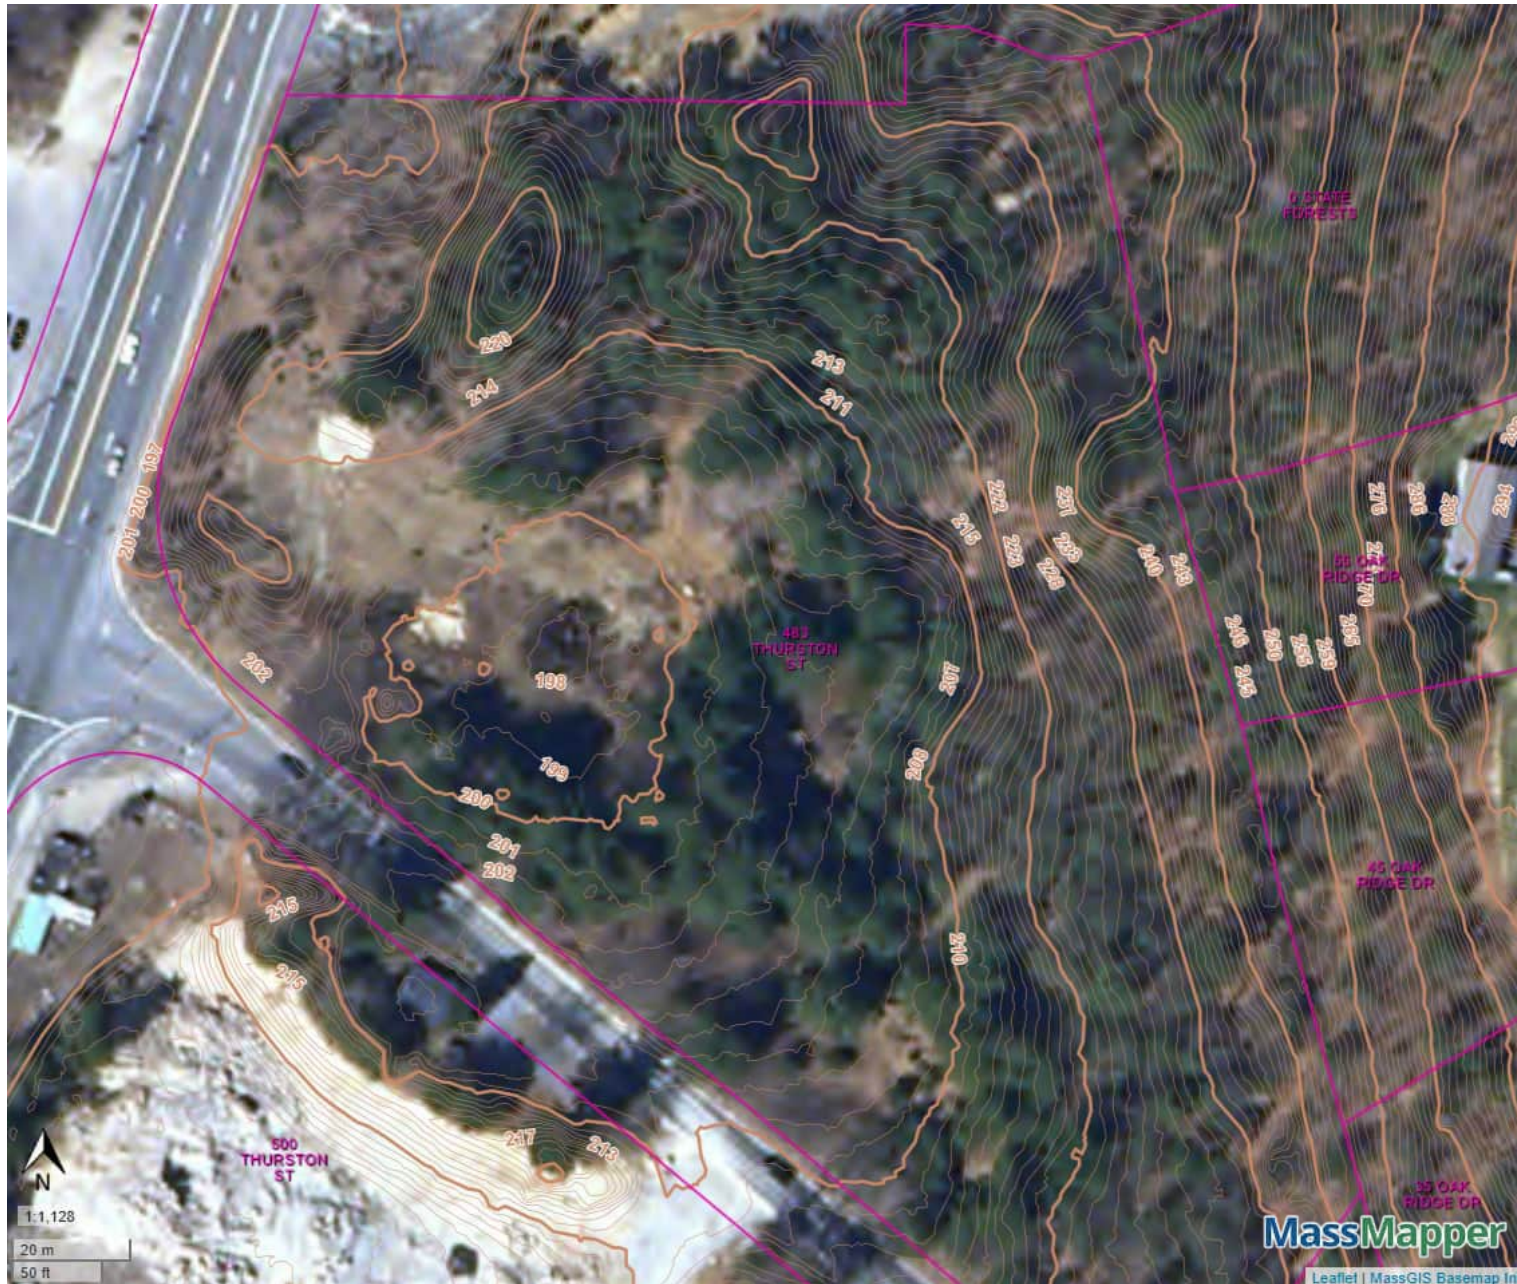
2005 Imagery

Property Tax Parcels
Contours 1ft (Labels in Feet)
2005 Aerial Imagery

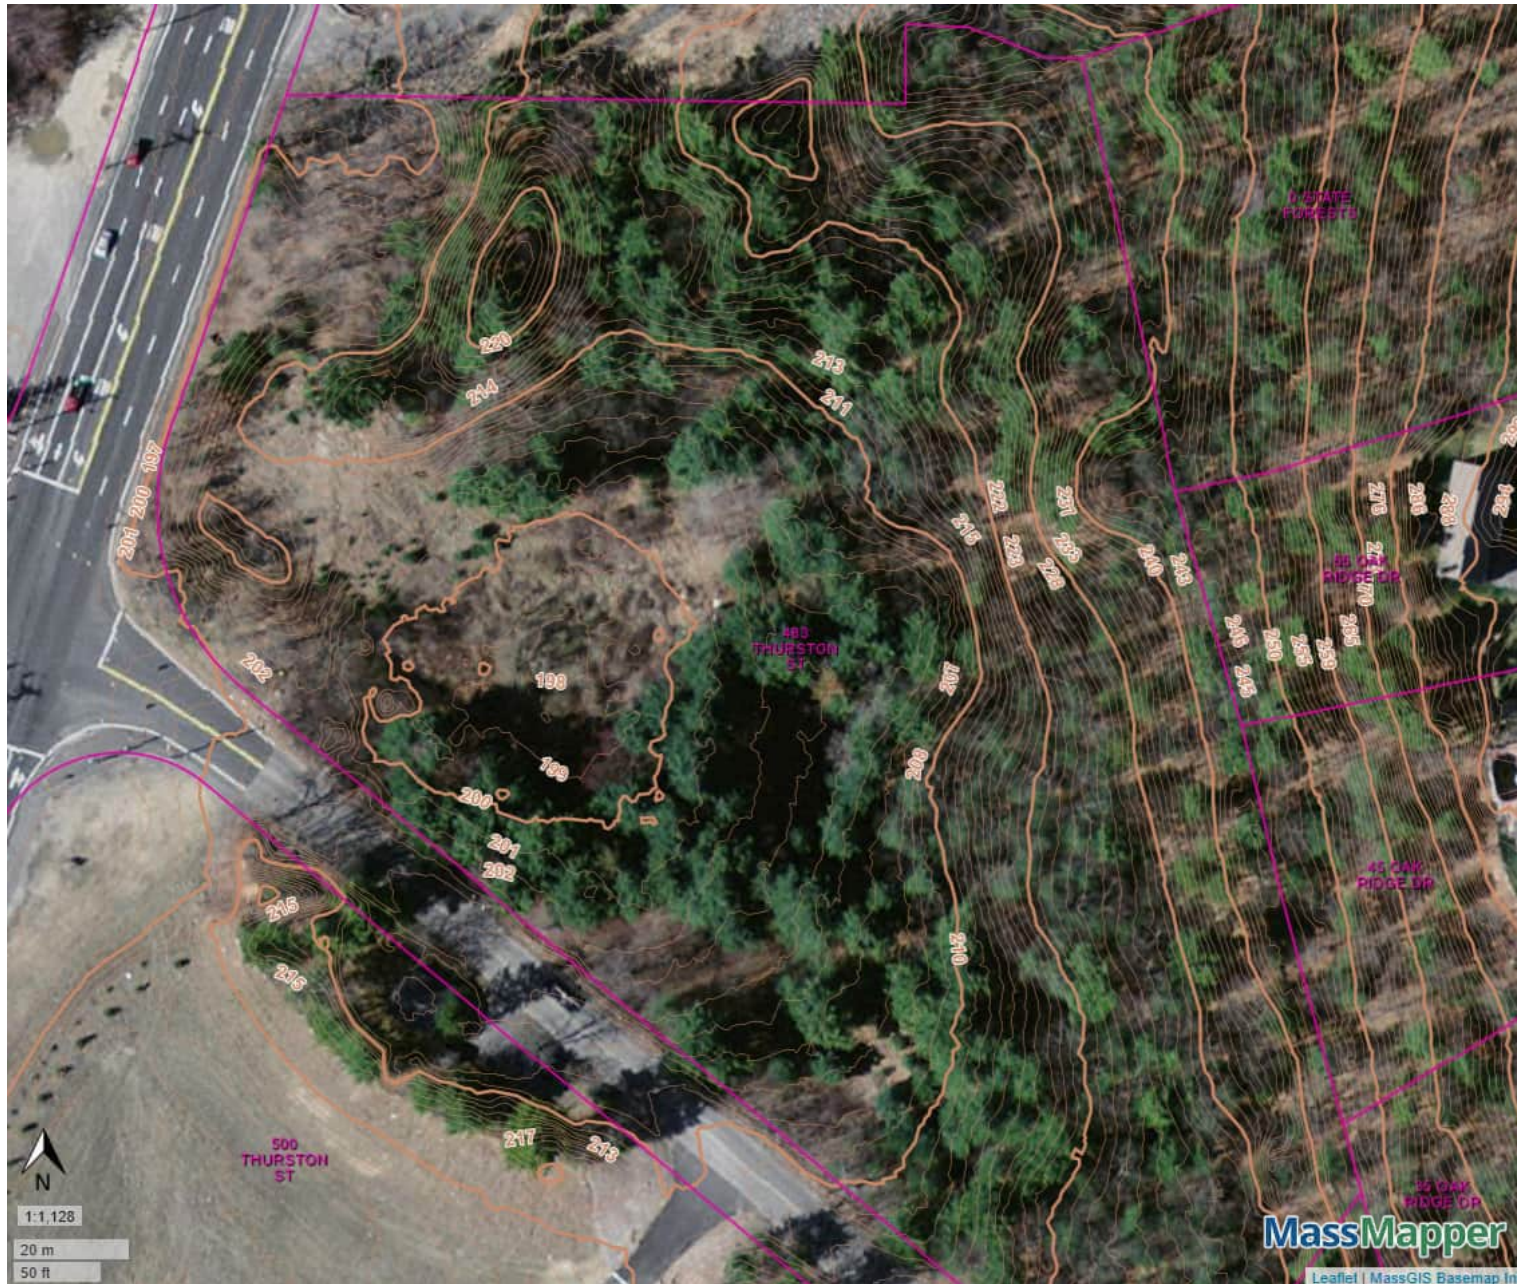
2008/2009 Imagery

Property Tax Parcels
Contours 1ft (Labels in Feet)
2008/2009 Aerial Imagery

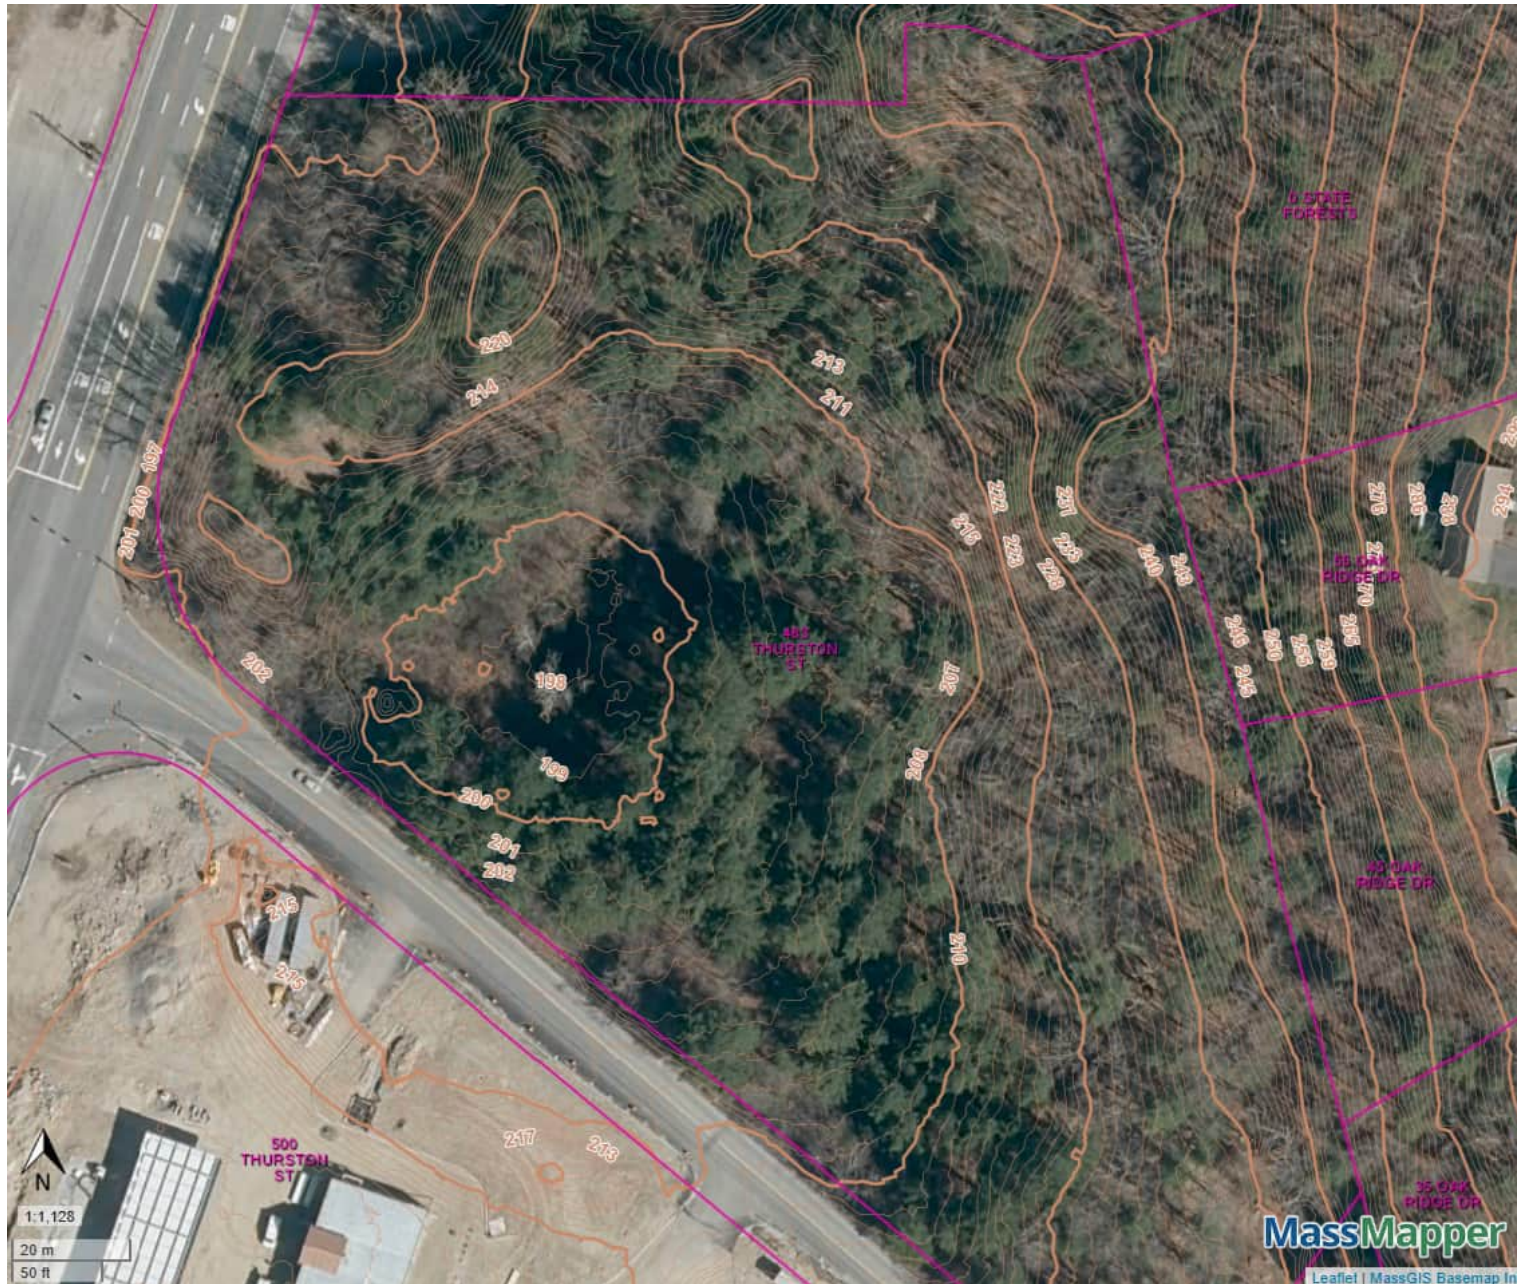
2025 Imagery

Property Tax Parcels
Contours 1ft (Labels in Feet)
2023 Aerial Imagery
