RE: Environmental Site Inspection  
2.19-acre property located at  
4640 Calle Corto, Titusville, FL 32780  
Tax ID: 2216905, Parcel ID: 22-35-29-25-1-1

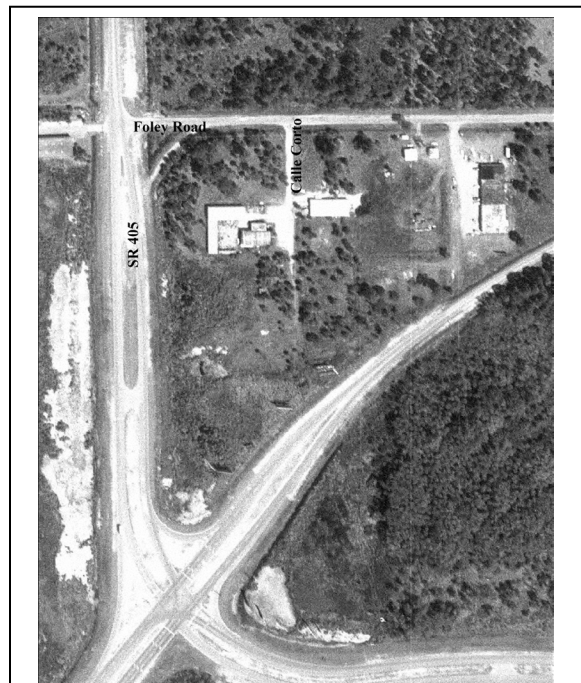
Photograph 1: FDOT 1972 Aerial

The property's elevation drops from the high along Calle Corto to the low along SR 405's drainage ditches. A review of property appraiser records, historical aerial imagery produced by FDOT, and permit records maintained by the SJRWMD indicate that the property was developed as early as 1972. (Photograph 1). The structures were cleared by late 2012 and the area was left to go fallow. A remnant edge of a larger wetland system persists in the southwest corner of the site (Figure 2). This wetland system was taken as part of the development of the Cumberland Farms convenience store and gas station, Pep Boys Tire, and Aspen

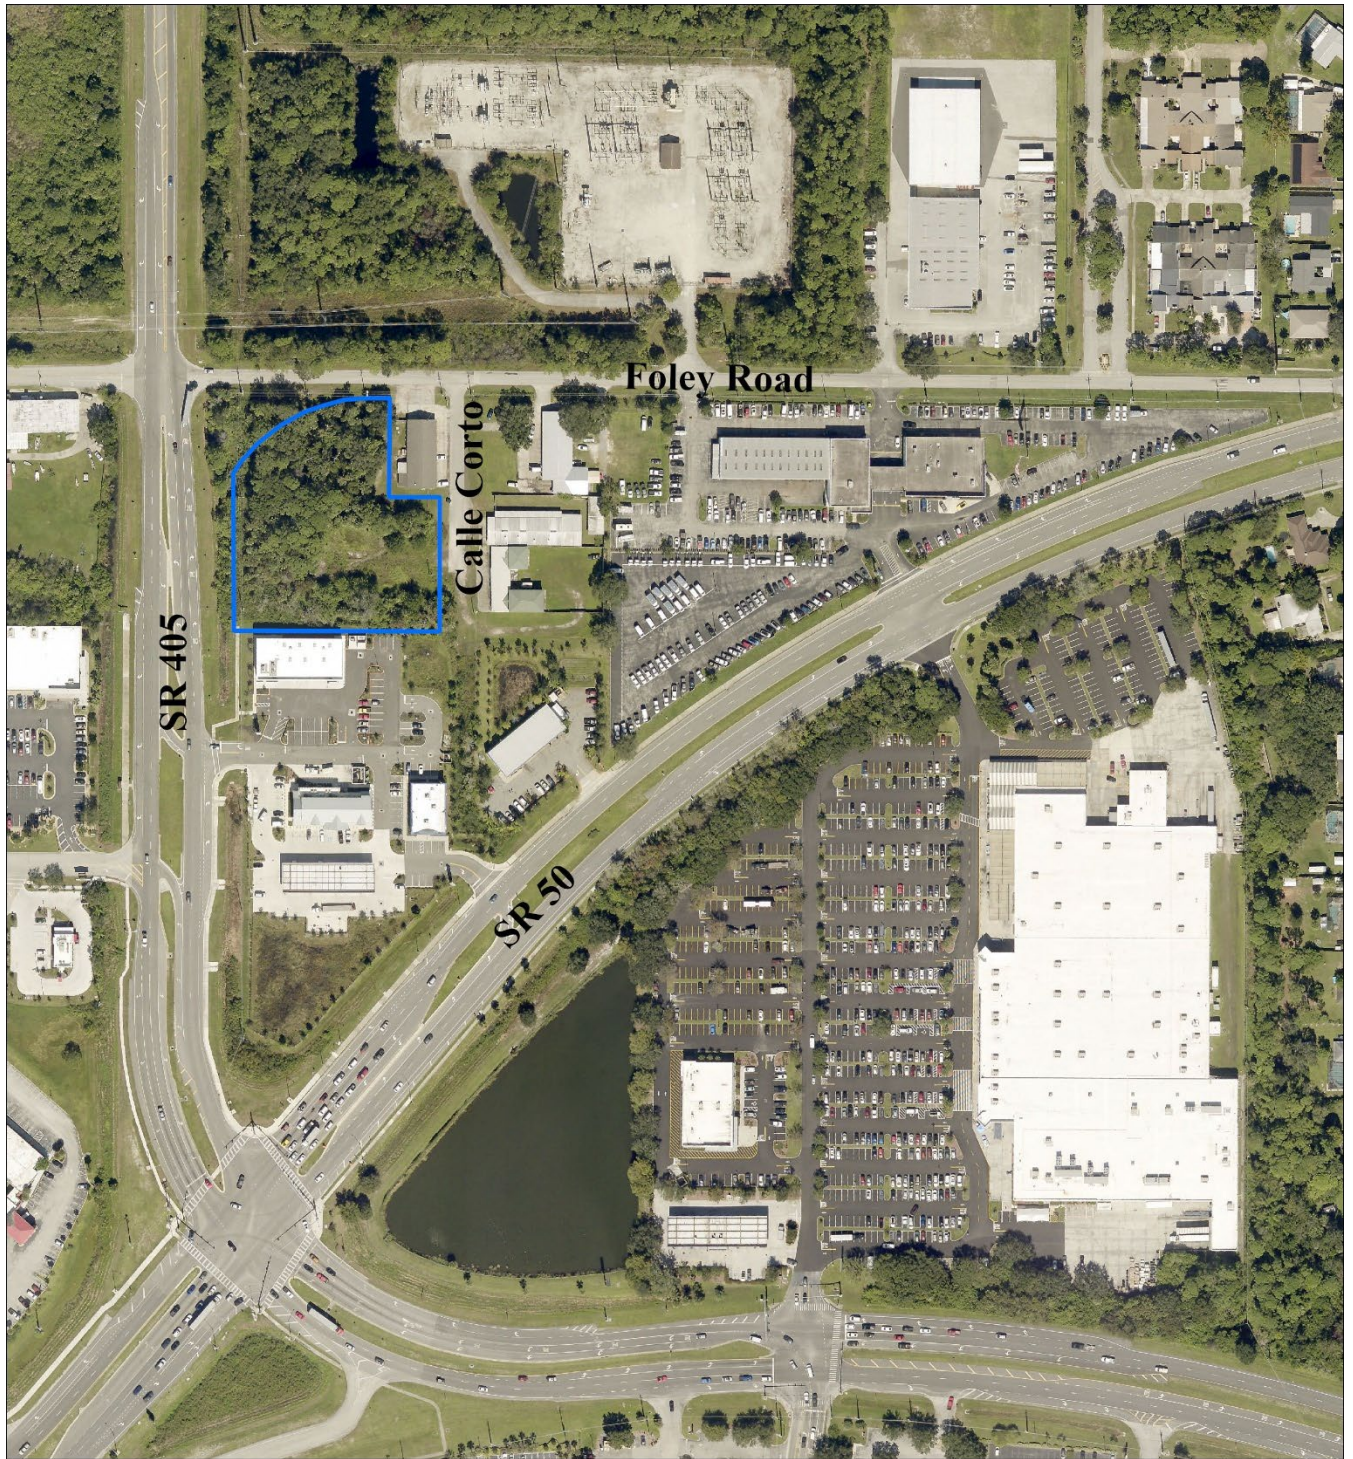
Figure 2: FDOT 1986 Aerial Image with SJRWMD 1986 Wetlands Map

SJRWMD 1986 Wetland Maps

Dental Practice (SJRWMD Permit #148738 1-3). The Technical Staff Report (TSR) associated with these permits found that “There are no remaining wetlands within the property and no adjacent wetlands that might sustain secondary impacts”, and no secondary impacts were assessed as part of the District’s permitting process. Over time, the low-lying area in the southwest corner of the property has evolved into a jurisdictional wetland that was likely formed by blocking predevelopment sheet flow to historical drainage ways and sloughs to the south and west with large-scale development and major roadway improvements, thereby allowing more water to stage in this area.

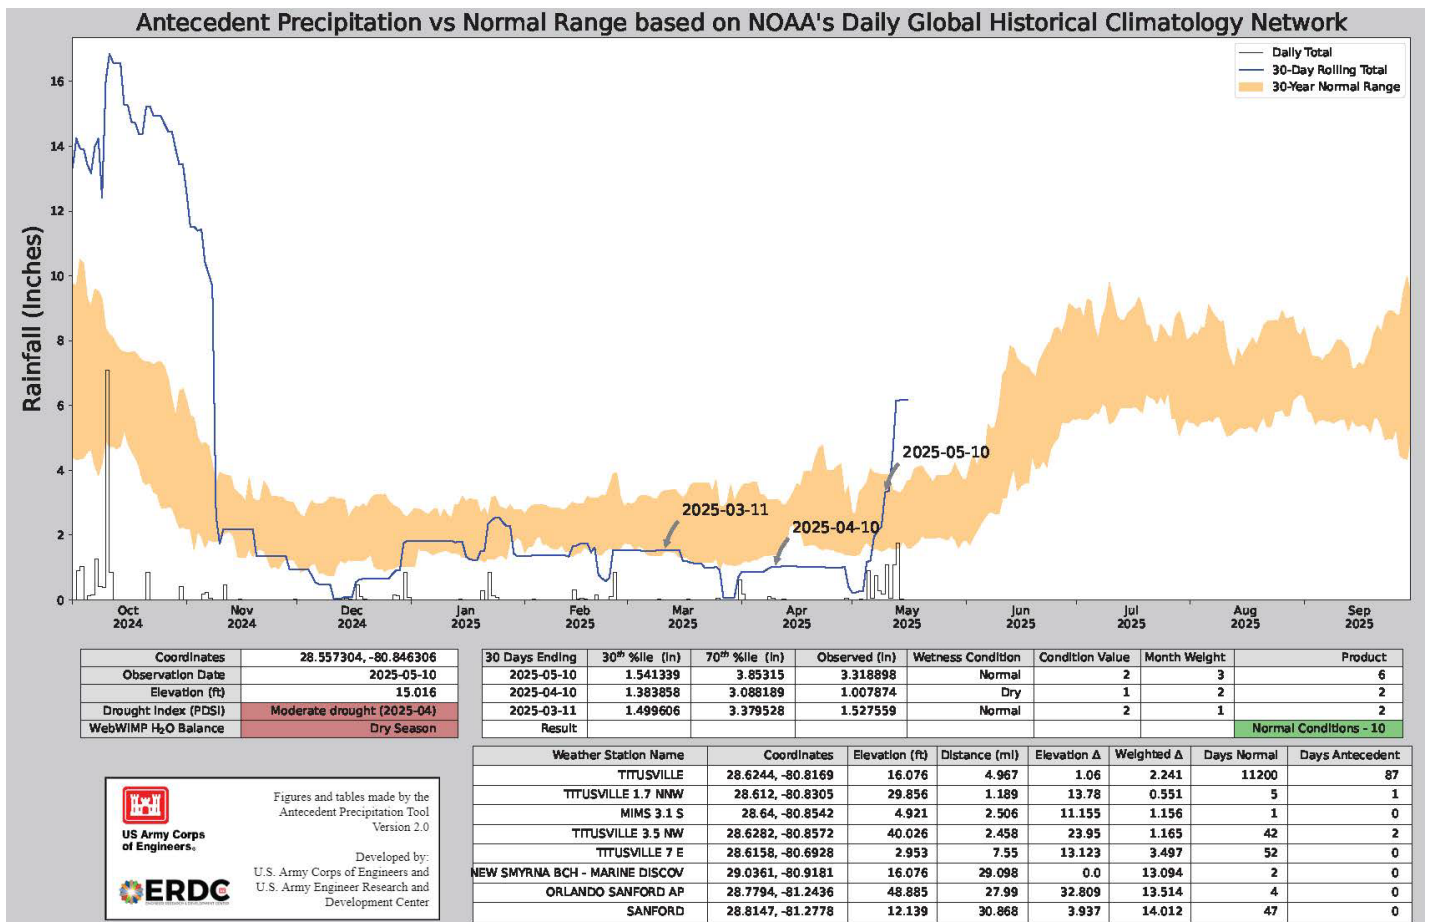
Figure 3: ACOE Antecedent Precipitation Tool

On May 10, 2025, TEC ground-truthed, delineated, and described the natural communities with reference to both the FLUCCS system and Florida’s Cooperative Land Cover (CLC) classification system as maintained and last updated in September 2018 by the Florida Fish and Wildlife Conservation Commission (FWC). Weather conditions during TEC’s field review, as determined by the US Army Corps of Engineers (ACOE) Antecedent Precipitation Tool, were within the thirty-year normal range for dry season conditions (Figure 3).

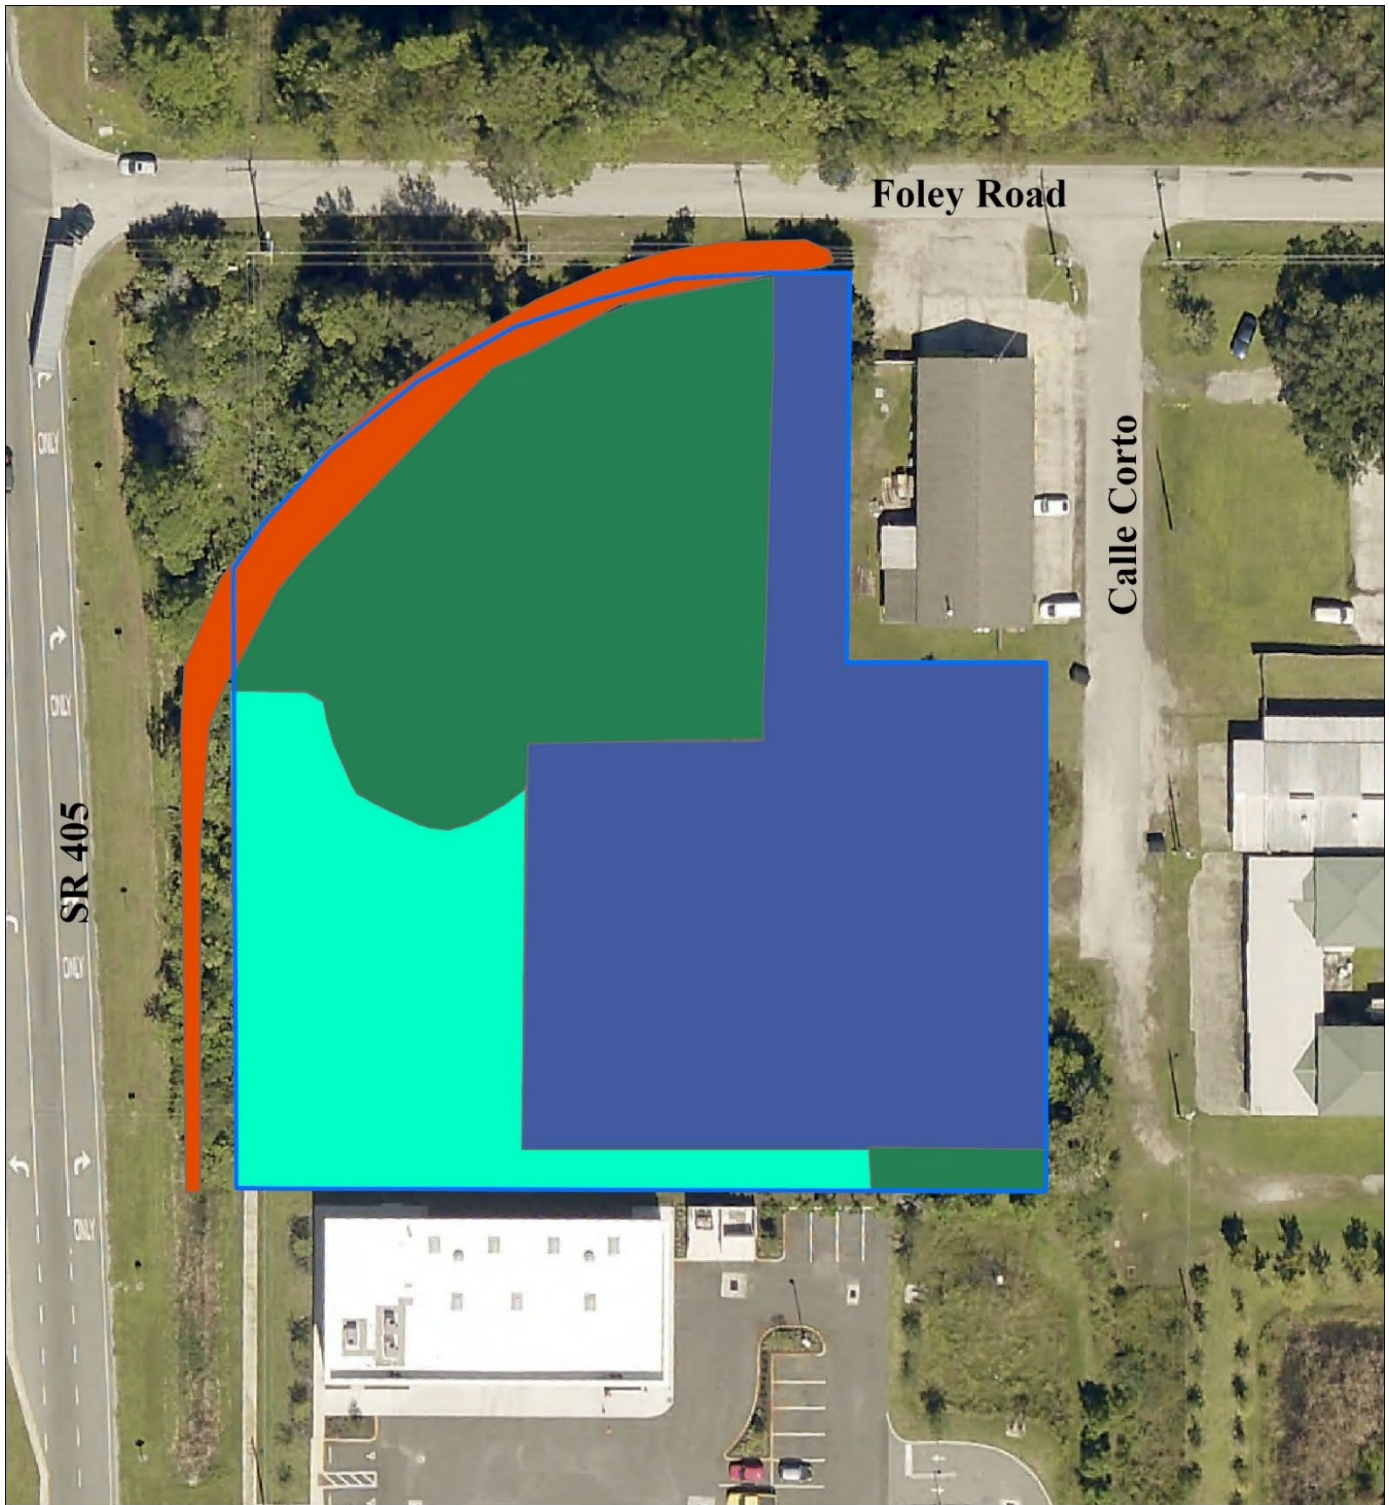
Figure 4: Natural Communities Cover Map

In its current condition, the property would be classified by CLC as being 0.88 acres of CLC 18224 Industrial (FLUCCS 1500 – Light Industrial), 0.64 acres of CLC 1311 Mesic Flatwoods (FLUCCS 4110 Pine Flatwoods), 0.46 acres of Freshwater Forested Wetlands (FLUCCS =6300 Wetland Forested Mixed), and 0.21 acres of CLC 4420 Artificial Ditch/Stream (FLUCCS 740 Disturbed Uplands) (Figure 4)

CLC 1311 Mesic Flatwoods (FLUCCS 4110 Pine Flatwoods)
-

CLC 18224 Industrial (FLUCCS 1550 Light Industrial)
-

CLC 2200 Freshwater Forested Wetlands (FLUCCS 6300 Wetland Forested Mix)
-

CLC 4420 Ditch/Artificial Stream (FLUCCS 740 Disturbed Lands)
