**TEXAS OFFICIAL WOOD DESTROYING INSECT REPORT**

1207 E Rio Grande Ave

El Paso, TX

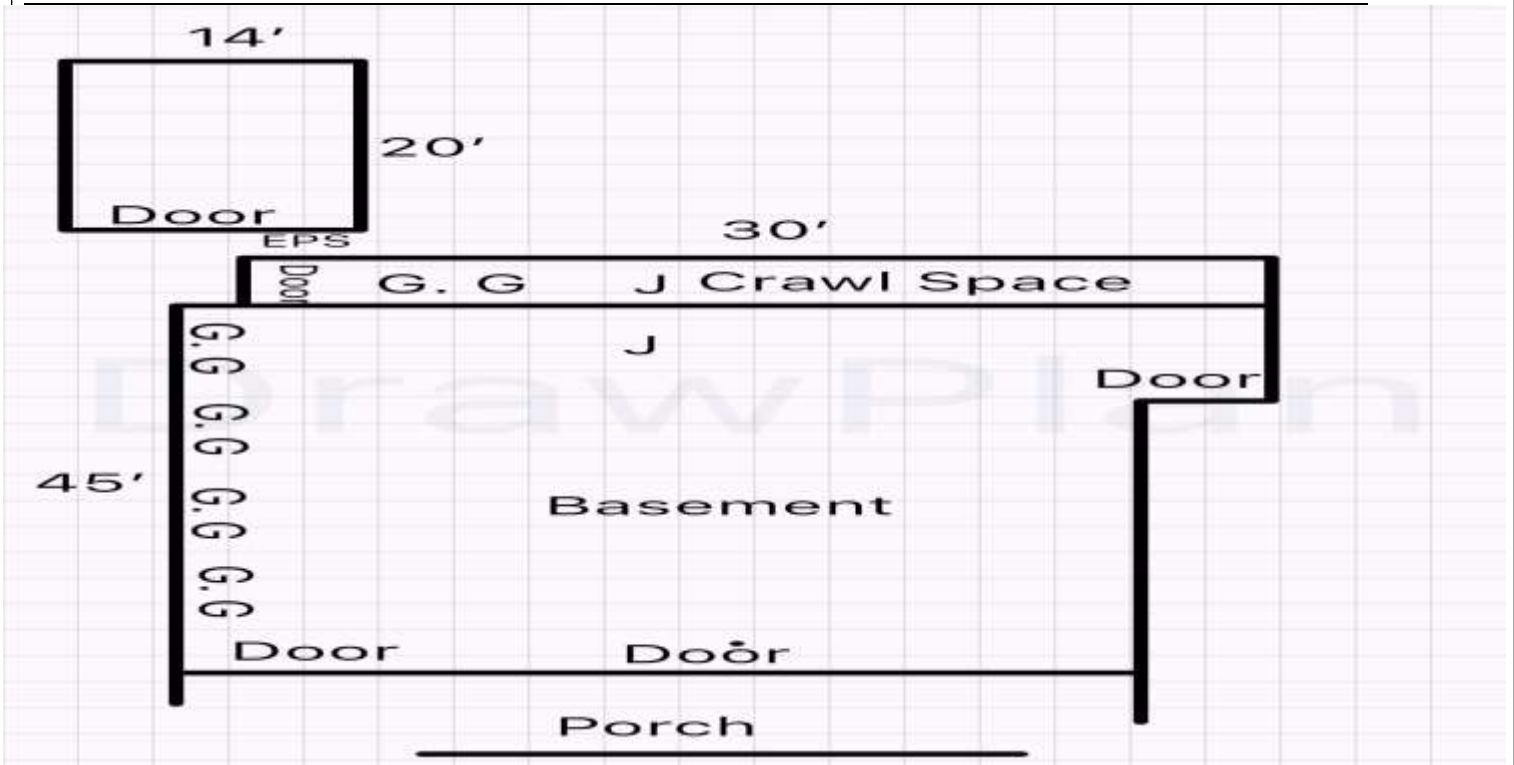
**Diagram of Structure(s) Inspected**

11G. Visible evidence of: 11A has been observed in the following areas: DETACHED STRUCTURE DOOR FRAME

Specify reason: G: WOOD TO GROUND CONTACT IN CRAWLSPACE. J: EXCESS MOISTURE IN CRAWL SPACE AND BASEMENT

Additional Comments RECOMMEND TREATMENT
