WOOD DESTROYING PESTS AND ORGANISM INSPECTION REPORT

Building No. 12700	Street State Route 1	City Point Reyes Station	ZIP 94956	Date of Inspection 8/7/2020	Number of Pages Page 1 of 29

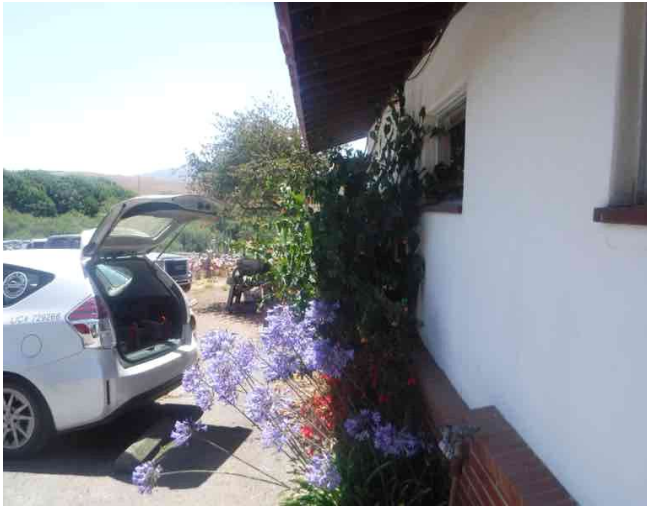
Photo 01

2A. FINDING: There is vegetation in contact with the structure. (See Photo 1) (See Photo 20) (See Photo 63)

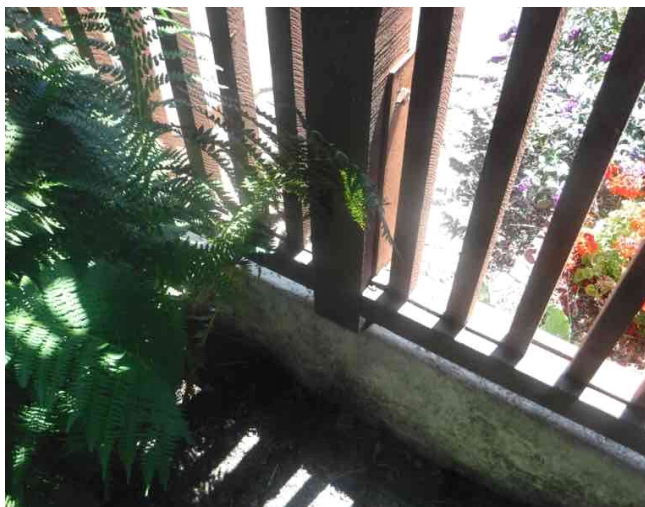
Photo 10

1G. FINDING: The front deck hand railings have been damaged by fungus. The contributing moisture source appears to be exposure to the weather. (See Photo 10) (See Photo 11)

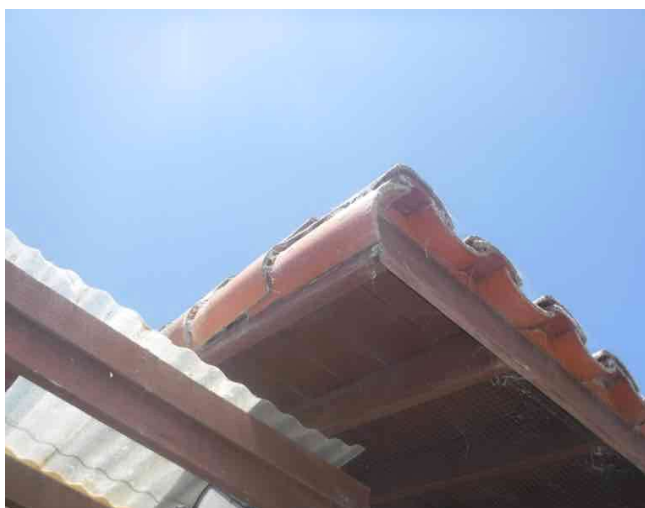
Photo 12

1H. FINDING: The barge rafter(s) as indicated on the diagram are damaged by fungus. The contributing moisture source appears to be exposure to the weather. (See Photo 12) (See Photo 15)

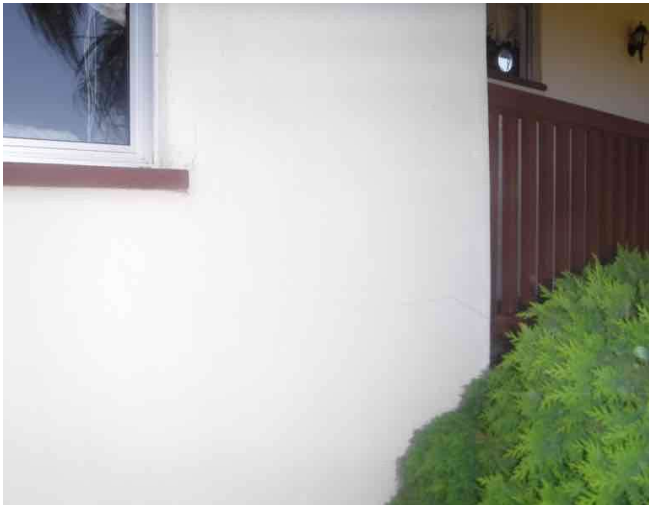
Photo 21

2C. FINDING: Minor stress cracks were noted in the exterior stucco as indicated on the diagram. (See Photo 14) (See Photo 21) (See Photo 25)

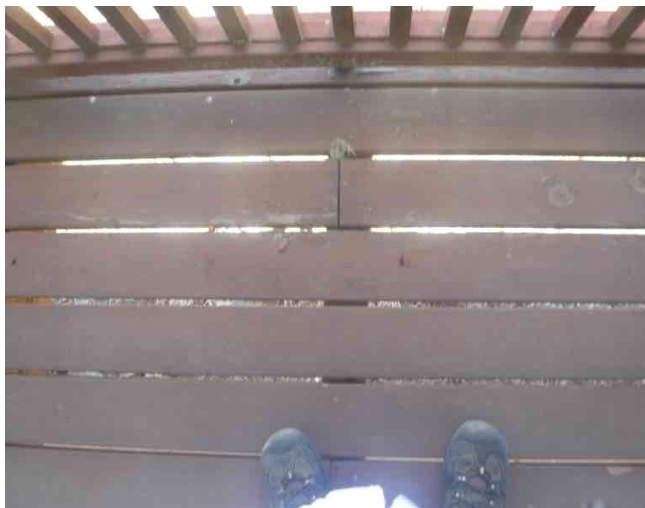
Photo 42

1J. FINDING: The fascia board and deck boards at the front deck has been damaged by drywood termites. The contributing moisture source appears to be exposure to the weather. (See Photo 19) (See Photo 42) (See Photo 43)

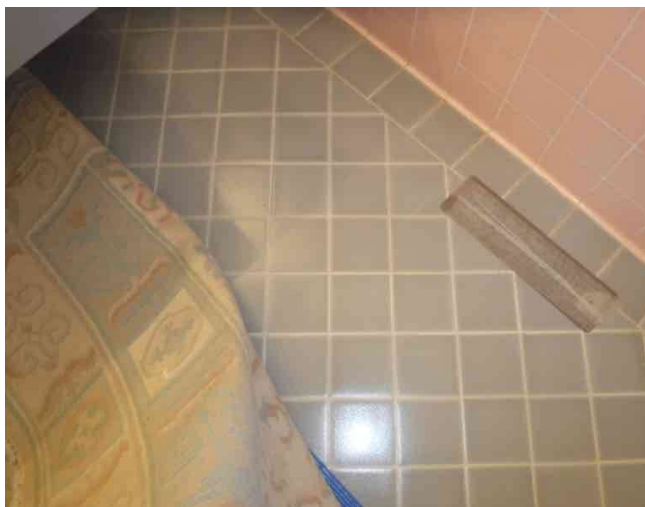
Photo 44

2H. FINDING: Cracked tiles were noted on the bath floor. (See Photo 44) (See Photo 47)

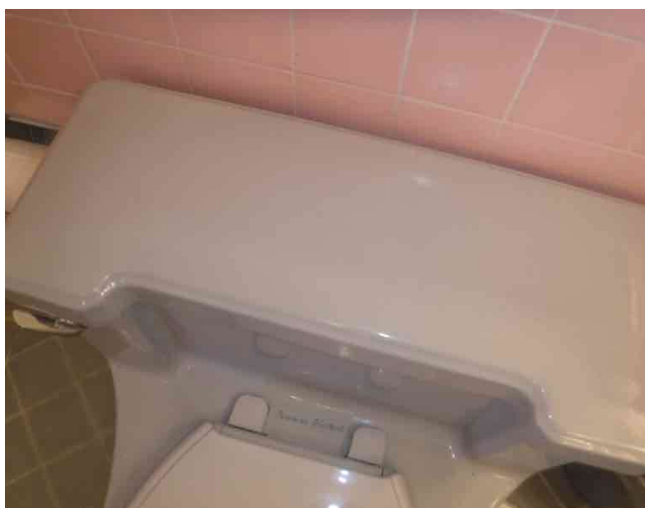
Photo 46

2J. FINDING: We observed the following conditions in the course of our inspection: The bathroom toilet tank was noted to be cracked. (See Photo 46)

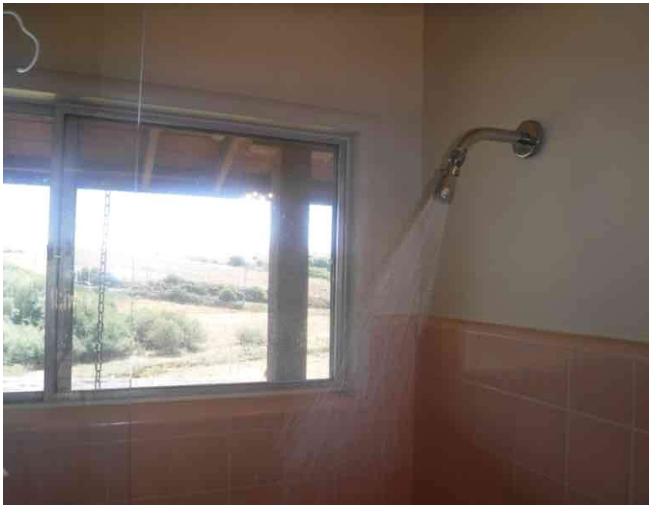
Photo 49

2L. FINDING: The window is lower than the shower head at the hall bath. This could allow moisture intrusion onto the enclosed framing. (See Photo 49)

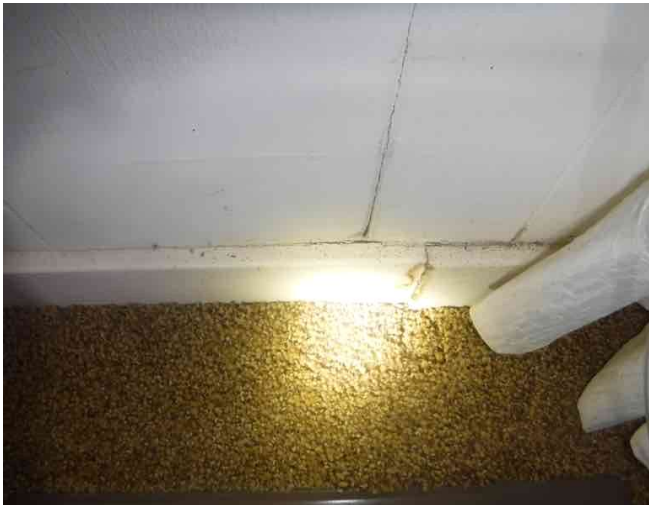
Photo 55

1B. FINDING: Drywood termite pellets were evident as noted in the above recommendation. (See Photo 2) (See Photo 55)

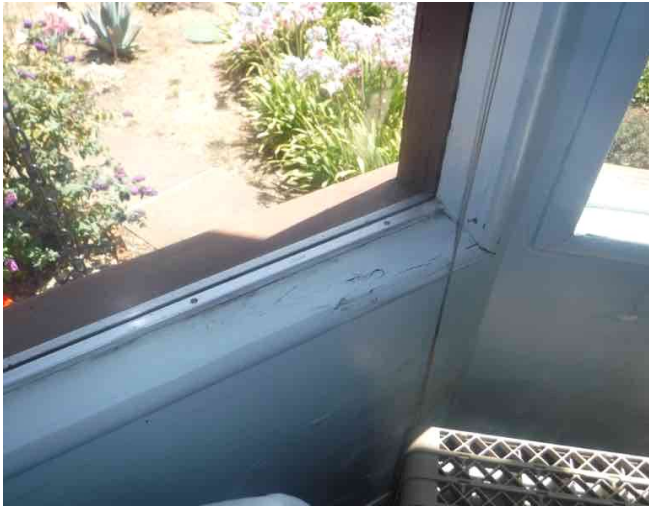
Photo 62

1Q. FINDING: The interior dining area window trim has been damaged by drywood termites. (See Photo 62)

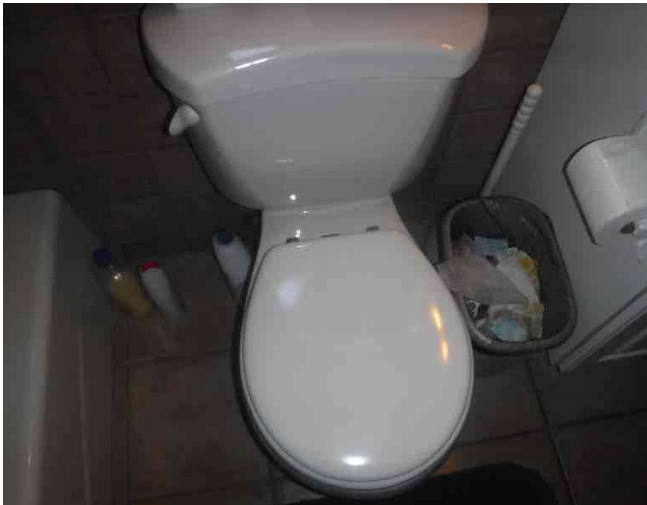
Photo 89

2S. FINDING: The toilet is loose or improperly mounted at the detached guest house master bathroom. (See Photo 89)

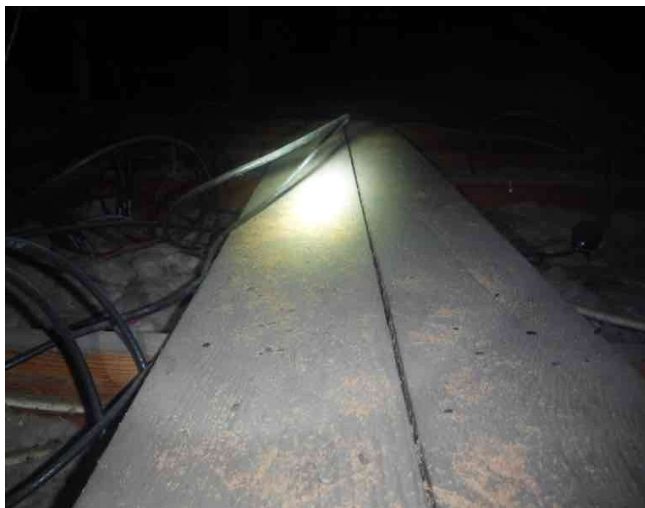
Photo 94

1A. FINDING: Infestation by Drywood Termites was noted at the exterior rafters, patio cover, front deck, attic rafters at the main house and the detached guest house. (See Photo 2) (See Photo 54) (See Photo 94)

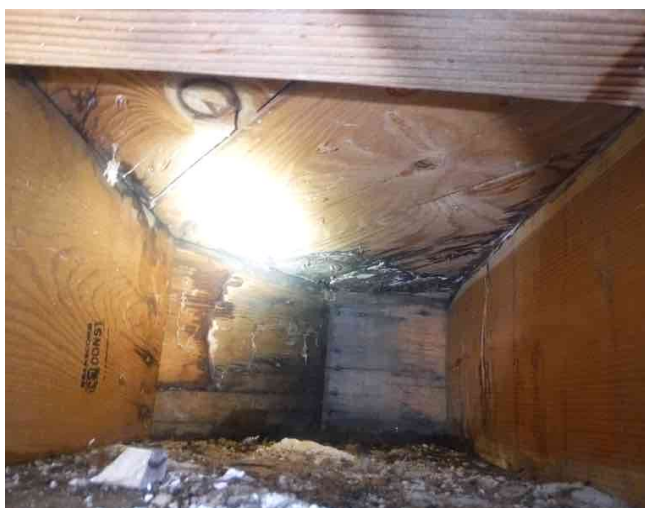
Photo 99

1X. FINDING: The subfloor has been damaged by fungus subarea. (See Photo 98) (See Photo 99)
