202 - 220 S. State Street

Appendices

Appendix C: Building Preservation Plans (BPP)

220 South State Street
Chicago, Illinois, IL0315ZZ

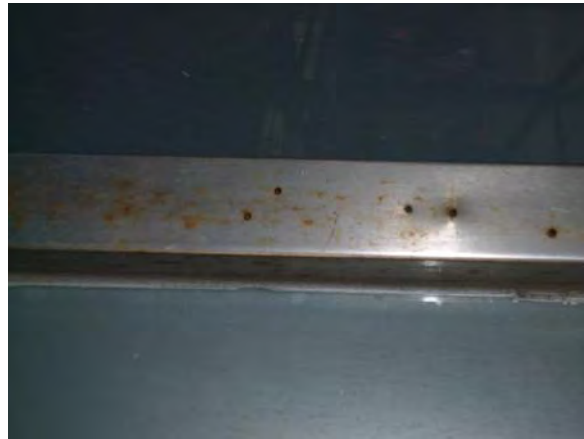
Image 60: Steel storefront frame, east façade.

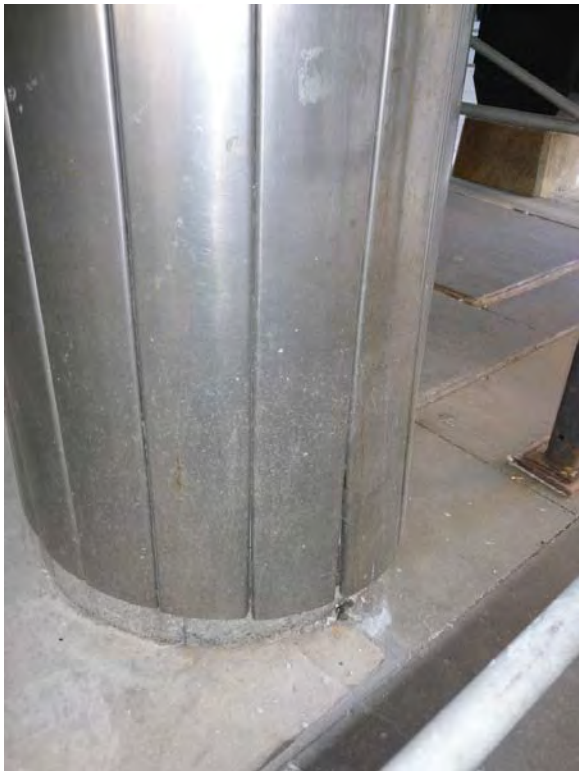
Image 61: Northeast exterior column and steel cladding.

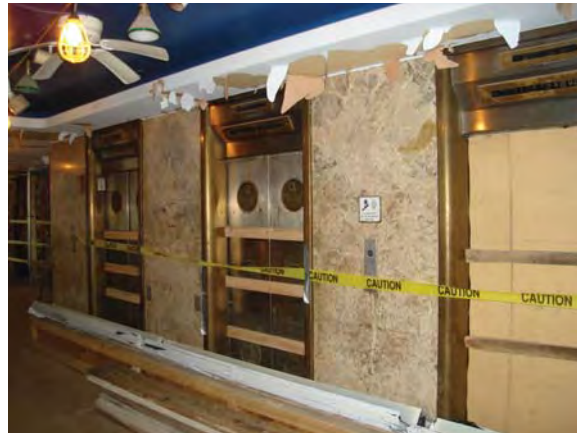
Image 62: Elevator lobby, first floor. Typical of all elevator doors on this floor.

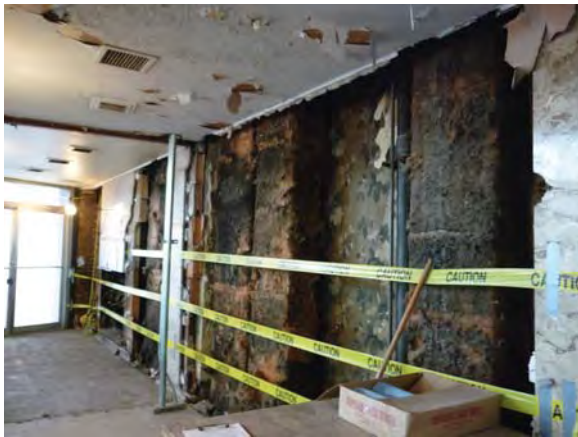
Image 63: South wall of main lobby. Much of the 1951 marble cladding has been removed.

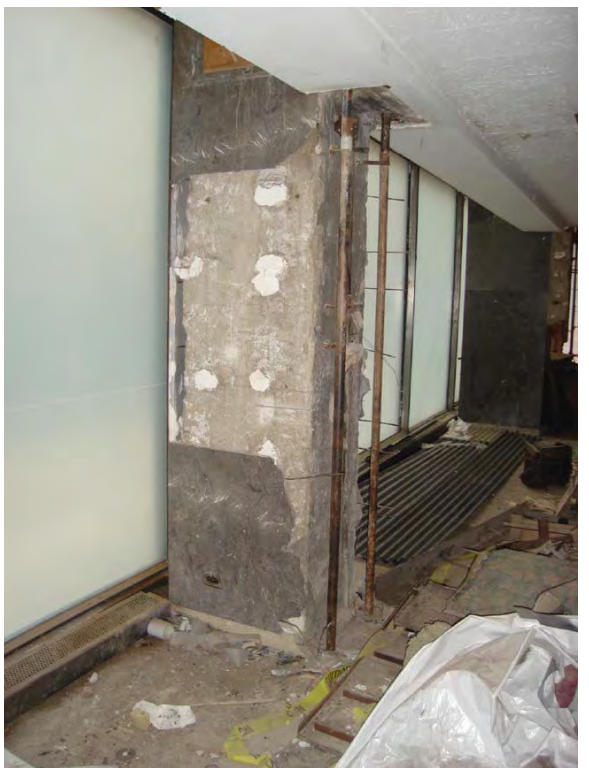
Image 66: Typical condition of columns along the north and east facades on the first floor.

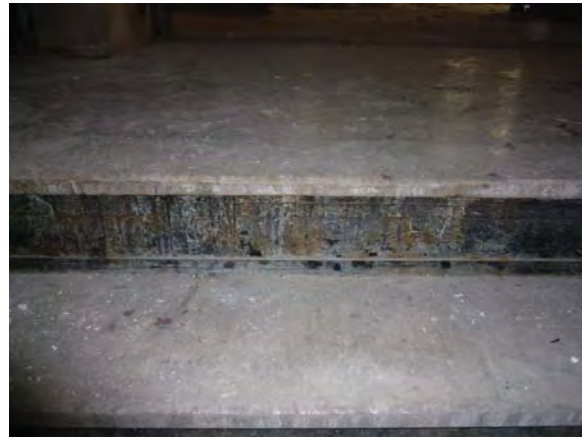
Image 68: Main stair, typical riser condition, floors 2 and above.

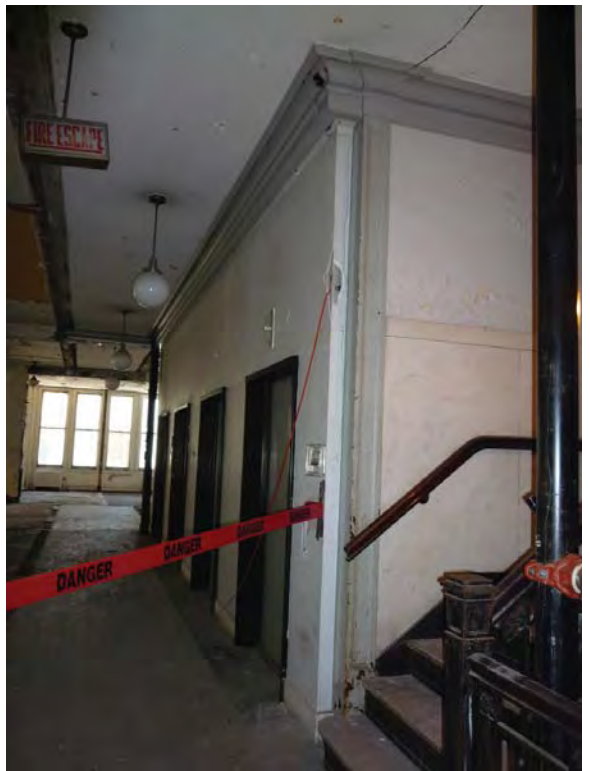
Image 73: Elevator doors, floor 2.

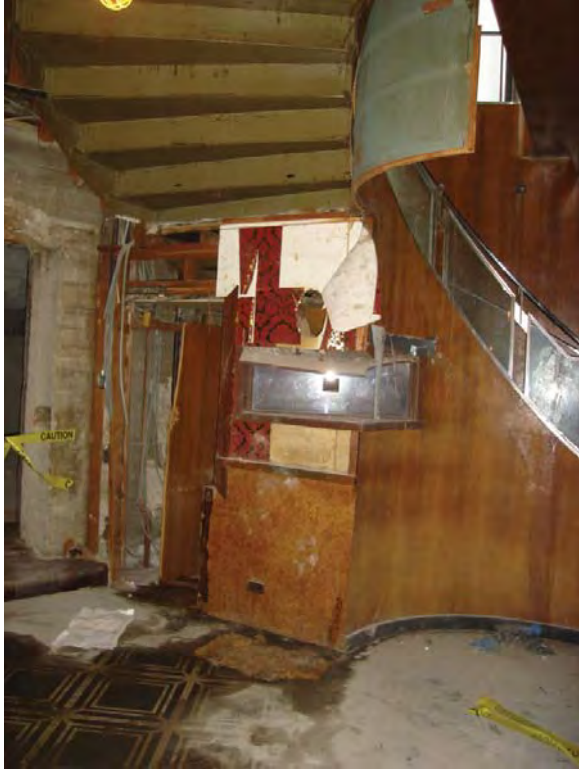
Image 75: Underside of decorative stair, first basement.

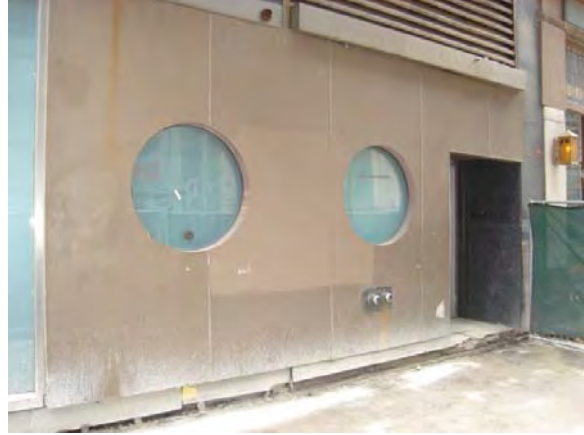
Image 76: Northwest entry, cladding over 1951 storefront.

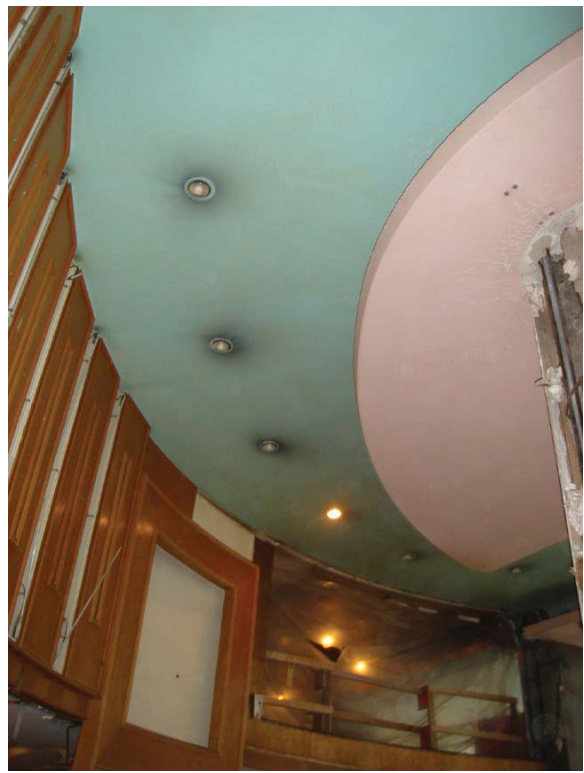
Image 78: First floor tenant space; 1951 lighting and ceiling.

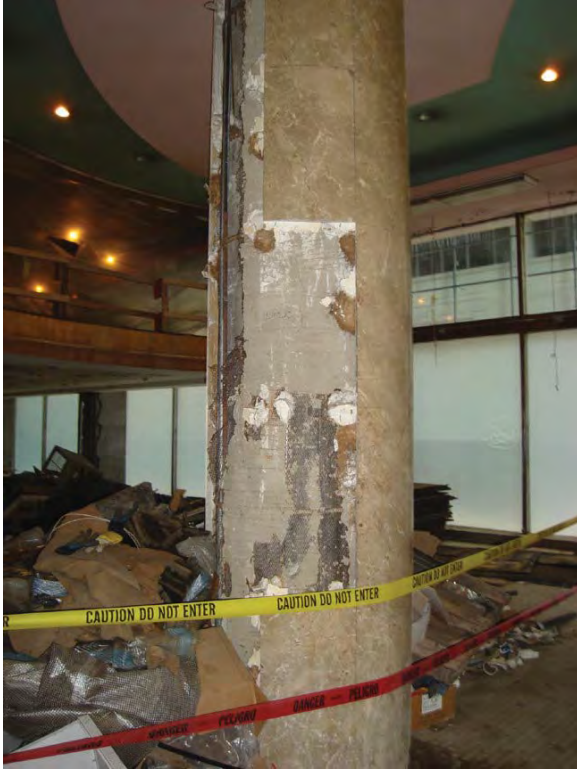
Image 79: Cylindrical column, first floor tenant space.

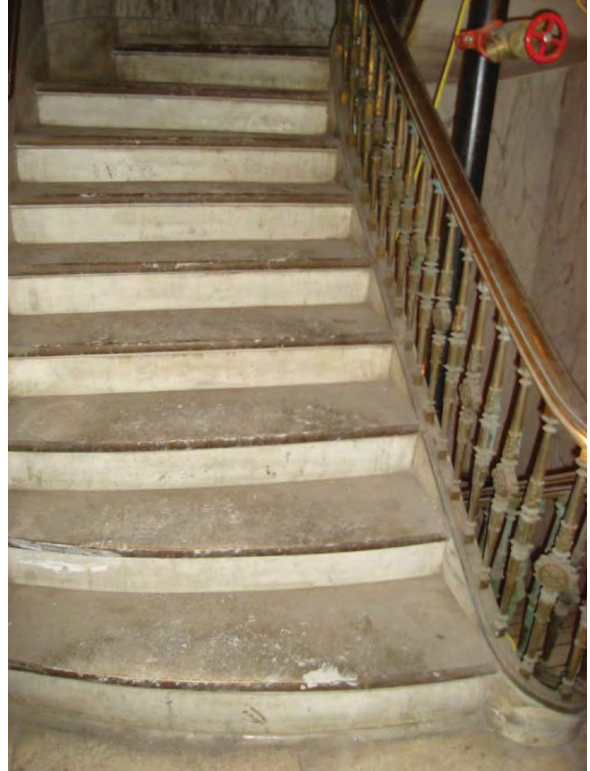
Image 80: Main stairway between basement and mezzanine. Note standpipe at right.

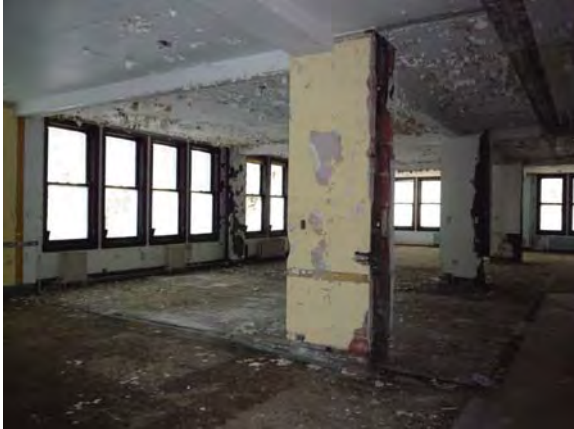
Image 81: 14th floor tenant space. Typical condition of floors 2-15.

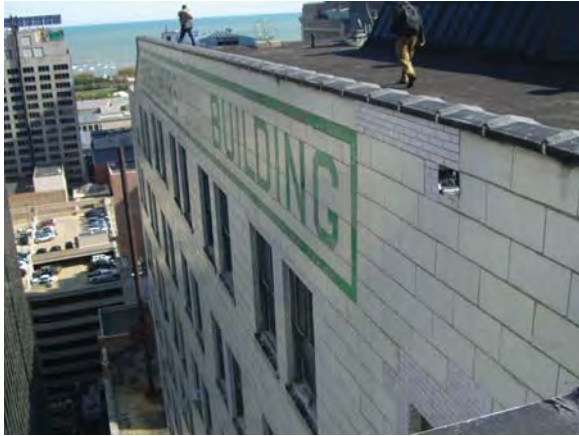
Image 23: North façade signage.

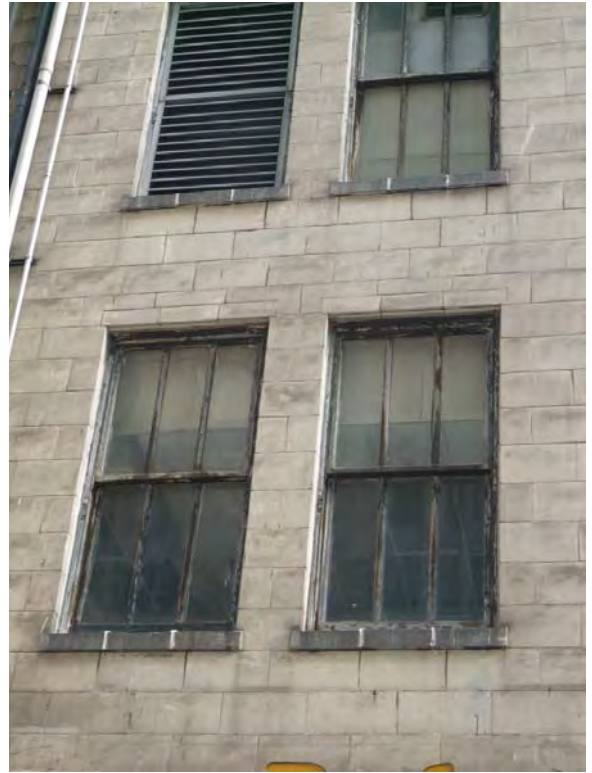
Image 30: Typical windows, west façade.

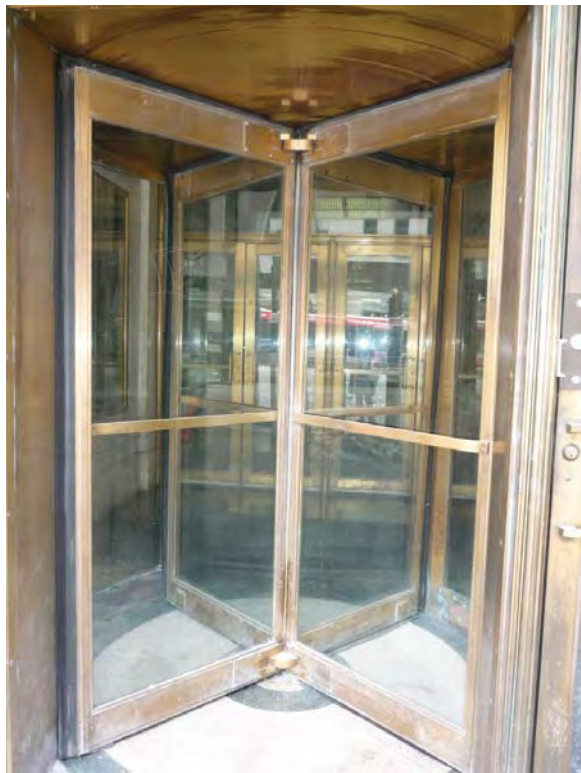
Image 33: Existing revolving door.

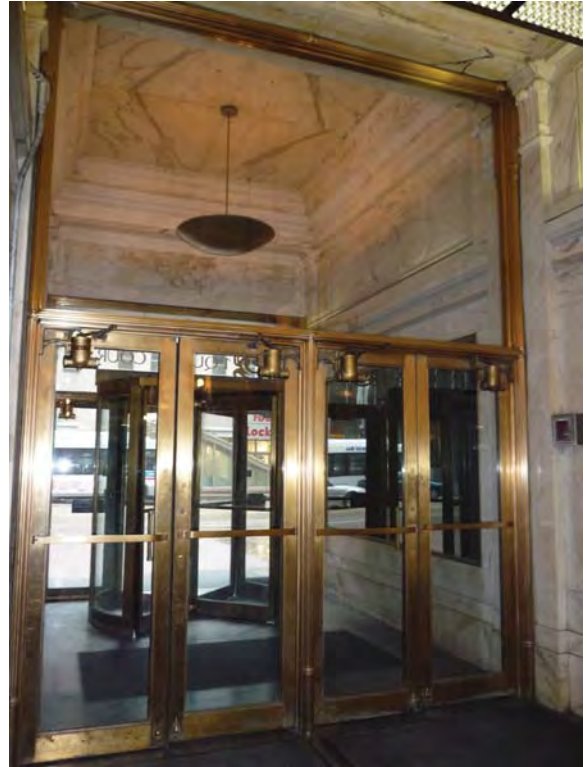
Image 36: Entry vestibule, view east from main lobby.

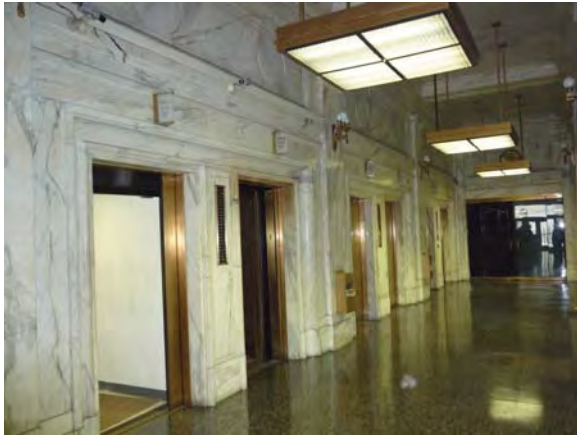
Image 39: Main lobby, view southwest.

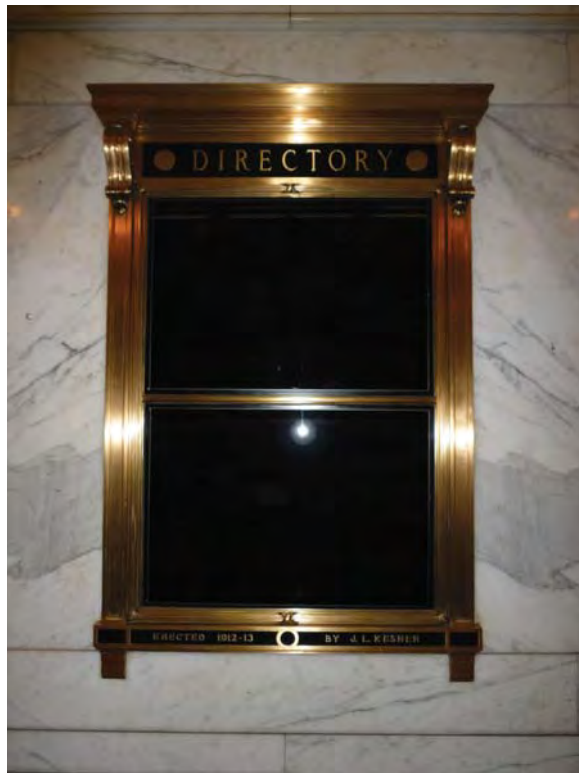
Image 42: Building directory, main lobby.

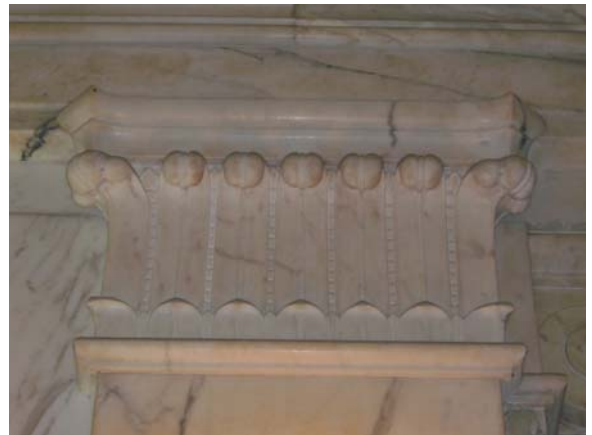
Image 44: Typical column capital, main lobby.

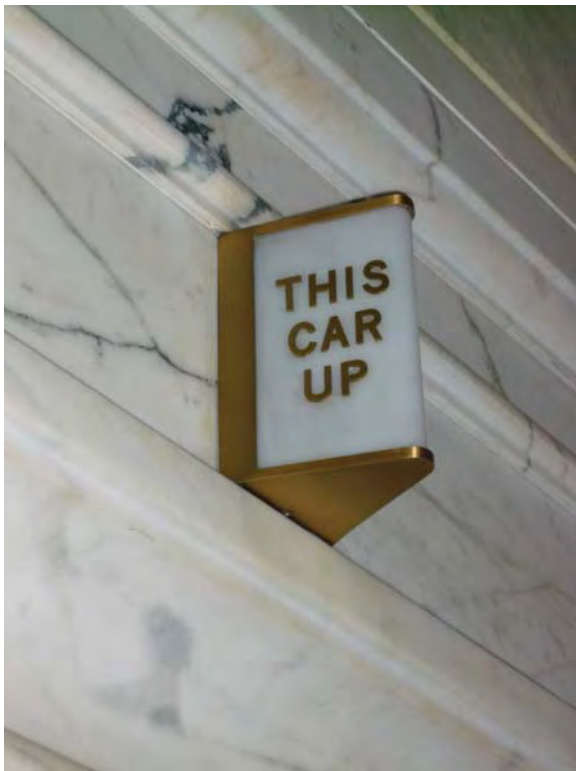
Image 45: Elevator sconce, main lobby.

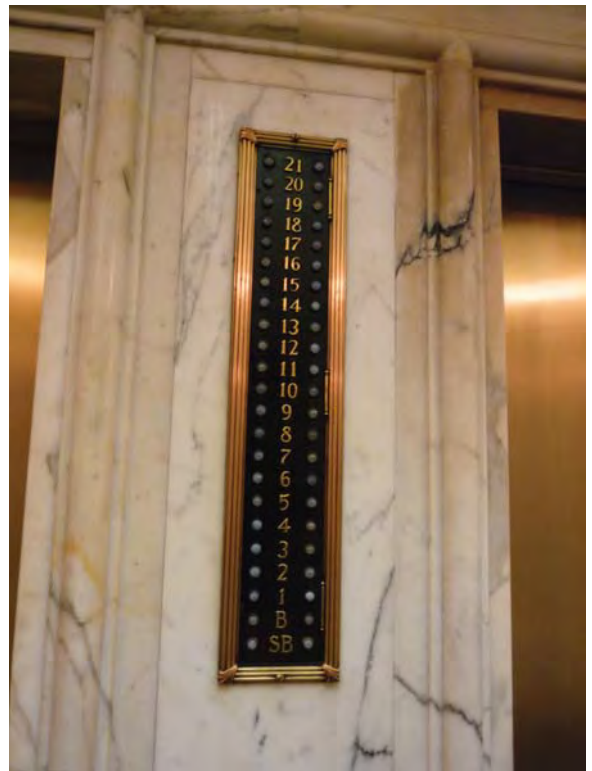
Image 46: Elevator indicator, main lobby.

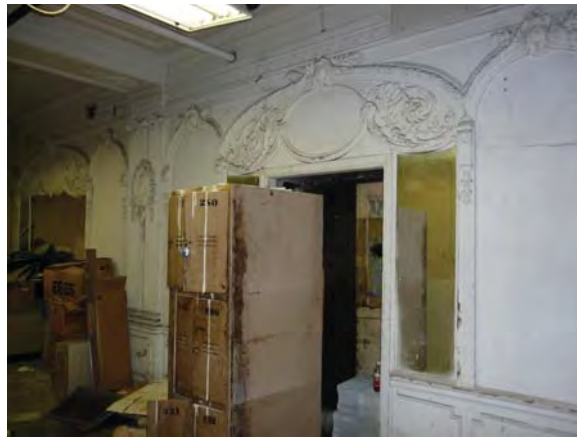
Image 48: 1st basement, decorative plasterwork.

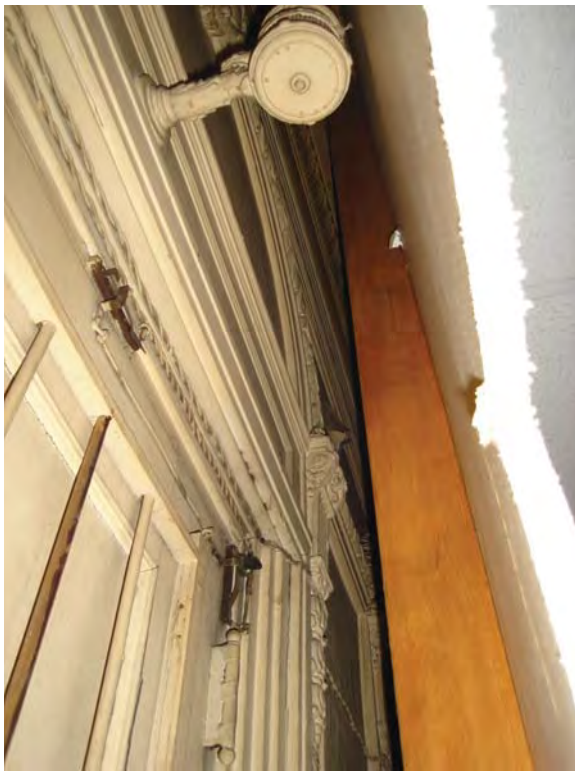
Image 49: 1st basement, decoration remaining on elevator wall and doors.

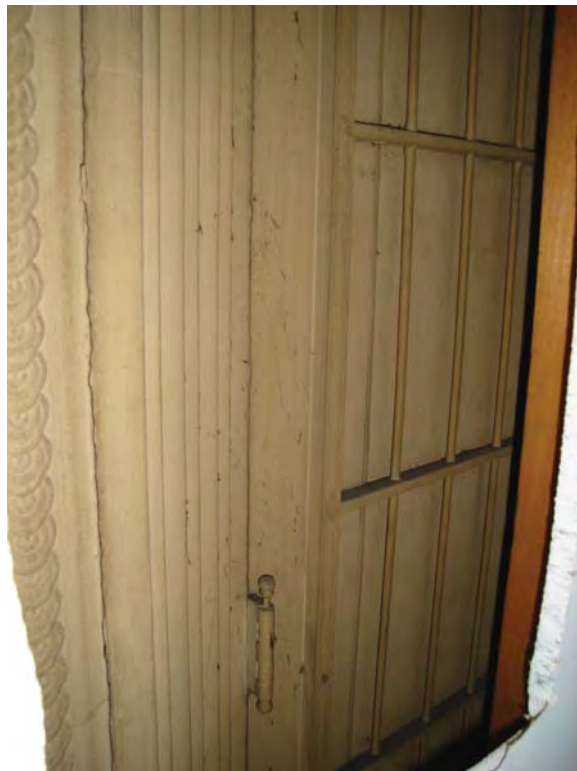
Image 50: 1st basement, decoration remaining on elevator wall and doors.

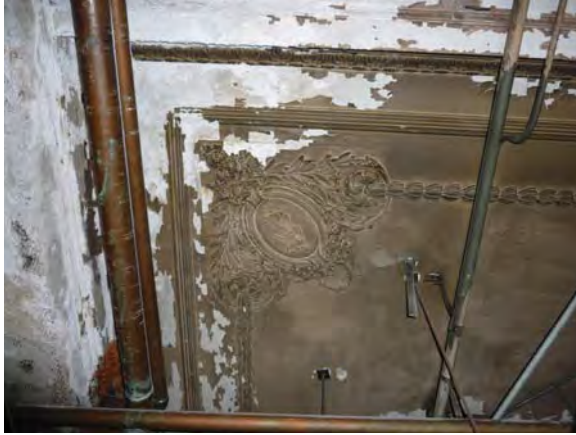
Image 51: 1st basement, plasterwork on ceiling.

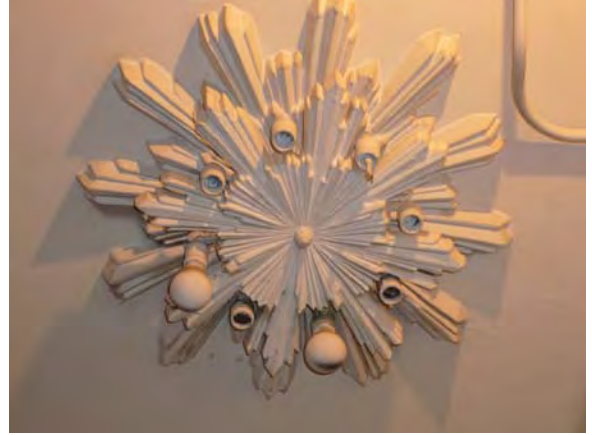
Image 52: 1st basement, ceiling light fixture.

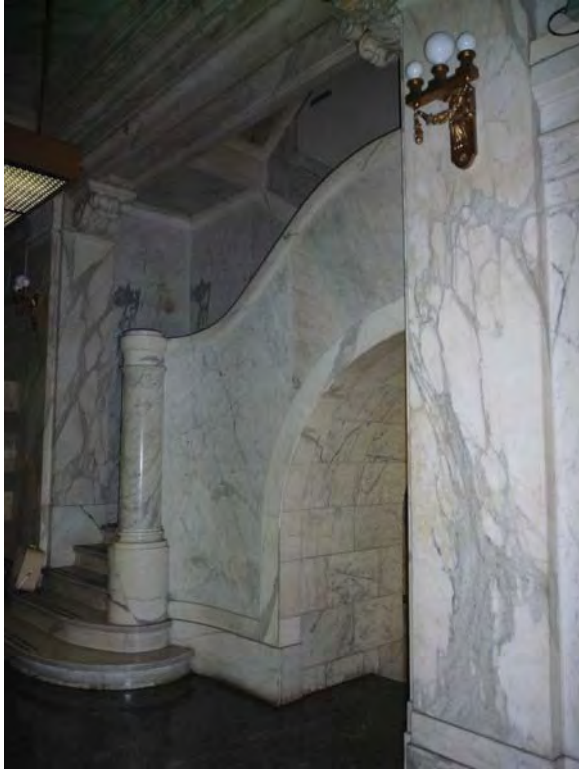
Image 55: East stair, first floor.

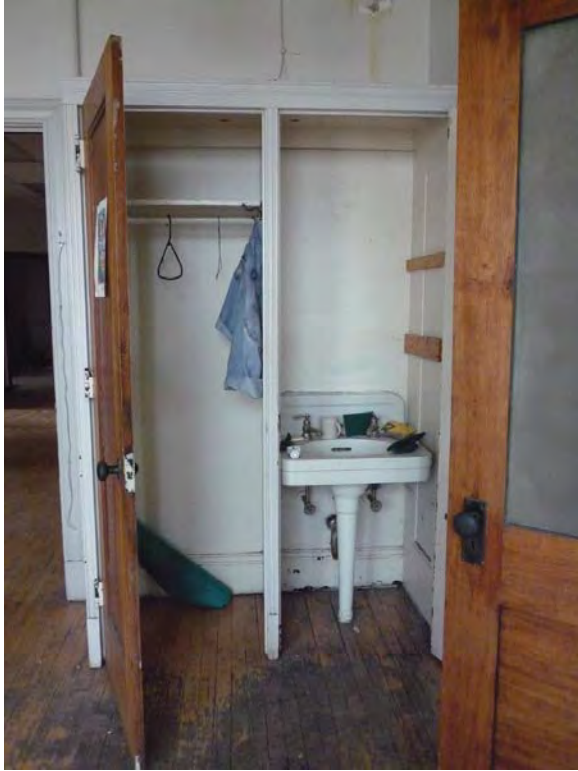
Image 74: 20th floor, southeast office suite.

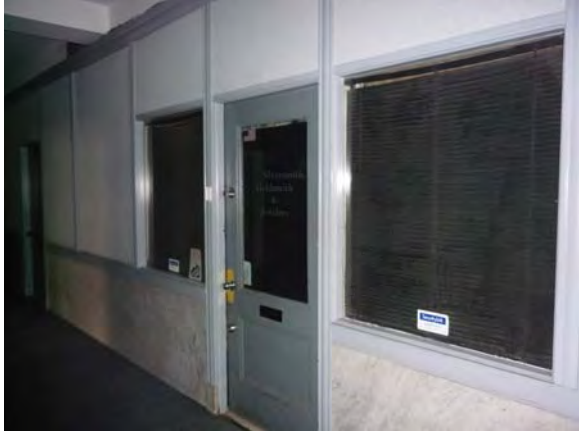
Image 78: Remaining storefront wall to west stair, 22nd floor.

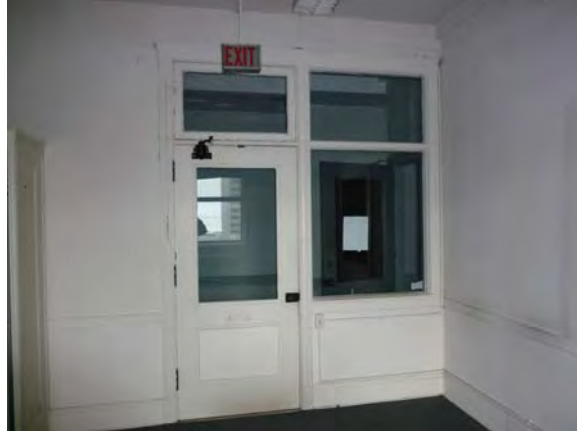
Image 79: Remaining storefront wall, main corridor 13th floor.

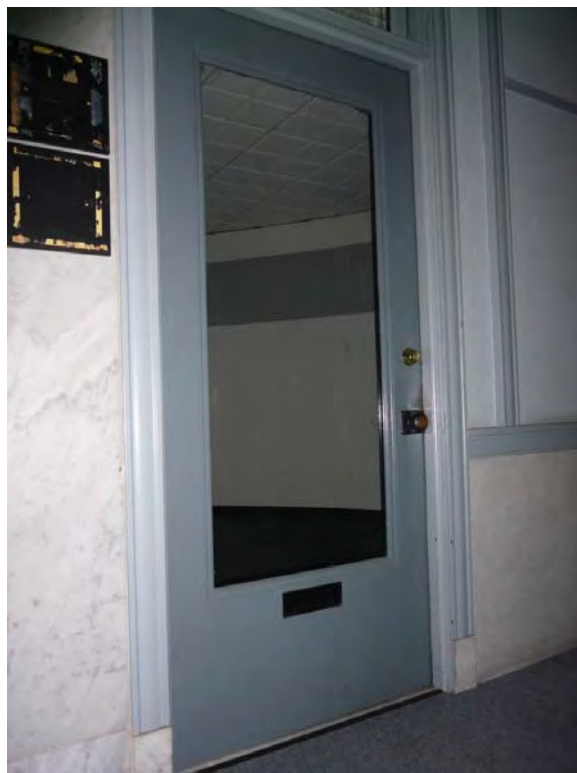
Image 81: Covered storefront wall, main corridor, typical of floors 2 through 21.

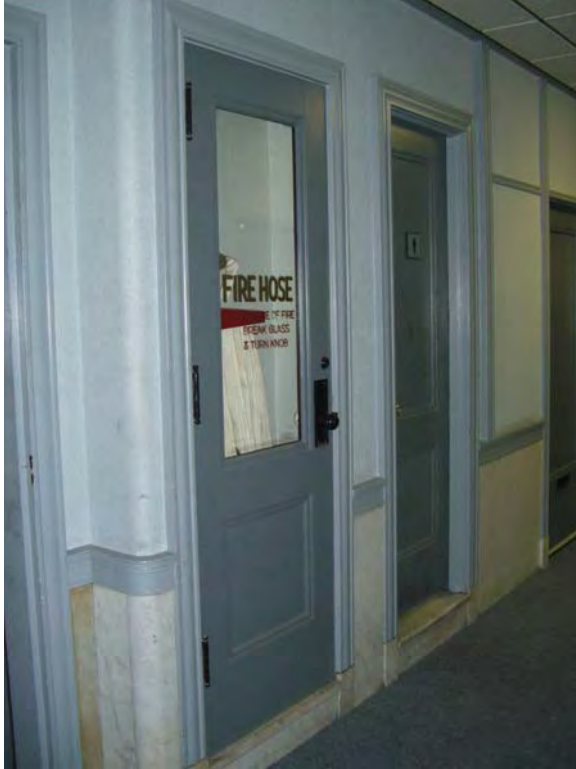
Image 82: Original door design, main corridor.

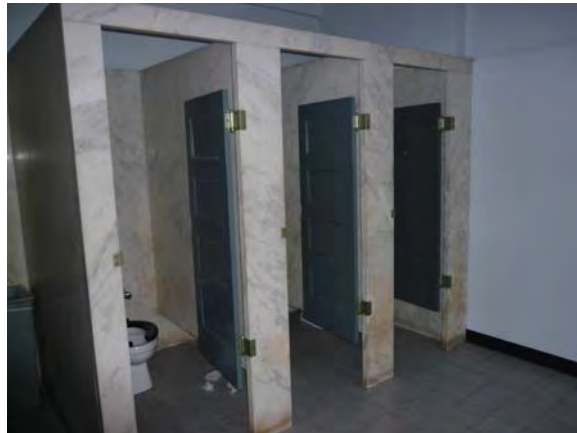
Image 89: 14th floor water closet, typical of several floors and offices.

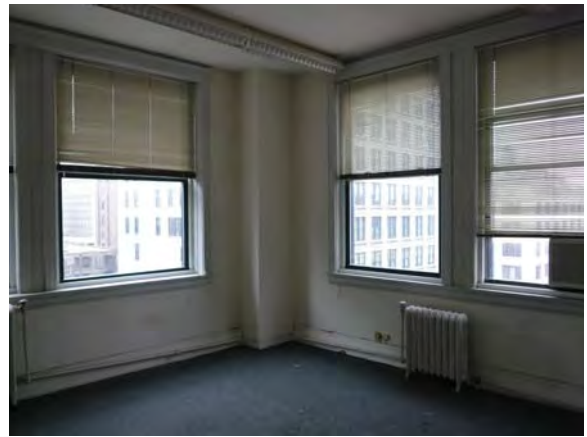
Image 91: West windows, 21st floor. Typical of west façade.

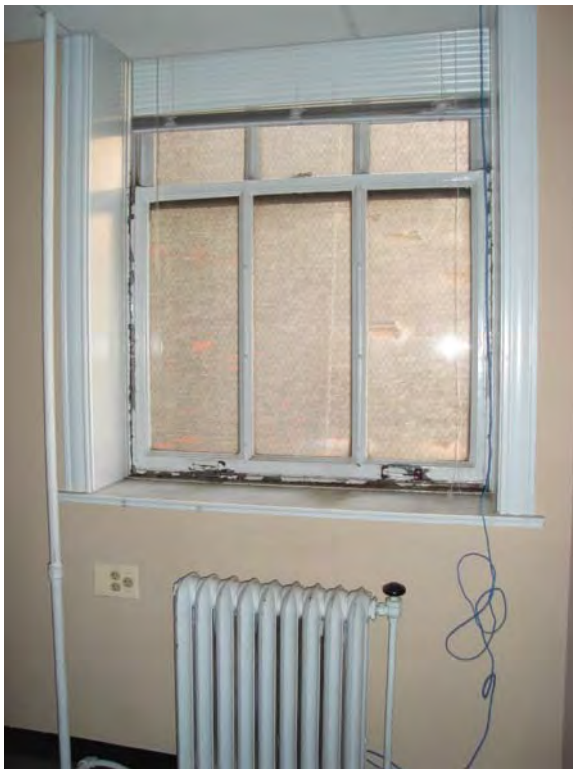
Image 92: East and south windows, 13th floor. Typical of floors 5 through 21.

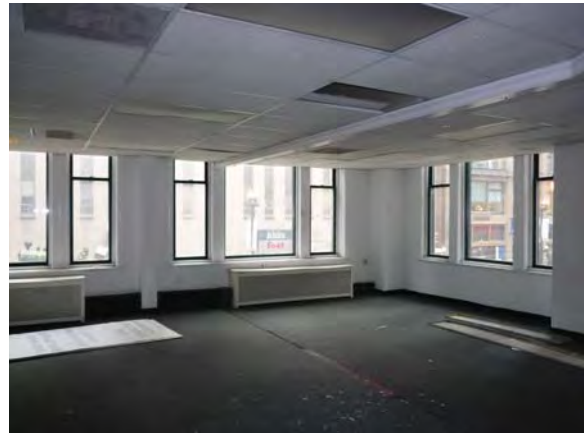
Image 93: North fire window, 7th floor.

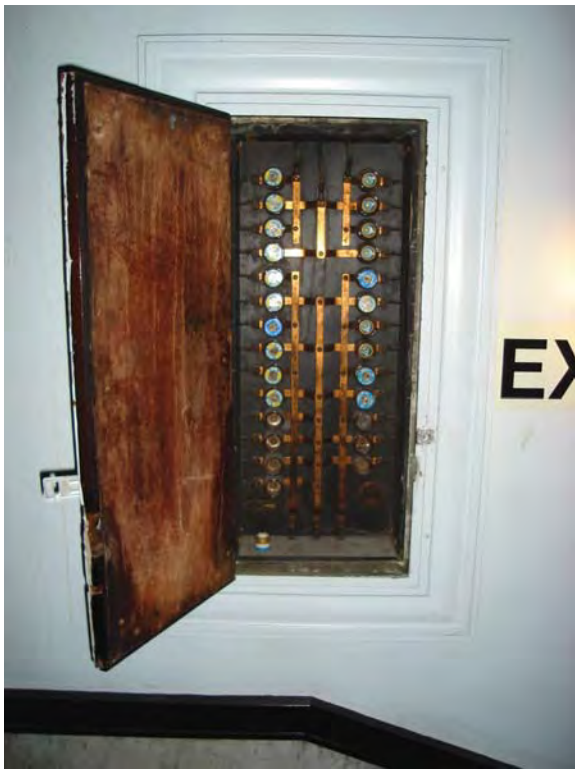
Image 97: Circuit box, 9th floor.

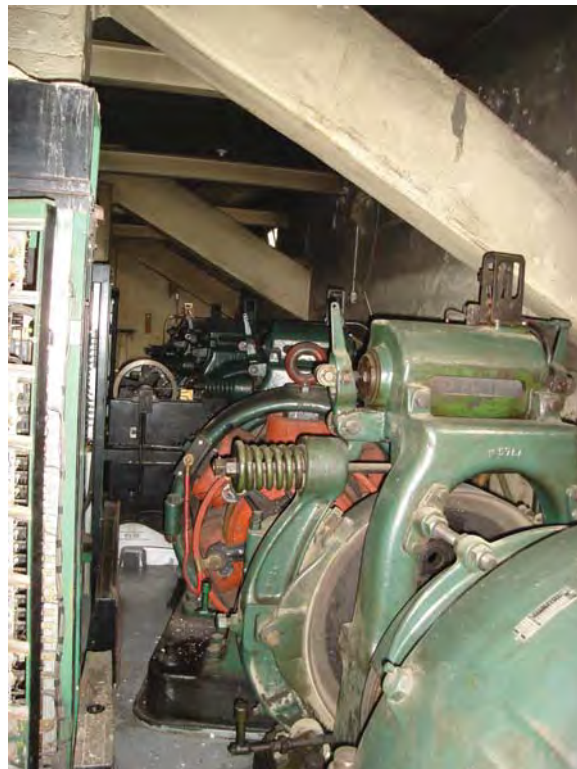
Image 98: Elevator equipment, 22nd floor.

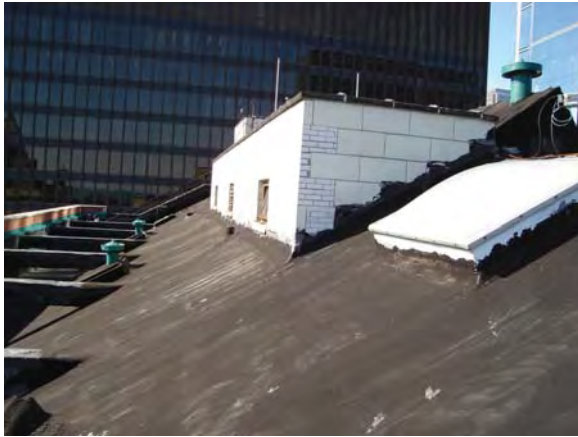
Image 99: Rooftop, view west.

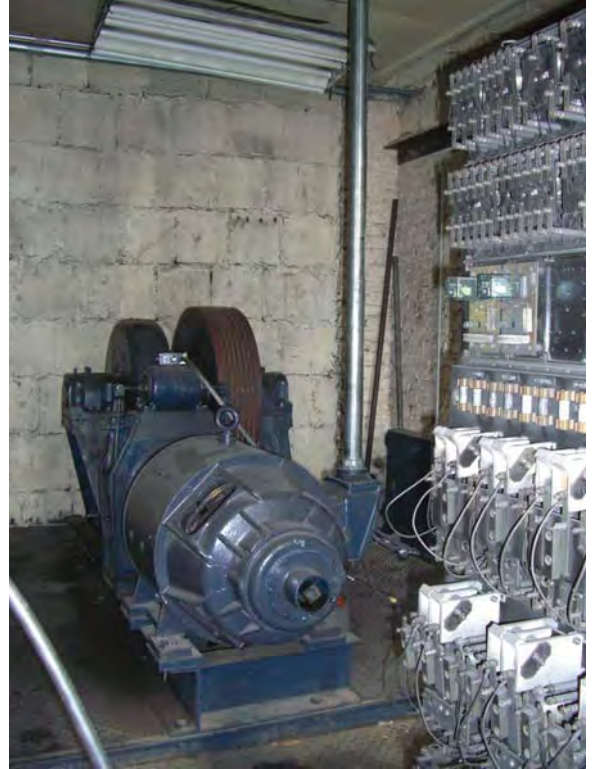
Image 100: Elevator equipment, freight elevator penthouse.

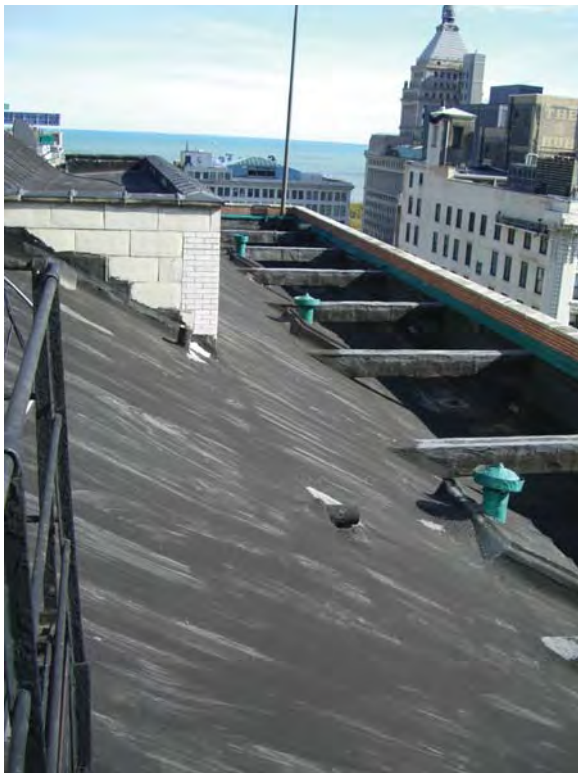
Image 101: Rooftop, view east.

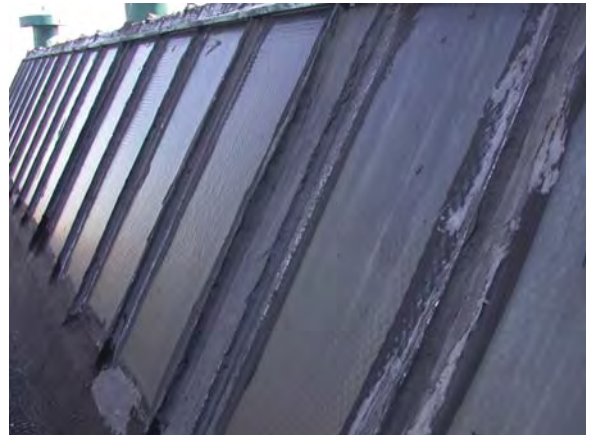
Image 102: Rooftop skylights, view west.

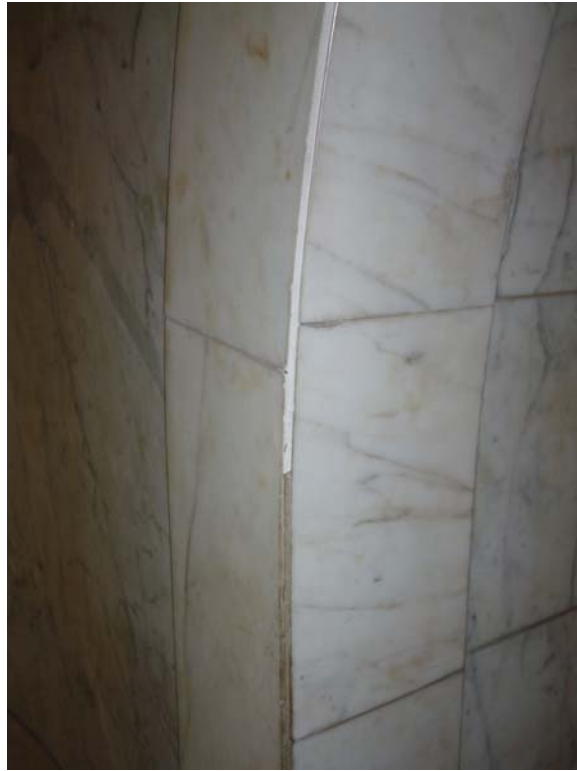
Image 104: Marble cladding, first floor lobby.

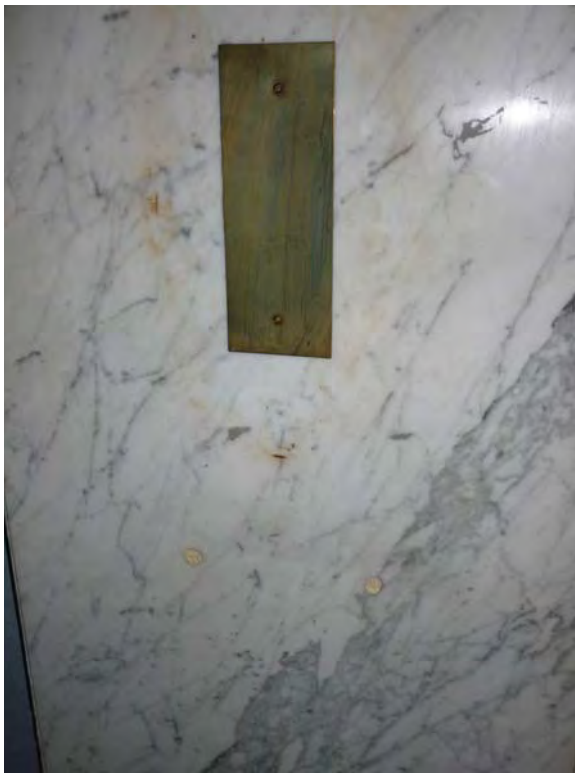
Image 105: Typical marble condition, elevator lobby, floors 2 through 21.

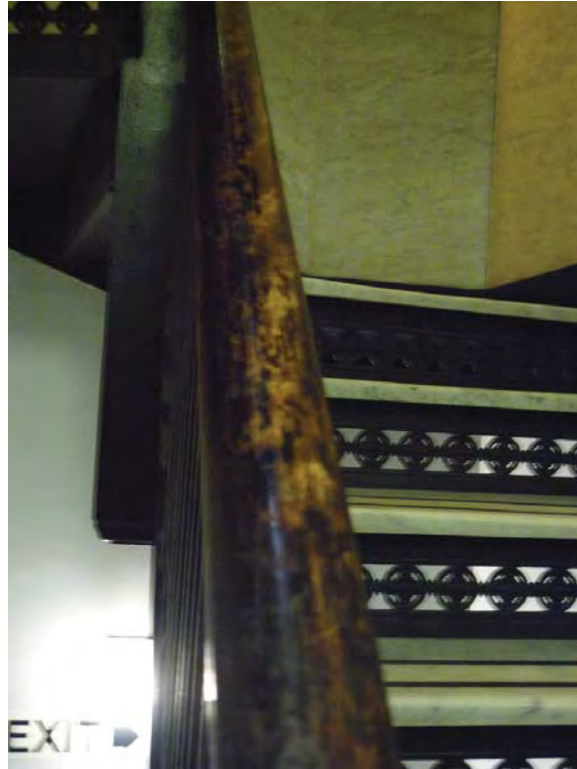
Image 112: Typical condition of railing finish, east stair.

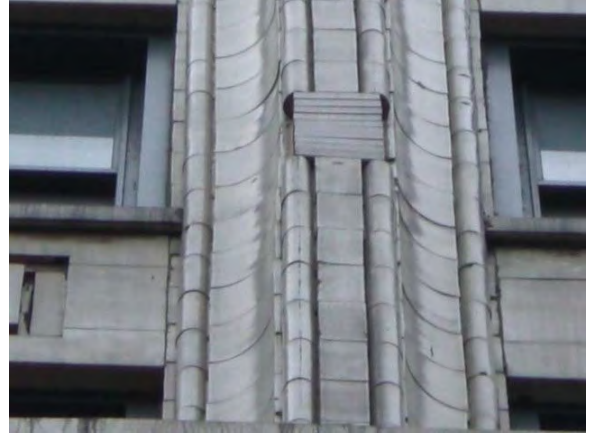
Image 116: Poor substitution of glazed brick for terra cotta, east façade.
