## Inspection Report

**Property Address:**  
3620 Elkhorn Blvd  
North Highlands CA 95660

**Granite Bay Home-Building Inspections**

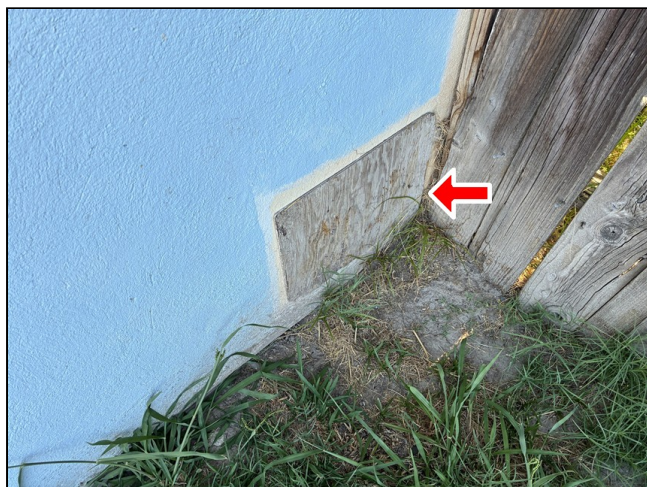
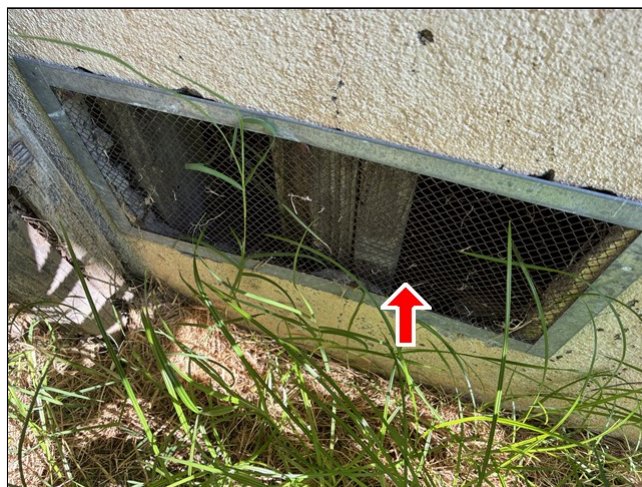
Issue: It appear there is a space under the units. We are un-able to crawl this (tight) space, and no inspection is possible. Review pest report on this property.

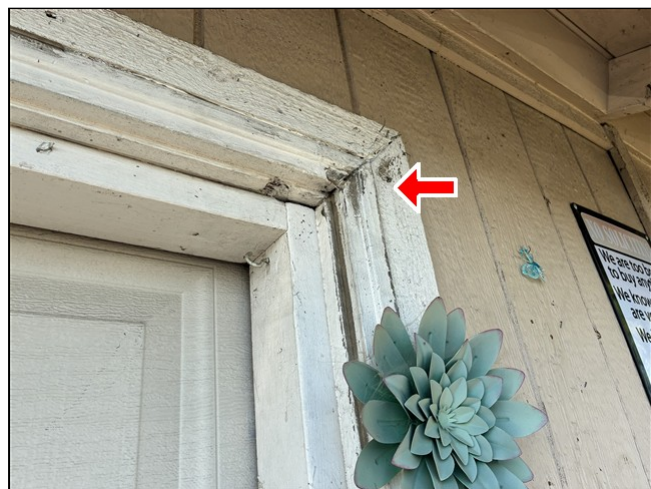
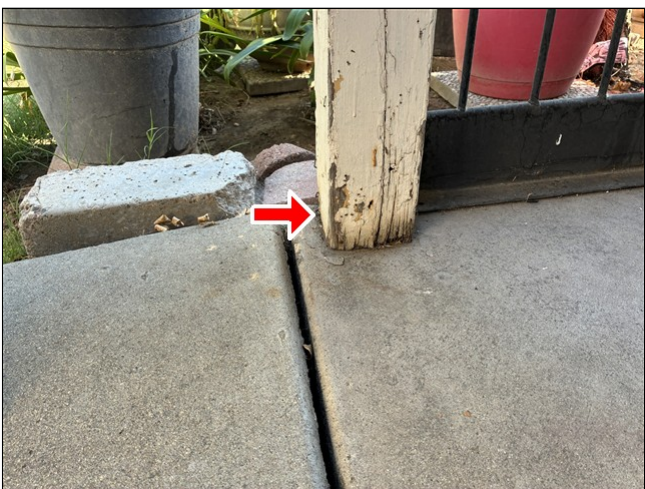
Issue: Areas of the building's exterior wood trim / paint show evidence of deterioration by way of rot, breakage, weathering, or wear.

Both units 3622 - 3620

Recommend: A licensed, qualified contractor should review and repair or replace as necessary to help maintain wall integrity and water resistance. Regular routine maintenance is recommended. For additional details, refer to pest report.

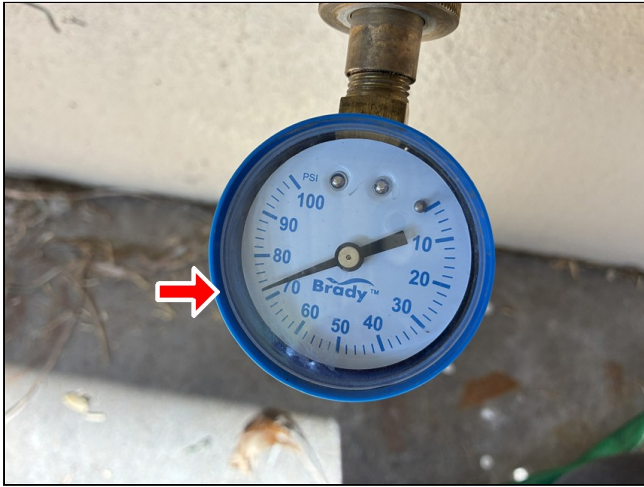
5.2 Item 1(Picture) 3622

Issue: System pressure, as measured by a gauge at an exterior hose bibb, was **high side of normal ( 72 PSI)**. **Average PSI is between 40 and 60. 80+ PSI is considered excessive.** Excessive pressure can result in damage or failure to valves, seats and washers, and fixture supply lines.

Recommend: A qualified plumber could review and further advise.

**Review:** pressure regulator (if currently installed) or install an approved pressure regulator and adjust home water pressure to standards. **Review** if old galvanized pipe for blocking mineral deposits, need for re-piping the home.

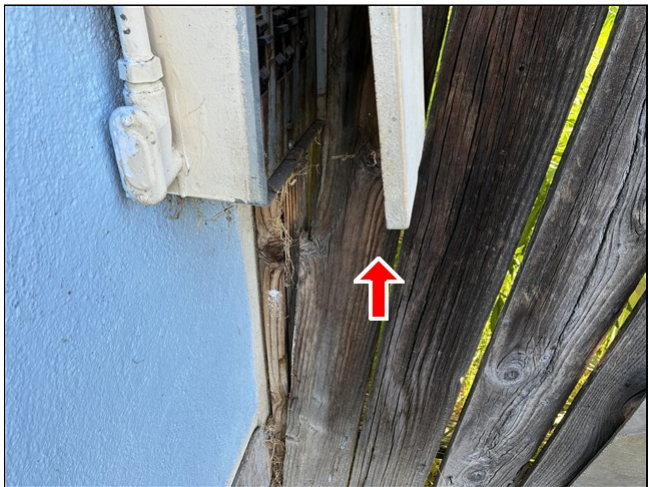
6.1 Item 3(Picture) Stuck panel cover

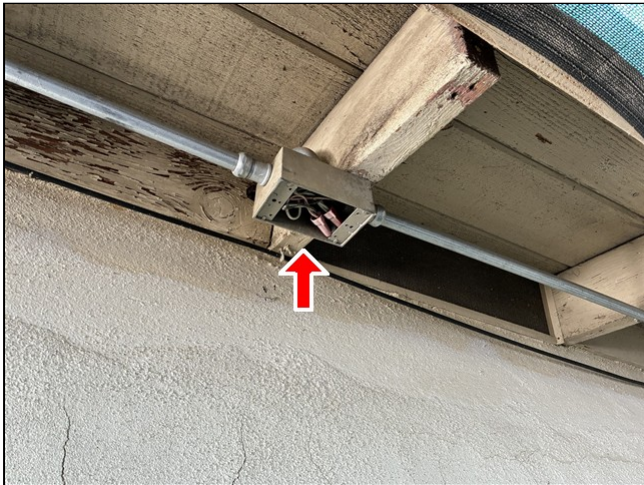
6.3 Item 1(Picture)

(1) Issue: A junction is noted is note without a cover plate, exposing the inside wiring. This (may) create a fire hazard. Unit 3620.

Recommend: A qualified handyman or contractor may replace cover as required.

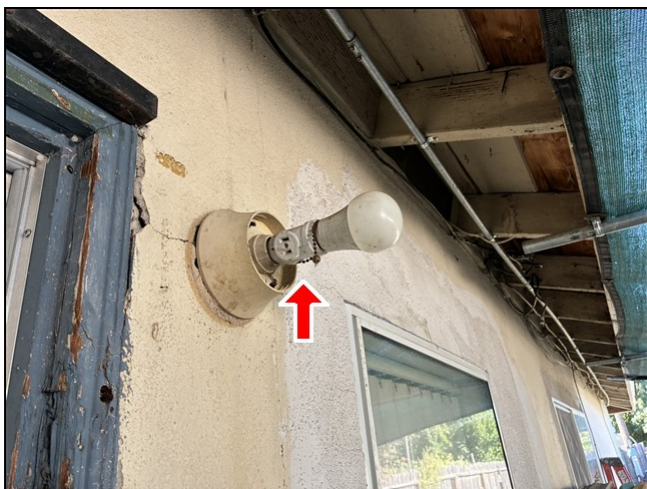
6.3 Item 2(Picture)

(2) Issue; The globe or cover for the light fixture at the ( 3620, right side )

Recommend: A proper cover should be installed.

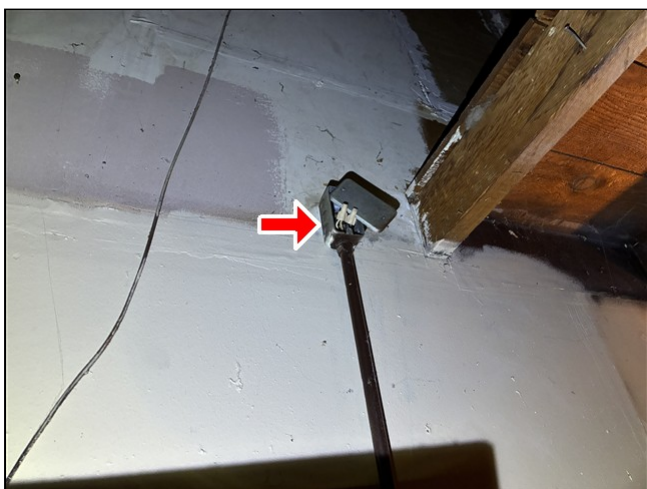
6.4 Item 1(Picture)

(1) Issue: A garage junction box was found without a properly installed cover, exposing the inside wiring. This (may) cause a fire hazard.

Recommend: A qualified handyman or contractor may replace cover as required.

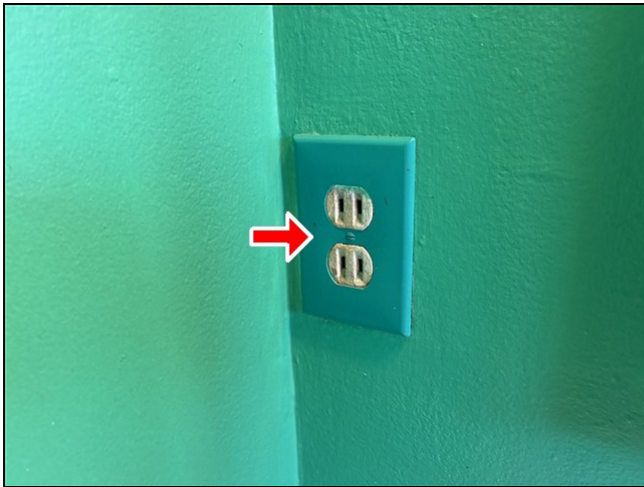
6.4 Item 2(Picture)

(2) Issue: This home shows two prong outlets. The electrical system in this building was installed (before) grounding was required. Properly grounded receptacles provide an increased margin of safety for the occupants and equipment.

Recommend: As a safety precaution, we recommend a qualified, licensed electrician replace the current two-prong ungrounded receptacles with grounded three-prong outlets.

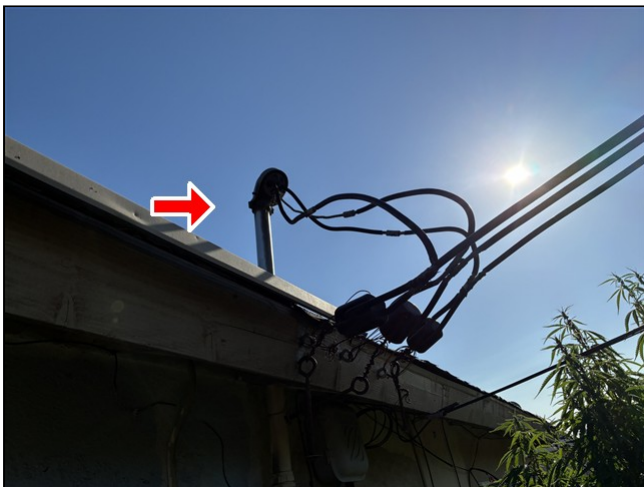
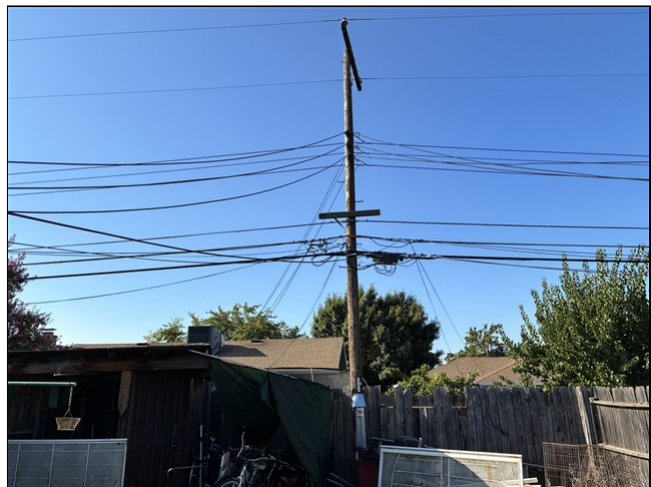
Issue: Splices between the overhead service drop conductors and the service entrance conductors from the mast are exposed and / or the insulation is gapped. This is contrary to industry standards.

Recommend: Electric utility company should review and properly insulate the exposed splices.

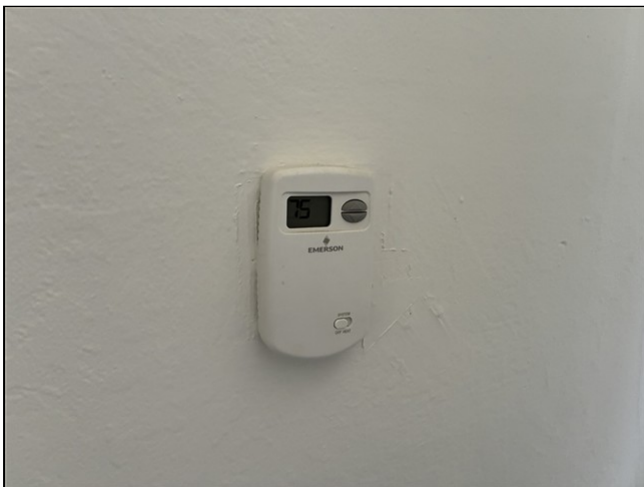
7.1 Item 1(Picture)

**Issue:** Both units have wall heaters in need of maintenance, repairs. There is dirt, rust and scale on the top of the burners. This can prevent our ability to observe the burners or possible heat exchanger holes or cracks. Rust accumulations that cover burners affect their operation.

Wall heater not operational unit 3622. Wall heaters are operational unit 3620

**Recommend:** A qualified technician should thoroughly clean and adjust the burners and their orifices BEFORE escrow closing. Both units.

**Recommend:** The wall heater should be properly cleaned by a qualified HVAC technician.

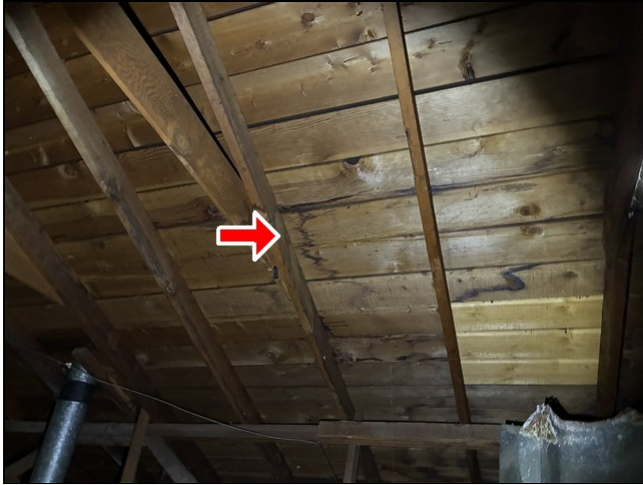
8.2 Item 1(Picture)

Issue: We note evidence of (past) water staining at roof sheathing/members. Stain(s) may also have occurred around a penetration (plumbing vent, roof vent) through the roof surface. While we see no active leaks, the area(s) should be monitored.

Recommend: If concerned, a qualified roofing contractor could review and further advise.

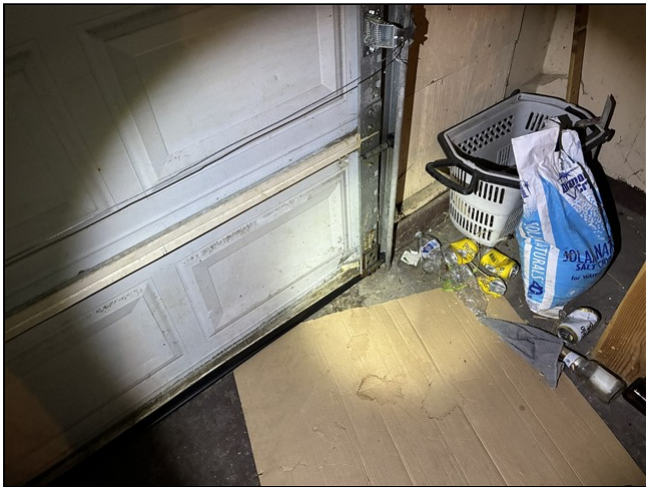
9.1 Item 1(Picture)

Manual operation door.

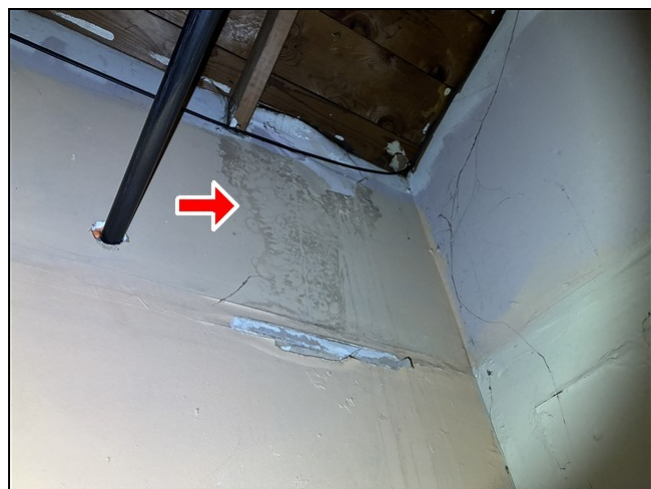
9.3 Item 1(Picture)

Issue: There are water stains on the walls. However, we found no sign of active leaks.

Recommend: If additional staining develops, the source of the leak(s) should be identified and repairs performed as necessary. Preparing and refinishing the surface could restore its appearance.

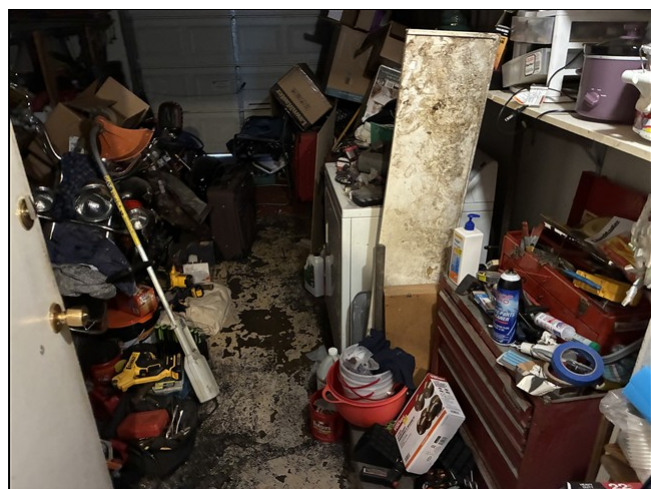
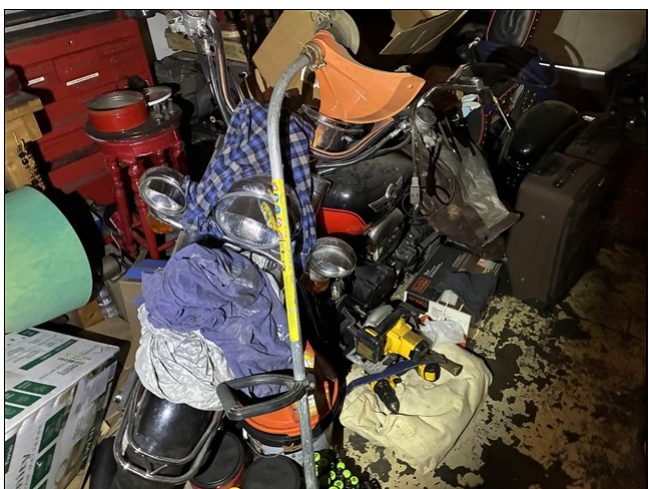
Issue: Personal belongings prevented full access to the garage at the time of this inspection.

Recommend: A walk-through is recommended when the area is cleared and accessible.

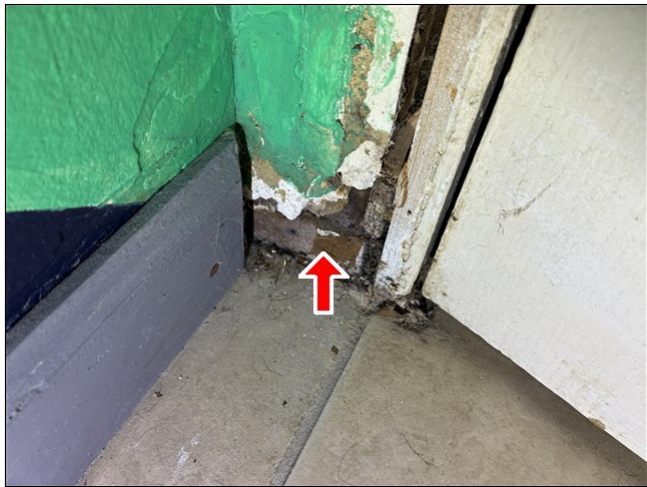
Issue: There is a large wall crack(s) in the bathroom wall (unit 3620)..

10.1 Item 1(Picture) Behind bathroom door

Recommend: A qualified technician could make repairs or modifications as necessary.

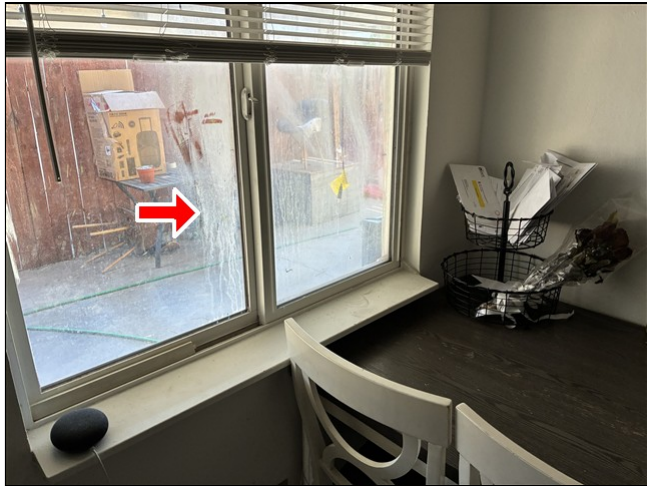
Issue: Condensation, staining, dust crystals, or droplets are present between the panes of one or more insulated glass windows in the home. This suggests a failure of the factory seal between the twin pieces of glass. While this does not effect the water tight integrity of the window, it creates a visual defect and lessens the windows energy efficiency.

10.3 Item 1(Picture) Unit 3622

Recommend: If concerned, we recommend a qualified, licenced window contractor could check any affected windows and further advise you as to repair or replacement of affected windows.

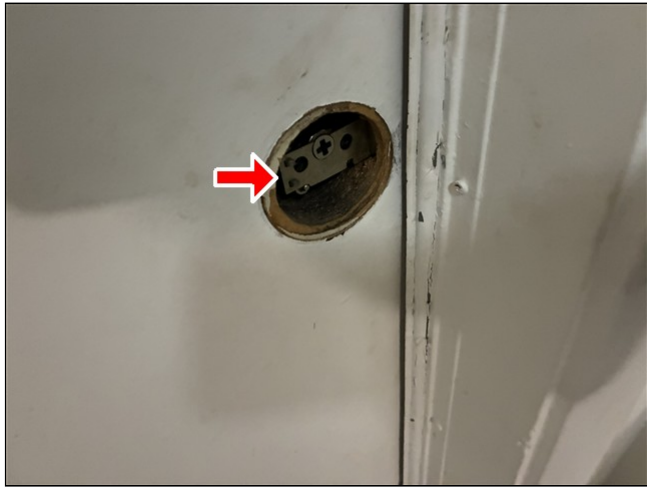
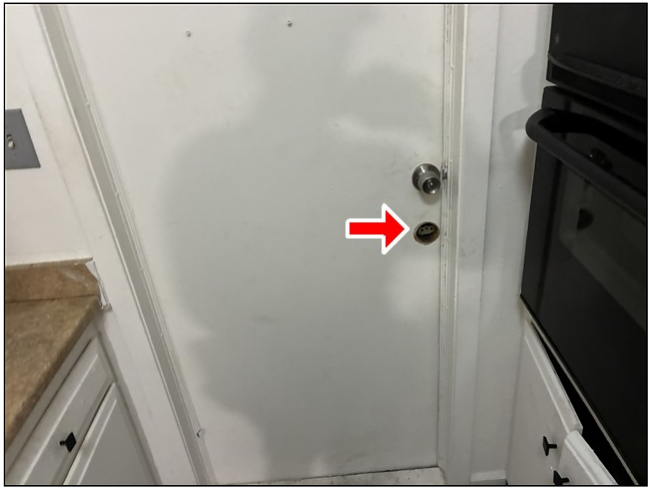
(1) Issue: Hardware is missing or has been removed from the garage entry door(s). We recommend all loose or missing hardware should be repaired or replaced.

Recommend: A qualified handyman may do this work.

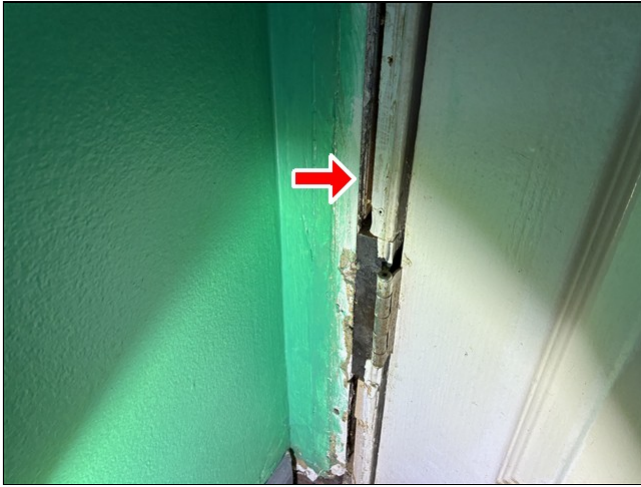
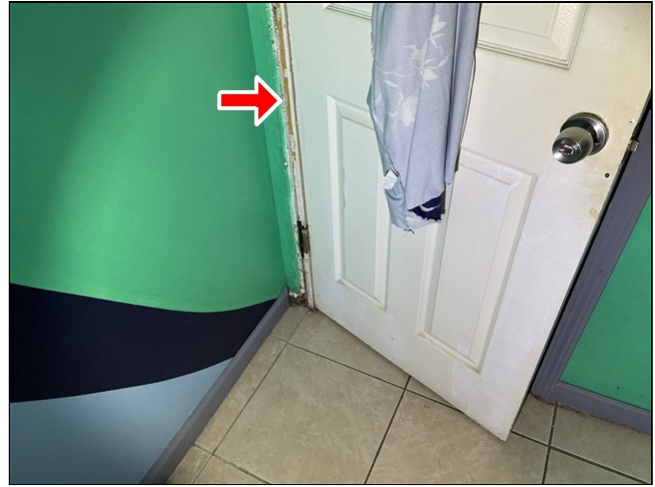
(2) Issue: A doorway in the bathroom is damaged or deteriorated.

Recommend: Doorway should be repaired, refinished as necessary.

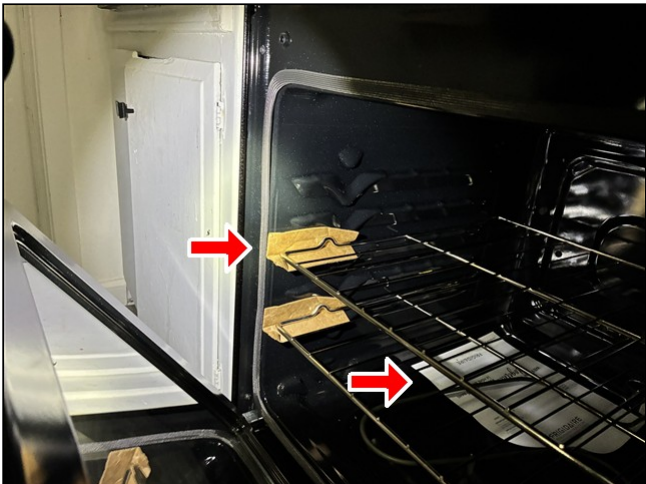
11.1 Item 4(Picture) Unit appears un-used

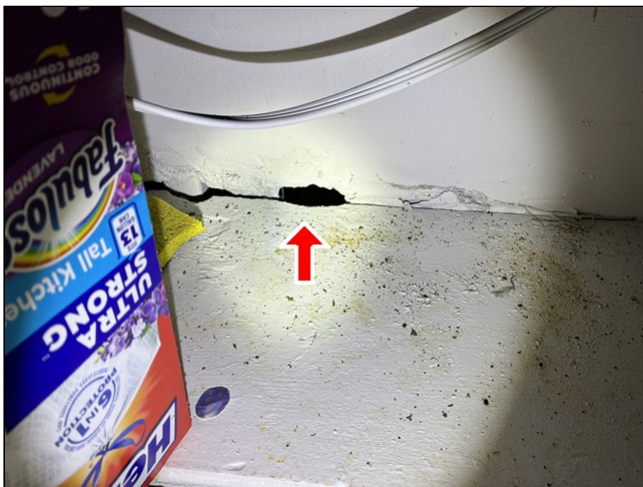
11.3 Item 1(Picture) 3622

(2) Note: Hole noted under sink. This (may) allow pests into home.

Recommend: A qualified handyman should review and seal as needed.

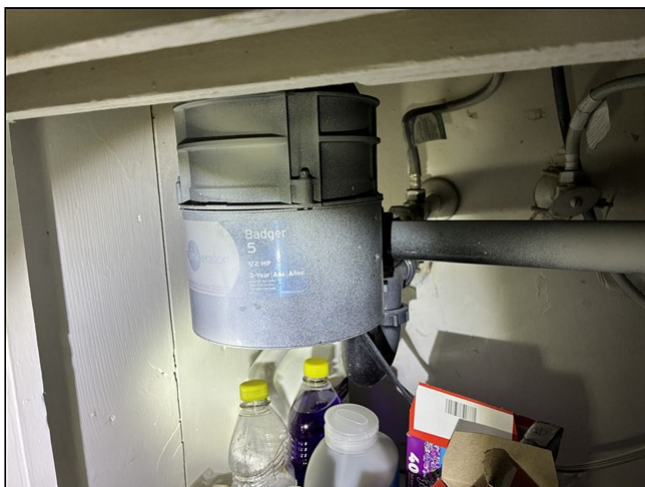
11.4 Item 2(Picture)

(2) Issue: The garbage disposal did not respond to normal user controls. 3622.

Recommend: A qualified appliance technician should review and repair or replace the disposal as needed.

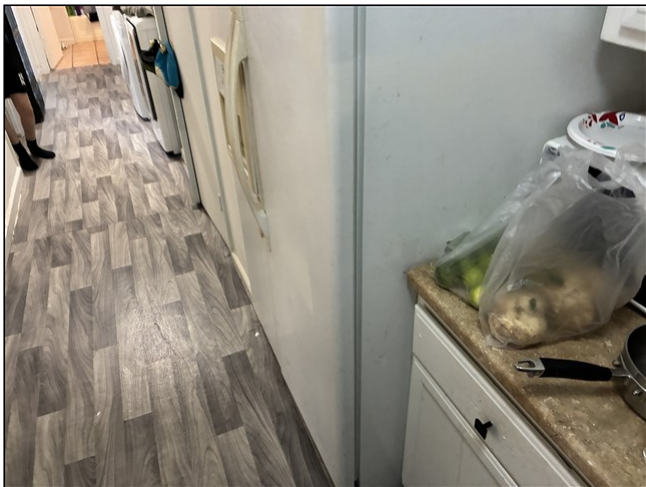
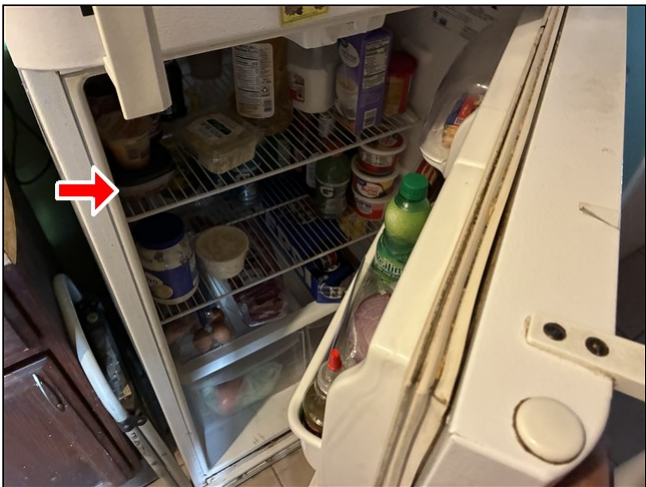
Lights did not operating in unit. 3620.

Recommendation: If you are concerned, we recommend you have a professional appliance technician move the unit for further examination of plumbing fittings, wall, and floor conditions.

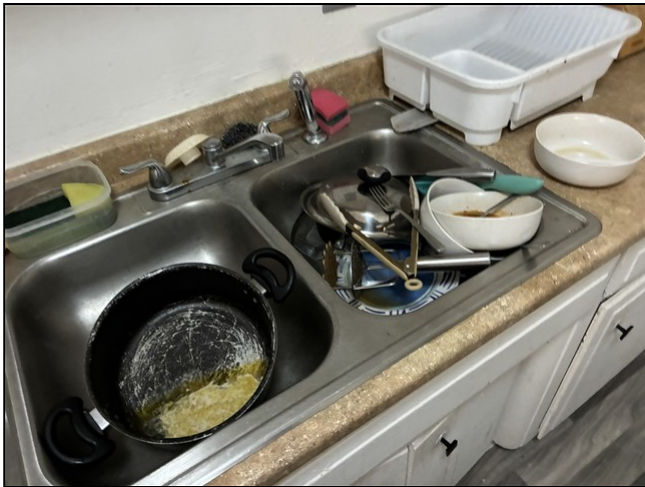
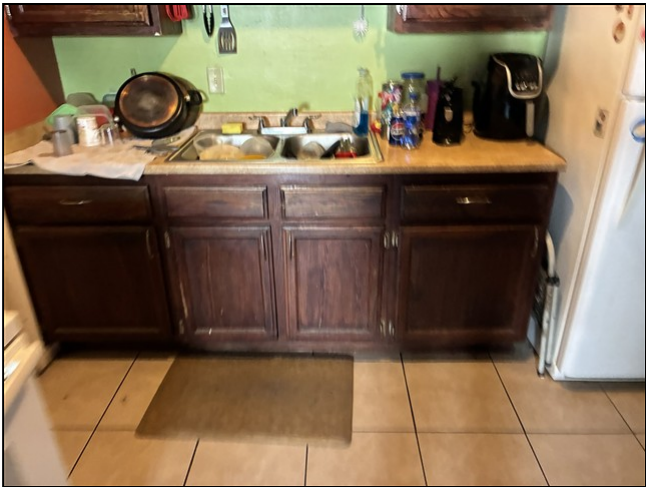
Issue:     Stored personal items blocked our access to the area in and under the sink in the kitchen.   units 3622-20.

Recommend: After the stored items have been removed, this area should be inspected.

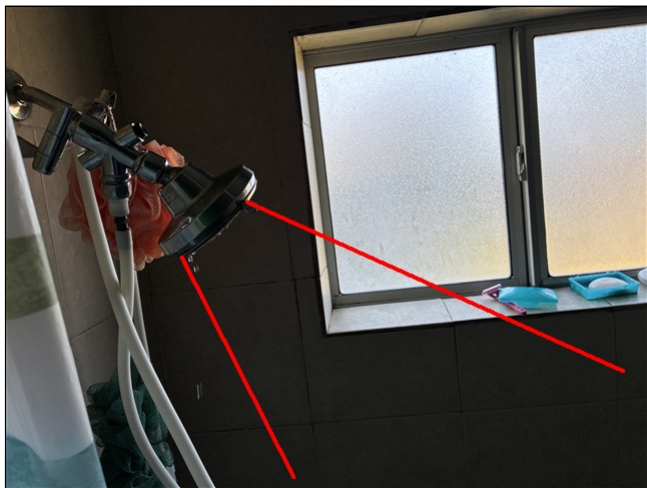
12.3 Item 1(Picture)

Issue: The window inside the shower area is set low where water from the shower nozzle may collect on the window sill. While we see no evidence of damage at this time, this setting may allow / cause a leak and window / wall damage.

Recommend: Review by a qualified contractor who may further advise.

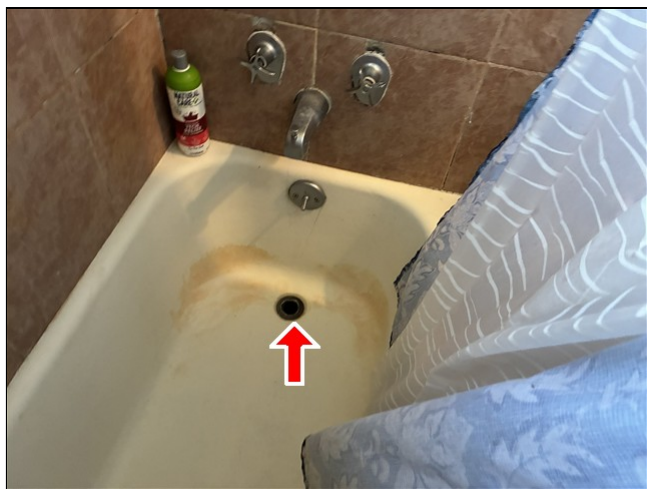
12.5 Item 1(Picture)

(1) The bathtub drain stop and/or related parts are missing. Noted at the hallway bathroom

Recommend: A qualified technician could make repairs or modifications as necessary.

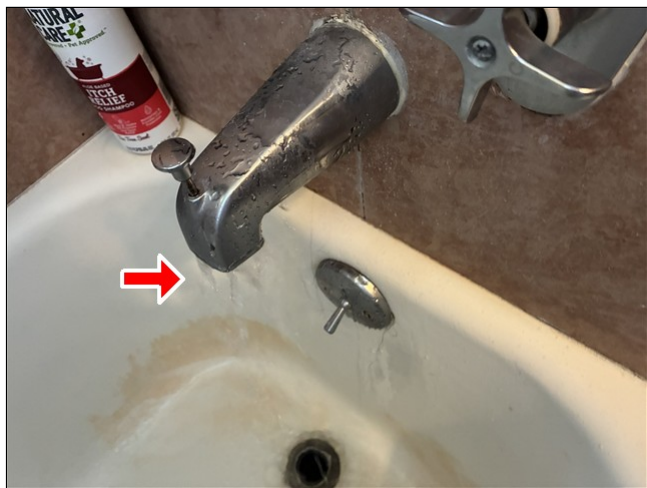
12.5 Item 2(Picture)

(2) The water diverter valve for tub - shower choice is deteriorated/not working properly. 3622.

Recommend: A qualified handyman review and repair/replace as needed.

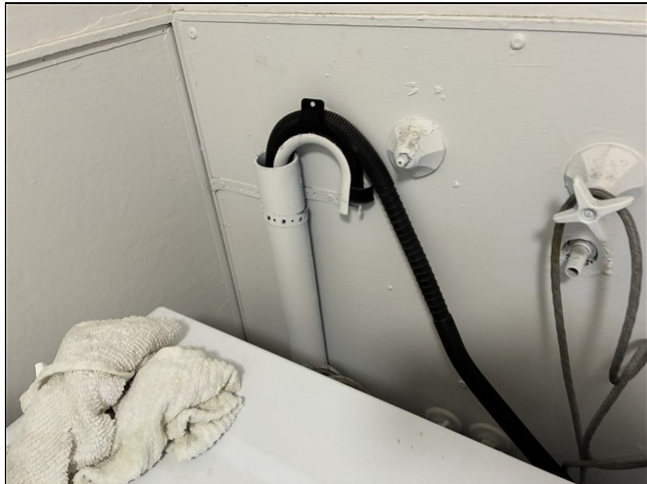
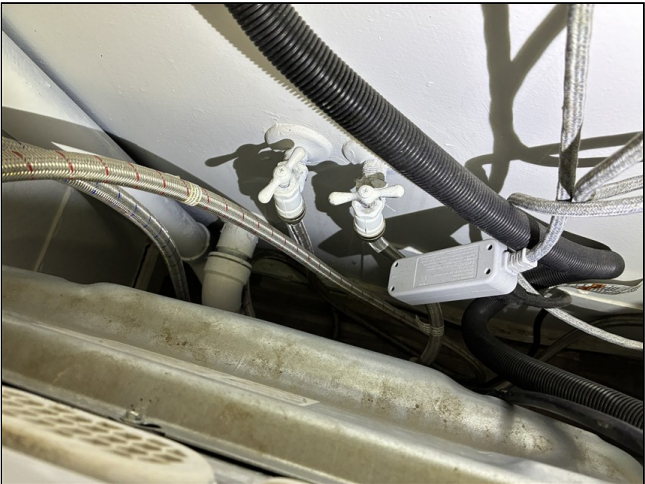
Note: 1) The clothes washer drain and hot/cold water sources were not tested. It is beyond the scope of this inspection. 2) Due to The placement of laundry appliances, the wall and plumbing behind the units are not easily accessible nor visible for inspection. It is beyond the scope of this inspector to move appliances.

Recommend: If concerned, 1) have the owner demonstrate the function of the drain prior to the close of escrow. 2) If further concerned, we recommend a qualified appliance tech or handyman (carefully) move the units for further inspection prior to the close of escrow.

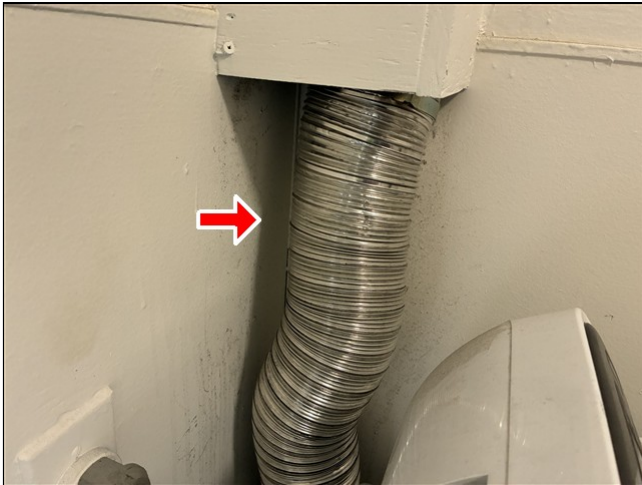
13.3 Item 1(Picture)

(1) Issue: The dryer vent should be kept clear of lint and other debris to ensure proper function. A vent clogged with debris or lint will decrease the efficiency of the dryer, and is a fire hazard.

Warning: The building should never be left unoccupied when the dryer is in use.
