# Pacific Inspection Services

Home Inspection Report for 18935 5th Street West, Sonoma CA

Property Address: 18935 5th Street West  
Sonoma, CA

Date Of Inspection: June 4, 2026

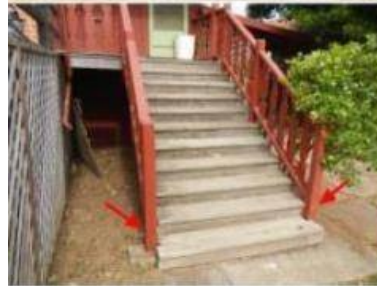
The handrails are loose at multiple stair assemblies around the structure. Recommend having this condition evaluated and corrected by the appropriate qualified trades person.

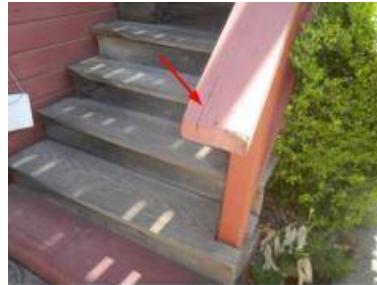
Damage / deterioration is noted to one or more of the railings or railing components around the house. Recommend having this condition evaluated and corrected by the appropriate qualified trades person.

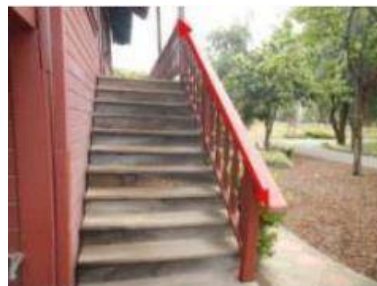
There are NO graspable handrails installed at some of the stairways around the house. For safety, current standards require a graspable handrail be installed on at least one side of a stairway. Recommend having this condition evaluated and corrected by a licensed and qualified building contractor.

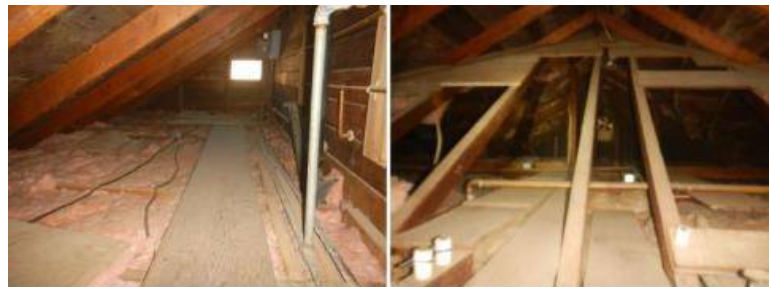
Water staining is noted to some roof sheathing and/or framing in the attic. These stains appear to be from a past moisture challenge, however we cannot be absolutely sure. We recommend that this area be monitored in the future for any signs of active moisture leakage.

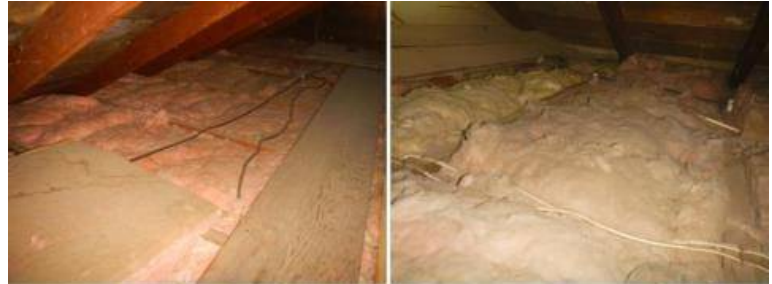
The insulation in some areas is placed / installed against the underside of the roof sheathing instead of on the upper side of the ceiling. This allows any moisture that condensates in the attic to get trapped against the framing members.

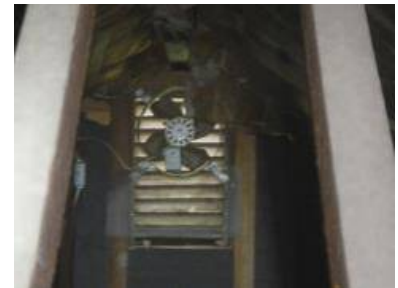
There is a mechanically controlled attic fan noted to be present in the attic. This fan is either solar, manual or thermostatically controlled. Adjusting and/or testing these devices is beyond the scope of this inspection. Recommend having the seller demonstrate proper operation. Also, sometimes there is a main power switch located remotely at the interior of the house. If there is a switch, we recommend inquiring of the seller as to its location.

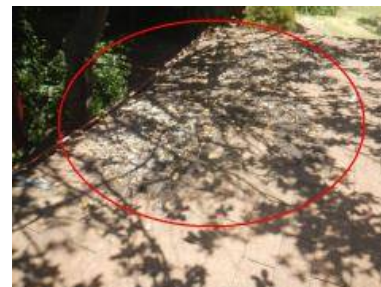
There is debris (leaves, sticks, etc.) accumulating on the patio covering roof surfaces. We recommend that roof surfaces are cleaned on a regular basis.

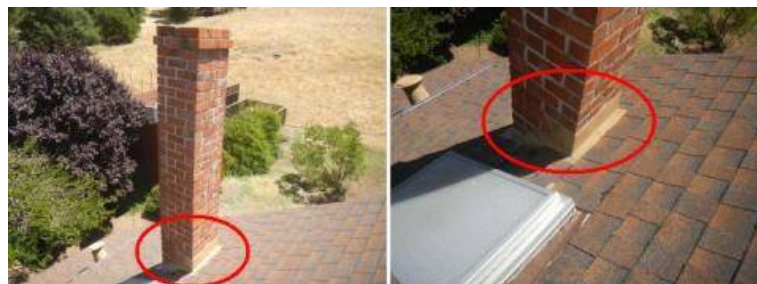
Even though we do not inspect fireplaces and chimneys, we did evaluate the structural integrity of the chimney. We found that the exterior chimney is broken completely through at or near the roof line.

This condition was determined by standing on the roof and putting moderate side pressure on the chimney. This type of damage is typically the result of seismic activity and IF the chimney is still in 'use', may allow flames to enter the attic in the event of a chimney fire. It also causes the chimney to be very unstable from the roof upwards. We recommend having the chimney further evaluated and repaired by the appropriate, qualified professional.

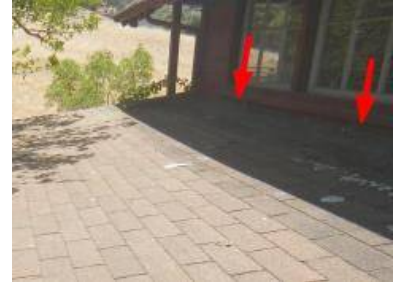
There is no flashing installed between the rear patio roof and the vertical walls of the house. This condition can allow moisture to gain entry. We recommend further evaluation and correction by the appropriate, qualified professional.

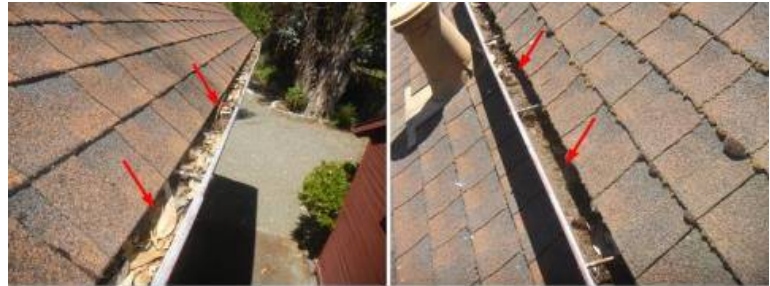
There is debris (from overhanging vegetation, mineral deposits from roof shingles, etc.) accumulating in one or more of the rain gutters. We recommend having the gutters cleaned to prevent premature rusting and improper drainage. Recommend having this condition evaluated and corrected by the appropriate qualified trades person.

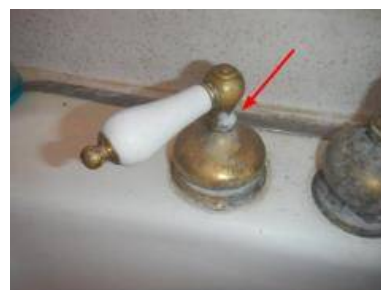
The left side water control handle does not turn and hit a positive stop. Instead the handle will turn around and around. This is not typical. We recommend correction by an appropriate qualified tradesperson.

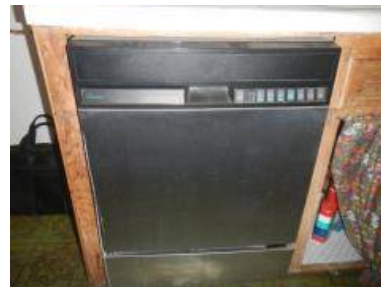
The dishwasher is not functioning properly. It did not respond to operation of the front onboard controls. Recommend further evaluation and repair by the appropriate appliance repair technician.

**DISHWASHER:** The dishwasher is not functioning properly. It did not respond to operation of the front onboard controls. Recommend further evaluation and repair by the appropriate appliance repair technician.

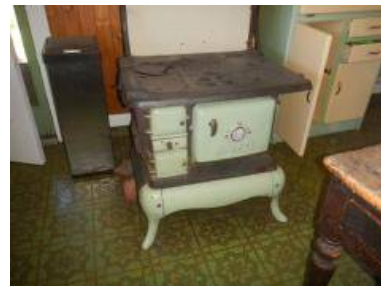
A natural gas supply pipe is present however it was not connected to the range / oven. No testing was possible. We recommend having these conditions further evaluated and corrected by the appropriate, qualified professional.

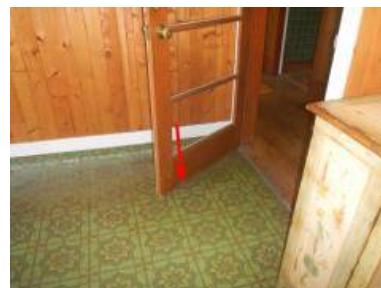
The interior door leading to the hallway is rubbing or dragging the flooring during operation. We recommend adjustment or repair by the appropriate qualified trades person.

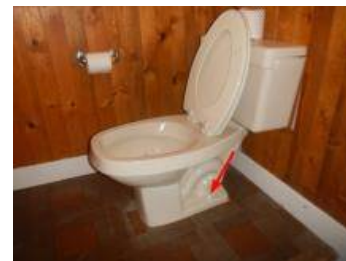
The toilet in this bathroom is loose at the connection to the floor. There are no visible signs of leakage at this time, however loose toilets are prone to leaking. We recommend further evaluation and correction by the appropriate, qualified professional.

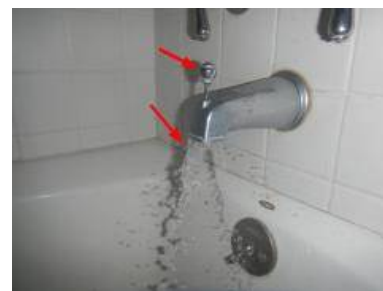
During operation of the shower, water was observed to be dripping / running from the water spout. Ideally, this diverter valve will stop all of the water from the spout and divert it to the shower head. This is a common condition and does not appear to be adversely affecting the water flow from the showerhead.

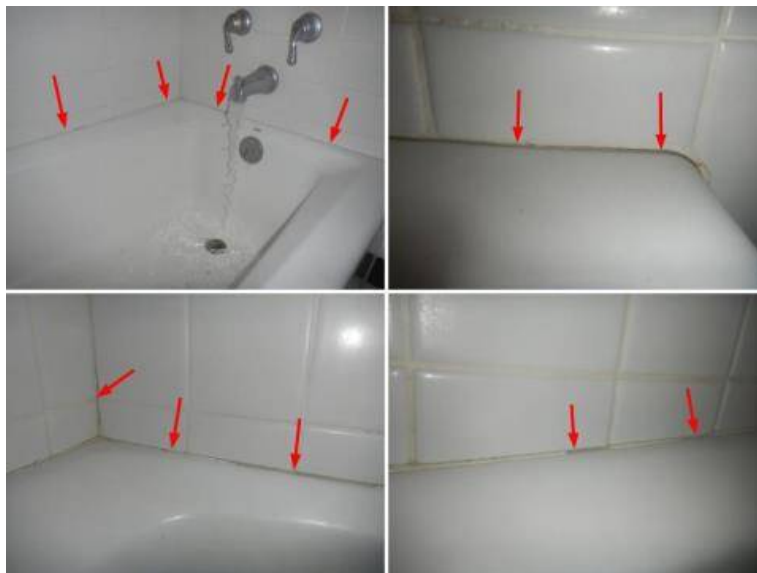
There are cracks, voids, or openings in the caulking and/or grout at one or more locations in the bathtub or shower surround. This condition may allow moisture to gain entry. We recommend having any voids sealed (by the appropriate qualified tradesperson) to prevent moisture entry.

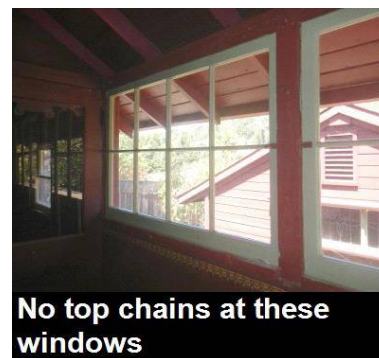
There are no chains to hold the windows up when they are opened. Additionally, one of the windows was stuck in the closet position. We recommend having these conditions further evaluated and corrected by the appropriate, qualified professional.

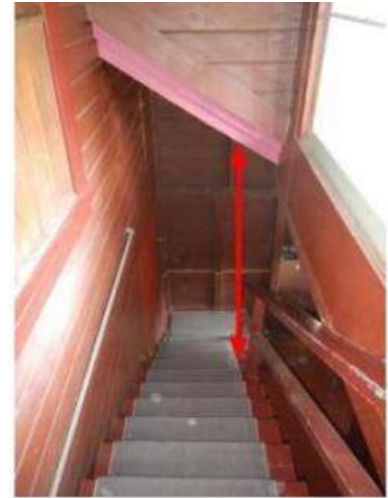
Potential Head Bump Warning! The stairway headroom should be greater than or equal to six feet eight inches (6' 8") between the stair tread upper surface measured at the tread outer edge, and the ceiling above. The clearance present does NOT meet this industry standard. Recommend having this condition evaluated and corrected by the appropriate qualified trades person.

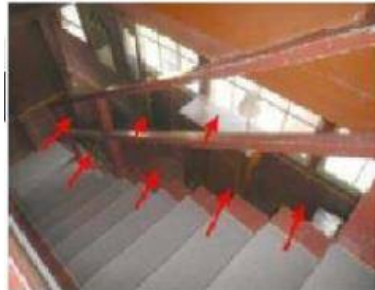
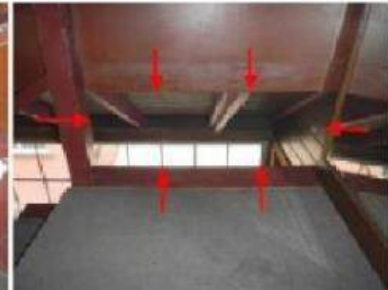
There is NO graspable hand rail installed at the stairway. For safety, current standards require a graspable handrail be installed. Recommend having this condition evaluated and corrected by a licensed and qualified building contractor.

There are NO vertical balustrades installed at the railings. As a result, there are opening present that pose a potentially hazardous condition. Current requirements are to have balustrades with a spacing not to exceed 4 inches. We recommend having these conditions further evaluated and corrected by the appropriate, qualified professional.

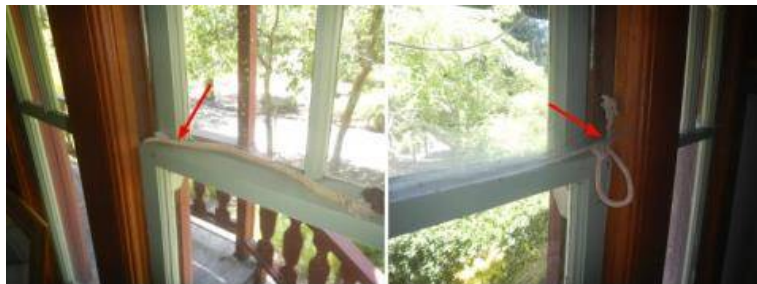
There are damaged or broken sash cords, ropes or balances noted at one or more windows. As a result, the windows do not stay properly in the open position. Recommend having this condition evaluated and corrected by the appropriate qualified trades person.

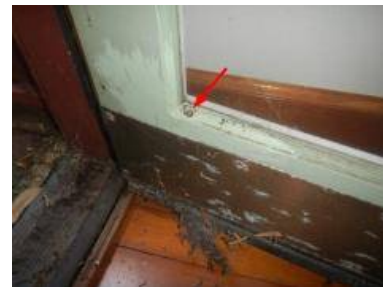
There is moisture damage to some of the trim around the windows in the exterior entry door. We recommend further evaluation and correction by the appropriate, qualified professional.

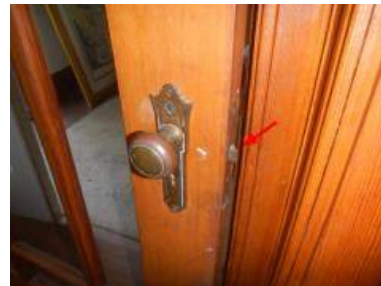
The striker plate / latch on the interior sun room door is misaligned and as a result the door does not close and latch properly. We recommend adjustment or repair by the appropriate qualified trades person.

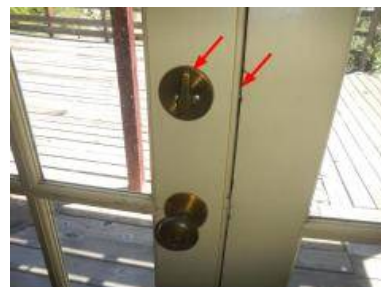
The deadbolt latch is not functioning properly at the exterior door and as a result we were unable to open / operate the doors. We recommend further evaluation and correction by the appropriate, qualified professional.

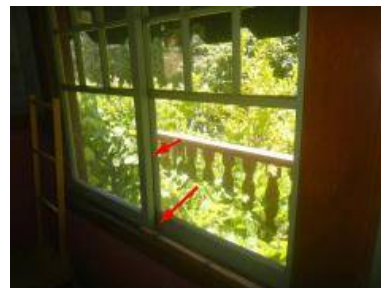
One of the sun room windows appears to be pushed out at the bottom as indicated by a visible gap. We recommend further evaluation and correction by the appropriate, qualified professional.

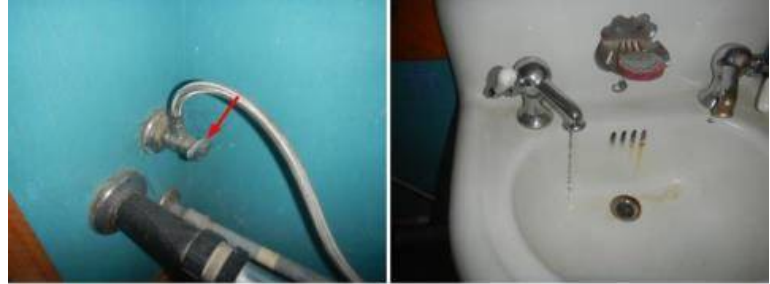
One or both of the angle stops (water supply line shut-off valves) under the sink had been turned OFF prior this inspection. These valves are typically turned OFF as a result of leaks at the sink faucet or other water supply components (including the angle stop itself.) We did NOT operate these valves as part of this inspection. We recommend inquiring of the seller as to the history of this condition.

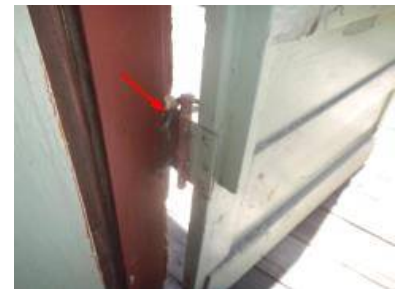
The hinge is loose on the front facing balcony screen door. We recommend having these conditions further evaluated and corrected by the appropriate, qualified professional.

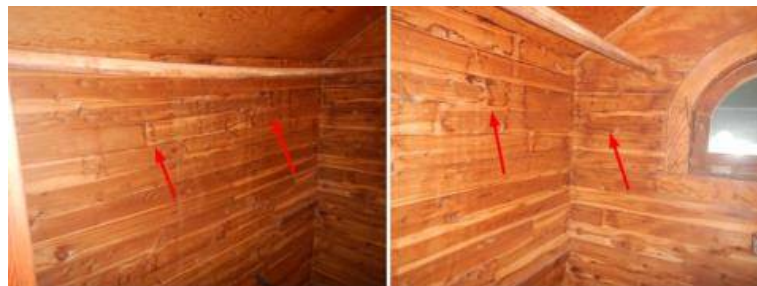
There are moisture stains on the walls in the closet. We recommend further evaluation and correction by the appropriate, qualified professional.

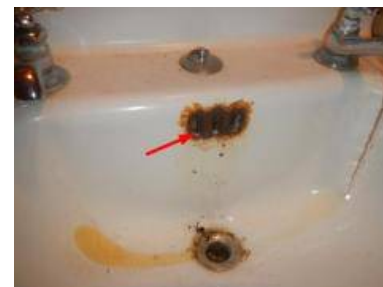
Heavy rusting is noted around the overflow opening in the sink. We recommend further evaluation and correction by the appropriate, qualified professional.

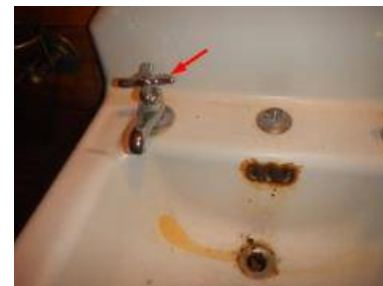
The left side water control valve handle at the sink in this room was stuck and did not function properly. We recommend further evaluation and correction by the appropriate, qualified professional.

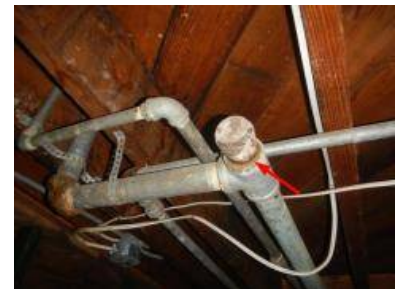
There is a non-standard plumbing cap (ie: wooden plug) being used at one of the waste lines in the under floor / basement area. As a result, there is an active waste line water leak visible. We recommend further evaluation and correction by a licensed plumbing contractor.

Since one or more waste line plumbing leaks are currently noted in the system, we recommend that it be immediately repaired by a licensed Plumber. We cannot predict when or if the system will develop future leaks, therefore you are advised to monitor the system.

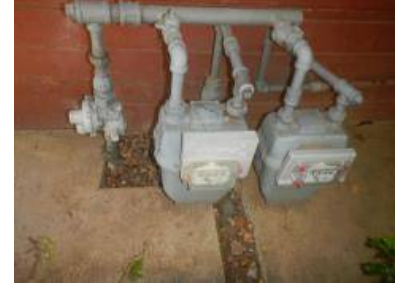
There was NO visible wrench present or near the gas meter and shut-off valve at the time of the inspection. We recommend having the appropriate wrench located in visible proximity to the gas meter and shut-off valve so you can turn the gas 'Off' in the event of an emergency (ie: fire or earthquake). Gas valves are often very difficult to turn / operate and we recommend becoming familiar with the process of turning the main gas valve 'Off' should the circumstances arise.

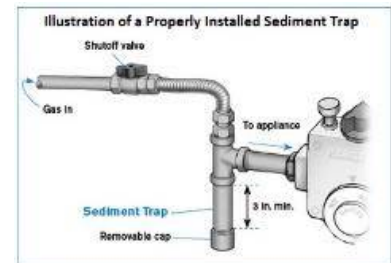
There is NO capped sediment trap installed at the incoming gas supply line for this appliance. This is commonly a code requirement as well as a requirement by most appliance manufacturers. The sediment trap, when properly installed, will change the direction of the gas flow thereby allowing it to collect any sediment or debris before it reaches the appliance gas controls. We recommend having this gas line modified to incorporate a sediment trap.

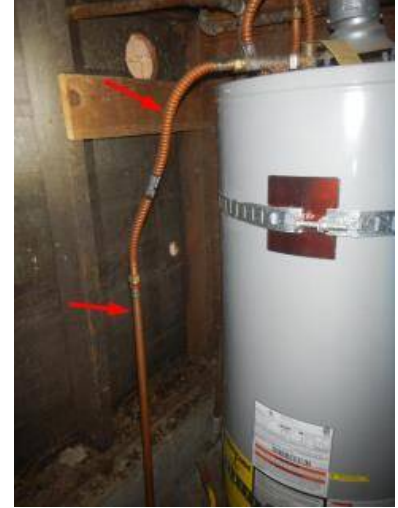
The drain line for the TPR valve is not properly supported. This drain line should be secured to prevent it from movement, damage, or failure (ie: coming apart at one of the connections). Recommend having this condition evaluated and corrected by the appropriate qualified trades person.

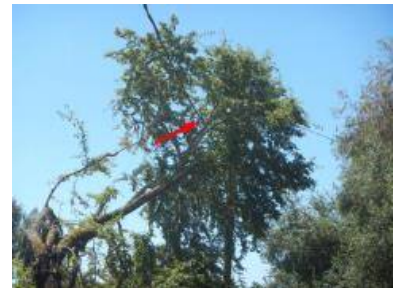
The incoming overhead service conductors are routed through and contacting tree branches or limbs. Tree limbs can place strain on the electrical weatherhead, possibly causing damage and creating hazardous conditions. Recommend either contacting the local utility company or a licensed electrician to determine what course of action should be taken.

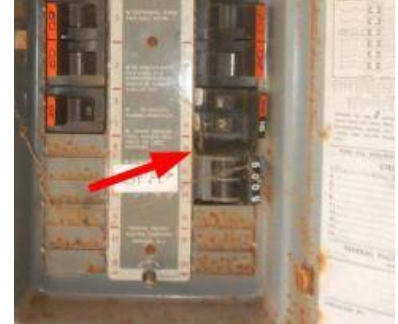
There is an unused circuit breaker opening in this panel that does not have a proper protective cover installed. These covers are important because without them, someone could stick their fingers into the panel and come into direct contact with high voltage. Recommend having this condition evaluated and corrected by a licensed electrician.

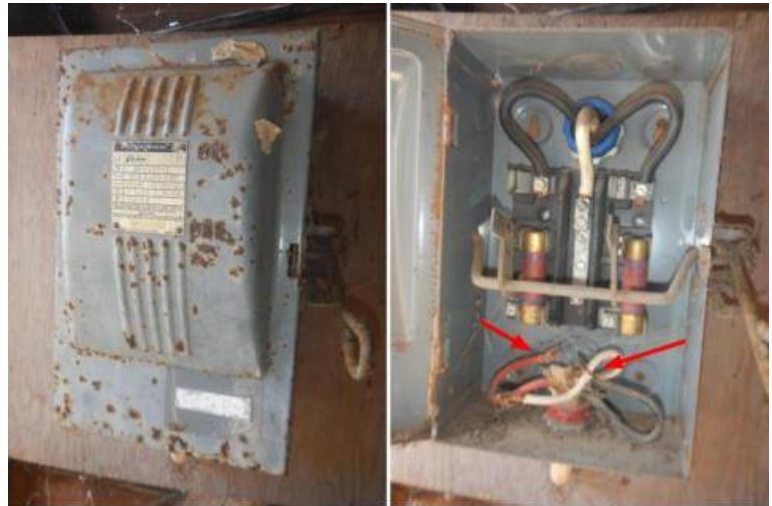
There is an electrical disconnect box present behind one of the electrical meters in the water tower that is no longer in use as the wires have been disconnected inside the assembly. We recommend inquiring of the seller / occupants for more information about the cause / history of this condition.

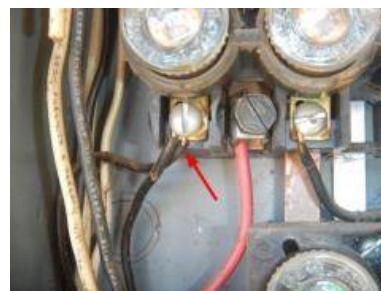
Multiple wires are connected to a single lug on one or more of the fuses inside this panel. Manufacturers require that only one wire be secured at each lug. We recommend contacting a licensed electrician to reposition these wires so that no more than one wire is secured at each circuit lug.

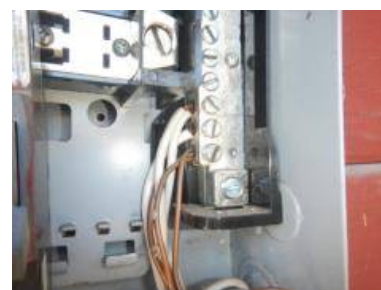
One or more grounding wires are connected to the neutral bus bar. In a sub-panel only neutral wires should be connected to the neutral bus bar (which is isolated from the metal panel housing via a plastic riser). All grounding wires should be connected to a bus bar which is directly grounded to the sub-panel housing. Recommend having a licensed electrician further evaluate and repair as needed.

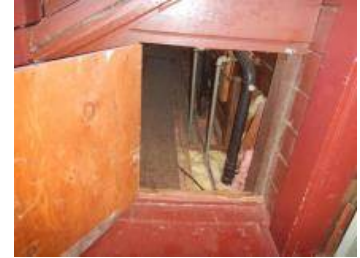
**LOCATION:** Located in the attic area of the house with access via the small door opening at the top of the stairs.

**PANEL LOCATION COMMENT:** Access to this panel is restricted and limited. For safety reasons there needs to be free and clear access to panels for servicing, etc. When / where practical, consideration should be given to relocating this panel.

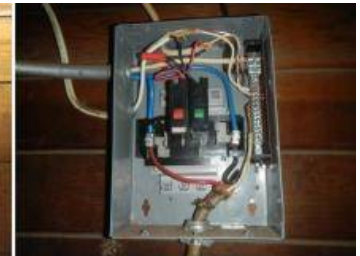
There are one or more unused circuit breaker openings in this panel that do not have proper protective covers installed. These covers are important because without them, someone could stick their fingers into the panel and come into direct contact with high voltage. Recommend having this condition evaluated and corrected by a licensed electrician.

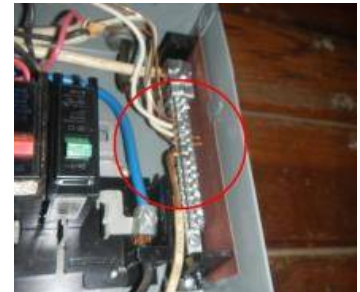
One or more grounding wires are connected to the neutral bus bar. In a sub-panel only neutral wires should be connected to the neutral bus bar (which is isolated from the metal panel housing via a plastic riser). All grounding wires should be connected to a bus bar which is directly grounded to the sub-panel housing. Recommend having a licensed electrician further evaluate and repair as needed.

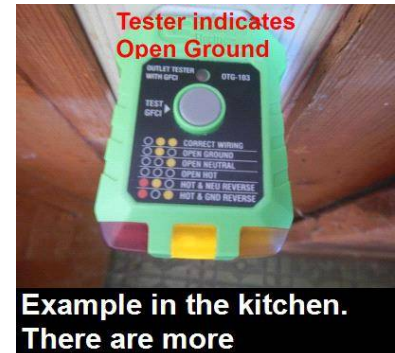
There are one or more 3-prong electrical outlets in the house that do not appear to be properly grounded as our tester indicated an 'Open Ground' condition. We recommend all ungrounded three pronged receptacles be grounded or restored to their original two prong configuration (except where upgrading to GFCI protection would be appropriate). Recommend having this condition evaluated and repaired by a licensed electrician.

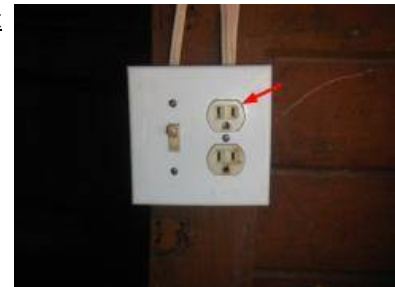
There are outlets in the lower level basement area that did not appear to be energized. Our tester indicated "No Electricity Present". If there is a switch that controls this outlet, we did not locate it. Recommend having this condition evaluated and corrected by a licensed electrician.
