## COMMERCIAL BUILDING INSPECTION REPORT

2100 Hwy 290 E  
Brenham, TX 77833

JR Enterprises

02/26/2026

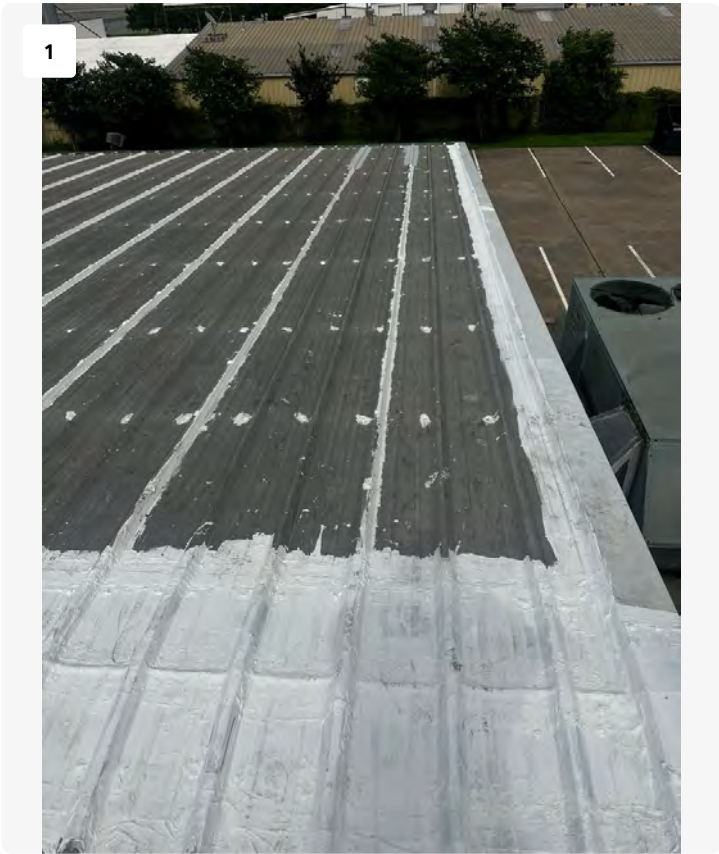
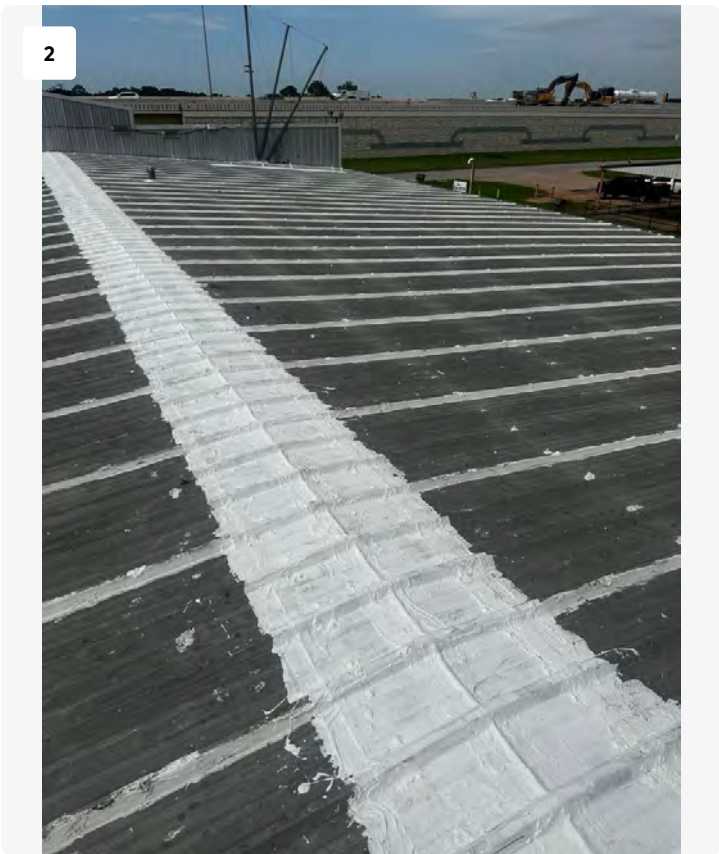
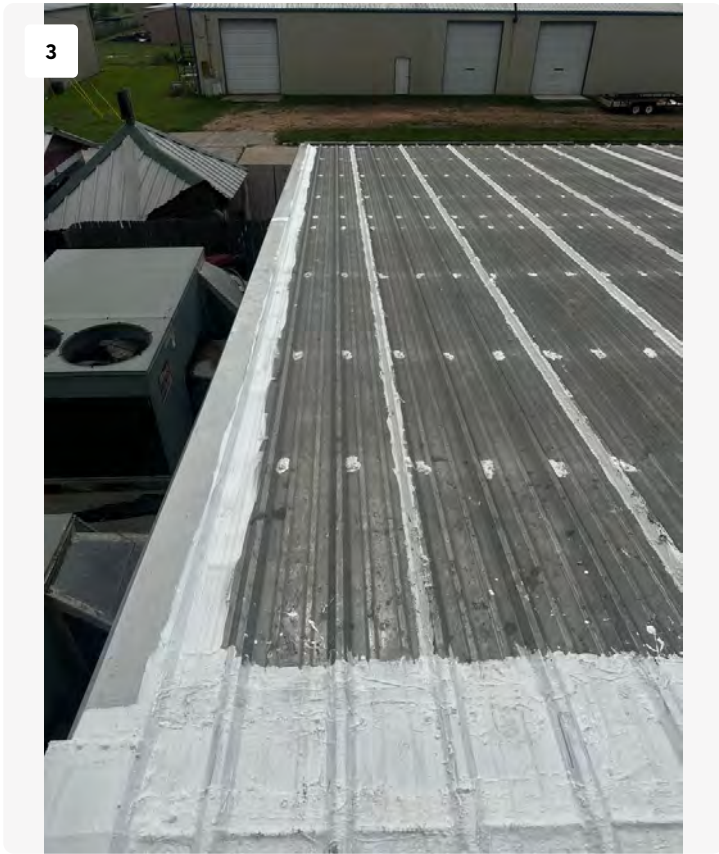
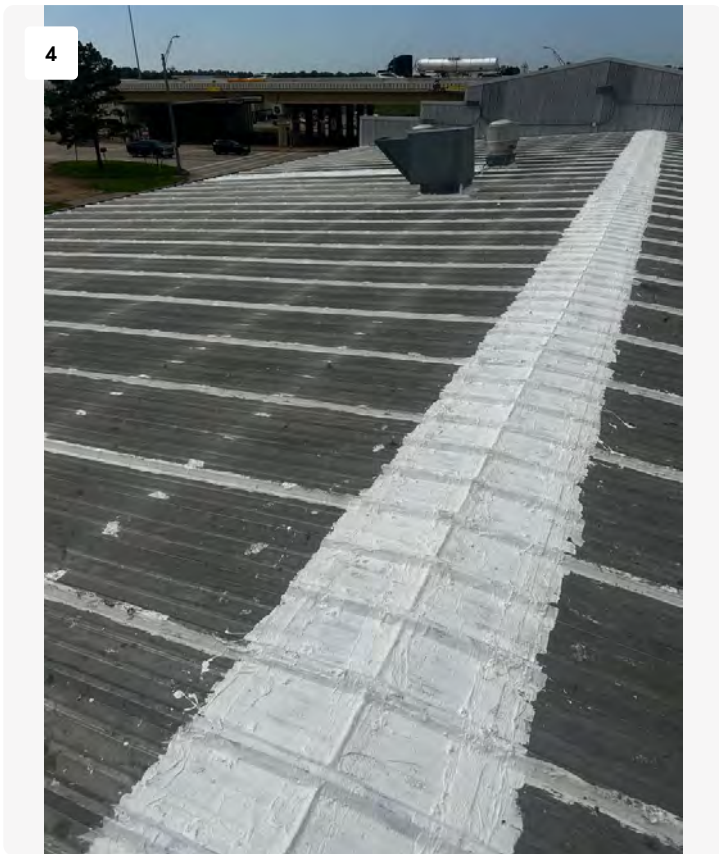
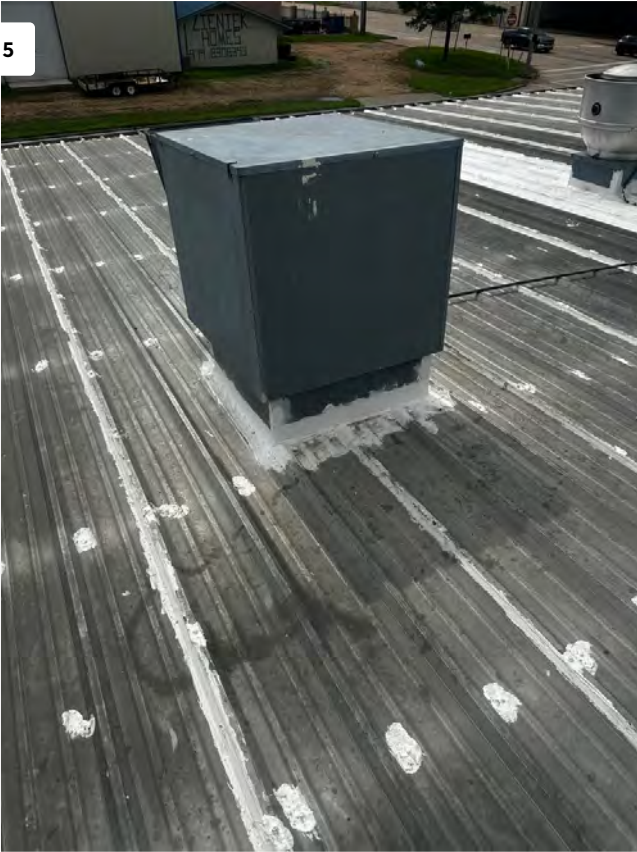
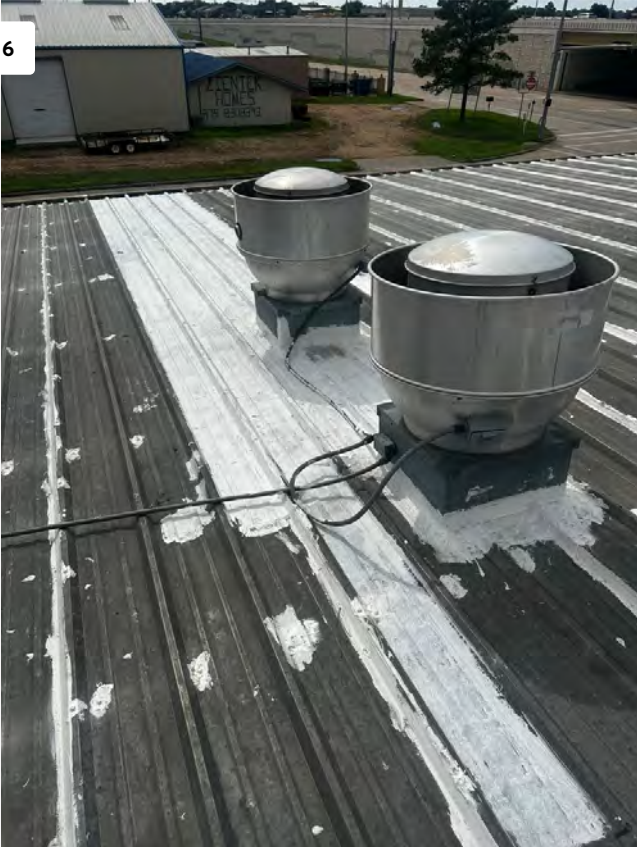
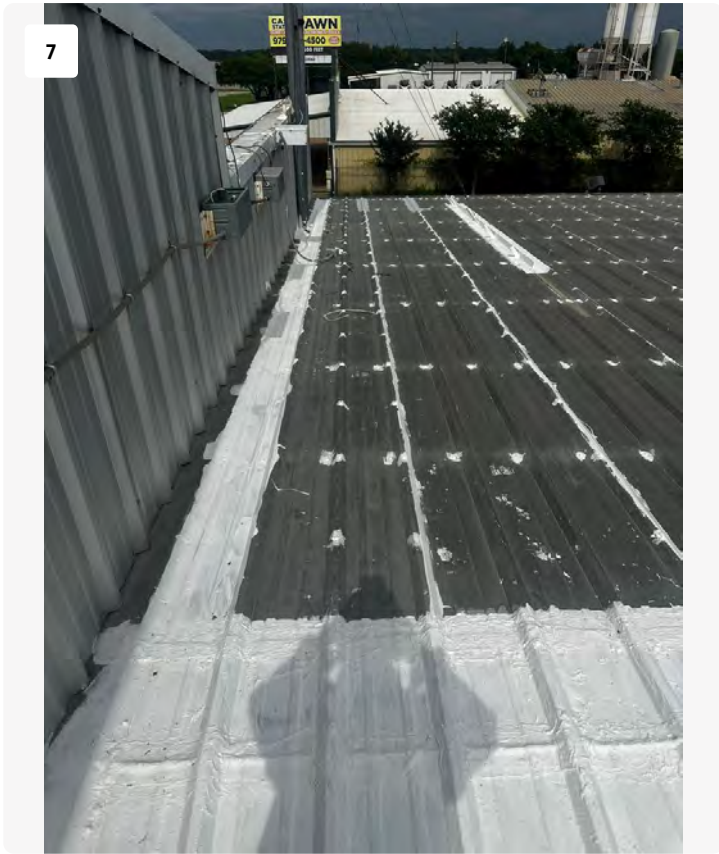
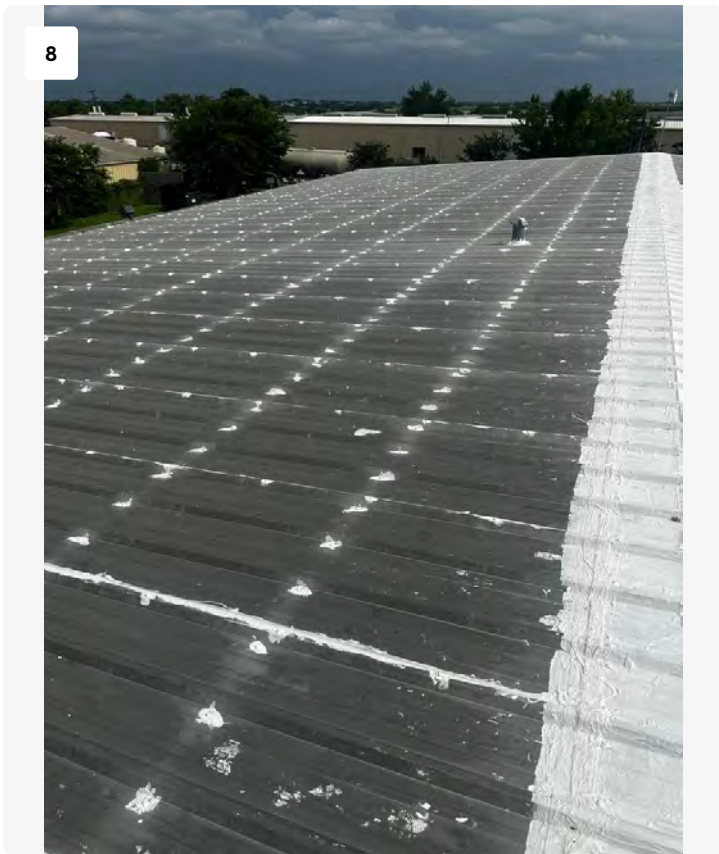
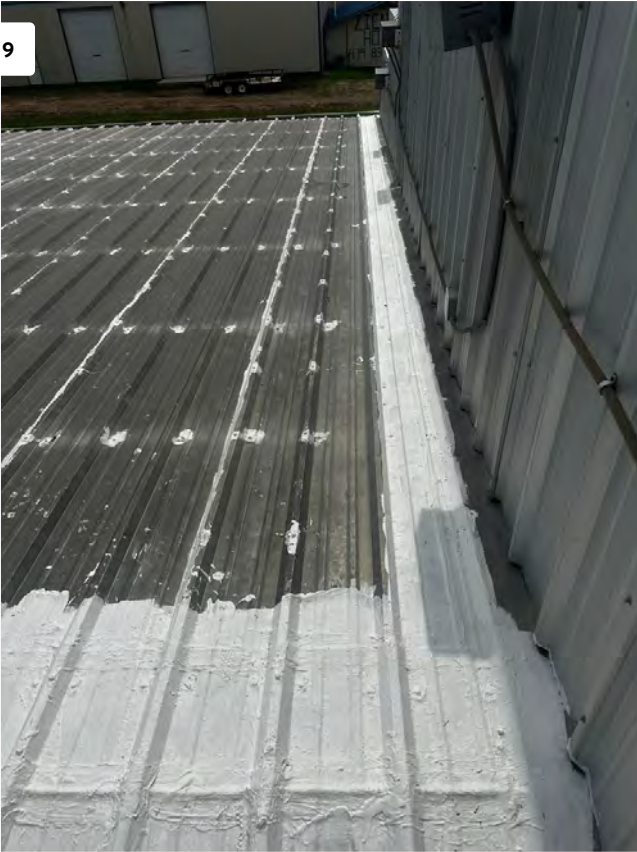
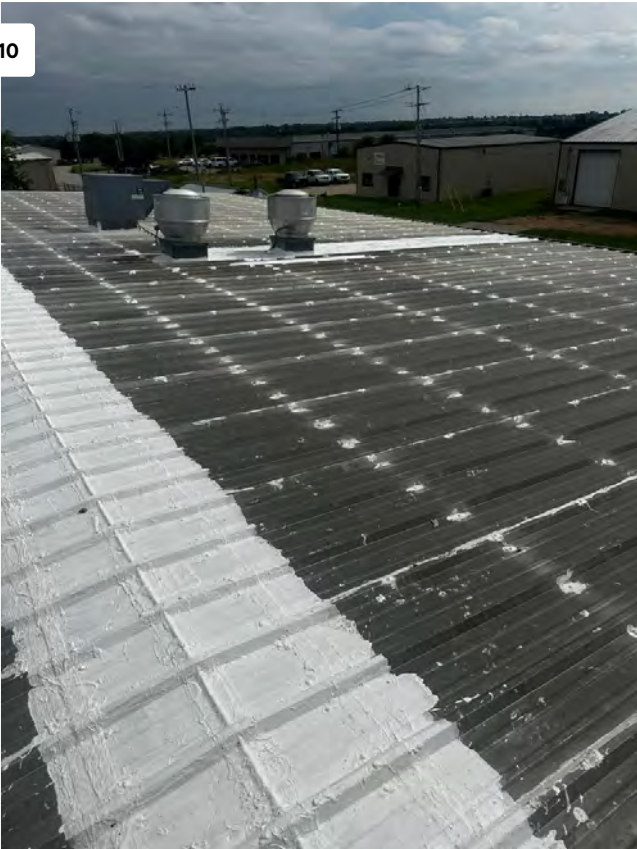
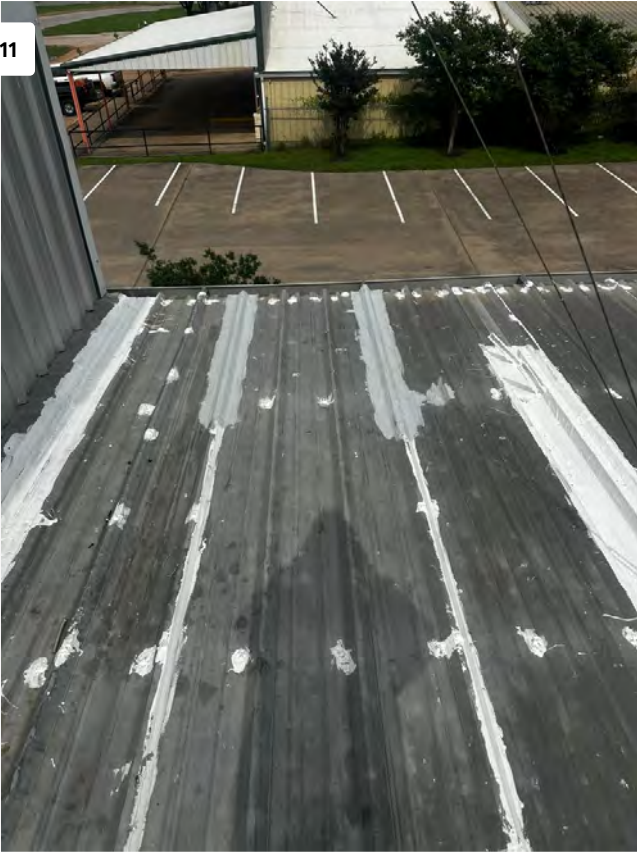
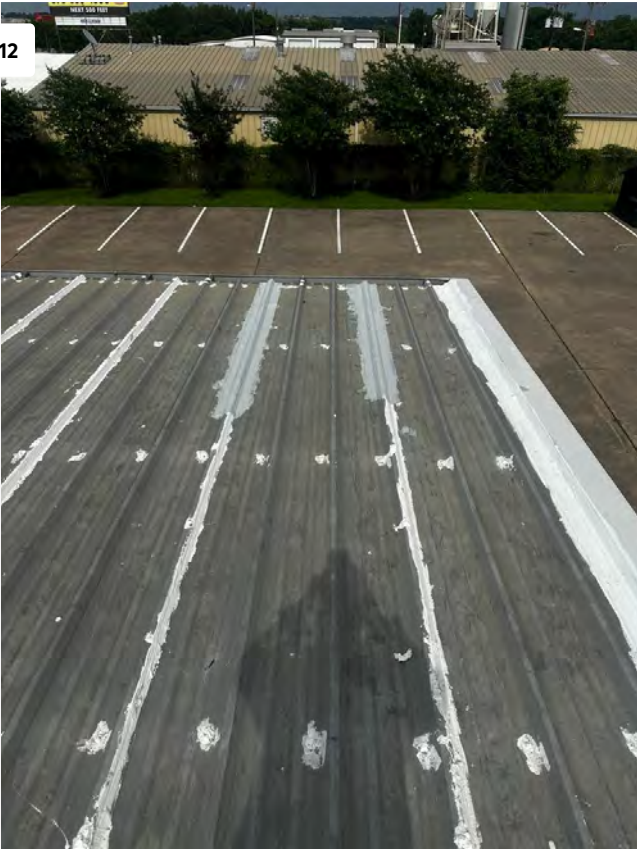
We were called out due to leaks spread across multiple areas in the roof. After inspecting the roof, we noticed that the panels seemed to be in good condition, but noticed there were several loose screws laying across the roof. We felt the best solution for a R Panel roof in this condition would be a coating system. A full coating wasn't necessary due to the panels still being in good condition, so we applied coating to all empty holes, screws, seams, and rake trim. The rake trim, main ridge seams, and penetrations have a 3-course coating system which includes a middle layer of fabric.

After the coating system was applied, there was a storm that blew through with large amounts of water and major wind speeds, but no leaks were found by the tenant.
