Home Inspection Report

5418 Park Heights Ave
Park Heights, MD 21215

Prepared for: Charles Shelton

Inspected by:
Luke Bunting
Blue Crab Inspections

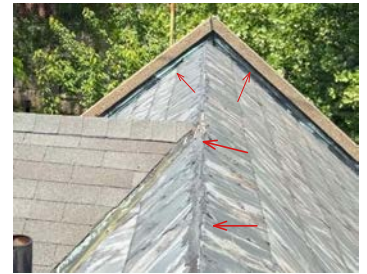
1. Main Roof Surface Material: Slate - Cracked sealant noted throughout. A qualified roofing contractor is recommended to evaluate and estimate repairs.

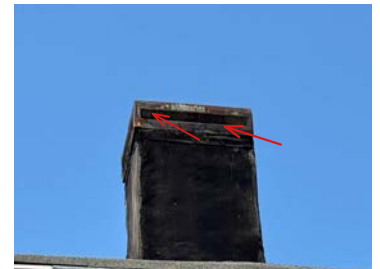
4. Center Chimney Flue/Flue Cap: Metal - Corrosion noted around the cap and covering. A qualified contractor is recommended to evaluate and estimate repairs

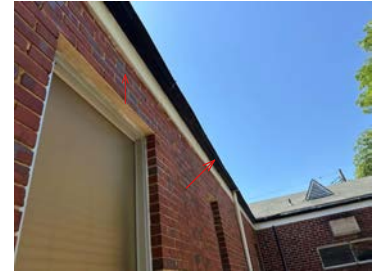
5. Fascia: Metal, Wood - Loose sections noted, recommend securing. A qualified contractor is recommended to evaluate and estimate repairs.

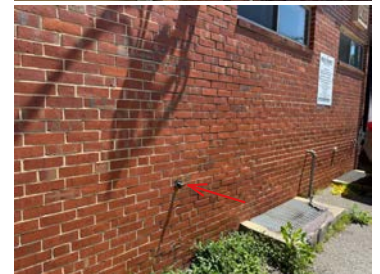
6. Hose Bibs: Present - Missing handle, recommend replacing. A qualified contractor is recommended to evaluate and estimate repairs.

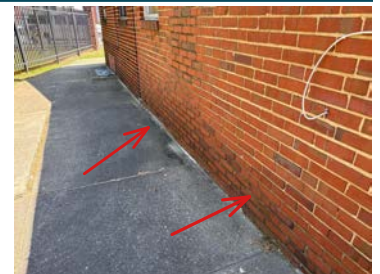
7. Grading: Negative Slope - Improper slope towards foundation, recommend improving grade to move water away from the house. A qualified contractor is recommended to evaluate and estimate repairs.

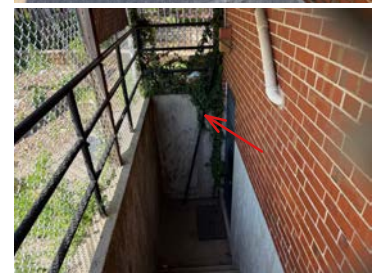
8. Vegetation: Vines - Vines are growing up the structure. Recommend removing vines from house structure. A qualified contractor is recommended to evaluate and estimate repairs.

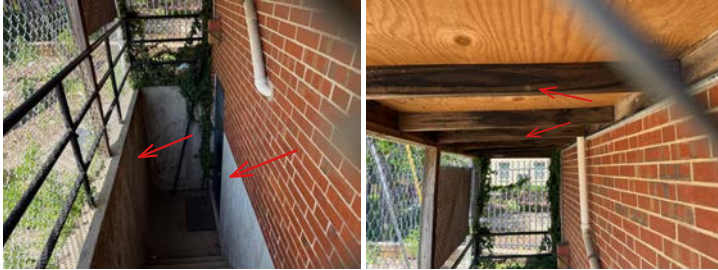
10. Sewer Cleanout: Not Visible - No exterior sewer cleanout was visible at the time of inspection. Recommend further investigation into whether the existence of a sewer cleanout is present or missing. If no sewer cleanout is present, recommend proper access be installed.
11. Basement Stairwell: Masonry - Railings missing at the basement stairwell, recommend installing. Undersized supports noted at roof covering. A qualified contractor is recommended to evaluate and estimate repairs.

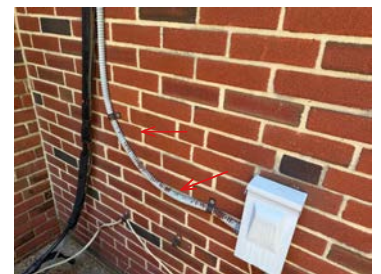
14. Right Side AC System Electrical Disconnect: Pull out - Corrosion noted on conduit. Recommend evaluation by a licensed electrician.

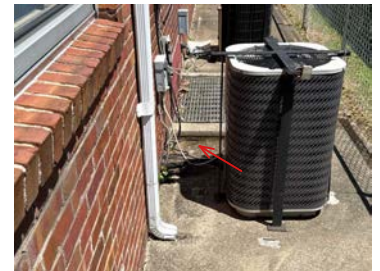
16. Rear Left AC System Condensate Removal: Plastic - Condensate line discharges next to the structure, recommend adjustment. A qualified contractor is recommended to evaluate and estimate repairs.

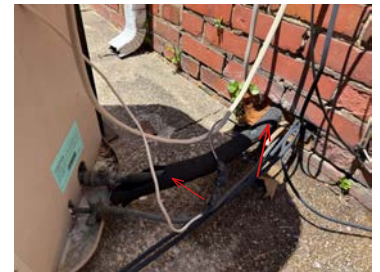
17. Rear Left AC System Refrigerant Lines: Suction/Liquid Line - Insulation for refrigerant lines is torn, missing, and deteriorated. Recommend replacing the insulation to improve energy efficiency. Entry point into home is not sealed, recommend sealing to prevent moisture penetration. A qualified air conditioning contractor is recommended to evaluate and estimate repairs.

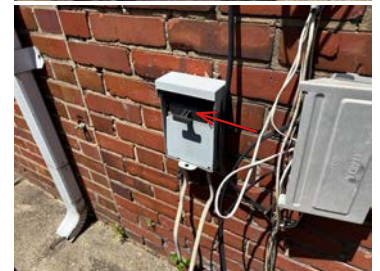
18. Rear Left AC System Electrical Disconnect: Pull out - Missing cover, recommend replacing. A qualified contractor is recommended to evaluate and estimate repairs.

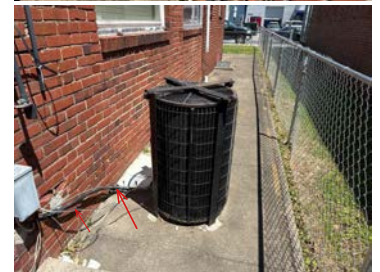
19. Left Front AC System Refrigerant Lines: Suction/Liquid Line - Insulation for refrigerant lines is torn, missing, and deteriorated. Recommend replacing the insulation to improve energy efficiency. Entry point into home is not sealed, recommend sealing to prevent moisture penetration. A qualified air conditioning contractor is recommended to evaluate and estimate repairs.

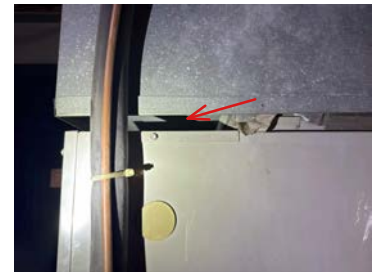
21. Basement Center Heating System Distribution: Duct Work - Gaps noted in the ducts. A qualified heating system contractor is recommended to evaluate and estimate repairs.

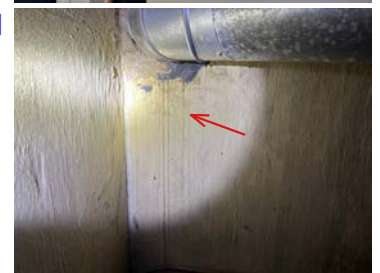
22. Basement Rear Heating System Flue Pipe: Metal - Staining and evidence of potential past leak at connection. A qualified contractor is recommended to evaluate and estimate repairs.

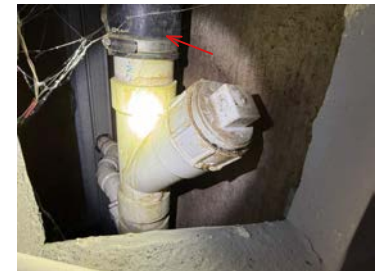
24. Sewer Cleanout Location Rear Of Basement - Evidence of previous repair noted, recommend further investigation. A licensed plumber is recommended to evaluate and estimate repairs.

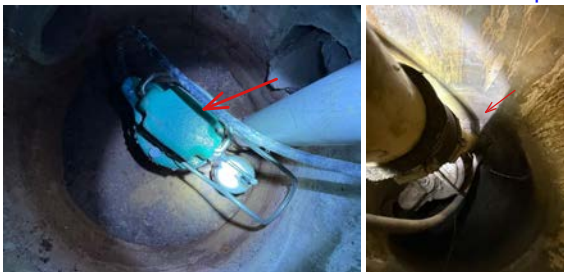
25. Exterior Hose Bib Shut Off Location: Not Visible
- Unable to locate interior hose bib shut off locations, recommend verifying. A qualified contractor is recommended to evaluate and estimate repair.
26. Sump Pump: Functional - Both sump pits were dry, recommend further evaluation. A qualified contractor is recommended to evaluate and estimate repairs.

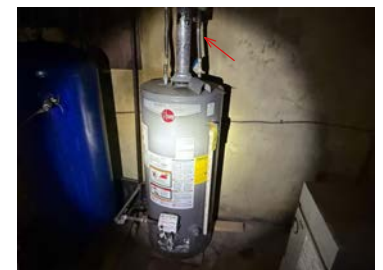
27. Basement Rear Water Heater Water Heater Operation: Functional - Missing expansion tank, recommend installing. A licensed plumber is recommended to evaluate and estimate repairs.

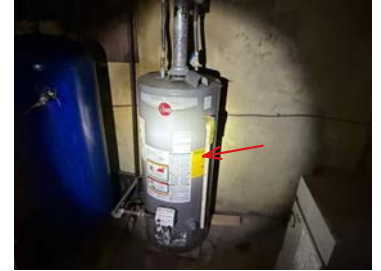
28. Basement Rear Water Heater TPRV and Drain Tube: Plastic - PVC is typically not rated for use in this role, recommend following manufactures installation guidance. A qualified contractor is recommended to evaluate and estimate repairs.

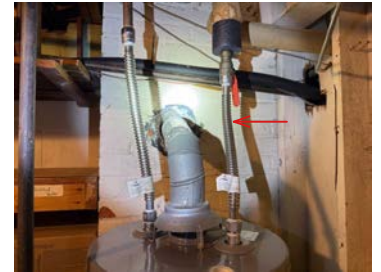
29. Basement Front Water Heater Water Heater Operation: Functional - Missing expansion tank, recommend installing. A licensed plumber is recommended to evaluate and estimate repairs.

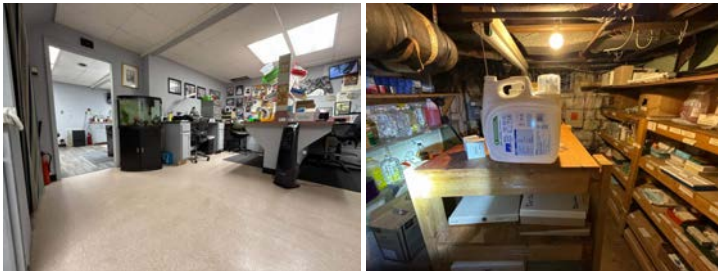
30. Structure Type: Wood Frame, Masonry - Multiple areas of the foundation and structure are not able to be fully inspected due to the installation of finished surfaces and personal belongings. A qualified contractor is recommended to evaluate and estimate repairs.

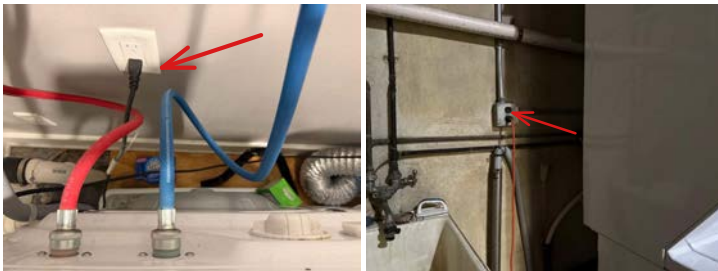
31. Basement Laundry Room/Area Electrical: Light(s) And Outlet(s) - Non-GFCI circuit, recommend GFCI circuit be installed. A licensed electrician is recommended to evaluate and estimate repairs.

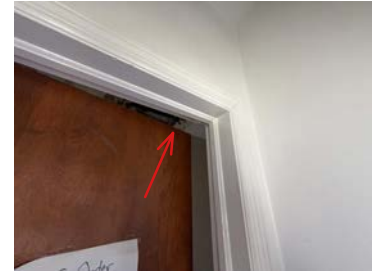
32. Front entrance Bathroom Doors: Wood - Door is striking frame, recommend trimming or adjustment. A qualified contractor is recommended to evaluate and estimate repairs.

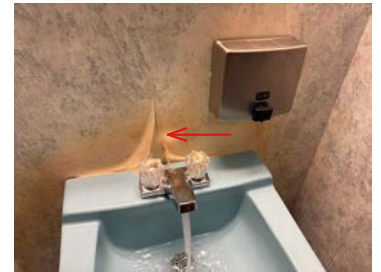
34. Rear Left Bathroom Walls: Paint - Peeling material noted. A qualified contractor is recommended to evaluate and estimate repairs.

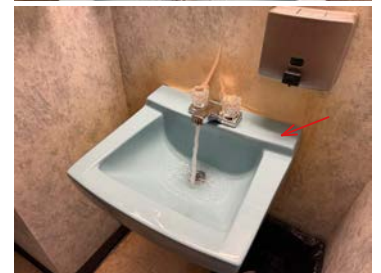
35. Rear Left Bathroom Counter/Cabinet: Present - Loose to the wall. A qualified contractor is recommended to evaluate and estimate repairs.

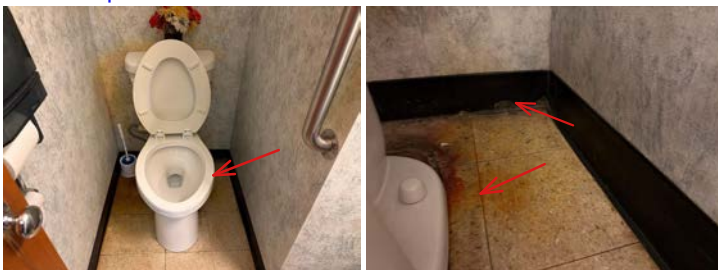
36. Rear Left Bathroom Toilets: Present - The toilet is loose at the floor. Loose toilets can lead to moisture penetration into the not visible sub-flooring. Recommend securing to prevent movement. Water damage around toilet. A qualified contractor is recommended to evaluate and estimate repairs.

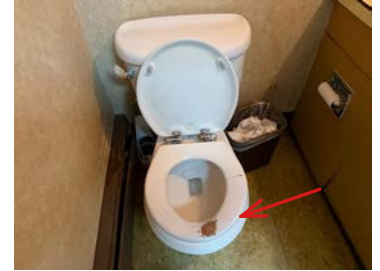
37. Break room Bathroom Toilets: Present - The toilet is loose at the floor. Loose toilets can lead to moisture penetration into the not visible sub-flooring. Recommend securing to prevent movement. A qualified contractor is recommended to evaluate and estimate repairs.

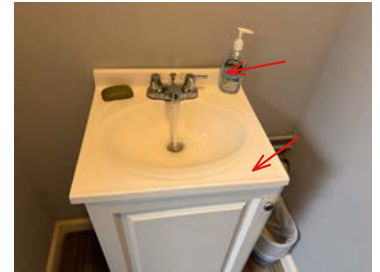
38. Basement Rear Bathroom Counter/Cabinet: Present - Countertop is loose from cabinet/wall, recommend it be secured. A qualified contractor is recommended to evaluate and estimate repairs.

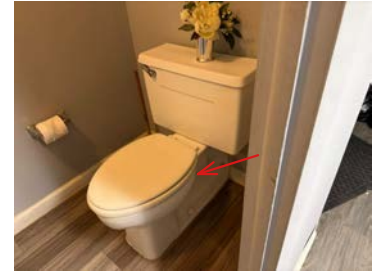
39. Basement Rear Bathroom Toilets: Present - The toilet is loose at the floor. Loose toilets can lead to moisture penetration into the not visible sub-flooring. Recommend securing to prevent movement. Slow flush noted. A qualified contractor is recommended to evaluate and estimate repairs.

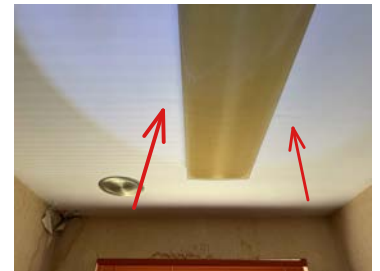
40. Office 1 Living Space Ceiling: Paint - Crack(s) noted, recommend they be patched and or repaired. A qualified contractor is recommended to evaluate and estimate repairs.

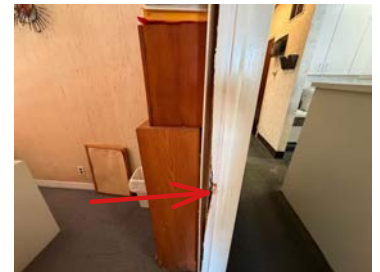
41. Office 1 Living Space Doors: Wood - Door frame damage noted, recommend repair and replacement of damaged material. A qualified contractor is recommended to evaluate and estimate repairs.

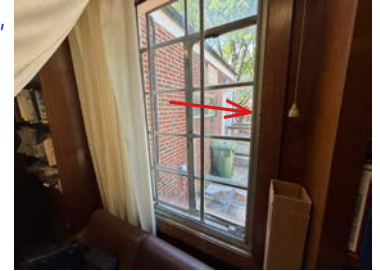
42. Office 4 Living Space Windows: Stationary, Metal - Window has missing components, recommend identifying and replacing/repairing. A qualified contractor is recommended to evaluate and estimate repairs.

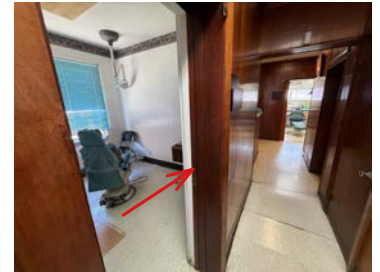
43. Office 5 Living Space Doors: Wood - Door is sticking, recommend adjustment. A qualified contractor is recommended to evaluate and estimate repairs.

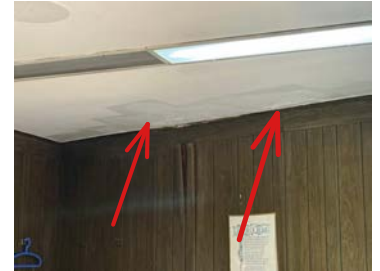
44. Rear Hallway/Office spaces Living Space Ceiling: Paint - Evidence of previous repairs, recommend further investigation regarding why repairs were made.

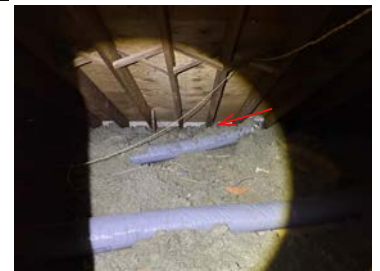
46. Main Attic Sheathing: Wood - Daylight visible. Recommend a qualified contractor to evaluate and estimate repairs.

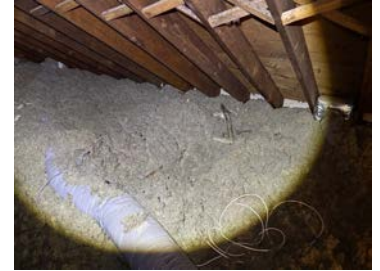
47. Main Attic Insulation: Present - Insulation is compressed throughout. A qualified contractor is recommended to evaluate and estimate repairs.

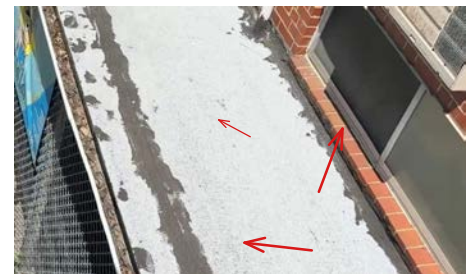
2. Basement Cover Roof Surface Material: Rolled Roofing Material - **Cracked sealant and granule loss noted throughout. Roofing material is reaching average age expectancy, recommend budgeting for replacement. A qualified roofing contractor is recommended to evaluate and estimate repairs.**

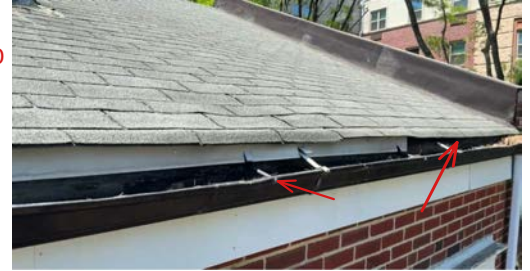
3. Flashing: Rubber, Metal, Missing - Missing drip edge flashing noted, recommend it be added. A qualified roofing contractor is recommended to evaluate and estimate repairs.

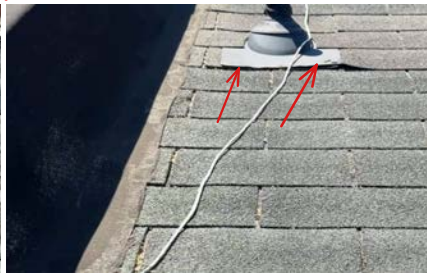
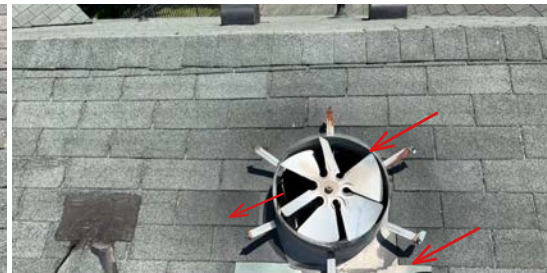
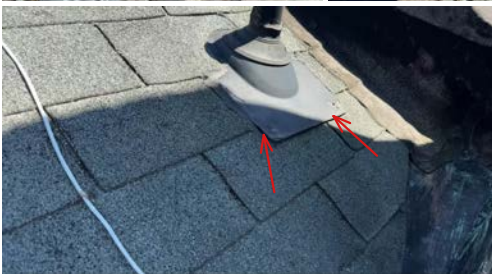
4. Vent Pipes: Plastic, Metal - Cracks in sealant around the vent penetration, recommend repair. Lifted vent boots noted, recommend repair. Evidence repairs noted around rear vent. A qualified contractor is recommended to evaluate and estimate repairs.

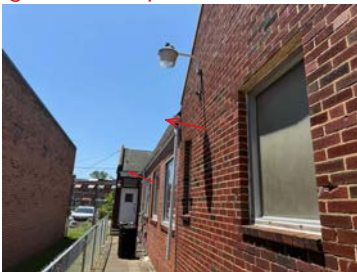
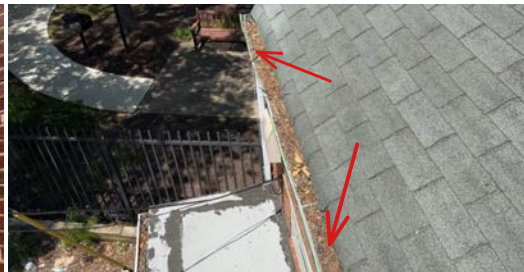
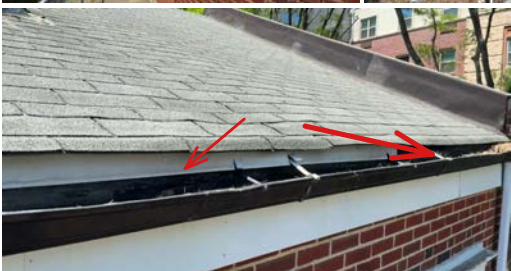
5. Gutters: Metal - Gutters were loose, sagging, and bent throughout. Large amount of debris present in multiple gutters. A qualified contractor is recommended to evaluate and estimate repairs.

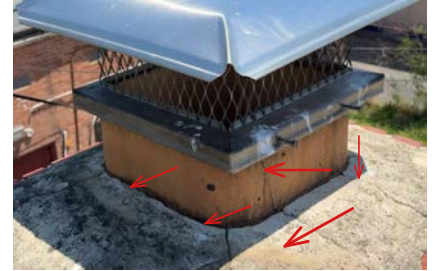
6. Rear Chimney Chimney: Masonry - Cracks present on the flue pipe, recommend repair. Cracks and damaged crown noted. A qualified contractor is recommended to evaluate and estimate repairs.

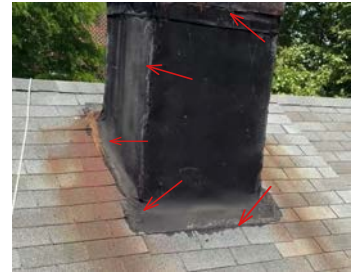
7. Center Chimney Chimney: Unknown/Roofing Material - Cracking noted on material throughout and the chimney was not properly flashed to the roof. A qualified contractor is recommended to evaluate and estimate repairs.

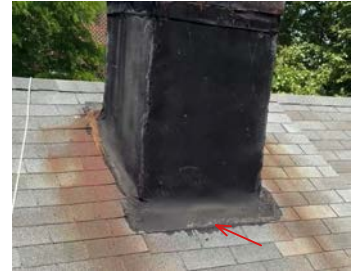
8. Center Chimney Chimney Flashing: Roofing Material - Improper flashing noted, recommend repair. A qualified contractor is recommended to evaluate and estimate repairs.

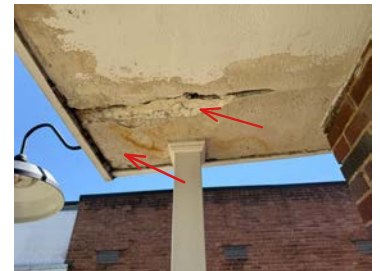
11. Soffits: Wood - Water damage and deteriorated material present. A qualified contractor is recommended to evaluate and estimate repairs.

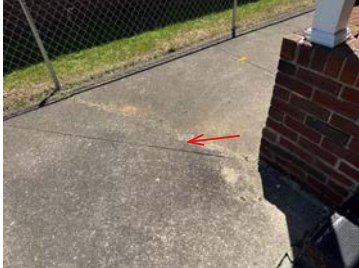
13. Walks: Present - Walkway is no longer level and a trip hazard is present. Cracks and gaps noted in multiple locations. A qualified contractor is recommended to evaluate and estimate repairs.

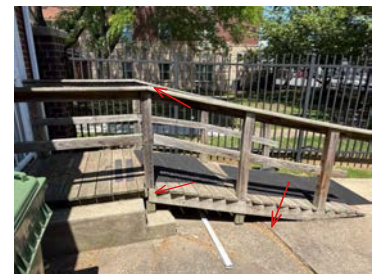
14. Steps: Present - The ramp was not properly secured, loose posts/railings and deck boards, recommend further evaluation. A qualified contractor is recommended to evaluate and estimate repairs.

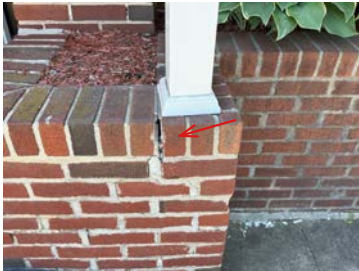
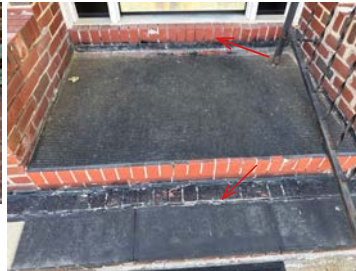
15. Porch: Present - Cracked and shifted material noted. Loose and corroded railing present. Gaps and cracks present in porch material. Recommend filling cracks and gaps to prevent moisture penetration. A qualified contractor is recommended to evaluate and estimate repairs.

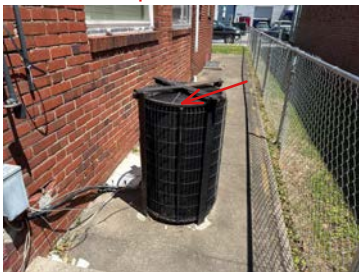
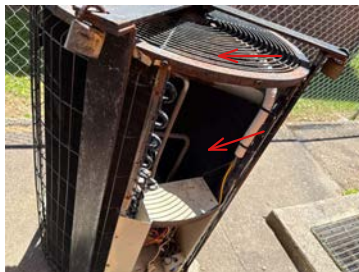
16. Left Front AC System A/C System Operation: Not Functional - Unit did not function at time of inspection. Missing sections and corroded sections. The unit is currently in service beyond average life expectancy, recommend budgeting for repair and or replacement. A qualified air conditioning contractor is recommended to evaluate and estimate repairs.

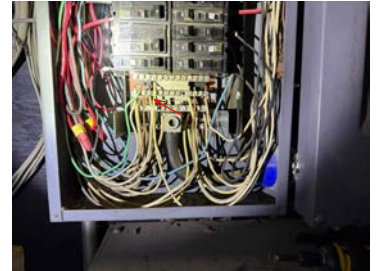
17. Aluminum Wiring: Present - Aluminum wiring noted on 120v circuitry. Recommend evaluation of aluminum wiring by a licensed electrician.

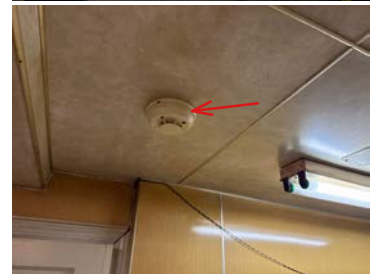
18. Smoke Detectors: Present - Missing on first floor. Smoke detectors were in use beyond their average life expectancies. Recommend having smoke detectors updated to be in compliant with State laws. A qualified contractor is recommended to evaluate and estimate repairs.

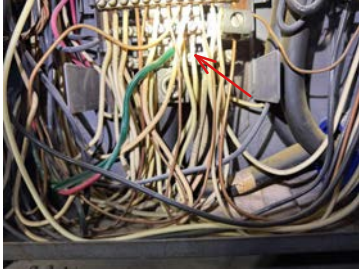
21. Basement Center Electric Panel Manufacturer: Square D - Double taps present. Unlabeled circuitry present in panel, recommend all circuitry have correct labeling. Corrosion present on and inside the panel. Neutrals and grounds bonded together at subpanel installation. A licensed electrician is recommended to evaluate and estimate repairs.

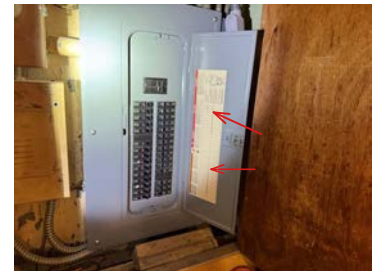
23. Basement Front Electric Panel Manufacturer: Square D - Unlabeled circuitry present in panel, recommend all circuitry have correct labeling. A licensed electrician is recommended to evaluate and estimate repairs.

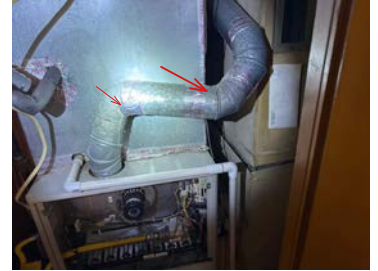
26. Basement Heating System Flue Pipe: Metal - The flue pipe improperly downturns, recommended adjustment. A qualified contractor is recommended to evaluate and estimate repairs.

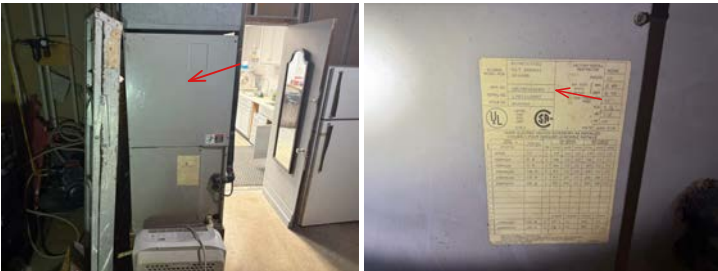
27. Basement Center Heating System Heating System Operation: Non-Functional - The system was off, recommend further evaluation. The unit is in service beyond its expected life expectancy, recommend budgeting for repair or replacement. Unable to determine the last service date for the heating/cooling system. Heating/cooling systems should be serviced annually. A licensed HVAC contractor is recommended to evaluate and estimate repairs.

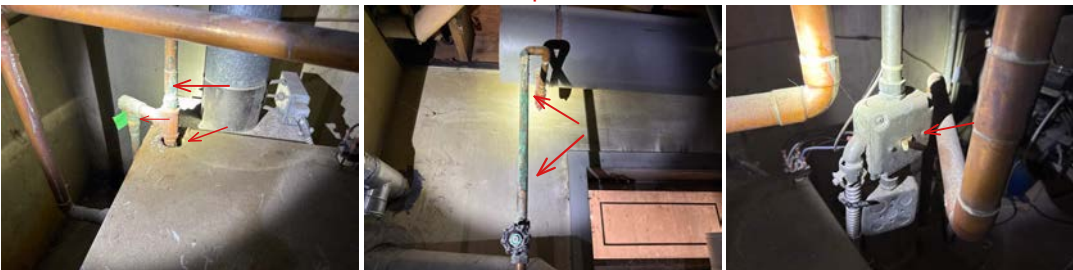
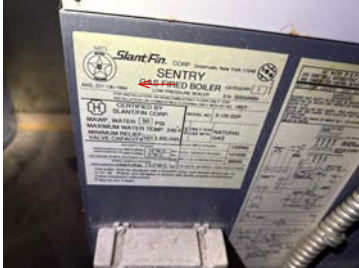
28. Basement Rear Heating System Heating System Operation: Non-Functional - Corrosion and evidence of potential past leak noted in multiple areas, recommend further evaluation. The system was off at time of inspection, recommend verifying function. Missing sediment drip leg on gas line. The unit is in service beyond its expected life expectancy, recommend budgeting for repair or replacement. Unable to determine the last service date for the heating/cooling system. Heating/cooling systems should be serviced annually. A licensed HVAC contractor is recommended to evaluate and estimate repairs.

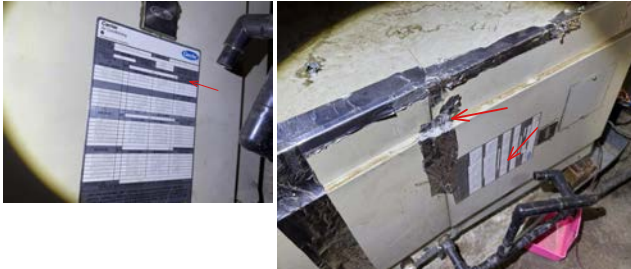
29. Attic Heating System Heating System Operation: Functional - The unit is in service beyond its expected life expectancy, recommend budgeting for repair or replacement. Corrosion and water staining noted around the furnace cabinet. A licensed HVAC contractor is recommended to evaluate and estimate repairs.

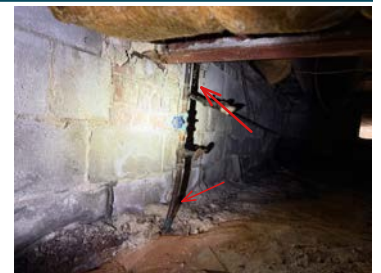
31. Service Line: Metal - Excessive condensation noted and pipes were not insulated throughout the crawl space. A licensed plumber is recommended to evaluate and estimate repairs.

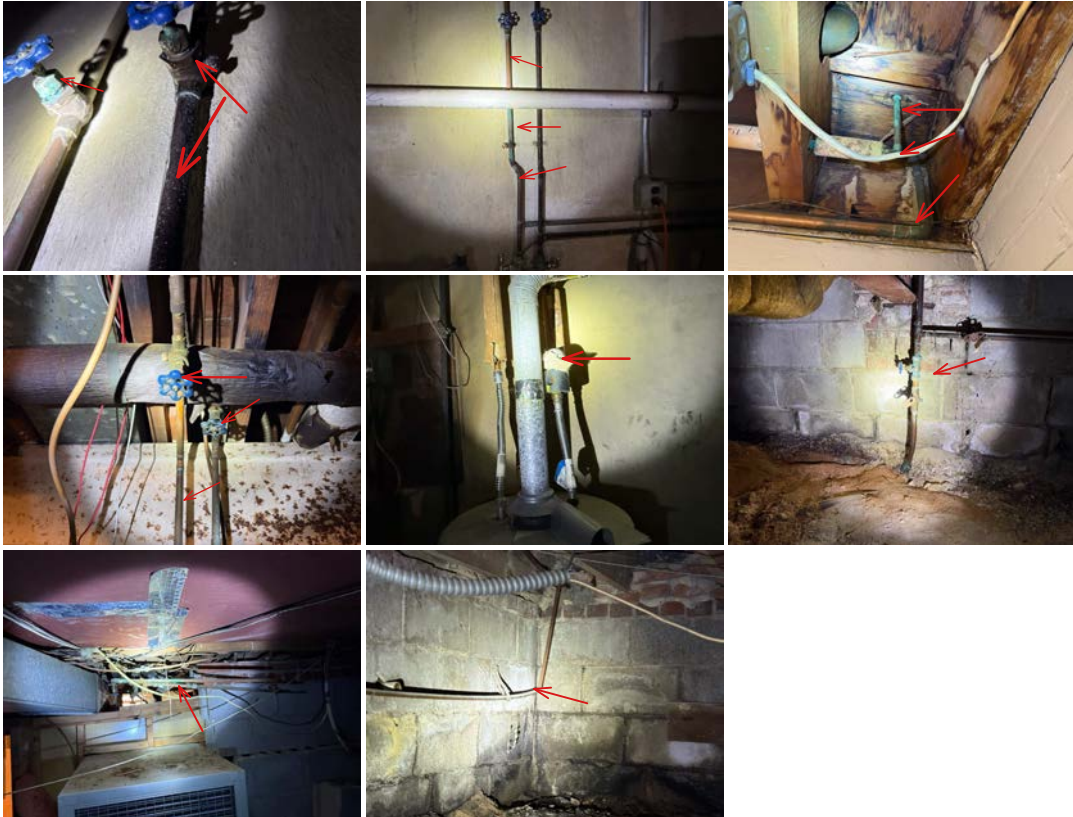
32. Water Lines: Plastic, Metal - Corrosion and evidence and past leaking noted at multiple lines and excessive amount of condensation noted. Unknown pipe wrap noted. Multiple abandoned plumbing lines throughout the crawl space, recommend further evaluation. Kinked line noted. A licensed plumber is recommended to evaluate and estimate repairs.

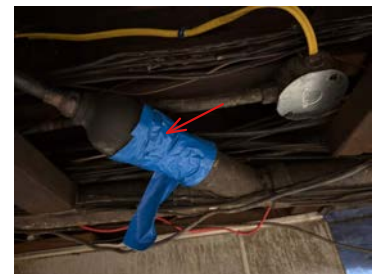
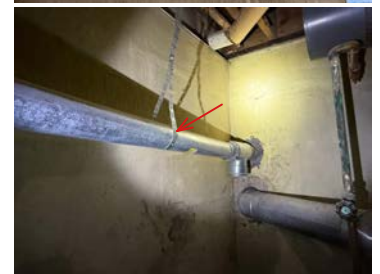
34. Basement Rear Water Heater Flue Pipe: Present - **Flue piping was loose and improperly pitched. A qualified contractor is recommended to evaluate and estimate repairs.**

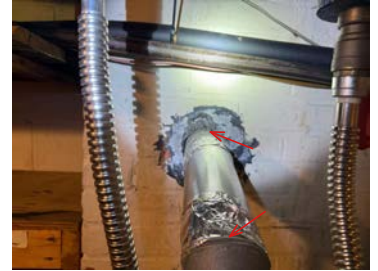
35. Basement Front Water Heater Flue Pipe: Metal - Piping was improperly taped. Gaps in flue piping chimney connection. Recommend sealing vent penetration into wall/chimney to prevent gases coming back into the home. A qualified contractor is recommended to evaluate and estimate repairs.

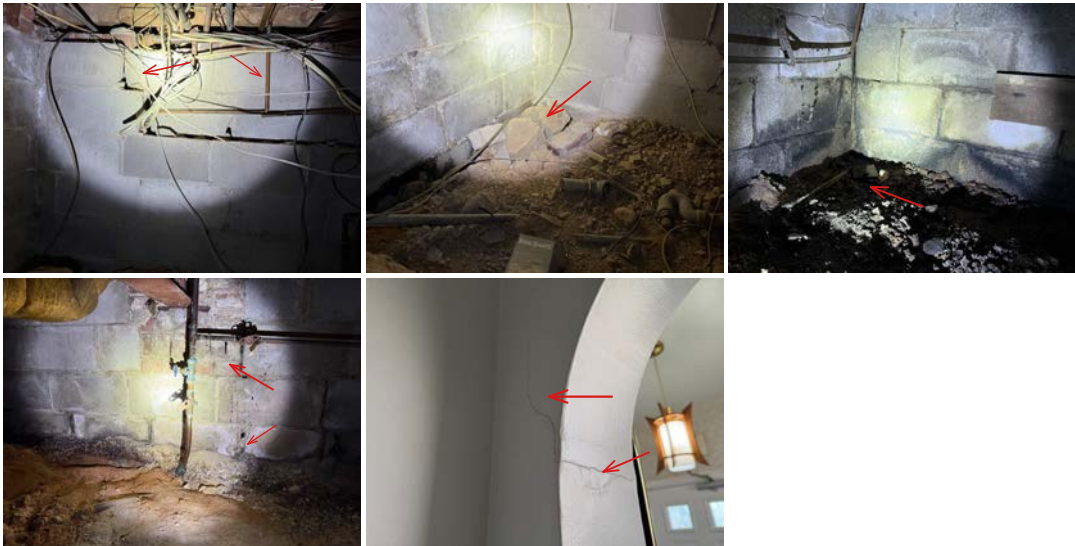
36. Foundation: Masonry - Center wall was pushed in. Excess erosion around the foundation and cracks in the block and mortar. Cracking noted at archway on sink floor. A qualified foundation contractor is recommended to evaluate and estimate repairs.

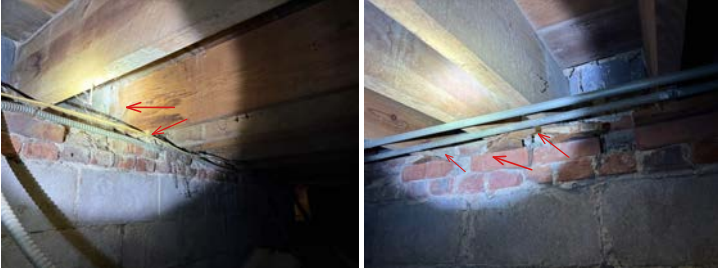
37. Joists/Trusses: Wood - Water and fire damage on multiple joists. Water damage noted on multiple joists and shims and bricks were loose throughout the crawl space. A qualified contractor is recommended to evaluate and estimate repairs.

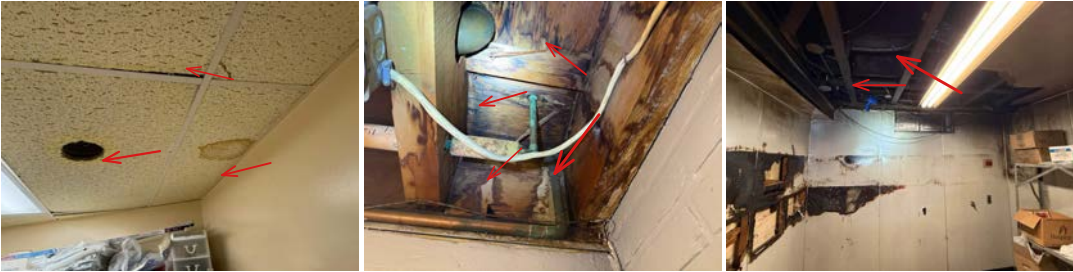
38. Main Basement Ceiling: Exposed Frame, Paneling - Moisture staining and fire damage noted in multiple areas, recommend further evaluation. A qualified contractor is recommended to evaluate and estimate repairs.

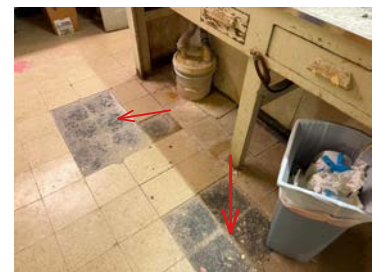
40. Main Basement Floor: Carpet, Tile - Damaged tile noted in multiple areas. Most 9x9 tile may contain asbestos fiber material. Recommend encapsulating to prevent damage to tile. A qualified contractor is recommended to evaluate and estimate repairs.

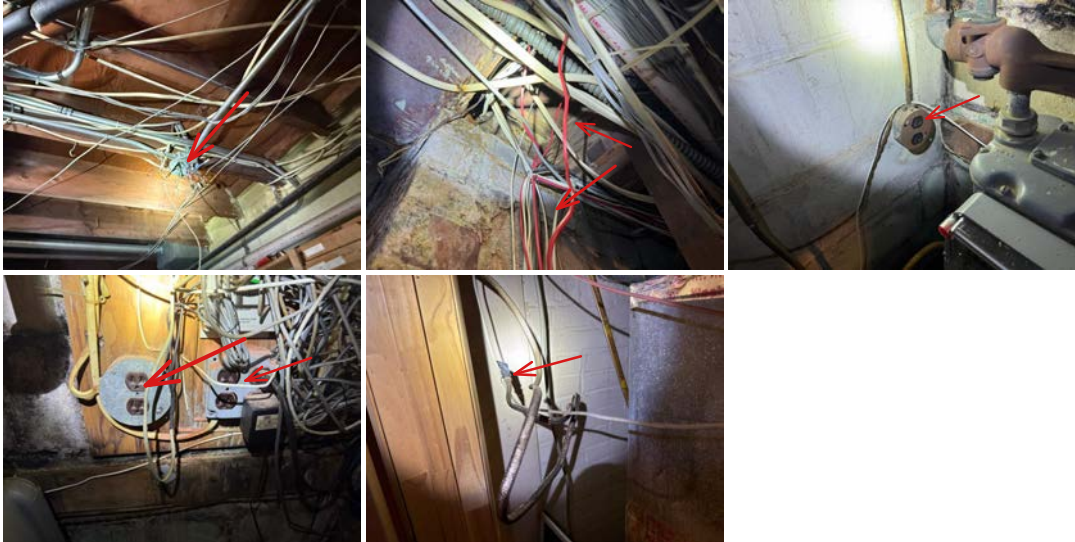
41. Main Basement Electrical: Light(s) And Outlet(s) - Exposed and unsecured wiring noted. Two prong outlet, recommend updating. Corrosion noted on outlets. A licensed electrician is recommended to evaluate and estimate repairs.

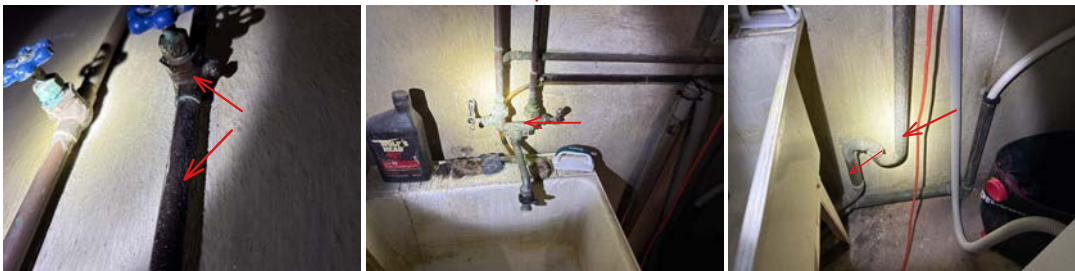
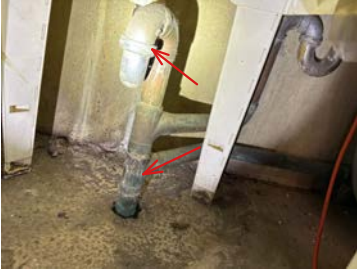
43. Basement Laundry Room/Area Laundry Tub: present - Leaking and condensation on pipes. Corrosion noted on drain lines and improper drain piping configuration. The water was off to the bibs. A qualified contractor is recommended to evaluate and estimate repairs.

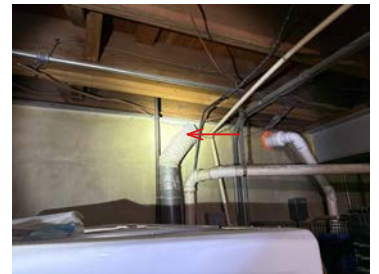
44. Basement Laundry Room/Area Dryer Vent: Metal Flex - Plastic dryer vent piping noted in use, plastic dryer vent piping is a known fire hazard. Recommend replacing plastic flex pipe. A qualified contractor is recommended to evaluate and estimate repairs.

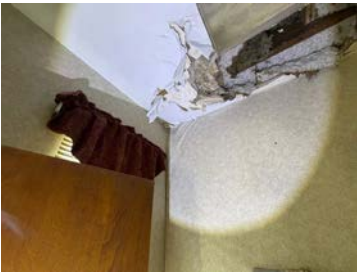
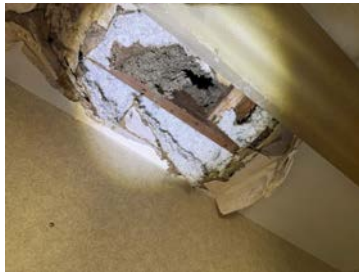
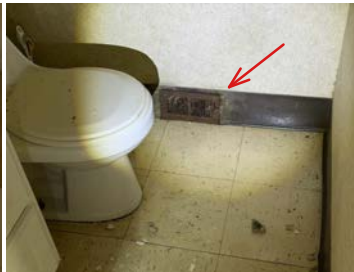
45. Front entrance Bathroom Ceiling: Exposed Frame - Moisture damage identified in the restroom ceiling. Recommend the source of the moisture intrusion be identified and corrected. Moisture may be present in other not visible locations. Recommend further investigation and repair. Evidence of potential biological growth. Recommend further testing and evaluation. A qualified contractor is recommended to evaluate and estimate repairs.

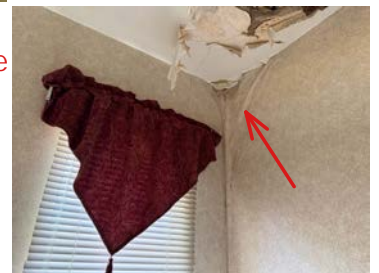
46. Front entrance Bathroom Walls: Wallpaper - Moisture penetration present. Recommend the source of the moisture intrusion be identified and corrected. Moisture may be present in other not visible locations. Recommend further investigation and repair. A qualified contractor is recommended to evaluate and estimate repairs.

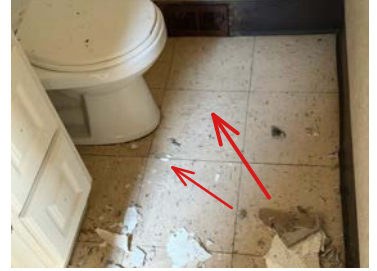
47. Front entrance Bathroom Floor: Tile - Most 9x9 tile may contain asbestos fiber material. Recommend encapsulating to prevent damage to tile. Cracked tile(s) noted. A qualified contractor is recommended to evaluate and estimate repairs.

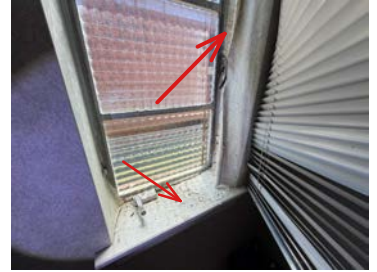
48. Front entrance Bathroom Windows: Metal, Stationary - Window sill has damaged material from moisture penetration, recommend repair and replacement of existing material. A qualified contractor is recommended to evaluate and estimate repairs.

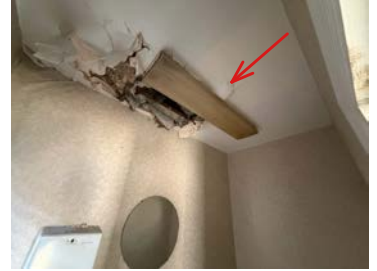
49. Front entrance Bathroom Electrical: Light(s) - Unable to operate electrical components due to current hazard. A licensed electrician is recommended to evaluate and estimate repairs.

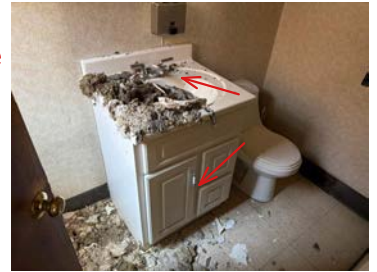
50. Front entrance Bathroom Sink/Basin: Single Bowl - Due to insulation and damage the sink was not accessible to test. A qualified contractor is recommended to evaluate and estimate repairs.

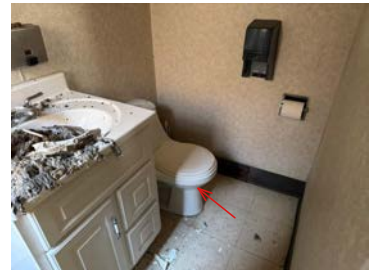
51. Front entrance Bathroom Toilets: Present - Due to insulation and damage the toilet was not accessible to test. A qualified contractor is recommended to evaluate and estimate repairs.

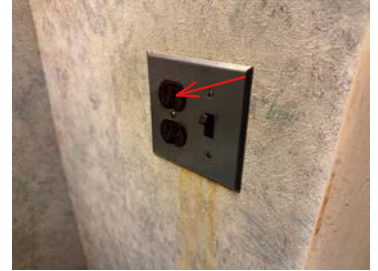
52. Rear Left Bathroom Electrical: Light(s) And Outlet(s) - **Non-GFCI circuit, recommend GFCI circuit be installed. A licensed electrician is recommended to evaluate and estimate repairs.**

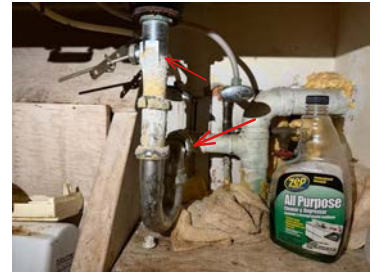
53. Break room Bathroom Sink/Basin: Single Bowl - **Excessive corrosion noted under the sink. A qualified contractor is recommended to evaluate and estimate repairs.**

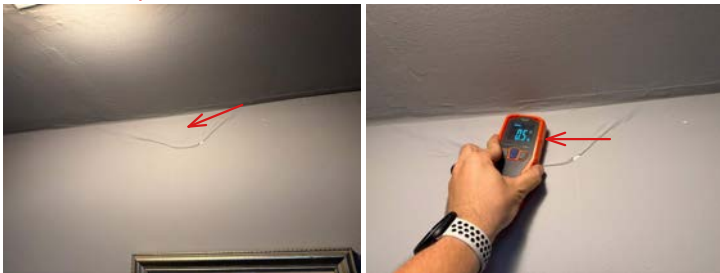
54. Basement Rear Bathroom Walls: Paint - **Moisture stain(s) noted, verified dry at time of inspection. Recommend further investigation into whether the source of the water penetration has been corrected. Crack(s) noted, recommend they be patched during routine maintenance. A qualified contractor is recommended to evaluate and estimate repairs.**

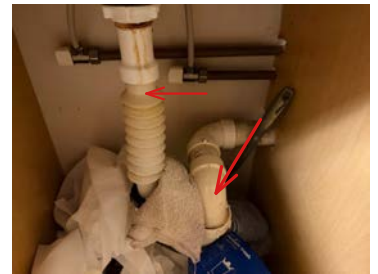
55. Basement Rear Bathroom Sink/Basin: Single Bowl - **Leaking noted under the bathroom sink. Flexible drain piping is installed under sink. Flexible drain piping is more prone to leakage, recommend replacement with appropriate material. A qualified contractor is recommended to evaluate and estimate repairs.**

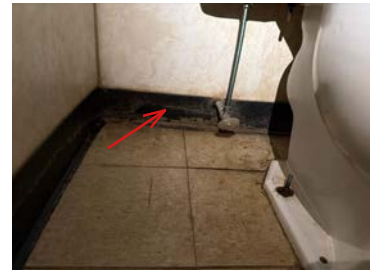
56. Basement Front Bathroom Floor: Tile, Vinyl - **Water damage on the flooring, recommend further investigation. A qualified contractor is recommended to evaluate and estimate repairs.**

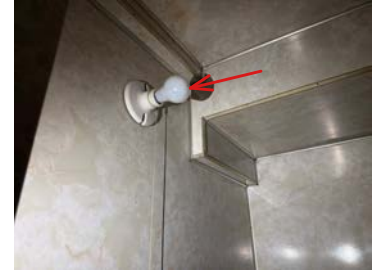
57. Basement Front Bathroom Electrical: Light(s) - Light did not function, recommend change bulb and re-test. A qualified contractor is recommended to evaluate and estimate repairs.

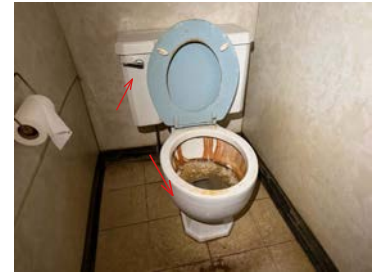
58. Basement Front Bathroom Toilets: Present - The toilet is loose at the floor. Loose toilets can lead to moisture penetration into the not visible sub-flooring. Recommend securing to prevent movement. The tank is loose, recommend securing to prevent movement. A qualified contractor is recommended to evaluate and estimate repairs.

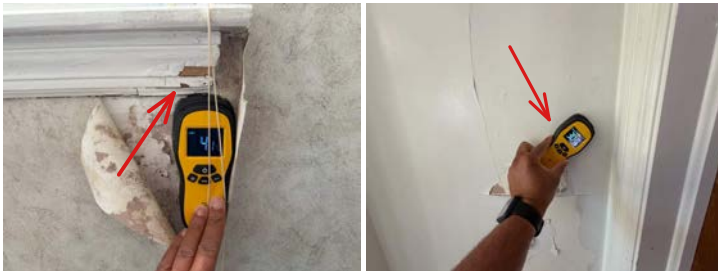
59. Entryway Living Space Walls: Wallpaper - Moisture penetration present. Recommend the source of the moisture intrusion be identified and corrected. Moisture may be present in other not visible locations. Recommend further investigation and repair. A qualified contractor is recommended to evaluate and estimate repairs.

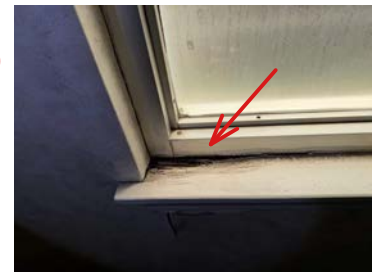
60. Entryway Living Space Windows: Metal, Stationary - Wood rot present in wood window, recommend repair or replacement. A qualified contractor is recommended to evaluate and estimate repairs.

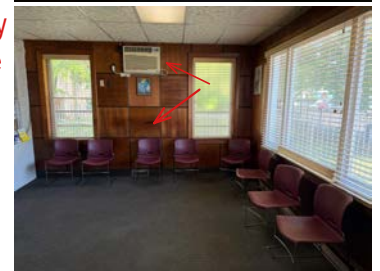
61. Front sitting Room Living Space Walls: Paneling - Moisture stain(s) noted, verified dry at time of inspection. Recommend further investigation into whether the source of the water penetration has been corrected.

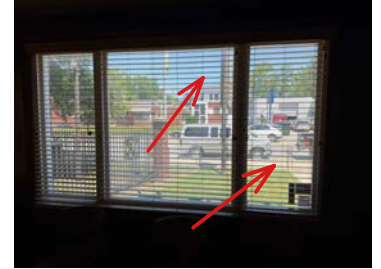
62. Front sitting Room Living Space Windows: Metal, Stationary - Cracks in windows noted, recommend replacement. A qualified contractor is recommended to evaluate and estimate repairs.

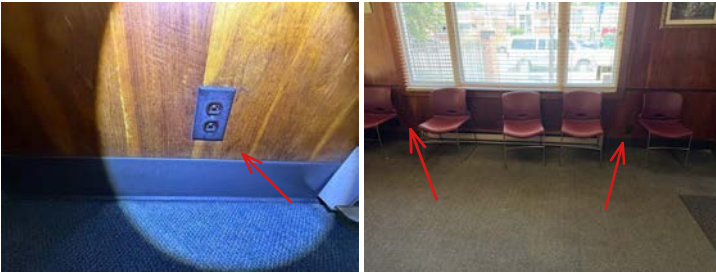
63. Front sitting Room Living Space Electrical: Light(s) And Outlet(s) - Recommend replacing two prong outlets with grounded three prong outlets. A licensed electrician is recommended to evaluate and estimate repairs.

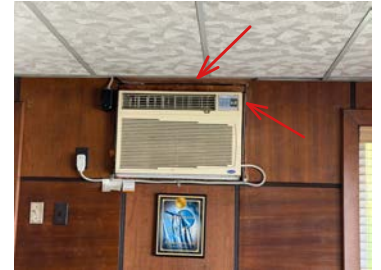
64. Front sitting Room Living Space HVAC Source: Present - Window AC noted, area around unit has damaged material present. A qualified contractor is recommended to evaluate and estimate repairs.

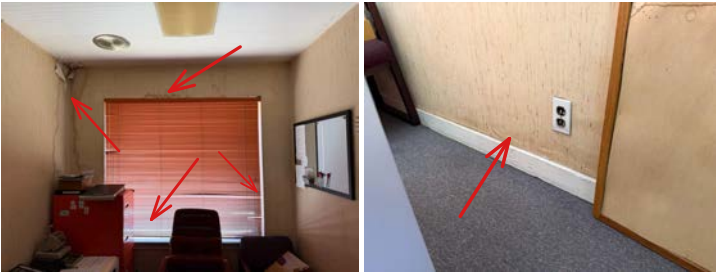
65. Office 1 Living Space Walls: Wallpaper - Moisture damage present throughout the space, recommend identifying the source and conducting repairs. A qualified contractor is recommended to evaluate and estimate repairs.

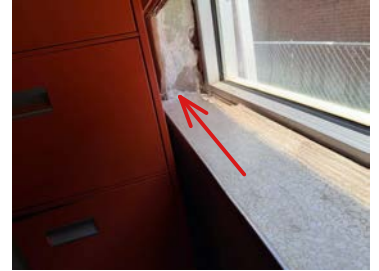
67. Office 1 Living Space Windows: Stationary, Metal - **Damaged window sill noted throughout the property, recommend addressing the cause and conducting repairs as needed. A qualified contractor is recommended to evaluate and estimate repairs.**

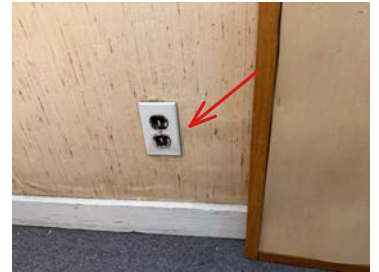
68. Office 1 Living Space Electrical: Light(s) And Outlet(s) - **Two prong outlets are present throughout the property Recommend replacing all two prong outlets with grounded three prong outlets to ensure safety and proper function. A licensed electrician is recommended to evaluate and estimate repairs.**

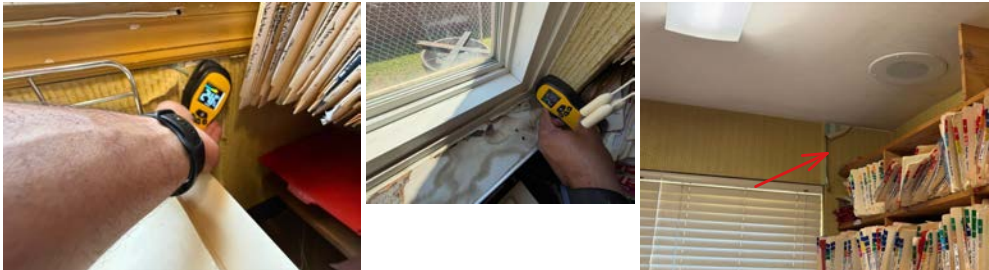
69. Office 2 Living Space Walls: Wallpaper - **Moisture penetration present. Recommend the source of the moisture intrusion be identified and corrected. Moisture may be present in other not visible locations. Recommend further investigation and repair. A qualified contractor is recommended to evaluate and estimate repairs.**

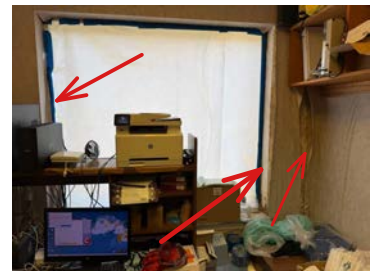
70. Office 3 Living Space Walls: Wallpaper - **Moisture damage present throughout the space, recommend identifying the source and conducting repairs. A qualified contractor is recommended to evaluate and estimate repairs.**

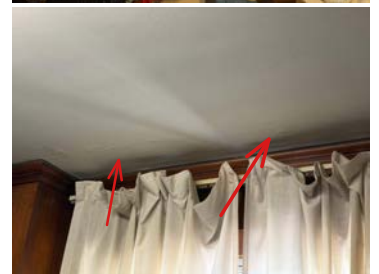
71. Office 4 Living Space Ceiling: Paint - **Moisture penetration present. Recommend the source of the moisture intrusion be identified and corrected. Moisture may be present in other not visible locations. Recommend further investigation and repair. A qualified contractor is recommended to evaluate and estimate repairs.**

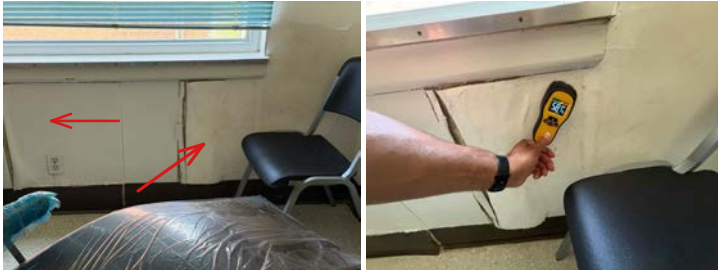
72. Office 5 Living Space Walls: Paint - **Moisture penetration present. Recommend the source of the moisture intrusion be identified and corrected. Moisture may be present in other not visible locations. Recommend further investigation and repair. A qualified contractor is recommended to evaluate and estimate repairs.**

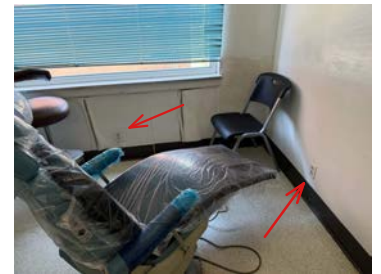
73. Office 5 Living Space Electrical: Light(s) And Outlet(s) - Reversed polarity noted at outlet. A licensed electrician is recommended to evaluate and estimate repairs.

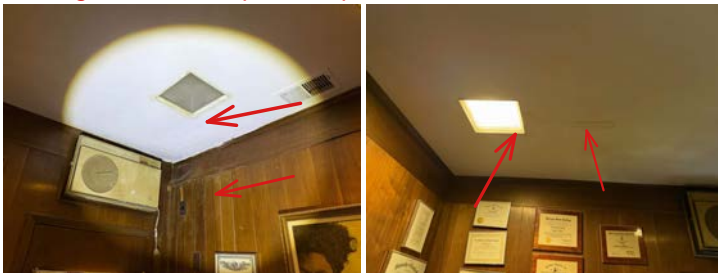
74. Office 6 Living Space Ceiling: Paint - Moisture penetration present. Recommend the source of the moisture intrusion be identified and corrected. Moisture may be present in other not visible locations. Recommend further investigation and repair. A qualified contractor is recommended to evaluate and estimate repairs.

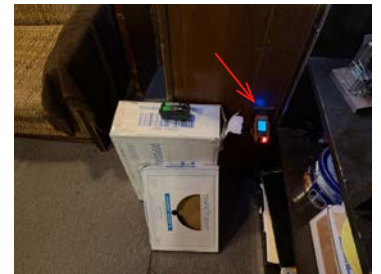
75. Office 6 Living Space Electrical: Light(s) And Outlet(s) - Open grounds noted at three prong outlets in multiple areas throughout the property. A licensed electrician is recommended to evaluate and estimate repairs.

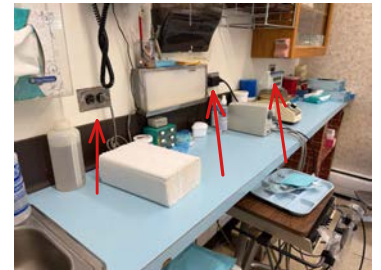
76. Office 7 Living Space Electrical: Light(s) And Outlet(s) - Open grounds noted at three prong outlets. A licensed electrician is recommended to evaluate and estimate repairs.

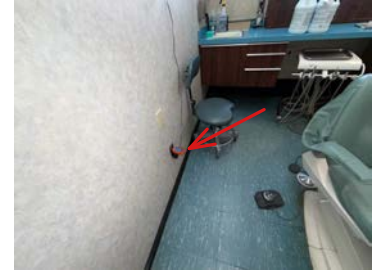
77. Rear Hallway/Office spaces Living Space Electrical: Light(s) And Outlet(s) - **Open grounds noted at three prong outlets. A qualified contractor is recommended to evaluate and estimate repairs.**

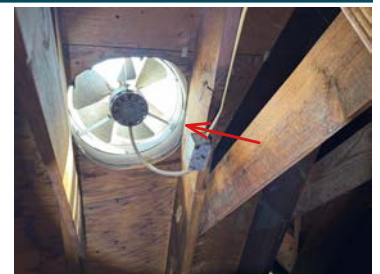
78. Main Attic Ventilation: Fan - **Limited ventilation, recommend adding additional venting. Fan was not functioning and attic was excessively hot. A qualified contractor is recommended to evaluate and estimate repairs.**

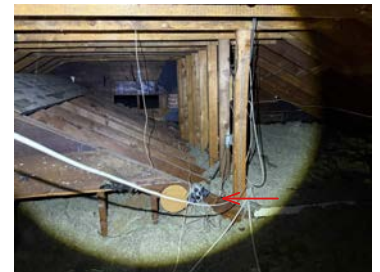
79. Main Attic Wiring/Lighting: Light(s) - **Exposed and unsecured wiring throughout. A qualified contractor is recommended to evaluate and estimate repairs.**

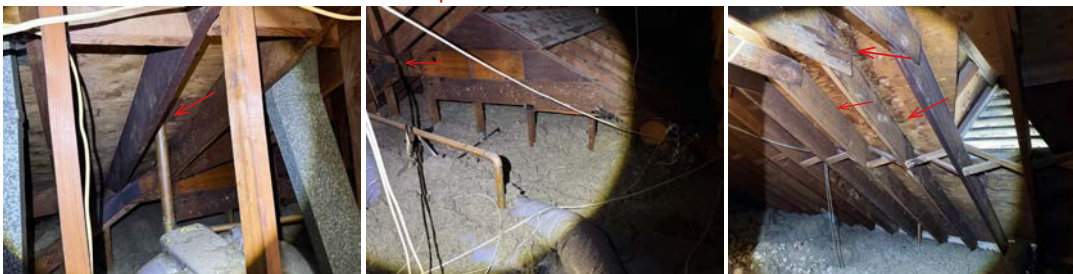
80. Main Attic Moisture Penetration: No Moisture Present At Time Of Inspection - **Moisture stain(s) noted throughout, verified dry at time of inspection. Recommend further investigation into whether the source of the water penetration has been corrected. A qualified contractor is recommended to evaluate and estimate repairs.**

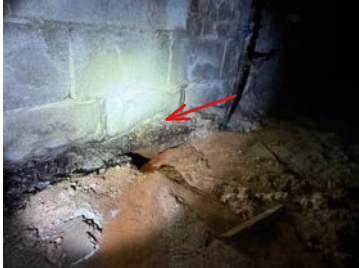
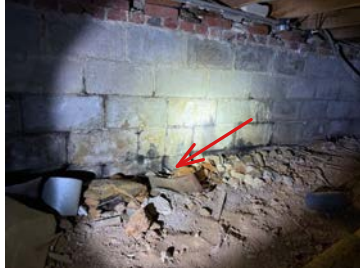
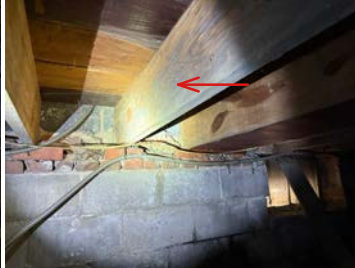
81. Main Crawl Space Moisture Penetration: Present - **Water penetration noted. Potential biological growth noted in the crawl space. A qualified contractor is recommended to evaluate and estimate repairs.**
