Home Inspection Report

5418 Park Heights Ave
Park Heights, MD 21215

Prepared for: Charles Shelton

Inspected by:
Luke Bunting
Blue Crab Inspections

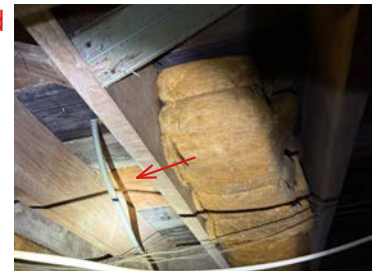
83. Main Crawl Space Insulation: Not Present - Missing insulation throughout. A qualified contractor is recommended to evaluate and estimate repairs.

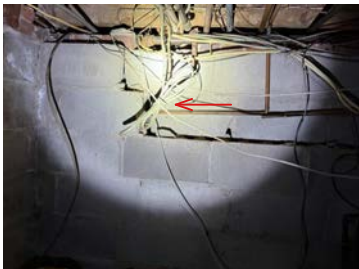
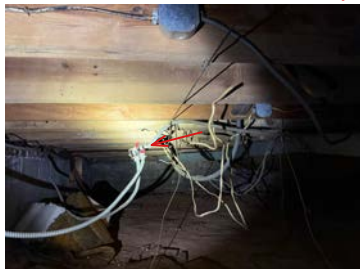
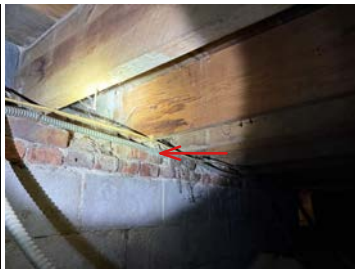
84. Main Crawl Space Electrical: Wiring - Exposed, unsecured, and corrosion on wiring throughout. A licensed electrician is recommended to evaluate and estimate repairs.

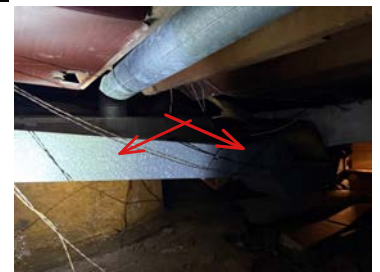
85. Main Crawl Space HVAC Components: Present - Falling sections noted and missing insulation. A qualified contractor is recommended to evaluate and estimate repairs.

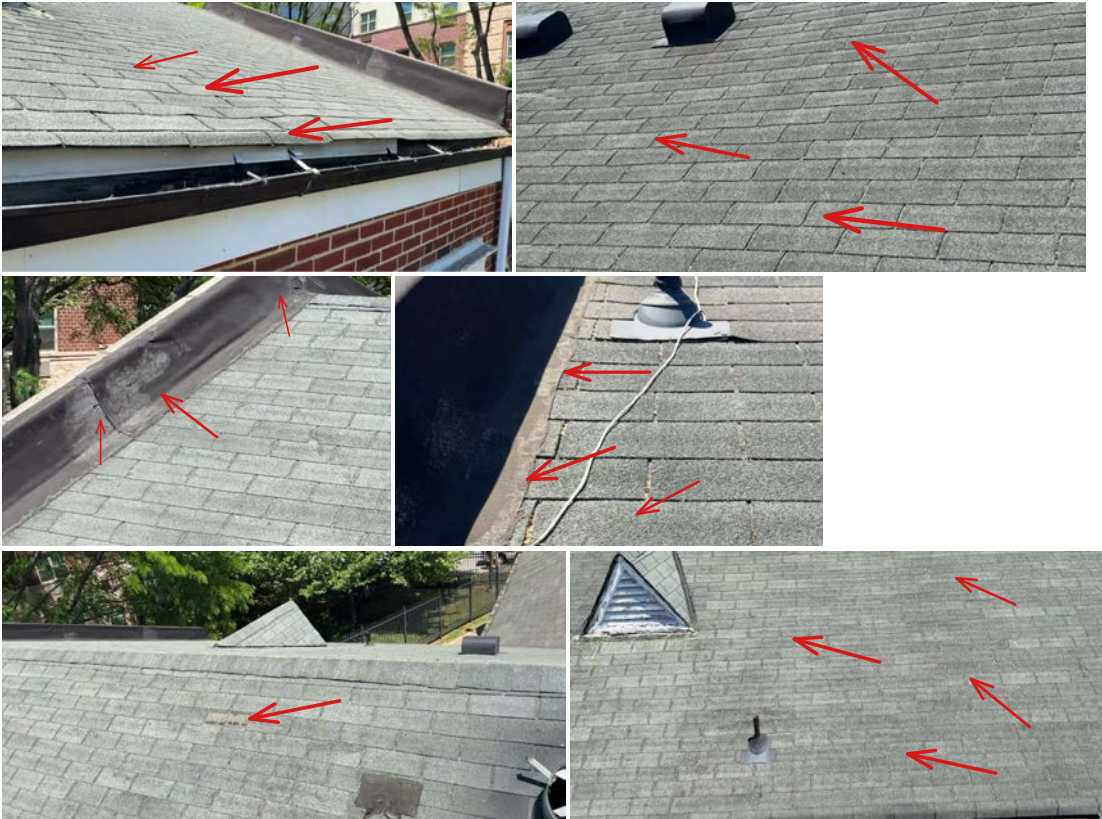
1. Method of Inspection: Telescoping Pole With Camera, Ladder At Eaves
2. Material: Asphalt Shingle, Rubber - **Soft and damaged area noted. Granule loss noted throughout the roofing surface, recommend further evaluation. Missing shingles and rubber material was not properly sealed on side walls. Roofing material is reaching average age expectancy, recommend budgeting for replacement. A qualified roofing contractor is recommended to evaluate and estimate repairs.**

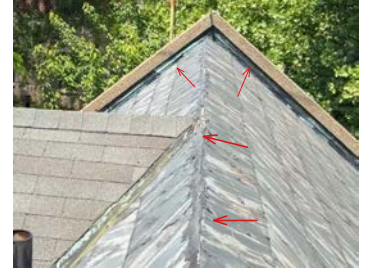
- 6. Material: Slate - Cracked sealant noted throughout. A qualified roofing contractor is recommended to evaluate and estimate repairs.

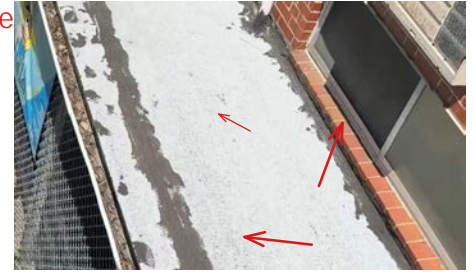
- 10. Material: Rolled Roofing Material - Cracked sealant and granule loss noted throughout. Roofing material is reaching average age expectancy, recommend budgeting for replacement. A qualified roofing contractor is recommended to evaluate and estimate repairs.

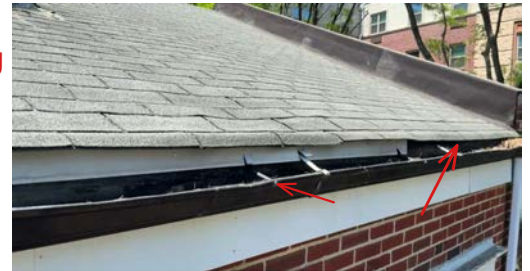
- 13. Flashing: Rubber, Metal, Missing - Missing drip edge flashing noted, recommend it be added. A qualified roofing contractor is recommended to evaluate and estimate repairs.

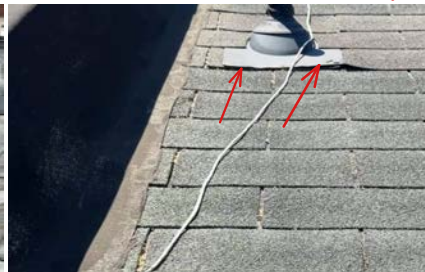
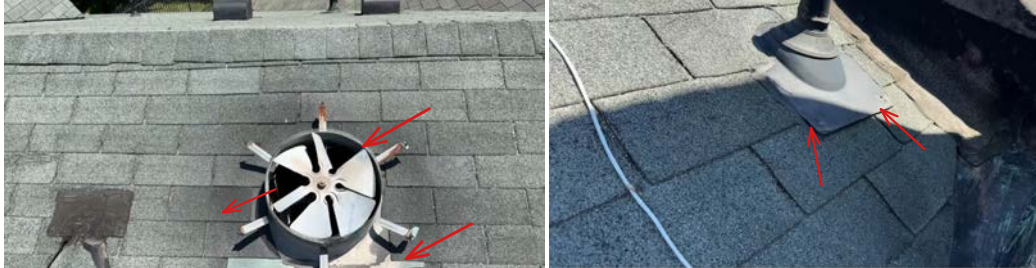
- 15. Vent Pipes: Plastic, Metal - Cracks in sealant around the vent penetration, recommend repair. Lifted vent boots noted, recommend repair. Evidence repairs noted around rear vent. A qualified contractor is recommended to evaluate and estimate repairs.

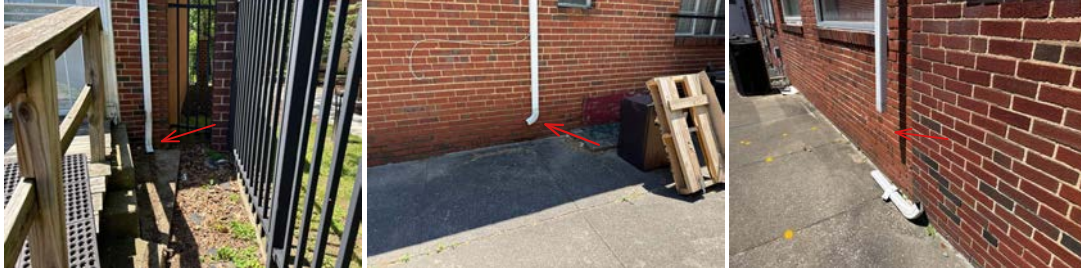
- 20. Leader/Extension: Missing - Roof drainage system is discharging next to home. Recommend extending runoff drains to move water away from foundation. A qualified contractor is recommended to evaluate and estimate repairs.

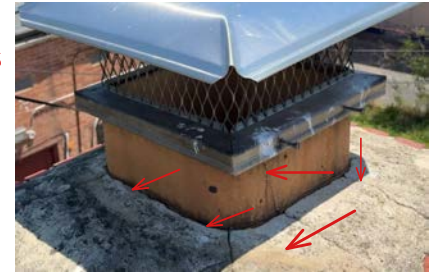
21. Chimney: Masonry - Cracks present on the flue pipe, recommend repair. Cracks and damaged crown noted. A qualified contractor is recommended to evaluate and estimate repairs.

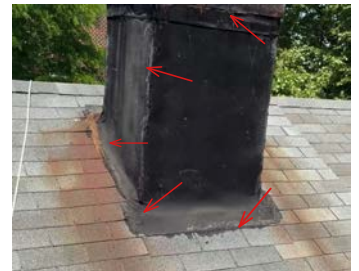
24. Chimney: Unknown/Roofing Material - Cracking noted on material throughout and the chimney was not properly flashed to the roof. A qualified contractor is recommended to evaluate and estimate repairs.

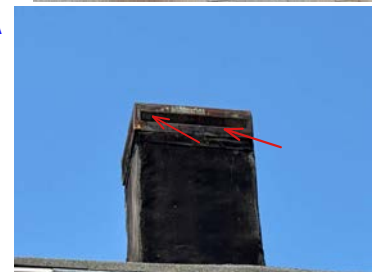
25. Flue/Flue Cap: Metal - Corrosion noted around the cap and covering. A qualified contractor is recommended to evaluate and estimate repairs

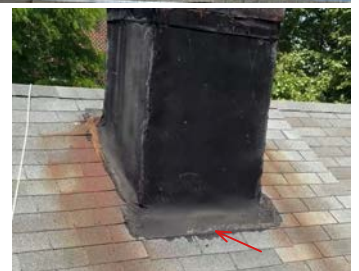
26. Chimney Flashing: Roofing Material - Improper flashing noted, recommend repair. A qualified contractor is recommended to evaluate and estimate repairs.

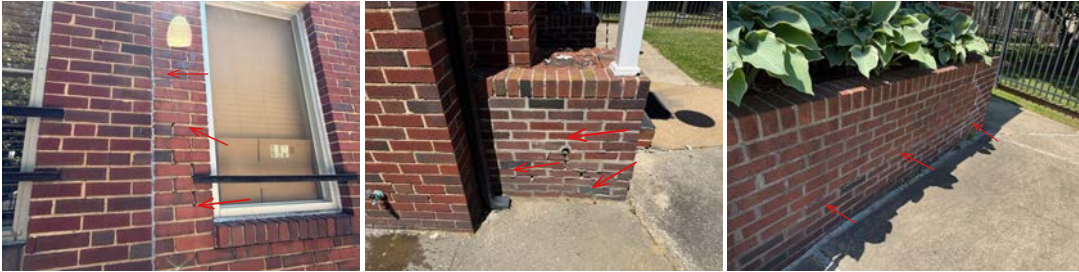
1. Type: Metal - **Step cracks noted in multiple areas and gaps in the mortar throughout the exterior, recommend repair. A qualified contractor is recommended to evaluate and estimate repairs.**

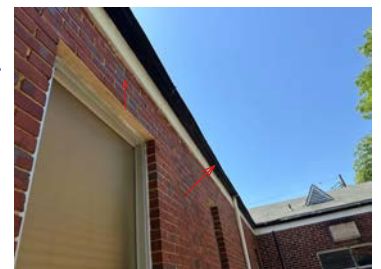
3. Fascia: Metal, Wood - **Loose sections noted, recommend securing. A qualified contractor is recommended to evaluate and estimate repairs.**

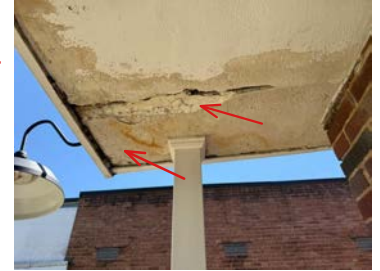
4. Soffits: Wood - **Water damage and deteriorated material present. A qualified contractor is recommended to evaluate and estimate repairs.**

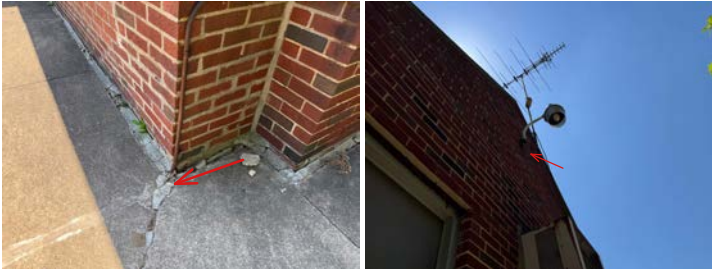
5. Door Bell: Present
 6. Windows: Metal, Stationary, Vinyl
 7. Exterior Lighting: Present - **Cut in underground wiring. Exposed wiring noted. A qualified contractor is recommended to evaluate and estimate repairs.**

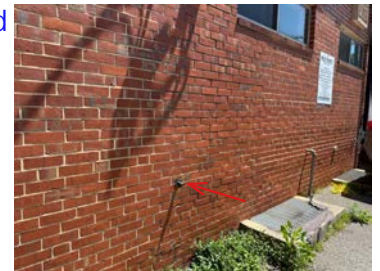
8. Exterior Electric: Not Visible
 9. Hose Bibs: Present - **Missing handle, recommend replacing. A qualified contractor is recommended to evaluate and estimate repairs.**

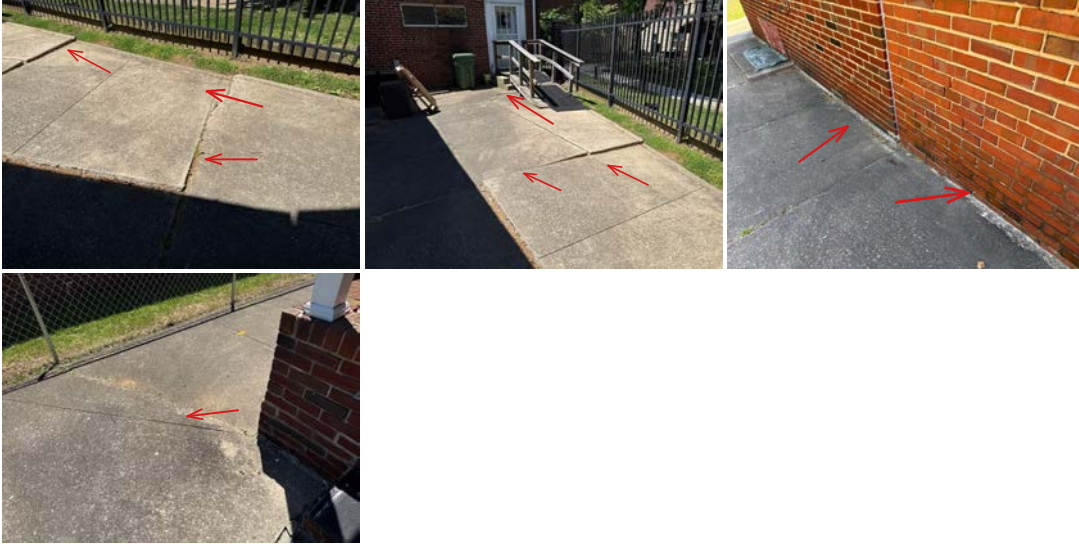
2. Walks: Present - Walkway is no longer level and a trip hazard is present. Cracks and gaps noted in multiple locations. A qualified contractor is recommended to evaluate and estimate repairs.

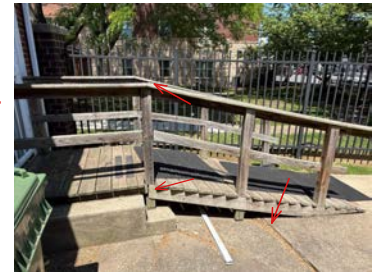
3. Steps: Present - The ramp was not properly secured, loose posts/railings and deck boards, recommend further evaluation. A qualified contractor is recommended to evaluate and estimate repairs.

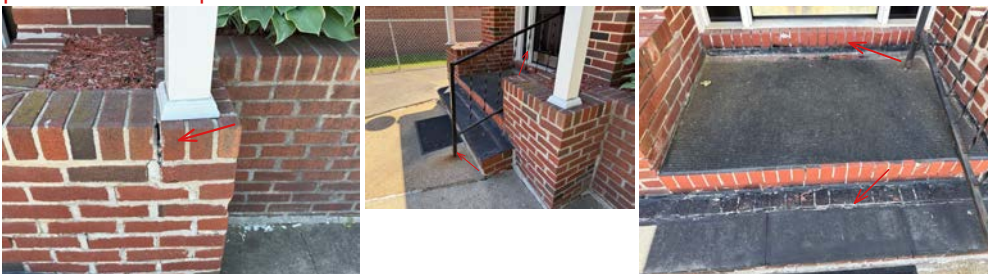
4. Porch: Present - Cracked and shifted material noted. Loose and corroded railing present. Gaps and cracks present in porch material. Recommend filling cracks and gaps to prevent moisture penetration. A qualified contractor is recommended to evaluate and estimate repairs.

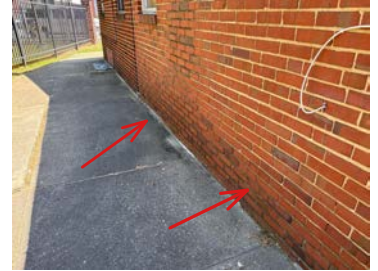
8. Grading: Negative Slope - Improper slope towards foundation, recommend improving grade to move water away from the house. A qualified contractor is recommended to evaluate and estimate repairs.

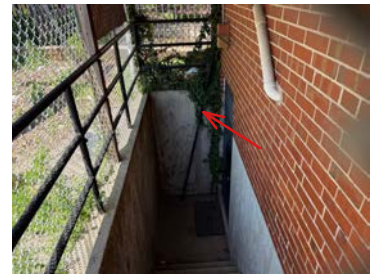
9. Vegetation: Vines - Vines are growing up the structure. Recommend removing vines from house structure. A qualified contractor is recommended to evaluate and estimate repairs.

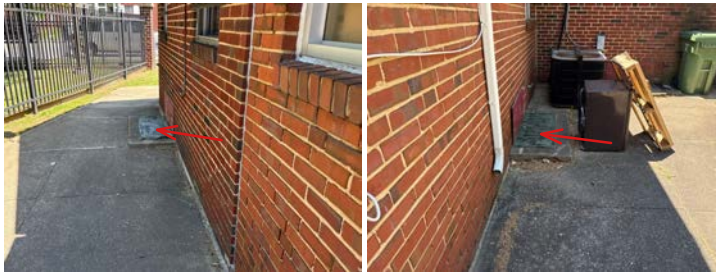
10. Window Wells: Covered - Covers were torn, recommend replacing. A qualified contractor is recommended to evaluate and estimate repairs.

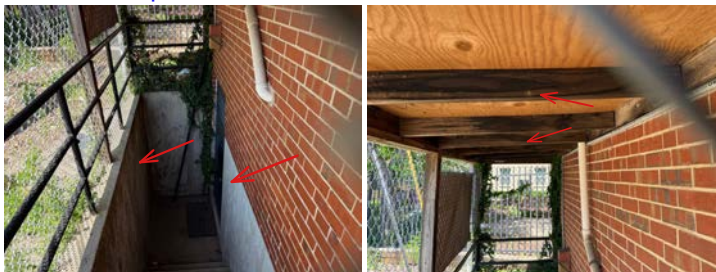
13. Basement Stairwell: Masonry - Railings missing at the basement stairwell, recommend installing. Undersized supports noted at roof covering. A qualified contractor is recommended to evaluate and estimate repairs.

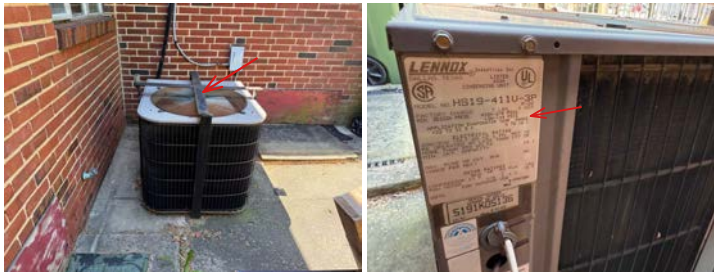
- A/C System Operation: Functional - **The unit is currently in service beyond average life expectancy, recommend budgeting for repair and or replacement. A qualified air conditioning contractor is recommended to evaluate and estimate repairs.**

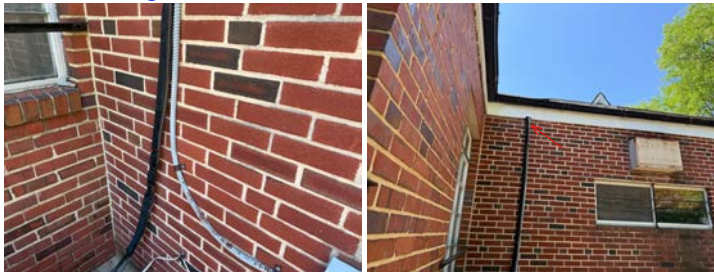
- Condensate Removal: Plastic
- Exterior Unit: Pad
- Area Served: Rear Right Approximate Age: 1991
- Fuel Type: Electric Temperature Differential: 14 Degrees F
- Type: Central A/C Capacity: 2 Ton
- Visible Coil: Not Visible
- Refrigerant Lines: Suction/Liquid Line - **Insulation for refrigerant lines is torn, missing, and deteriorated. Recommend replacing the insulation to improve energy efficiency. Entry point into home is not sealed, recommend sealing to prevent moisture penetration. A qualified air conditioning contractor is recommended to evaluate and estimate repairs.**

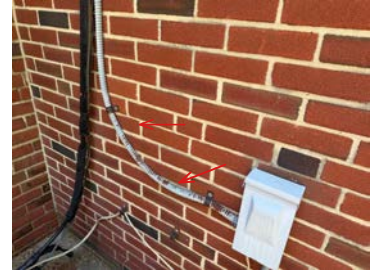
9. Electrical Disconnect: Pull out - Corrosion noted on conduit. Recommend evaluation by a licensed electrician.

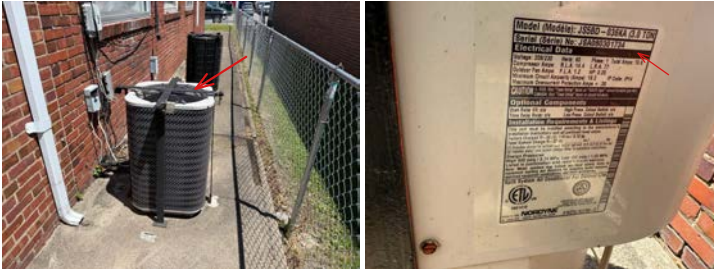
10. A/C System Operation: Functional - The unit is currently in service beyond average life expectancy, recommend budgeting for repair and or replacement. A qualified air conditioning contractor is recommended to evaluate and estimate repairs.

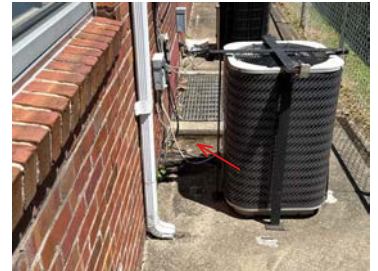
11. Condensate Removal: Plastic - Condensate line discharges next to the structure, recommend adjustment. A qualified contractor is recommended to evaluate and estimate repairs.

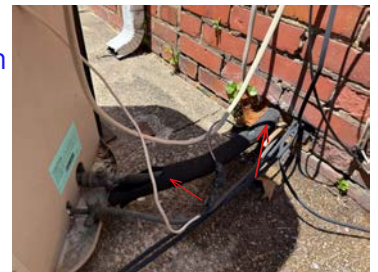
12. Exterior Unit: Pad
 13. Area Served: First Floor Approximate Age: 2008
 14. Fuel Type: Electric Temperature Differential: 14 Degrees F
 15. Type: Central A/C Capacity: 3 Ton
 16. Visible Coil: Not Visible
 17. Refrigerant Lines: Suction/Liquid Line - Insulation for refrigerant lines is torn, missing, and deteriorated. Recommend replacing the insulation to improve energy efficiency. Entry point into home is not sealed, recommend sealing to prevent moisture penetration. A qualified air conditioning contractor is recommended to evaluate and estimate repairs.

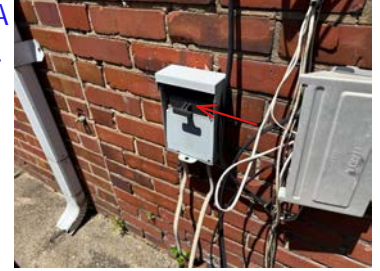
18. Electrical Disconnect: Pull out - **Missing cover, recommend replacing. A qualified contractor is recommended to evaluate and estimate repairs.**

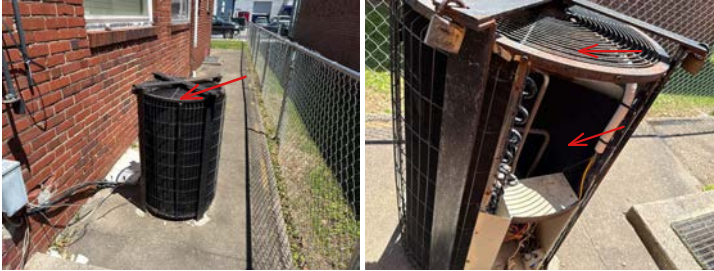
19. A/C System Operation: Not Functional - **Unit did not function at time of inspection. Missing sections and corroded sections. The unit is currently in service beyond average life expectancy, recommend budgeting for repair and or replacement. A qualified air conditioning contractor is recommended to evaluate and estimate repairs.**

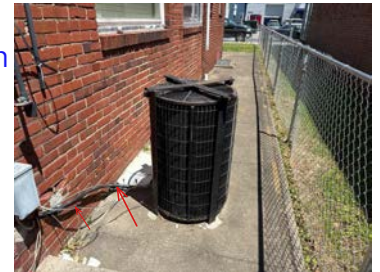
20. Condensate Removal: Plastic
 21. Exterior Unit: Pad
 22. Area Served: Unknown Approximate Age: Unknown
 23. Fuel Type: Electric Temperature Differential: Unknown
 24. Type: Central A/C Capacity: Unknown
 25. Visible Coil: Not Visible
 26. Refrigerant Lines: Suction/Liquid Line - **Insulation for refrigerant lines is torn, missing, and deteriorated. Recommend replacing the insulation to improve energy efficiency. Entry point into home is not sealed, recommend sealing to prevent moisture penetration. A qualified air conditioning contractor is recommended to evaluate and estimate repairs.**

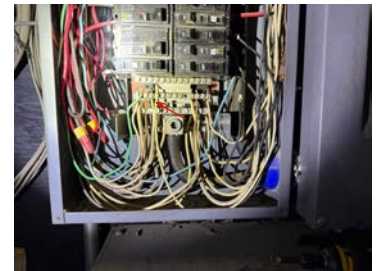
- 1. Service Size Amps: 600 Volts: 120-240 VAC
- 2. Service: Aluminum
- 3. 120 VAC Branch Circuits: Copper, Aluminum
- 4. 240 VAC Branch Circuits: Copper, Aluminum
- 5. Aluminum Wiring: Present - **Aluminum wiring noted on 120v circuitry. Recommend evaluation of aluminum wiring by a licensed electrician.**

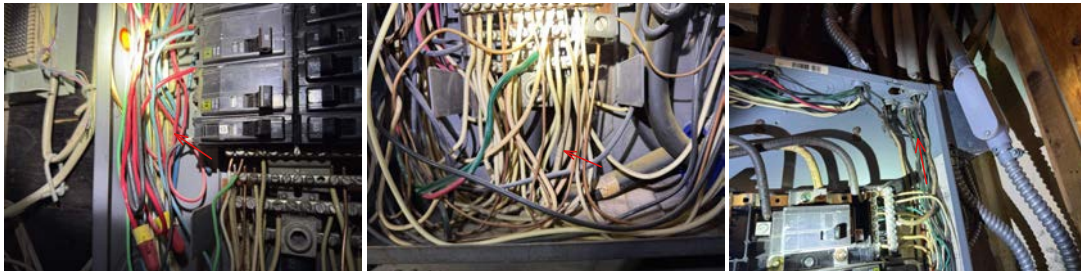
- 6. Conductor Type: Cloth, Non-Metallic Sheathed Cable - **Cloth wiring noted throughout, recommend updating. Evaluation by a licensed electrician is recommended.**

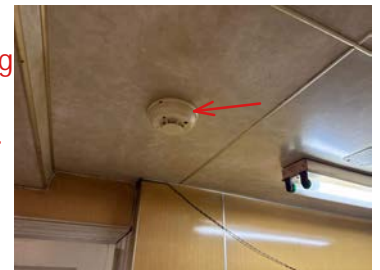
- 7. Ground: Not Visible
- 8. Smoke Detectors: Present - **Missing on first floor. Smoke detectors were in use beyond their average life expectancies. Recommend having smoke detectors updated to be in compliant with State laws. A qualified contractor is recommended to evaluate and estimate repairs.**

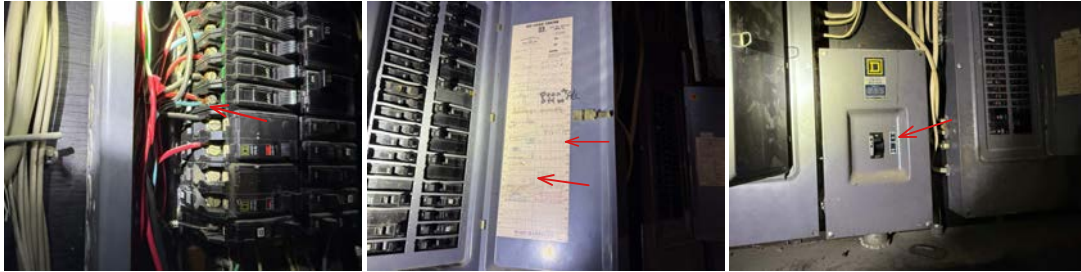
Basement Left Electric Panel

10. Manufacturer: Square D - Double taps present. Unlabeled circuitry present in panel, recommend all circuitry have correct labeling. Unable to remove front panel for main shut off. Neutrals and grounds bonded together at subpanel installation. A licensed electrician is recommended to evaluate and estimate repairs.

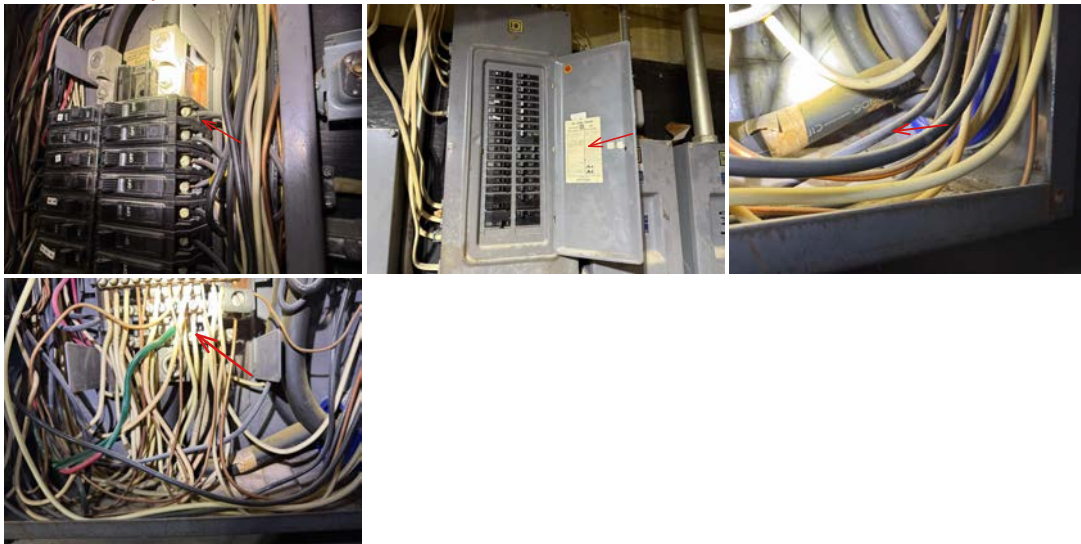
17. Manufacturer: Square D - Double taps present. Unlabeled circuitry present in panel, recommend all circuitry have correct labeling. Corrosion present on and inside the panel. Neutrals and grounds bonded together at subpanel installation. A licensed electrician is recommended to evaluate and estimate repairs.

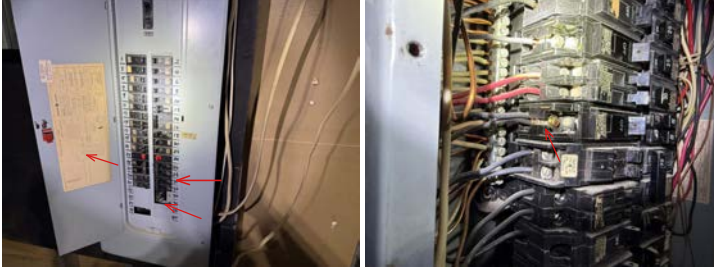
Basement Right Electric Panel

24. Manufacturer: General Electric - **Unlabeled circuitry present in panel, recommend all circuitry have correct labeling. Missing knock-out recommend replacing to cover opening. Double taps present. Multiple breakers were off at time of inspection. A licensed electrician is recommended to evaluate and estimate repairs.**

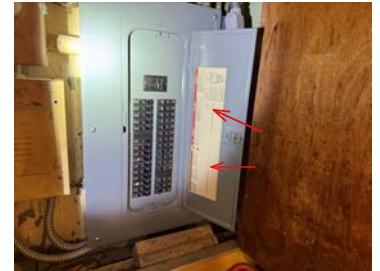
Basement Front Electric Panel

31. Manufacturer: Square D - **Unlabeled circuitry present in panel, recommend all circuitry have correct labeling. A licensed electrician is recommended to evaluate and estimate repairs.**

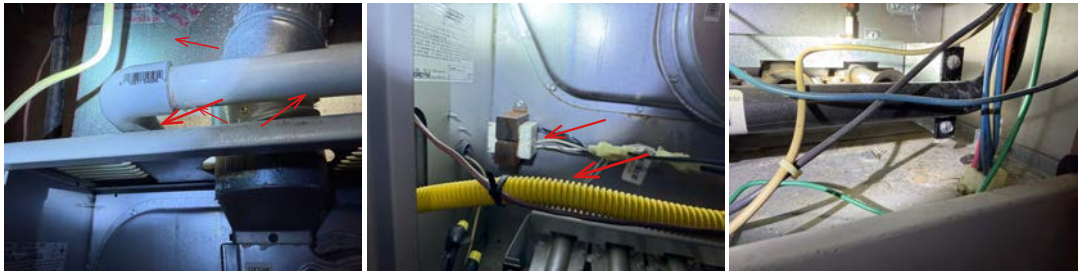
Basement Heating System

- Heating System Operation: Functional - **Condensation line was leaking, recommend repair. Corrosion and debris noted throughout the interior. Flexible gas piping improperly penetrates the furnace cabinet. The unit is nearing the end of its expected average life expectancy, recommend budgeting for repair and or replacement. Unable to determine the last service date for the heating/cooling system. Heating/cooling systems should be serviced annually. A licensed HVAC contractor is recommended to evaluate and estimate repairs.**

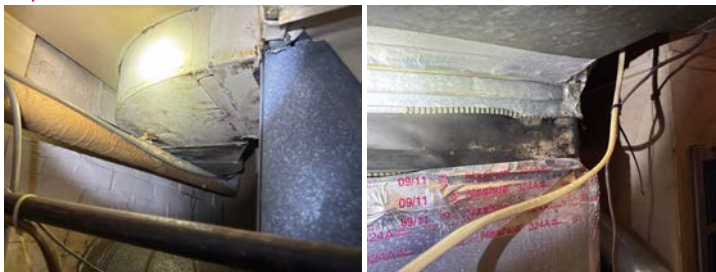
- Type: Forced Air
- Area Served: First Floor, Basement Approximate Age: 2012
- Fuel Type: Gas
- Filter: Disposable Filter
- Distribution: Duct Work - **Evidence of potential biological growth noted on the ductwork, recommend further evaluation. A qualified contractor is recommended to evaluate and estimate repairs.**

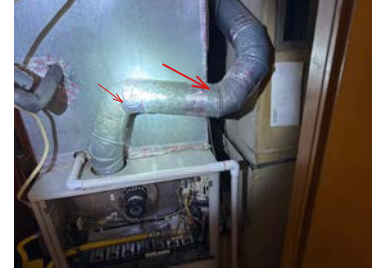
7. Flue Pipe: Metal - The flue pipe improperly downturns, recommended adjustment. A qualified contractor is recommended to evaluate and estimate repairs.

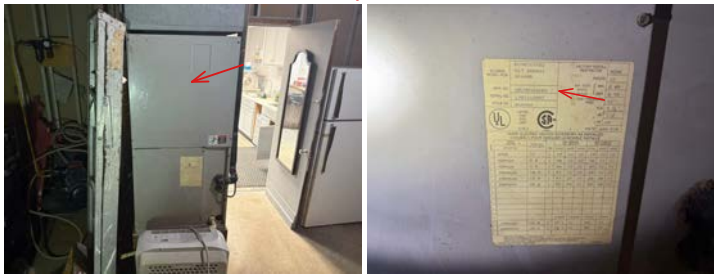
Basement Center Heating System

8. Heating System Operation: Non-Functional - The system was off, recommend further evaluation. The unit is in service beyond its expected life expectancy, recommend budgeting for repair or replacement. Unable to determine the last service date for the heating/cooling system. Heating/cooling systems should be serviced annually. A licensed HVAC contractor is recommended to evaluate and estimate repairs.

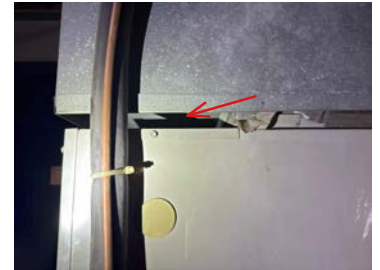
9. Type: Forced Air
 10. Area Served: Basement Approximate Age: 1990
 11. Fuel Type: Electric
 12. Distribution: Duct Work - Gaps noted in the ducts. A qualified heating system contractor is recommended to evaluate and estimate repairs.

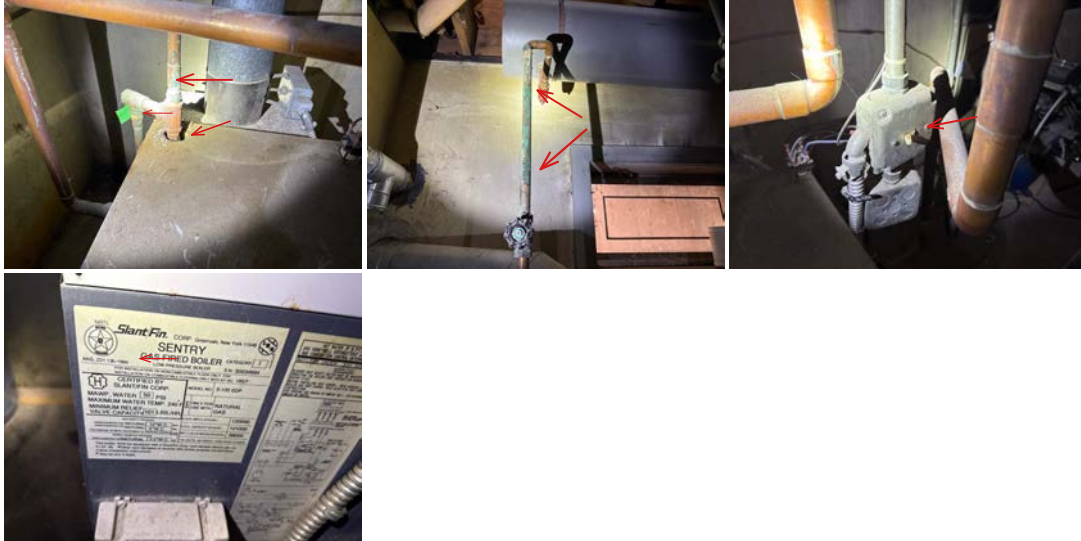
Basement Rear Heating System

14. Heating System Operation: Non-Functional - Corrosion and evidence of potential past leak noted in multiple areas, recommend further evaluation. The system was off at time of inspection, recommend verifying function. Missing sediment drip leg on gas line. The unit is in service beyond its expected life expectancy, recommend budgeting for repair or replacement. Unable to determine the last service date for the heating/cooling system. Heating/cooling systems should be serviced annually. A licensed HVAC contractor is recommended to evaluate and estimate repairs.

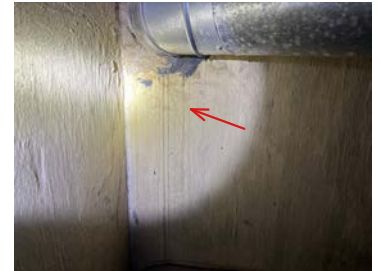
18. Flue Pipe: Metal - **Staining and evidence of potential past leak at connection. A qualified contractor is recommended to evaluate and estimate repairs.**

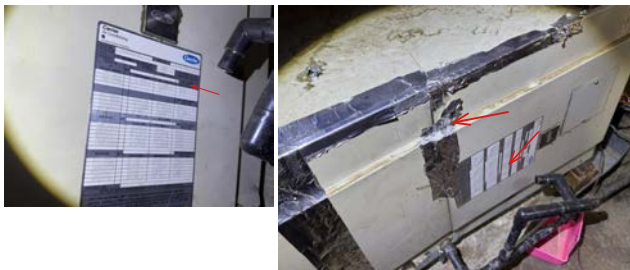
Attic Heating System

19. Heating System Operation: Functional - **The unit is in service beyond its expected life expectancy, recommend budgeting for repair or replacement. Corrosion and water staining noted around the furnace cabinet. A licensed HVAC contractor is recommended to evaluate and estimate repairs.**

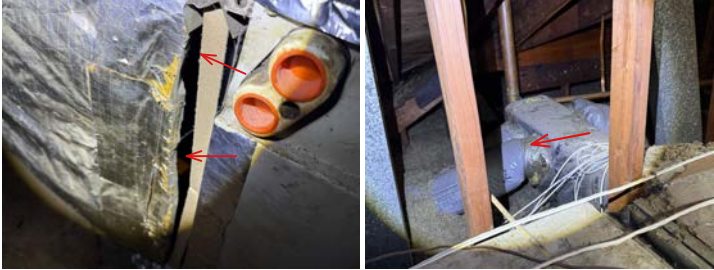
22. Distribution: Duct Work - Separated and gaps in the ducts in the attic space. A qualified heating system contractor is recommended to evaluate and estimate repairs.

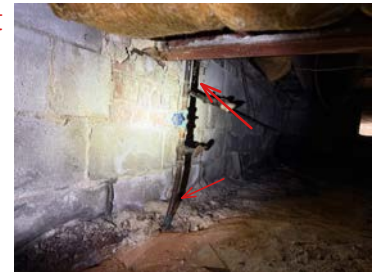
1. Service Line: Metal - Excessive condensation noted and pipes were not insulated throughout the crawl space. A licensed plumber is recommended to evaluate and estimate repairs.

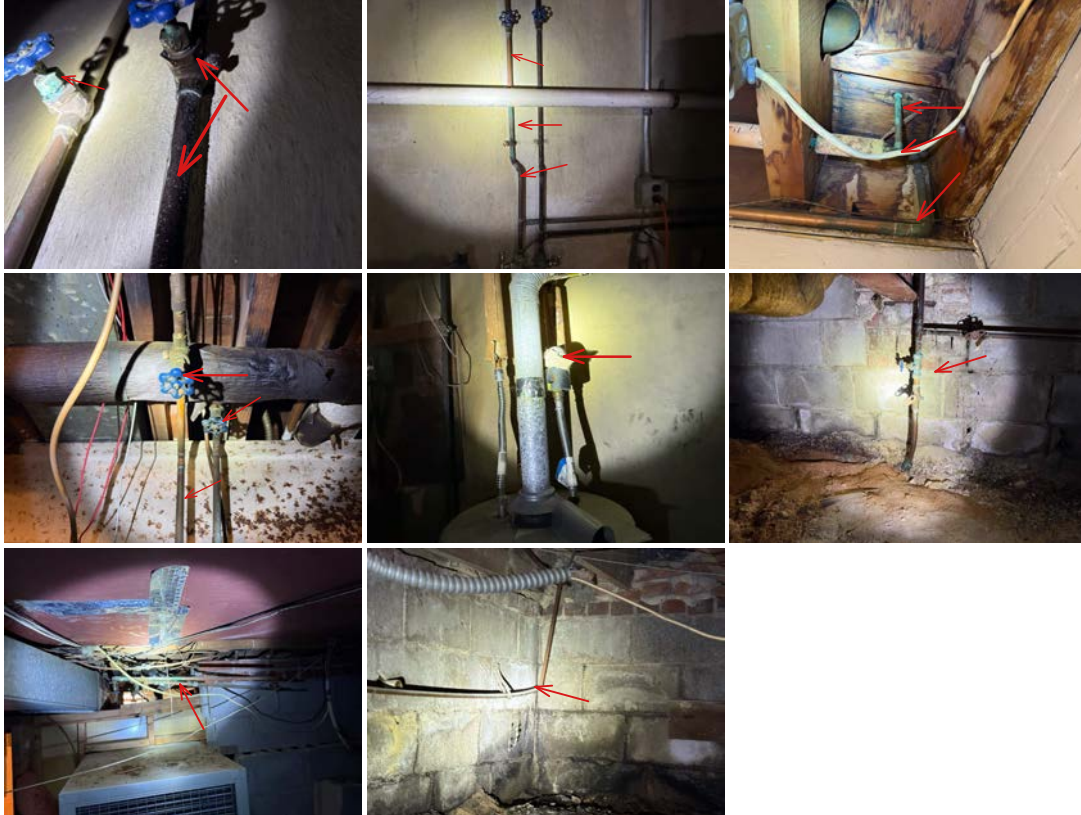
3. Water Lines: Plastic, Metal - Corrosion and evidence and past leaking noted at multiple lines and excessive amount of condensation noted. Unknown pipe wrap noted. Multiple abandoned plumbing lines throughout the crawl space, recommend further evaluation. Kinked line noted. A licensed plumber is recommended to evaluate and estimate repairs.

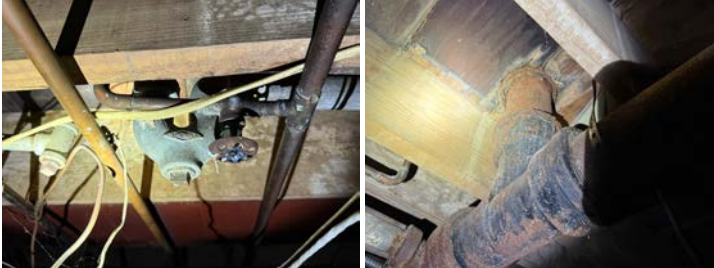
4. Drain Pipes: Plastic, Metal - Large amount of debris inside the drains, recommend cleaning. Evidence of past leaking noted. Slow drain noted, recommend repair. Due to the age and nature of metal drain piping, a sewer scope is recommended. Galvanized steel piping observed in use. Galvanized steel piping corrodes from inside causing decreased flow-rates and will eventually require updating. Improper support and support was loose. Evidence of previous leak noted. A licensed plumber is recommended to evaluate and estimate repairs.

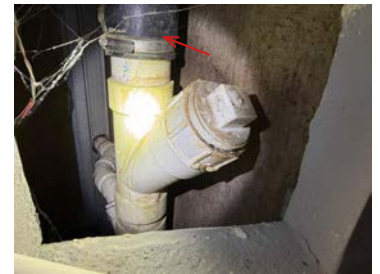
- 5. Sewer Cleanout Location Rear Of Basement - Evidence of previous repair noted, recommend further investigation. A licensed plumber is recommended to evaluate and estimate repairs.

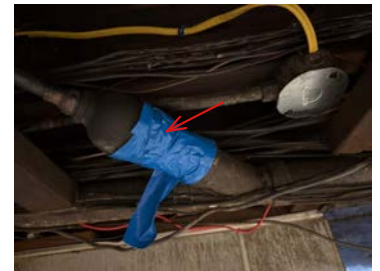
- 7. Gas Meter: Interior
- 8. Fuel Shut Off: At Meter, Utility Room - Unknown line making a hissing noise and improper repair noted, recommend further evaluation.

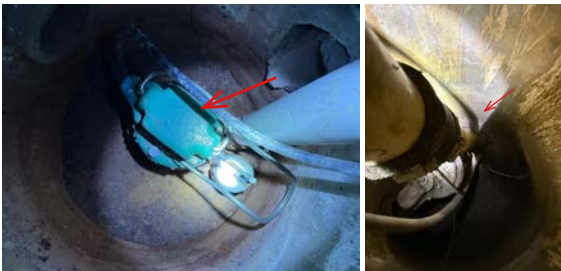
- 9. Fuel Lines: Plastic Covered, Black Steel Pipe
- 10. Sprinklers: Not Present
- 11. Ejector Pump: Not Present
- 12. Radon Mitigation: Not Present
- 13. Sump Pump: Functional - Both sump pits were dry, recommend further evaluation. A qualified contractor is recommended to evaluate and estimate repairs.

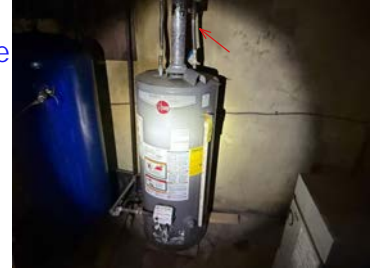
Basement Rear Water Heater

14. Water Heater Operation: Functional - **Missing expansion tank, recommend installing. A licensed plumber is recommended to evaluate and estimate repairs.**

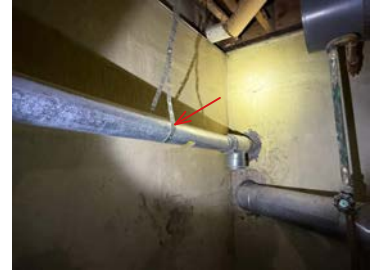
17. Flue Pipe: Present - **Flue piping was loose and improperly pitched. A qualified contractor is recommended to evaluate and estimate repairs.**

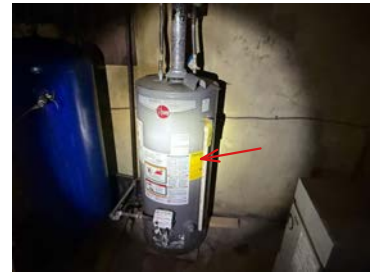
18. TPRV and Drain Tube: Plastic - **PVC is typically not rated for use in this role, recommend following manufactures installation guidance. A qualified contractor is recommended to evaluate and estimate repairs.**

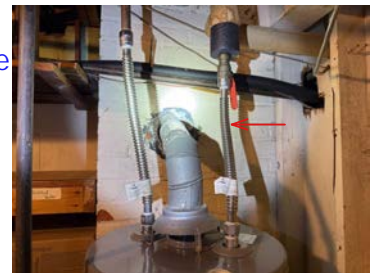
Basement Front Water Heater

19. Water Heater Operation: Functional - **Missing expansion tank, recommend installing. A licensed plumber is recommended to evaluate and estimate repairs.**

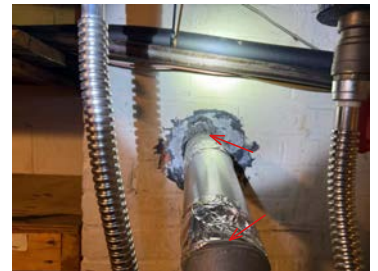
22. Flue Pipe: Metal - **Piping was improperly taped. Gaps in flue piping chimney connection. Recommend sealing vent penetration into wall/chimney to prevent gases coming back into the home. A qualified contractor is recommended to evaluate and estimate repairs.**

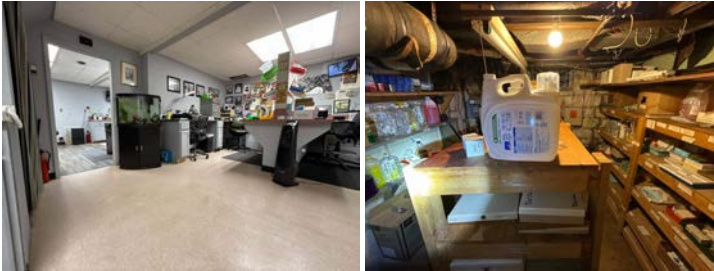
1. Structure Type: Wood Frame, Masonry - Multiple areas of the foundation and structure are not able to be fully inspected due to the installation of finished surfaces and personal belongings. A qualified contractor is recommended to evaluate and estimate repairs.

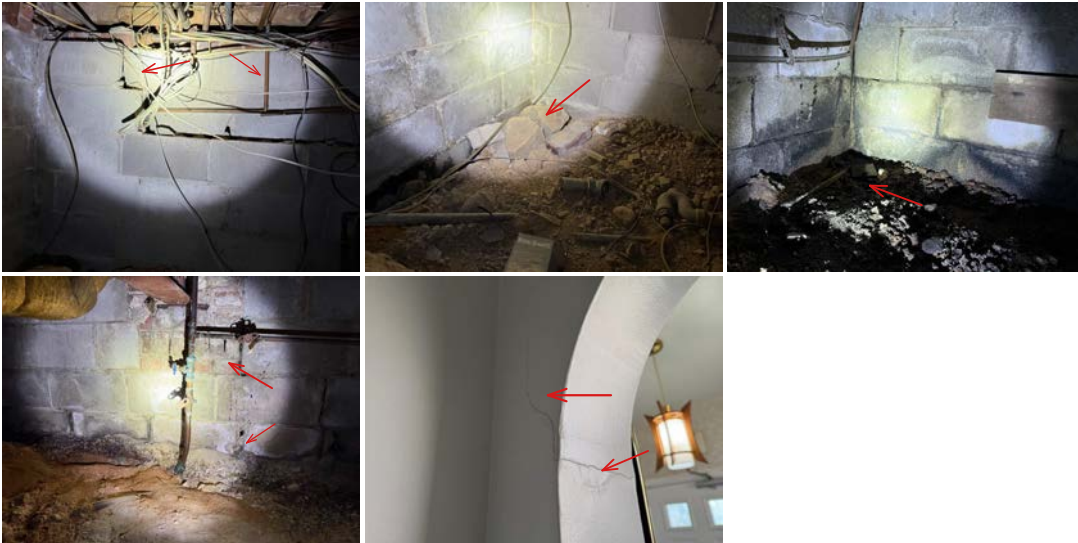
2. Foundation: Masonry - Center wall was pushed in. Excess erosion around the foundation and cracks in the block and mortar. Cracking noted at archway on sink floor. A qualified foundation contractor is recommended to evaluate and estimate repairs.

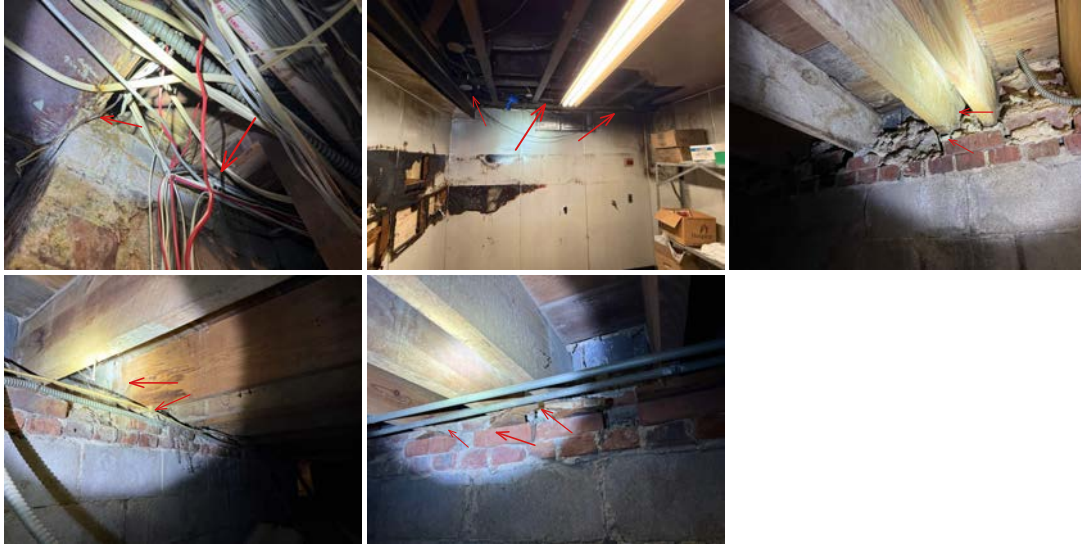
7. Joists/Trusses: Wood - Water and fire damage on multiple joists. Water damage noted on multiple joists and shims and bricks were loose throughout the crawl space. A qualified contractor is recommended to evaluate and estimate repairs.

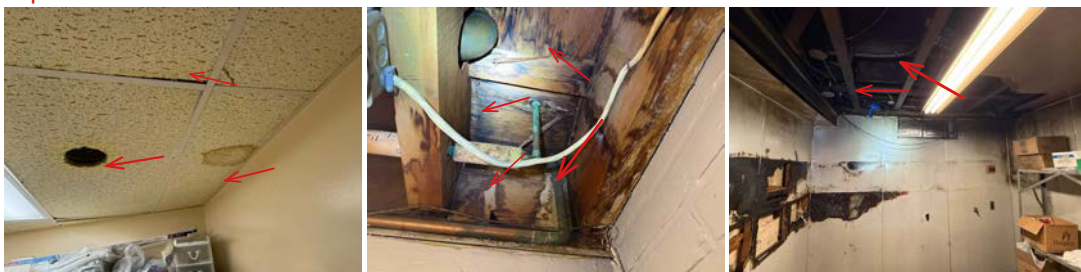
1. Ceiling: Exposed Frame, Paneling - Moisture staining and fire damage noted in multiple areas, recommend further evaluation. A qualified contractor is recommended to evaluate and estimate repairs.

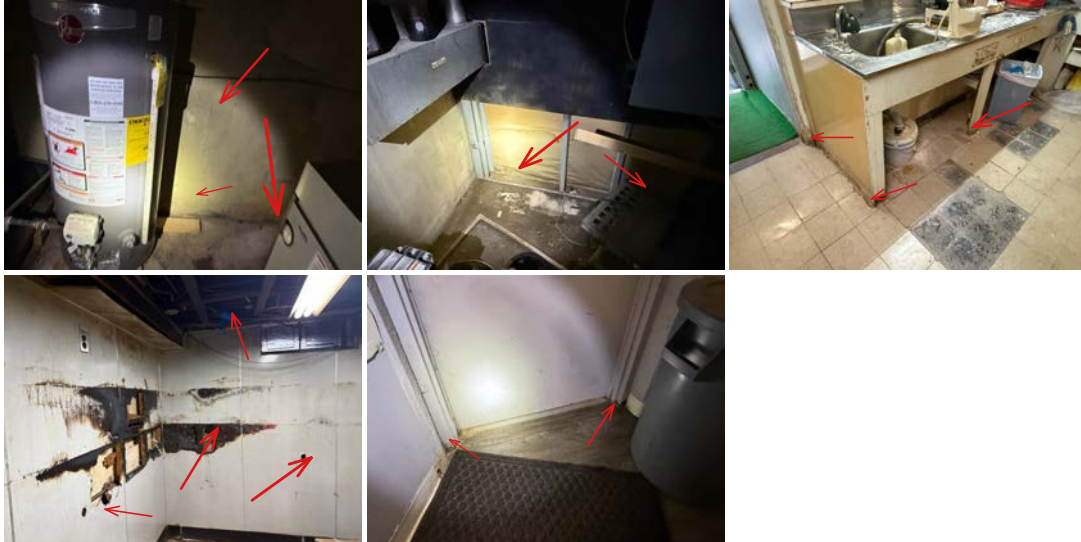
2. Walls: Paint, Paneling, Exposed Framing - Moisture staining and fire damage noted in multiple areas, recommend further evaluation. A qualified contractor is recommended to evaluate and estimate repairs.

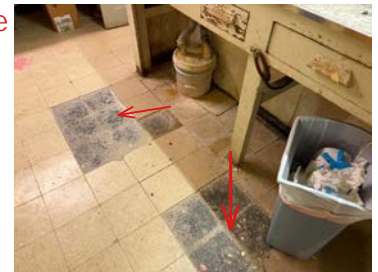
3. Floor: Carpet, Tile - Damaged tile noted in multiple areas. Most 9x9 tile may contain asbestos fiber material. Recommend encapsulating to prevent damage to tile. A qualified contractor is recommended to evaluate and estimate repairs.

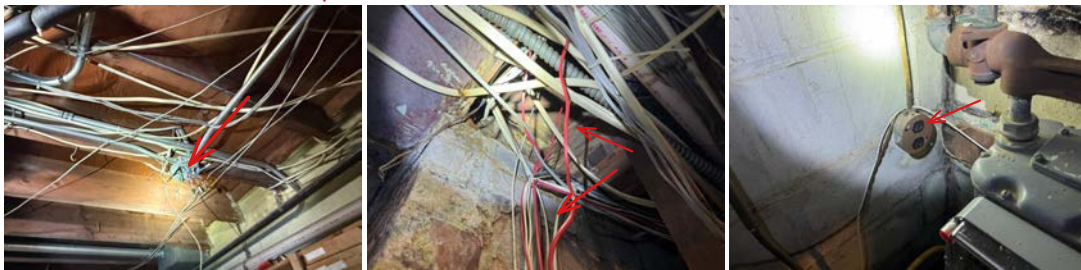
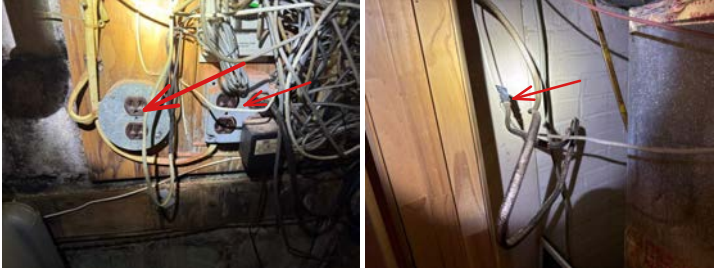
6. Electrical: Light(s) And Outlet(s) - Exposed and unsecured wiring noted. Two prong outlet, recommend updating. Corrosion noted on outlets. A licensed electrician is recommended to evaluate and estimate repairs.

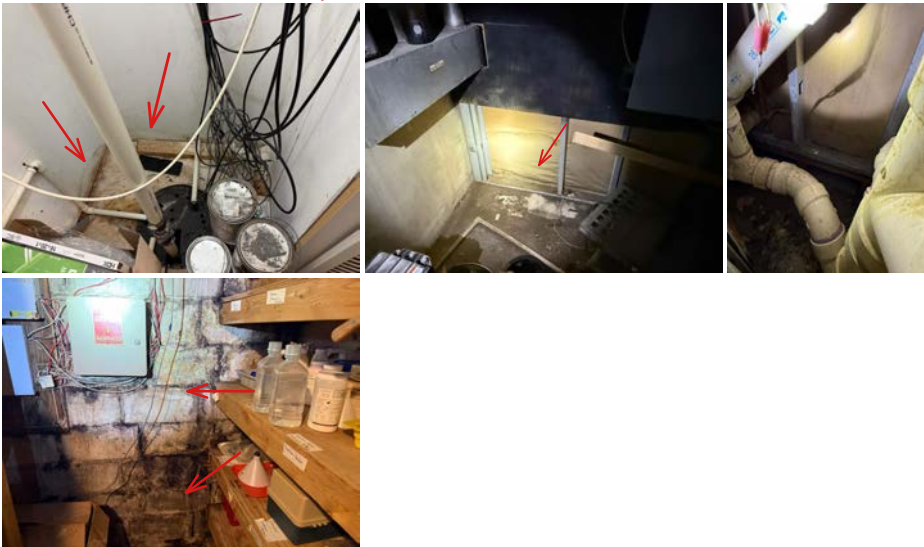
- 7. Smoke Detector: Present
- 8. HVAC Source: Present
- 9. Vapor Barrier: Not Visible
- 10. Insulation: Present
- 11. Ventilation: Present
- 12. Moisture Penetration: Present - Evidence of potential biological growth and moisture staining, recommend further testing and evaluation. Moisture penetration present in basement area. Recommend the source of the moisture penetration be identified and corrected. Moisture penetration may be present in other areas not visible. A qualified contractor is recommended to evaluate and estimate repairs.

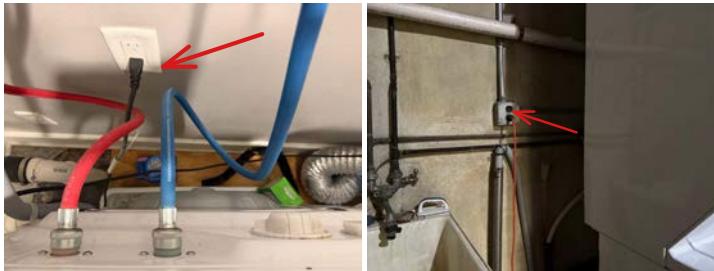
- 1. Closet: Not Present
- 2. Ceiling: Exposed Frame
- 3. Walls: Paneling
- 4. Floor: Concrete
- 5. Doors: Wood
- 6. Windows: Stationary
- 7. Electrical: Light(s) And Outlet(s) - **Non-GFCI circuit, recommend GFCI circuit be installed. A licensed electrician is recommended to evaluate and estimate repairs.**

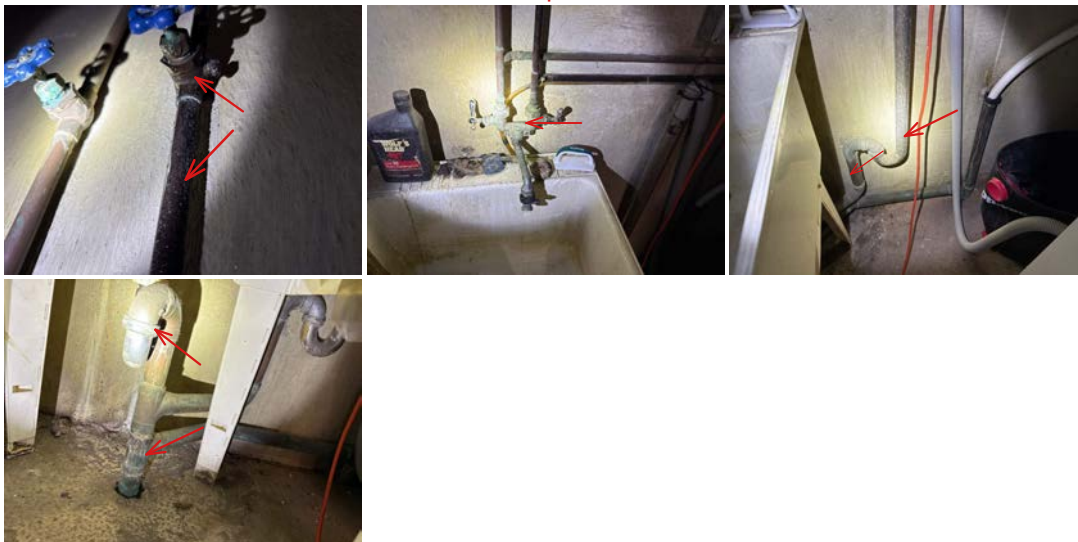
- 8. Smoke Detector: Not Present
- 9. HVAC Source: Present
- 10. Laundry Tub: present - **Leaking and condensation on pipes. Corrosion noted on drain lines and improper drain piping configuration. The water was off to the bibs. A qualified contractor is recommended to evaluate and estimate repairs.**

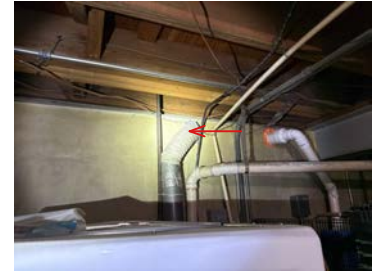
- 12. Washer and Dryer: Present
- 13. Washer and Dryer Electrical: 120-240 VAC
- 14. Dryer Vent: Metal Flex - **Plastic dryer vent piping noted in use, plastic dryer vent piping is a known fire hazard. Recommend replacing plastic flex pipe. A qualified contractor is recommended to evaluate and estimate repairs.**

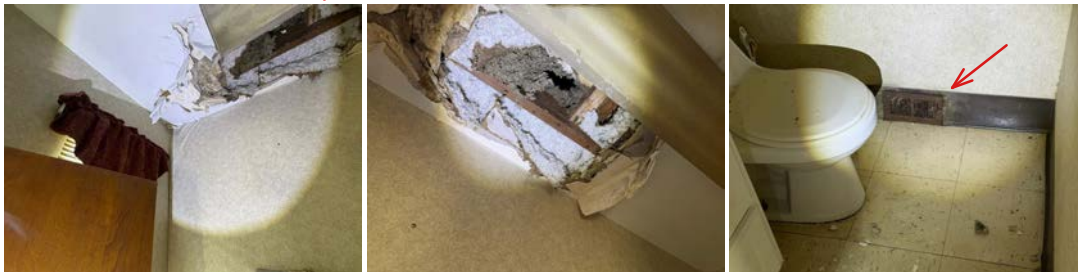
- 1. Closet: Not Present
- 2. Ceiling: Exposed Frame - **Moisture damage identified in the restroom ceiling. Recommend the source of the moisture intrusion be identified and corrected. Moisture may be present in other not visible locations. Recommend further investigation and repair. Evidence of potential biological growth. Recommend further testing and evaluation. A qualified contractor is recommended to evaluate and estimate repairs.**

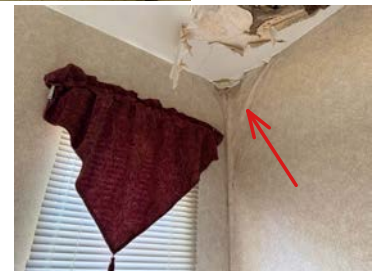
- 3. Walls: Wallpaper - **Moisture penetration present. Recommend the source of the moisture intrusion be identified and corrected. Moisture may be present in other not visible locations. Recommend further investigation and repair. A qualified contractor is recommended to evaluate and estimate repairs.**

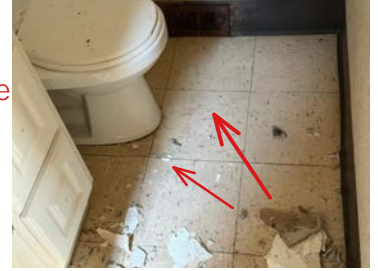
4. Floor: Tile - Most 9x9 tile may contain asbestos fiber material. Recommend encapsulating to prevent damage to tile. Cracked tile(s) noted. A qualified contractor is recommended to evaluate and estimate repairs.

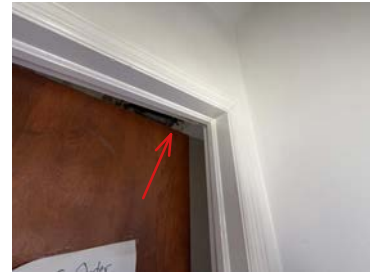
5. Doors: Wood - Door is striking frame, recommend trimming or adjustment. A qualified contractor is recommended to evaluate and estimate repairs.

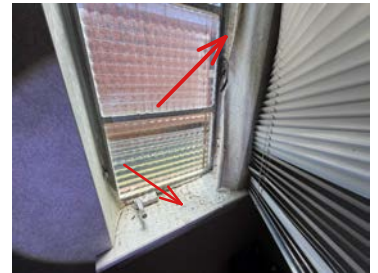
6. Windows: Metal, Stationary - Window sill has damaged material from moisture penetration, recommend repair and replacement of existing material. A qualified contractor is recommended to evaluate and estimate repairs.
