Home Inspection Report

5418 Park Heights Ave
Park Heights, MD 21215

Prepared for: Charles Shelton

Inspected by:
Luke Bunting
Blue Crab Inspections

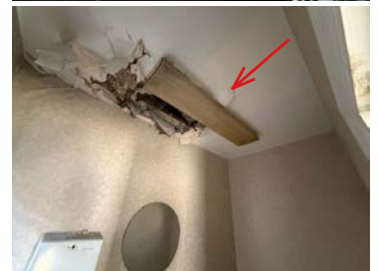
7. Electrical: Light(s) - Unable to operate electrical components due to current hazard. A licensed electrician is recommended to evaluate and estimate repairs.

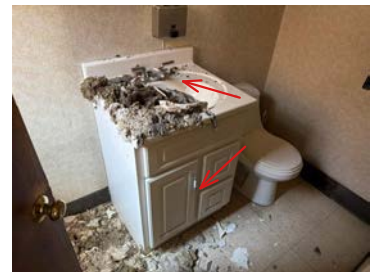
8. Counter/Cabinet: Present
9. Sink/Basin: Single Bowl - Due to insulation and damage the sink was not accessible to test. A qualified contractor is recommended to evaluate and estimate repairs.

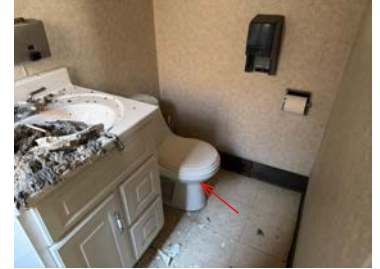
12. Toilets: Present - Due to insulation and damage the toilet was not accessible to test. A qualified contractor is recommended to evaluate and estimate repairs.

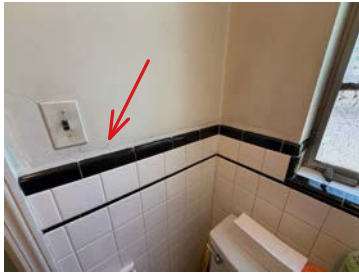
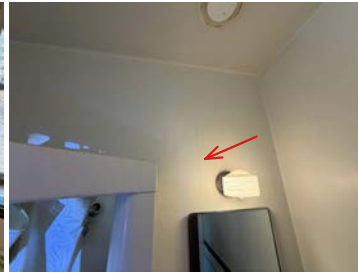
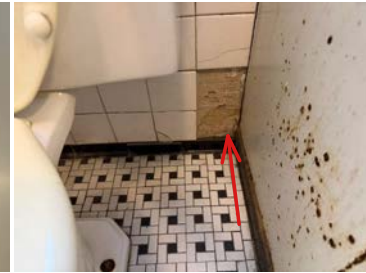
15. Closet: Not Present
 16. Ceiling: Paint
 17. Walls: Paint - Crack(s) and damaged wall material noted, recommend identifying the source and conducting repairs. A qualified contractor is recommended to evaluate and estimate repairs.

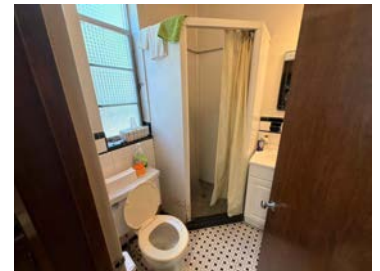
18. Floor: Tile
 19. Doors: Wood
 20. Windows: Stationary, Metal
 21. Electrical: Light(s)
 22. Counter/Cabinet: Present
 23. Sink/Basin: Single Bowl
 24. Tub: Not Present
 25. Shower: Present - Not in use.

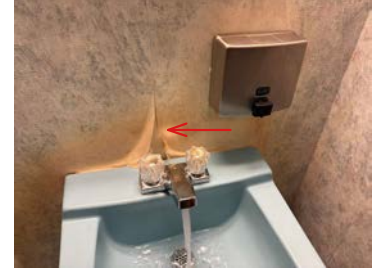
31. Walls: Paint - Peeling material noted. A qualified contractor is recommended to evaluate and estimate repairs.

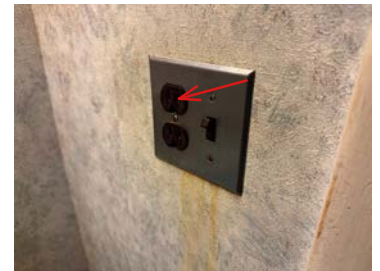
32. Floor: Vinyl
 33. Doors: Wood
 34. Windows: Not Present
 35. Electrical: Light(s) And Outlet(s) - Non-GFCI circuit, recommend GFCI circuit be installed. A licensed electrician is recommended to evaluate and estimate repairs.

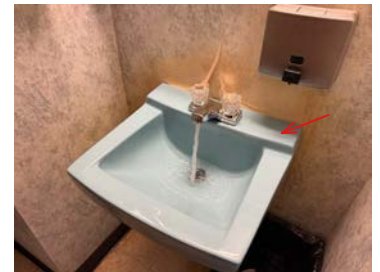
36. Counter/Cabinet: Present - Loose to the wall. A qualified contractor is recommended to evaluate and estimate repairs.

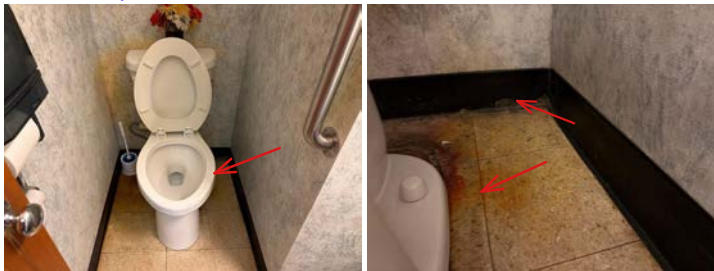
37. Sink/Basin: Single Bowl
 38. Toilets: Present - The toilet is loose at the floor. Loose toilets can lead to moisture penetration into the not visible sub-flooring. Recommend securing to prevent movement. Water damage around toilet. A qualified contractor is recommended to evaluate and estimate repairs.

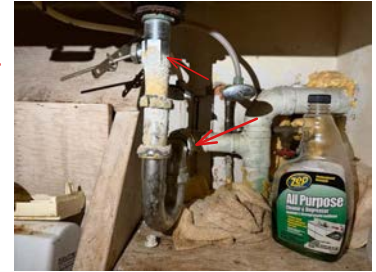
- 45. Doors: Wood
- 46. Windows: Not Present
- 47. Electrical: Light(s)
- 48. Counter/Cabinet: Present
- 49. Sink/Basin: Single Bowl - Excessive corrosion noted under the sink. A qualified contractor is recommended to evaluate and estimate repairs.

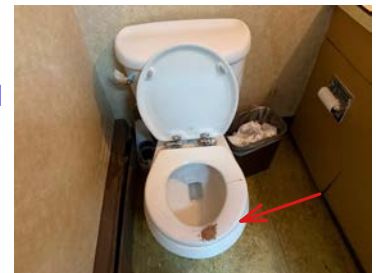
- 50. Toilets: Present - The toilet is loose at the floor. Loose toilets can lead to moisture penetration into the not visible sub-flooring. Recommend securing to prevent movement. A qualified contractor is recommended to evaluate and estimate repairs.

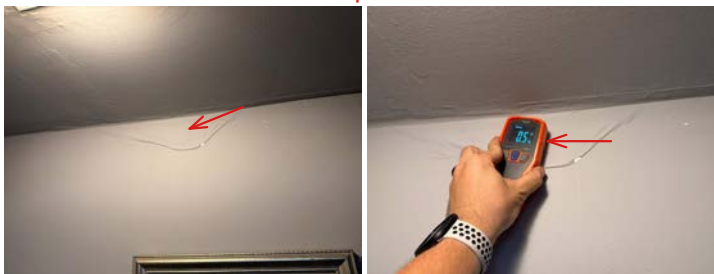
- 53. Closet: Not Present
- 54. Ceiling: Paint
- 55. Walls: Paint - Moisture stain(s) noted, verified dry at time of inspection. Recommend further investigation into whether the source of the water penetration has been corrected. Crack(s) noted, recommend they be patched during routine maintenance. A qualified contractor is recommended to evaluate and estimate repairs.

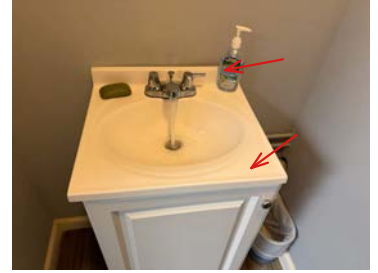
60. Counter/Cabinet: Present - Countertop is loose from cabinet/wall, recommend it be secured. A qualified contractor is recommended to evaluate and estimate repairs.

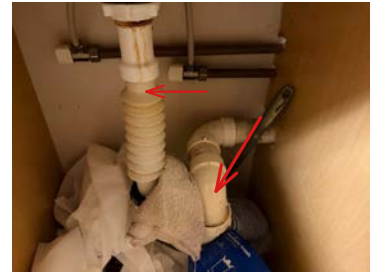
61. Sink/Basin: Single Bowl - Leaking noted under the bathroom sink. Flexible drain piping is installed under sink. Flexible drain piping is more prone to leakage, recommend replacement with appropriate material. A qualified contractor is recommended to evaluate and estimate repairs.

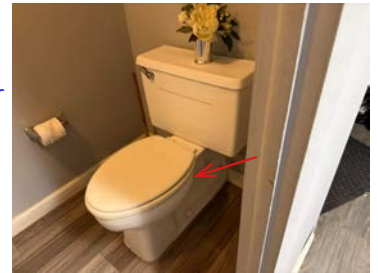
62. Toilets: Present - The toilet is loose at the floor. Loose toilets can lead to moisture penetration into the not visible sub-flooring. Recommend securing to prevent movement. Slow flush noted. A qualified contractor is recommended to evaluate and estimate repairs.

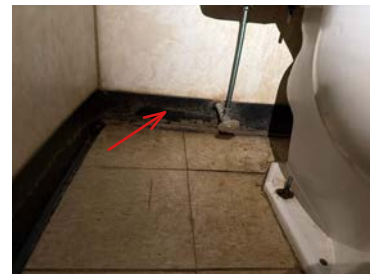
68. Floor: Tile, Vinyl - Water damage on the flooring, recommend further investigation. A qualified contractor is recommended to evaluate and estimate repairs.

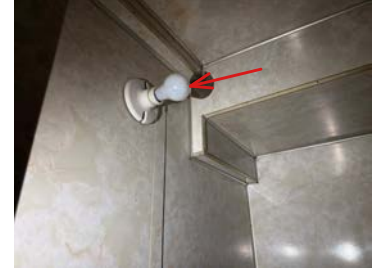
71. Electrical: Light(s) - Light did not function, recommend change bulb and re-test. A qualified contractor is recommended to evaluate and estimate repairs.

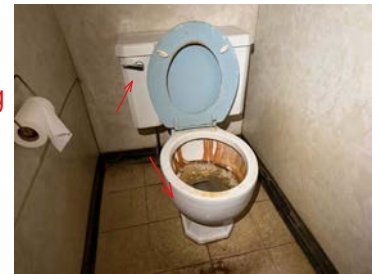
73. Toilets: Present - The toilet is loose at the floor. Loose toilets can lead to moisture penetration into the not visible sub-flooring. Recommend securing to prevent movement. The tank is loose, recommend securing to prevent movement. A qualified contractor is recommended to evaluate and estimate repairs.

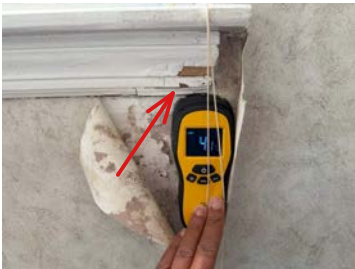
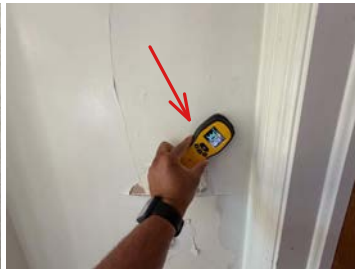
1. Closet: Present
2. Ceiling: Paint
3. Walls: Wallpaper - Moisture penetration present. Recommend the source of the moisture intrusion be identified and corrected. Moisture may be present in other not visible locations. Recommend further investigation and repair. A qualified contractor is recommended to evaluate and estimate repairs.

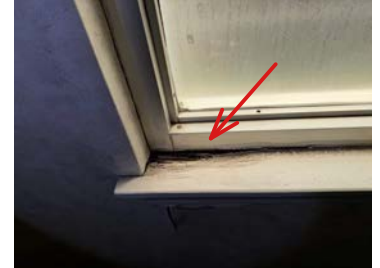
- 5. Doors: Vinyl
- 6. Windows: Metal, Stationary - **Wood rot present in wood window, recommend repair or replacement. A qualified contractor is recommended to evaluate and estimate repairs.**

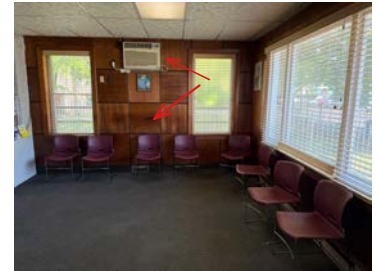
- 10. Closet: Not Present
- 11. Ceiling: Tile
- 12. Walls: Paneling - **Moisture stain(s) noted, verified dry at time of inspection. Recommend further investigation into whether the source of the water penetration has been corrected.**

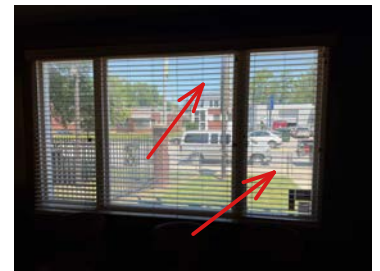
- 13. Floor: Carpet
- 14. Doors: Metal
- 15. Windows: Metal, Stationary - **Cracks in windows noted, recommend replacement. A qualified contractor is recommended to evaluate and estimate repairs.**

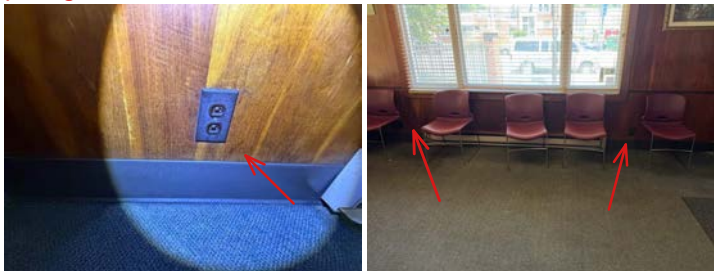
- 16. Electrical: Light(s) And Outlet(s) - **Recommend replacing two prong outlets with grounded three prong outlets. A licensed electrician is recommended to evaluate and estimate repairs.**

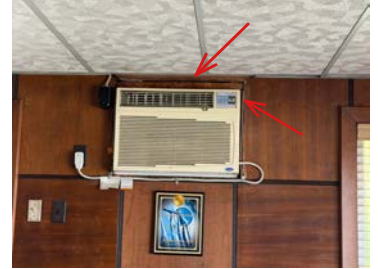
17. HVAC Source: Present - **Window AC noted, area around unit has damaged material present. A qualified contractor is recommended to evaluate and estimate repairs.**

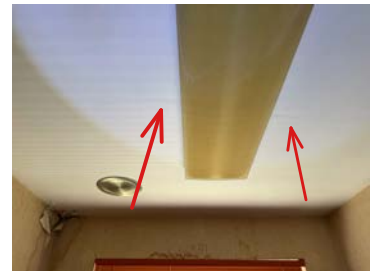
20. Ceiling: Paint - **Crack(s) noted, recommend they be patched and or repaired. A qualified contractor is recommended to evaluate and estimate repairs.**

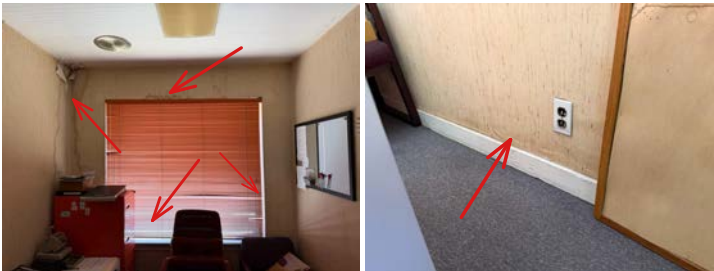
21. Walls: Wallpaper - **Moisture damage present throughout the space, recommend identifying the source and conducting repairs. A qualified contractor is recommended to evaluate and estimate repairs.**

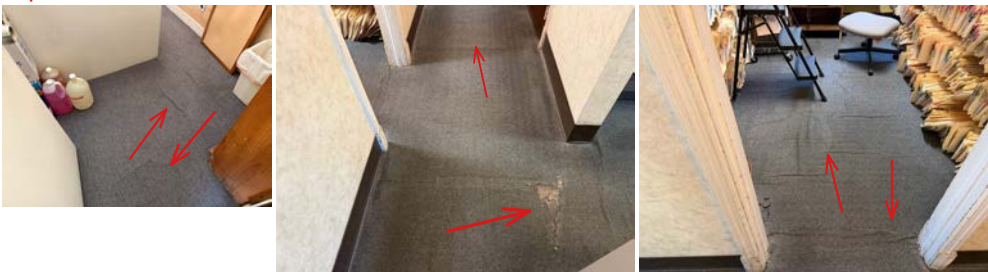
22. Floor: Carpet - **Loose/torn carpeting noted throughout the property, recommend addressing the affected areas to prevent hazards. A qualified contractor is recommended to evaluate and estimate repairs.**

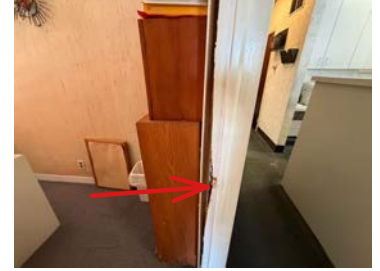
23. Doors: Wood - Door frame damage noted, recommend repair and replacement of damaged material. A qualified contractor is recommended to evaluate and estimate repairs.

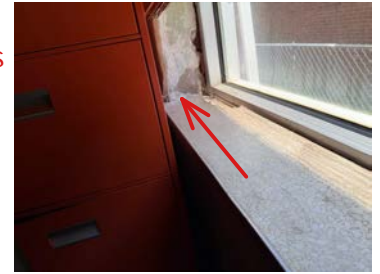
24. Windows: Stationary, Metal - Damaged window sill noted throughout the property, recommend addressing the cause and conducting repairs as needed. A qualified contractor is recommended to evaluate and estimate repairs.

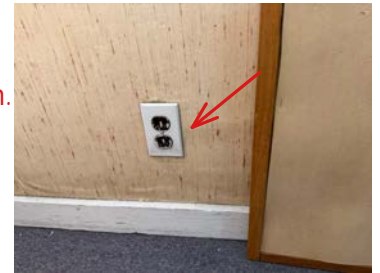
25. Electrical: Light(s) And Outlet(s) - Two prong outlets are present throughout the property Recommend replacing all two prong outlets with grounded three prong outlets to ensure safety and proper function. A licensed electrician is recommended to evaluate and estimate repairs.

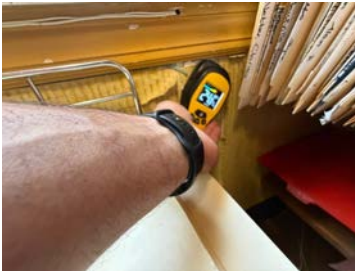
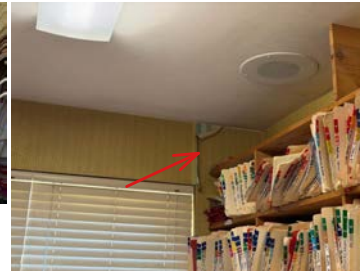
30. Walls: Wallpaper - Moisture penetration present. Recommend the source of the moisture intrusion be identified and corrected. Moisture may be present in other not visible locations. Recommend further investigation and repair. A qualified contractor is recommended to evaluate and estimate repairs.

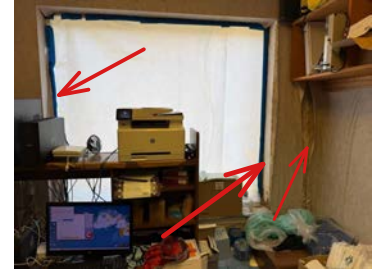
- 37. Closet: Not Present
- 38. Ceiling: Paint
- 39. Walls: Wallpaper - **Moisture damage present throughout the space, recommend identifying the source and conducting repairs. A qualified contractor is recommended to evaluate and estimate repairs.**

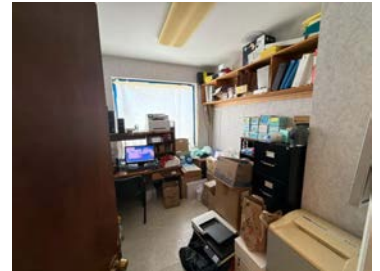
- 40. Floor: Tile
- 41. Doors: Wood
- 42. Windows: Stationary, Metal - **Unable to be inspected due to stored items**

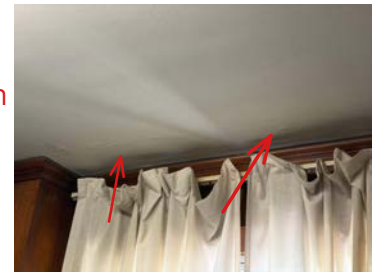
- 46. Closet: Present
- 47. Ceiling: Paint - **Moisture penetration present. Recommend the source of the moisture intrusion be identified and corrected. Moisture may be present in other not visible locations. Recommend further investigation and repair. A qualified contractor is recommended to evaluate and estimate repairs.**

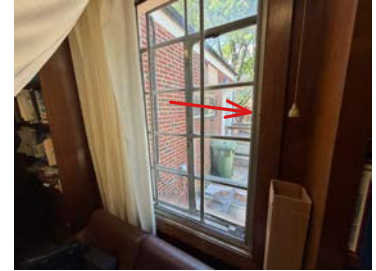
- 51. Windows: Stationary, Metal - Window has missing components, recommend identifying and replacing/repairing. A qualified contractor is recommended to evaluate and estimate repairs.

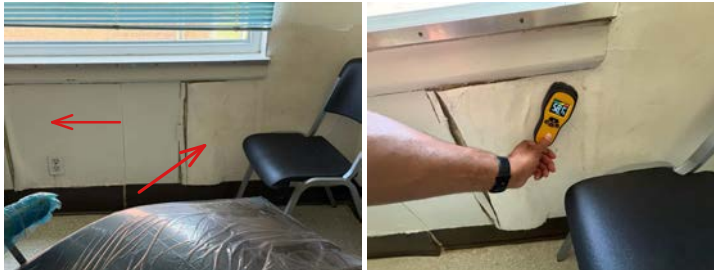
- 55. Closet: Not Present
- 56. Ceiling: Paint
- 57. Walls: Paint - Moisture penetration present. Recommend the source of the moisture intrusion be identified and corrected. Moisture may be present in other not visible locations. Recommend further investigation and repair. A qualified contractor is recommended to evaluate and estimate repairs.

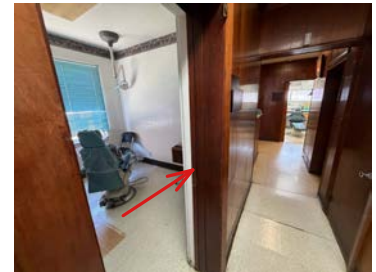
- 58. Floor: Vinyl
- 59. Doors: Wood - Door is sticking, recommend adjustment. A qualified contractor is recommended to evaluate and estimate repairs.

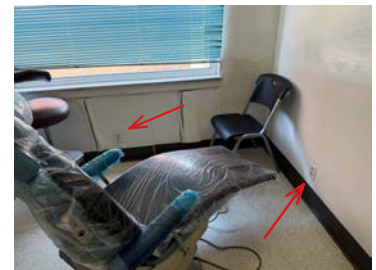
- 60. Windows: Metal, Stationary
- 61. Electrical: Light(s) And Outlet(s) - Reversed polarity noted at outlet. A licensed electrician is recommended to evaluate and estimate repairs.

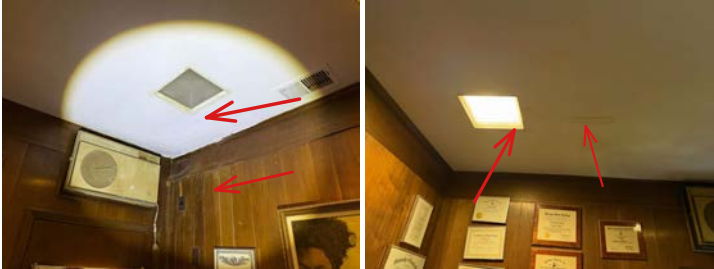
65. Ceiling: Paint - **Moisture penetration present. Recommend the source of the moisture intrusion be identified and corrected. Moisture may be present in other not visible locations. Recommend further investigation and repair. A qualified contractor is recommended to evaluate and estimate repairs.**

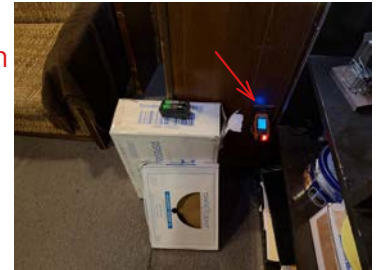
70. Electrical: Light(s) And Outlet(s) - **Open grounds noted at three prong outlets in multiple areas throughout the property. A licensed electrician is recommended to evaluate and estimate repairs.**

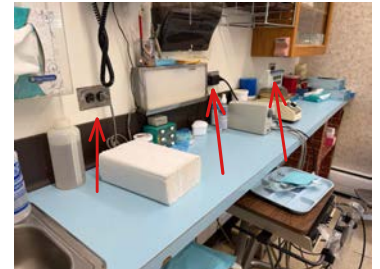
79. Electrical: Light(s) And Outlet(s) - **Open grounds noted at three prong outlets. A licensed electrician is recommended to evaluate and estimate repairs.**

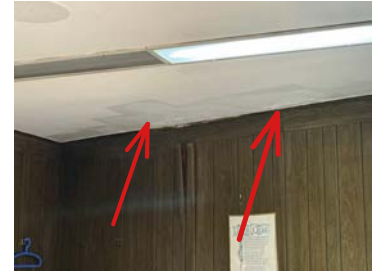
- 82. Closet: Present
- 83. Ceiling: Paint - Evidence of previous repairs, recommend further investigation regarding why repairs were made.

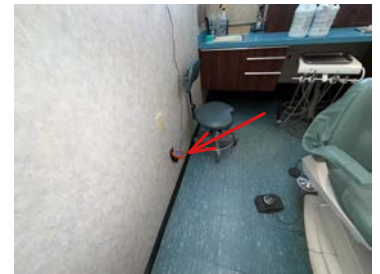
- 84. Walls: Paneling
- 85. Floor: Carpet, Vinyl
- 86. Doors: Wood
- 87. Windows: Stationary, Metal
- 88. Electrical: Light(s) And Outlet(s) - Open grounds noted at three prong outlets. A qualified contractor is recommended to evaluate and estimate repairs.

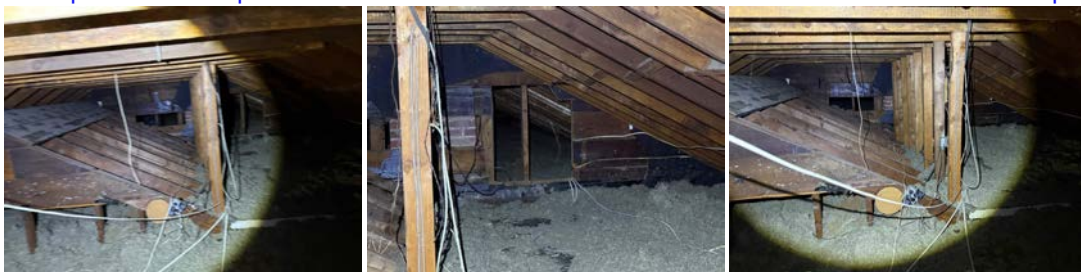
1. Method of Inspection: In The Attic, From The Attic Access
2. Roof Framing: Trusses - Multiple areas were not fully accessible to inspect and space constraints in multiple areas. A qualified contractor is recommended to evaluate and estimate repairs.

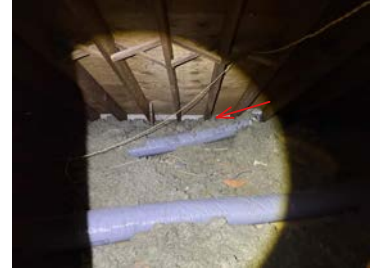
3. Sheathing: Wood - Daylight visible. Recommend a qualified contractor to evaluate and estimate repairs.

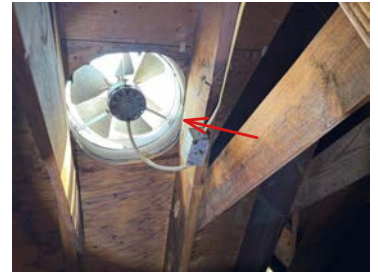
4. Ventilation: Fan - Limited ventilation, recommend adding additional venting. Fan was not functioning and attic was excessively hot. A qualified contractor is recommended to evaluate and estimate repairs.

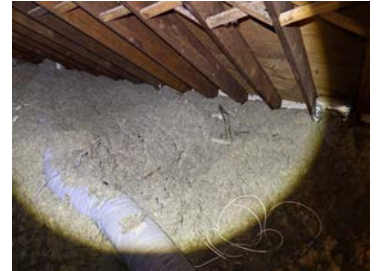
5. Insulation: Present - Insulation is compressed throughout. A qualified contractor is recommended to evaluate and estimate repairs.

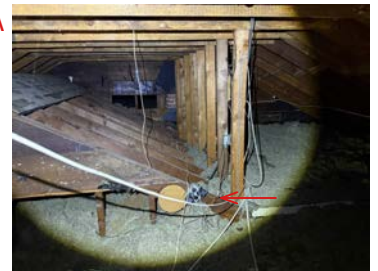
8. Wiring/Lighting: Light(s) - Exposed and unsecured wiring throughout. A qualified contractor is recommended to evaluate and estimate repairs.

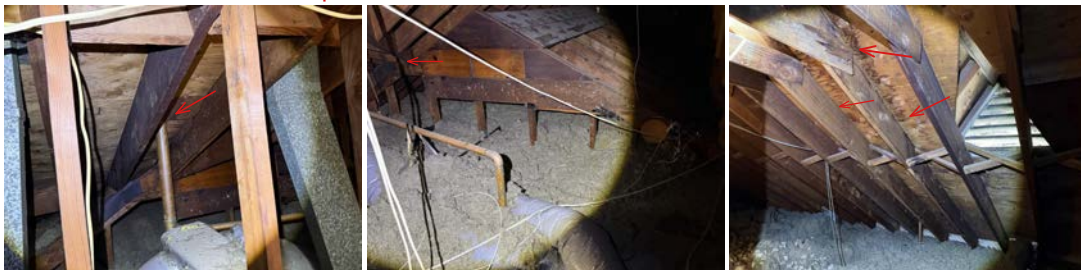
9. Moisture Penetration: No Moisture Present At Time Of Inspection - Moisture stain(s) noted throughout, verified dry at time of inspection. Recommend further investigation into whether the source of the water penetration has been corrected. A qualified contractor is recommended to evaluate and estimate repairs.

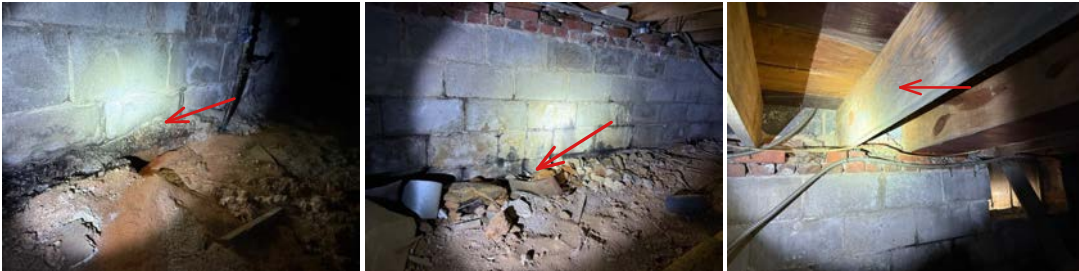
3. Moisture Penetration: Present - **Water penetration noted. Potential biological growth noted in the crawl space. A qualified contractor is recommended to evaluate and estimate repairs.**

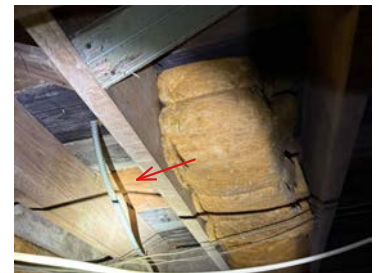
6. Insulation: Not Present - **Missing insulation throughout. A qualified contractor is recommended to evaluate and estimate repairs.**

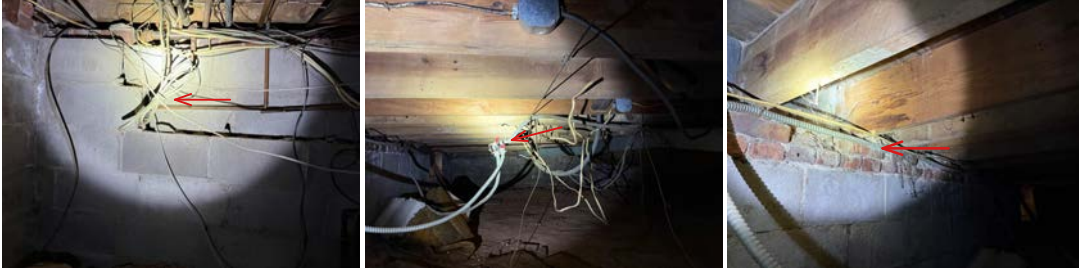
9. Electrical: Wiring - **Exposed, unsecured, and corrosion on wiring throughout. A licensed electrician is recommended to evaluate and estimate repairs.**

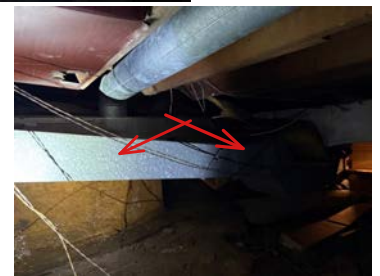
10. HVAC Components: Present - **Falling sections noted and missing insulation. A qualified contractor is recommended to evaluate and estimate repairs.**
