# *Evolve Property Inspections*

1011 Euclid Ave, Miami Beach, FL 33139  
Inspection prepared for: Jason Saint  
Real Estate Agent: -

Date of Inspection: 10/13/2023 Time: 10:30 AM  
Age of Home: 1959 Size: 0  
Weather: sunny  
unit 1

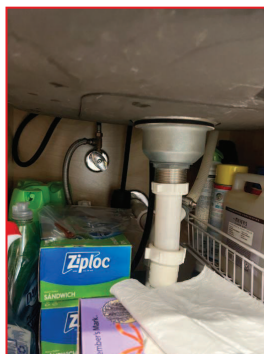
Under Kitchen Sink

- No deficiencies noted at time of inspection

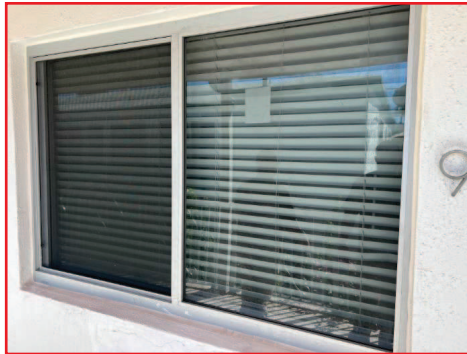
- Tested windows appeared functional, at time of inspection

Impact Windows Noted

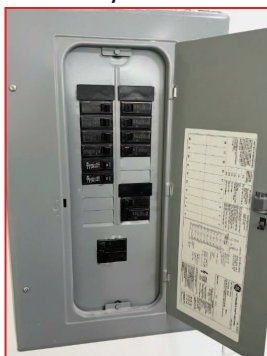
- No major system safety or function concerns noted at time of inspection at main panel box.

Electrical Panel, Cover On
