Home Inspection Report for 18935 5th Street West, Sonoma CA

## HOME INSPECTION REPORT

Property Address: 18935 5th Street West  
Sonoma, CA

Report Number: 60426-2

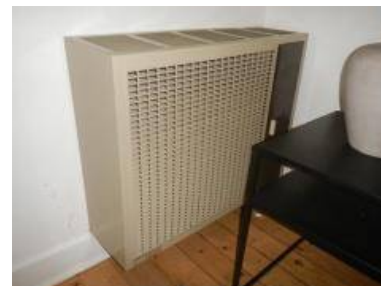
This wall heater is statistically at the end of its useful life. Additionally, these units are not as energy efficient as newer units due to the presence of a standing pilot light. Consideration should be given to upgrading this heating unit.

**OVERALL CONDITION:** Fair condition. The system responded to operation of the thermostat control(s) and appeared to be functioning properly.

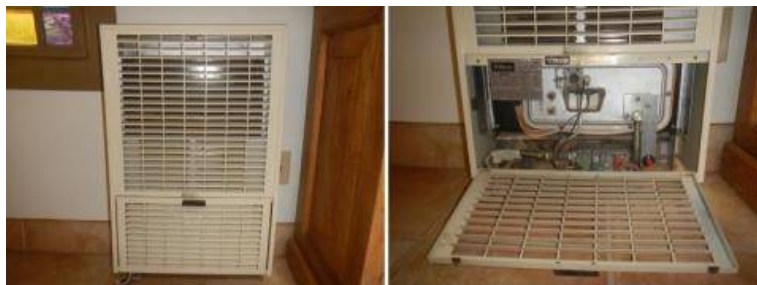
This wall heater is statistically at the end of its useful life. Additionally, these units are not as energy efficient as newer units due to the presence of a standing pilot light. Consideration should be given to upgrading this heating unit.

**OVERALL CONDITION:** Fair condition. The furnace responded to operation of the thermostat control(s) and appeared to be functioning properly.

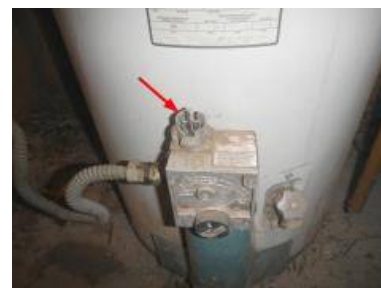
The upper gas control adjustment valve handle / cover is missing. This will make it difficult to operate. We recommend further evaluation and correction by the appropriate, qualified professional.

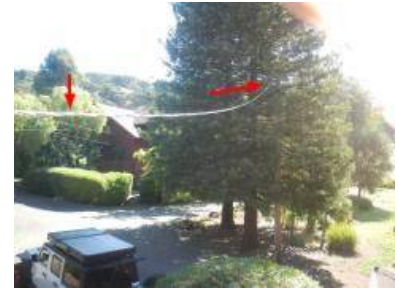
The incoming overhead service conductors are routed through and contacting tree branches or limbs. Tree limbs can place strain on the electrical weatherhead, possibly causing damage and creating hazardous conditions. Recommend either contacting the local utility company or a licensed electrician to determine what course of action should be taken.

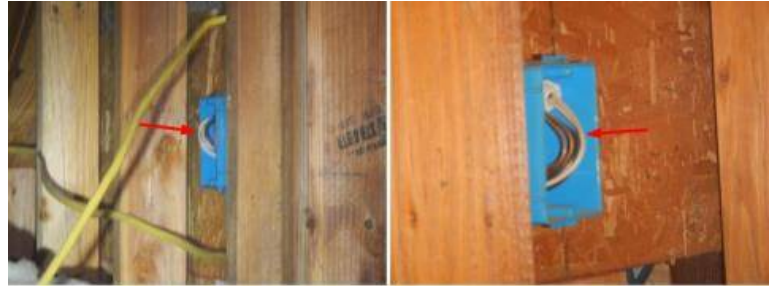
One or more electrical junction boxes were noted in the attic area over the kitchen that were missing the protective covers. The lack of appropriate covers exposes live conductors. For your safety we recommend the installation of covers as soon as possible by the appropriate qualified professional.

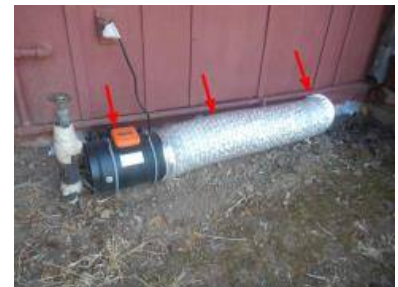
**SEISMIC BOLTING / ANCHORING:** No foundation bolts, tie-down brackets, or equivalent are present. This condition can allow the structure to shift off of the foundation in the event of major earth movement. It may also affect your ability to secure homeowners insurance with some insurance companies.

**OTHER OBSERVATIONS:** There is an under floor exhaust fan system installed as indicated by a duct and fan motor assembly on the exterior, rear of the structure. This system was running and exhausting air at the time of the inspection. We recommend inquiring of the seller / occupants for more information about this system.
