## Home Inspection Report

**12700 State Route 1, Point Reyes Station**

Cameron Jones  
August 7, 2020

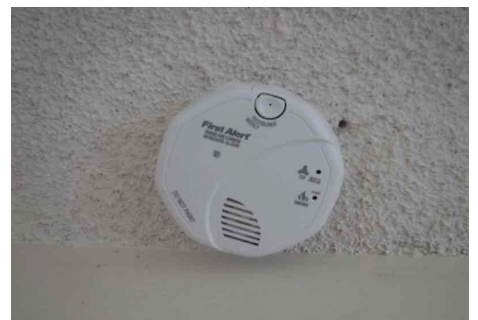
Photo 31

46. This home does not have enough smoke detectors installed. The installation of smoke detectors should be placed on each floor in non-sleeping areas. In addition, one smoke alarm must be installed in each room where sleeping occurs and one smoke alarm should be located in each hallway that leads directly to sleeping rooms. (See Photo 31)

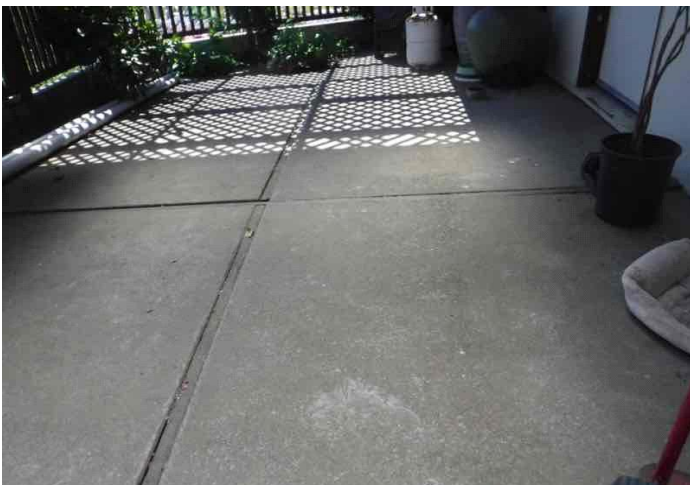
Photo 03

7. The wood borders between the slab sections of the patio have deteriorated. These voids create a trip hazard and should be filled in or replaced with treated wood or mortar. (See Photo 3)

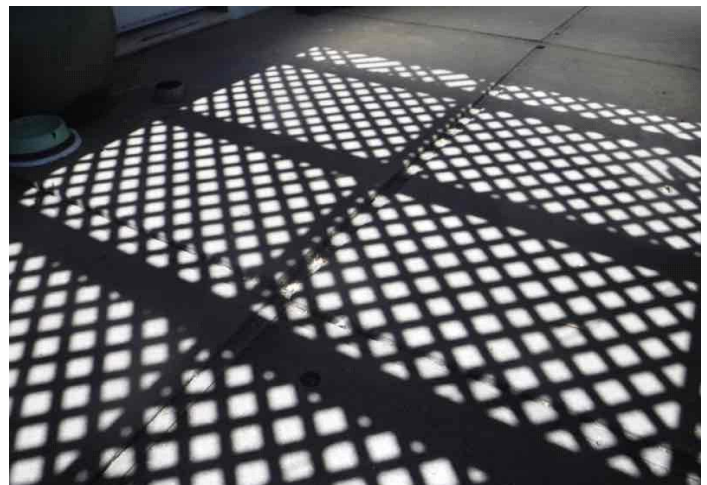
Photo 04

8. The cracked and heaved sections of the patios present a trip hazard. This condition should be corrected for improved safety. (See Photo 4)

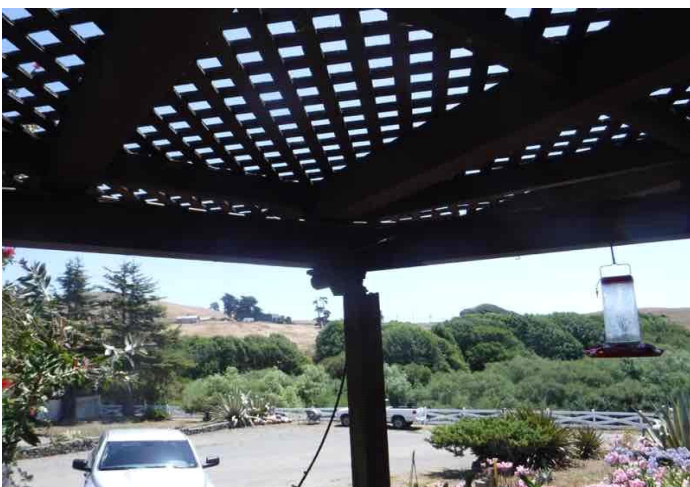
Photo 05

12. Evidence of water damage was noted at the patio covers. Consult a licensed structural pest control company regarding necessary repairs. (See Photo 5) (See Photo 15)

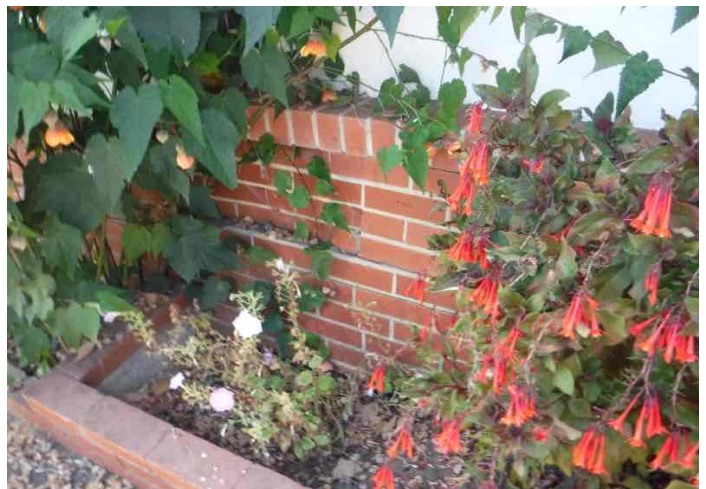
Photo 10

19. The veneer at the left side is damaged and has pulled away from the building and/or has become unbounded from the wood frame. The exterior brick masonry walls are only a veneer over the basic wood frame construction. The masonry is not a structural element of the house. Minor cracks are fairly typical and not considered a structural deficiency. We recommend repair or removal of the brick masonry. (See Photo 10)

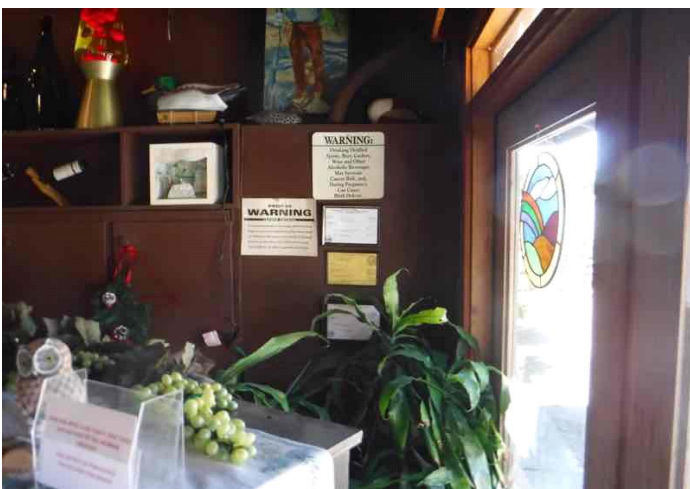
Photo 11

28. The main electrical panel was obstructed and inaccessible at the time of our inspection. We recommend the circuitry and wiring in the panel be inspected by a licensed electrical contractor when the obstructions/storage is removed. (See Photo 11)

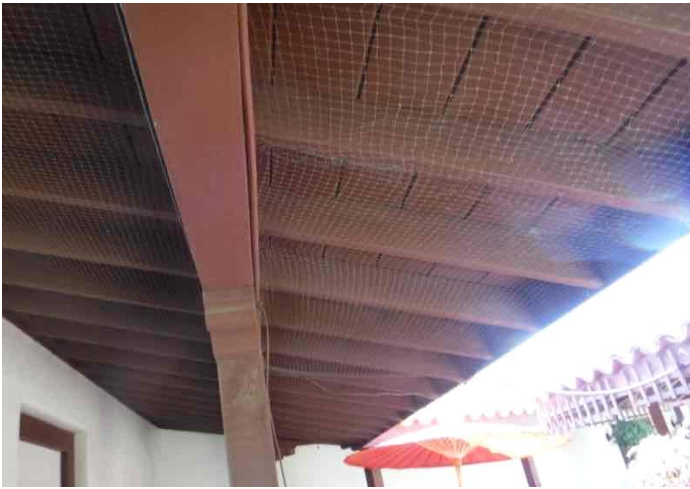
Photo 13

17. Water damage was observed to the rafters at various locations. We recommend the services of a licensed general contractor and/or structural pest control company. (See Photo 13)

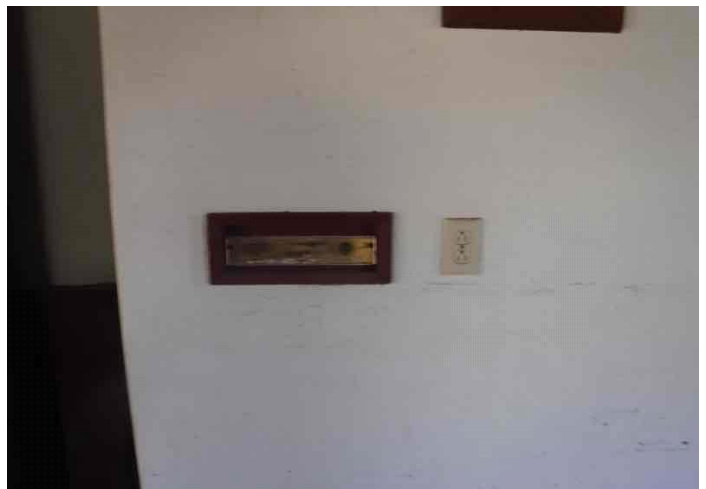
Photo 16

30. Exterior receptacles at various patio locations are missing water proof cover plates. We recommend approved exterior covers be installed. (See Photo 16)

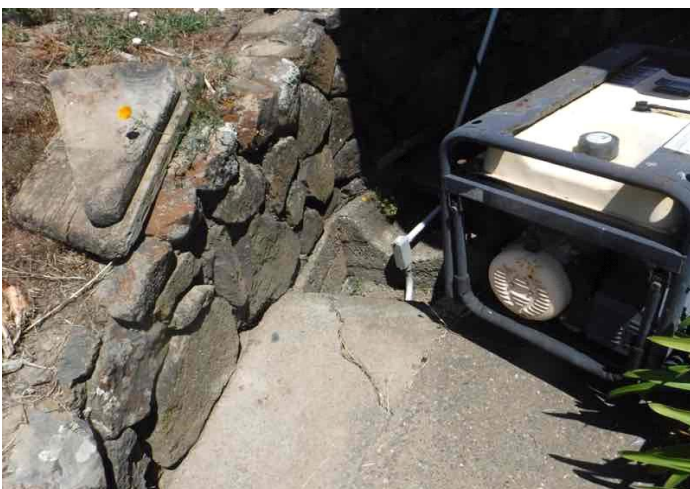
Photo 17

15. The open, cracked and/or heaved walkway sections at various locations present a trip hazard. This condition should be corrected for improved safety. (See Photo 17) (See Photo 18)

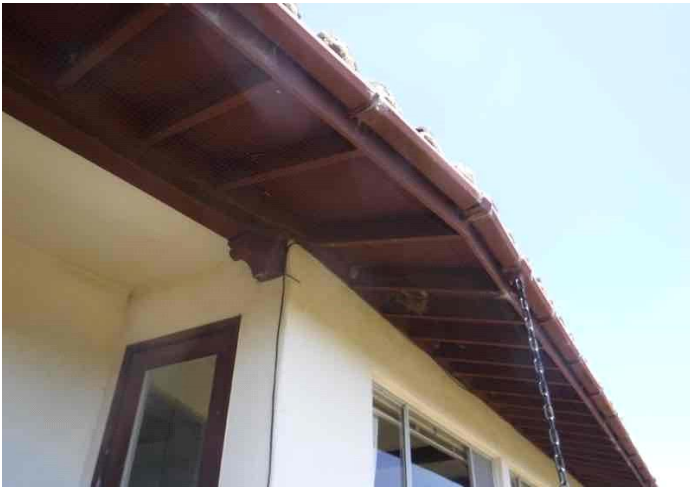
Photo 19

5. Leaks were noted in the downspouts and/or gutters. During wet weather conditions these areas are more obvious and during dry weather conditions they are noted from the stains at the areas where the leaks have occurred. We recommend all leaks be repaired. (See Illustration 2D) (See Photo 19)

6. Missing downspouts at the rear gutters should be replaced as necessary. (See Photo 19)

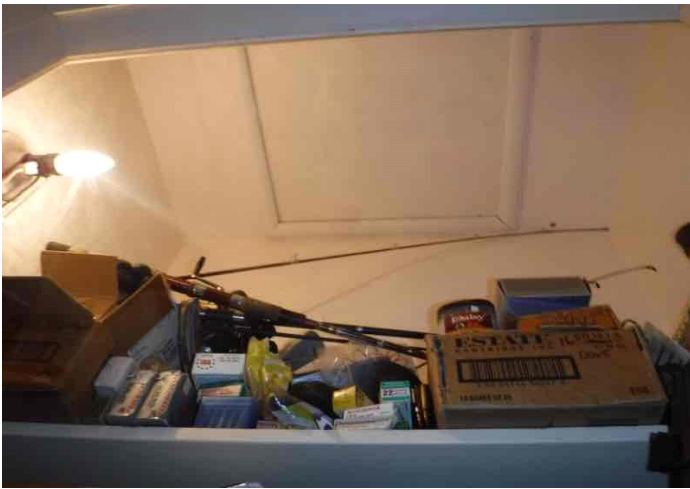
Photo 21

2. Personal storage was blocking the closet attic access opening, therefore, the attic space was not inspected. With access and an opportunity for a complete inspection, conditions in need of attention may be discovered. The personal belongings should be removed so the attic may be inspected. (See Photo 21)

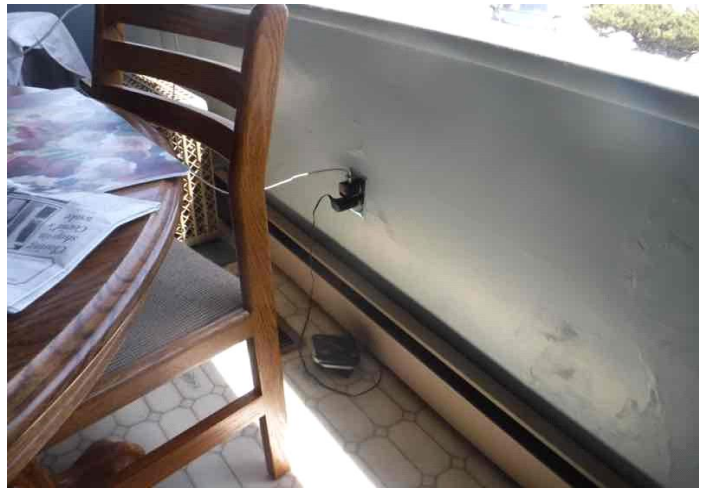
Photo 22

33. The location of the outlet over the baseboard heater at the kitchen can present a safety issue. We recommend the outlet be moved. (See Photo 22)

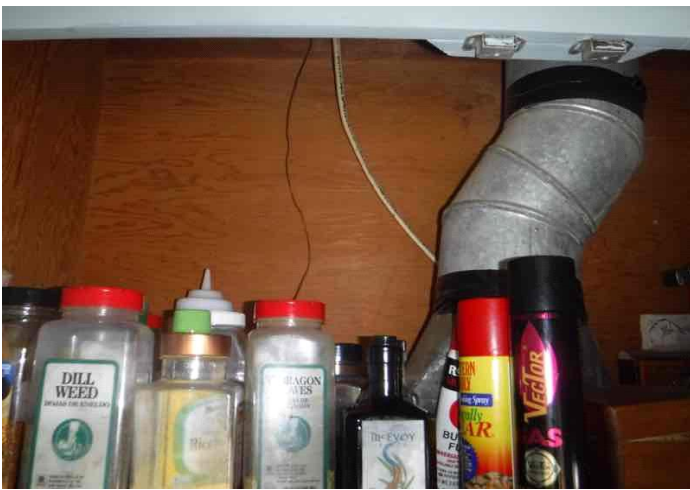
Photo 23

29. Exposed wiring inside the kitchen hood cabinet should be relocated, covered or protected by rigid conduit. (See Photo 23)

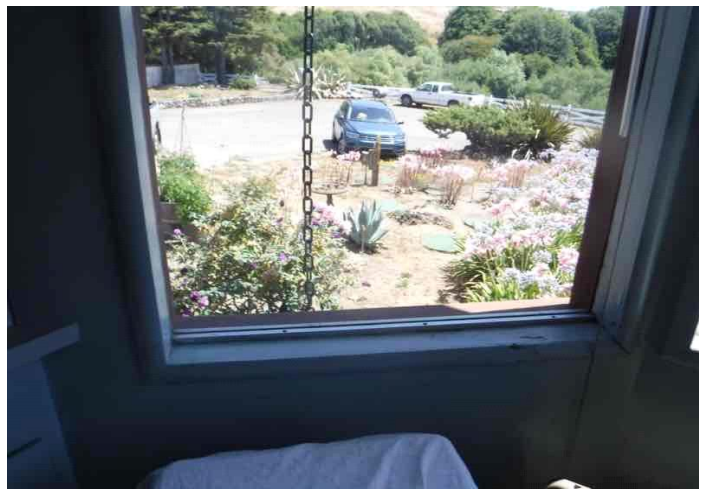
Photo 24

48. The window sills/frames at the kitchen, guest bedroom and various guest unit locations are water damaged. We recommend they be repaired or replaced. (See Photo 24) (See Photo 36) (See Photo 41)

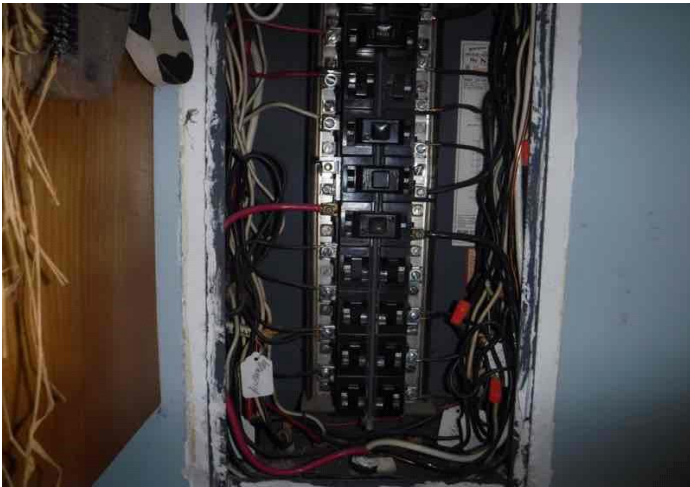
Photo 25

36. Circuits within the electrical branch/auxiliary panel that are doubled up (referred to as "double taps") should be separated. We recommend reconfiguration of the circuitry so that each wire connects only to one terminal. (See Illustration 4D) (See Photo 25)

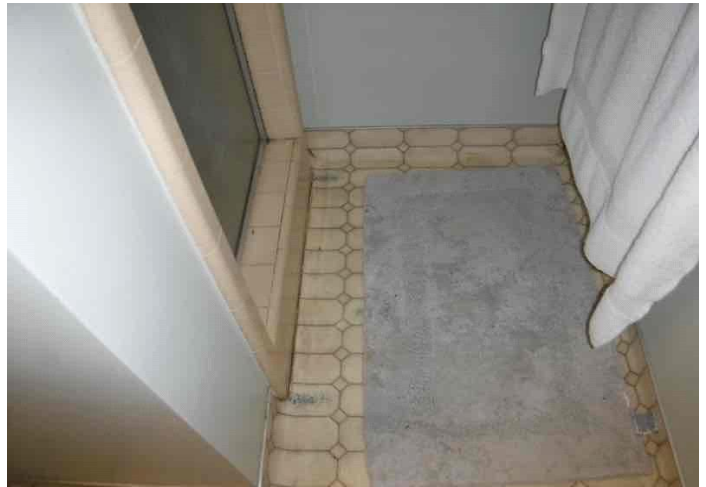
Photo 26

- ! 24. Evidence of water damage at the hall bathroom floor was observed. The extent of the damage is difficult to predict without removing floor coverings. We recommend the services of a licensed structural pest control operator for investigation of this condition. (See Photo 26)**

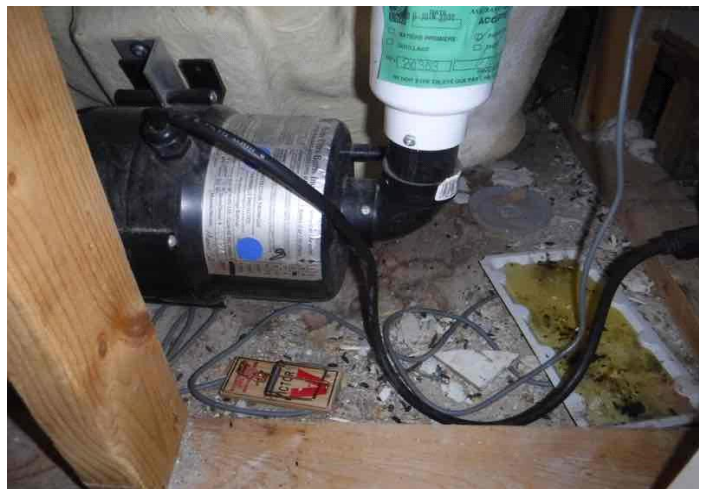
Photo 28

- ! 5. There is evidence of vermin activity in the structure. It is likely that this infestation is also in inaccessible areas. The owner is advised to contact the appropriate trades for all remedial measures necessary. (See Photo 28)

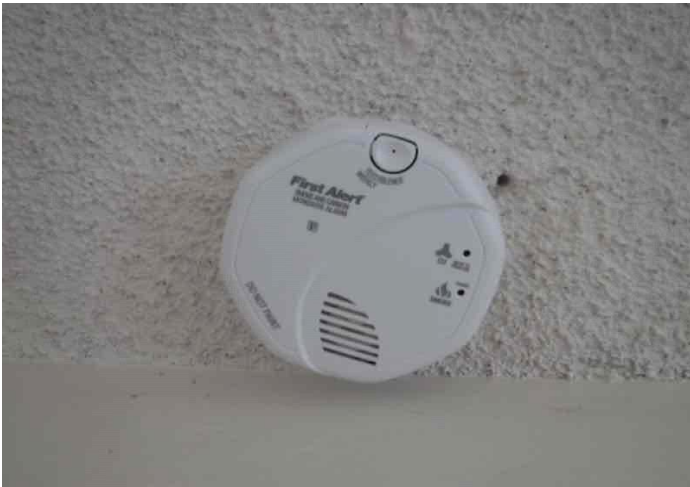
Photo 31

- ! 4. This home does not have enough smoke detectors installed. The installation of smoke detectors should be placed on each floor in non-sleeping areas. In addition, one smoke alarm must be installed in each room where sleeping occurs and one smoke alarm should be located in each hallway that leads directly to sleeping rooms. (See Photo 31)

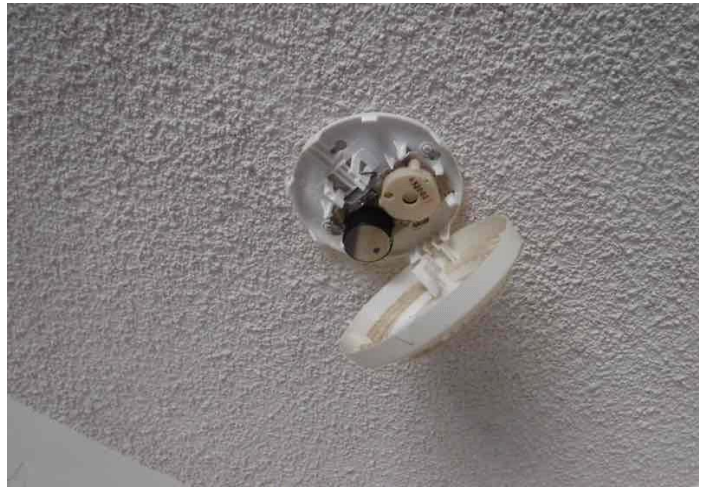
Photo 32

- ! 2. One or more smoke detector batteries have been removed. Interested parties are advised to replace the batteries and test for proper operation. (See Photo 32)

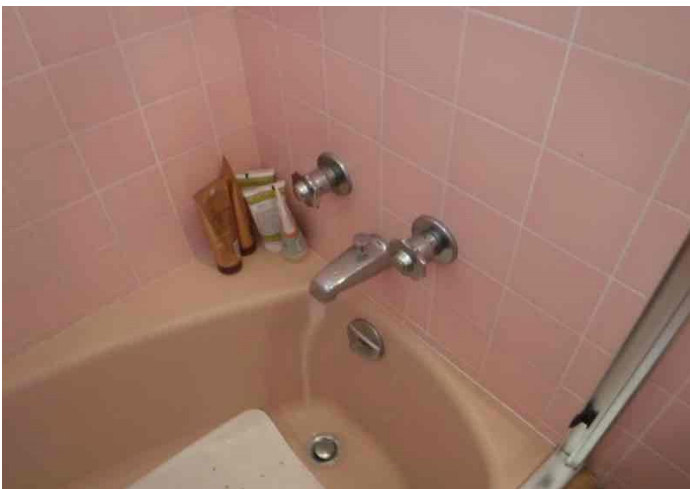
Photo 33

- ! 4. The tub faucet and/or handles are leaking at the right side hall bathroom. We recommend all leaks be repaired. (See Photo 33)
- ! 5. The exterior drain is leaking under the guest unit bathroom. We recommend all leaks be repaired. (See Photo 59)

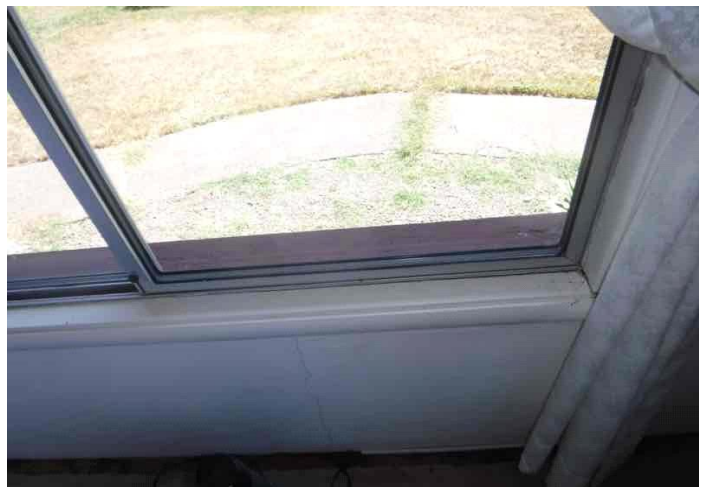
Photo 36

- ! 22. The window sills/frames at the kitchen, guest bedroom and various guest unit locations are water damaged. We recommend they be repaired or replaced. (See Photo 24) (See Photo 36) (See Photo 41)**
23. One or more of the control knobs or buttons at the electric range were worn and un-readable. We recommend repair or replacement of the knobs for full use of the appliance as designed.

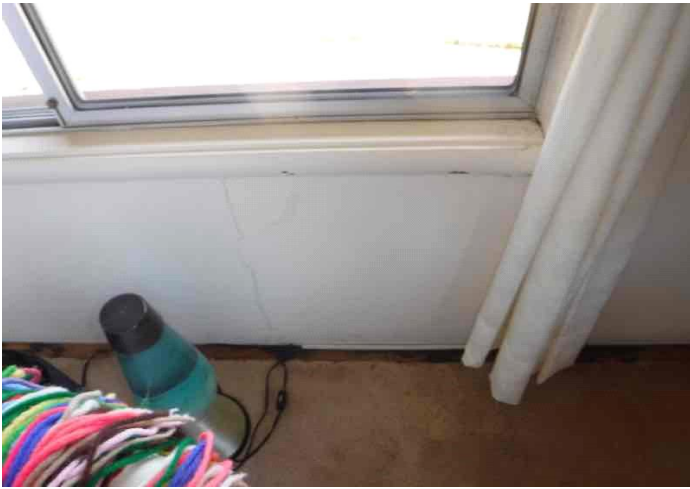
Photo 37

- ! 6. The wall at the guest bedroom shows evidence of water stains. It is recommended that the source of the moisture be identified and corrected and the surface be repaired and refinished to restore its appearance. (See Photo 37)

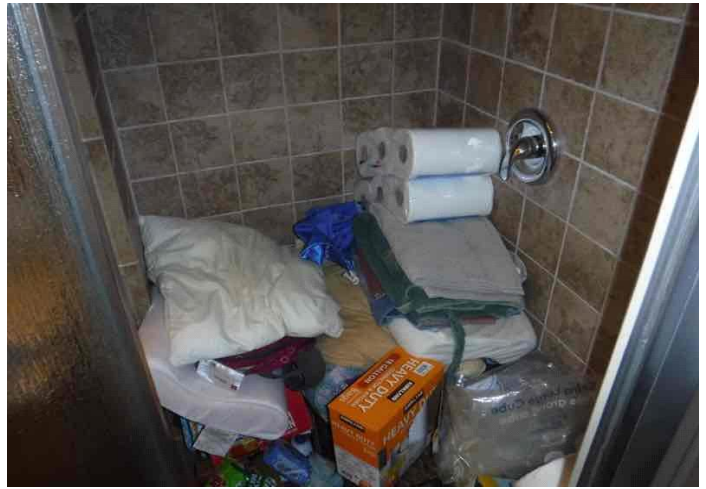
Photo 44

Personal storage was blocking access to the interior of the guest unit hall bathroom. Therefore, the area is considered inaccessible and was not fully inspected. With access and a opportunity for complete inspection, conditions in need of attention may be discovered. The personal belongings should be removed so the area may be examined. (See Photo 44)

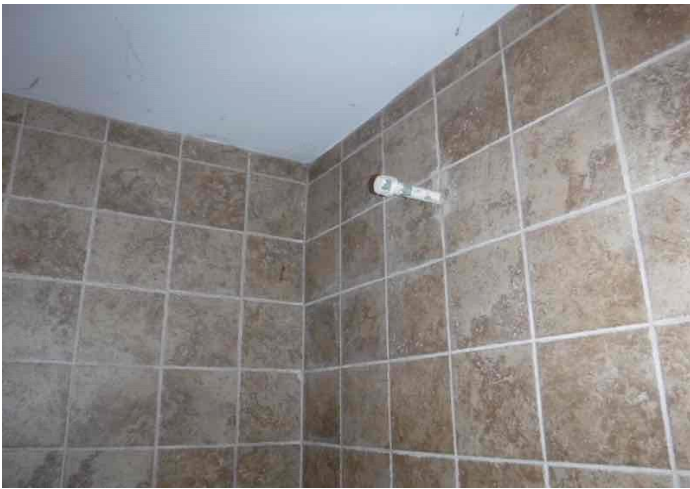
Photo 45

25. The shower head at the guest unit hall bathroom is missing. We recommend it be replaced. (See Photo 45)
  26. The seam for the floor at the base of the tub/shower at the hall bathroom is lifted or open. We recommend that the floor be sealed to avoid water penetration.

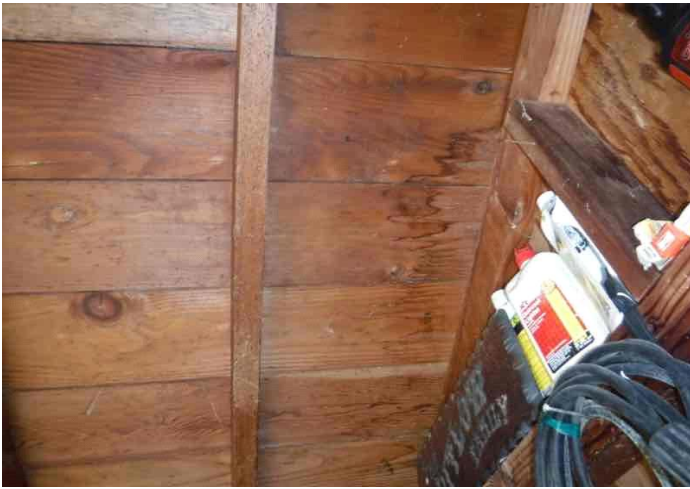
Photo 49

- ! 3. The ceilings at the exterior front and rear exterior guest unit closet show evidence of water stains. It is recommended that the source of these stains be identified and corrected and the surfaces be refinished. (See Photo 6) (See Photo 49)

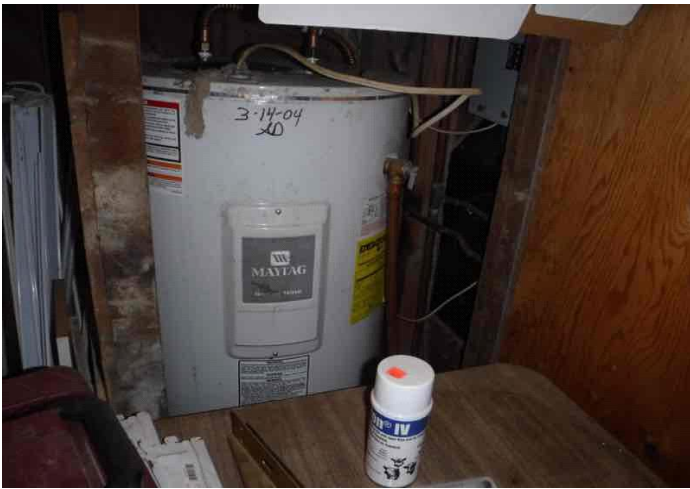
Photo 51

5. Straps should be secured to adjacent wall or stud and from opposing directions
  6. Straps should be secured to the wall or studs using 1/4" diameter by 3" long lag bolts with washers. (See Illustration 8E) (See Photo 51)

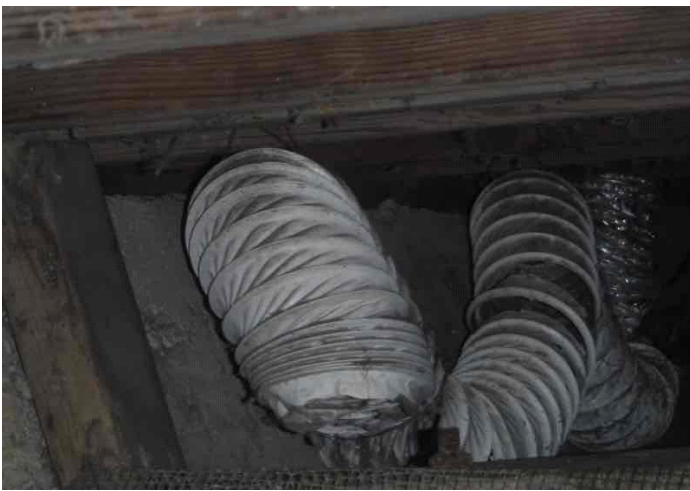
Photo 57

- ! 1. The clothes dryer is venting to the crawl space. We recommend the vent exhaust to the building exterior. Typical standards for dryer vents require a four inch, smooth wall duct, no longer than fourteen feet, with a hooded damper at the termination. A flexible vent six feet maximum may be used at the dryer connection but cannot pass through floors or walls. (See Photo 57)
