202 - 220 S. State Street

Appendices

Appendix C: Building Preservation Plans (BPP)

220 South State Street
Chicago, Illinois, IL0315ZZ

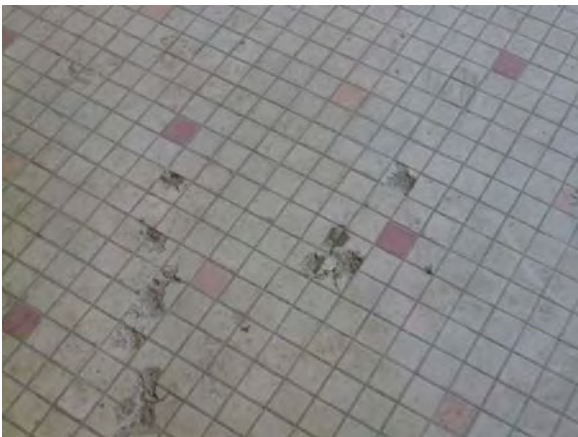
Image 65: Mosaic tile in main entry lobby.

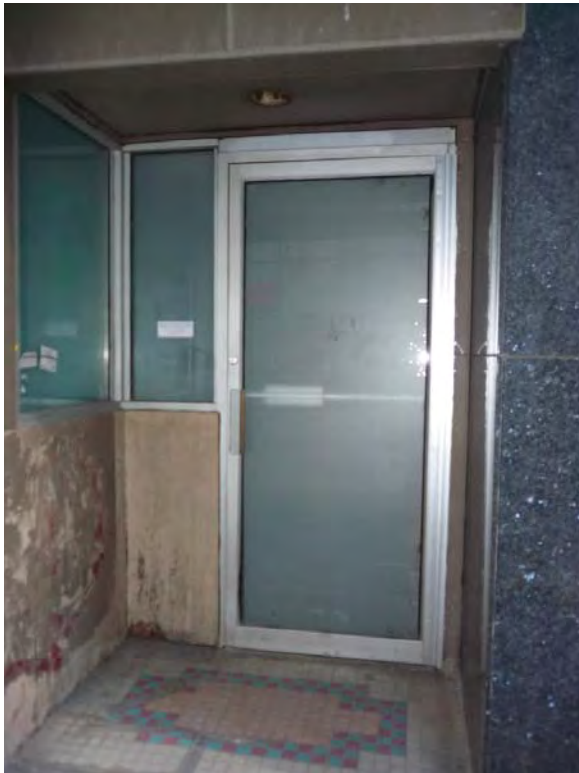
Image 77: Northwest entry, post-1951 door, tile, and cladding.

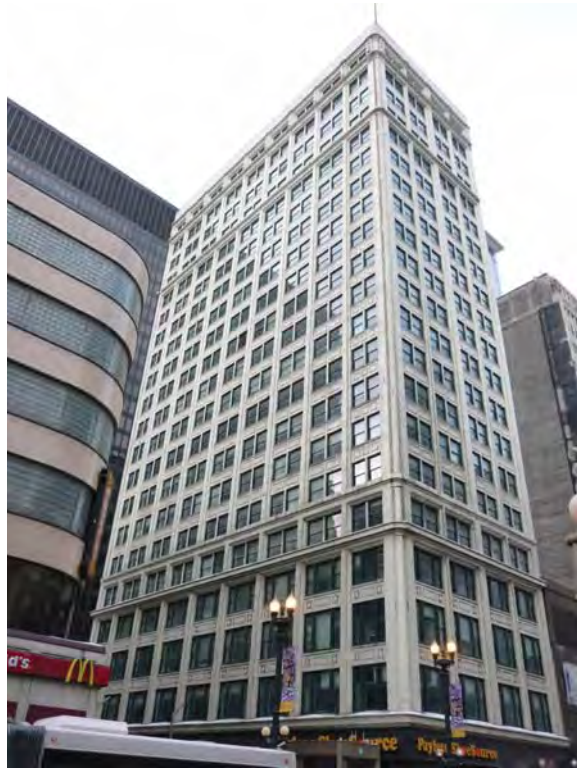
Image 24: South façade.

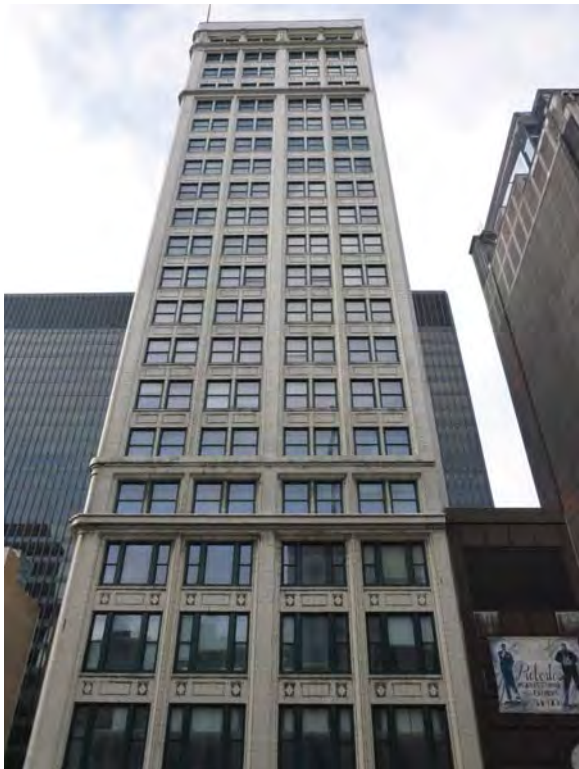
Image 25: East façade.

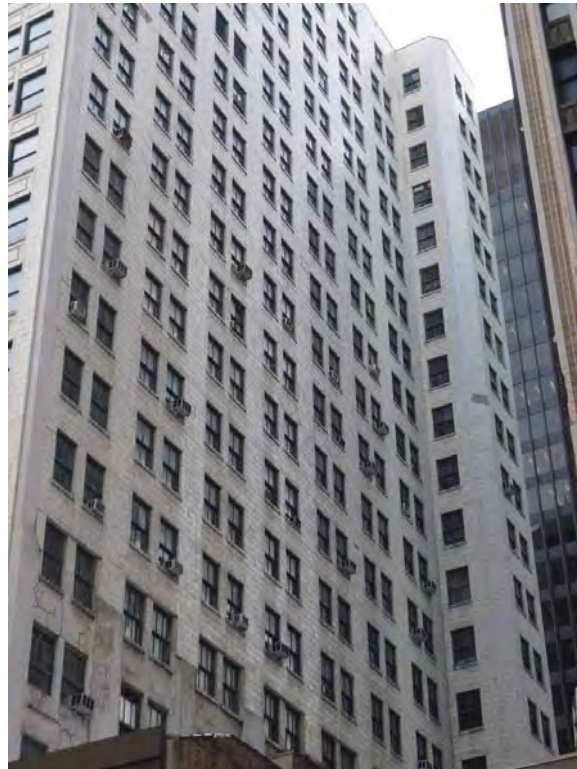
Image 26: North façade.

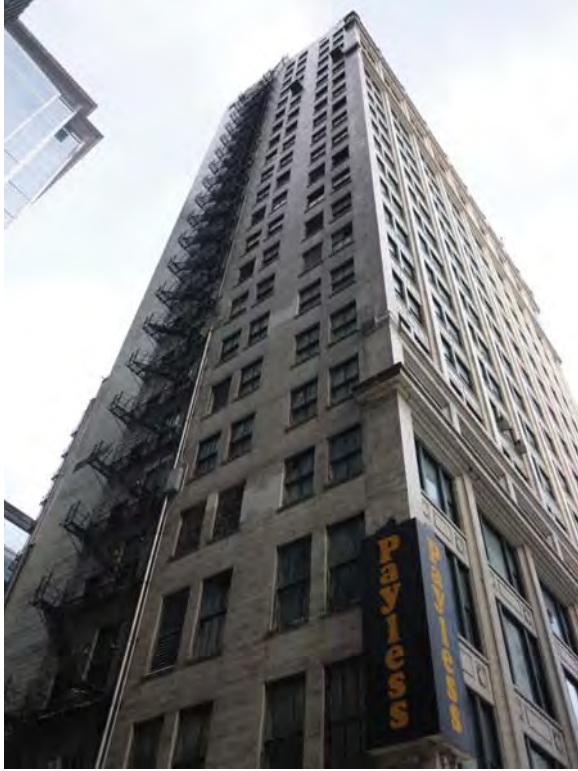
Image 27: West façade.

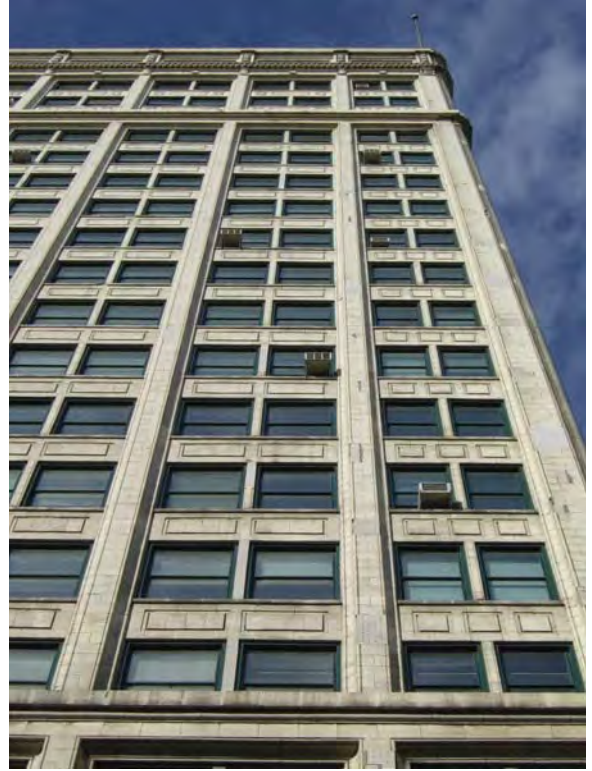
Image 28: Typical windows, floors 4 through 21, east and south façades.

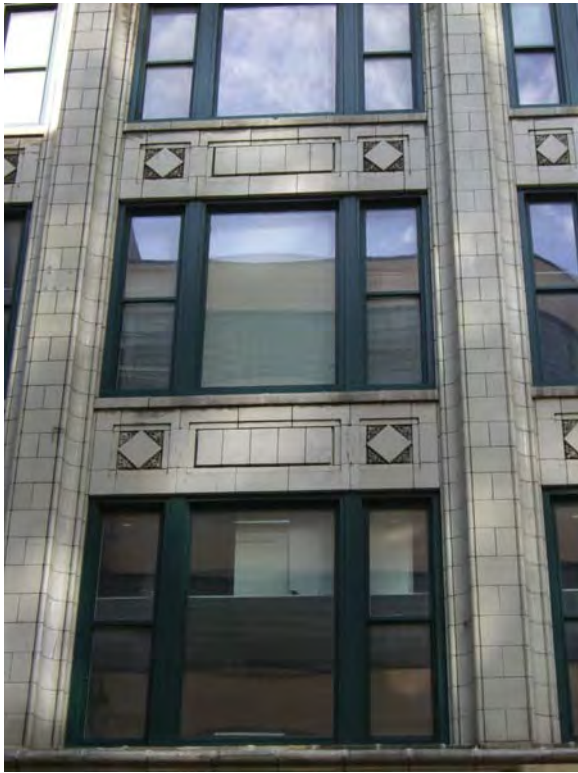
Image 29: Typical Chicago windows floors 2 through 4, east and south façades.

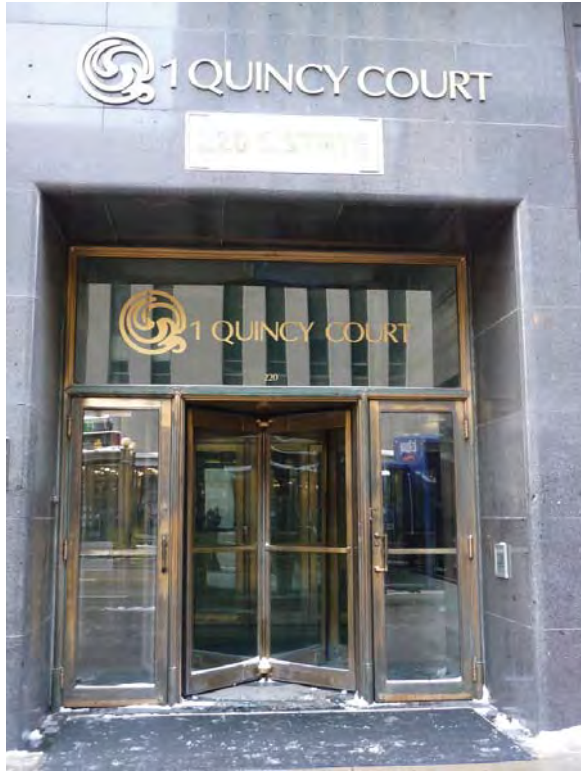
Image 31: Main entry, east façade.

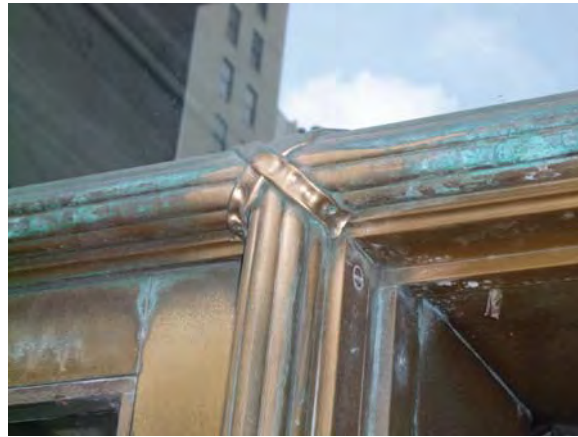
Image 32: Detail of original storefront frame.

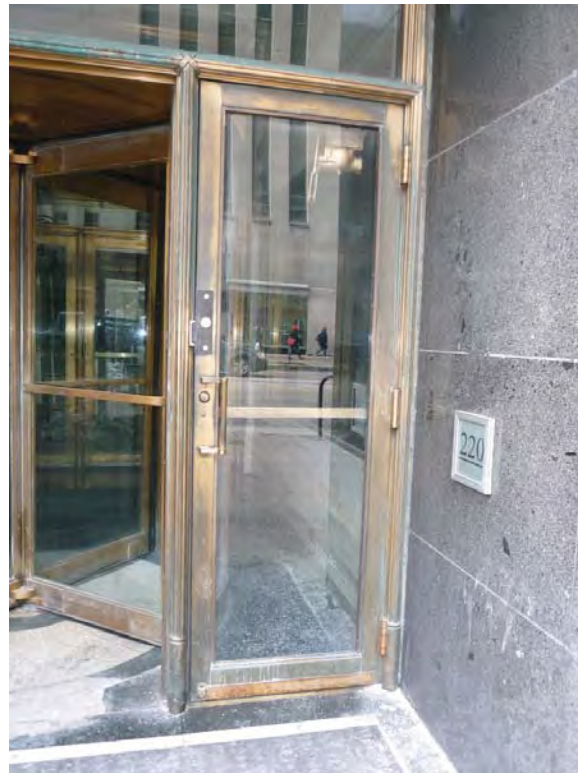
Image 34: Existing hinged door.

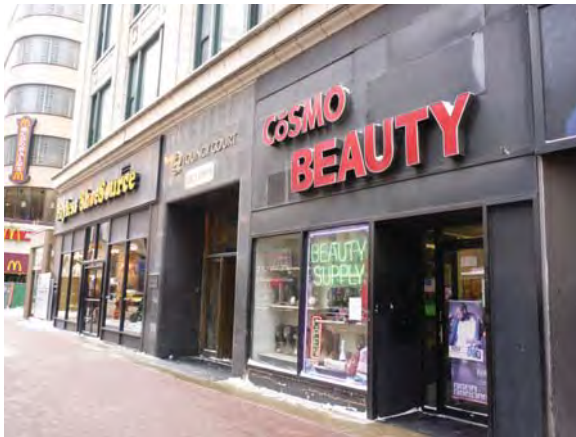
Image 35: Existing first floor façade.

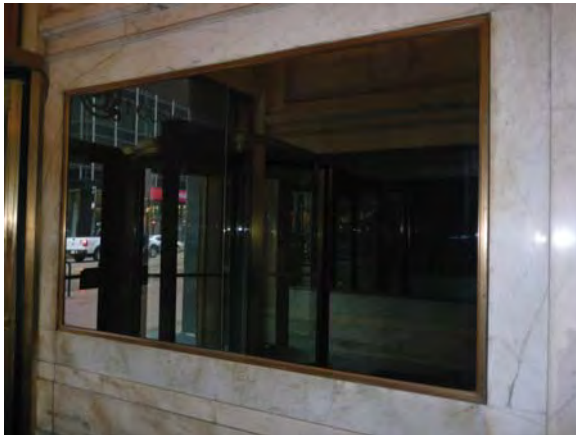
Image 37: Mirror within vestibule.

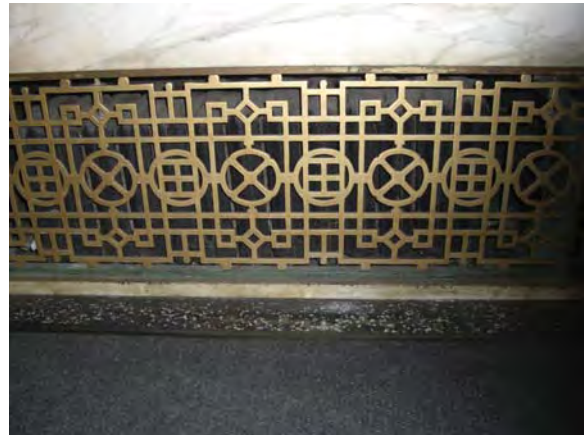
Image 38: Decorative grillwork, main lobby.

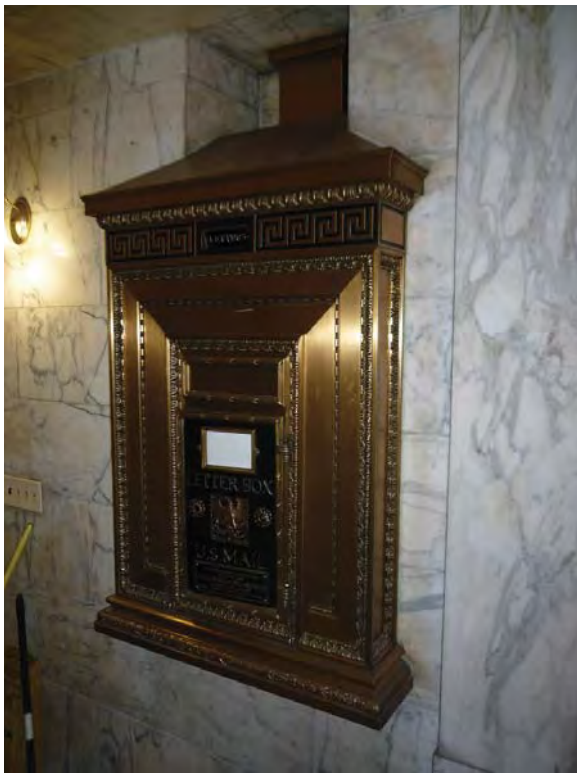
Image 41: Mailbox, in stairwell off of main lobby.

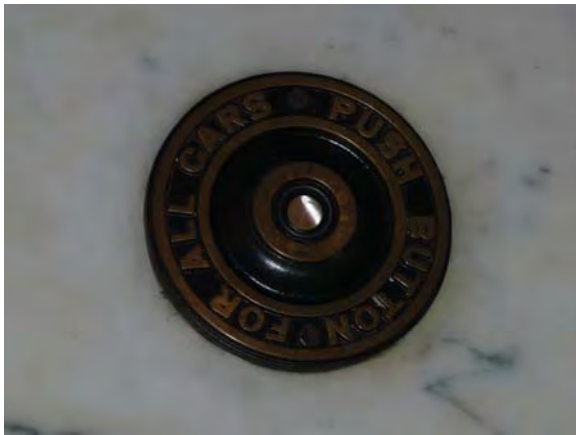
Image 43: Elevator call button, main lobby.

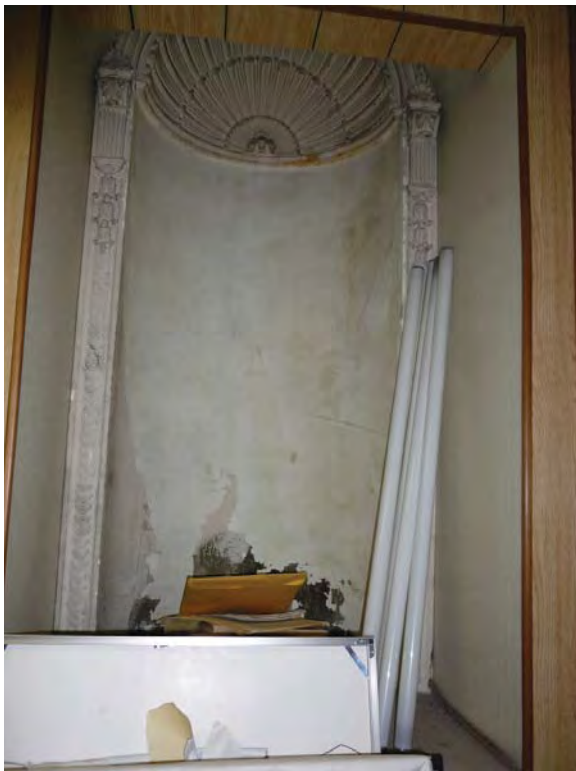
Image 53: 1st basement, statue niche.

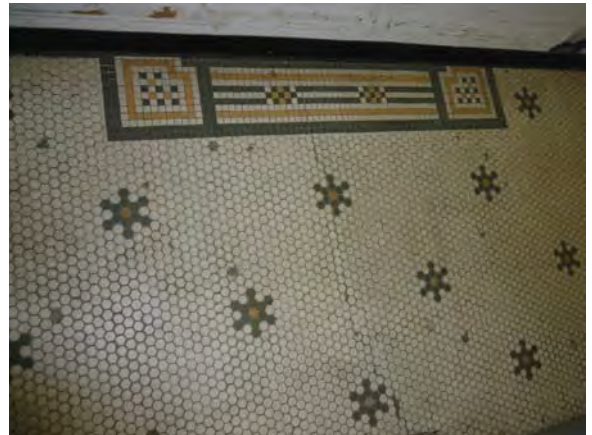
Image 54: 1st basement, mosaic tile floor.

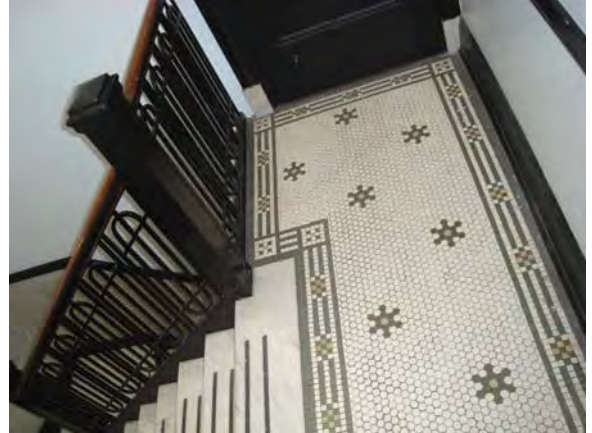
Image 59: East stair, cast iron balustrades and wood railing.

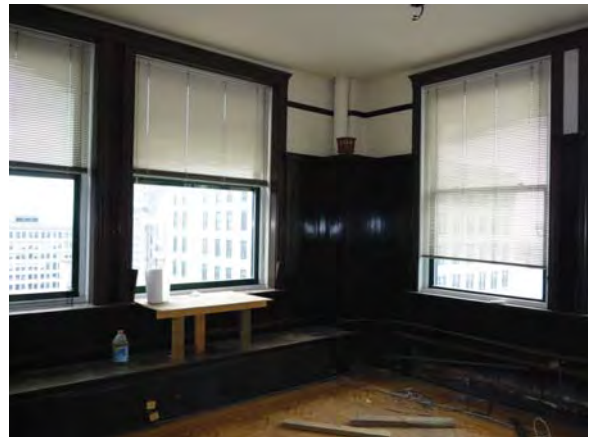
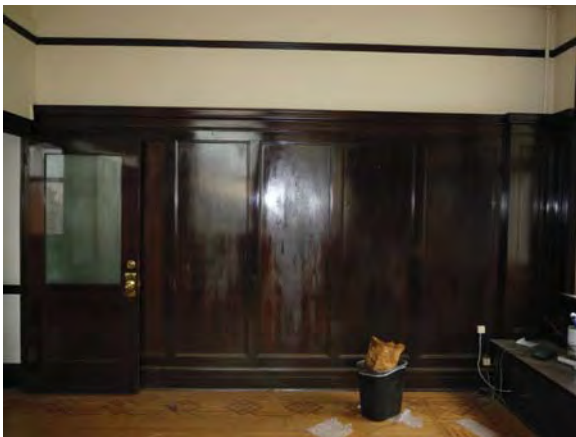
Image 67: 20th floor, southeast office suite.

Image 68: 20th floor, southeast office suite.

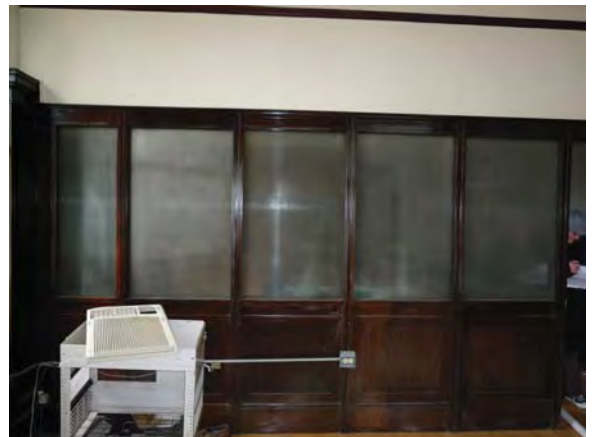
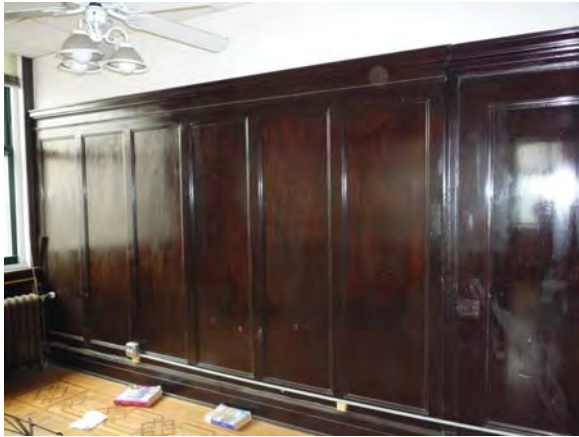
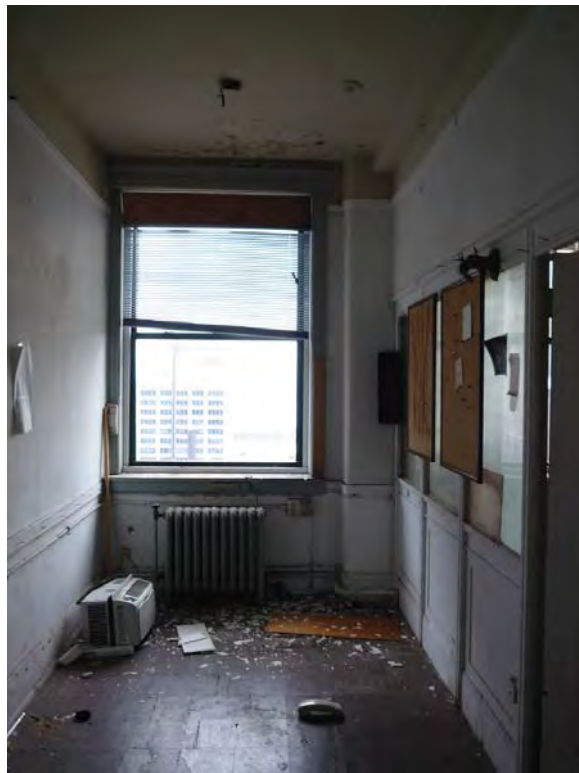
Image 69: 20th floor, southeast office suite,
partition wall.

Image 70: 20th floor, southeast office suite,
partition wall.

Image 71: 20th floor, southeast office suite, partition wall.

Image 73: 20th floor, southeast office suite, partition wall.

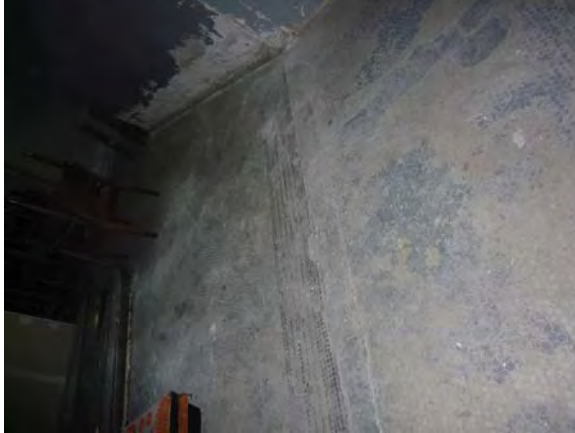
Image 103: Mosaic tile floor, first basement.

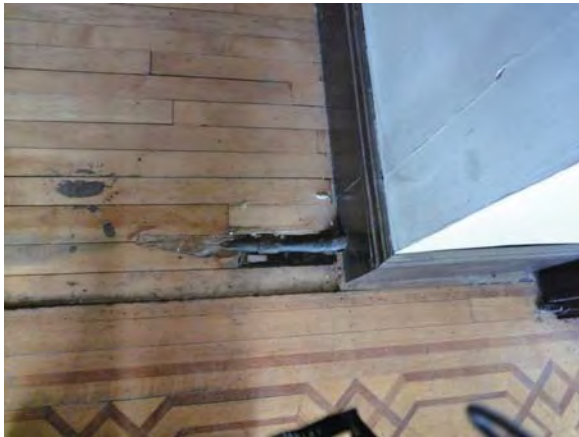
Image 111: Rare inlaid floor condition, 20th floor, southeast suite.
