# *Evolve Property Inspections*

1011 Euclid Ave, Miami Beach, FL 33139  
Inspection prepared for: Jason Saint  
Real Estate Agent: -

Date of Inspection: 10/13/2023 Time: 10:30 AM  
Age of Home: 1959 Size: 0  
Weather: sunny  
unit 1

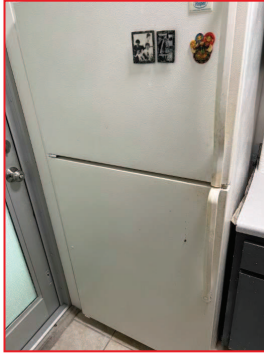
Refrigerator Observation

- The Refrigerator appears to be an older unit, and may have reached the end of its useful life. We make no guarantee, warranty or estimate of how long the unit will continue to function to its full capacity.

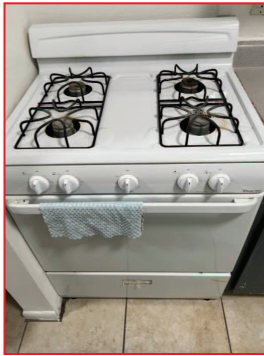
Oven and Range Observation

- **DEFERRED COST:** The oven and range appears to be an older unit, and may have reached the end of its useful life. We make no guarantee, warranty or estimate of how long the unit will continue to function to its full capacity.

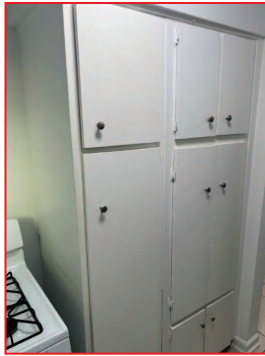
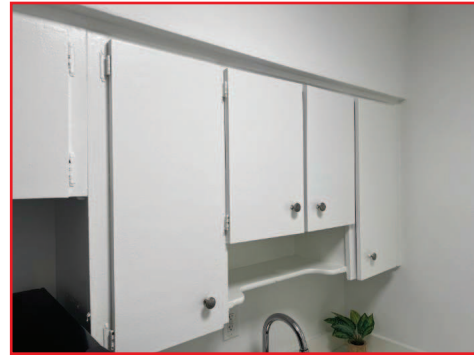
Cabinets Overview

- DEFERRED COST: The cabinets are older. Consider upgrade.

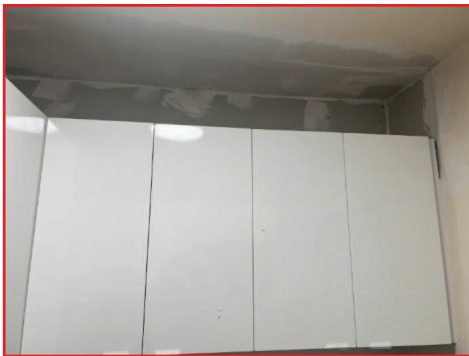
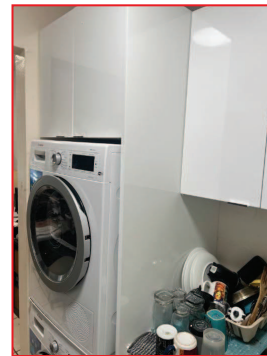
Cabinets Overview

- No deficiencies observed.

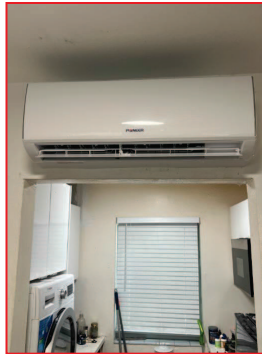
Air Handler

- No deficiencies noted at time of inspection.

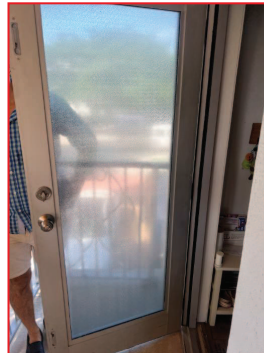
- No deficiencies observed.

Entry Door impact

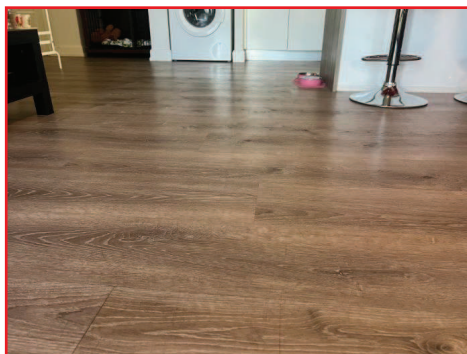
Laminated Wood Flooring

- No deficiencies observed.

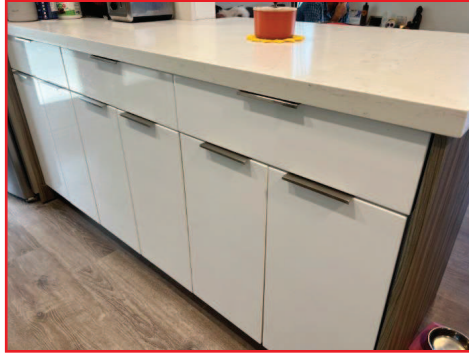
Counters Overview

- No major system safety or function concerns noted at time of inspection.

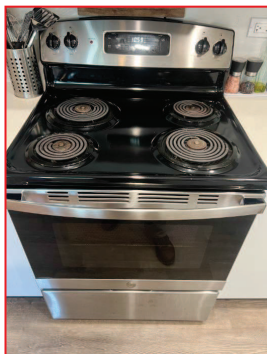
Oven and Range Observation

- **DEFERRED COST:** The oven and range appears to be an older unit, and may have reached the end of its useful life. We make no guarantee, warranty or estimate of how long the unit will continue to function to its full capacity.

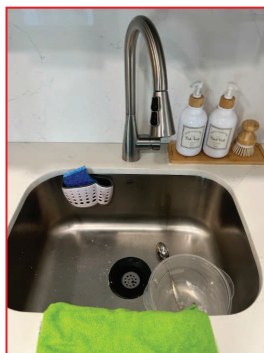
Sink Observation

- No deficiencies observed.

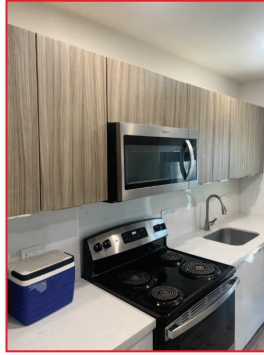
Counters Overview

- No major system safety or function concerns noted at time of inspection.

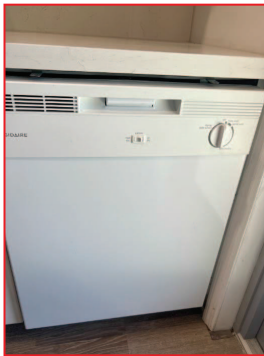
Dishwasher Observation

- No discrepancies noted at time of inspection.

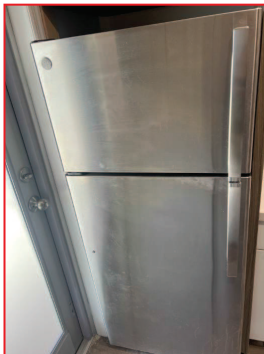
Refrigerator Observation

- No discrepancies noted at time of inspection.

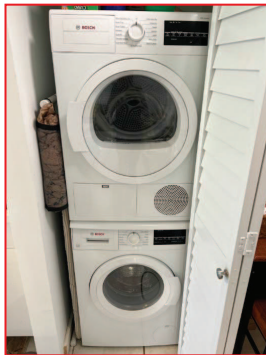
Washer and Dryer Observation

- No deficiency noted at time of inspection.

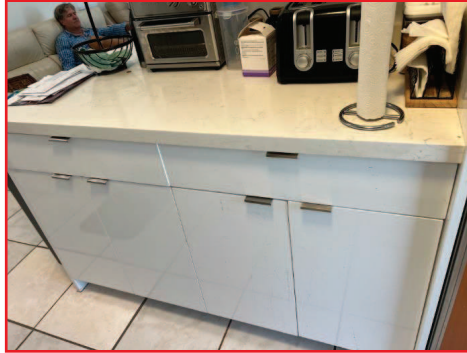
Counters Overview

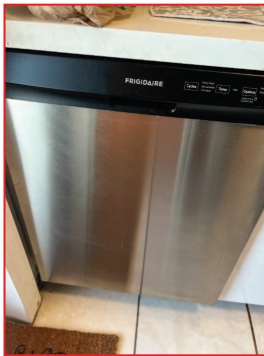
- No discrepancies noted at time of inspection.

Dishwasher Observation

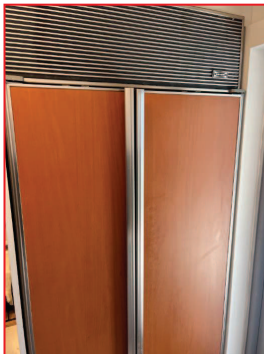
- No discrepancies noted at time of inspection.

Refrigerator Observation

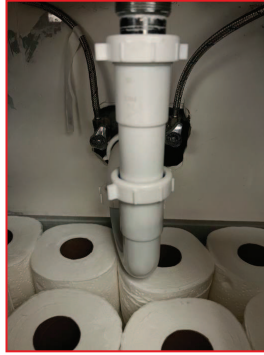
- No major system safety or function concerns noted at time of inspection.

Under Master Bathroom Sink

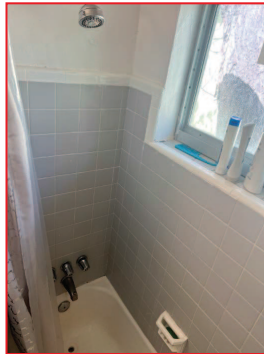
- No deficiencies noted at time of inspection

Bathtub view

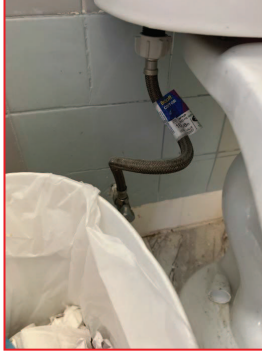
- No major system safety or function concerns noted at time of inspection.

Toilet Valve

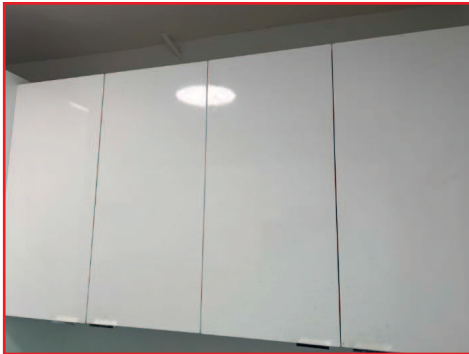
- No deficiencies observed.

Cabinets Overview

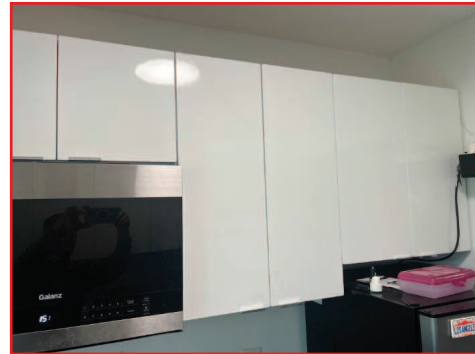
Cabinets Overview
